CRASH TESTING AND EVALUATION OF THE TXDOT SHORT-SPAN SHORT-RADIUS GUARDRAIL SYSTEM

Test Report 9-1002-15-9

1. Report No. FHWA/TX-17/9-1002-15-9		2. Government Accession No.		3. Recipient's Catalog No.	
4. Title and Subtitle CRASH TESTING AND EVALUATION OF THE TXDOT SHORT-SPAN SHORT-RADIUS GUARDRAIL SYSTEM				5. Report Date Published: January 2018

16. Abstract <p>This research evaluated the impact performance of the TxDOT short-span short-radius guardrail system according to the safety-performance evaluation guidelines included in American Association of State Highway and Transportation Officials, entitled <i>Manual for Assessing Safety Hardware (MASH)</i> for Test Level Three (TL-3).</p> <p>This report describes the TxDOT short-span short-radius guardrail system, documents the impact performance of the guardrail system according to <i>MASH</i> TL-3 evaluation criteria, and presents recommendations for implementation.</p> <p>The short-span short-radius guardrail system performed acceptably according to <i>MASH</i> for modified tests 3-33 and 3-32.</p>

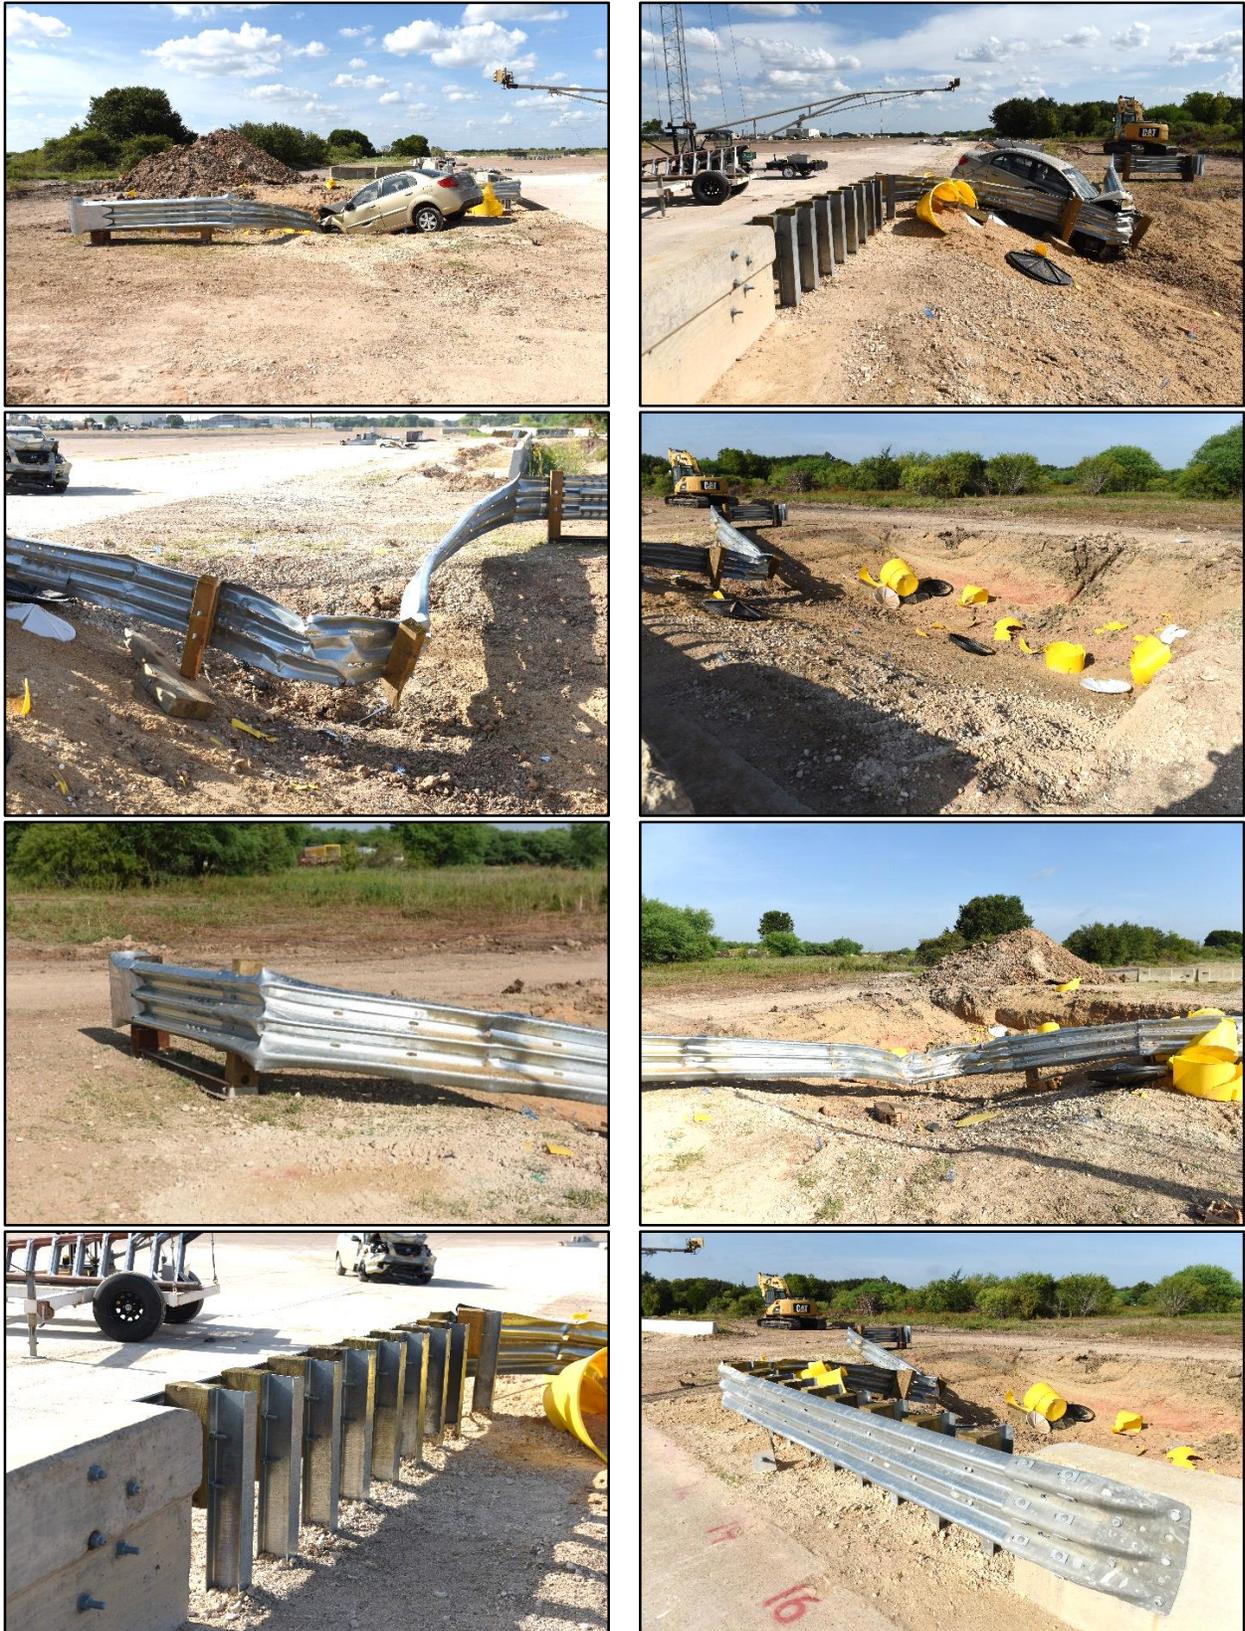
Figure 7.3. TxDOT Short-Span Short-Radius Guardrail System after Test No. 490026-3-2.

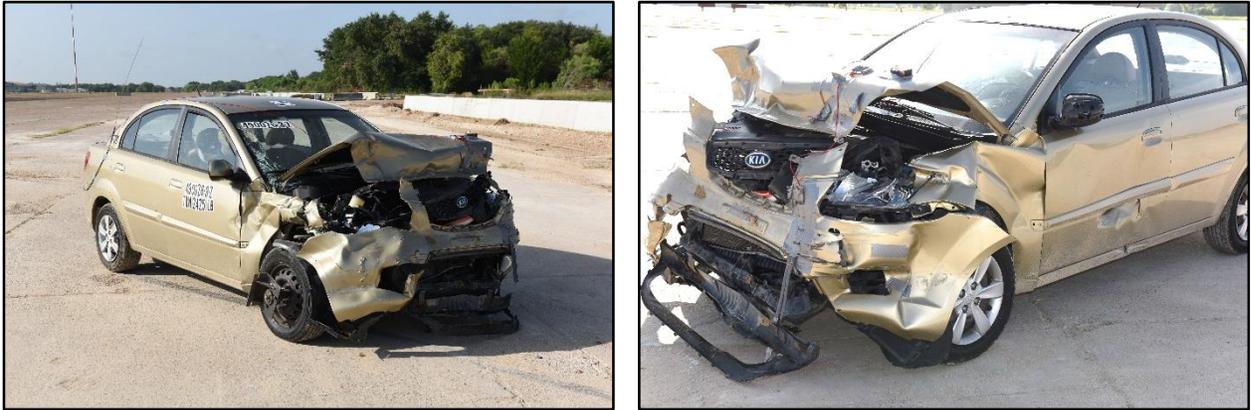
Figure 7.4. Test Vehicle after Test No. 490026-3-2.

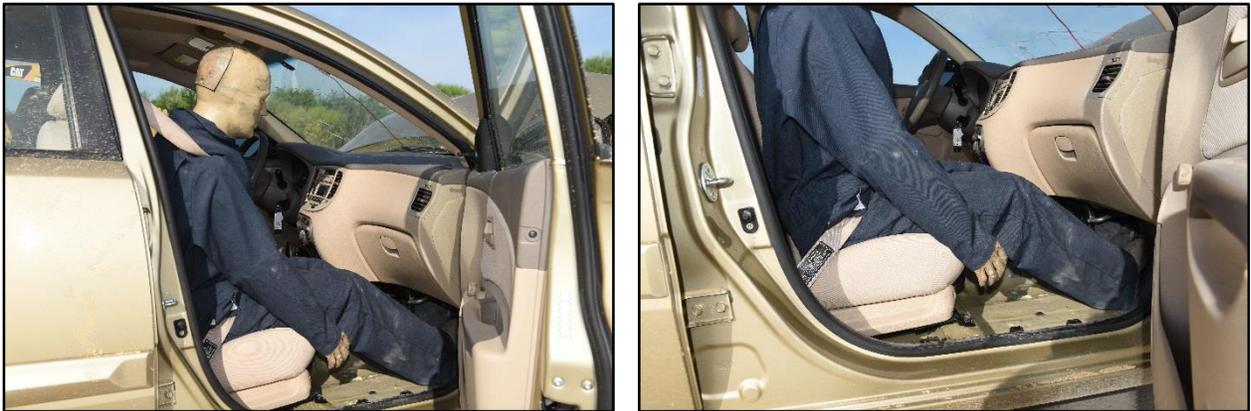
Figure 7.5. Interior of Vehicle after Test No. 490026-3-2.

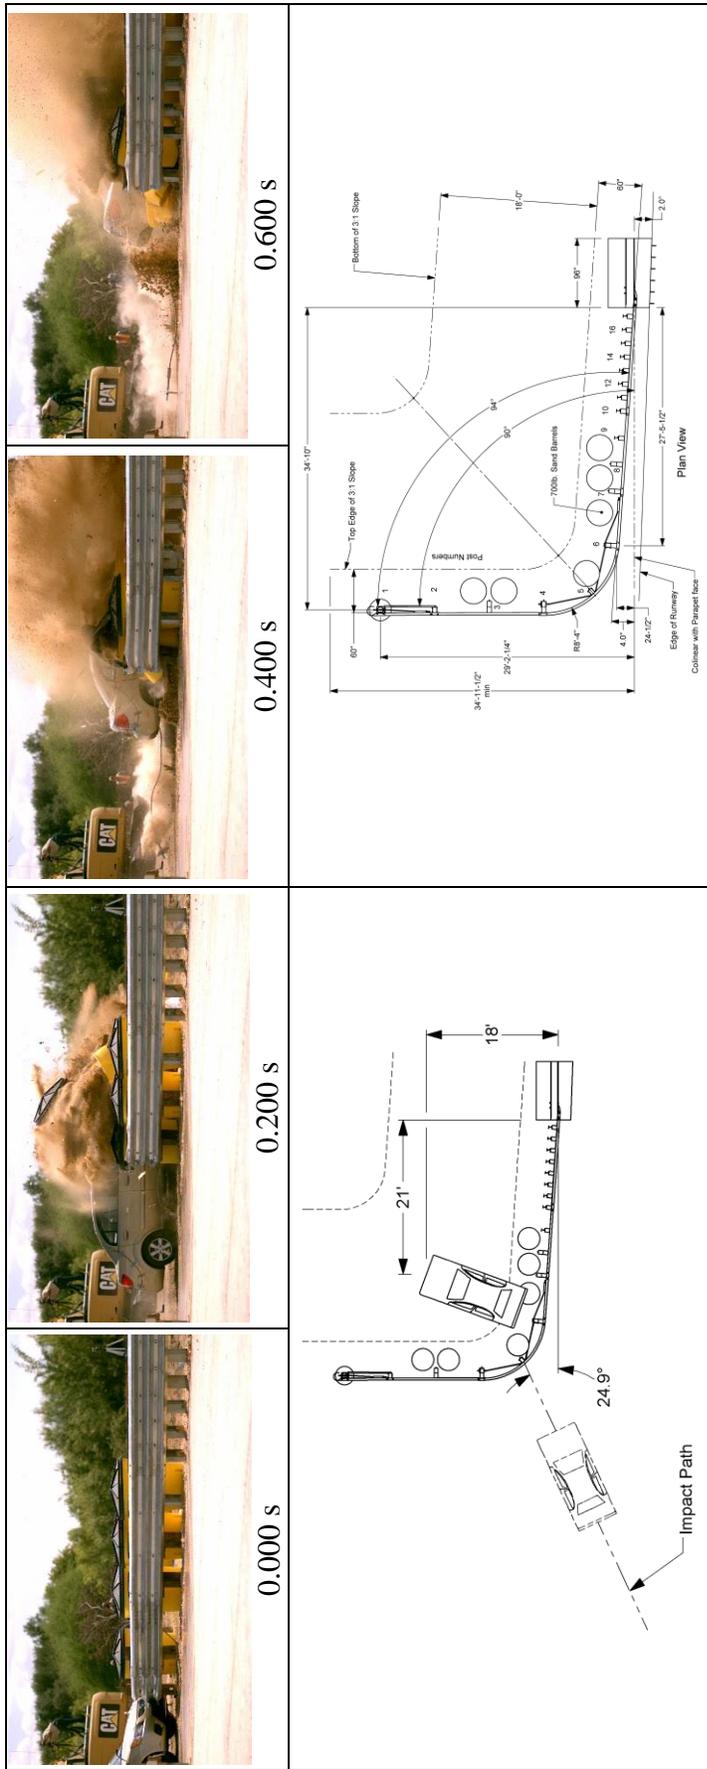
General Information	Texas A&M Transportation Institute (TTI)
Test Agency	Modified MASH Test 3-32
Test Standard	490026-3-2
TTI Test No.	2016-08-11
Test Date	
Test Article	Short-Radius Terminal
Type	Short-Span Short-Radius Guardrail
Name	42.8 ft x 29.2 ft
Installation Length	31-inch tall, 58-ft-10-inch long three-beam short-radius guardrail
Material or Key Elements	AASHTO M147-65(2004), grading B Soil (crushed limestone), dry
Soil Type and Condition	
Soil Type	
Condition	
Test Vehicle	
Type/Designation	1100C
Make and Model	2011 Kia Rio
Curb	2474 lb
Test Inertial	2453 lb
Dummy	165 lb
Gross Static	2618 lb

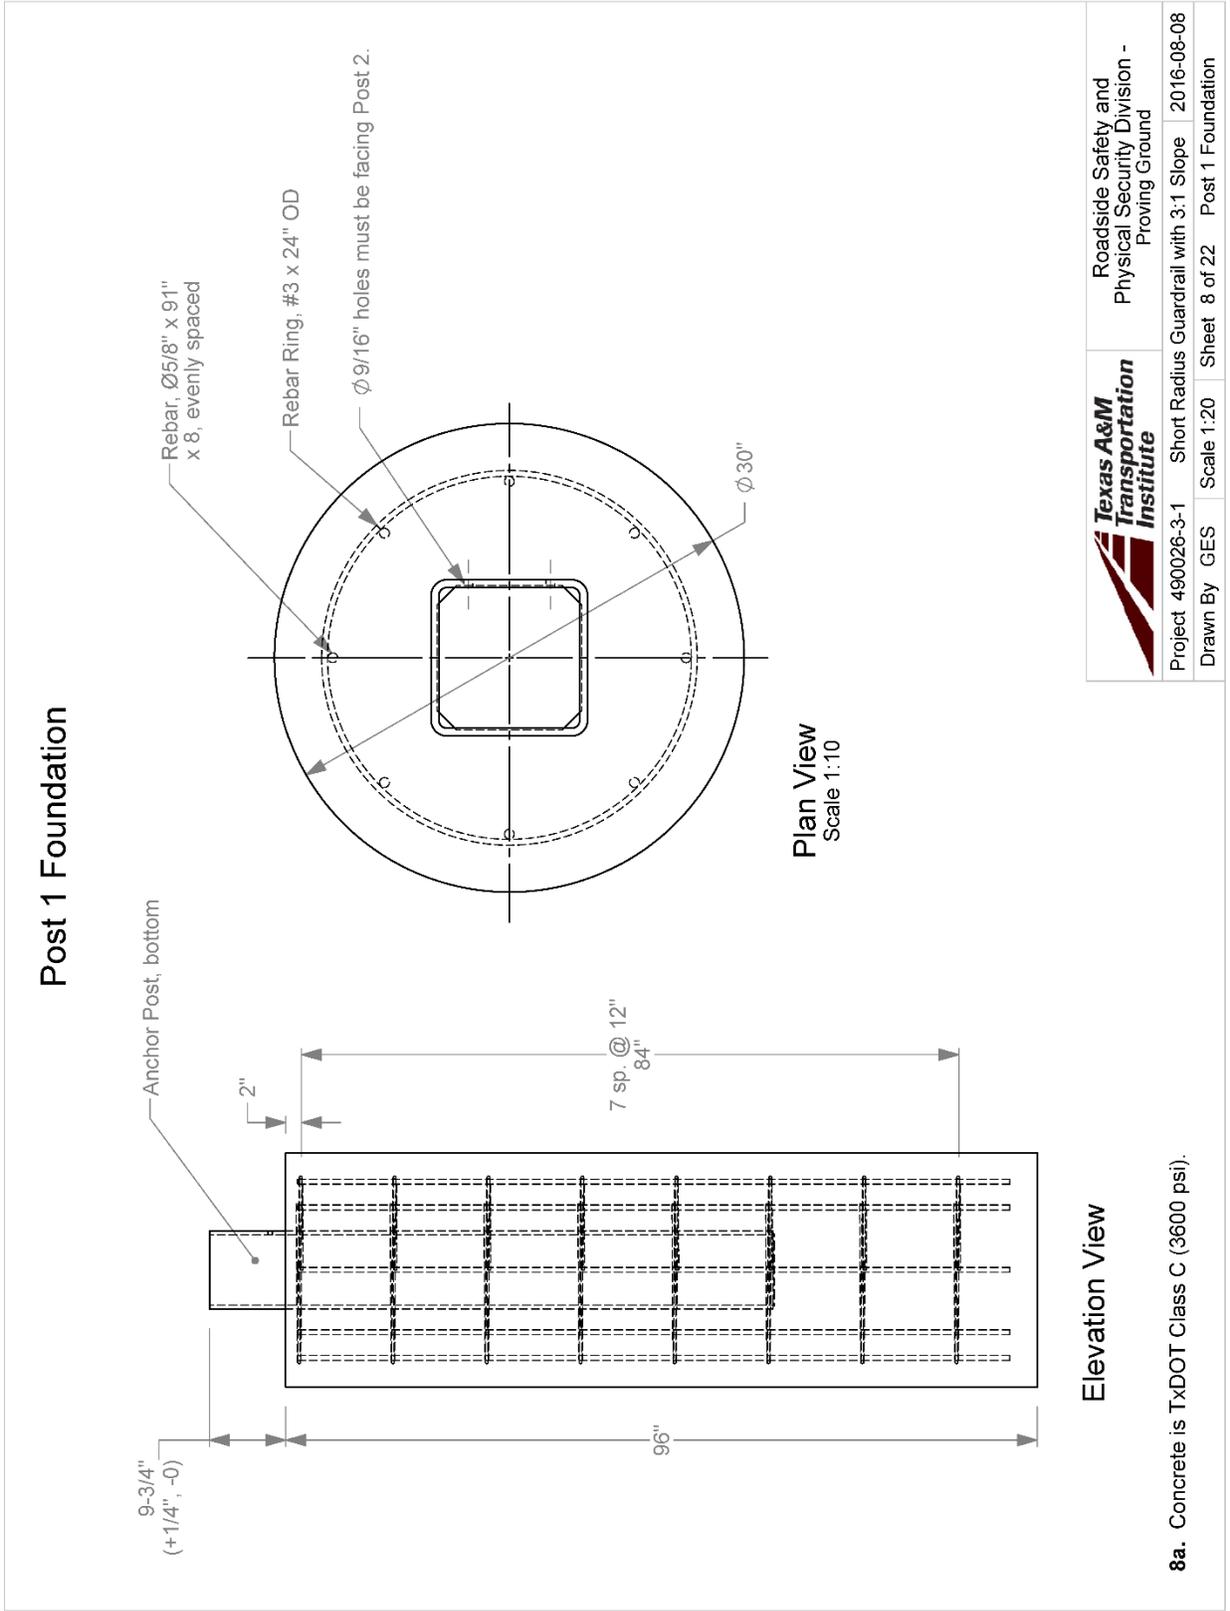
Roadside Safety and Physical Security Division - Proving Ground	
	Project 490026-3-1	Short Radius Guardrail with 3:1 Slope
Drawn By GES	Scale 1:20	Sheet 8 of 22
		Post 1 Foundation

8a. Concrete is TxDOT Class C (3600 psi).

[HSS] 10×10×½-inch wall A500 Grade B) embedded in a concrete foundation. The post was 80 inches tall with a 10-inch × 10-inch × ½-inch thick ASTM A36 square support collar welded to it at 2¼ inches below the top. The post was inserted into the 72-inch long square tube, and its support collar rested on top of the square tube, which was 9¼ inches above grade. Thus, the top of the post was 31½ inches above grade. The square tube was void of concrete and included a 9¼-inch square plate on the bottom. See Appendix B, Sheets 8, 15, and 16 for post 1 details.

Post 1's square tube socket was embedded 6¼ inches deep into a 96-inch deep × 30-inch diameter steel reinforced concrete foundation. The foundation contained a concentric 24-inch diameter reinforcing bar cage. The rebar cage was fabricated using eight 24-inch diameter #3 (¾-inch) rings vertically spaced at 12 inches, and eight 91-inch long #5 (5/8-inch) vertical bars. The vertical bars were equally spaced circumferentially inside the rings. Concrete cover over rebar at the top of the foundation was 2 inches, and the top of the foundation was at grade level. See Attachment B, Sheet 8 of 22 for details.

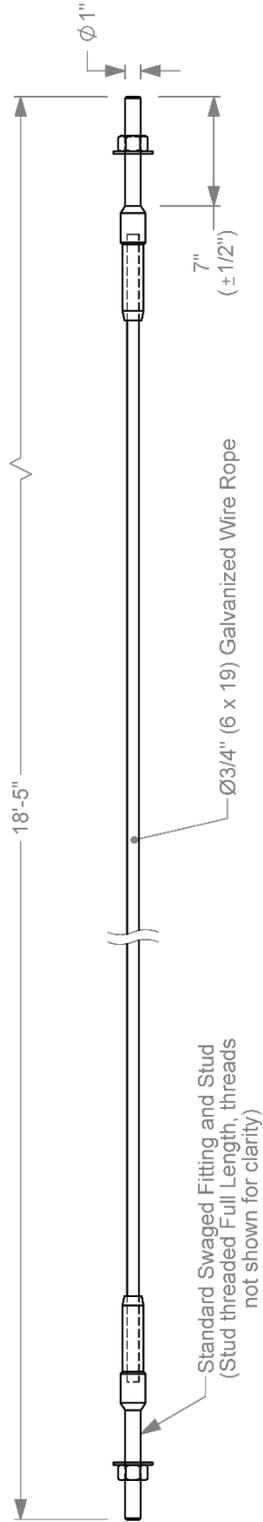
Anchor Cable for Short Radius Rail

22a. The Stud shall conform to the requirements of ASTM A449 and shall be galvanized in accordance with ASTM A153. The threads shall have a Class 2A fit before galvanizing.

An anchor cable attached at post 4, wove around post 5 on the traffic side and around post 6 on the field side using the anchor cable U-shaped bearing saddles installed near grade on the foundation tubes, and terminated on the thrie-beam near post 7. The $\frac{3}{4}$ -inch (6 \times 19; or IWRC; AASHTO M-30; 46 kips min.) galvanized wire rope measured 18 ft-5 inches end to end, inclusive of terminal fittings. Each termination consisted of a standard swaged fitting with a 1-inch diameter threaded stud, washer, and nut; the swage was specified to exceed the breaking strength of the wire rope. The post 4 weakening hole at grade contained a 2-inch schedule 40 (0.1535-inch wall thickness) BCT post sleeve (FMM02a) through which one terminal end of the anchor cable was secured via a 8-inch \times 8-inch \times $\frac{5}{8}$ -inch thick BCT bearing plate (FPB01), flat washer, and nut. The opposite end of the anchor cable was secured to the lower field side involute of the thrie-beam with a guardrail anchor bracket (FPA01). The swage stud nuts were tightened such that all slack was removed from the cable. See Appendix B, Sheets 4, 6, and 22 for details.

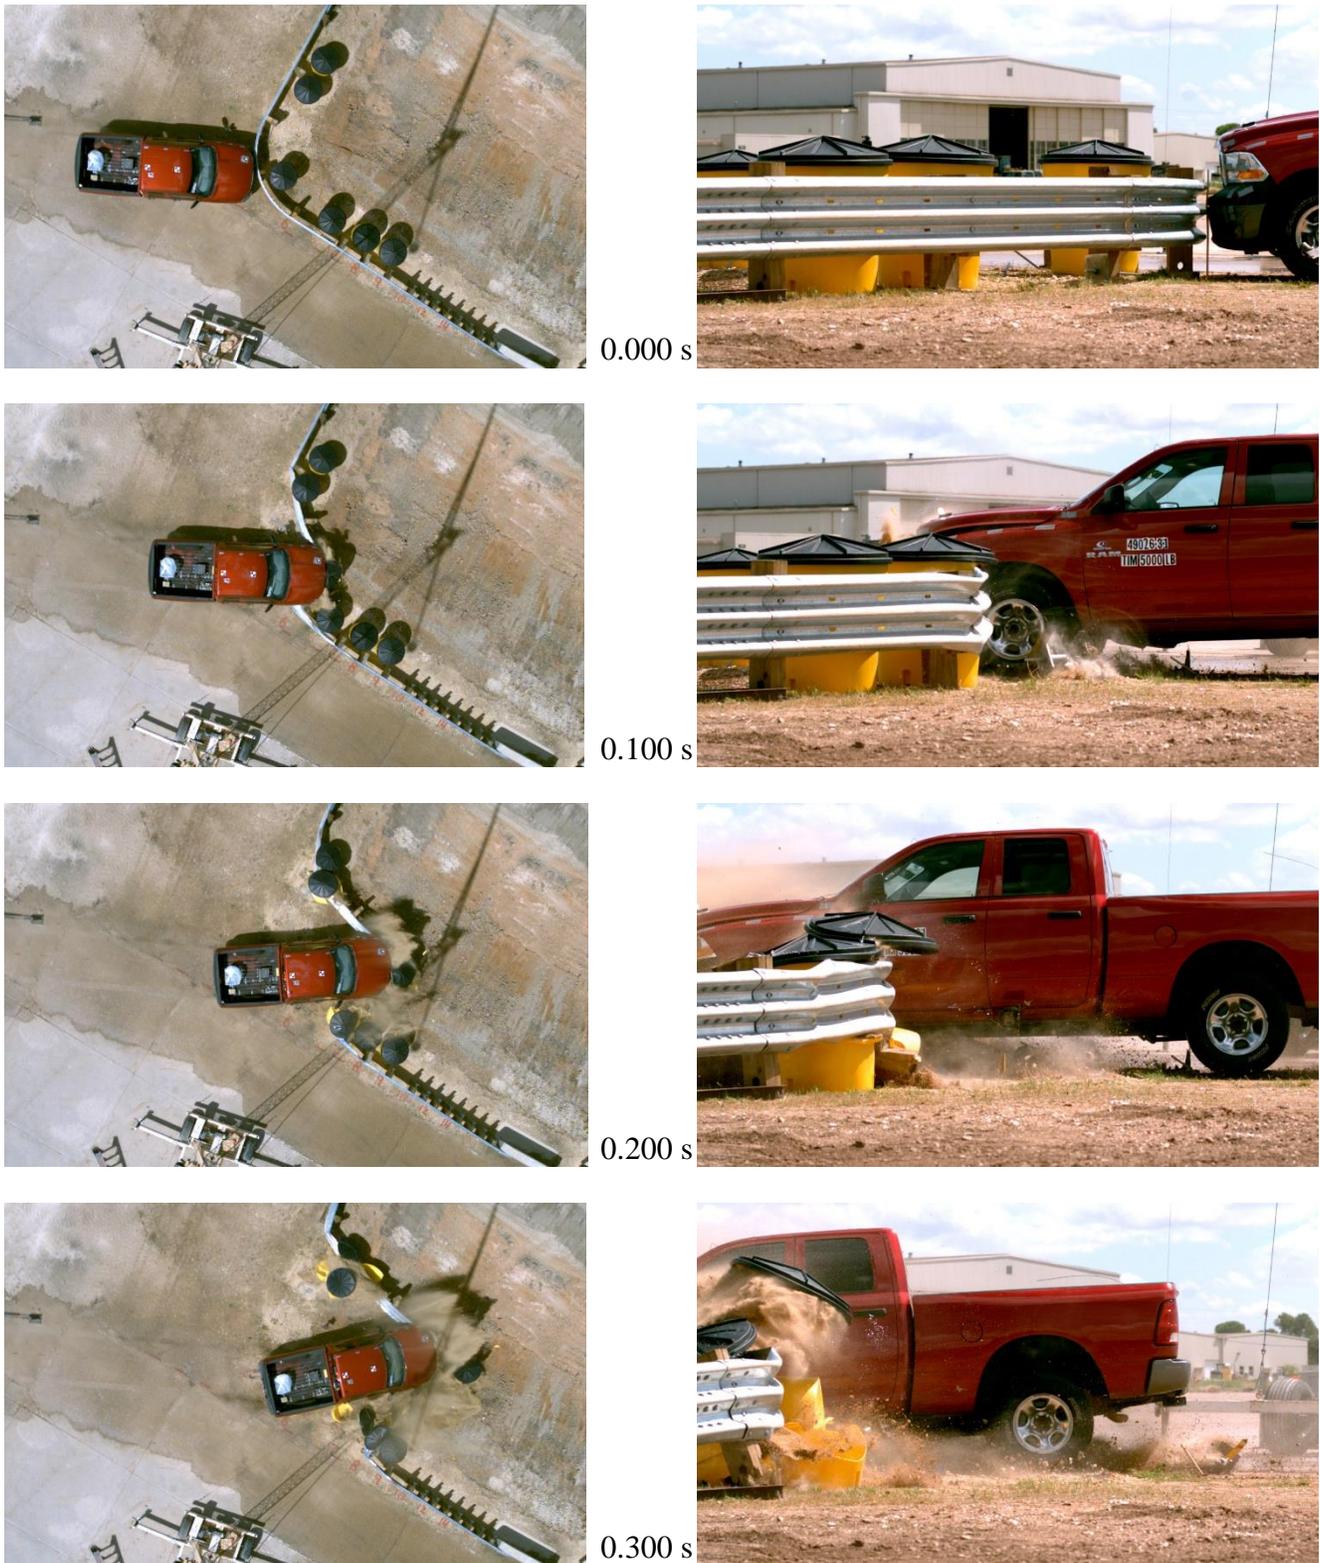
Figure D.1. Sequential Photographs for Test No. 490026-3-1 (Overhead and Perpendicular Views).

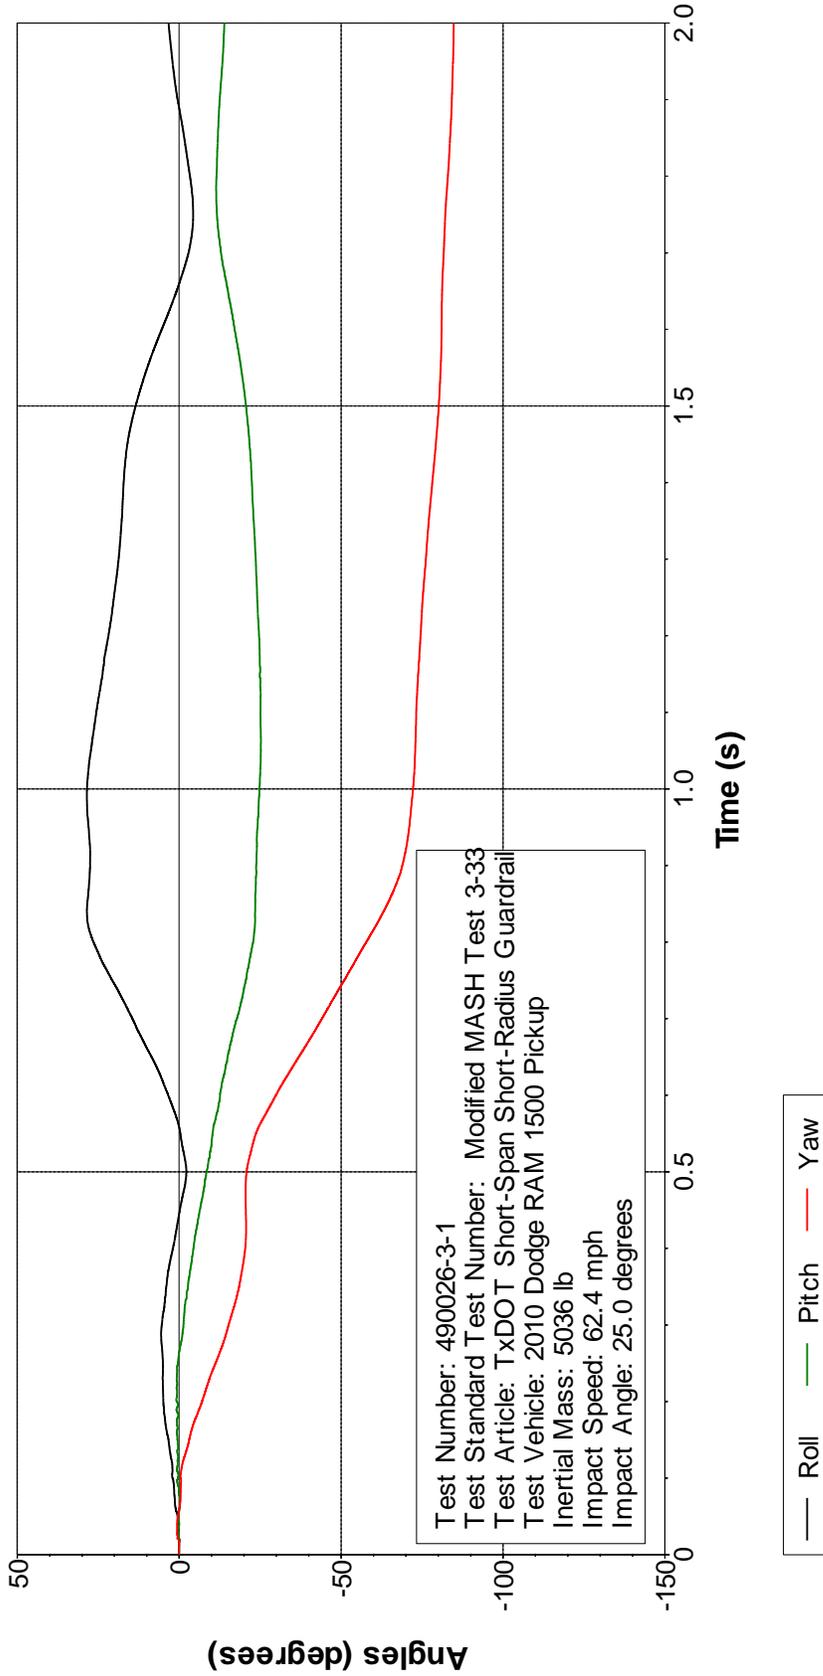
Figure D.3. Vehicle Angular Displacements for Test No. 490026-3-1.

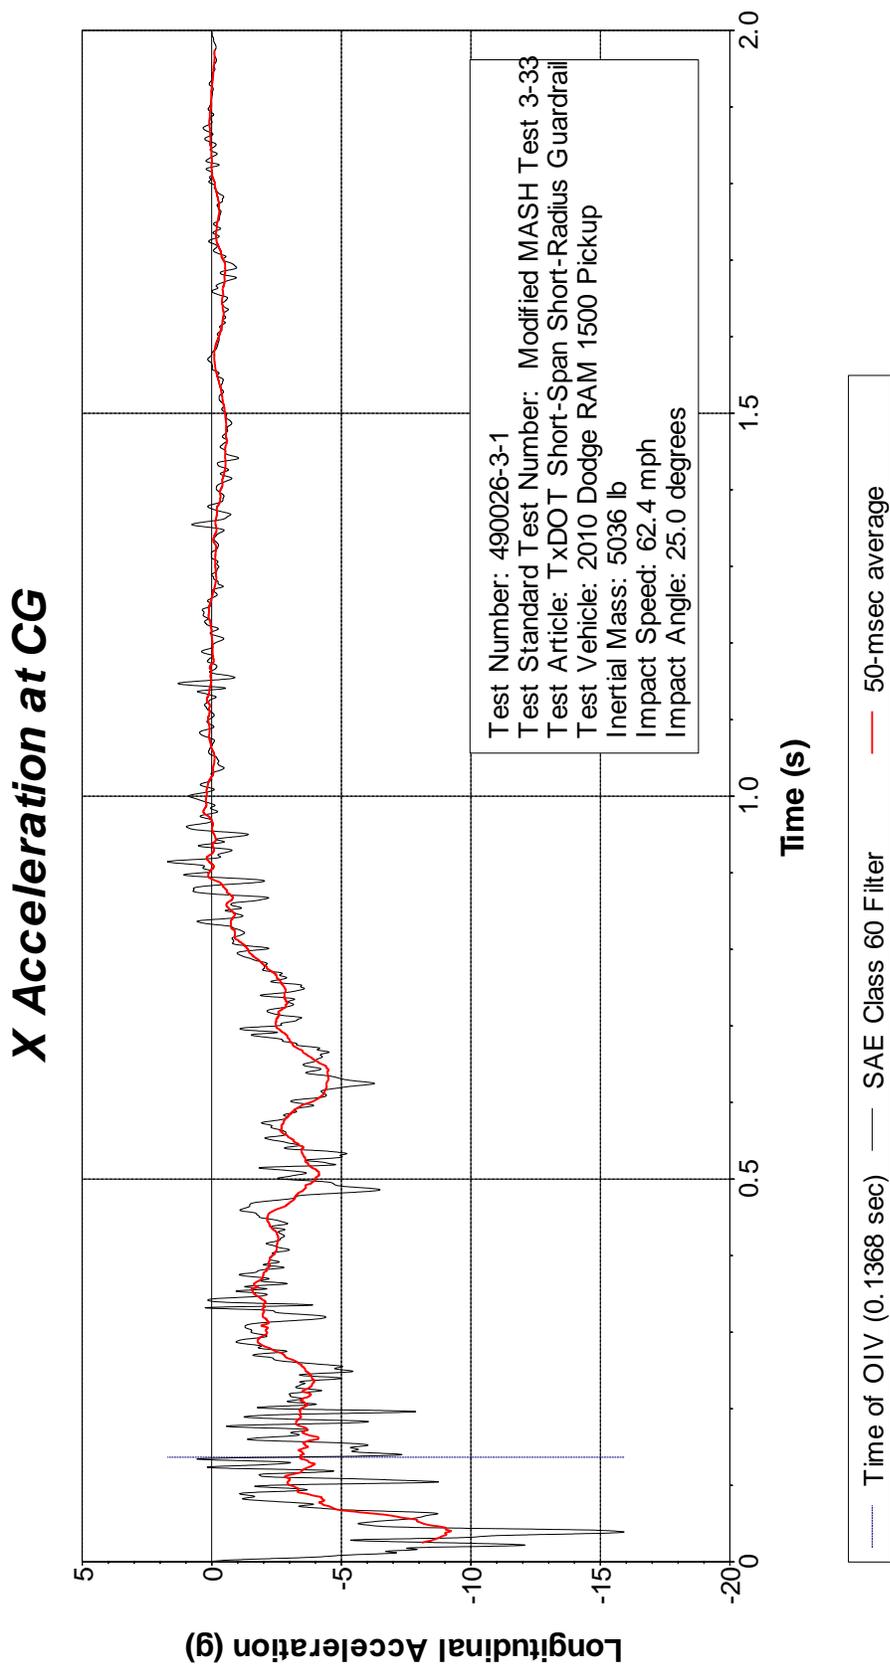
Figure D.4. Vehicle Longitudinal Accelerometer Trace for Test No. 490026-3-1 (Accelerometer Located at Center of Gravity).

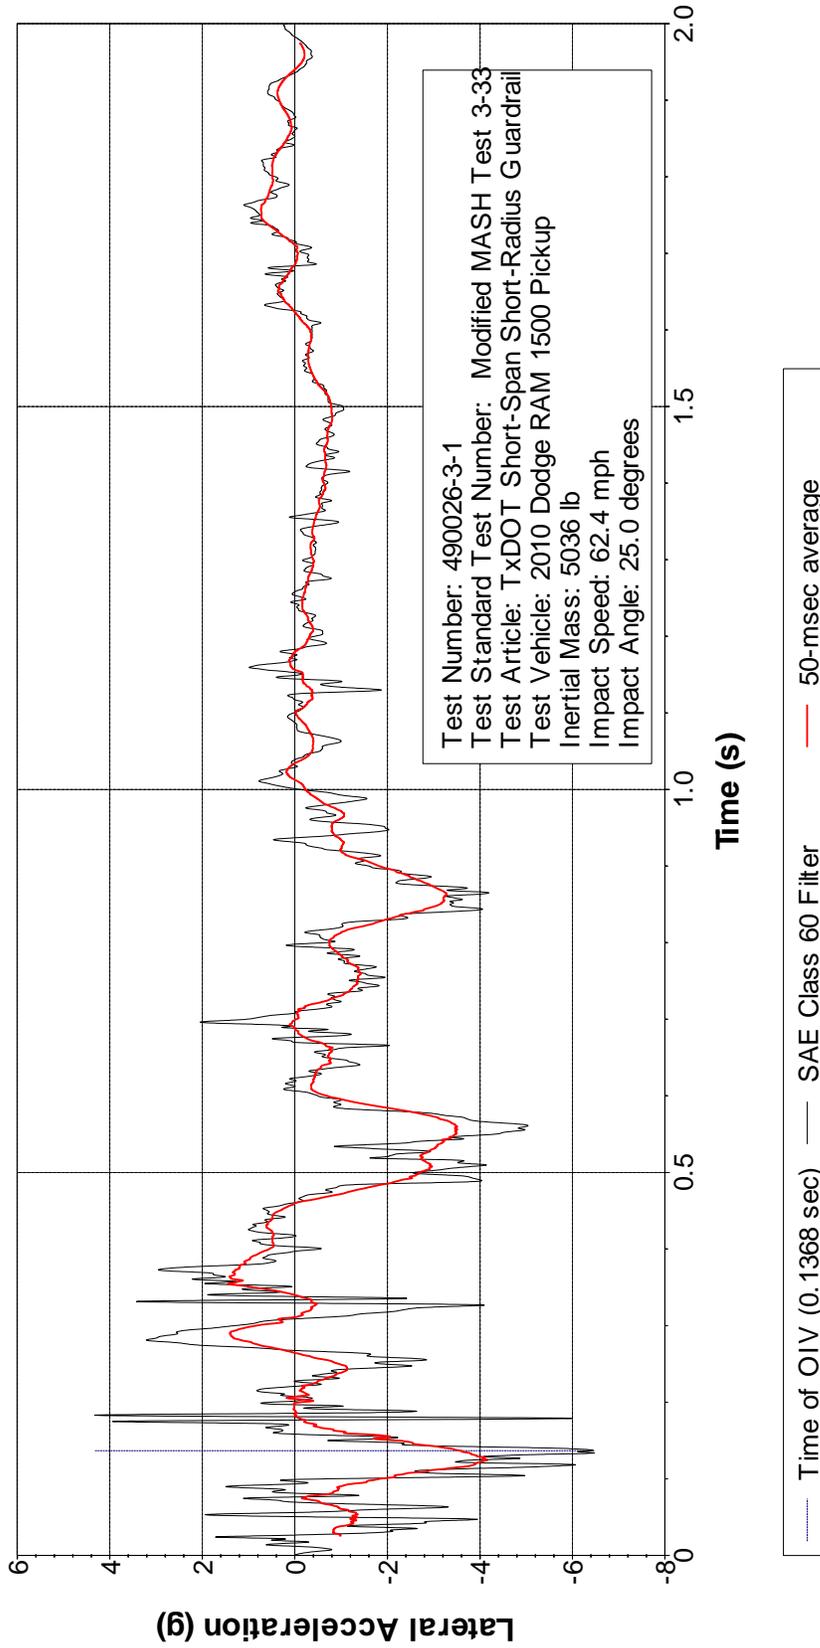
Figure D.5. Vehicle Lateral Accelerometer Trace for Test No. 490026-3-1 (Accelerometer Located at Center of Gravity).

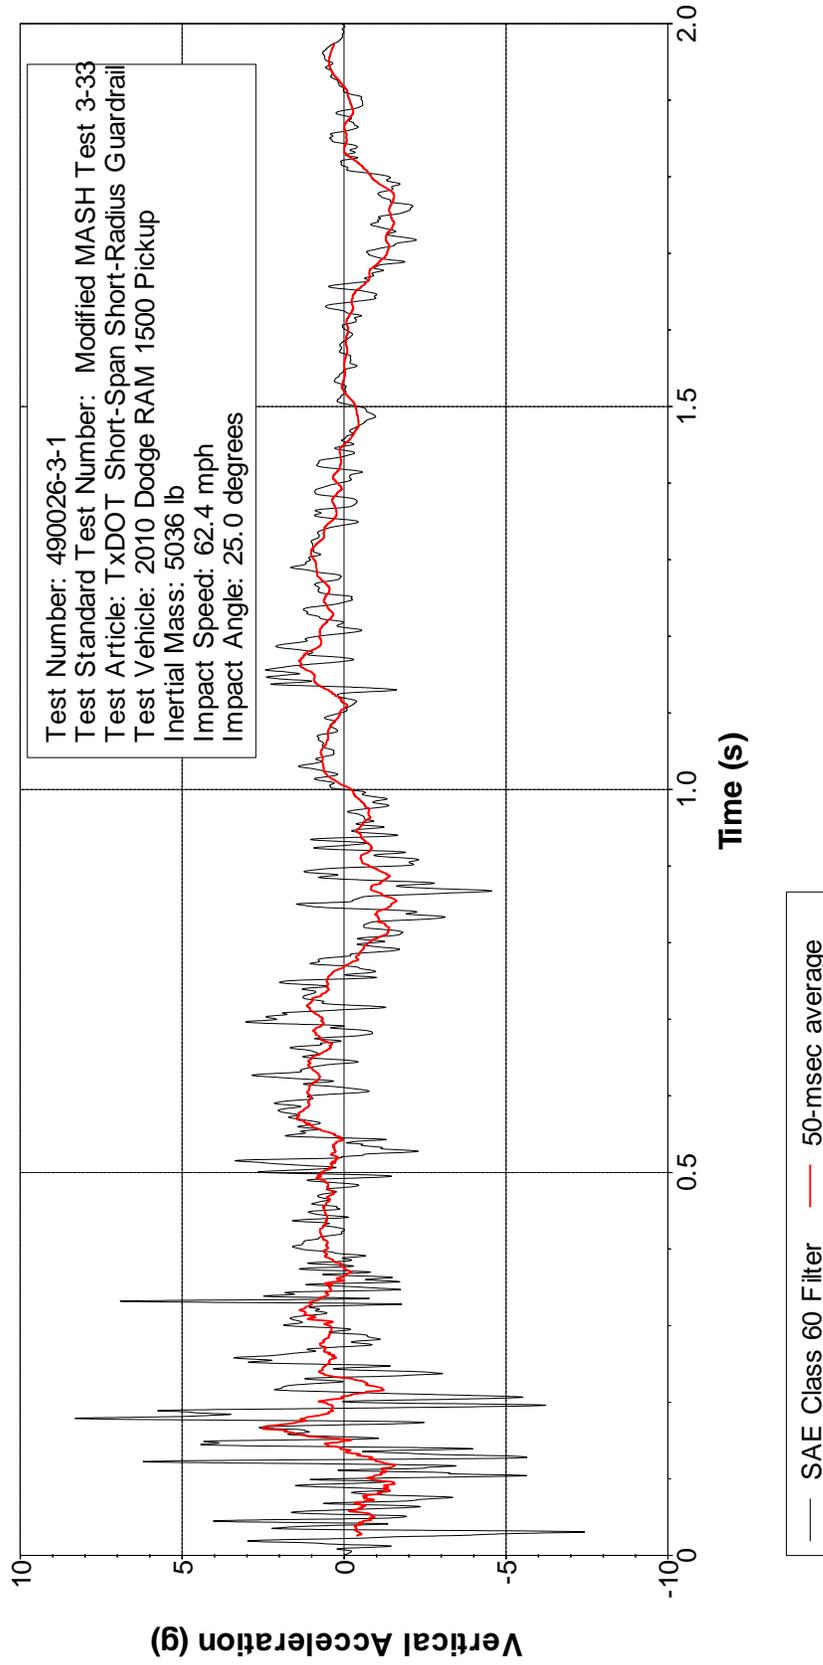
**Figure D.6. Vehicle Vertical Accelerometer Trace for Test No. 490026-3-1
(Accelerometer Located at Center of Gravity).**

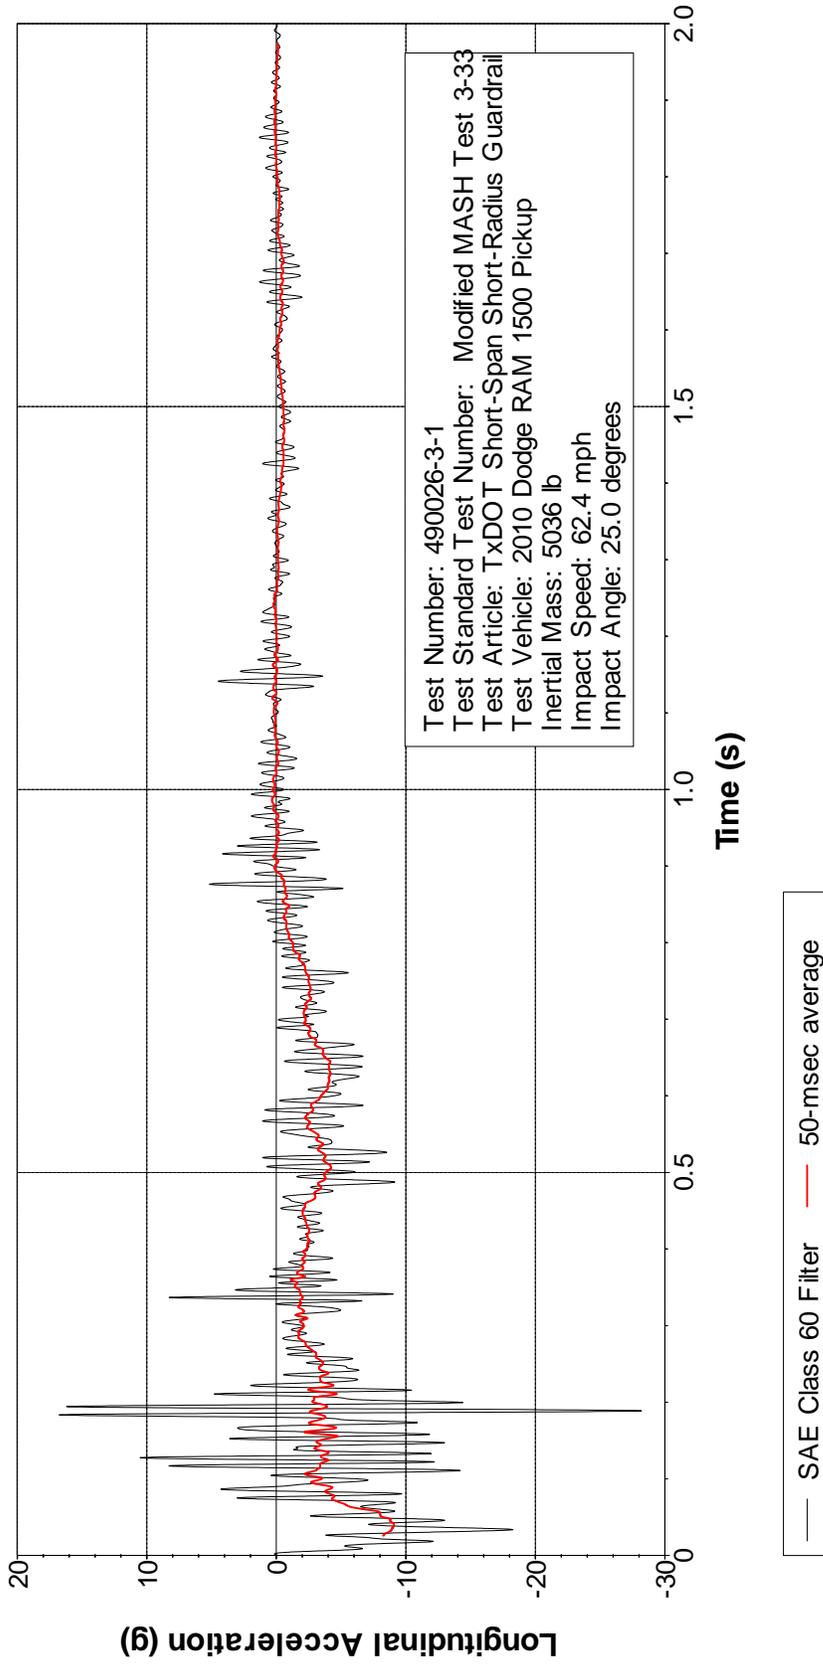
Figure D.7. Vehicle Longitudinal Accelerometer Trace for Test No. 490026-3-1 (Accelerometer Located Rear of Center of Gravity).

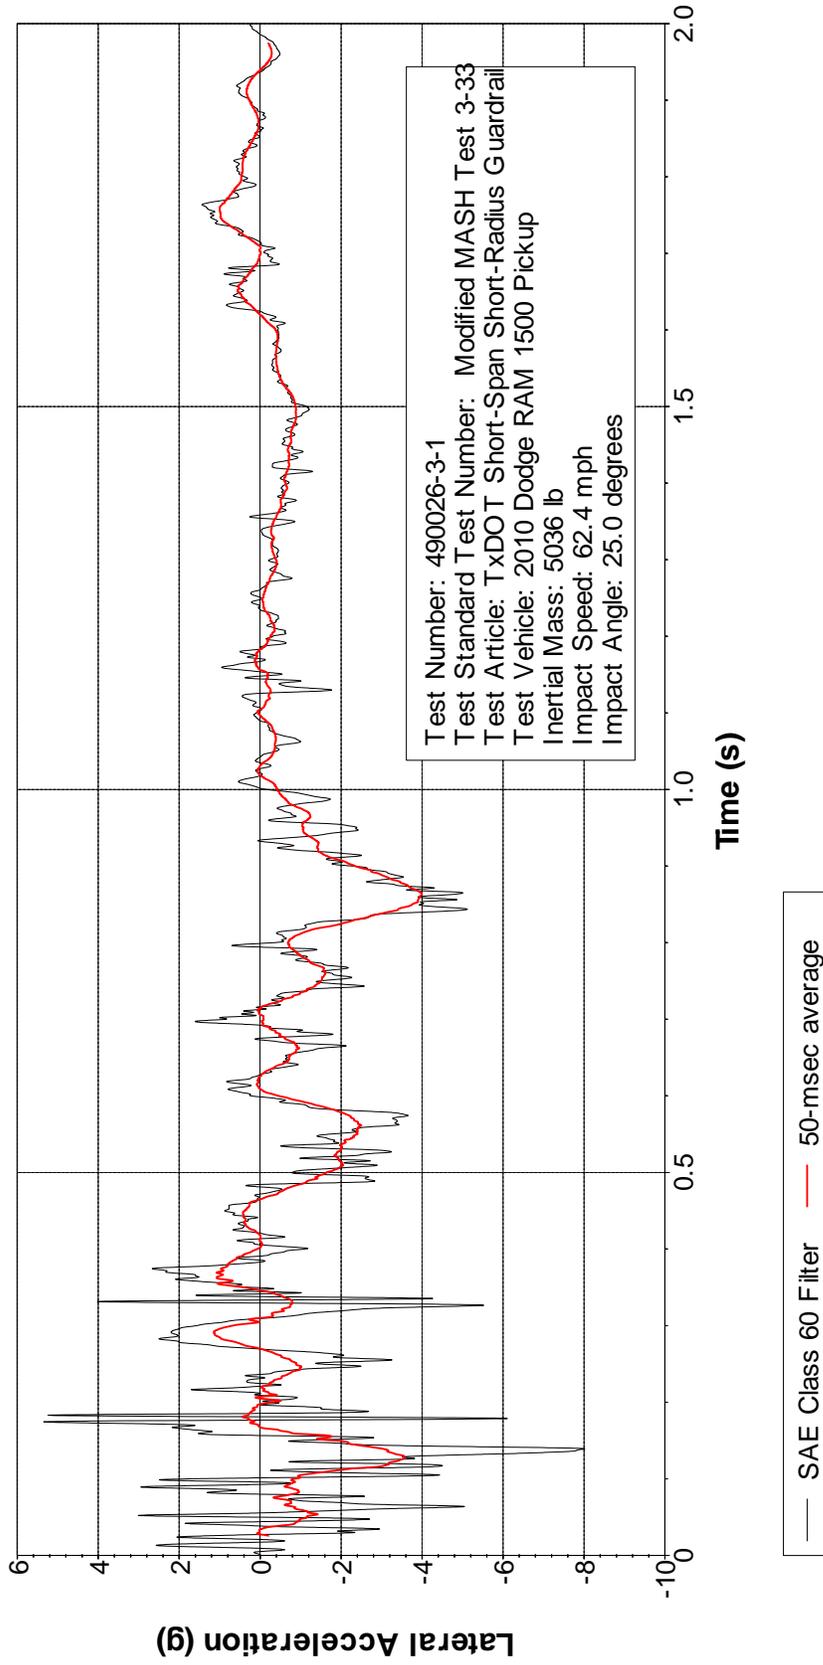
Figure D.8. Vehicle Lateral Accelerometer Trace for Test No. 490026-3-1 (Accelerometer Located Rear of Center of Gravity).

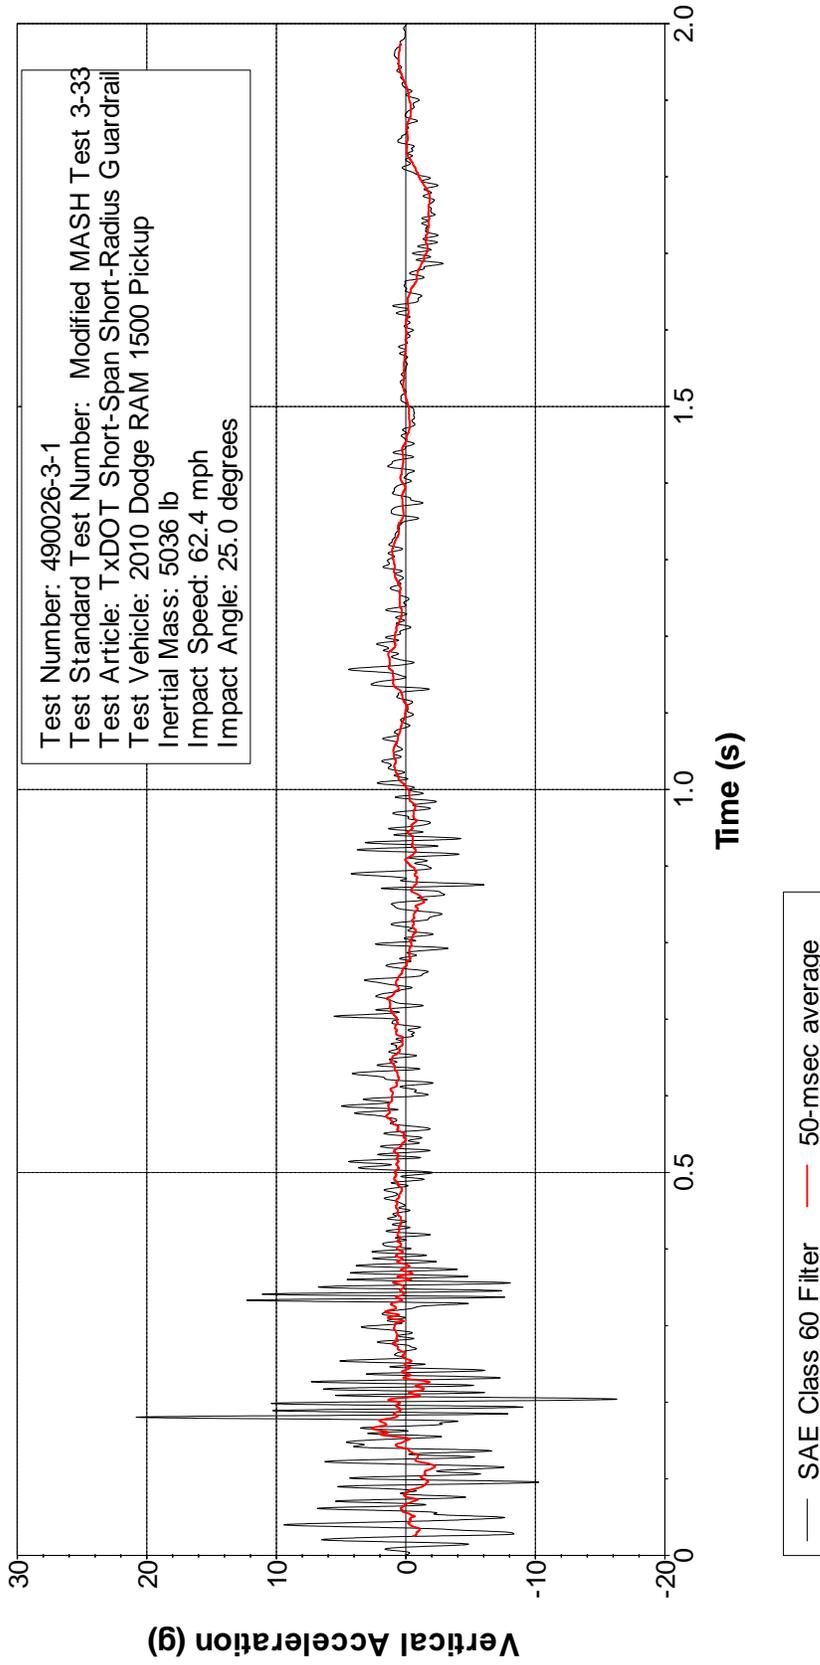
Figure D.9. Vehicle Vertical Accelerometer Trace for Test No. 490026-3-1 (Accelerometer Located Rear of Center of Gravity).

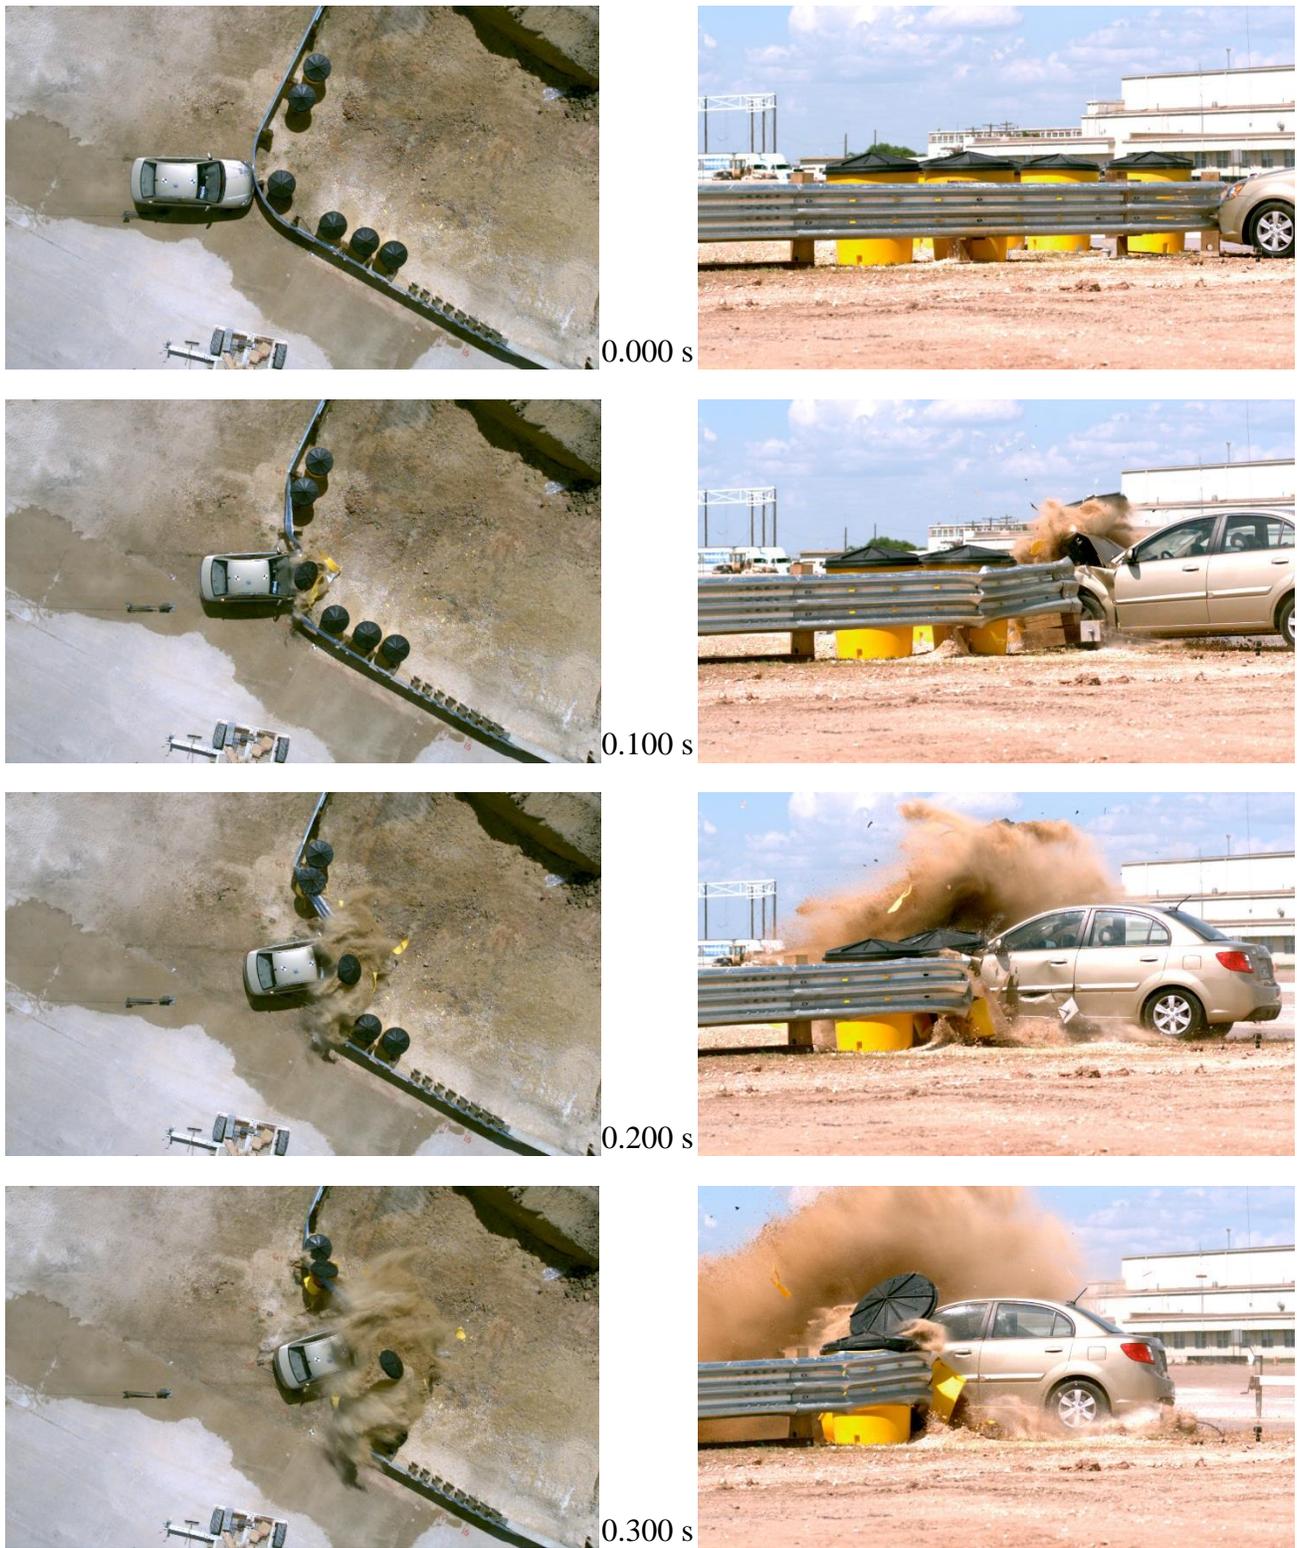
**Figure E.1. Sequential Photographs for Test No. 490026-3-2
(Overhead and Left Perpendicular Views).**
