CRASH TESTING AND EVALUATION OF THE TXDOT SHORT-SPAN SHORT-RADIUS GUARDRAIL SYSTEM

Test Report 9-1002-15-9

1. Report No. FHWA/TX-17/9-1002-15-9		2. Government Accession No.		3. Recipient's Catalog No.	
4. Title and Subtitle CRASH TESTING AND EVALUATION OF THE TXDOT SHORT-SPAN SHORT-RADIUS GUARDRAIL SYSTEM				5. Report Date Published: January 2018

16. Abstract <p>This research evaluated the impact performance of the TxDOT short-span short-radius guardrail system according to the safety-performance evaluation guidelines included in American Association of State Highway and Transportation Officials, entitled <i>Manual for Assessing Safety Hardware (MASH)</i> for Test Level Three (TL-3).</p> <p>This report describes the TxDOT short-span short-radius guardrail system, documents the impact performance of the guardrail system according to <i>MASH</i> TL-3 evaluation criteria, and presents recommendations for implementation.</p> <p>The short-span short-radius guardrail system performed acceptably according to <i>MASH</i> for modified tests 3-33 and 3-32.</p>

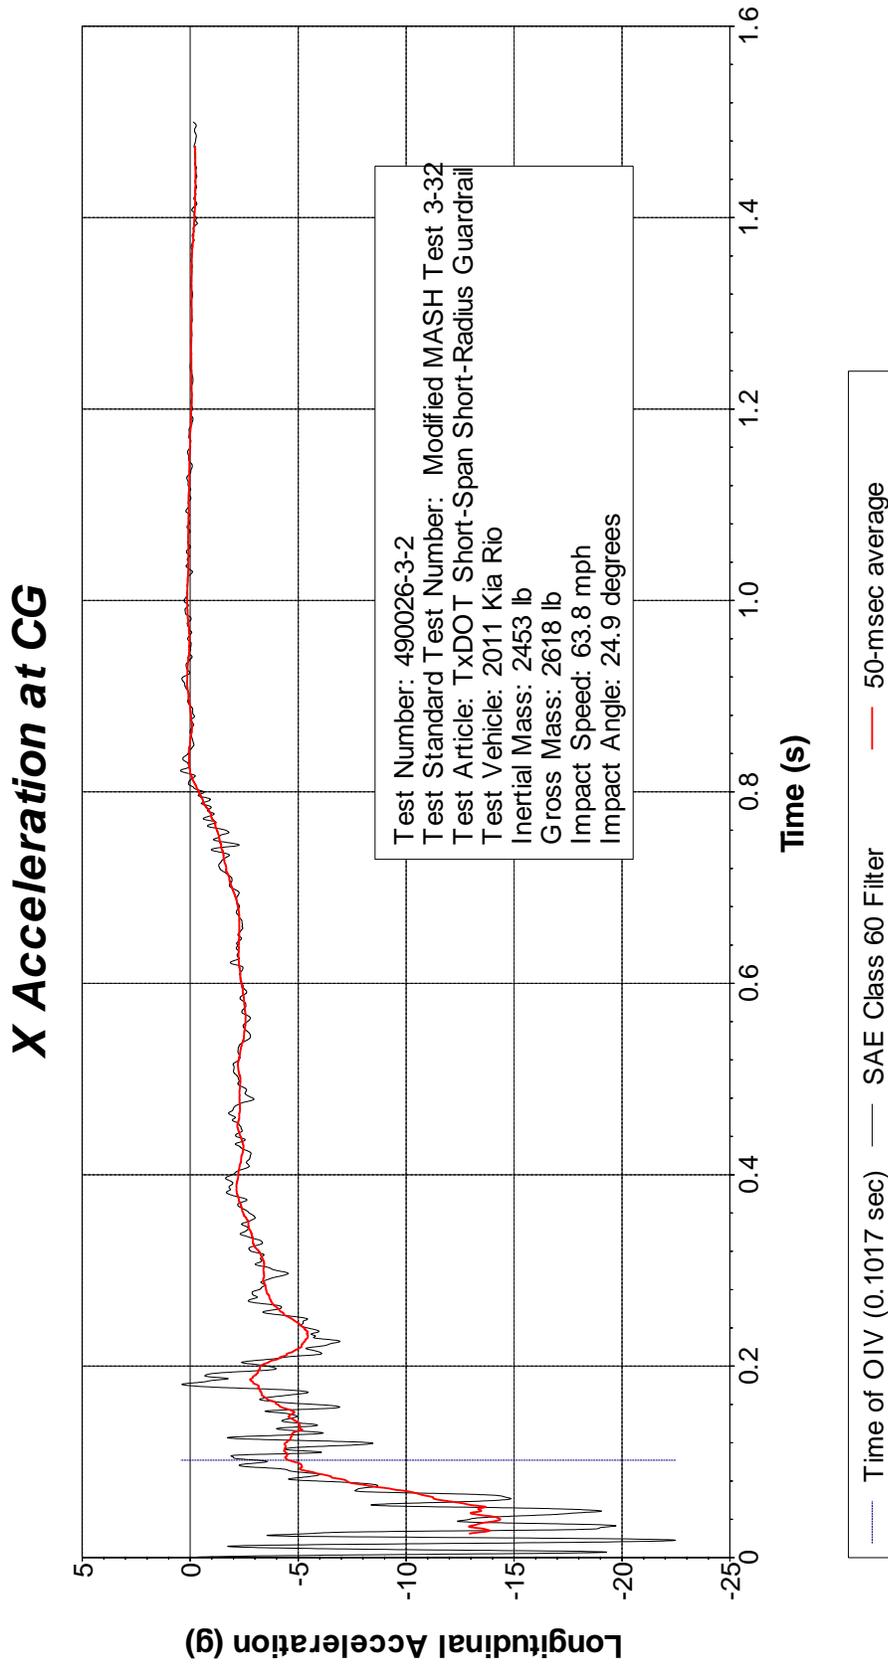
Figure E.4. Vehicle Longitudinal Accelerometer Trace for Test No. 490026-3-2 (Accelerometer Located at Center of Gravity).

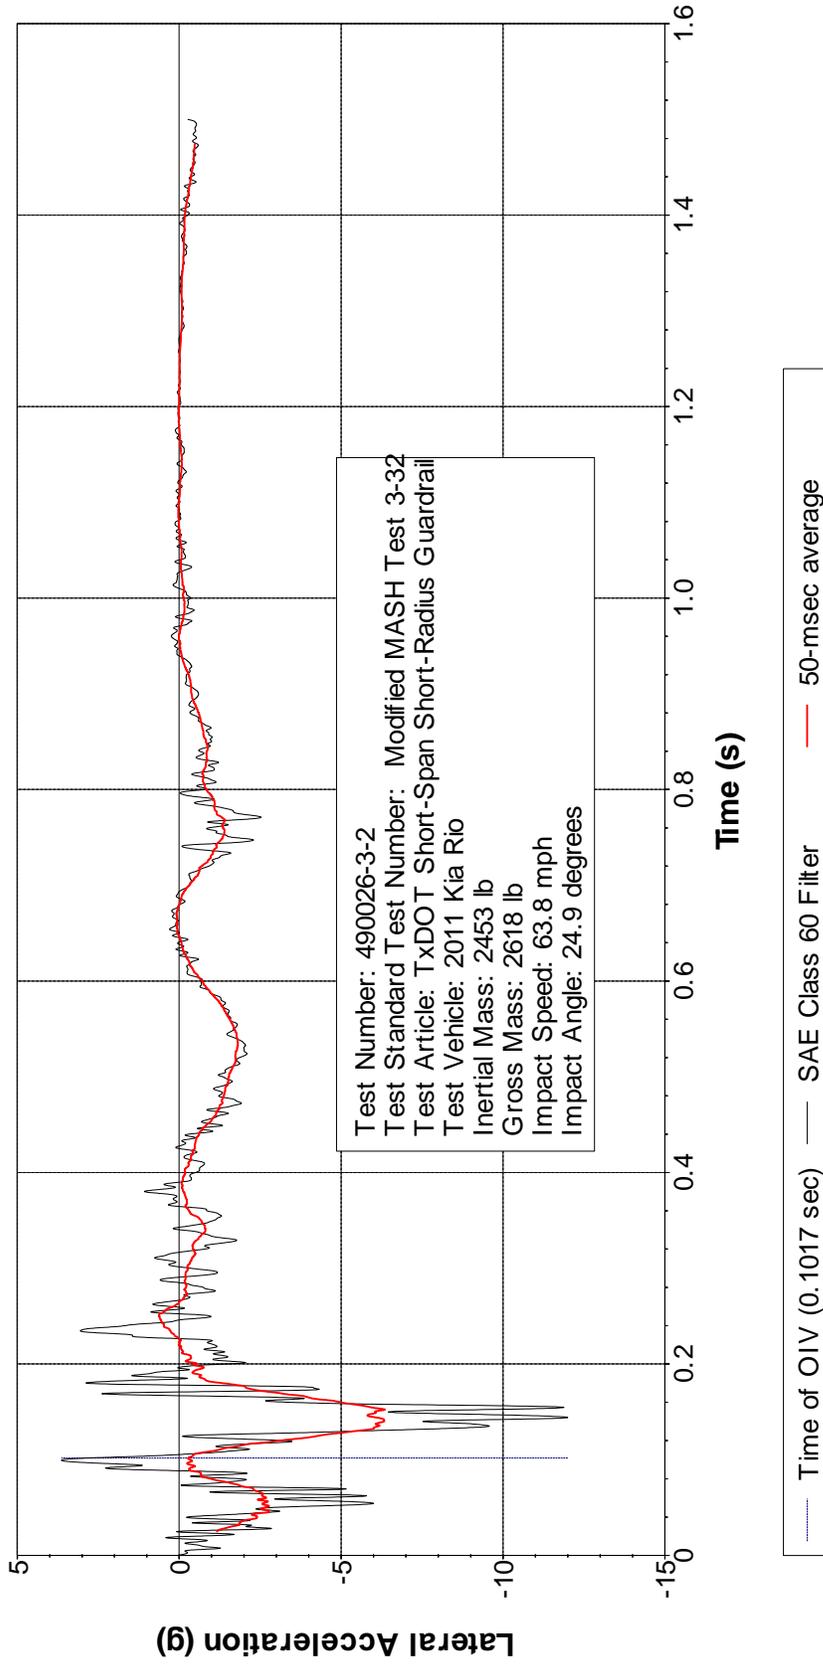
Figure E.5. Vehicle Lateral Accelerometer Trace for Test No. 490026-3-2 (Accelerometer Located at Center of Gravity).

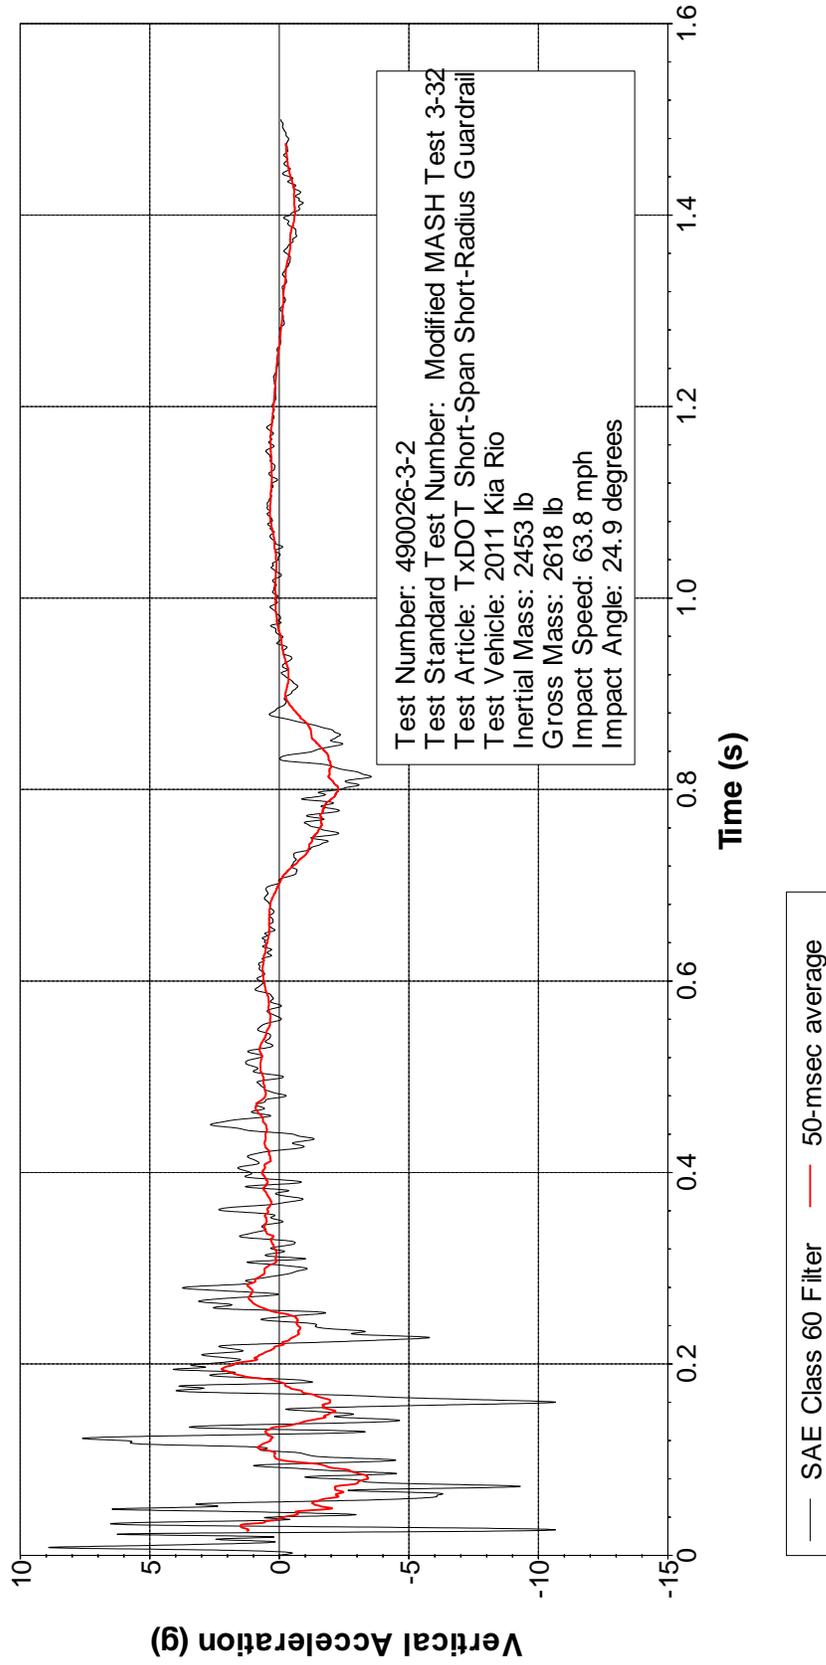
**Figure E.6. Vehicle Vertical Accelerometer Trace for Test No. 490026-3-2
(Accelerometer Located at Center of Gravity).**

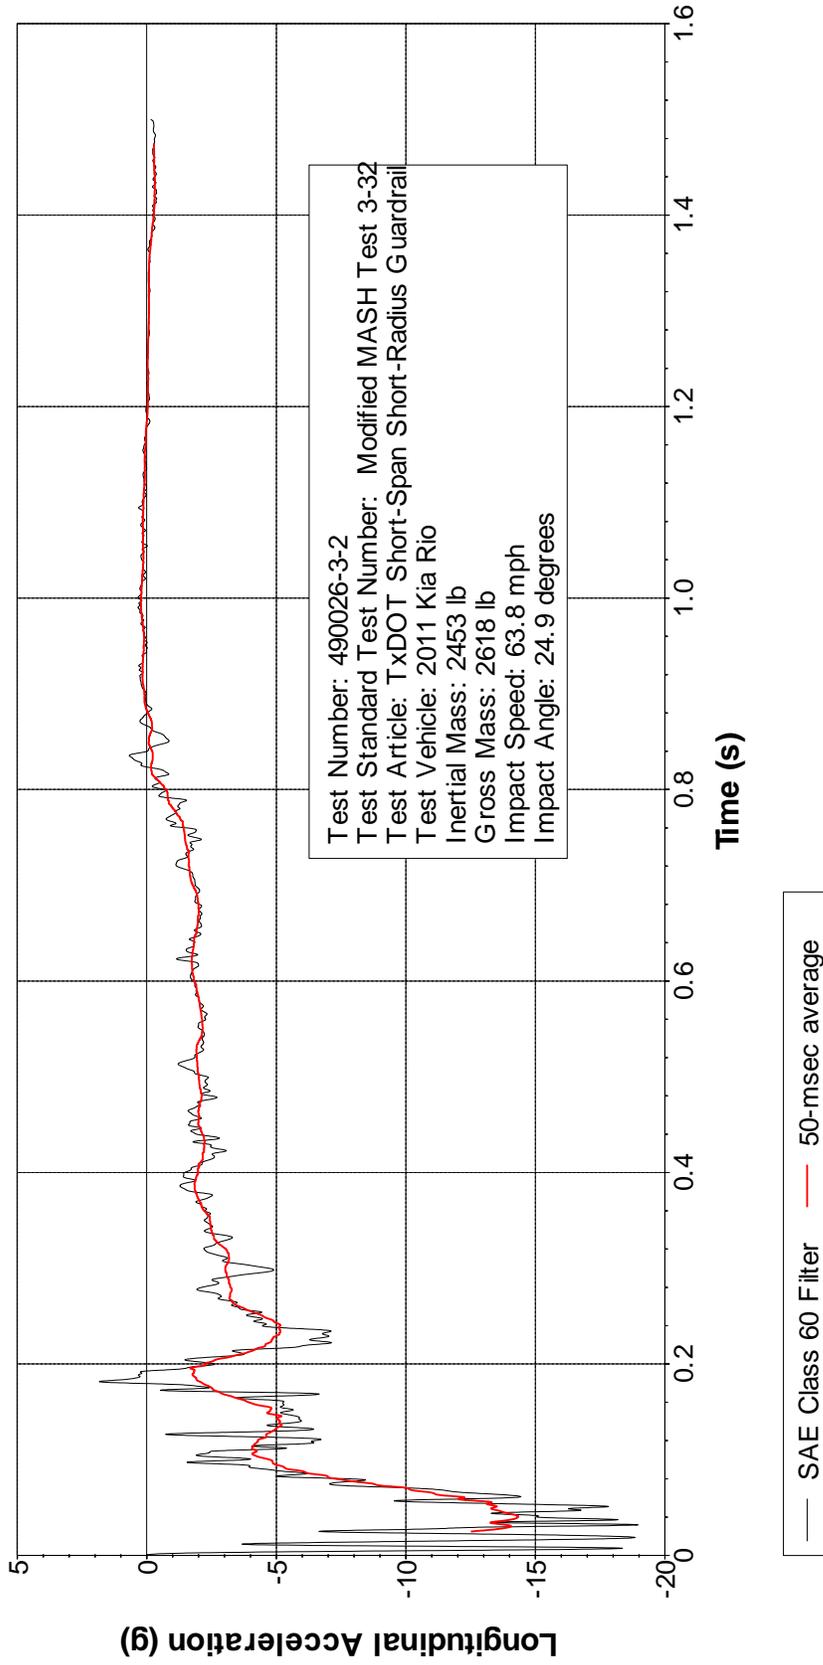
Figure E.7. Vehicle Longitudinal Accelerometer Trace for Test No. 490026-3-2 (Accelerometer Located Rear of Center of Gravity).

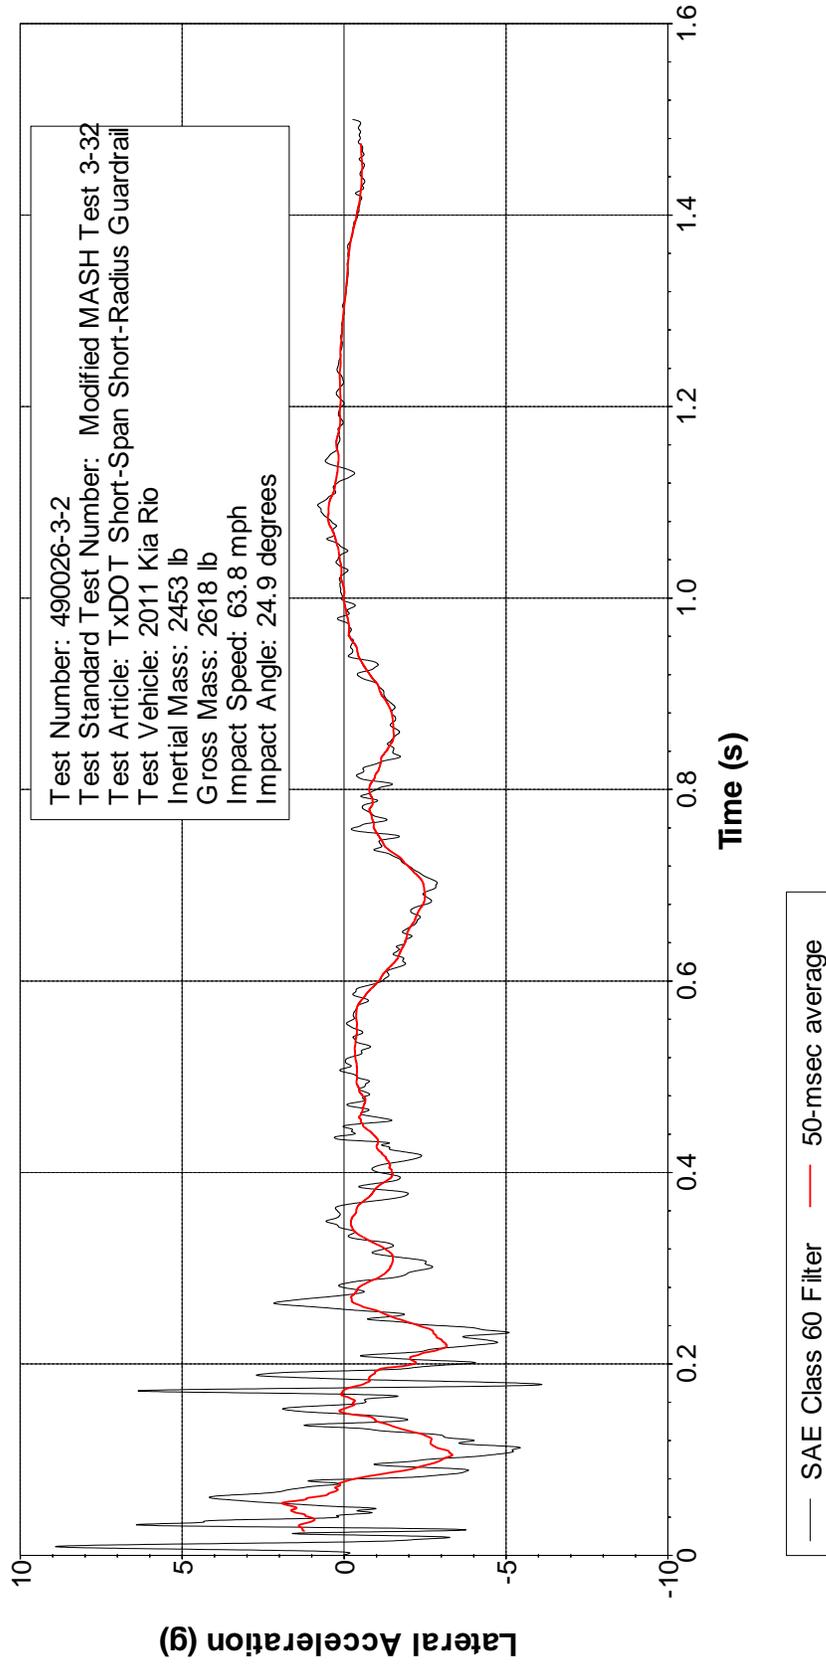
Figure E.8. Vehicle Lateral Accelerometer Trace for Test No. 490026-3-2 (Accelerometer Located Rear of Center of Gravity).

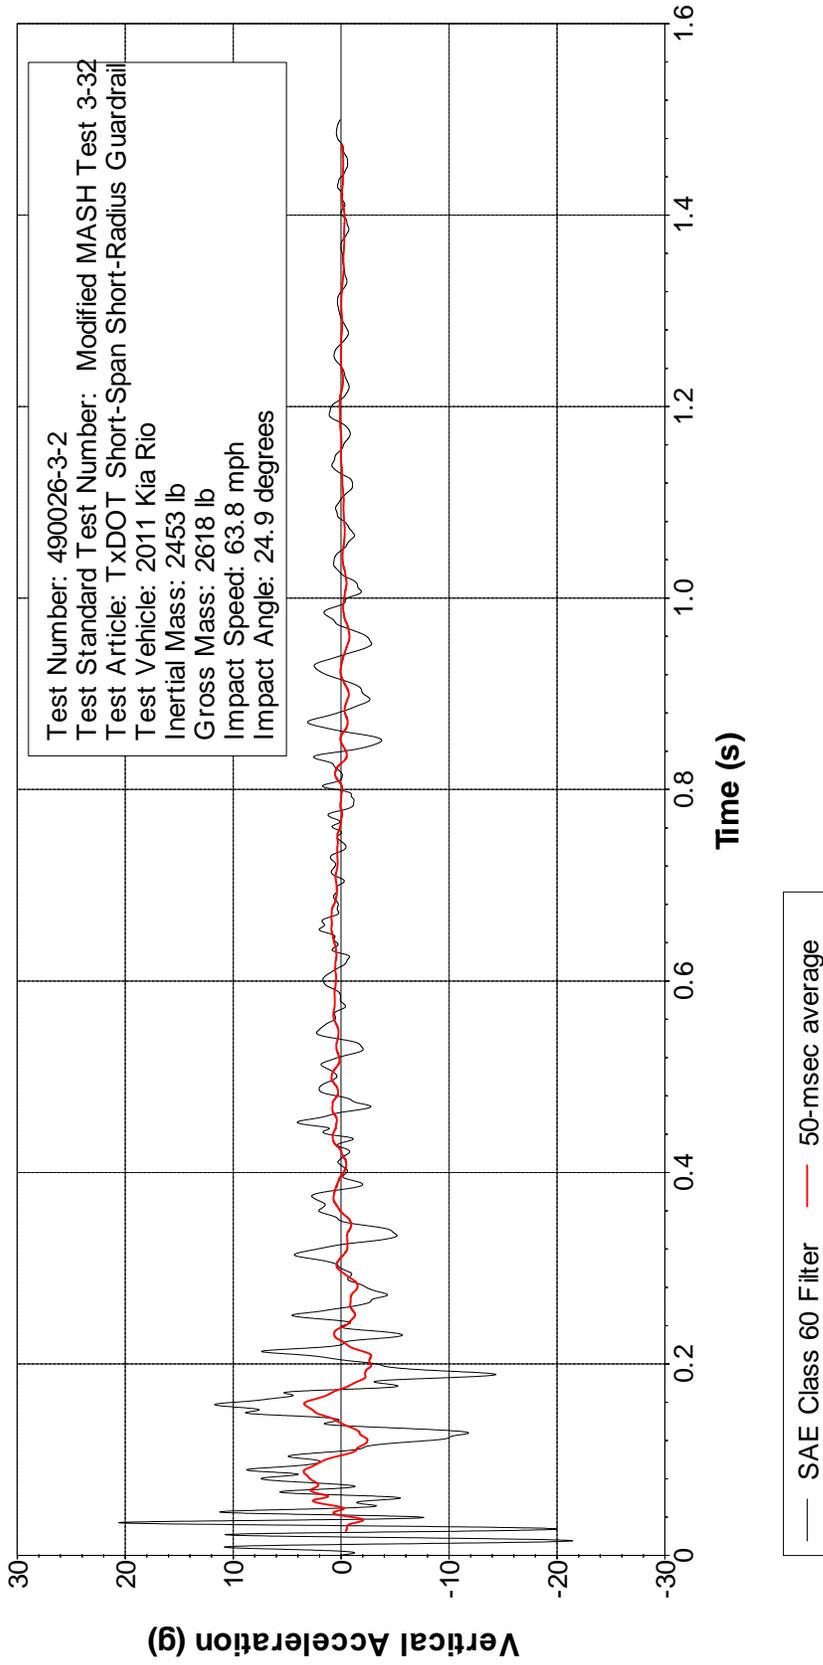
Figure E.9. Vehicle Vertical Accelerometer Trace for Test No. 490026-3-2 (Accelerometer Located Rear of Center of Gravity).
