## Analysis of Hamburg Wheel Tracking Device Results in Relation to Field Performance

PROJECT SUMMARY REPORT

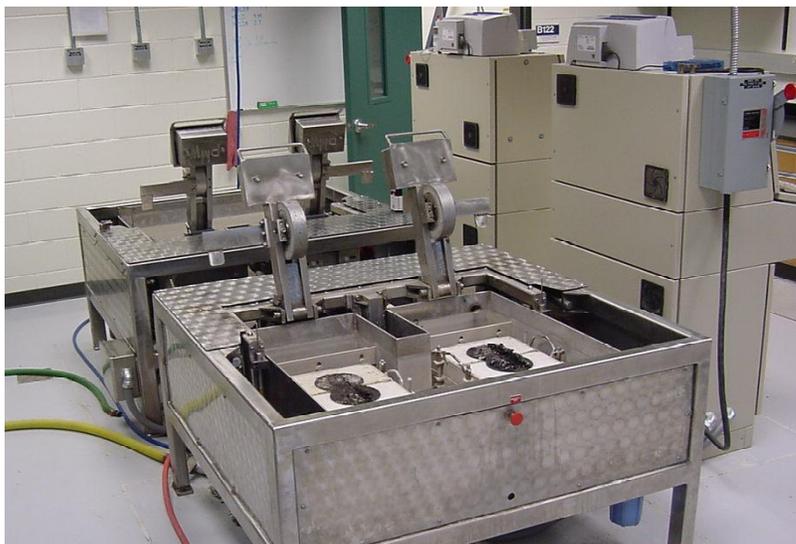
Figure 1: Hamburg Wheel Tracking Device

The HWTD was developed in Hamburg, Germany, in the 1970s by Esso A.G. This machine measures the combined effects of rutting and moisture damage by rolling a steel wheel across the surface of an asphalt concrete specimen that is immersed in hot water. The HWTD test is conducted on a pair of samples simultaneously. The sample is typically compacted to 7±1 percent air voids. The plate type compactor has been proposed for the

compaction of specimens. Use of cylindrical specimens, however, makes it possible to obtain compacted specimens very easily with the aid of gyratory compactors. Figure 1 shows the HWTD.
