Relationship Between Aggregate Properties and Hamburg Wheel Tracking Results: A Summary

7-4977-1 Relationship Between Aggregate Properties and Hamburg Wheel Tracking Results

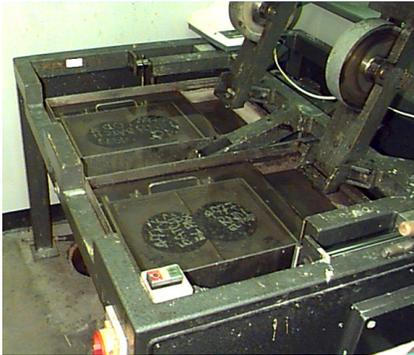
Figure 1. Hamburg Wheel Tracking Device

The HWTD, shown in Figure 1, has been developed for predicting rutting potential and moisture susceptibility of HMA specimens.

Originally, a pair of cubical or beam specimens were tested simultaneously. This type of HWTD specimen is typically 260 mm (10.2 in.) wide, 320 mm (12.6 in.) long, and 40 mm (1.6 in.) deep. However, with the increasing use of the Superpave Gyrotory Compactor, TxDOT has been using cylindrical specimens for testing with the HWTD. The cylindrical specimens are 150 to 300 mm in diameter and 62 mm thick, compacted to 7 ± 1 percent air voids. The setup takes advantage of four cylindrical specimens, two per steel wheel of HWTD.

Typically, a pair of two cylindrical samples, each two specimens assembled together, are tested under water simultaneously with two steel wheels moving concurrently through a crank connected to a flywheel. The steel wheel is approximately 47 mm (1.85 in.) wide and loads the sample with 705 N (158 lbs). The two specimens are attached together to provide the required length for a continuous path for the wheels. In order to have sufficient width, a small segment of each specimen is removed to create a smooth surface before the two specimens are attached together.

Rut depth measurements are taken at the center of each pair of specimens by a linear variable differential transducer (LVDT). The wheel performs 53 ± 2 passes per minute over each pair of two cylindrical samples. The test automatically stops at 20 mm of deformation or 20,000 cycles, whichever occurs first.

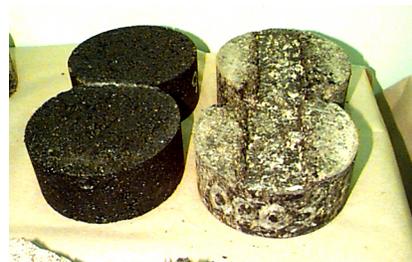
Figure 2. Specimens before and after HWTD Test

Visual evaluation of the specimens indicated moderate to severe damage because of testing specimens with a PG 64 binder at 50°C . This was indeed desired because the idea was evaluation of the aggregate toughness in the test through close interaction of the wheels with the aggregates. Figure 2 shows specimens before and after the test.

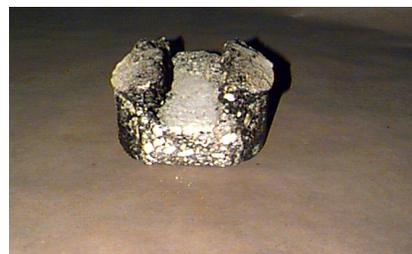
Figure 3. Specimen after HWTD Test (smooth surface-high degradation)

The severity of aggregate degradation varied for different sources. In general, these degradations could be classified as high, intermediate, and low levels (Figs. 3, 4, and 5, respectively).
