## Cathodic Protection: Coordinating Corrosion to Save State Structures

Research Project 7-2945, *Performance Evaluation of Cathodic Protection Systems for Queen Isabella PR 100*, evaluated the potential for use of cathodic protection for corrosion protection of the splash zone area elements in the substructure of the Queen Isabella Causeway (QIC) connecting Port Isabel, Texas, with South Padre Island, Texas. The splash zone is the area immediately above the water line where the elements go through routine wetting and drying cycles. The elements in that area that were protected by cathodic protection systems (CPSs) included footings

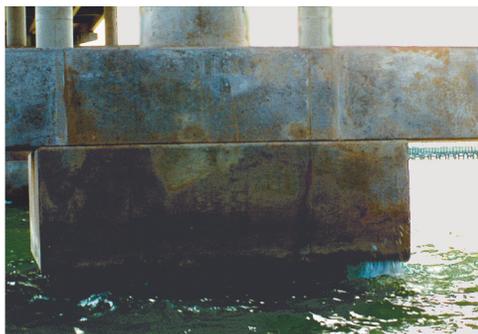
Figure 4 Even during calm seas, wave action attacks CPS anode margins at the bottom of the footers.

in the future. Estimates of service life for the systems had originally been based upon the normal sacrificial consumption of the anodes, but wave action and strong winds, pigeon and pelican droppings acting predominantly on the ends facing the Gulf of Mexico, and possibly excessive current being imposed on the system deteriorated all anode systems much faster than manufacturers expected (Figs. 4 and 5). Within the first year of activation bubbles developed under the anodes, especially at the margins, and soon many small pieces of anode cracked and peeled off. Performance monitoring indicates that a system of regular maintenance would be desirable to gauge the actual rate of anode deterioration. Because the non-impressed current sprayed zinc anode system and the non-impressed current sprayed aluminum-zinc alloy system both performed reasonably well, they are recommended for the Queen Isabella PR 100. The zinc anode system is less expensive, but the aluminum-zinc alloy appears to provide better protection in dryer conditions and more uniform protection overall.

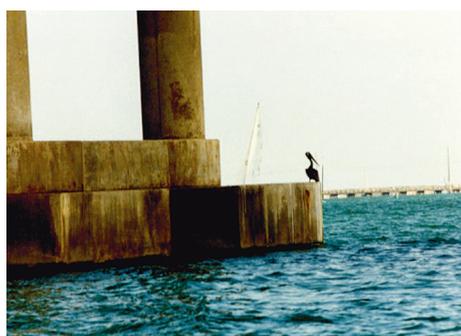
Figure 5 Pelicans, pigeons, and boats may contribute to premature anode deterioration.

5. It is also recommended that cellular-modem remote-reporting units be strategically installed at the most critical bents (wherever damage due to wind and wave action, pelicans, pigeons, or boats is most likely). These modems would allow data transfer to a remote office where effectiveness of the CPS on those bents could be reviewed monthly or as needed.
