# Traffic Control Device Analysis, Testing, and Evaluation Program: FY 2024 Activities

Technical Report 0-7198-R1

TEXAS A&M TRANSPORTATION INSTITUTE  
COLLEGE STATION, TEXAS

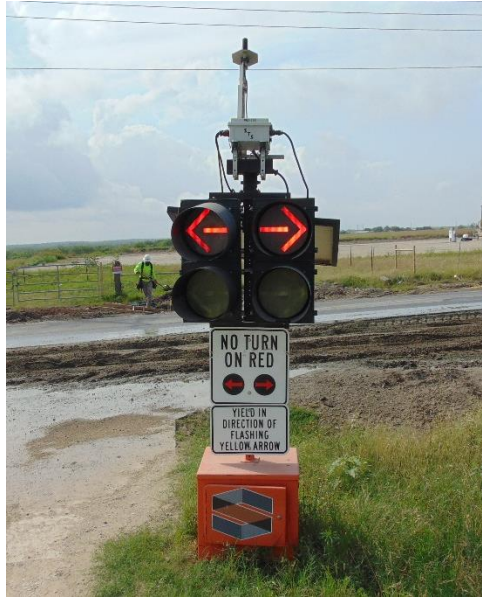
**Figure 1. Example of Four-Section Stacked DAD.**

steady red arrow indications, a modified R10-11 sign is typically used with a second supplemental sign (YIELD IN DIRECTION OF FLASHING YELLOW ARROW) (see Figure 1). However, based on previous study findings, TxDOT requested that TTI change out the two supplemental signs at the driveway where researchers collected data to a R10-11b sign (NO TURN ON RED) and a WAIT/TURN ONLY IN DIRECTION OF FLASHING YELLOW ARROW sign (see Figure 2).

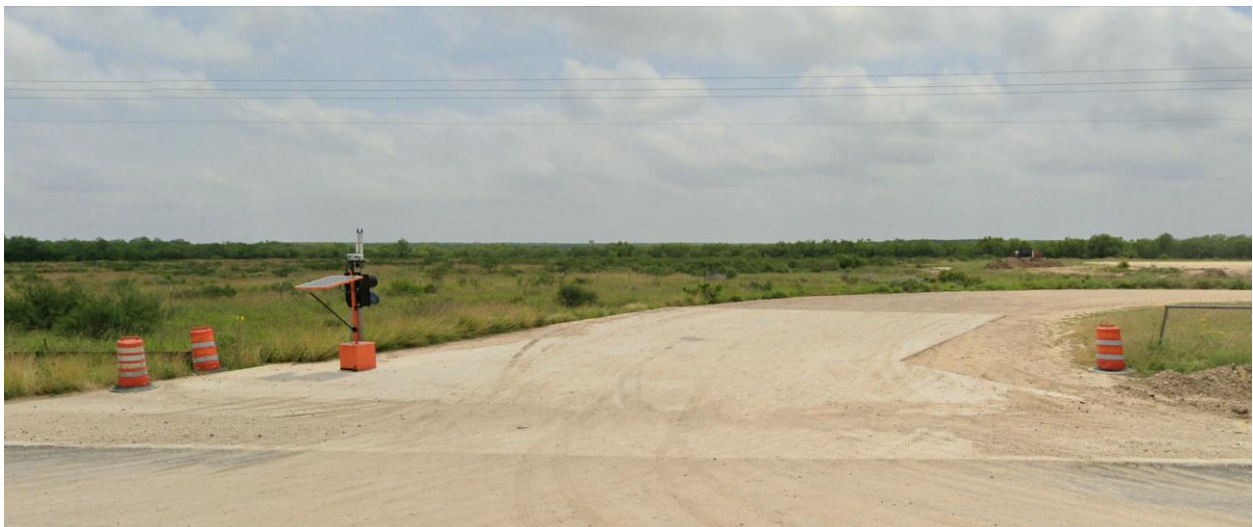
**Figure 5. Project 5 Driveway Exit SS 2nd from across the Road.**

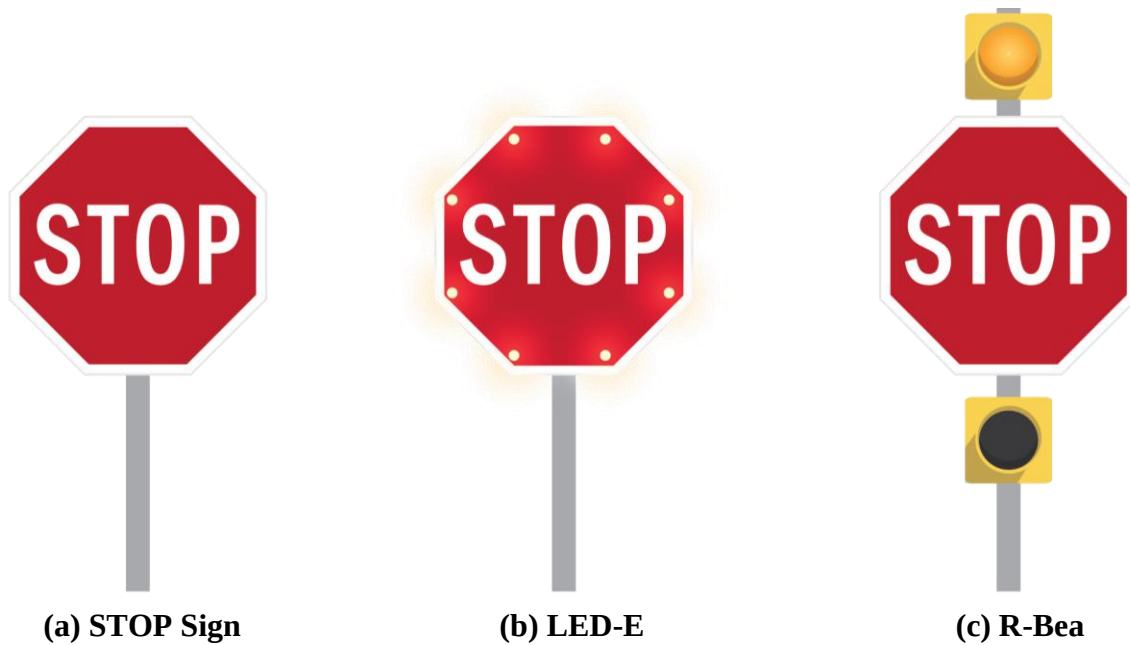
**Figure 16. Examples of Beacon Treatments Being Considered in This Research.**

The three treatments selected for this research are illustrated in Figure 16 and include the following:

- **STOP Sign.** A typical STOP sign installed at the intersection.
- **LED-E.** LED-embedded STOP signs.
- **R-Bea.** Roadside intersection beacons where the beacons are mounted above and below the STOP sign located at the intersection.
