1. Report No. FHWA/TX-24/0-7198-R1B		2. Government Accession No.		3. Recipient's Catalog No.	
4. Title and Subtitle TRAFFIC CONTROL DEVICE ANALYSIS, TESTING, AND EVALUATION PROGRAM: FY 2024 ACTIVITIES				5. Report Date Submitted: October 2024

TRAFFIC CONTROL DEVICE ANALYSIS, TESTING, AND EVALUATION PROGRAM: FY 2024 ACTIVITIES

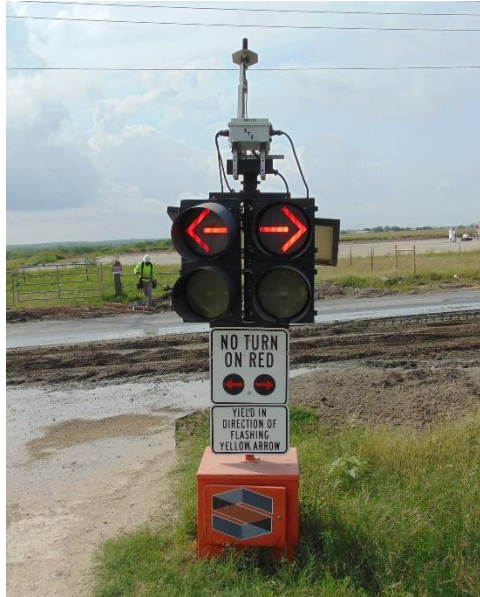
Figure 1. Example of Four-Section Stacked DAD.

steady red arrow indications, a modified R10-11 sign is typically used with a second supplemental sign (YIELD IN DIRECTION OF FLASHING YELLOW ARROW) (see Figure 1). However, based on previous study findings, TxDOT requested that TTI change out the two supplemental signs at the driveway where researchers collected data to a R10-11b sign (NO TURN ON RED) and a WAIT/TURN ONLY IN DIRECTION OF FLASHING YELLOW ARROW sign (see Figure 2).

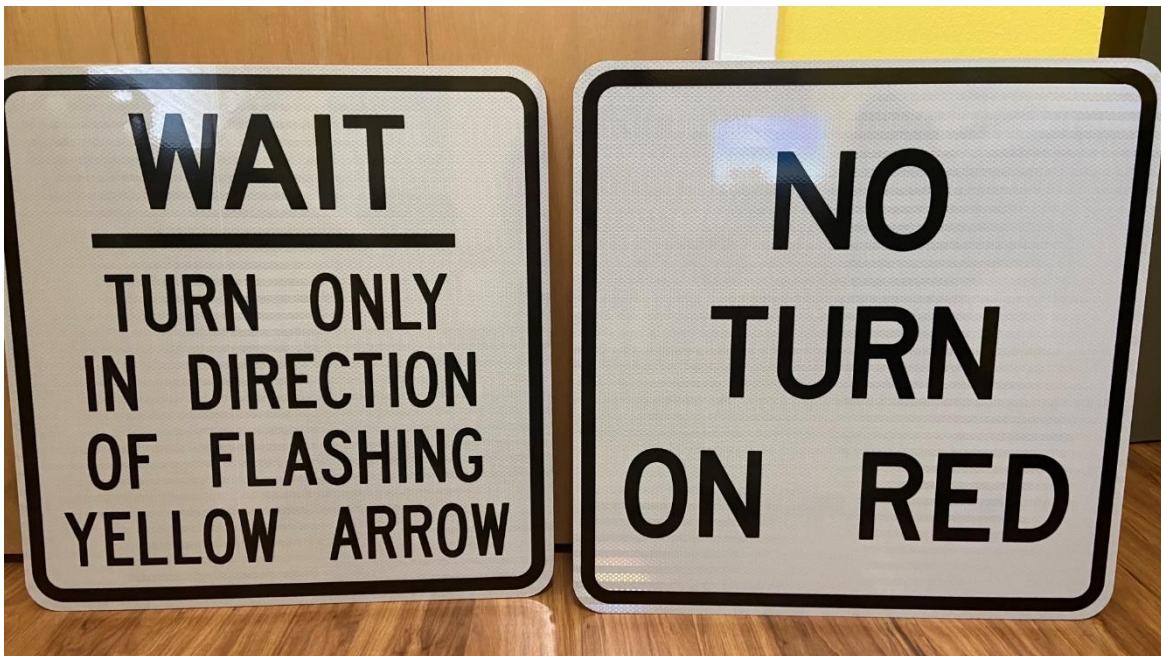
Figure 2. Project 5 Supplemental Signs Used at Driveway Studied.

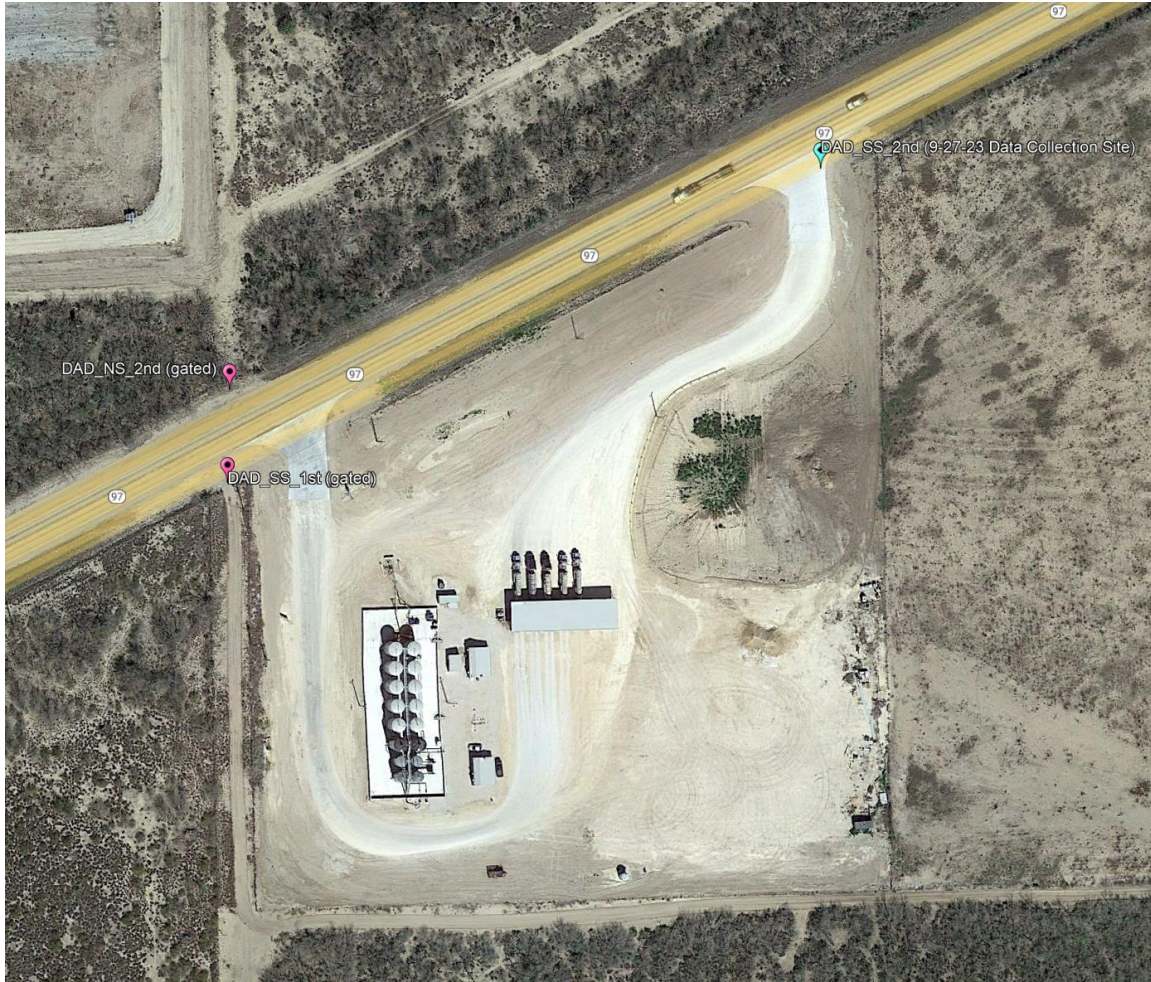
Figure 4. Project 5 SH 97 One-Lane Section near Driveway SS 2nd.

TTI collected data at a driveway that provided access to a saltwater disposal company (SS_2nd) on September 26–28, 2023 (see aqua pin with a diamond in Figure 4). The driveway was located approximately 2.2 miles from the westbound PTS and approximately 0.4 mile from the eastbound PTS. Vehicles entering SH 97 from the driveway could see the eastbound PTS. The DAD was located on the nearside of the intersection, and construction was occurring in the westbound lanes (see Figure 5). Data collection began around noon on Tuesday and ended around 5:00 a.m. on Thursday.

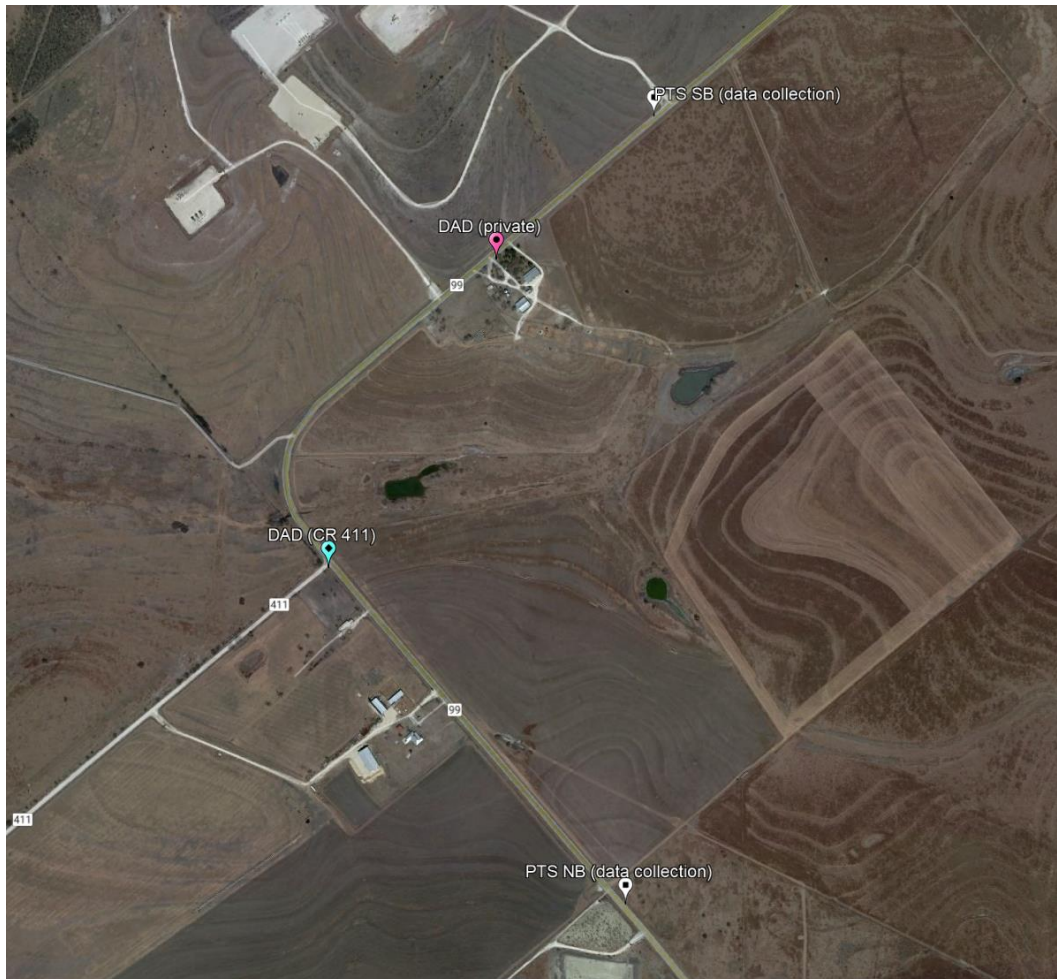
Figure 6. Project 13 FM 99 December 2023 One-Lane Study Section.

Figure 6 shows the section of roadway under construction in December 2023. The one-lane section was controlled by PTSs and was approximately 1.3 miles long (see white pins with squares in Figure 6). The northbound and southbound cycle times were approximately 3 minutes each. The average red time was 2 minutes and 36 seconds for both cycle times, so the green time for most cycles was less than 30 seconds. The red time appeared to be calculated assuming that vehicles were traveling 30 mph through the one-lane section. DADs were used at two locations (see the pink pin with a circle and the aqua pin with a diamond in Figure 6) although there were four other driveways in the one-lane section.

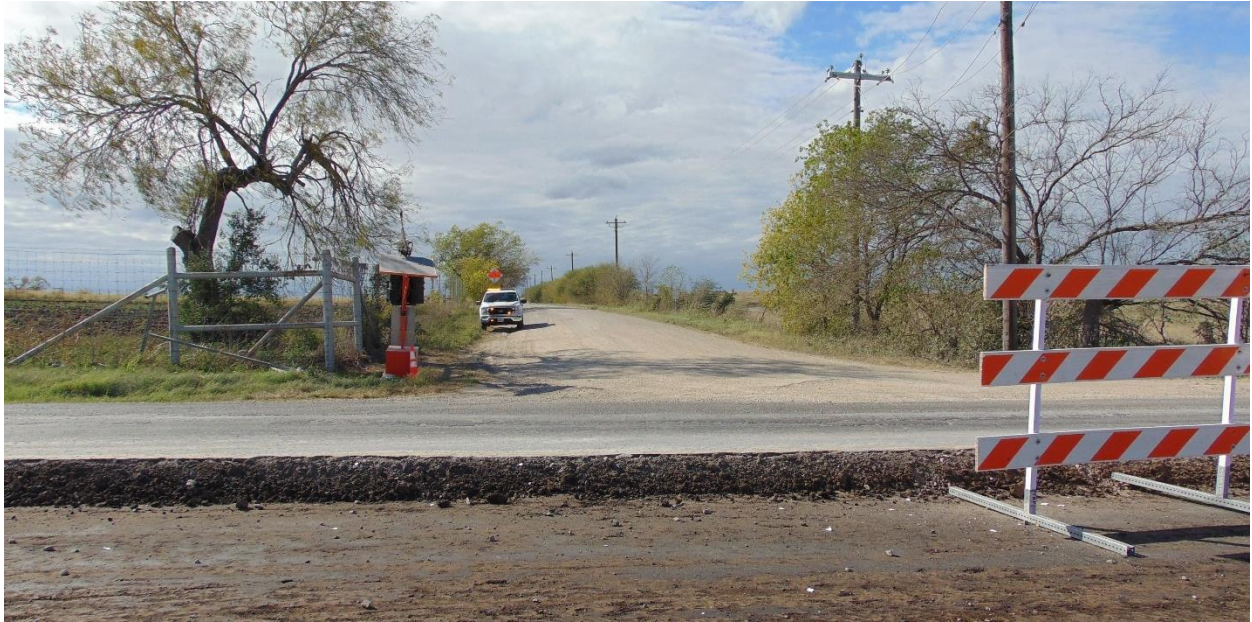
Figure 7. Project 13 DAD at CR 411 from across the Road.

TTI collected data at CR 411, which provided access to one residential home and several oil/gas industry pads, on December 20–22, 2023 (see aqua pin with a diamond in Figure 6). The driveway was located approximately 0.5 mile from the northbound PTS and approximately 0.75 mile from the southbound PTS. Vehicles entering FM 99 from CR 411 could not see either PTS due to a horizontal curve in the northbound direction and a vertical curve in the southbound direction. The DAD was located on the nearside of the intersection, and construction was occurring in the northbound lane (see Figure 7 and Figure 8). Data collection began around 11:00 a.m. on Tuesday and ended around 2:00 a.m. on Thursday.

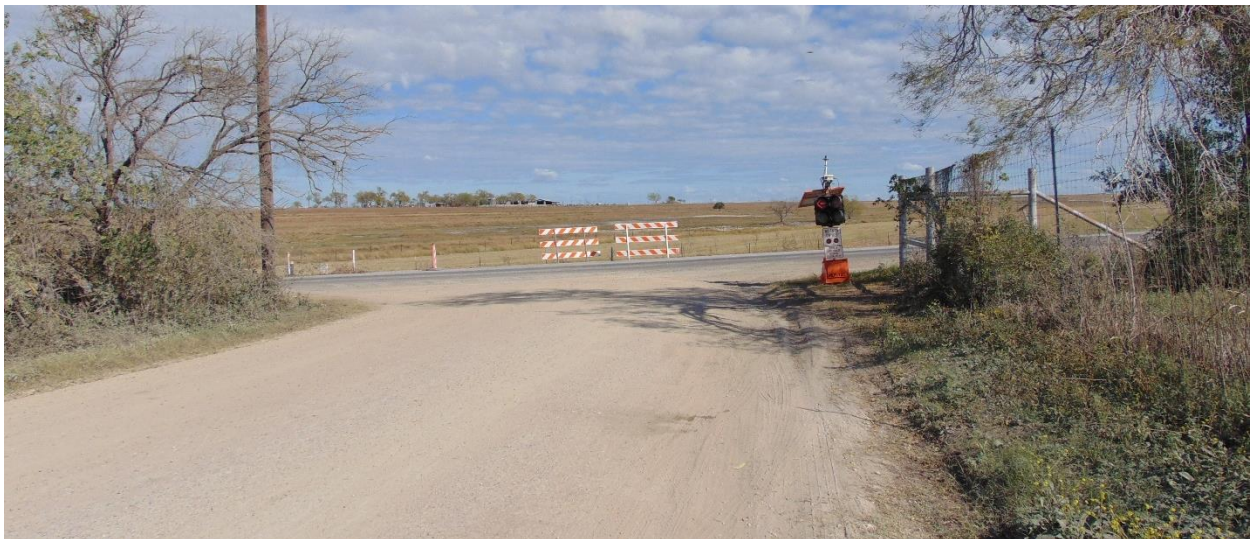
Figure 8. Project 13 DAD at CR 411 from Approaching Traffic Viewpoint.

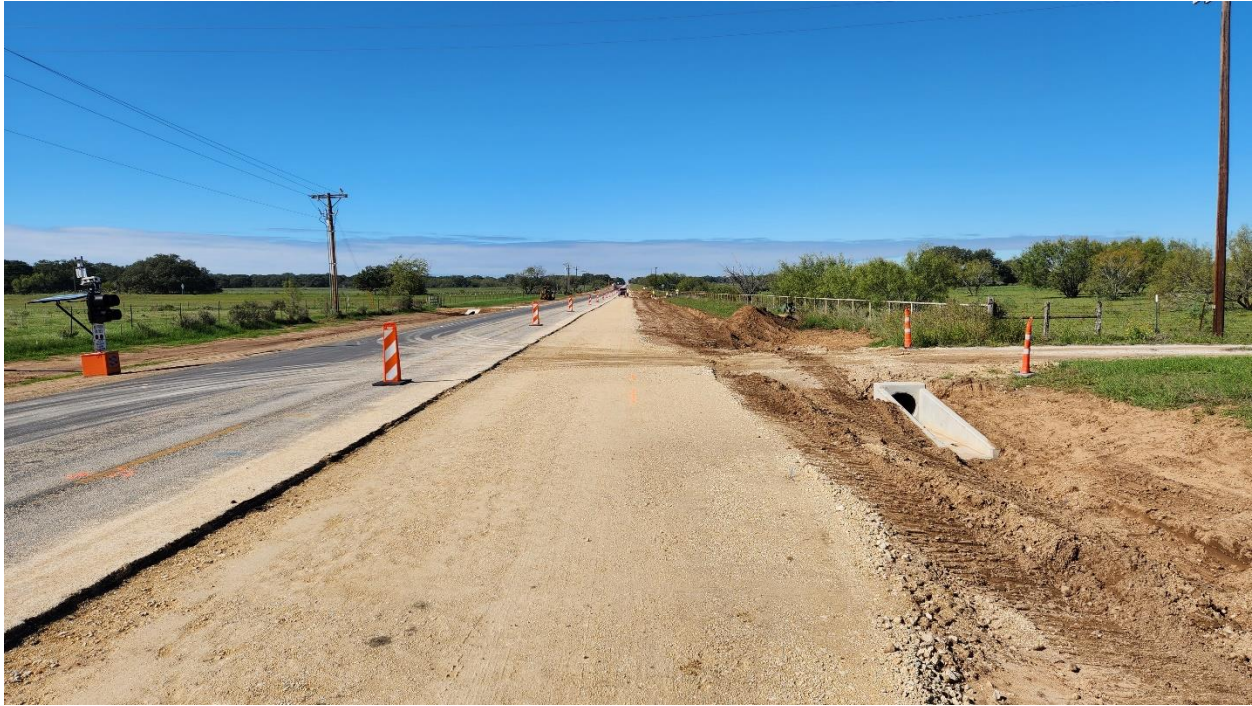
Figure 10. Project 14 DAD at D12 Looking Westbound.

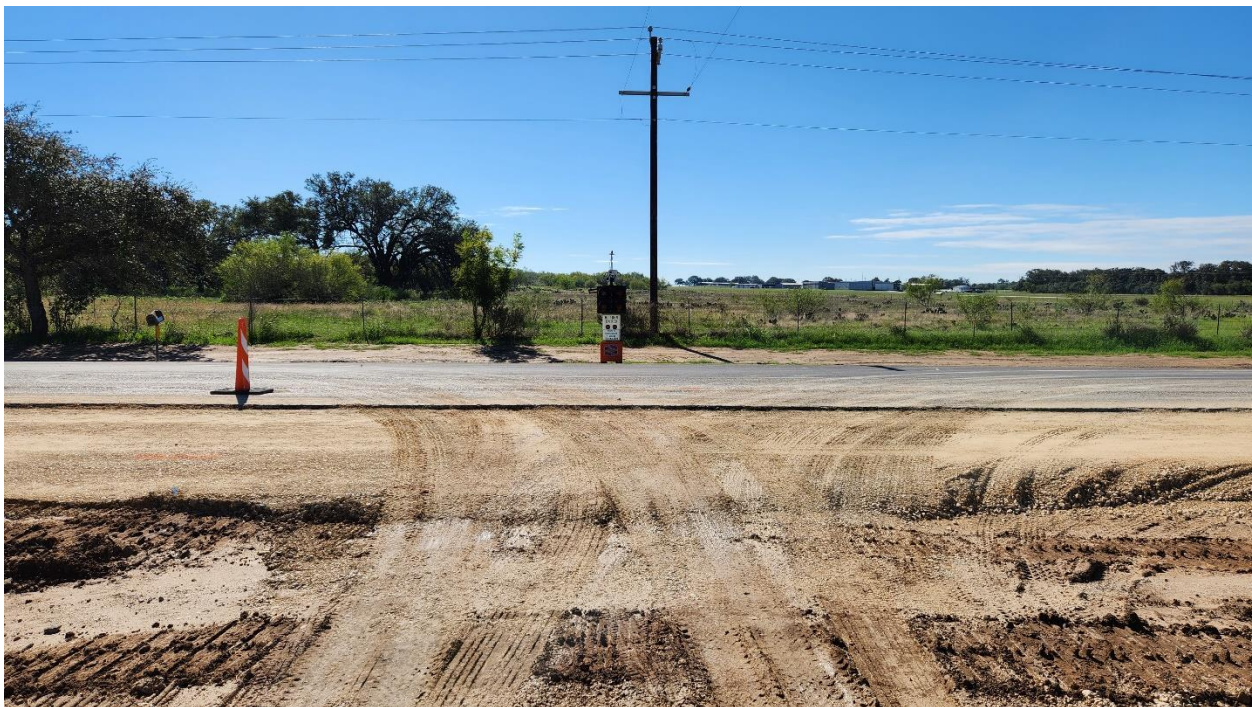
Figure 11. Project 14 DAD at D12 from Approaching Traffic Viewpoint.

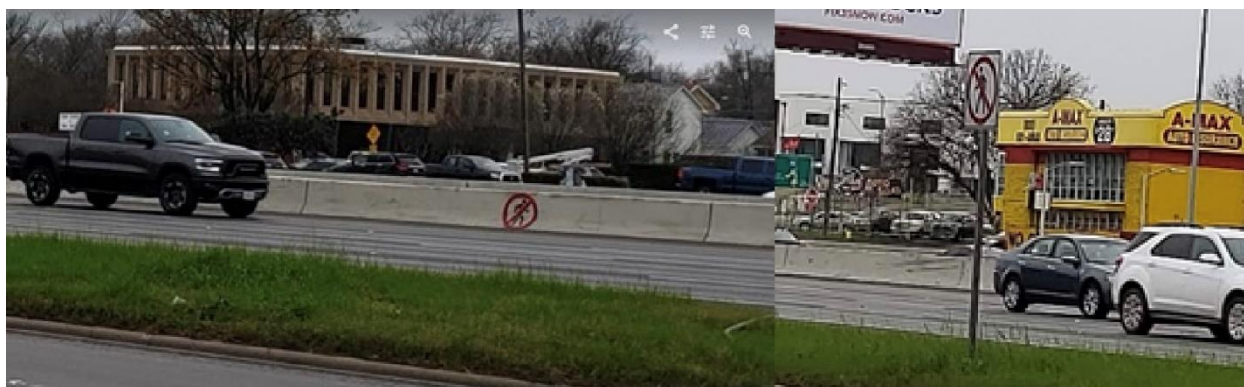
Figure 14. No Pedestrian Crossing Stencil and Signs on I-35 in Austin.

In 2018, the Austin District installed No Pedestrian Crossing symbol signs (R9-3) and stenciled No Pedestrian Crossing symbols on the concrete median barrier along this section of the highway (3). In 2020, the district installed an additional barrier on top of the existing concrete median barrier to reduce pedestrian crossings (see Figure 14 and Figure 15).

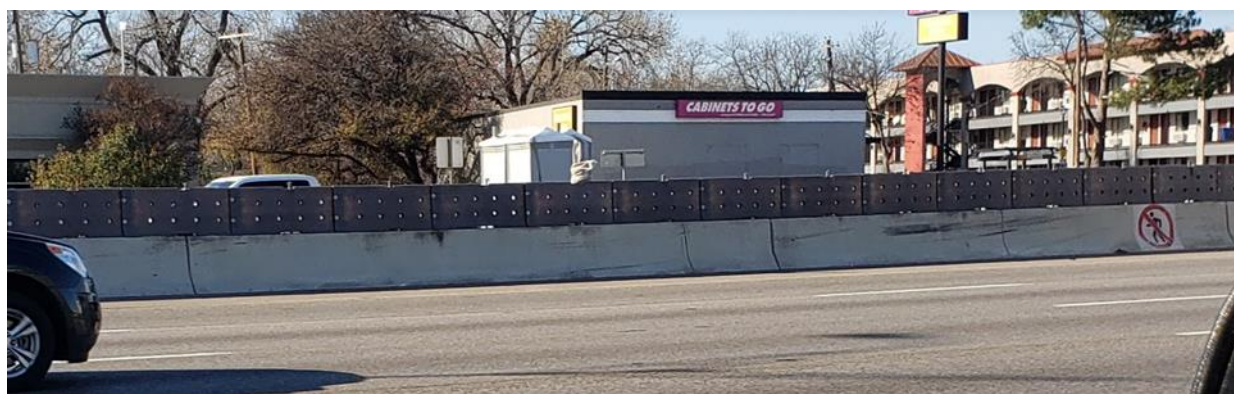
Figure 15. Stencil and Barrier on Top of Center Median on I-35 in Austin.

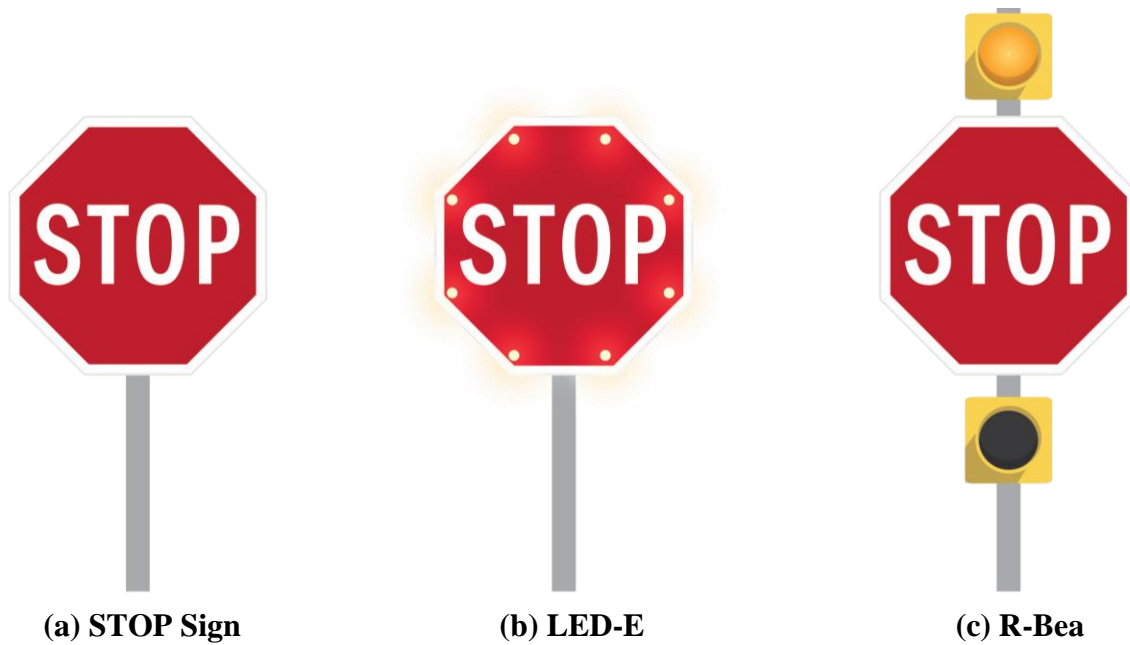
- **STOP Sign.** A typical STOP sign installed at the intersection.
- **LED-E.** LED-embedded STOP signs.
- **R-Bea.** Roadside intersection beacons where the beacons are mounted above and below the STOP sign located at the intersection.

Figure 16. Examples of Beacon Treatments Being Considered in This Research.

The three treatments selected for this research are illustrated in Figure 16 and include the following:

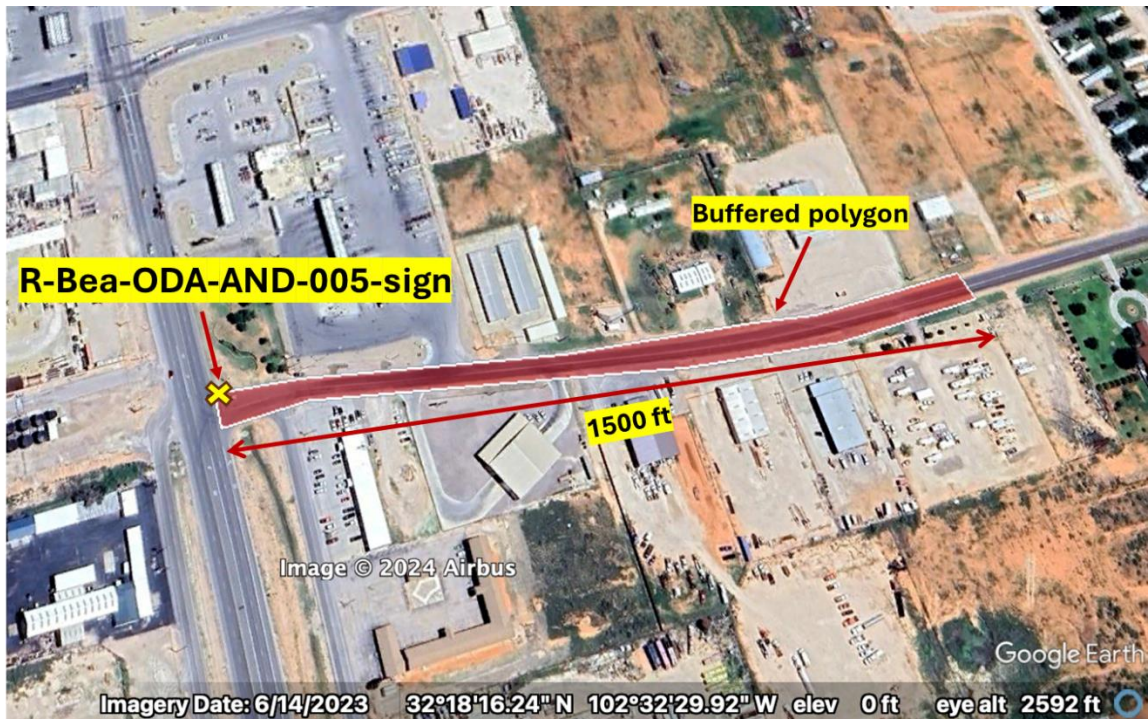
Figure 18. Buffered Polygon at Site R-Bea-ODA-AND-005.

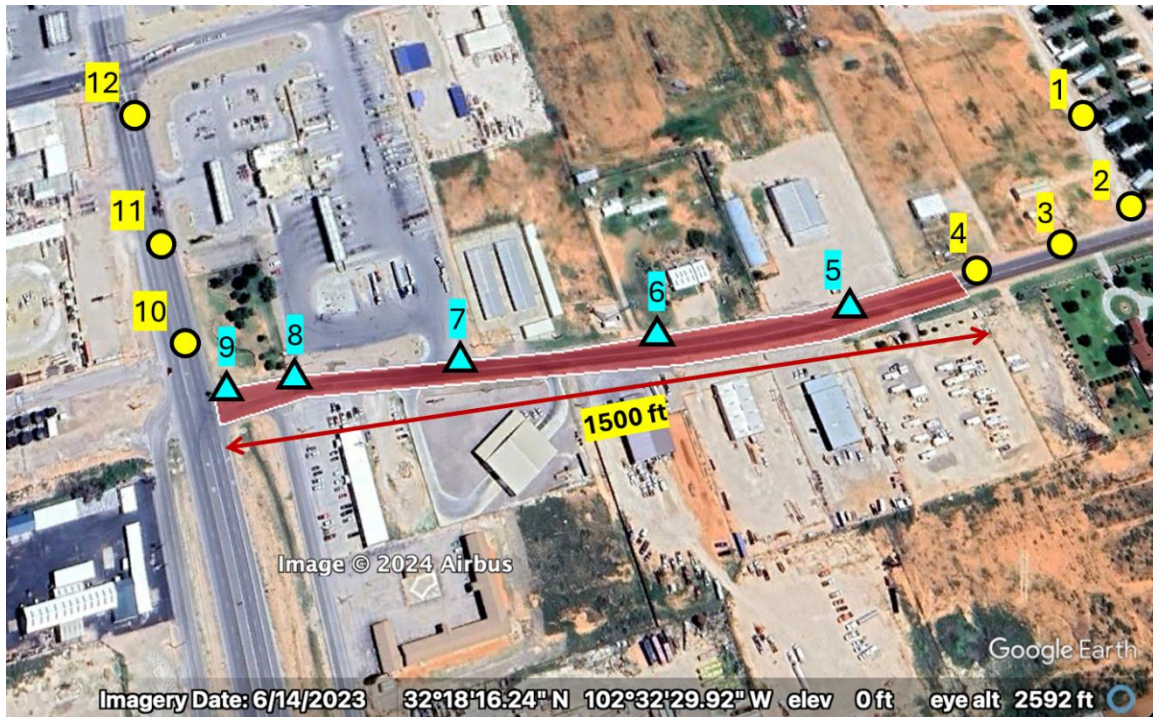
Figure 19. Data Points Selection (Subsetting) along a Trace at Site R-Bea-ODA-AND-005.

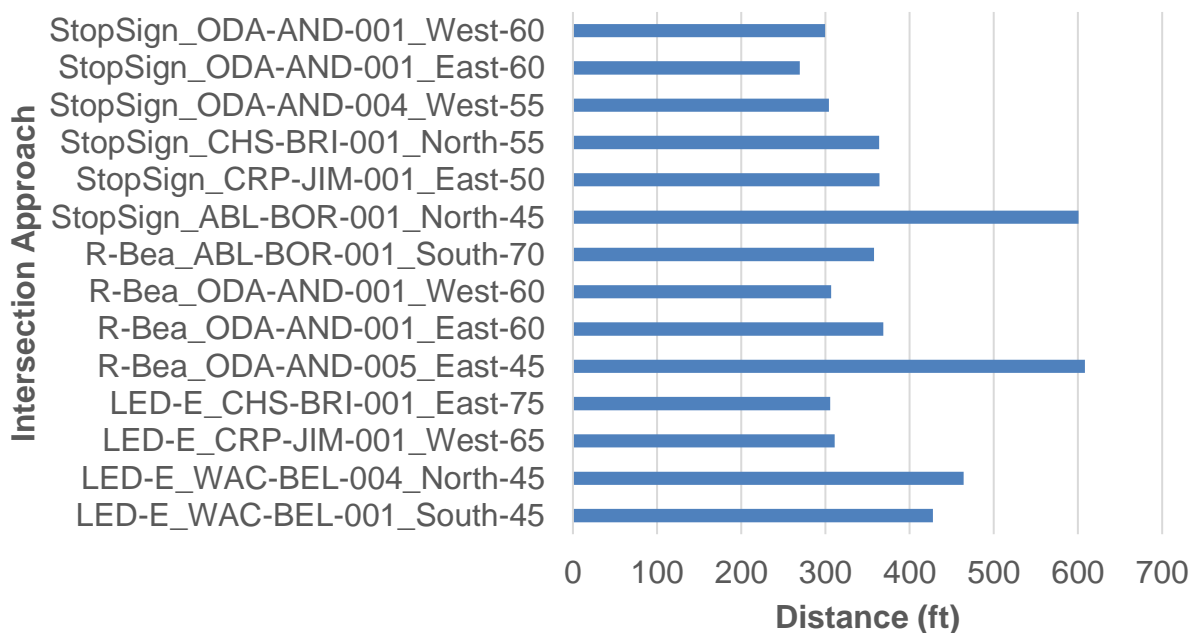
Figure 26. Average Distance Upstream When Drivers Were at 40 mph by Approach.

After a review of the available speed measures, the research team focused on the distance upstream when the driver was either at 40 mph or 20 mph. The plot of the distance upstream when drivers are at 40 mph by approach and by treatment is provided in Figure 26 by individual

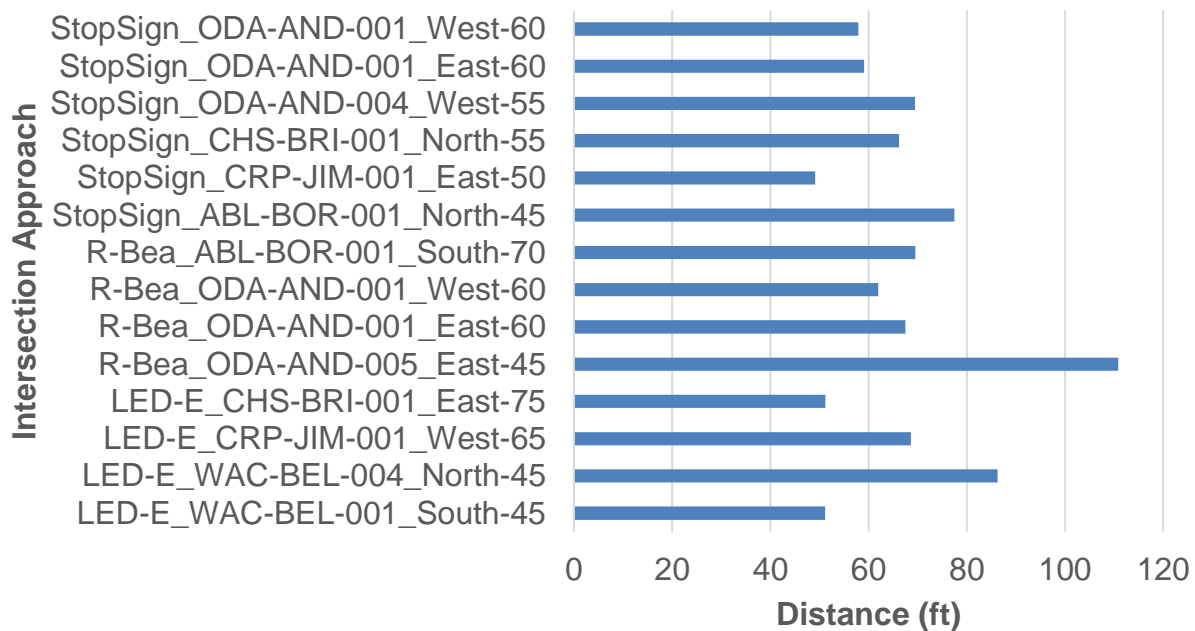
Figure 28. Average Distance Upstream When Drivers Were at 20 mph by Approach.

sites and in Figure 27 by treatment. Figure 28 shows the distances when drivers are at 20 mph by site, while Figure 29 shows those distances when the sites are grouped by treatment.
