## Preservation Alternatives for Historic Truss Bridges

### Introduction

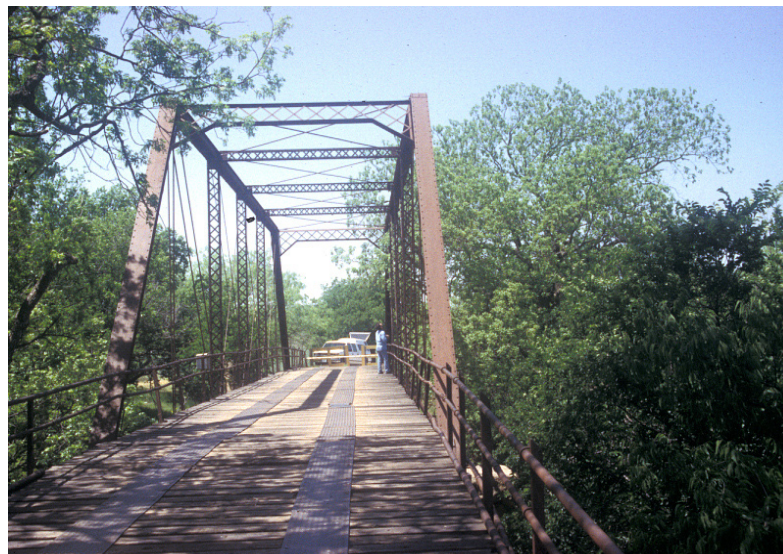
Figure 1: Case Study on CR 188 in Shackelford County, Texas

The second major phase of the project was a case study of an off-system historic metal truss bridge. The case study bridge (Figure 1) is located in Shackelford County, Texas, on County Road 188 near Fort Griffin, and crosses the North Fork of the Brazos River. This single-lane bridge was originally constructed in 1885 by a private bridge company. The bridge is a wrought iron pin-connected Pratt through truss with a span of 109 feet and is the oldest surviving Pratt through truss in Shackelford County and one of the oldest in the state of Texas.

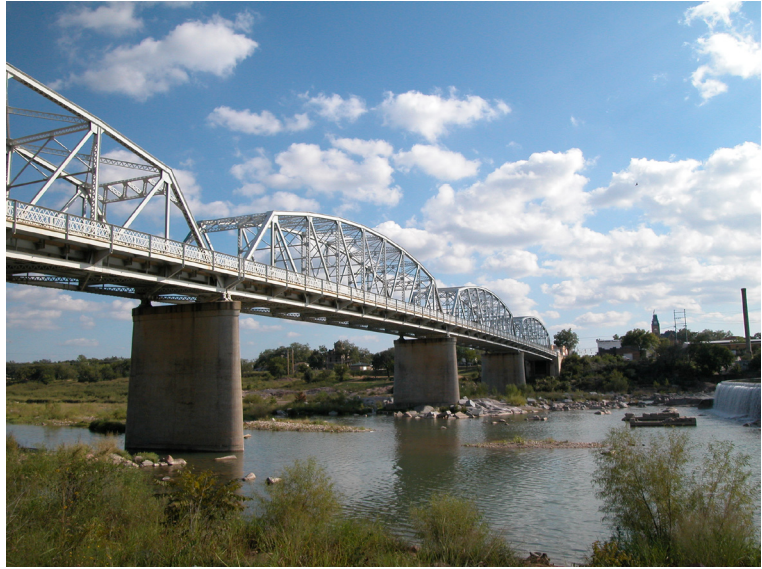
The third major phase of the project was a case study of an on-system historic metal truss bridge. The case study bridge (Figure 2) is located in Llano, Texas. Known as the Roy Inks Bridge, the main structure spans approximately 800 ft. over the Llano River, and was constructed in 1936. The bridge consists of four main spans, each approximately 200 ft. in length. Each span is a Parker through-truss, with a non-composite slab on steel beam and stringer floor system. The study of on-system truss bridges was further supplemented by addi-

Figure 2: Case Study Bridge in Llano, Texas

For the Llano case study bridge, the load rating for the bridge was controlled by the steel floor beams and stringers. A finite element model was developed for the bridge floor system to determine if a higher load rating could be justified by using analysis methods that are more advanced and more exact than those used in conventional load rating. The model was constructed using commercially available finite element analysis software. The finite element analysis showed significantly lower moments in the stringers and beams than conventional AASHTO calculations.
