## Guidelines for the Use of Underseals as a Moisture Barrier: Summary Report

Report 0-4391-1, *Guidelines for the Use of Underseals as a Moisture Barrier*

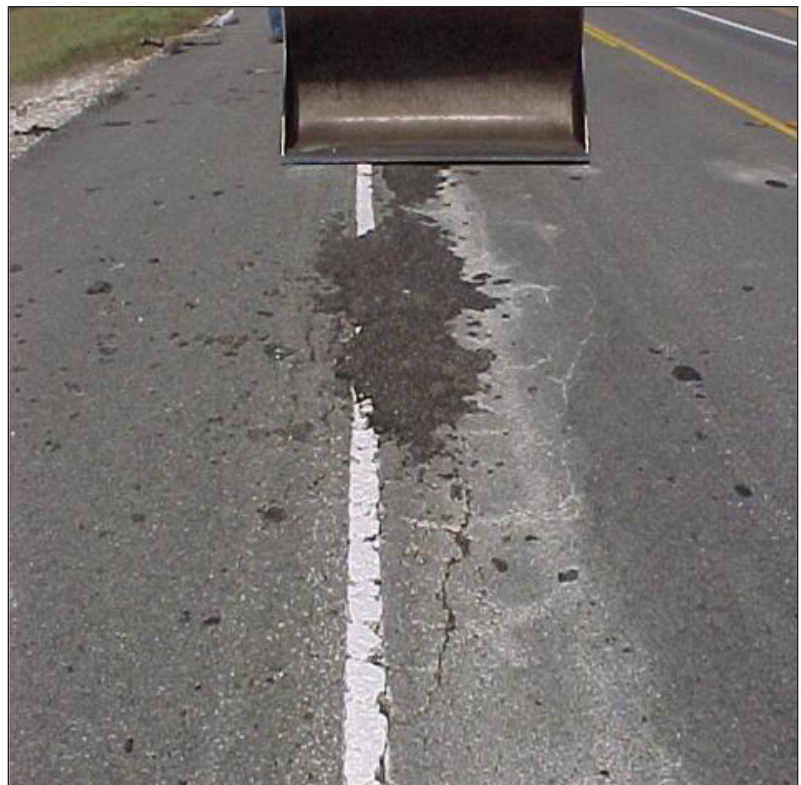
Figure 1. Premature Cracking Associated with Damaged Underseal.

- Base materials should be adequately cured prior to prime and surface treatment. This helps to ensure a good bond of the surface treatment and prevent highway traffic or construction traffic from damaging the surface treatment prior to overlay. Any damaged areas should be repaired. Even small and isolated areas associated with a damaged underseal have led to failure of the underlying base and HMAC overlay.

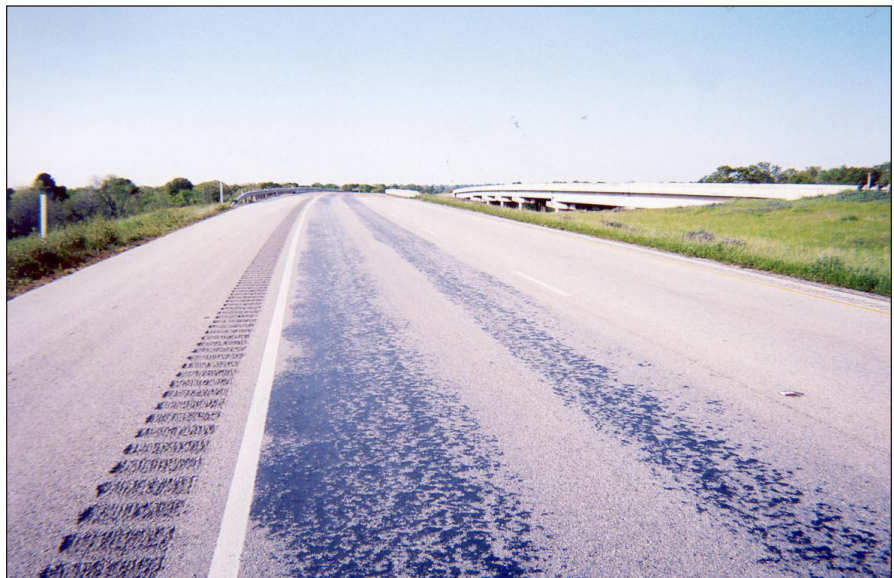
Figure 2. Underseal Bleeding through the Asphalt Concrete Overlay.

- The main problems or failures experienced with underseals include: asphalt binder from the underseal bleeds through to the surface of the overlay; underseals (on aggregate bases) sometimes get damaged by traffic or construction operations prior to overlay, allowing water to leak into the base; and the underseal traps moisture in a moisture-susceptible layer, causing it to fail.
- Excessive binder application rates for underseals can cause the binder to bleed through to the surface of the HMAC overlay. This is true for both very high-viscosity asphalt

binders, such as asphalt rubber, as well as low-viscosity binders. There is some evidence to suggest that low-viscosity binders (even when applied at appropriate application rates) have a propensity for bleeding.
