Using Carbon Fiber Composites to Increase the Flexural Capacity of Reinforced Concrete Bridges

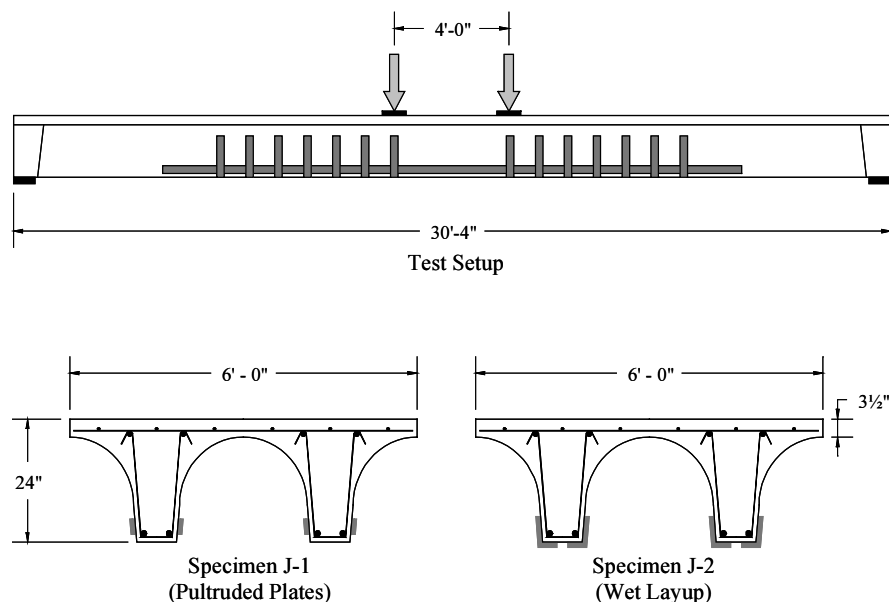
Figure 1 Full-Scale Pan-Girder Test Specimens

The test specimen based on the pan-girder bridge included two girders. Because the bottom surface of the girders is not smooth due to the presence of a joint in the forms, the longitudinal composites were not attached to the bottom surface of the joists along the centerline of the member. The configurations tested eliminated the need to grind the bottom surface of the girders and dramatically reduced the time needed to install the composite materials. Transverse straps were used along the span. The inventory load rating for the prototype bridge was HS-12.2 for flexure. The amount and distribution of the composite materials were selected to increase the inventory rating to HS-20.

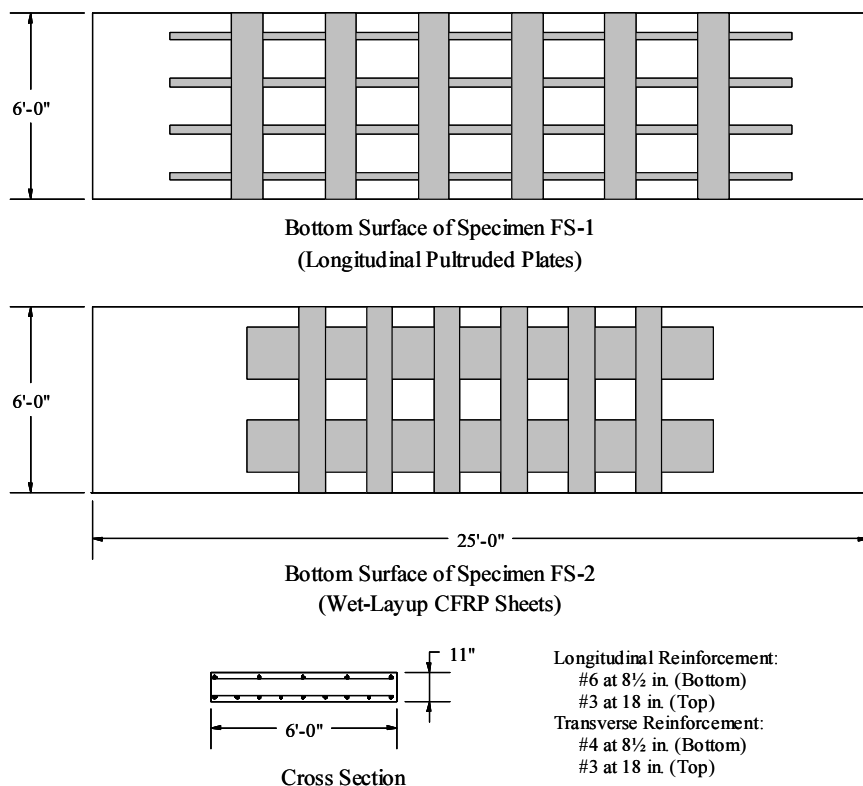
Figure 2 Full-Scale Flat-Slab Test Specimens

The test specimen based on the FS-slab bridge included only a 6-ft wide portion of slab. The structural curbs were not included because the most common concern with FS-slab bridges is the width, and the curbs must be removed in order to widen the deck. Without the structural curbs, the inventory rating for the prototype slab was HS-6.0. The amount and distribution of composite materials were selected to increase the inventory rating for the slab to H-10, which corresponded to the original design strength of the entire bridge.
