Project Summary Report O-4138-5

Project O-4138: Full-Scale Crash Tests of  
FRP Bar Reinforced Bridge Rails

## Crash Tests Evaluate Performance of GFRP Reinforced Bridge Rail

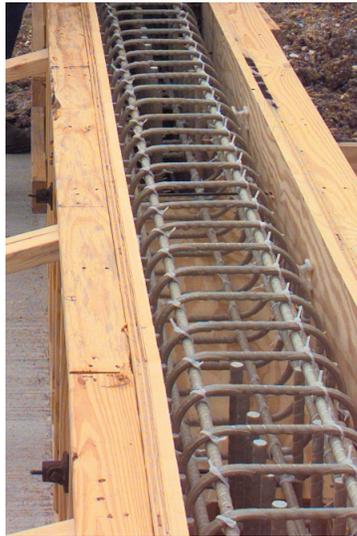
*GFRP bars in place immediately before placement of concrete. GFRP bars are tied with nylon cable tie.*

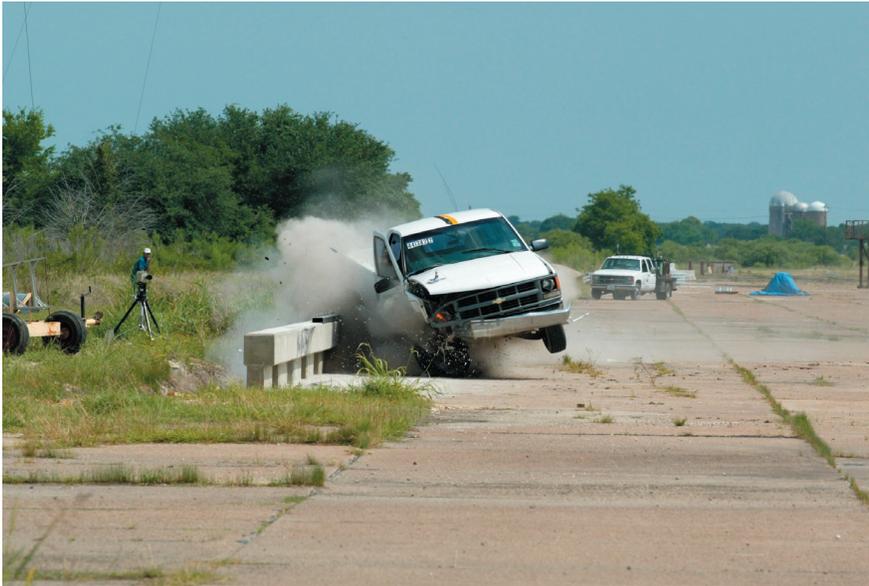
Vehicle during collision with 30-inch version of bridge rail.

TxDOT and TTI engineers decided to test the weaker portion of the railing with a structural steel tube added to the top to increase total height to 30 inches. The vehicle did not roll over in this test. The bridge rail demonstrated adequate structural capacity and met the performance requirements of NCHRP Report 350. A brief summary evaluation for each bridge rail is provided in [Table 1](#).

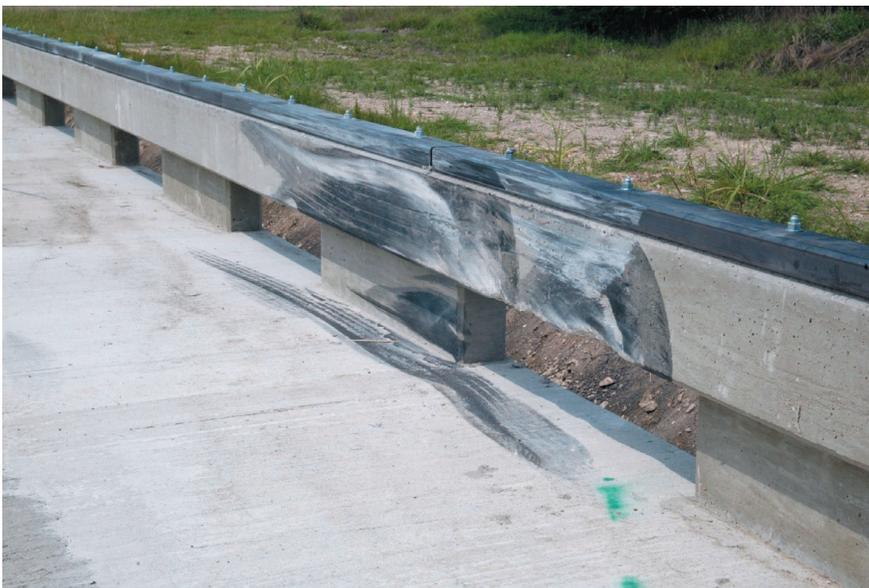
After-test photo of bridge rail showing marks from vehicle. Note that tire contacted post.
