CONTINUED EVALUATION OF MICROCRACKING IN TEXAS

Stephen Sebesta
Associate Transportation Researcher
Texas Transportation Institute

Report 0-4502-2
Project 0-4502
Project Title: Microcracking Stabilized Bases during
Construction to Minimize Shrinkage

November 2005

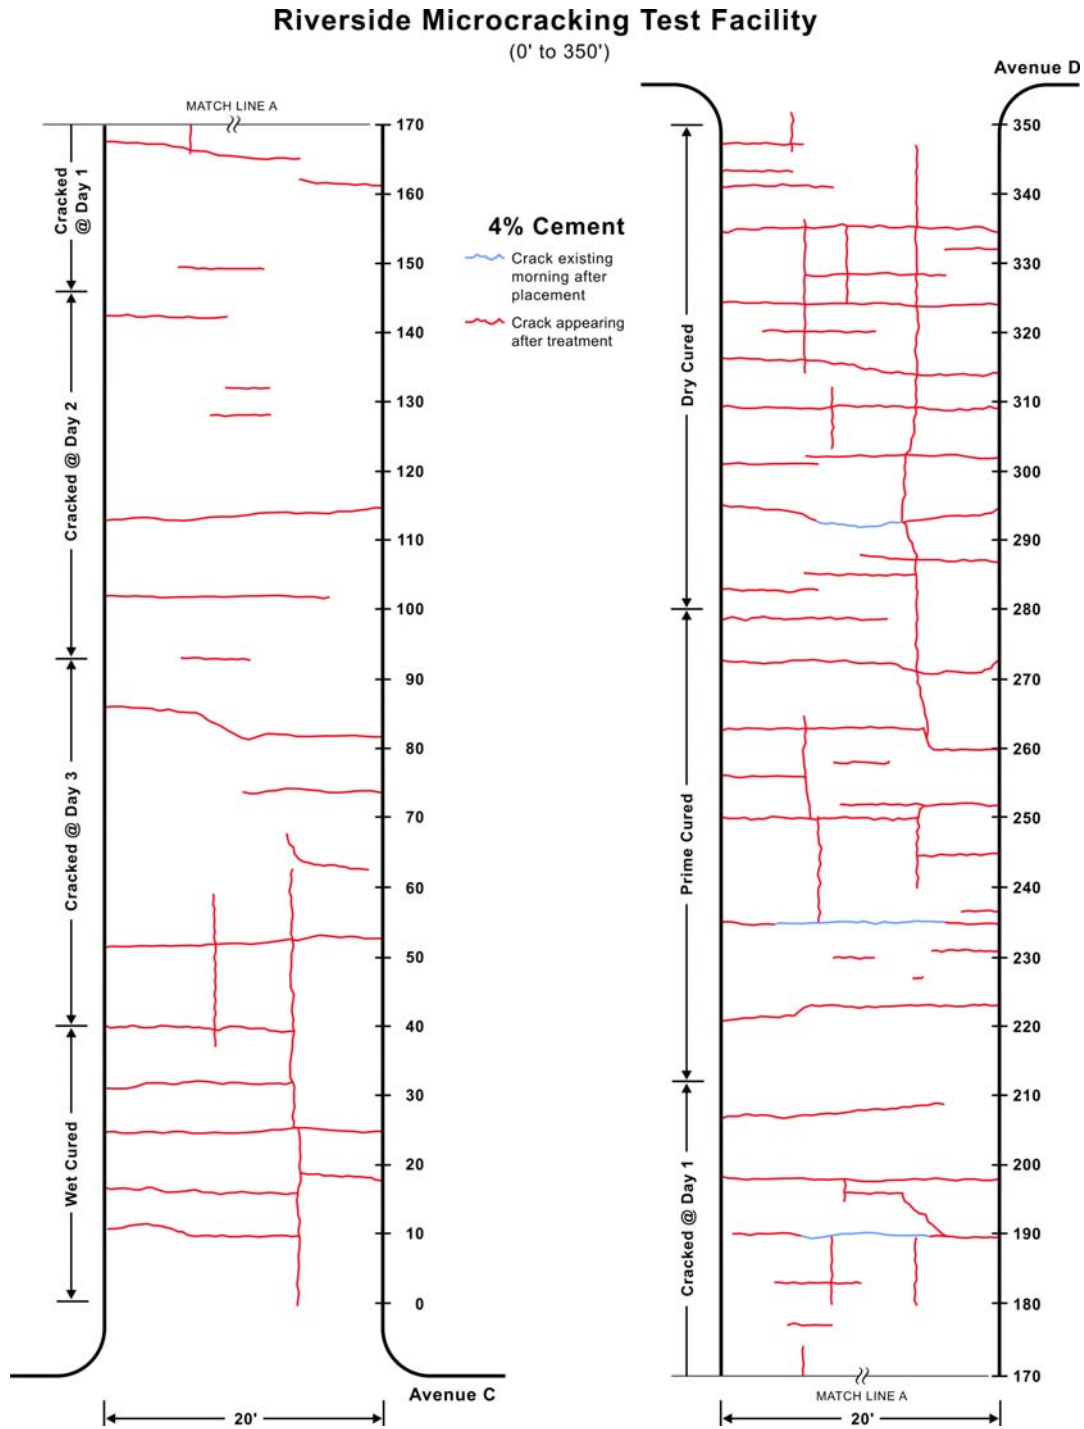
Figures 2.1 and 2.2 show the cracking present at the test sites as of June 2005. Table 2.1 shows the cracking statistics of the test sites through time. Table 2.1 also shows the cracks occurring after application of the treatment, or "preventable" cracking, as of June 2005, and the percent change in cracking for each treatment as a percentage of the amount of cracking in the control (moist cured) section. These data show:

Figure 2.1. Crack Map of Riverside Test Sites with 4 Percent Cement.

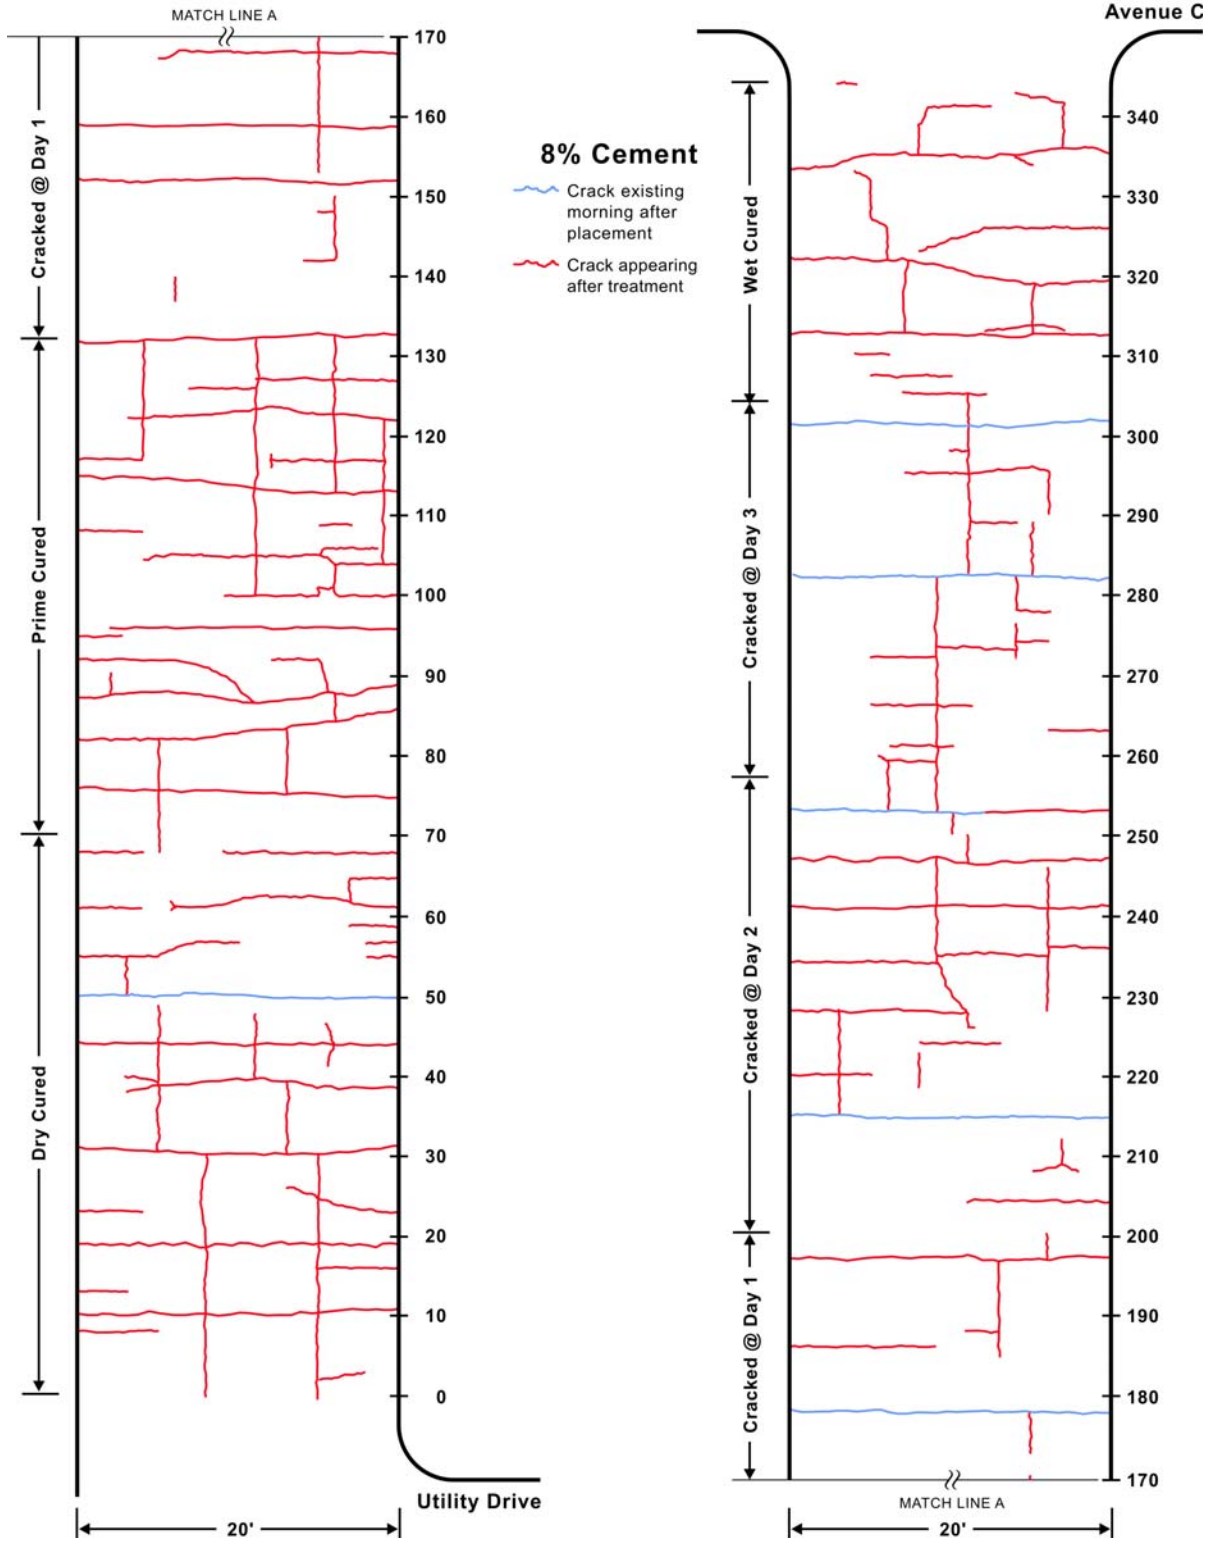
Figure 2.2. Crack Map of Riverside Test Sites with 8 Percent Cement.

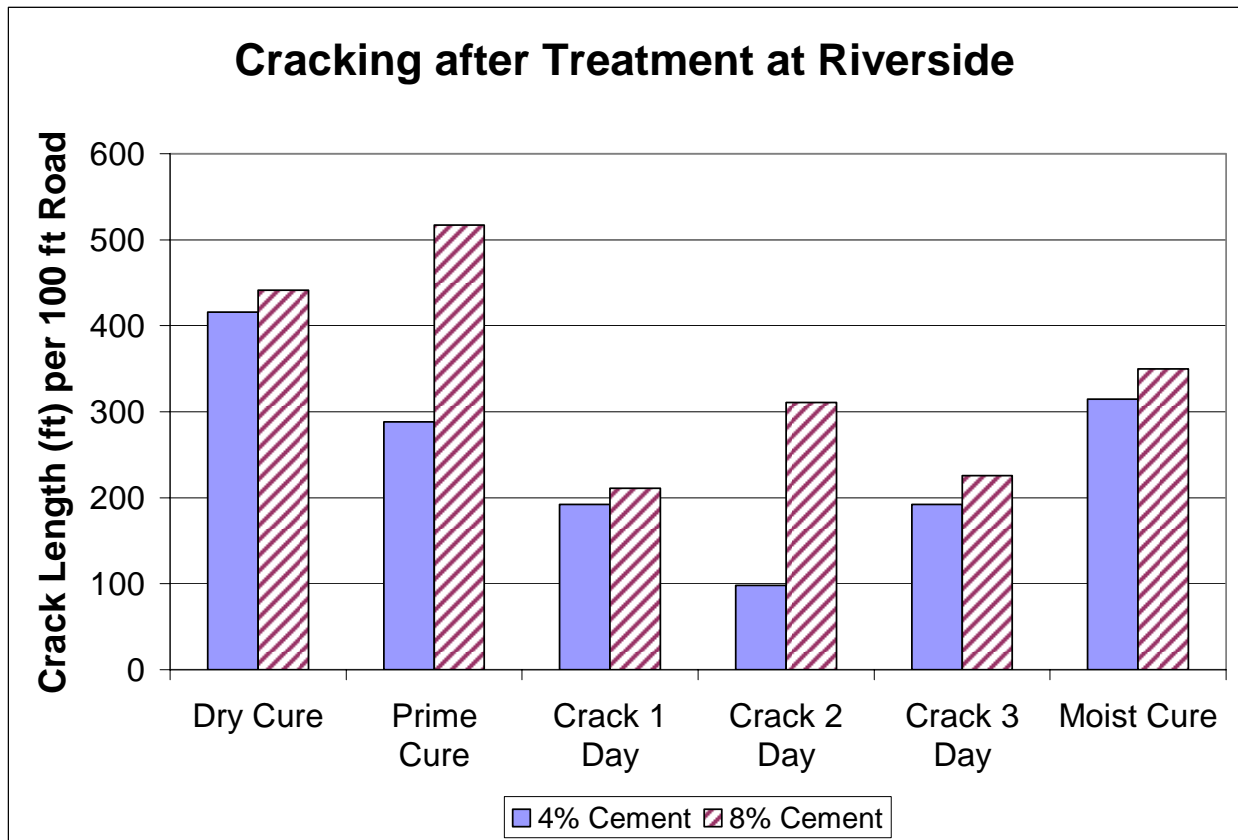
Figure 2.3. Crack Lengths after Treatment at Riverside Sites in June 2005.

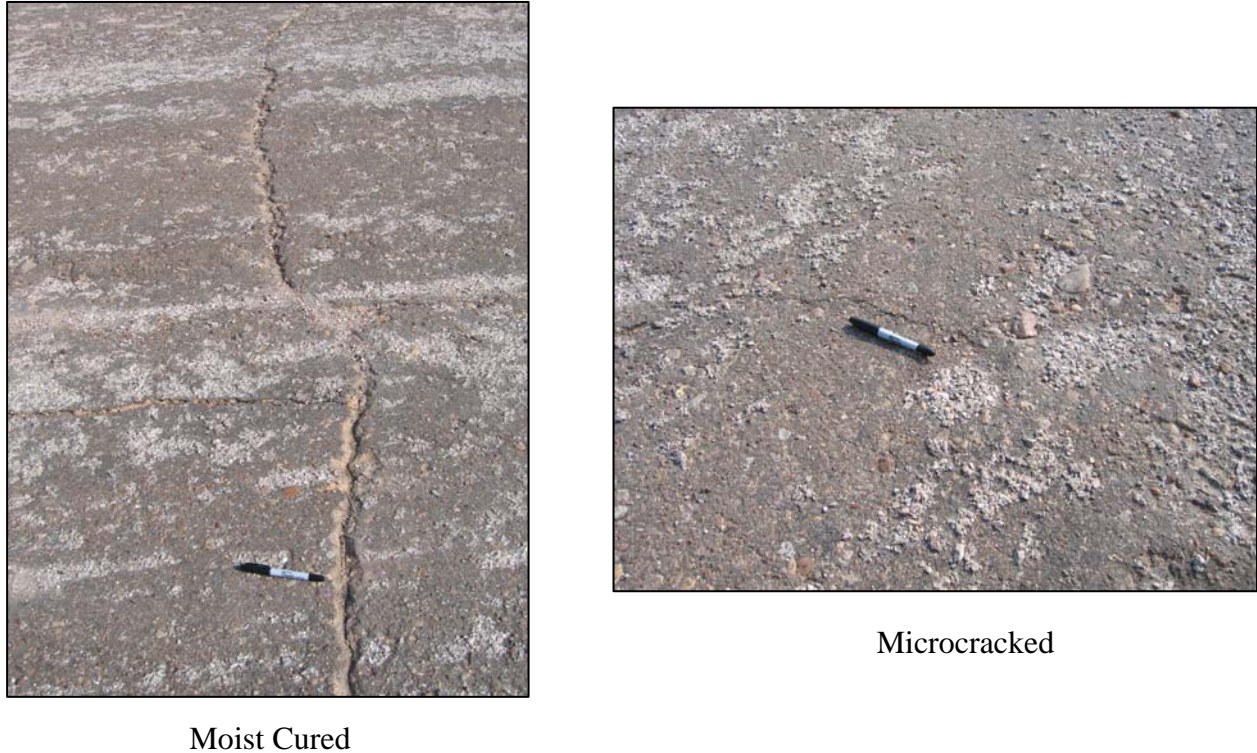
Another previously noted benefit of microcracking is reduction in crack severity. As observed previously, sections microcracked continue to exhibit an overall reduction in crack severity, as shown in Figure 2.4.

Figure 2.4. Reduction in Crack Severity by Microcracking.

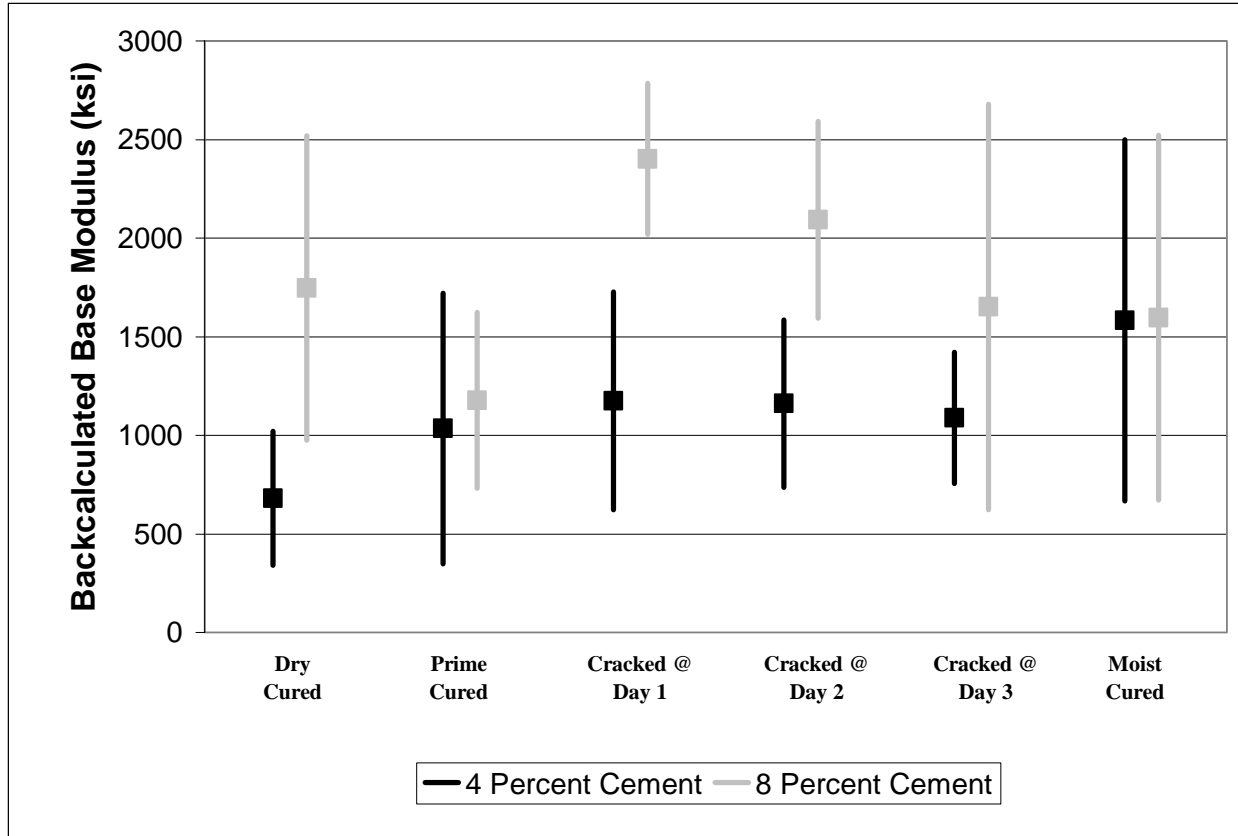
Tables 2.2 and 2.3 present the backcalculations from the survey conducted in June 2005. Figure 2.5 illustrates the average backcalculated modulus values for each of the Riverside sections at this time. The square marker denotes the average value, and the vertical lines represent the 95 percent confidence interval for the population mean. For a given treatment, statistical tests reveal when dry cured, microcracked after one day, or microcracked after two days, the sections with 8 percent cement currently have a higher mean modulus value than their counterpart sites treated with only 4 percent cement. The lower values at the sites with 4 percent cement are not a concern, however, since all of the backcalculated values are high, with all but one section greater than 1000 ksi.

The key question to answer from long-term FWD monitoring is whether microcracking reduces the in-service base modulus. Table 2.4 shows the results of an ANOVA test on the sites with 4 percent cement, which shows that no significant difference in mean modulus value exists among any of the sections treated with 4 percent cement. Table 2.5 shows the results of an ANOVA test on the sites with 8 percent cement, again showing no difference in mean modulus

Figure 2.5 Modulus Values of Riverside Test Sites in June 2005.
