TxDOT Report 0-7072-1
Improve Data Quality for Automated Pavement Distress Data Collection

Texas State University, Ingram School of Engineering; San Marcos, Texas
Feng Wang (PI)
Xiaohua Luo
Jueqiang Tao
Gauri Ravikant Mahajan
Ajmain Faieq

Submitted August 2024; Published November 2024

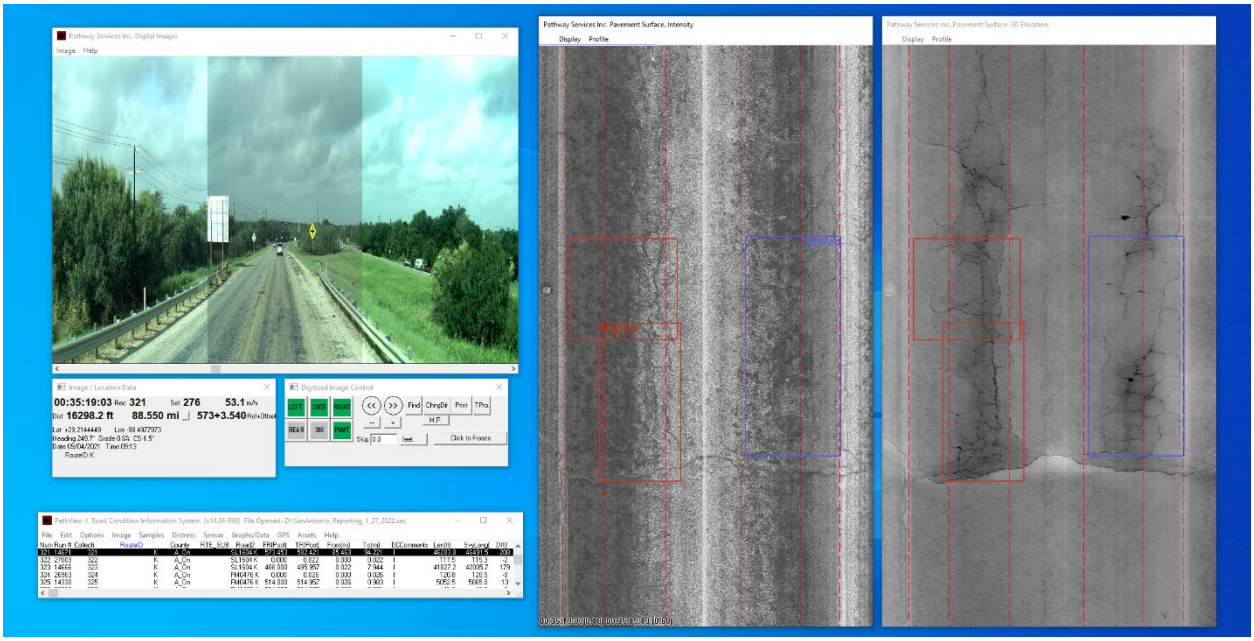
(1) SAN ANTONIO_BEXAR_SL1604_576+0.54 (ACP ALLIGATOR CRACKING PCT)

Figure 6.1 visually presents the outcomes of the automated data detection/identification process. It becomes apparent that certain discrepancies exist in the automated analysis. Specifically, FP cracks are observed in the detection of longitudinal cracking, while FN cracks are apparent in the identification of alligator cracking, transverse cracking, block cracking, and patching. Regarding failures, the audit rating incorrectly identifies overlay as failures. This misclassification requires attention and correction.

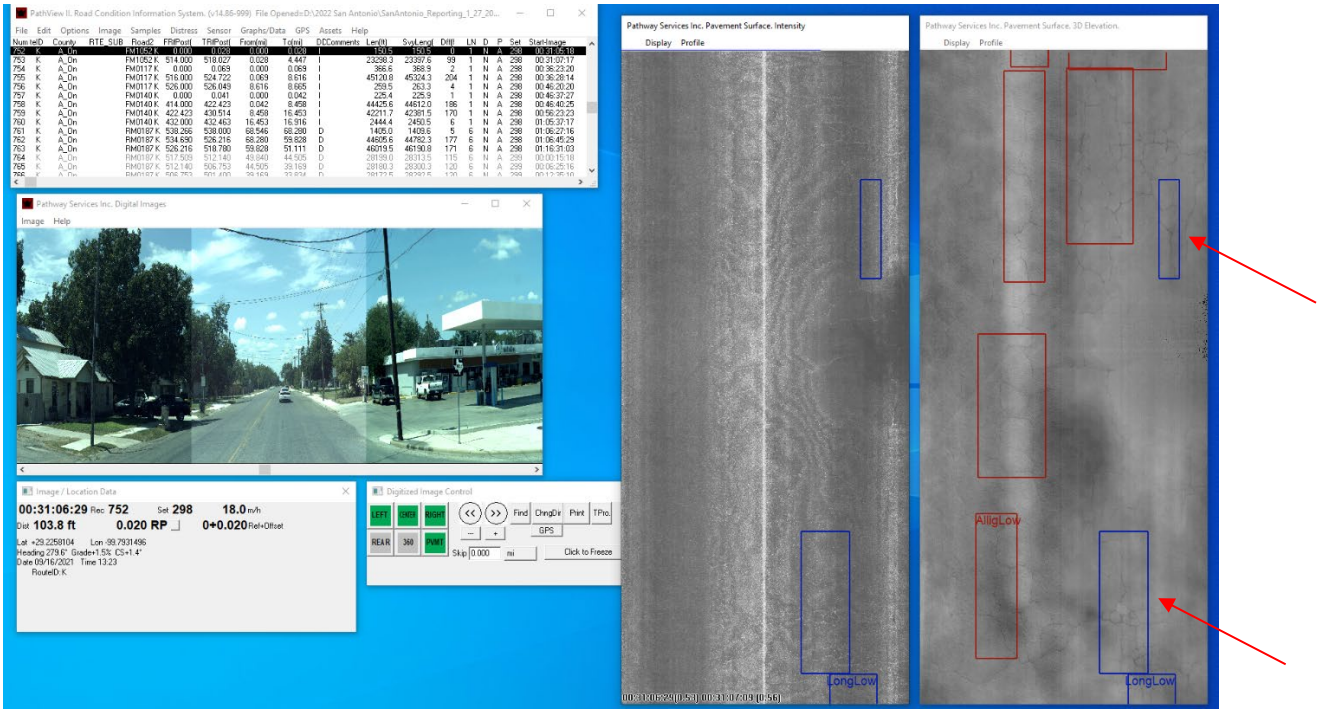
Case 1: Software identified alligator cracking as longitudinal cracking (blue box)

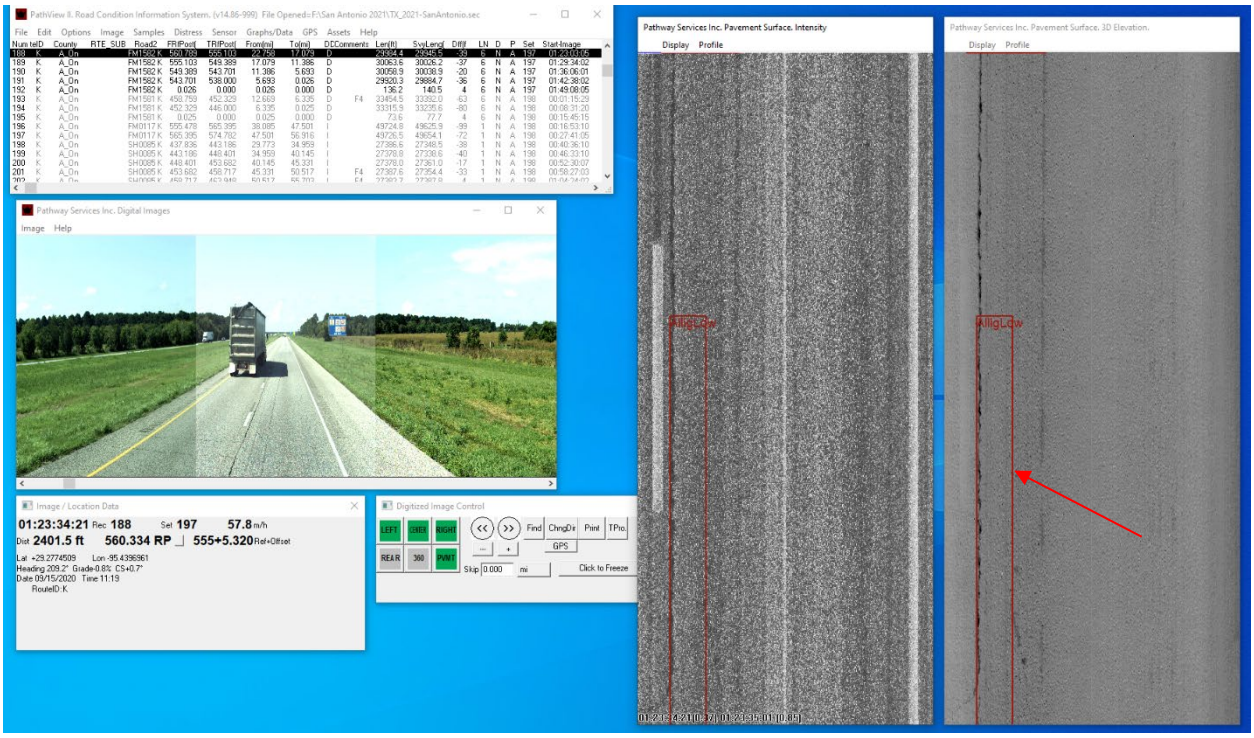
Case 2: Software identified longitudinal cracking as alligator cracking (red box)

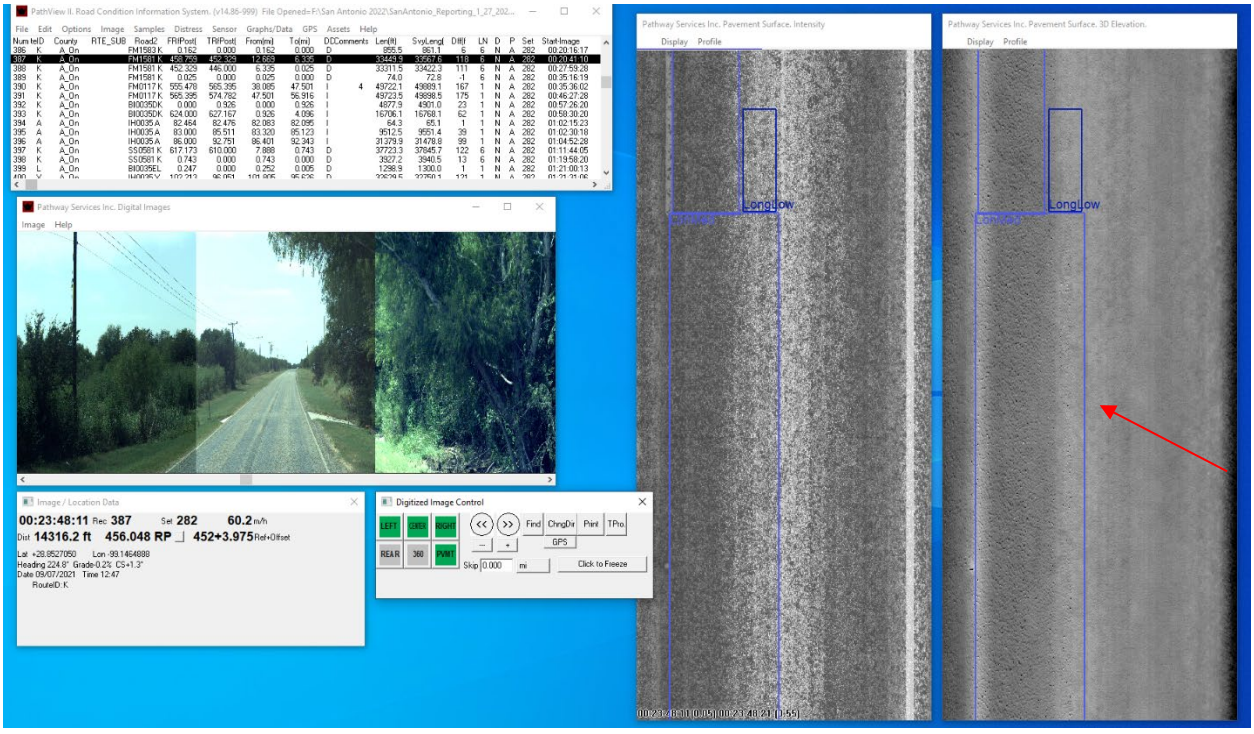
Case 3: Software identified raveling as longitudinal cracking (blue box)

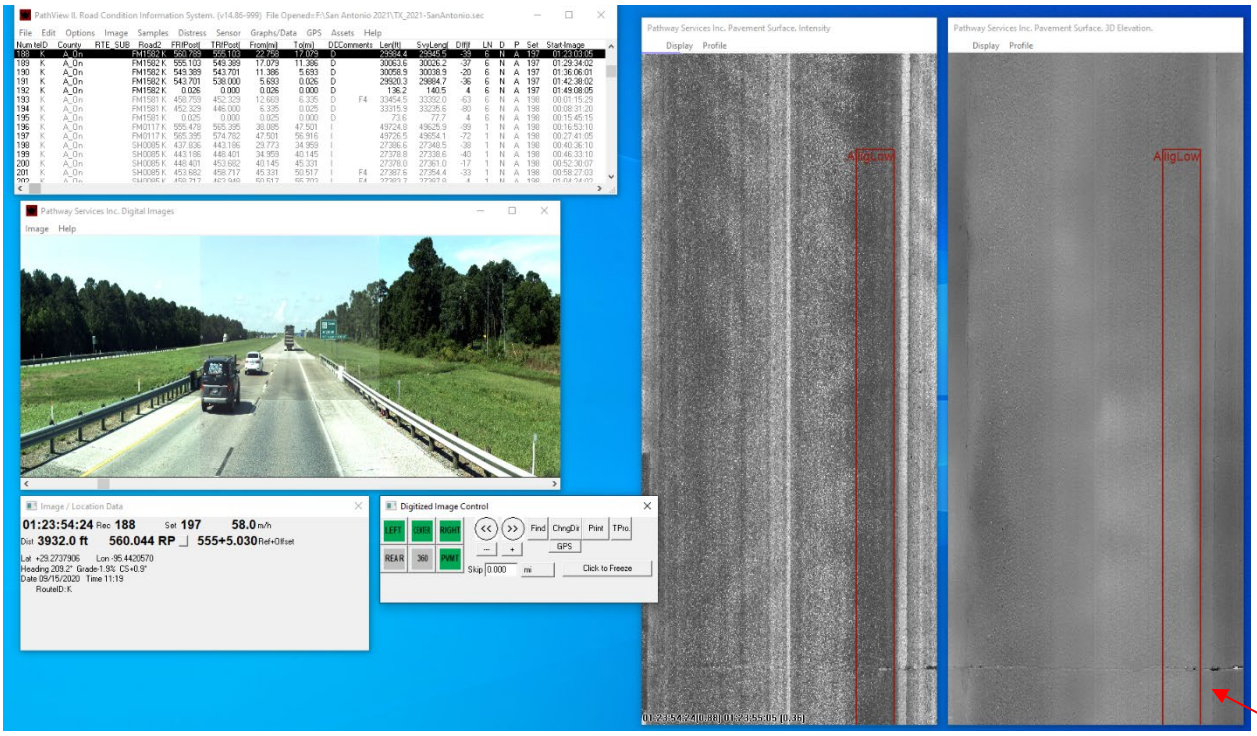
Case 4: Software identified transverse cracking as alligator cracking (red box)

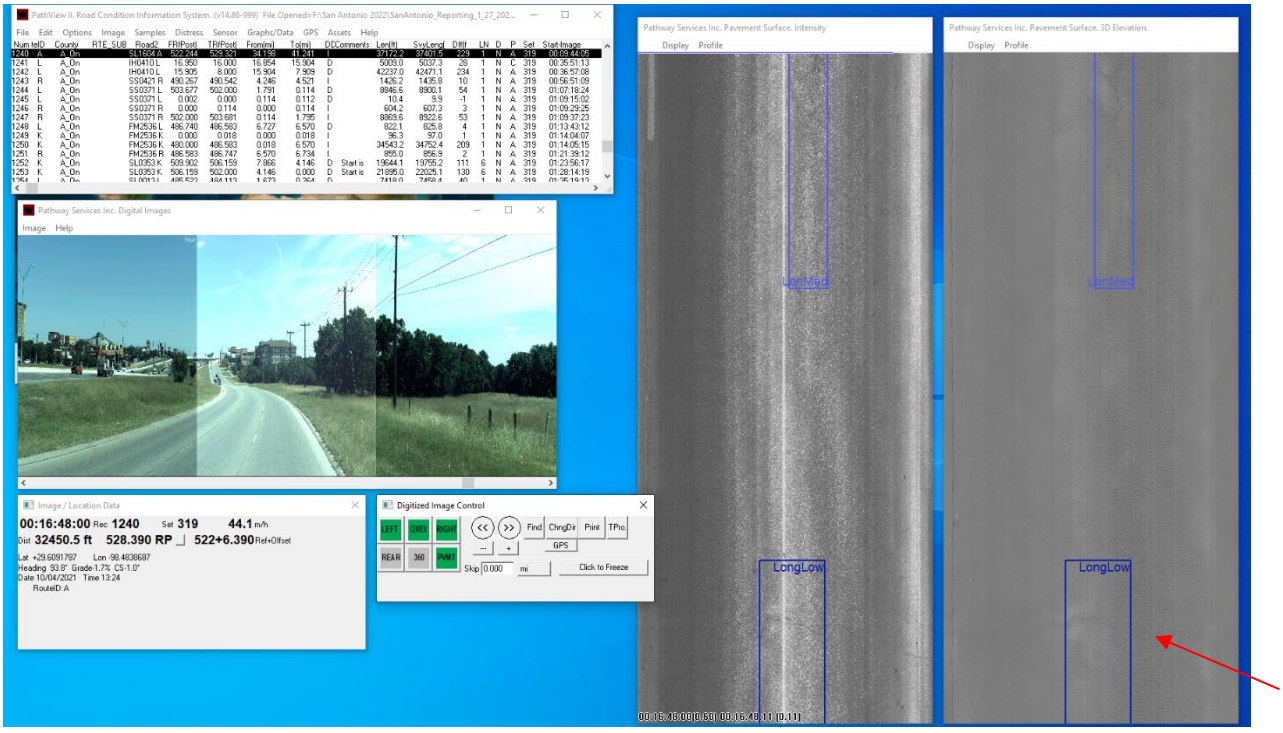
Case 5: Software identified transverse cracking as longitudinal cracking (blue box)

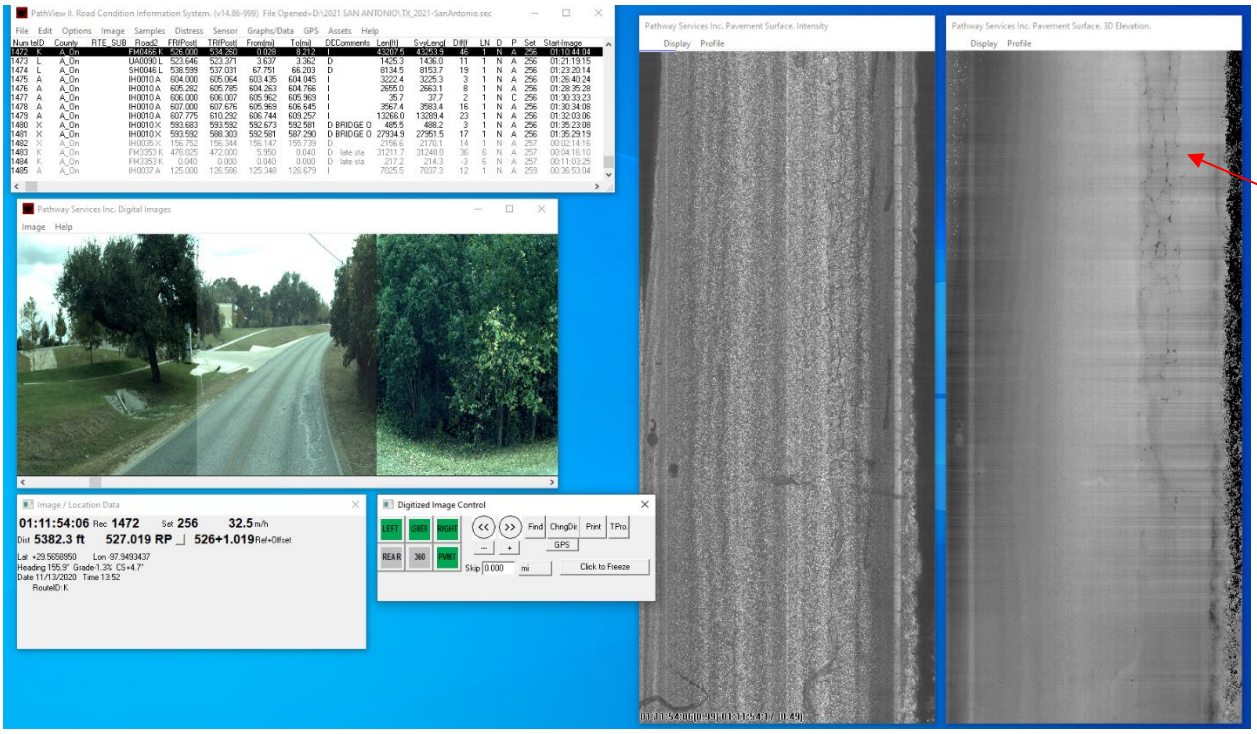
Case 6: Software failed to detect alligator cracking

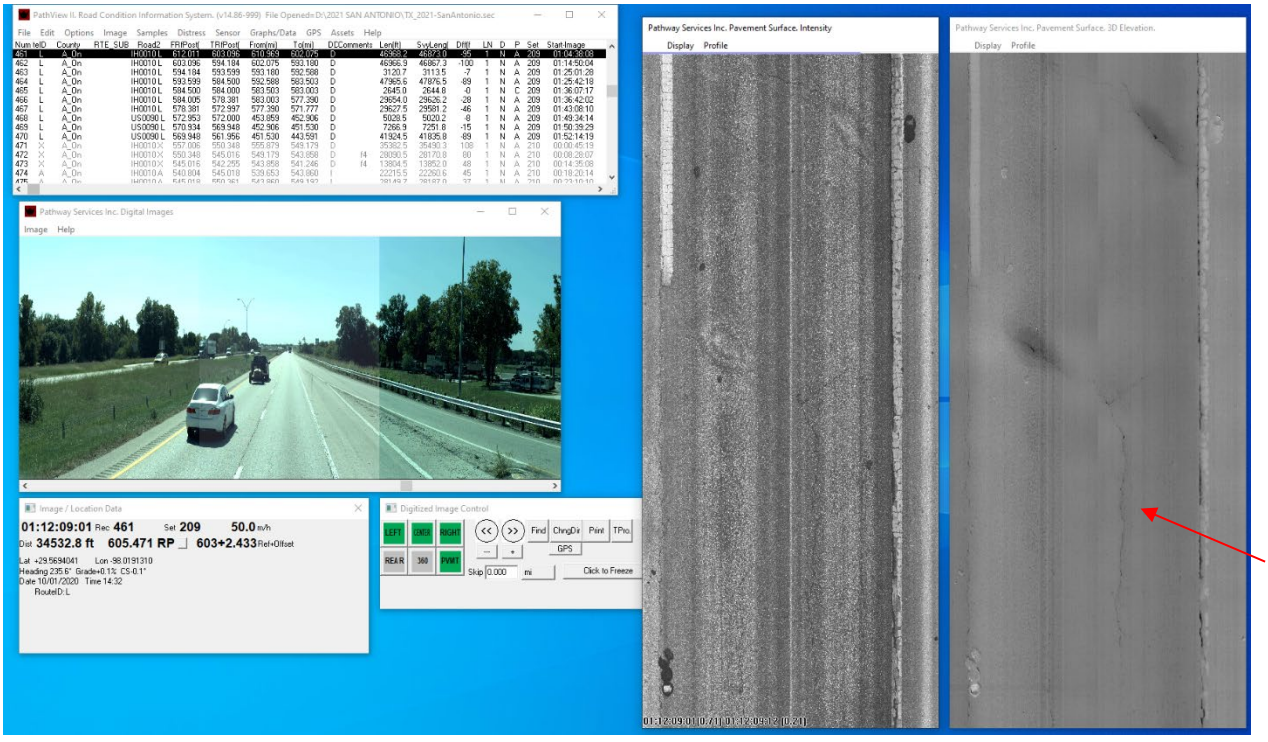
Case 7: Software failed to detect longitudinal cracking

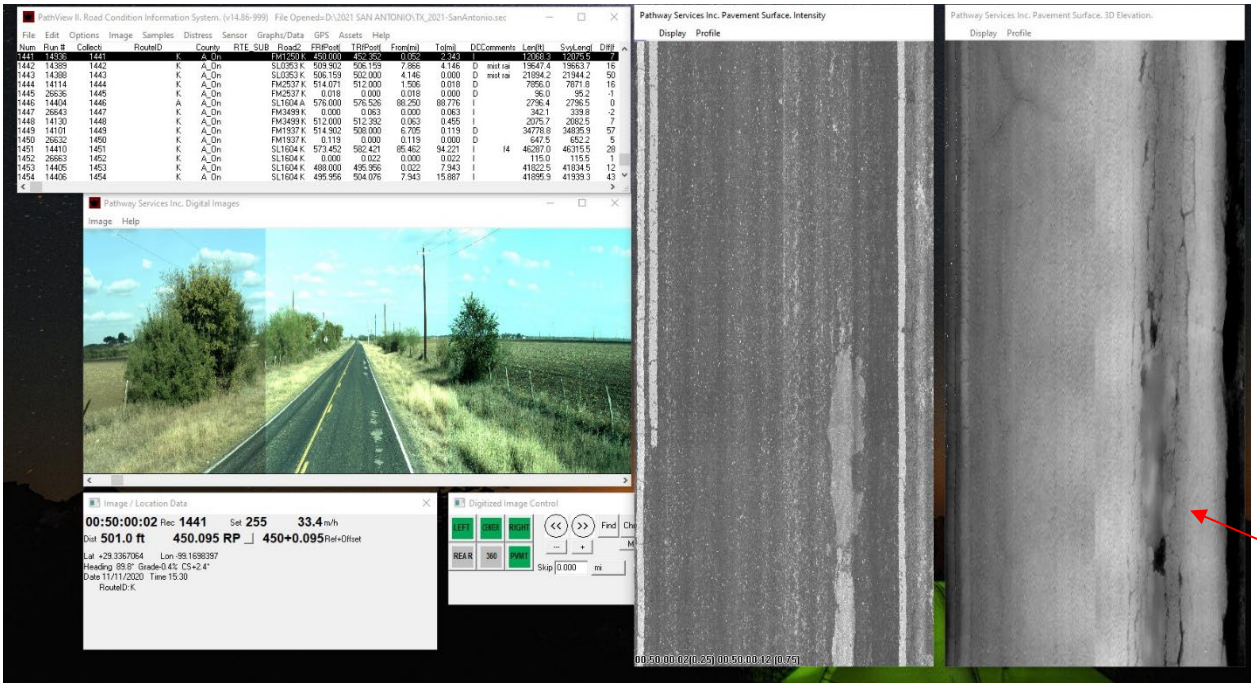
Case 8: Software failed to detect ACP failure
