## **Evaluation of Lightweight Noise Barrier on IH-30 Bridge Structure in Dallas, Texas**

CTR Technical Report:	0-6804-1
Report Date:	August 2014; Published March 2015
Project:	0-6804
Project Title:	Life Cycle Cost and Performance of Lightweight Noise Barrier Materials Along Bridge Structures
Sponsoring Agency:	Texas Department of Transportation
Performing Agency:	Center for Transportation Research at The University of Texas at Austin

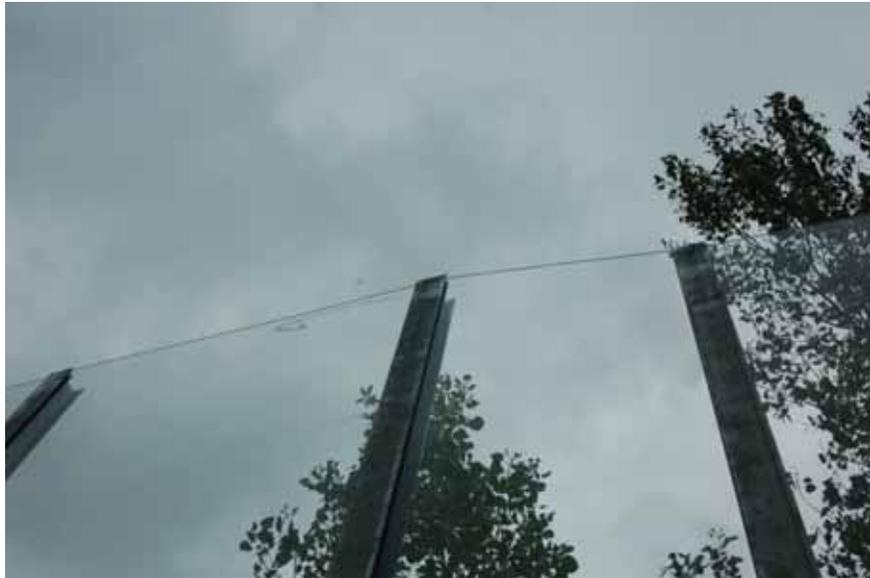
A few problems were noticed before the completion of the installation, such as some supports not being completely vertical (Figures 7.9 and 7.10), some apparently missing rubber gaskets between panels and the metal supports, some gaskets slightly out of place (Figure 7.11), as well as some gaps between gaskets and metal supports, both for vertical and horizontal gaskets (Figures 7.12 and 7.13).

*Figure 7.10: Vertical support off-plumb*

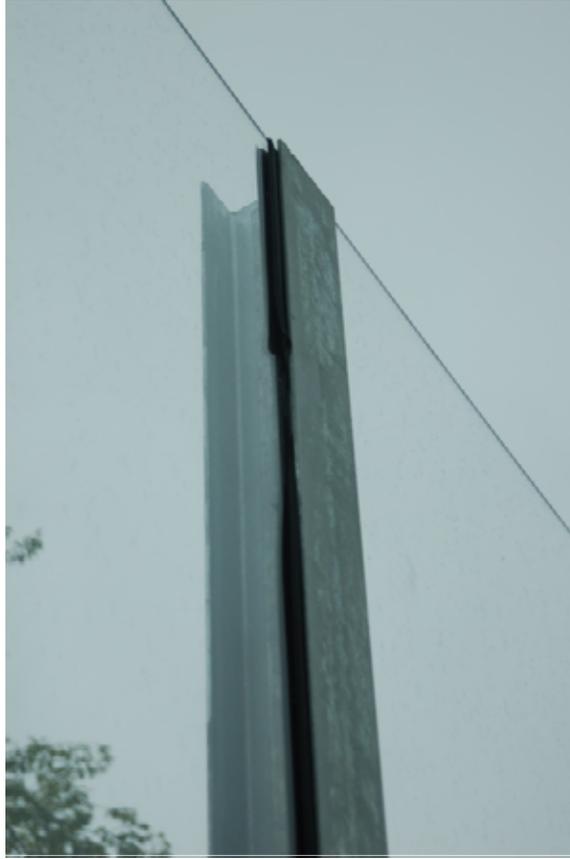
*Figure 7.11: Gasket shown protruding from metal support*

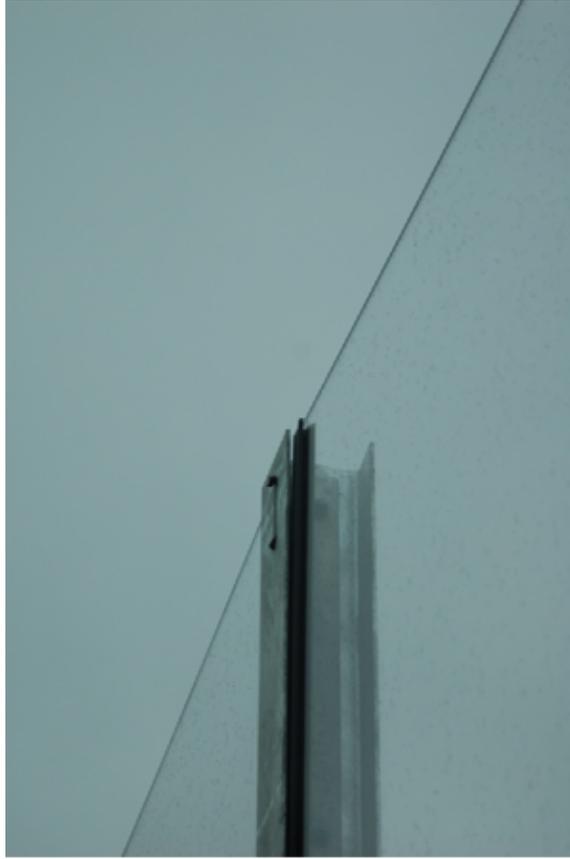
*Figure 7.12: Gap between vertical gasket and metal support*

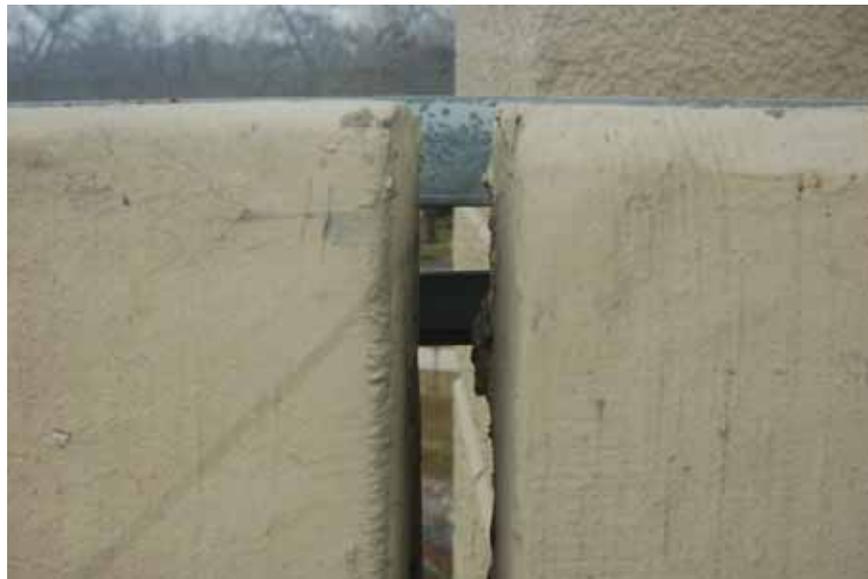
Additionally, some gaps were observed in the existing concrete wall at the expansion joints of the bridge (Figures 7.15 and 7.16), gaps that should be filled with some elastic joint sealing material allowing for the bridge’s thermal expansion and contraction. Such material should prevent the sound from traveling from the highway to the neighborhood to further attenuate the noise at the receivers’ locations and contribute to the wall’s effectiveness. This would be TxDOT’s responsibility, as it is not an issue of the transparent noise wall, but rather of the existing structure.

*Figure 7.16: Gap in existing concrete wall at bridge expansion joint as seen from the highway side*

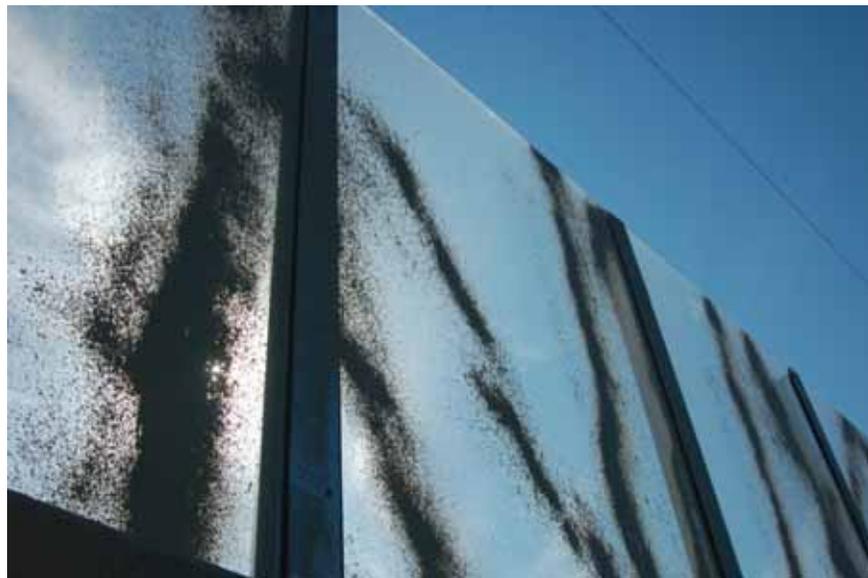
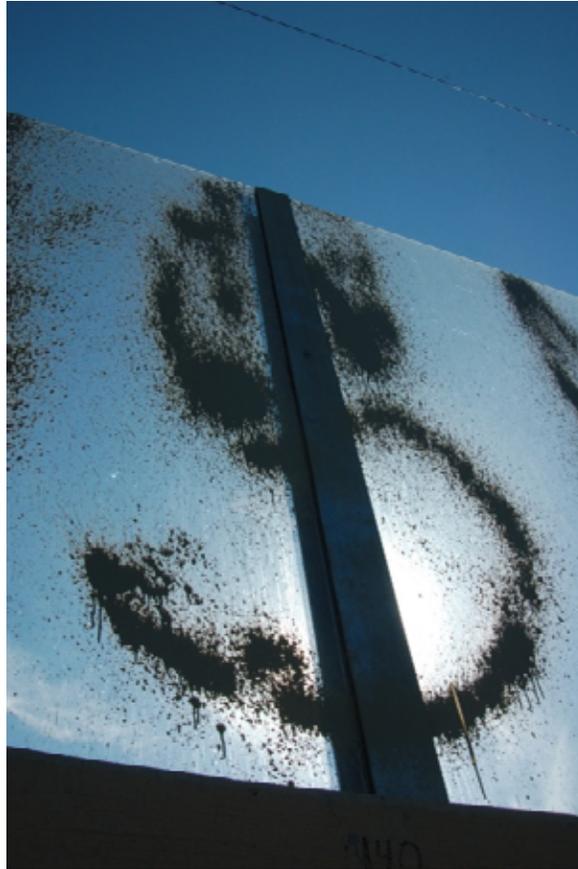
On November 11, 2013, while performing the wall inspection, it was noticed that some of the panels had been damaged by graffiti. Ten transparent panels, from spans # 135 to 144 (as marked by the contractor on the concrete wall during installation) were sprayed. The concrete wall under span # 144 was also painted. From the distance, the damage was barely noticeable, and from some angles, it was not visible at all. The appearance of the sprayed material was that

of some type of drywall mud or acoustic texture that is used in ceilings. Pictures of the graffiti are shown in Figures 7.17 to 7.23. The damage was reported immediately to TxDOT.

*Figure 7.18: Graffiti as seen from the highway shoulder on November 11, 2013*

*Figure 7.21: Graffiti as seen from the highway shoulder on November 11, 2013*

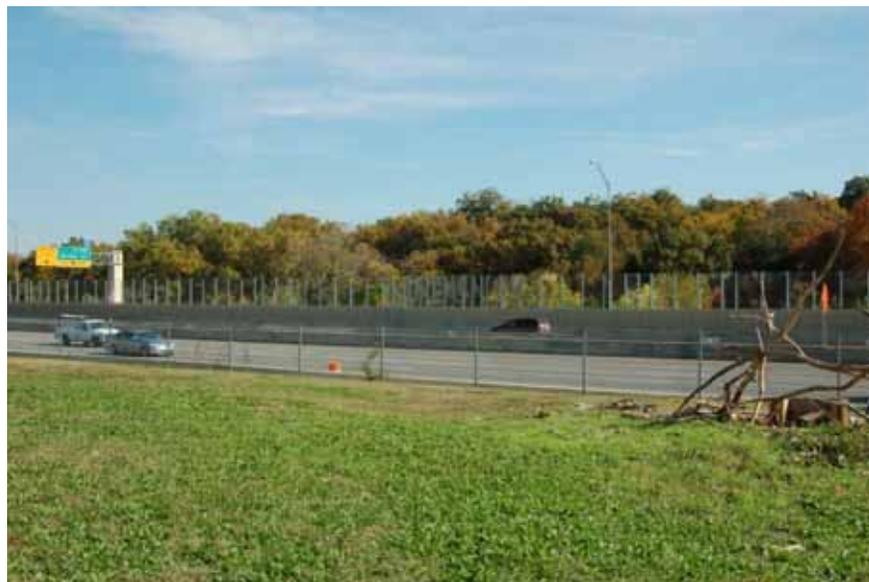
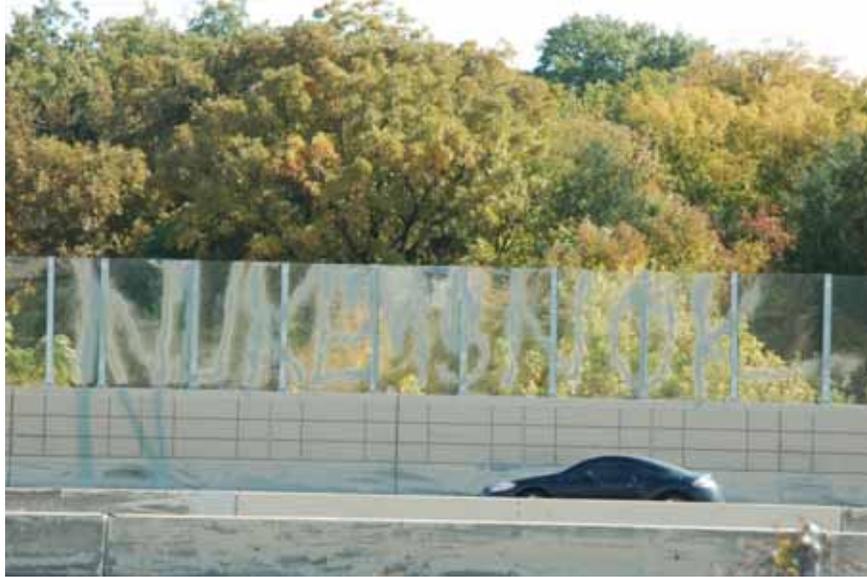
*Figure 7.22: Graffiti seen from the north side of IH 30*

*Figure 7.23: Graffiti seen from the north side of IH 30*

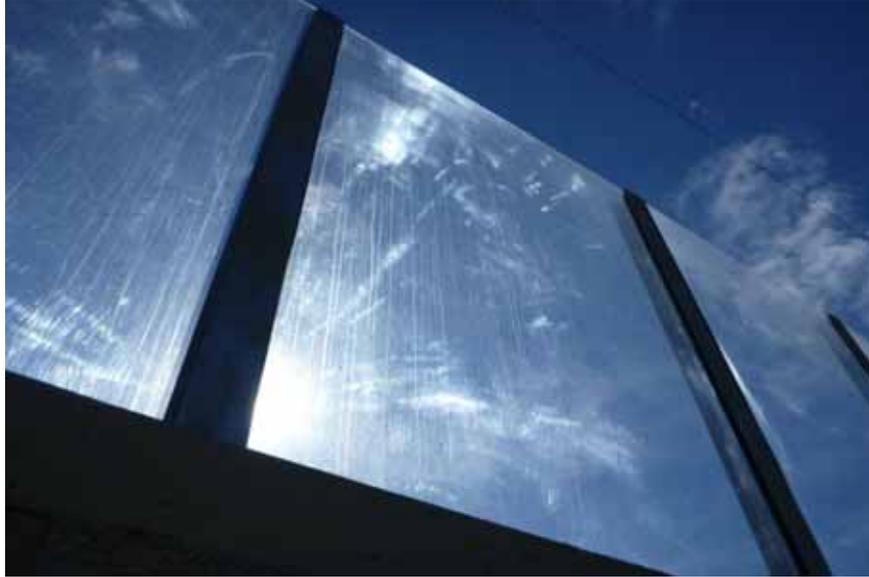
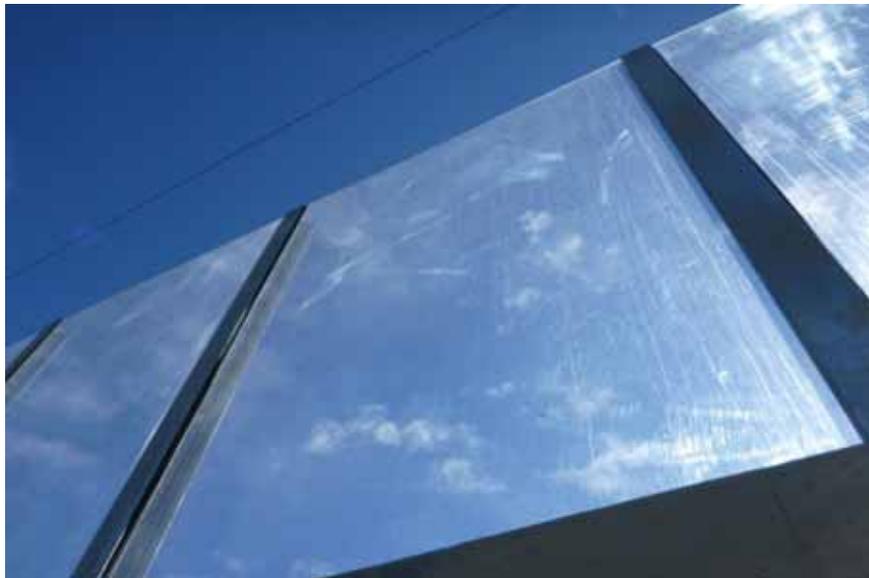
*Figure 7.24: Cleaned panel showing traces of the cleaning operation*

*Figure 7.25: Cleaned panel showing traces of the cleaning operation*

During the remaining part of November and December 2013, no work was performed to clean the sound wall. By January 28, 2014, the panels had been cleaned. The following cost information for the cleaning operations was kindly provided by Mr. Frank Jett, with the Dallas District, Heavy Equipment Maintenance:

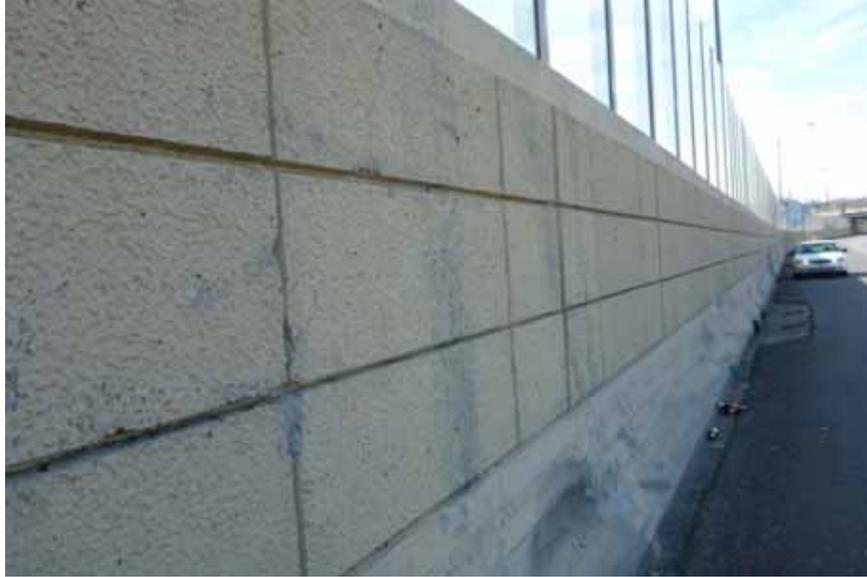
Figure 7.26 shows that the graffiti that extended to the concrete wall could not be entirely removed, and Figure 7.27 shows a photograph taken from afar after the panels had been cleaned.

*Figure 7.26: Remnants of the graffiti on the concrete wall below the panels*

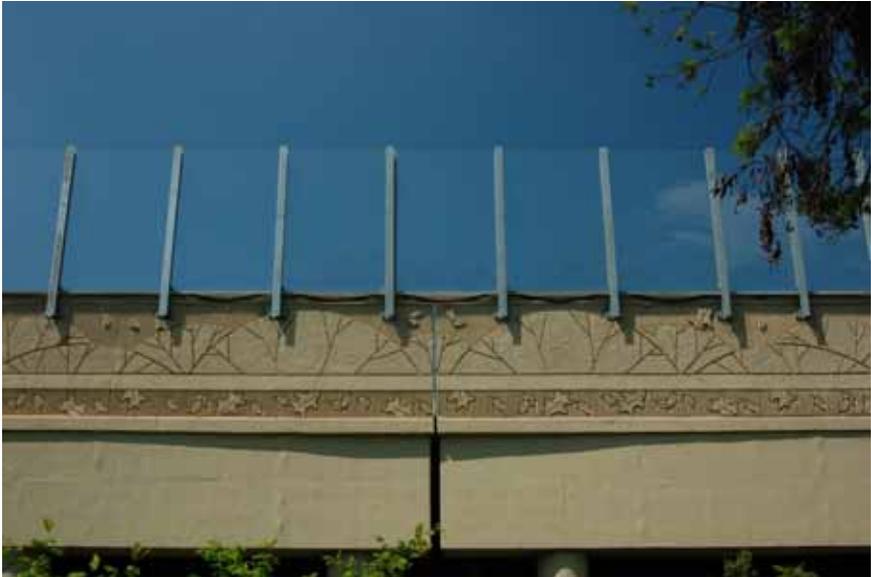
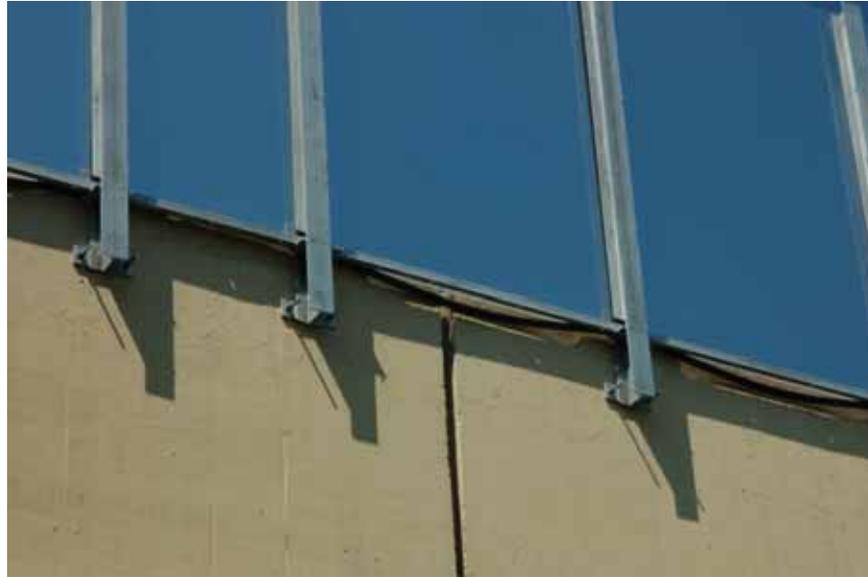
Besides the graffiti, which was successfully removed, the main problem with the wall has been the deteriorating condition of the rubber gaskets that are supposed to seal the spaces between panels and the metal supports and the existing concrete walls. This problem was reported shortly after the wall was installed, as it was detected in the inspections during the installation as mentioned before in this document. In the subsequent months, the condition of such gaskets appeared to worsen. Many of the gaskets were not properly placed from the time the wall was installed, and now, perhaps due to the weather, some of them are falling out of place, sagging and

even breaking, leaving open gaps through which the noise travels from the highway to the neighborhood. Making an analogy with architectural acoustics, this is similar to leaving an opening (e.g., an open window or a gap under a door) in a room, in which case the acoustic energy goes through the opening, and the transmission loss of the walls is undermined by the area of the opening, significantly reducing the transmission loss of the wall. The problem with the gaskets occurs in both the vertical and horizontal gaskets, but the worst cases correspond to the horizontal gaskets that seal the bottom of the acrylic panels with the concrete wall. The sagging of the horizontal gaskets can be seen in Figures 7.28 through 7.31.

*Figure 7.29: Sagging of horizontal rubber gaskets*

*Figure 7.30: Sagging of horizontal rubber gaskets*

In May 2014, CTR learned that the contractor had offered to fix the problems with the gaskets at no cost to TxDOT. As of the latest monitoring visit to the barrier on July 11, 2014 (prior to the finalizing this document), no repairs had been made to the gaskets. It is estimated that about 80% of the horizontal gaskets are in poor condition (broken, sagging, or out of place), which significantly hinders the acoustic performance of the barrier.
