TECHNICAL REPORT 5-6005-01-1

TxDOT PROJECT NUMBER 5-6005-01

**STATEWIDE IMPLEMENTATION OF THE TOTAL
PAVEMENT ACCEPTANCE DEVICE (TPAD)—
FINAL REPORT**

Kenneth H. Stokoe II
Jung-Su Lee
Tom Scullion

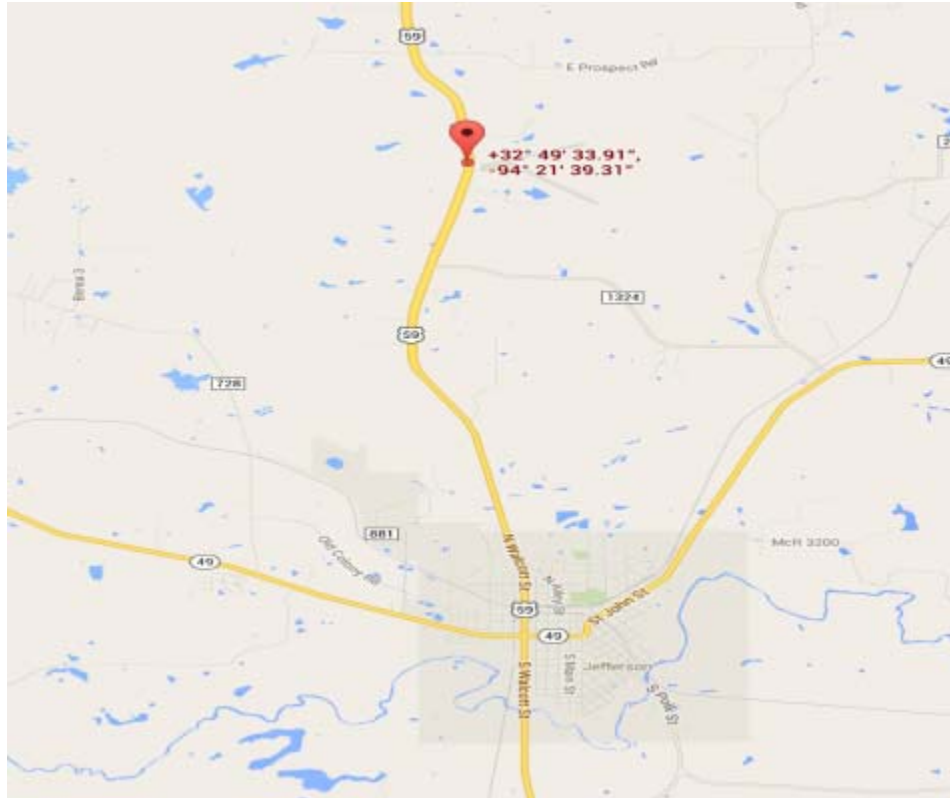
Figure 2.19: Test Location of Suspected Void (4.7 Miles North of Jefferson)

The TPAD was used to inspect a short section of US 59 that was still under construction in the Atlanta District. The District suspected that the fill material placed over the newly installed culvert had settled, resulting in a void being formed under the newly placed CRCP pavement. The location of the problem is shown in Figure 2.19.

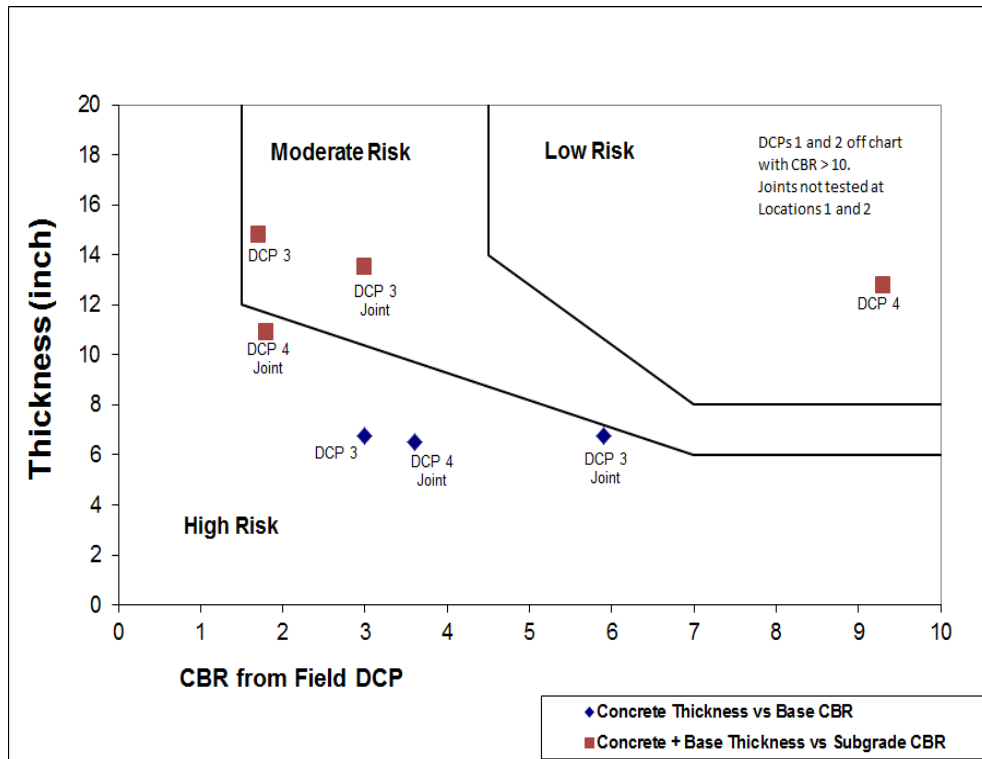
Figure 2.22: Risk Assessment of Rubblization on SH 6

Based on the TPAD data, six locations were selected for field investigation. Locations 1 and 2 were measured to have moderate deflections. The other four areas had either high deflections or suspect load transfer efficiencies. Table 2.1 and Figure 2.22 present the summary information from the focused field tests with the DCP, which is used to assess the risk level associated with rubblization. Analysis of the data shows that rubblization may not be the best option for this pavement due to marginal support conditions under the slab and substantial weak support, particularly at the transverse joints. The data suggest that the District may have decent success (~70%) rubblizing most of the slab area; however, each instance of testing near the joint showed extremely poor support in the vicinity. The data suggest that many localized full-depth repairs surrounding the joints would be necessary.

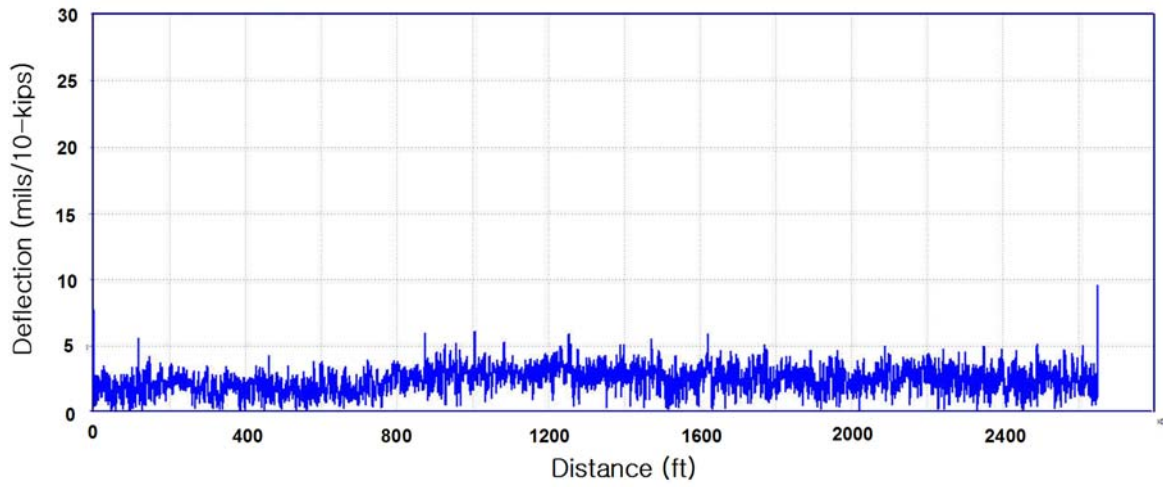
Figure 2.23: Deflection Profile Collected on a Good Section on IH 27 in Lubbock, TX

The TPAD testing on IH 27 in Lubbock was performed as a joint effort with Dr. Moon Won and his research team at Texas Tech University (TTU). The pavement type on IH 27 in Lubbock is a CRCP. The TPAD testing was performed on the outside lane of the pavement to investigate current structural conditions. Detailed interpretations by Dr. Moon Won were presented separately to TxDOT personnel. As an example of the work, two representative deflection profiles are shown in this document. The first deflection profile is the one that was collected on the stiffer section of IH 27. This profile is shown in Figure 2.23. Since this pavement is a CRCP, cracks with a range in spacings are shown in the profile by peaks at different irregular spacings. Mid-slab deflections are low (generally less than 2.5 mils), which are typical deflections of CRCP exhibiting good performance. The deflection profile collected on a somewhat less stiff section is shown in Figure 2.24. In this section, it is interesting to see the different deflection patterns before and after
