# PAVEMENT DAMAGE DUE TO HEAVY LOADS IN TEXAS: AN AREA STUDY

STATE DEPARTMENT OF HIGHWAYS  
AND PUBLIC TRANSPORTATION

**July 1978**

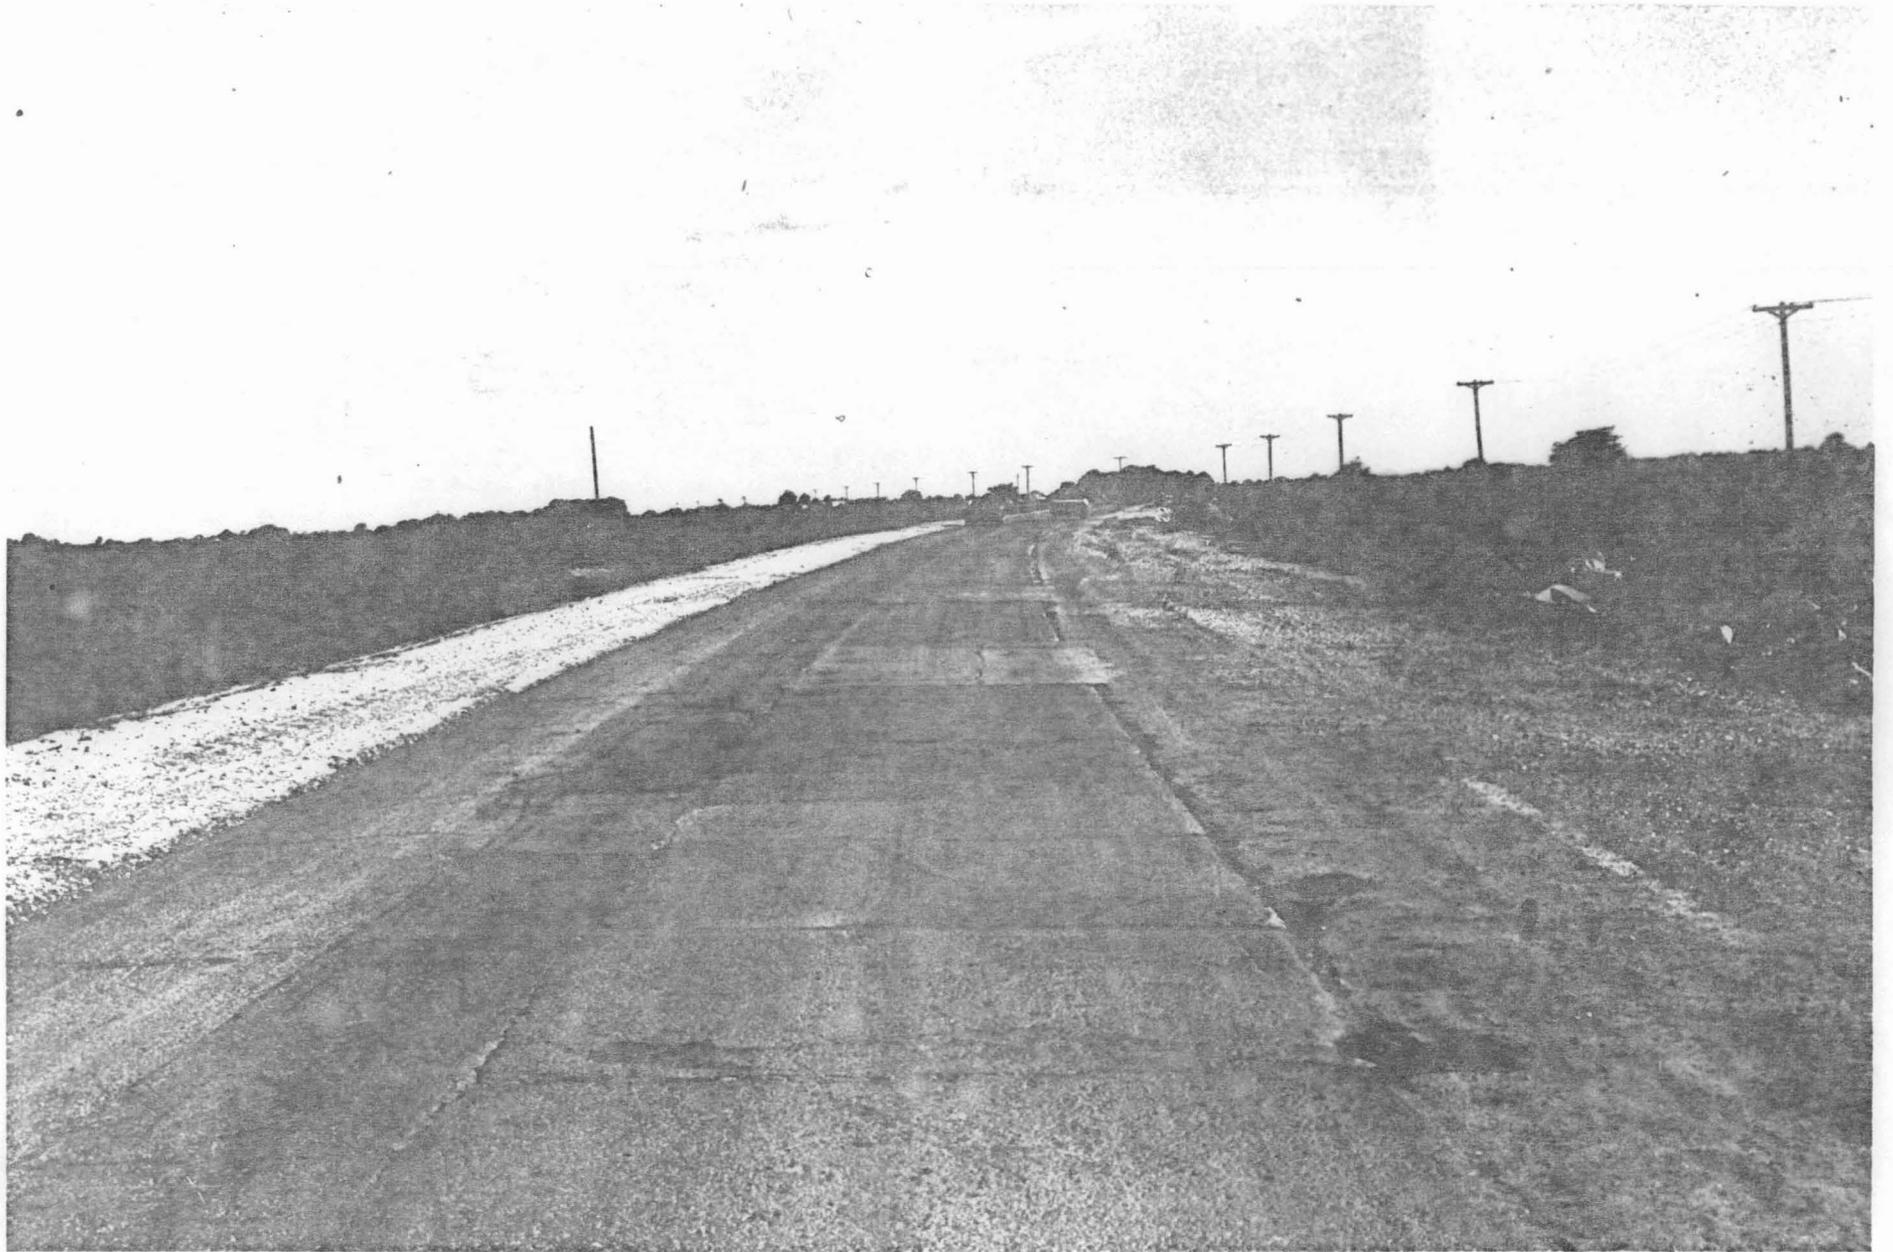
Picture 1

2. Pavement repairs required on the lanes carrying the loaded trucks are 2.46 times greater on the average as compared to the lanes carrying the empty trucks. Examples of pavement repair are the patches shown in Pictures 1,5, and 9.
