RESEARCH REPORT 1857-1

BRIDGES WITH PREMATURE CONCRETE
DETERIORATION: FIELD OBSERVATIONS
AND LARGE-SCALE TESTING

A. Boenig, L. Fúnez, R. E. Klingner, and T. J. Fowler

OCTOBER 2000

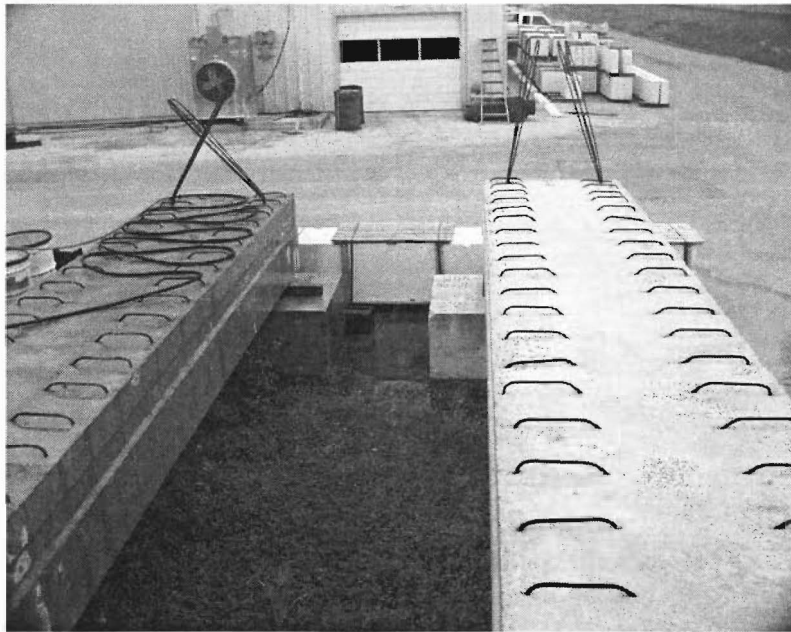
Figure 3.3 BG3 and BG4 (wetted) outside of FSEL

The box girders were designated BG1, BG2, BG3, and BG4 (“Box Girder 1,” etc.). BG1 and BG2 were immediately moved inside the laboratory (Figure 3.2), while BG3 and BG4 were left outside and uncovered. BG4 was subjected to random periods of wetting and drying in an effort to accelerate damage. Figure 3.3 shows BG3 and BG4 stored outside FSEL.

BG4 was significantly more damaged than BG1, BG2 and BG3 based on visual inspection. A crack 0.007 in. (0.18 mm) and 5.5 in. (0.14 m) from the bottom was visible for limited distances at the ends. A horizontal crack 0.009 to 0.025 in. (0.23 to 0.64 mm) wide and 17 in. (0.43 m) from the bottom extended the entire length on each side. The webs on the south end, extending 140 in. (3.6 m) north, had many

horizontal cracks roughly 0.05 in. (1.3 mm) wide and 100 in. (2.5 m) long, spaced about 4 in. (0.10 m) apart. The webs at the north end had similar damage. The worst cracking in the webs, near the solid blockouts, was accompanied by cracks across the top of the girder at 286 in. (7.3 m) from the north and south ends. A horizontal crack 0.06 to 0.25 in. (1.5 to 6.4 mm) was apparent at the level of the bottom layer of strand, 2 in. (0.051 m) from the bottom, on the east side of the south end face. The concrete in the middle third of the girder was in better condition.

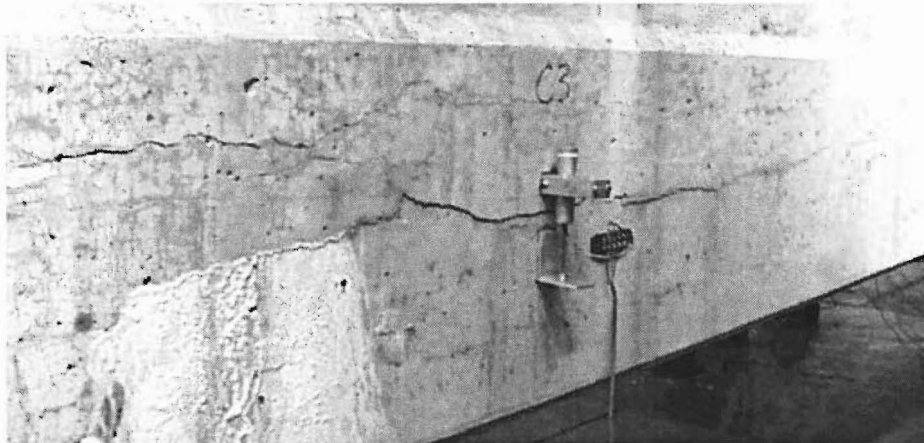
Figure 3.15 Linear potentiometer on west face of BG4F to monitor change in width of pre-existing crack

Because a longitudinal crack 5.5 in. (0.14 m) from the bottom was not obvious along the entire length of BG4, for the BG4F test, a single linear potentiometer was placed at the location of C3 in Figure 3.14. Additional linear potentiometers were attached on the east and west faces, 293 in. (7.44 m) from the south end, to measure possible growth of the crack 12 in. (0.31 m) from the bottom (Figure 3.15).

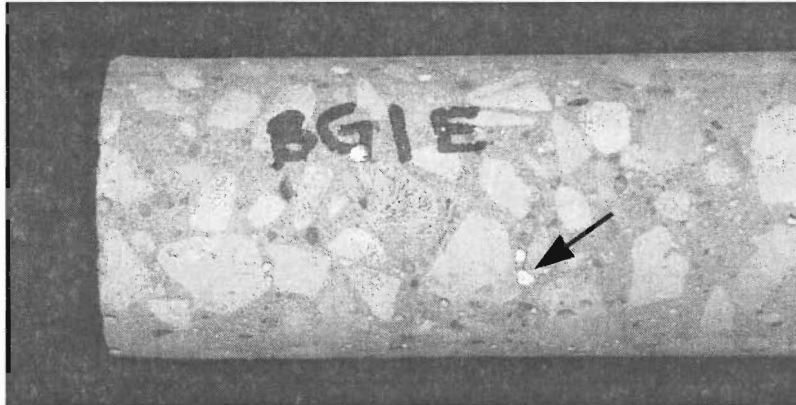
A white, soap-like substance was evident in the voids of the cores (Figure 3.29).

Figure 3.29 White, soap-like substance in voids of core from end-block of BG1

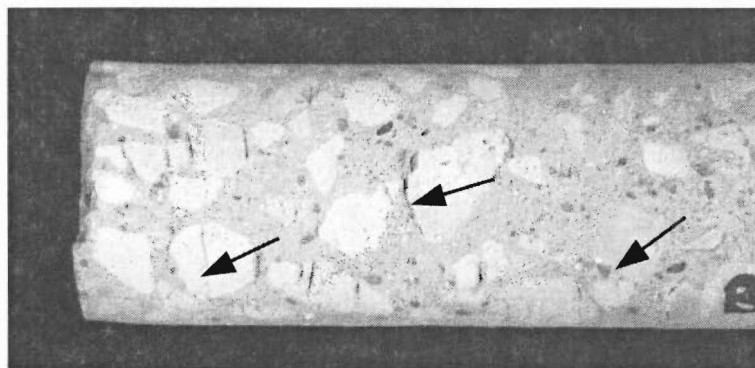
Placement of transverse reinforcement in BG2 was inconsistent, and the concrete was in such poor condition that many of the cores taken from the end-blocks crumbled inside the barrel of the core drill. Only two intact, steel-free cores were obtained from the end (BG2E-1 and BG2E-2), and two from the webs (BG2W-1 and BG2W-2). Cracked aggregate, a white, soap-like substance filling the voids, and separations between the aggregate and cement matrix were noted in these cores (Figure 3.30). The cores were tested for modulus of elasticity according to ASTM C469, and then loaded to failure to obtain data on compressive strength.

Figure 3.30 Cracked aggregate, separation between aggregate and cement matrix, and white substance in voids of core from end-block of BG2

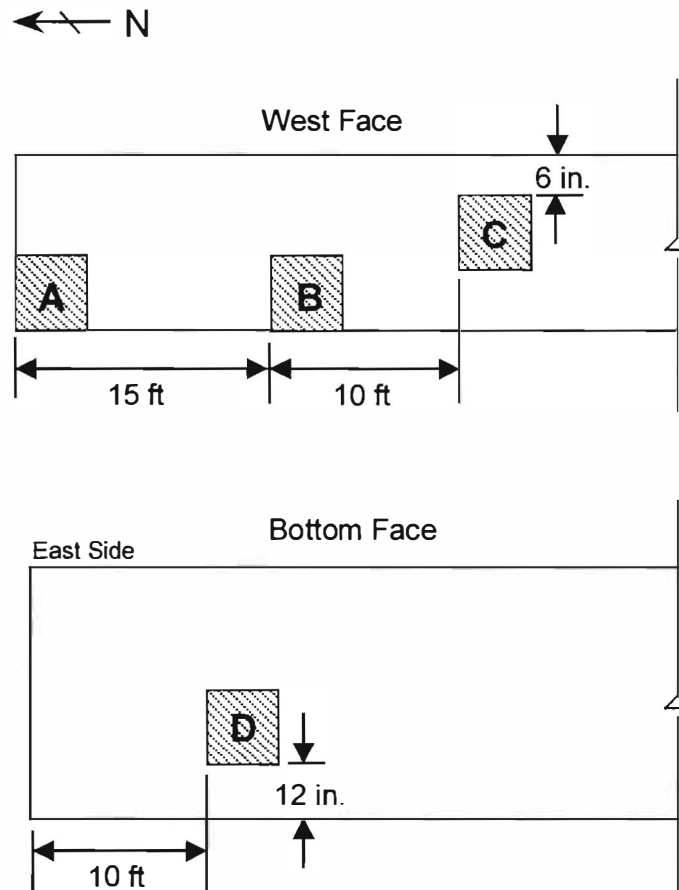
Figure 3.32 Locations of representative squares on box girders monitored for crack growth

Visible cracks in representative 12 in. (0.30 m) squares on BG1, BG3 and BG4 were measured and sketched (Appendix C). Square A, at the northern bottom corner of the west face; Square B, 15 ft (4.6 m) from the north end on the west face; Square C, 25 ft (7.6 m) from the north end on the west face; and Square D, 10 ft (3.0 m) from the north end on the bottom face, are shown in Figure 3.32.

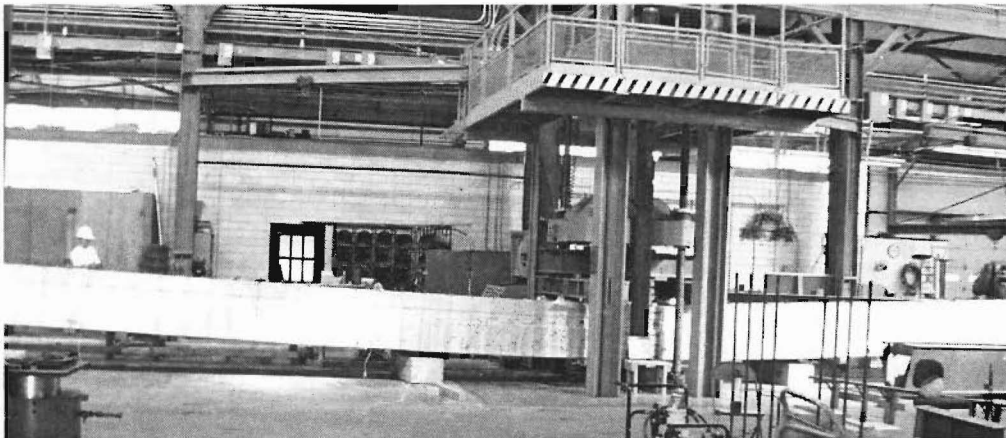
Figure 4.8 shows BG2F at a load of 110 kips (490 kN). Cracking, first heard at 113 kips (503 kN), was heard consistently as concrete at midspan crushed and spalled off the top and sides. At 115.7 kips (515 kN) the load was reduced slightly to lower the supports intended to catch the girder after failure. Loading then resumed until failure at 116.3 kips (517 kN), at which point flexural cracks had spread 13 ft (4.0 m) from midspan.

Figure 4.8 BG2F under 110 kips (490 kN)

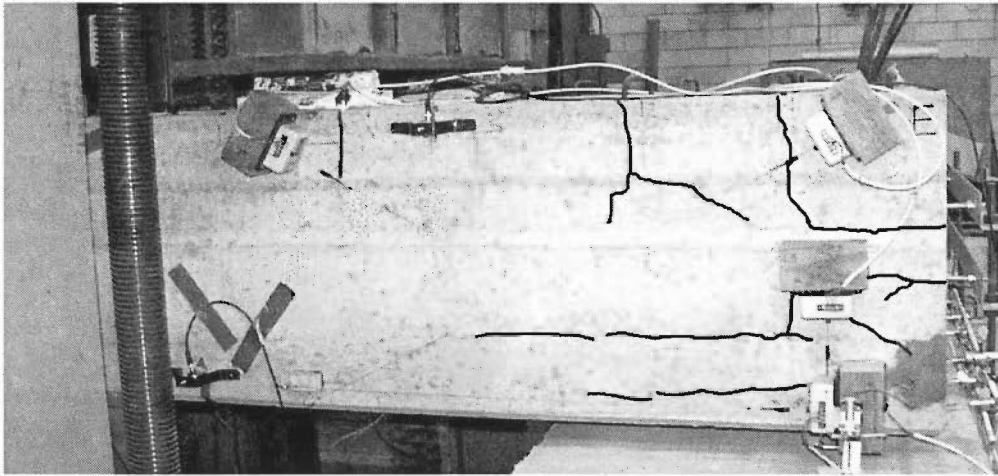
Figure 4.18 Pre-existing cracks on the east face of BG1S

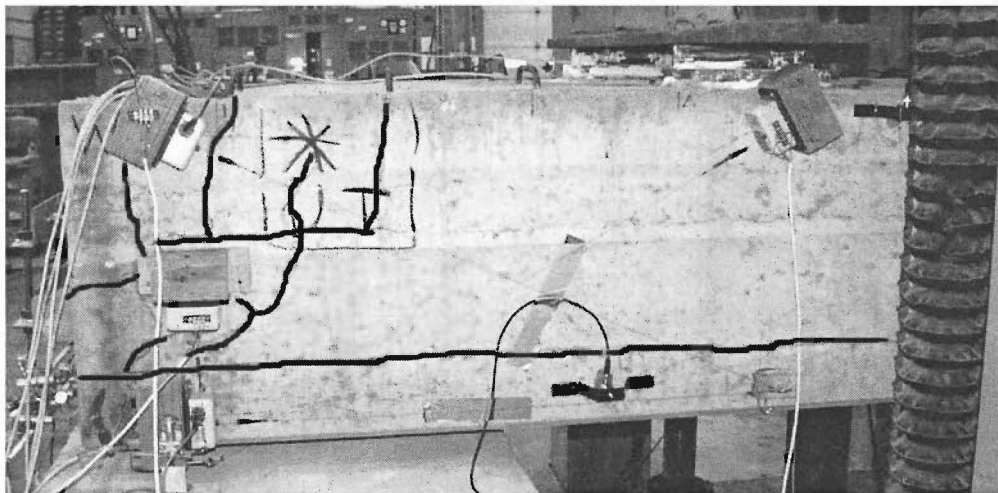
Figure 4.19 Pre-existing cracks on the west face of BG1S

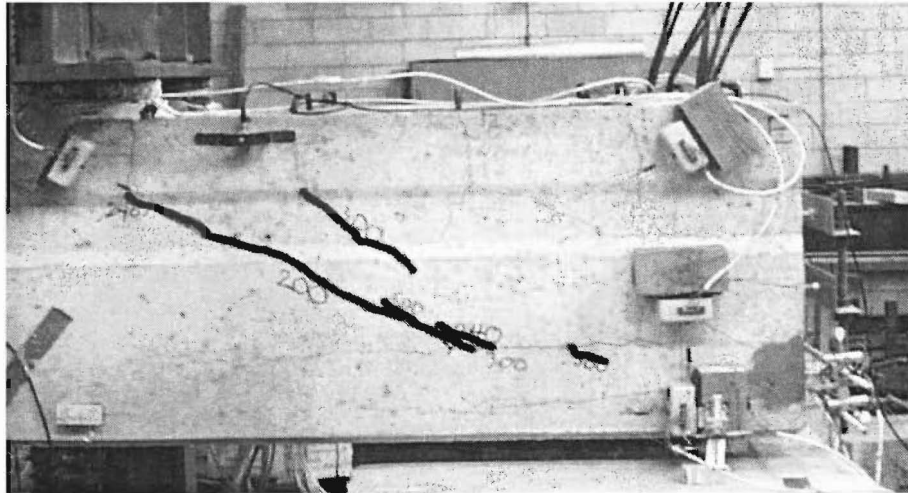
BG1S was tested on February 2, 2000. The first shear crack was visible at 160 kips (712 kN) on the west side, and at 200 kips (890 kN) on the east side. New cracks were concentrated primarily in the region directly in line between the first loading point and the bearing pad. Figures 4.20 and 4.21 show the development of cracks at 300 kips (1330 kN) on the east and west faces.

Figure 4.20 Shear-induced cracks on the east face of BG1S under a load of 300 kips (1330 kN)

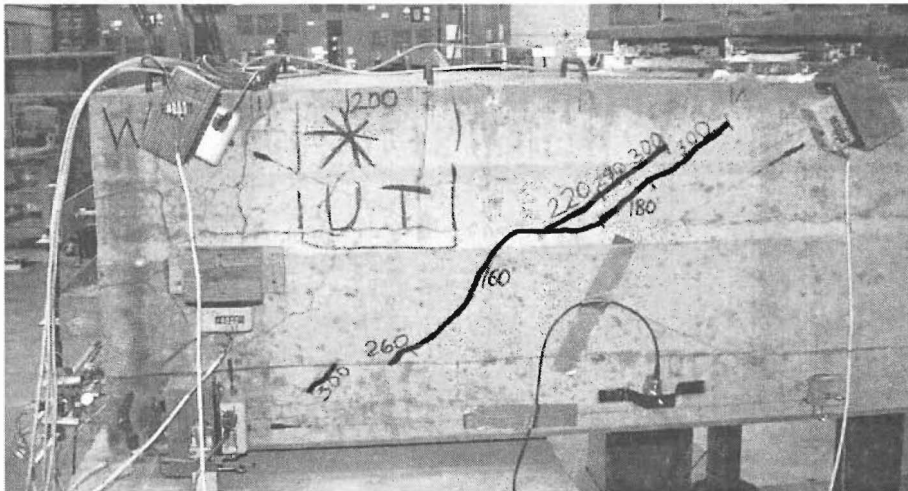
Figure 4.21 Shear-induced cracks on the west face of BG1S under a load of 300 kips (1330 kN)

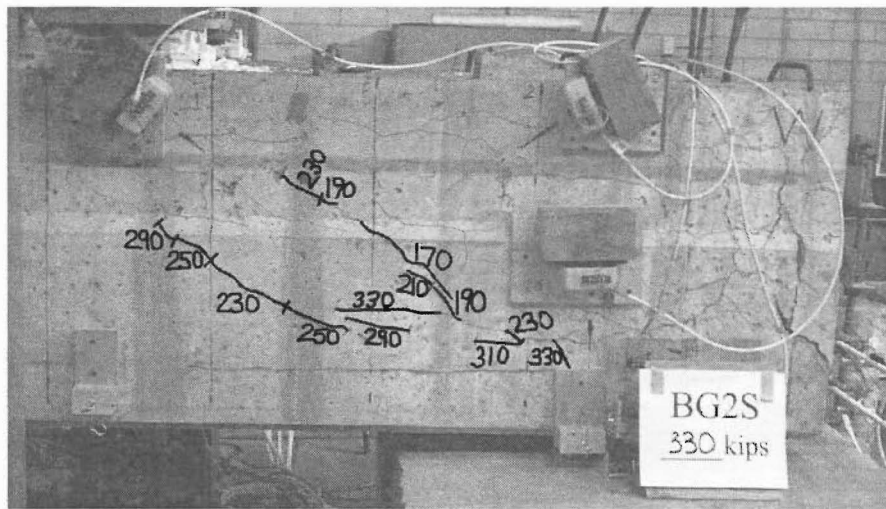
Figure 4.31 Shear-induced cracks on the west face of BG2S under a load of 330 kips (1470 kN)

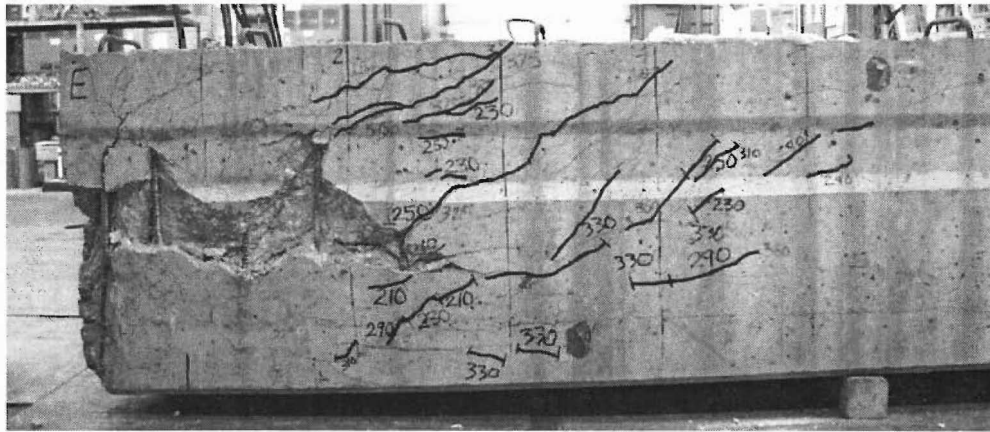
The transverse loading girders were replaced and the test resumed on December 16, 1999. Since the predicted load had been reached, load was applied continuously until failure. Shear cracks continued to extend and widen. On the east side the two most prominent cracks were 1/4 to 3/8 in. (6.35 to 9.53 mm) wide. A strip of cover concrete 33 in. (0.84 m) long and from 2 to 10 in. (0.05 to 0.25 m) wide broke off the east side, exposing the transverse reinforcement (Figure 4.32). A horizontal crack 9 in. (0.23 m) from the bottom, continuing from where the cover had spalled, appeared right before failure and extended northward to under the second loading point. On the west side, the final damage was significantly less dramatic; the web was still intact. The maximum load reached during the final continuous loading was 358 kips (1590 kN).

Figure 4.32 Failure of the east face of BG2S at 358 kips (1590 kN)

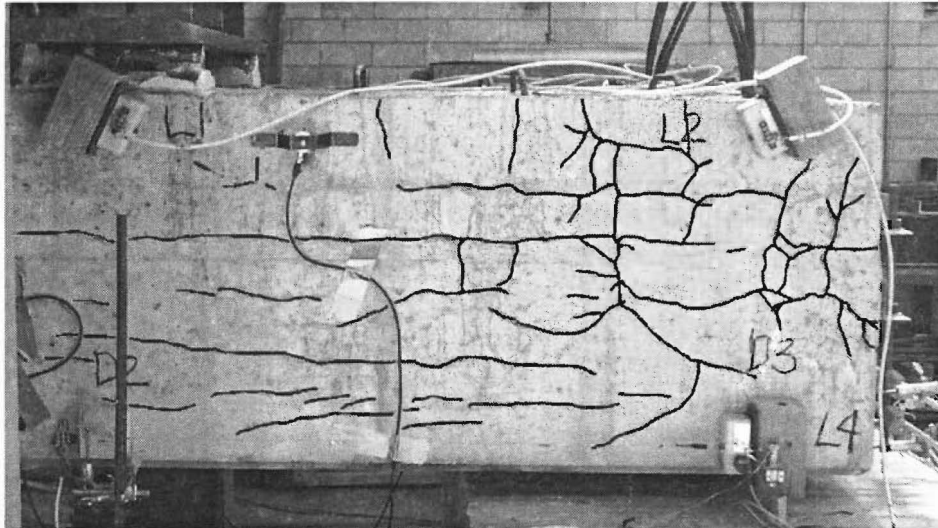
Figure 4.40 Pre-existing cracks on the west face of BG4S

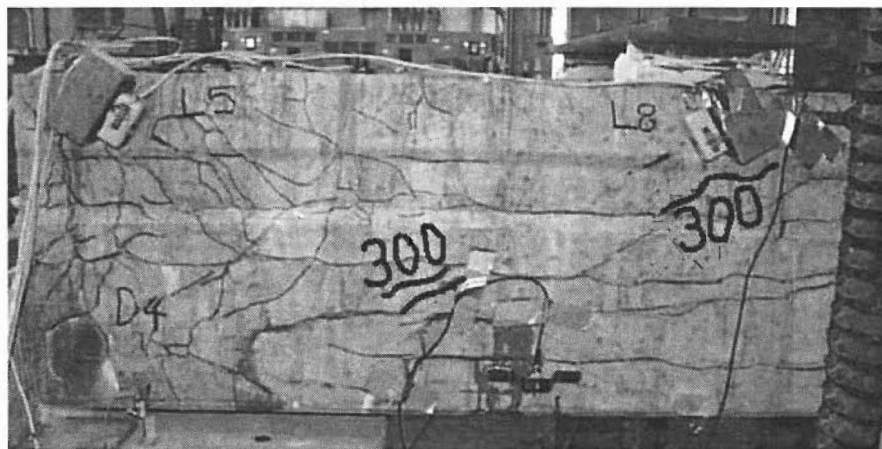
BG4S was tested on March 24, 2000. The first new visible cracks were seen at 260 kips (1160 kN) on the west side. At 300 kips (1330 kN) water began seeping out of pre-existing cracks and new shear-induced cracks in the webs. As in BG2S, shear cracks were not limited to the area directly between the first loading point and the bearing pad, but spread in a wider band. Figures 4.41 and 4.42 show the new shear-induced cracks after a load of 300 kips (1330 kN) was reached.

Figure 4.41 Shear-induced cracks on the east face of BG4S under a load of 300 kips (1330 kN)

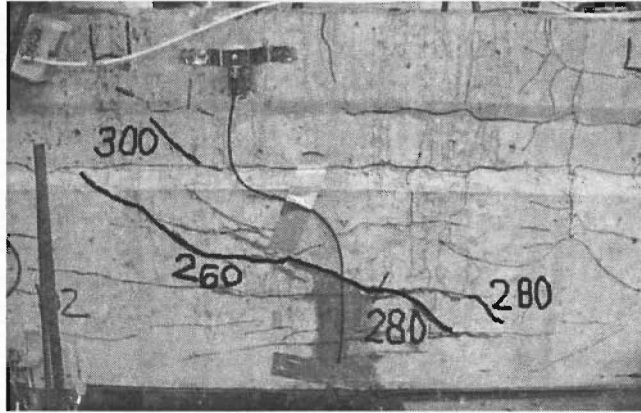
Figure 4.42 Shear-induced cracks on the west face of BG4S under a load of 300 kips (1330 kN)

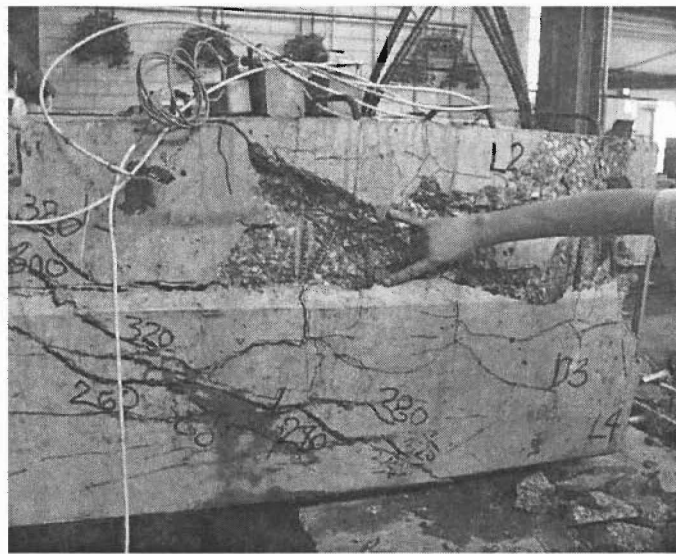
AE sensors were removed after a load of 340 kips (1510 kN) was attained. At 360 kips (1600 kN) a loud pop was heard and the load started to drop. On the west face the concrete cover spalled off the reinforcement in an area 36 in. (0.91 m) long, and the web blew open at failure (Figure 4.43). The bottom boundary of this failed area coincided with the pre-existing crack 17 in. (0.43 m) from the bottom of the girder. An area of cover concrete approximately 30 x 7 in. (0.76 x 0.18 m) blew off the east web at failure (Figure 4.44). The south three stirrups on the west side and the south two stirrups on the east side had corroded. Pre-existing cracks on the top of the girder, directly south of the first loading point, opened and the top flange crushed in that location.

Figure 4.43 Failure of the west face of BG4S at 361 kips (1610 kN)

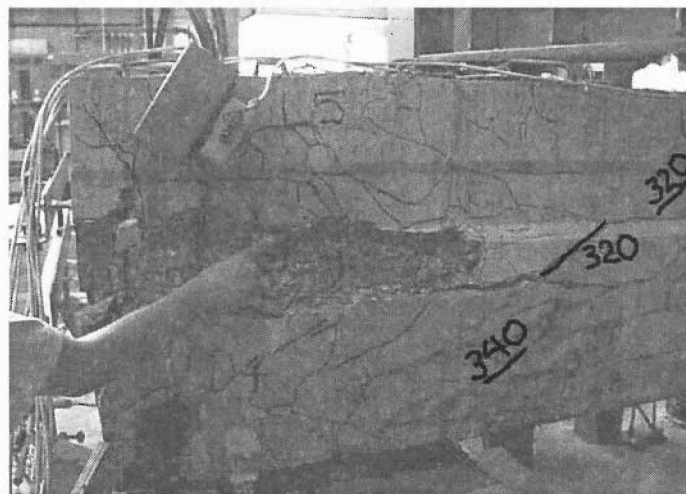
Figure 4.44 Failure of the east face of BG4S at 361 kips (1610 kN)

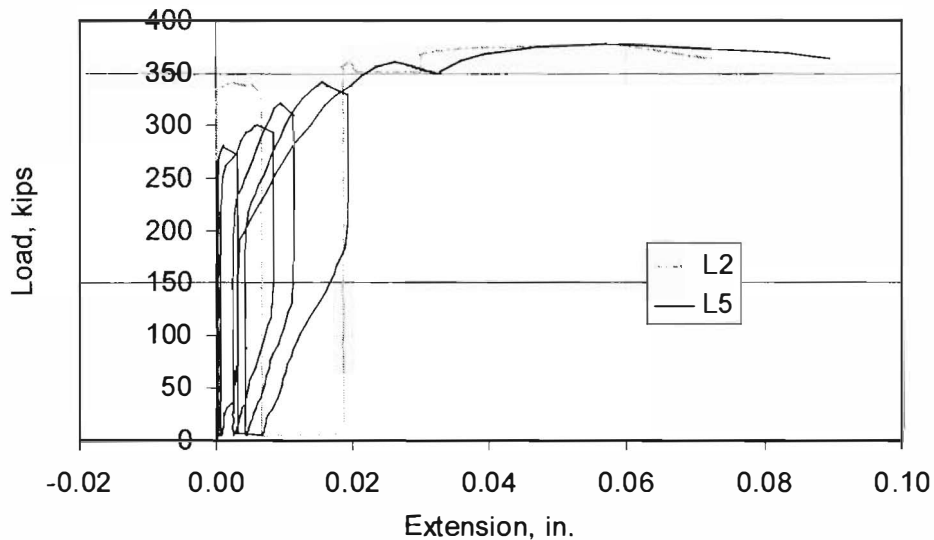
Figure 4.49 Extension of tension diagonals in the webs of BG4S

The shortening of compression diagonals, extension of tension diagonals, and extension of the bottom chord in the critical shear section are shown in Figures 4.48 through 4.50.

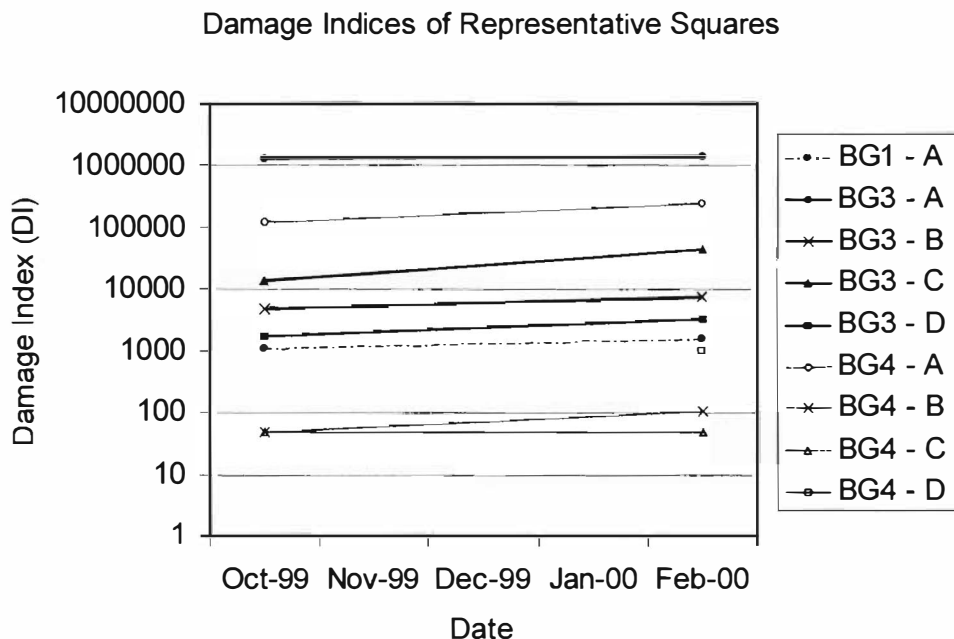
Figure 4.54 Damage Indices versus time for representative squares

The Damage Index (DI) vs. time for each representative square monitored is shown in Figure 4.54. A logarithmic scale was used for the DI axis to make the data more clear. Cracks were not visible in BG1-B, BG1-C, or BG1-D.

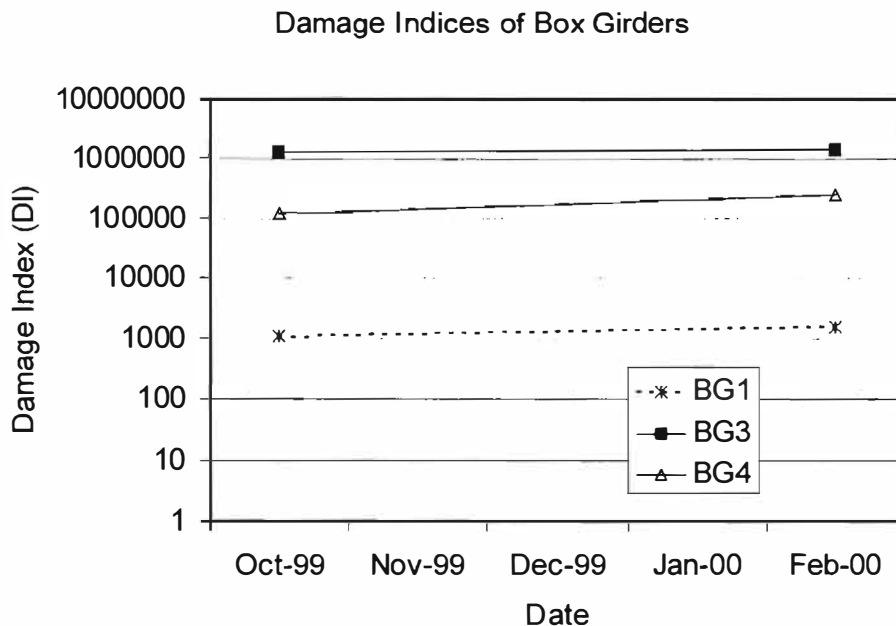
Figure 4.55 Damage Indices versus time for box girders

Figure 4.55 displays the total DI for each box girder, which was calculated by summing the DI's of the representative squares.

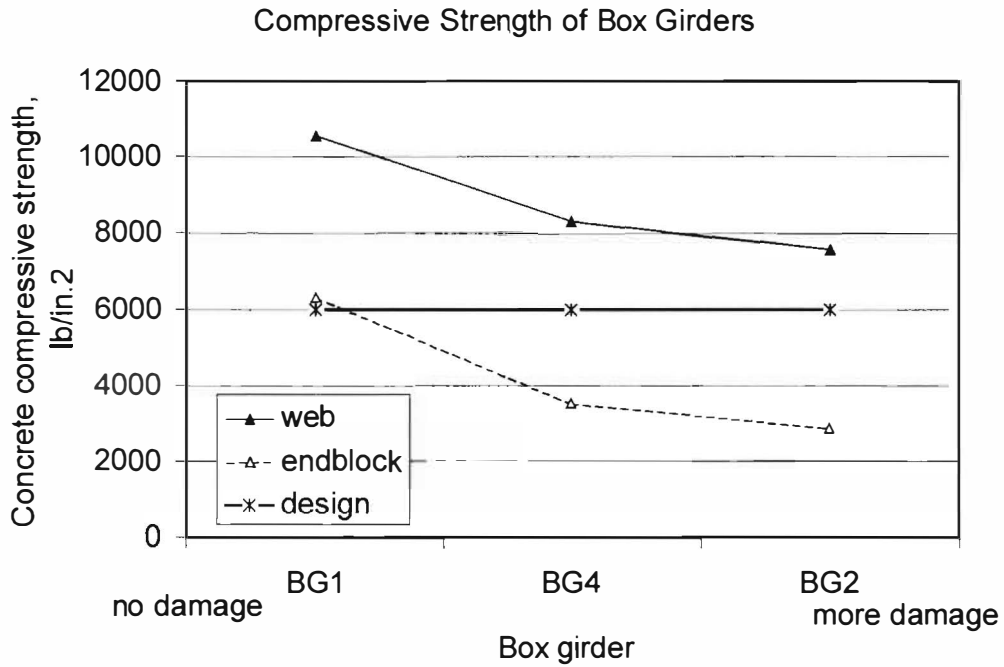
Figure 5.4 Concrete compressive strength of cores from box girders

As would be expected, concrete compressive strength and modulus of elasticity vary inversely with the degree of deterioration (Figures 5.4 and 5.5). BG1, with the least deterioration, had the highest compressive strength and modulus; BG2, with the most deterioration, had the lowest compressive strength and modulus.

The specified compressive strength of the girders was 6000 lb/in.² (41.4 MPa). Cores from the end-blocks of BG2 and BG4 have already deteriorated to the point that their compressive strength is below that value, and compressive strengths of cores from the end-block of BG1 are only 5% above it (Figure 5.4).

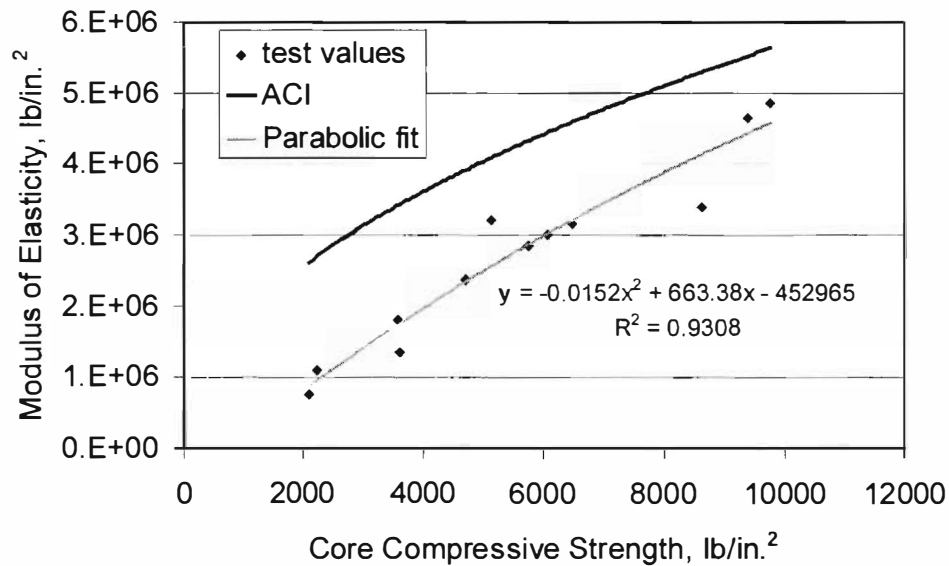
Figure 5.6 Modulus of elasticity versus concrete compressive strength of cores from box girders

In Figure 5.6 is shown the relationship between modulus of elasticity and compressive strength of cores from box girders. A parabolic curve fit to the test values, and the ACI 318-99 equation for modulus of elasticity, $E_c = 57,000(f_c)^{0.5}$ (US customary units), are also plotted.

According to the ACI 318-99 Commentary, Section R8.5.1, “measured values range typically from 120 to 80 percent of the specified value.” The parabolic curve fit to measured values from the box girder cores ranges from 81 to 33 percent of the specified value. The premature damage seems to not only reduce the compressive strength of cores, but also disproportionately reduce the modulus of elasticity relative to that compressive strength.

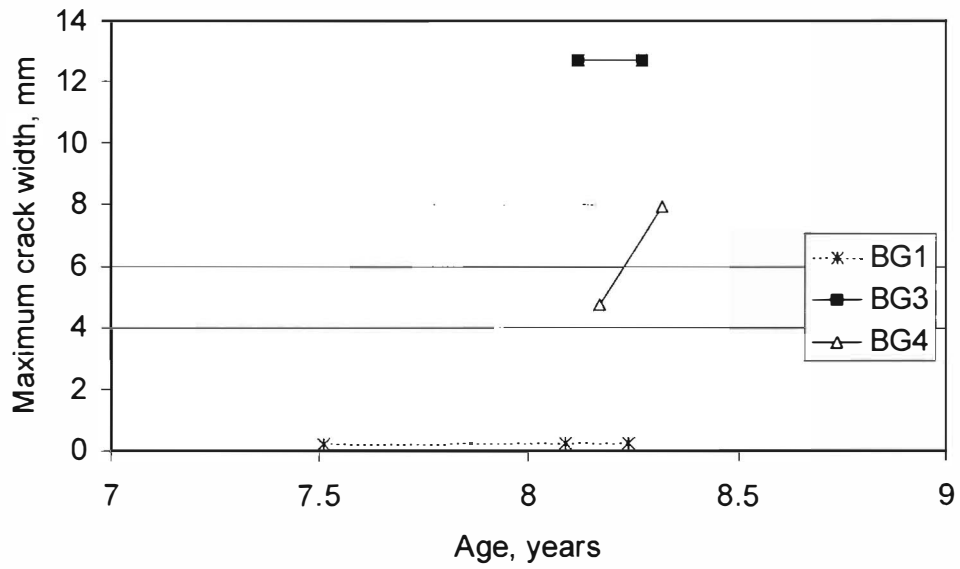
Figure 5.7 Maximum crack width versus age for box girders

The maximum crack widths of the girders monitored are displayed in Figure 5.7, in terms of the age of the girders. The effect of a more severe environment (exposure to water) is evident. BG4 (wetted) showed a drastic increase over time in maximum crack width. BG3 is considered to have severe inherent problems because of its constant, large maximum crack width.

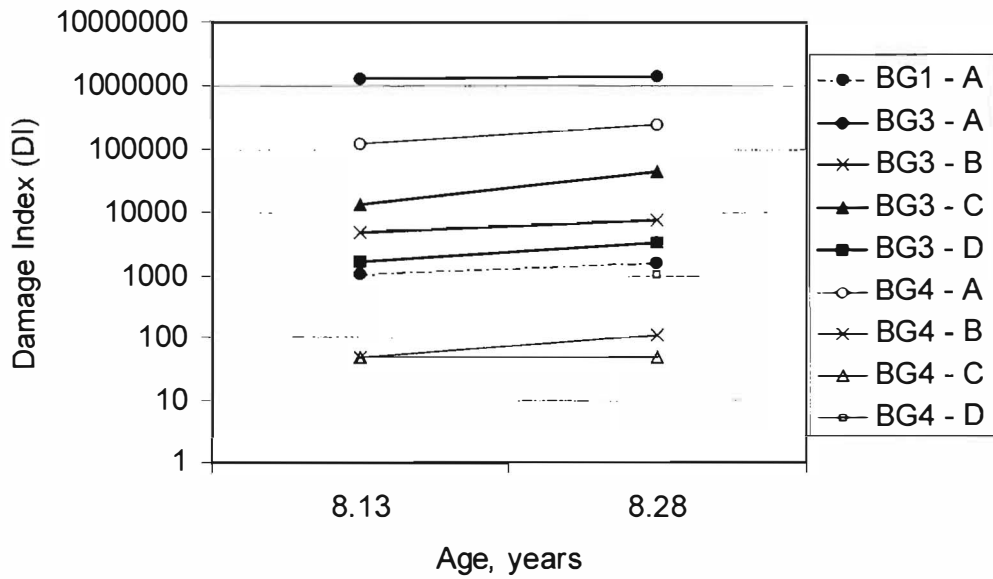
Figure 5.8 Damage Indices versus age for representative squares

Plots of damage index versus age for the representative squares, and of the average damage index for the box girders, are shown in Figures 5.8 and 5.9. Ages were determined by averaging the ages of the three box girders monitored based on their casting dates.

High damage indices correlate well with high levels of visually observed damage. All three girders monitored showed an increase in damage index over time. The slopes of the lines suggest that the damage index is increasing by 3500 per year for BG1, 815,100 per year for BG3 and 839,200 per year for BG4. The percentage increases in damage index for the representative squares and box girders from 8.13 years to 8.28 years are shown in Table 5.2.

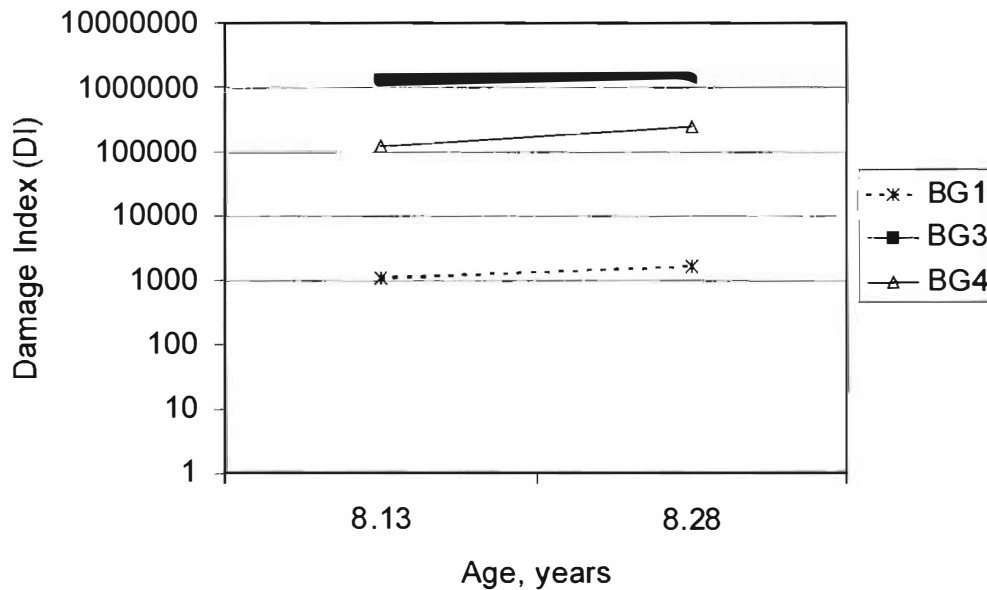
Figure 5.9 Average damage indices versus age for box girders

The comparative percentage increases in Total DI for the box girders also suggest that exposure to water accelerates the damage process.

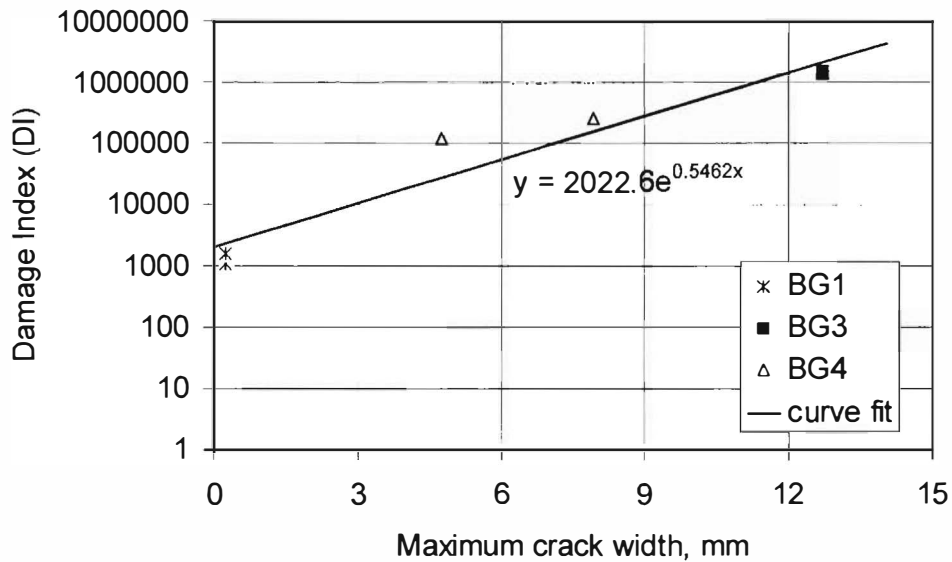
Figure 5.10 Damage index versus maximum crack width of box girders

A correlation is seen between maximum crack width and damage index (Figure 5.10). The best-fit curve shows that damage index increases exponentially as maximum crack width increases.

The first method should be used as a preliminary assessment tool. For example, the latest maximum crack width measured on the US-90 structure is 0.13 in. (3.4 mm). Using Figure 5.10, this corresponds to a damage index of 13,097 (US customary units). Using Figure 5.11, the compressive strength is estimated as 5170 lb/in.². If this is below the specified compressive strength, ACI Equation 11-2 should be used to estimate the reduced shear capacity of end regions of affected girders. If the shear capacity estimated in this way fell significantly below that used for design, compressive strengths could be verified by core tests.

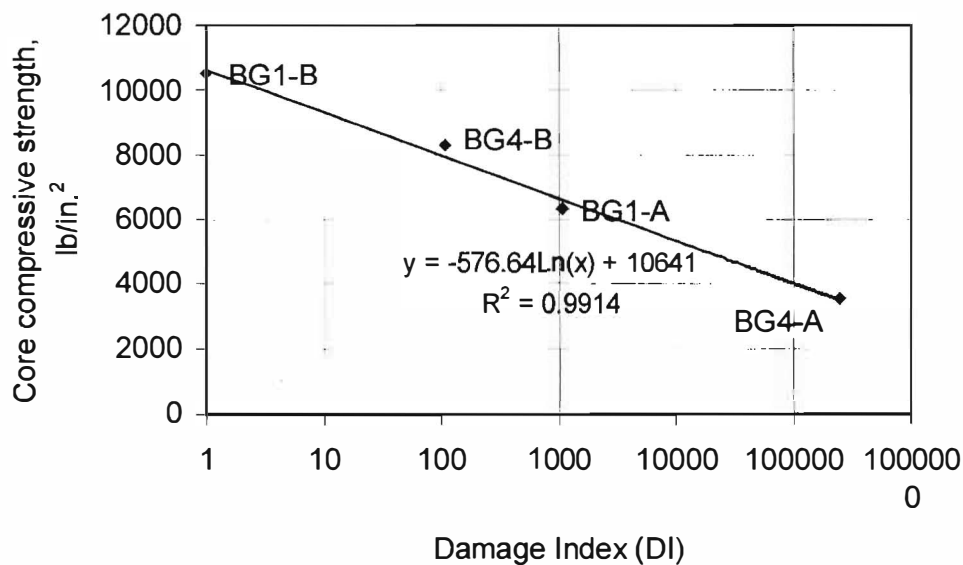
Figure 5.11 Concrete compressive strength of cores from box girders versus damage index

As would be expected, cores taken from areas with greater Damage Indices have lower compressive strengths. Figure 5.11 shows this relationship; a logarithmic fit to the data is also plotted. The points plotted are from cores of BG1 (representing girders with slight inherent problems and mild exposure) and BG4 (representing girders with severe inherent problems and severe exposure). The damage indices used are those that correspond most closely to the test date of the core in question. The damage index from Square A was used to represent end-block damage, and the damage index from Square B was used to represent web damage, since those locations corresponded most closely to the areas from which cores were taken.

- 5) Reductions in compressive strength are very strongly correlated to damage indices (Figure 5.11).
- 6) Reductions in compressive strength can be correlated to reductions in structural capacity, using strut-and-tie models. Structural capacity of prestressed girders can be governed by the tensile capacity of prestressing strand and by the bond of that strand to the surrounding concrete. It can also be governed by the compressive strength of the compression diagonals and compression chords comprising the strut-and-tie model. Gross strand slip, while not observed in these tests, is another possible failure mechanism. It is being investigated in a separate part of this overall study.

- 3) To predict capacity of a field girder with premature concrete deterioration, two methods are recommended:
 - Determine a damage index. Use that damage index with Figure 5.11 to estimate the compressive strength of the deteriorated concrete. Use that compressive strength with ACI Equation 11-2 to estimate the remaining shear strength.

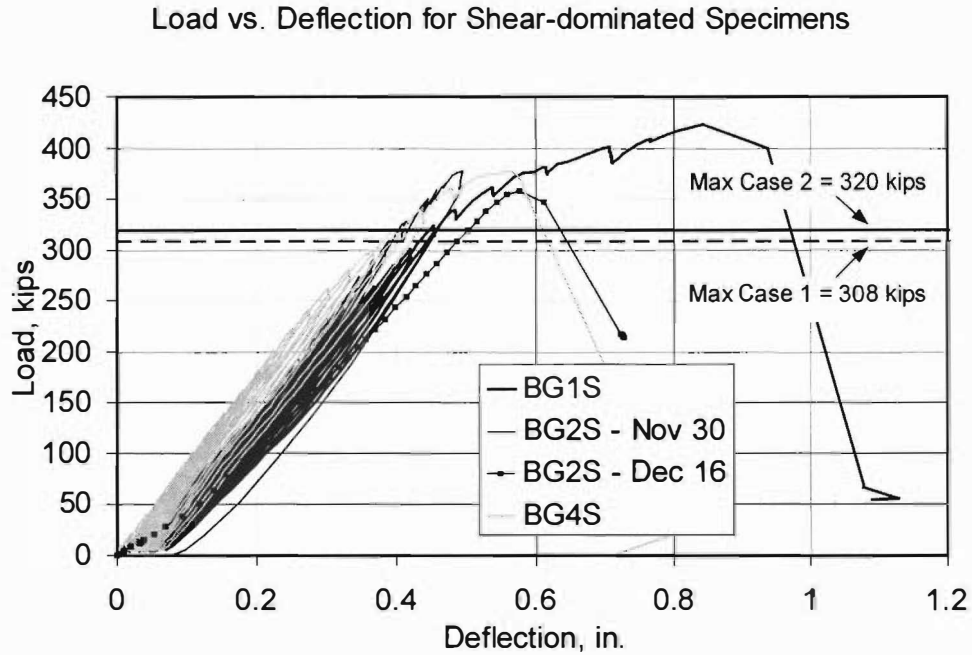
Figure 5.14 Load-deflection curves and predicted maximum loads for shear-dominated specimens

Figure 5.14 shows the load-deflection curves for the shear-dominated specimens as well as the maximum expected load calculated according to ACI 318-99, assuming a specified concrete compressive strength of 6,000 lb/in.² (41.4 MPa).

BG2S and BG4S had ultimate capacities of 377.1 kips (1680 kN) and 377.8 kips (1681 kN) respectively, while BG1S had an ultimate capacity of 422.6 kips (1880 kN). BG2S and BG4S had final deflections of 0.73 in. (19 mm) and 0.88 in. (22 mm) respectively; BG1S had a final deflection of 1.13 in. (29 mm). Thus the less damaged girder, BG1S, carried 12% more load and deflected 40% more than the severely damaged girders, BG2S and BG4S.

The ratios of tested to calculated ultimate strength were 1.32, 1.18, and 1.18 for BG1S, BG2S, and BG4S respectively. Though these ratios exceed 1.0, they fall below the average ratio of 1.368 found by Hognestad et al. (1967) - even for BG1S, which had the least damage. The more-damaged specimens are almost 14% below the average expected for specimens with normal concrete.

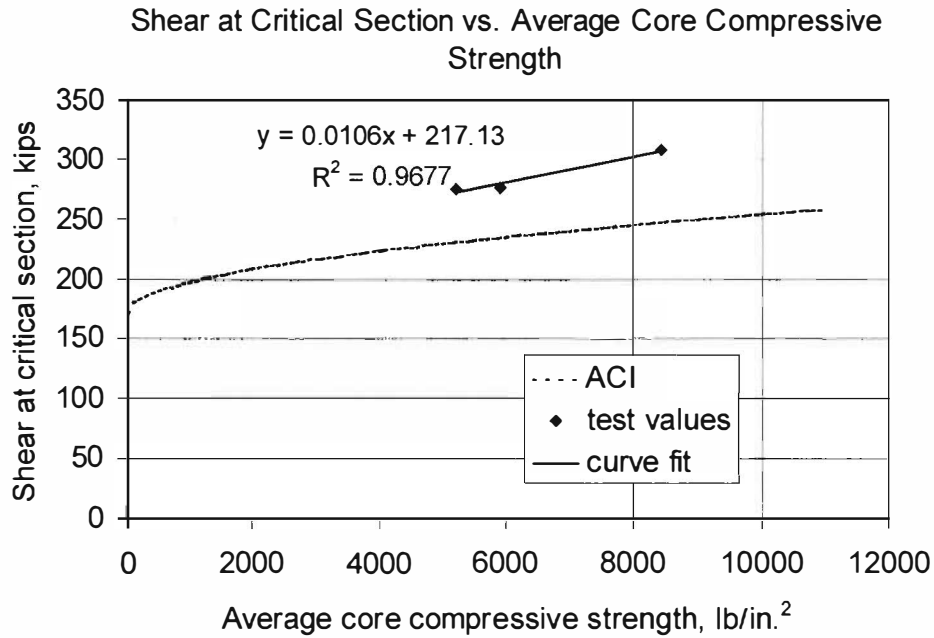
Figure 5.15 Shear strength versus average core compressive strength

Figure 5.15 shows the relationship between shear at the critical section at failure and the compressive strength of concrete cores. Also plotted in that figure are the best straight-line fit to the test data, and ACI Equation 11-2 for nominal shear strength (V_c plus V_s) of prestressed-concrete beams. The shear at the critical section at failure is the end reaction minus the self-weight between the support and the end of the void. An average core strength was used because cores were not taken from the critical shear area. The amount of pre-existing damage in the critical shear area was less than the amount seen in the end-blocks, but more than that seen in the webs.

From the limited data available, it appears that ACI Equation 11-2 can safely be used to predict shear strength, based on the compressive strength of concrete cores from the critical region. Because damage reduces not only compressive strength, but also bond strength, as strand slip in BG2S and BG4S and the crumbled concrete in ends of BG2 imply, capacities for specimens with very low compressive strengths might drop below the ACI curve. At very low strengths, the concrete is no longer a solid matrix holding the shear reinforcement and prestressed strand in formation. Table 5.4 shows the maximum strand slip recorded during the shear-dominated tests.

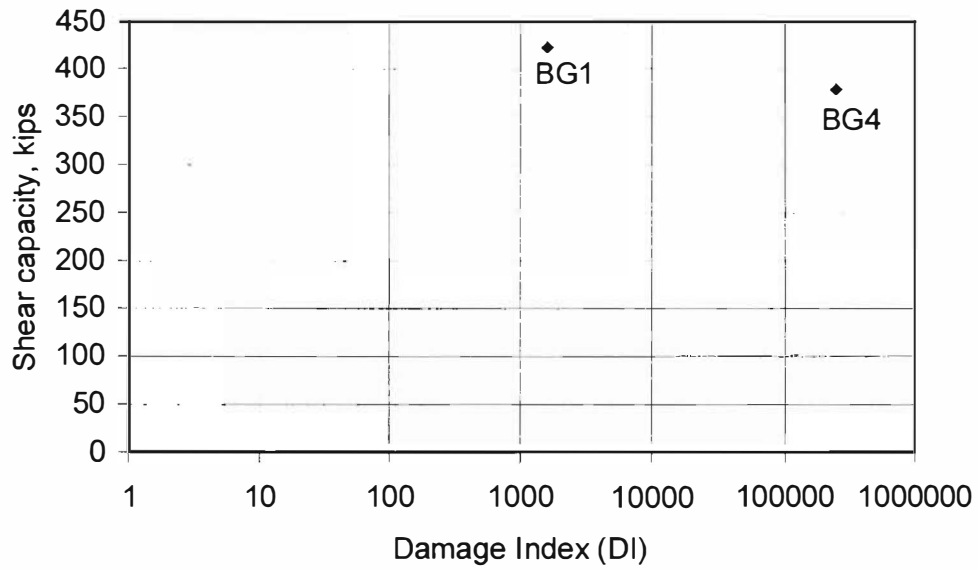
Figure 5.16 Shear capacity versus damage index

Shear capacity is plotted against damage index in Figure 5.16. The damage indices and specimens plotted were chosen as described in Section 5.3.

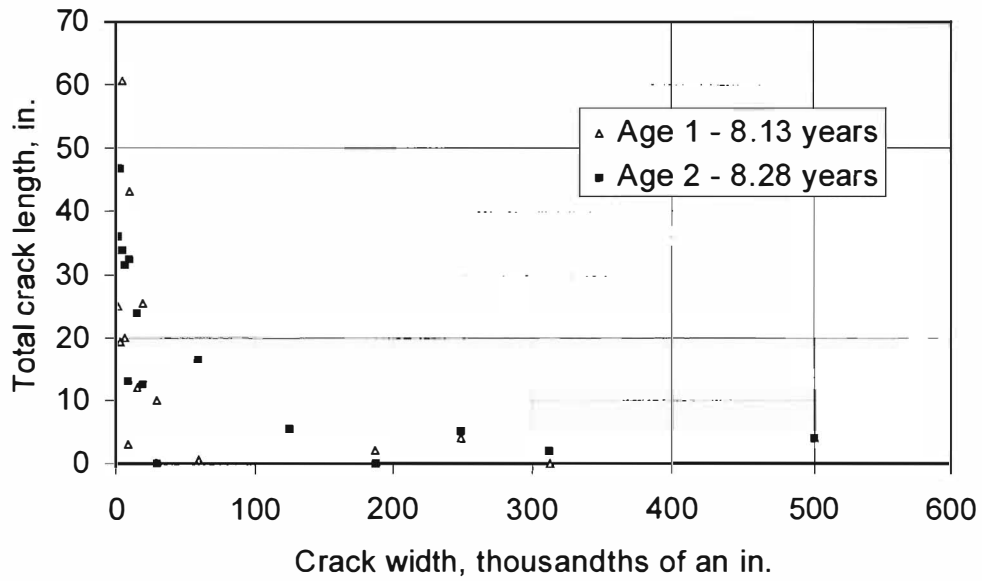
Figure 5.17 Damage histogram of box girders (US Customary units)

Damage histograms for the box girders at two ages are shown in Figures 5.17 and 5.18. They represent the total crack length observed in the representative squares for cracks of each width. With time, the damage histogram shifts towards the right (towards more cracks with larger widths).

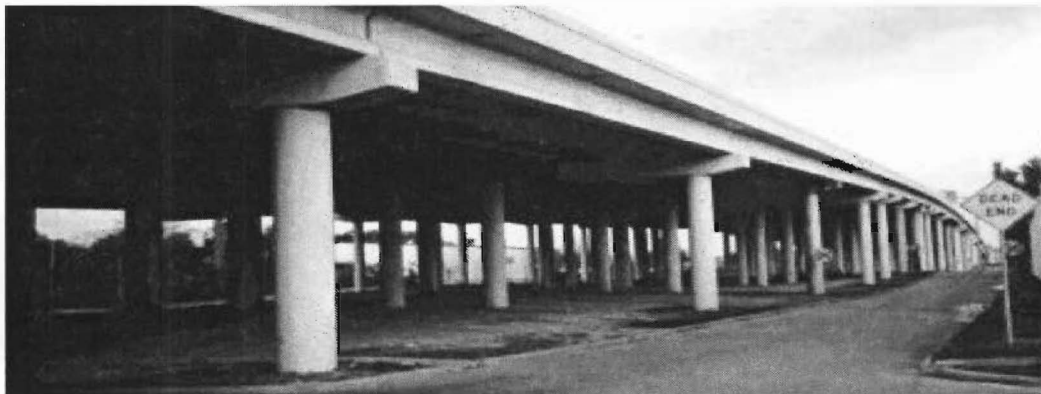
Figure 6.1 I-10 at AT & SF RR

The first structure inspected (Figure 6.1) is in Beaumont, TX on I-10 crossing the Atchison Topeka and Santa Fe railway lines (I-10 eastbound, take 7th Street exit). The affected elements are standard AASHTO Type C prestressed girders, fabricated in 1987.

In November of 1998, two of the exterior girders near the northwest abutment were replaced, and the original girders were sent to The University of Texas for testing.

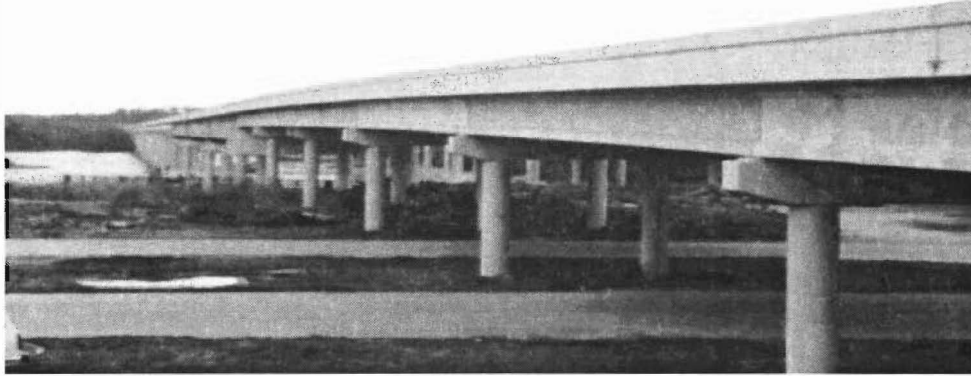
Figure 6.2 US-90 at San Jacinto River

The US Highway 90 structure crossing the San Jacinto River (Figure 6.2) is approximately 25 miles northeast of Houston (US-90 eastbound, exit before San Jacinto River). The affected elements are Type 54 prestressed girders, cast in 1986.

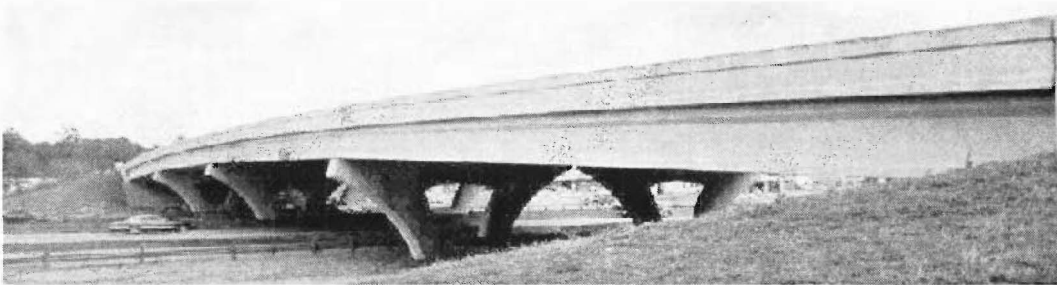
Figure 6.3 Robinson Road at I-45

The Robinson Road overpass of I-45 (Figure 6.3) is located north of Houston in the Woodlands (I-45 northbound, exit before Woodlands Parkway). The affected elements are Type IV prestressed girders, fabricated in 1987.

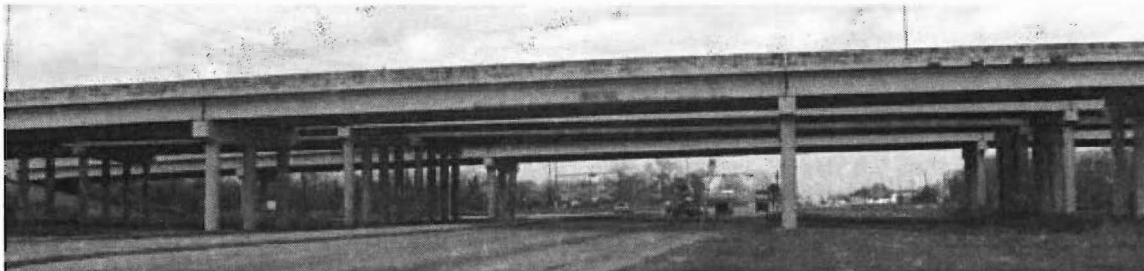
Figure 6.4 Beltway 8 at State Highway 3

Beltway 8 over State Highway 3 (Figure 6.4) is approximately 15 miles southeast of downtown Houston. The affected elements are Type IV prestressed girders over the northbound lanes of State Highway 3, fabricated in 1987.

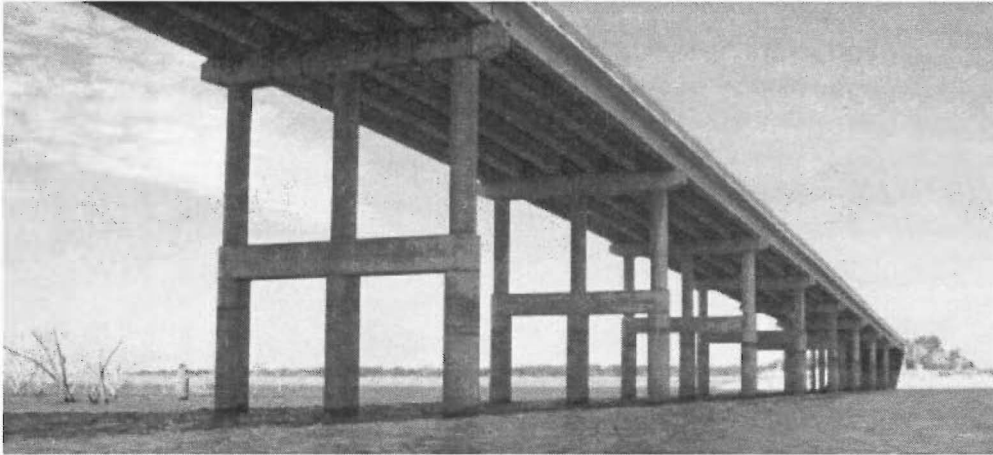
Figure 6.5 FM 1979 at Lake Ivie

FM 1979 crosses Lake Ivie (Figure 6.5) near San Angelo, TX. The bent caps and columns, built in 1989, are affected.

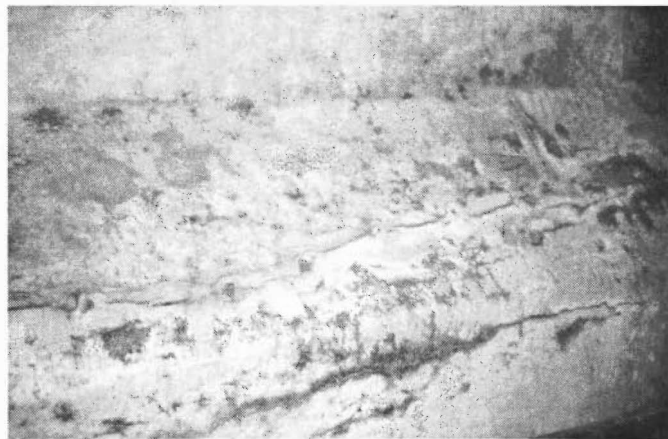
Two types of repair materials were observed in some of the cracks. One was hard and gray, and appeared to be applied to the surface only. According to TxDOT, it was a paste-type epoxy¹. The other type, less common than the first, was clear, yellow, and more pliable. It was probably an elastometric sealant, injected through ports that are apparent on the face of the girder (Figure 7.3).

Figure 7.3 Injected sealant on I-10 structure
