RESEARCH REPORT 1857-1

BRIDGES WITH PREMATURE CONCRETE
DETERIORATION: FIELD OBSERVATIONS
AND LARGE-SCALE TESTING

A. Boenig, L. Fúnez, R. E. Klingner, and T. J. Fowler

OCTOBER 2000

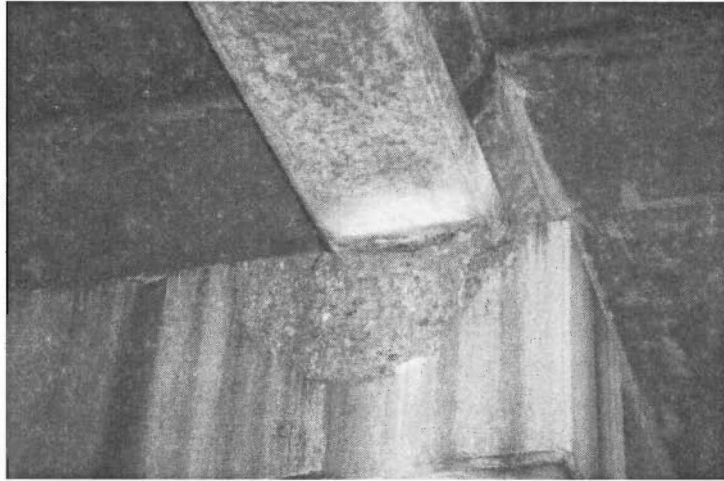
At one bearing point, the bearing pad had slipped out, causing the girder to rest directly on the concrete support. This had caused a portion of the support to spall off (Figure 7.4).

Figure 7.4 Missing bearing pad at I-10 structure

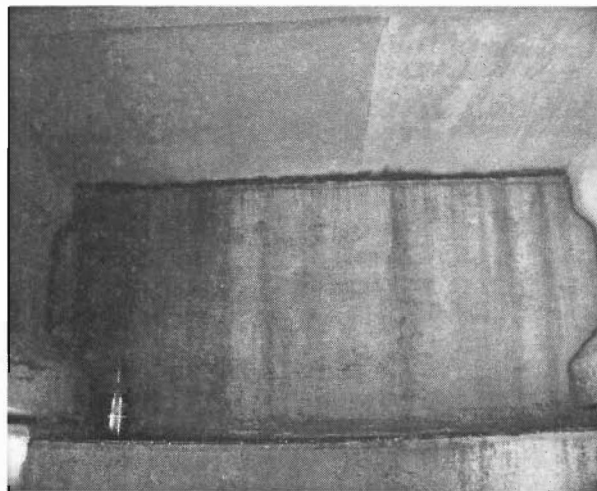
On October 22, 1999, the role of water in accelerating damage was more evident. In Figure 7.5, the west abutment between SW Girder 2 and SW Girder 3 is shown. Note the staining that indicates more water on SW Girder 2 than on SW Girder 3. In Figures 7.6 and 7.7, respectively, damage to SW Girder 2 is seen to be heavier than to SW Girder 3.

Figure 7.5 View of west abutment between SW Girder 2 (left) and SW Girder 3 (right)

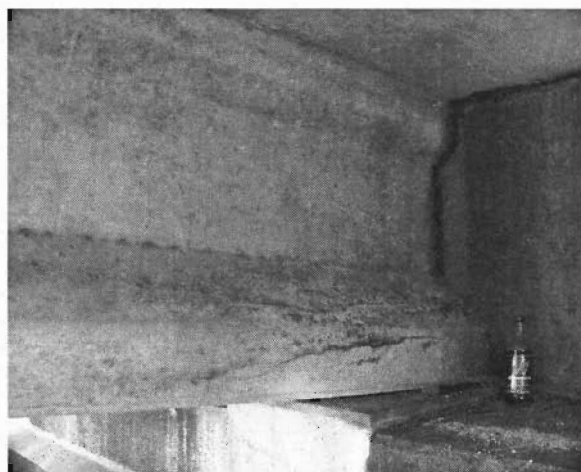
Figure 7.6 View of greater damage to SW Girder 2

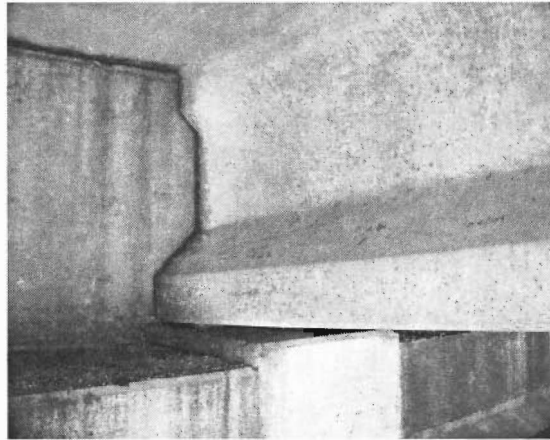
Figure 7.7 View of lesser damage to SW Girder 3

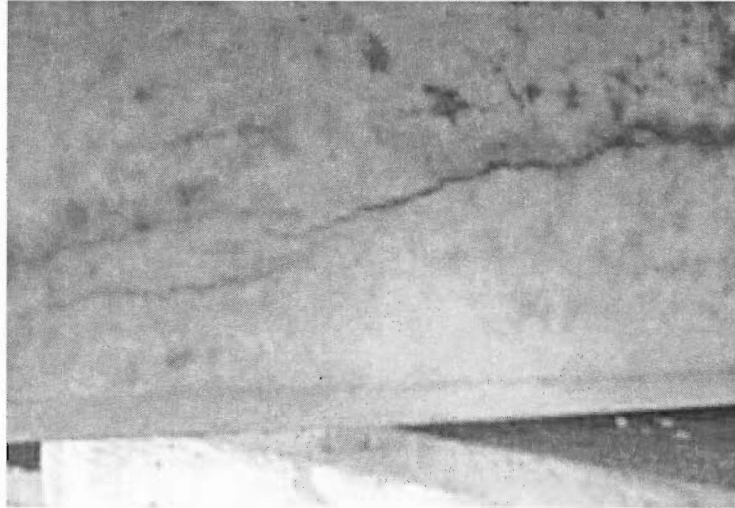
TxDOT personnel had filled some cracks with some type of repair material, and had also monitored their length in September 1998. The markings they left suggested that while the cracks had not grown much, new cracks had formed slightly above and below the old ones. These new cracks extended several inches past the ends of the old ones (Figure 7.9).

Figure 7.9 New cracks extending past the end of the old crack

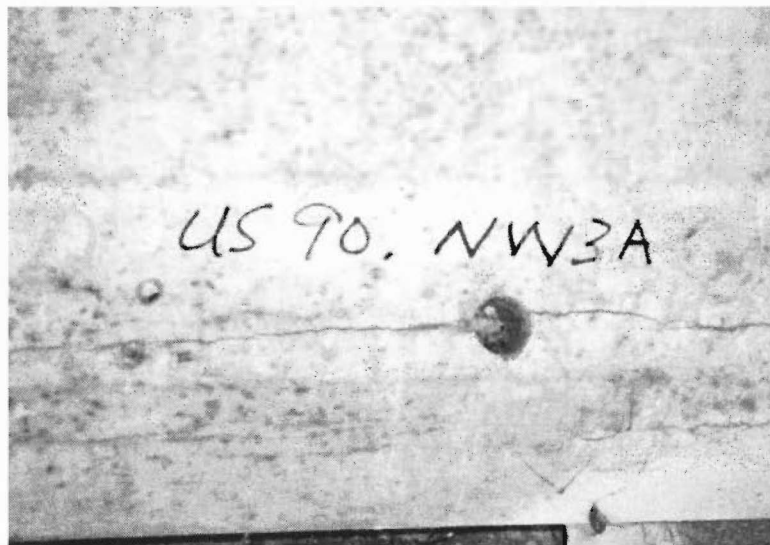
Cores had been taken from other girders in the span (Figure 7.10). Some core holes had been filled with grout; others were left unfilled. In one of the holes, a strand had also been cut and was exposed. The anchor bolts for the coring machine seemed to have been set into existing cracks, making them wider.

Figure 7.10 Core removed from US-90 girder

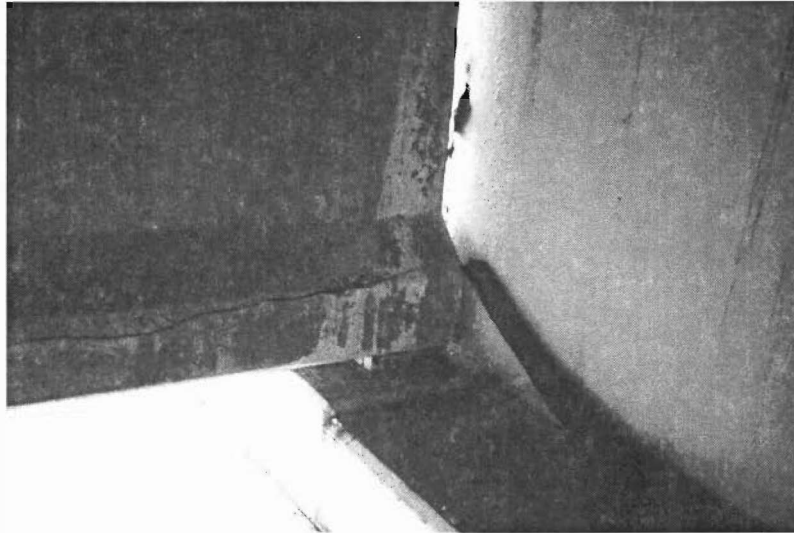
More severe damage was present on girders below where a section of the rubber seal, normally compressed between two spans of slab, had fallen out (Figure 7.11).

Figure 7.11 Rubber seal dropped from joint above at west abutment of US-90 structure

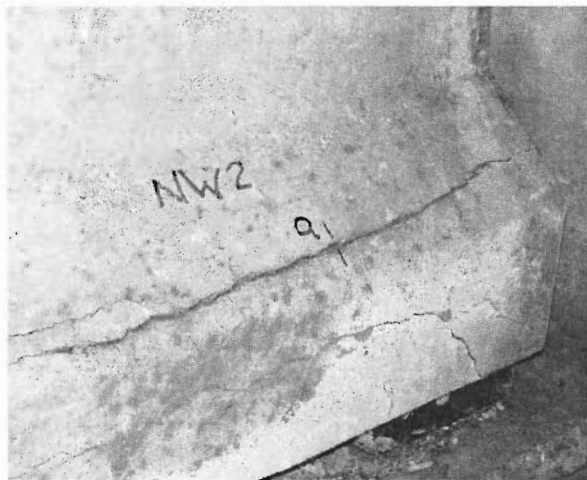
On October 22, 1999, cracking on the outside of the NW Girder 1 appeared markedly more severe than on previous trips, probably because the paint there had begun to peel, exposing the cracking beneath. At the north side of NW Girder 2, Point “a” was marked (Figure 7.12). The crack at that location was more than 1/4 in. (6.4 mm) wide.

Figure 7.12 Point “a” on NW Girder 2 of US-90 structure

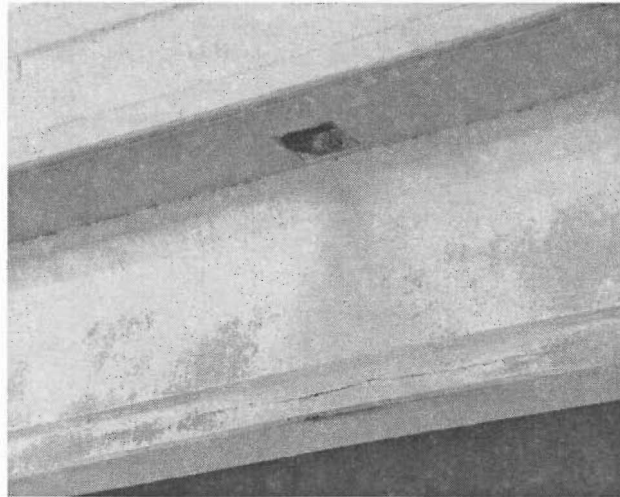
The apparent role of exposure to water was more evident than before. In examining overall damage on the northwest portion of the bridge, horizontal cracks were clearly visible on Face 5 of the northwest girders, directly below each drain scupper (Figure 7.13).

Figure 7.13 Cracking on Face 5 of exterior girder under drain scupper

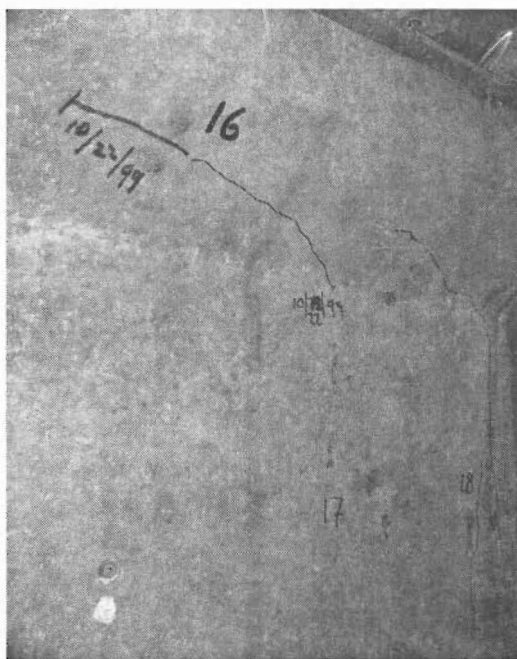
On October 22, 1999, cracks on Face 6 of NW Girder 3 had not propagated since the last visit. On the north face of NW Girder 3, previously identified cracks on Face 2 had continued to propagate (Figure 7.15). Lettered Points "a" through "f" were marked and measured with the crack comparator.

Figure 7.15 Extension of crack on Face 2 of NW Girder 3 at Robinson Road structure

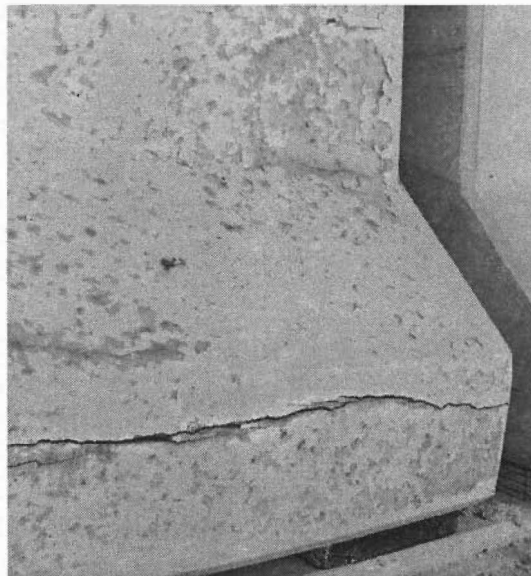
On June 4, 1999, Location 1 and Location 2 were chosen for closer study. At Location 1 large cracks were noticed on Face 5 of the southernmost girder, as well as minor cracking in the web and top flange. The paint was peeling excessively, and remaining paint seemed to obscure some minor cracks (Figure 7.17). At Location 1, the contrast between damaged and undamaged girders is quite striking (Figure 7.18).

Figure 7.17 Typical cracks on bottom flange of Beltway 8 girders

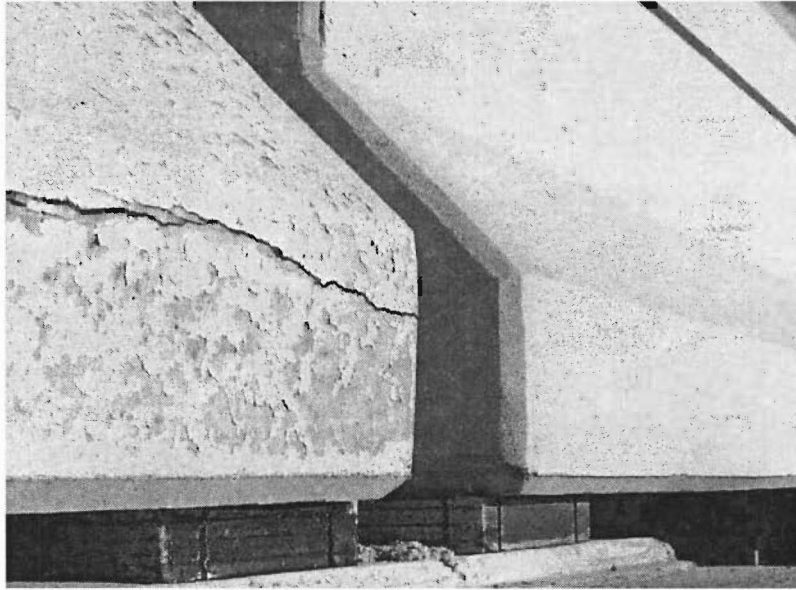
Figure 7.18 Contrast between damaged and undamaged girders at Location 1

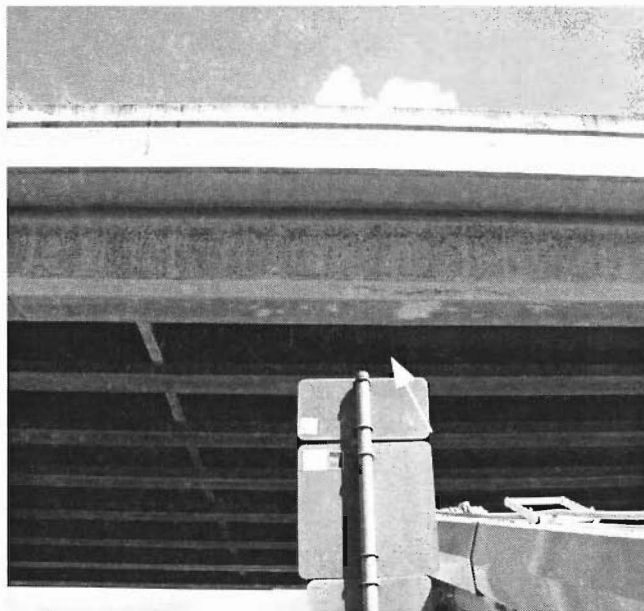
Cracks were mapped, and two Demec points were placed on the bottom flange of the east end of the girder: Point 1 on Face 5, and Point 2 on Face 4. At Location 2, cracks approximately 0.06 in. (1.5 mm) wide and 5 to 10 ft (1.5 to 3.0 m) long were noted directly on either side of the midspan diaphragm (Figure 7.19). Three additional Demec points were placed to the west of this diaphragm on the exterior of the north girder: Points 3 and 5 on Face 4, and Point 4 on Face 5.

Figure 7.19 Cracks on Face 5 of exterior girder at Location 2

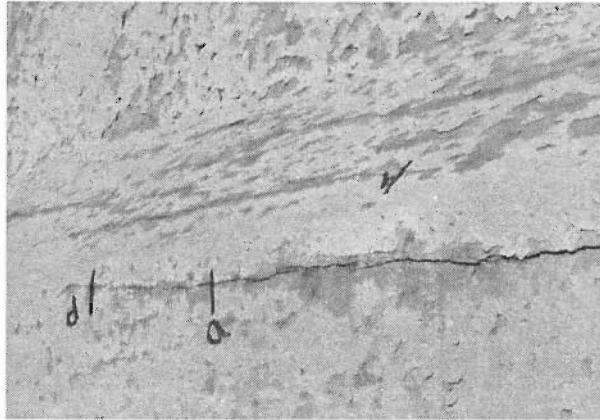
Figure 7.20 Marked points at Location 1

Cracks at Location 1 were about 1/8 in. (3.2 mm) wide. On the bottom flange, cracks were as wide as 1/4 in. (6.4 mm). The Demec discs had fallen off at Points 1 and 4. At Location 2, Points “e” through “i” on the bottom and sides of the bottom flange were marked and measured. Points “e” and “f” correspond to Points 4 and 5 respectively (Figures 7.21). Cracks at Locations 3 and 4 looked very similar to those at Location 1.

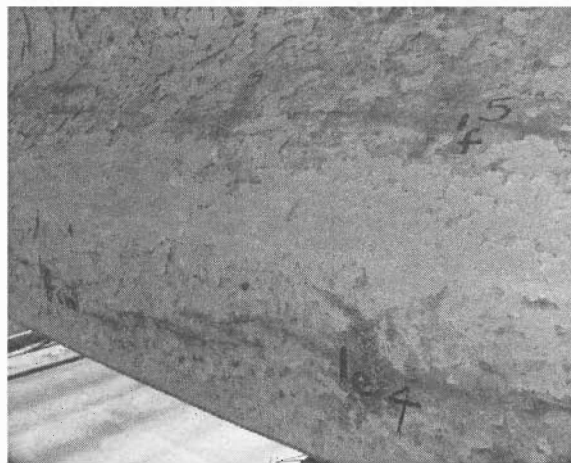
Figure 7.21 Marked points on Faces 4 and 5 at Location 2

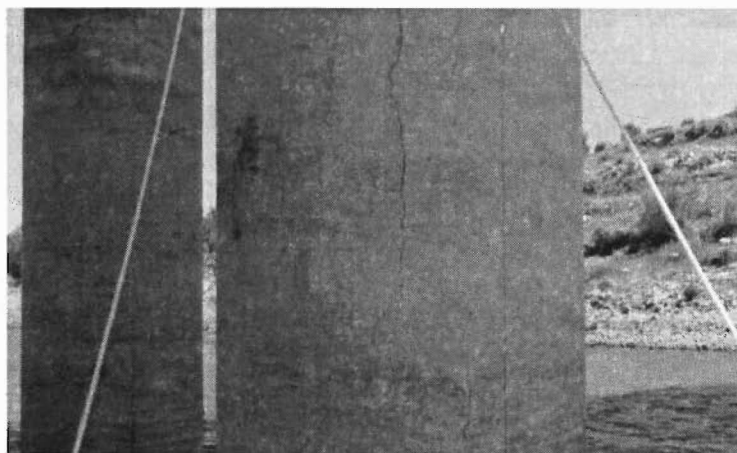
On September 29, 1999, cracks could be seen at each bent. Damage was concentrated at bents with expansion joints, probably because of greater exposure to rain of bent caps and girders in those locations. Bents 5, 9, 10 and 11 were visually assessed. Bent 10 showed clearly visible cracks, about 1/8 in. (3 mm) wide, over the entire height of the lower columns. The cracks appeared to coincide with the locations of

the longitudinal reinforcement in the lower columns. Bents 9 and 11 show similar cracks, about 1/16 in. (2 mm) wide. Examples of these cracks are shown in Figure 7.24. Bent 5 shows similar vertical cracks, about 1/16 in. (2 mm) wide. It also showed clearly visible horizontal cracks, about 1/32 in. (1 mm) wide, apparently in line with the locations of the transverse reinforcement in the lower columns. This cracking is shown in Figure 7.25.

Figure 7.24 Vertical cracking typical of Bents 9, 10 and 11 of FM 1979 structure (Bent 10)

An underwater investigation revealed that the vertical cracks go all the way to the mud line. At Bent 10 the cracks are 1/8 in. (3 mm) wide and at Bent 5, 1/16 in. (2 mm) wide down to the mud line.

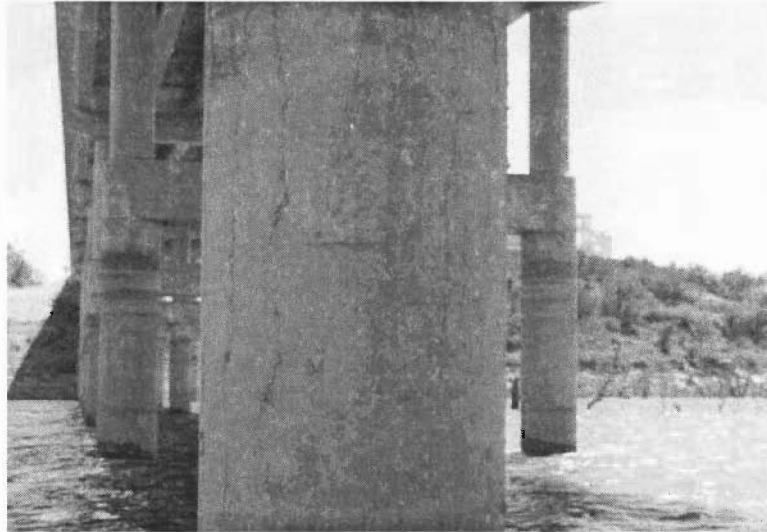
Figure 7.25 Horizontal and vertical cracking in Bent 5 of FM 1979 structure

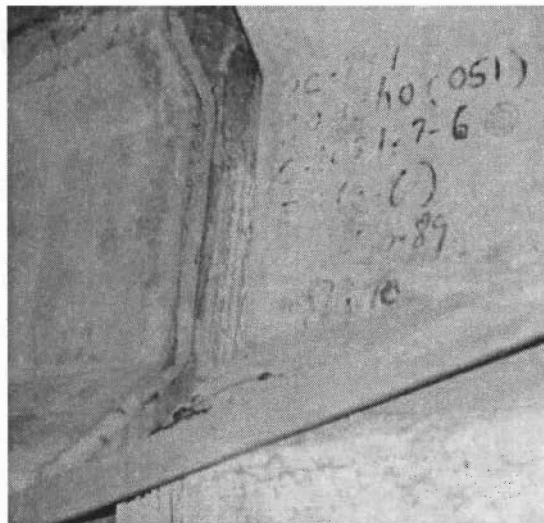
Observations on the west side of the structure revealed damage on the bent caps, upper columns and tie beams in those same bents. At Bent 5, the girder ends showed horizontal cracking on their bottom flanges, and map cracking on their webs (Figures 7.26 and 7.27). The bent cap showed extensive map cracking, with a typical width of 1/16 in. (2 mm), on the top, sides and ends (Figure 7.28). On the sides of the bent cap, some diagonal cracks propagated outward from the top of the upper column (Figure 7.29).

Figure 7.26 Horizontal cracking on bottom flanges of outside girder ends (Bent 5)

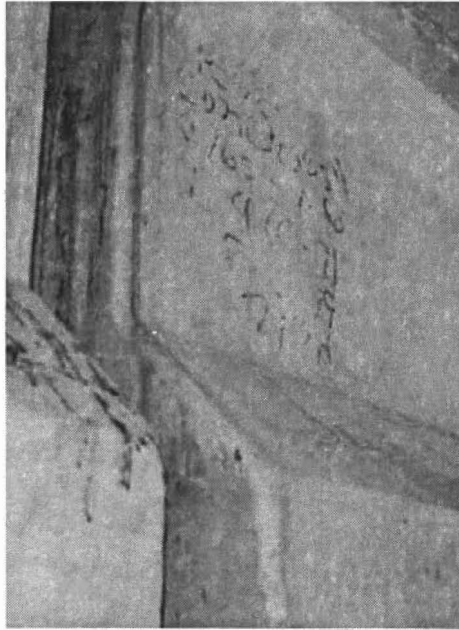
Figure 7.27 Horizontal cracking at bottom flanges of inside girder ends (Bent 5)

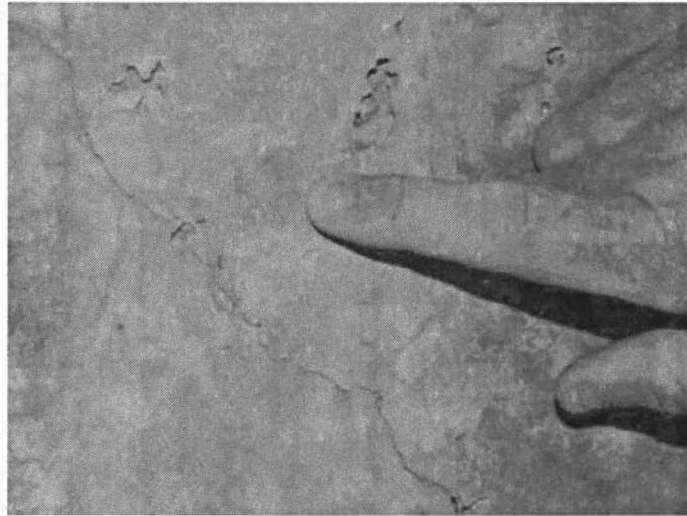
Figure 7.29 Map cracking on side of bent cap (Bent 5)

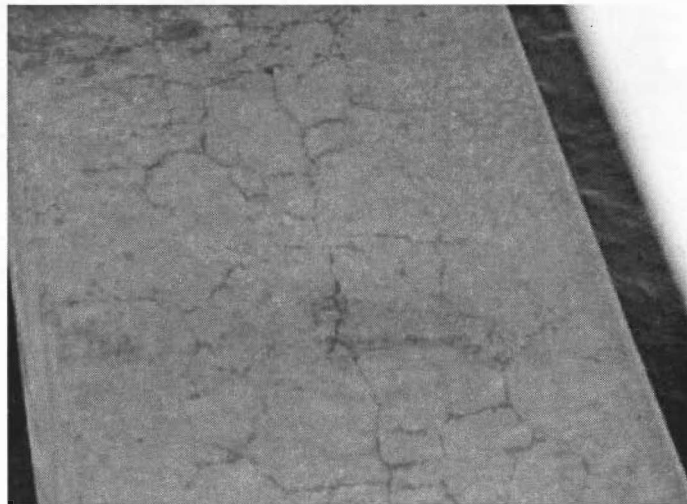
At Bent 5, map cracking was clearly visible on the upper columns, and on the upper surfaces of the tie beams (Figure 7.30). The vertical cracks on the lower columns extended upward to the upper surface of the tie beam (Figure 7.31).

Figure 7.30 Map cracking on upper surface of tie beam (Bent 5)

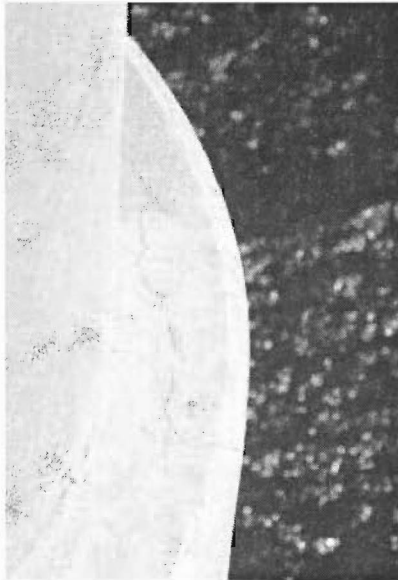
Figure 7.31 Propagation of vertical cracks in lower column to top of tie beam (Bent 5)

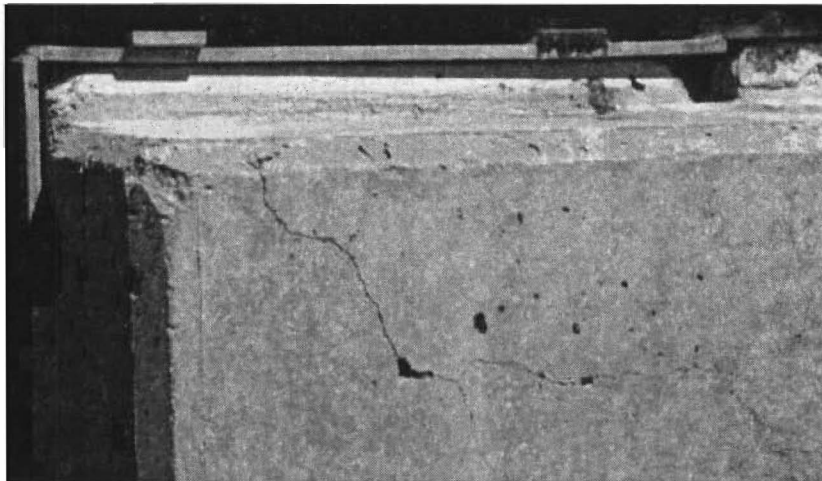
At Bent 9, similar damage was evident to the bent caps (Figure 7.32) and girder ends (Figure 7.33).

Figure 7.32 Map cracking at ends of bent cap (Bent 9)

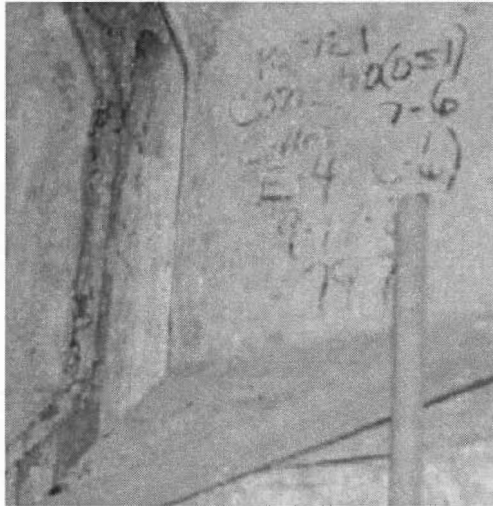
Figure 7.33 Horizontal and map cracking at girder ends (Bent 9)

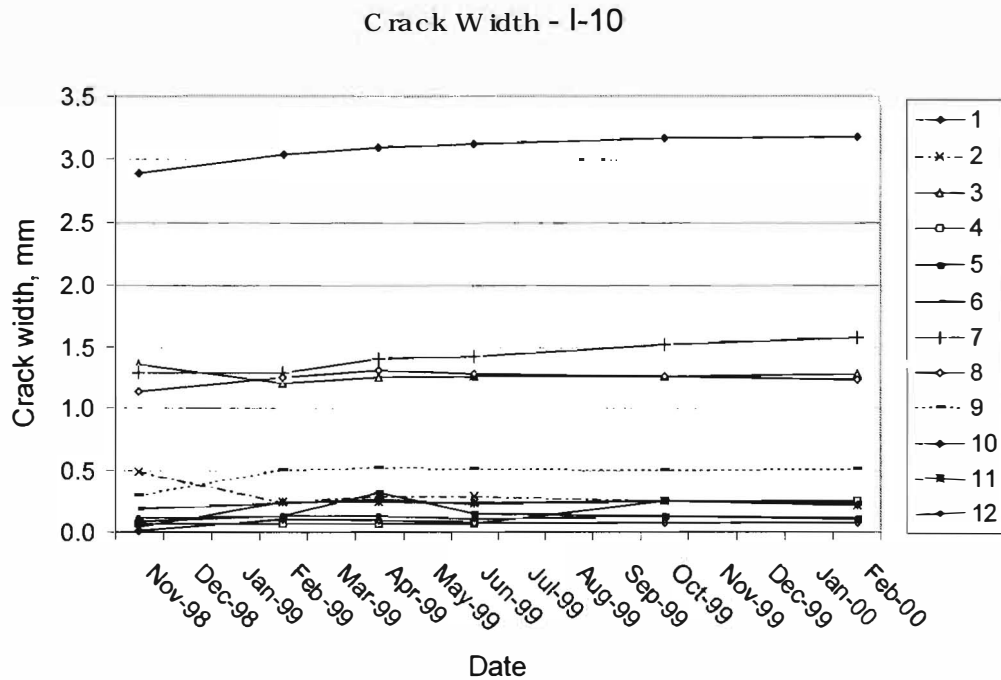
Figure 7.34 Crack width over time for I-10 structure

On the I-10 structure, cracks at Points 1, 3, 7 and 8 were significantly wider than others, and were all within 65 in. (1.65 m) of the ends of the girders. Cracks at Points 1 and 7, which consistently grew in width, were within 36 in. (0.91 m) of the ends. On the US-90 structure, cracks at Points 1, 3, 7, and 12 were significantly wider than others, and were all within 53 in. (1.35 m) of the ends of the girders. Only Point 1 consistently grew in width; it was 24 in. (0.61 m) from the ends. No significant crack growth was observed on the Robinson Road structure. Conclusions regarding the Beltway 8 structure cannot be made at this time.

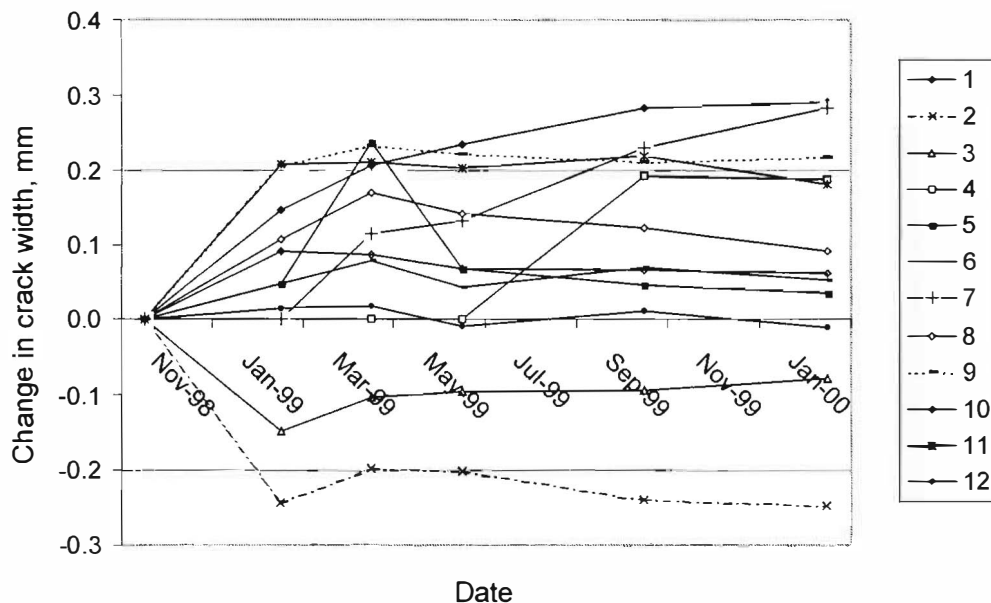
Figure 7.35 Change in crack width over time for I-10 structure

Figures 7.34 through 7.39 show the crack widths and change in crack widths determined from Demec gage measurements over time. Due to the loss of Demec points, only crack comparator measurements are presented for the Beltway 8 structure (Figure 7.40). Note that different locations were measured on each date.

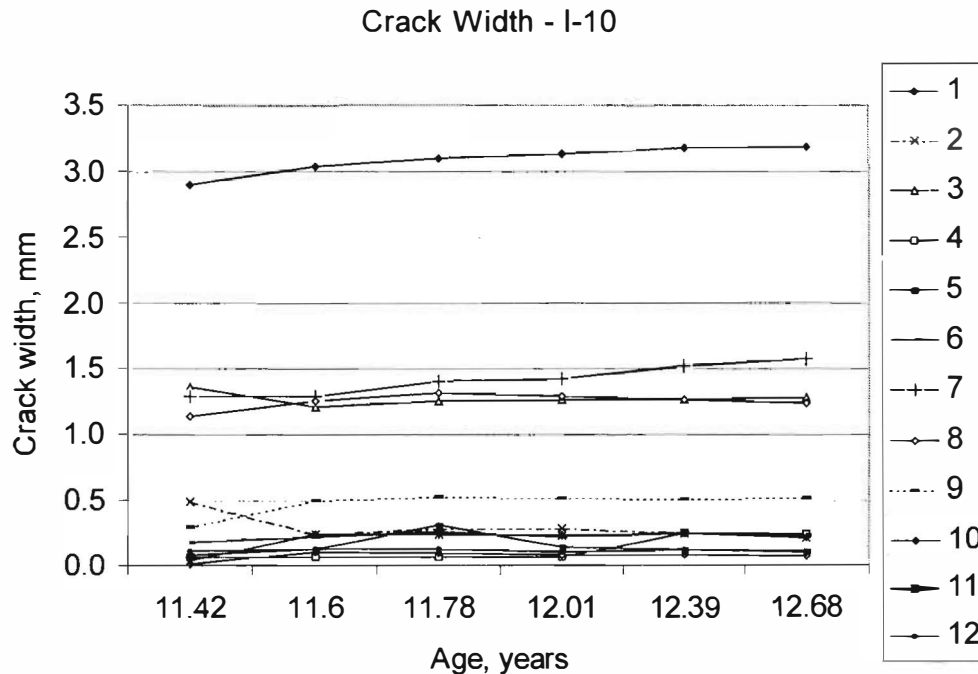
Figure 8.1 Crack width versus age of beam for I-10 structure

All documented points where cracks grew significantly were near the ends of the girders, where they were subjected to a more extreme exposure.

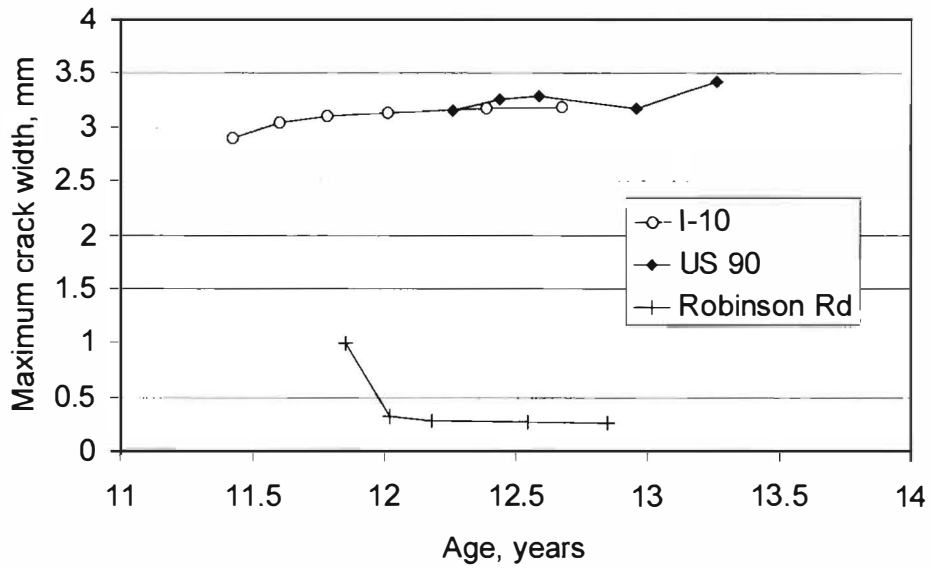
Figure 8.7 Maximum crack width of field girders

Figure 8.7 shows the maximum crack widths of the field girders studied.

Effect of exposure on level of damage and rate of deterioration is evident. For a common age of 12.5 years, structures with severe exposure had maximum crack widths 13 times greater than structures with mild exposure. In structures with severe exposure, maximum crack widths continued to increase; in the structure with mild exposure, maximum crack widths were relatively stable.

For the age of structures monitored, some cracks stop growing, while others continue to grow. Looking at one crack could lead one to conclude that the damage has stopped progressing. Looking at a different crack, however, could lead one to conclude that the damage is progressing rapidly. Visual inspection shows that most cracks that stopped growing are adjacent to a new crack that is growing. The rate of change in width of individual cracks may indicate that the rate of damage is increasing or decreasing. The plot of maximum crack width, however, along with visual inspection, confirms that overall damage is progressing.

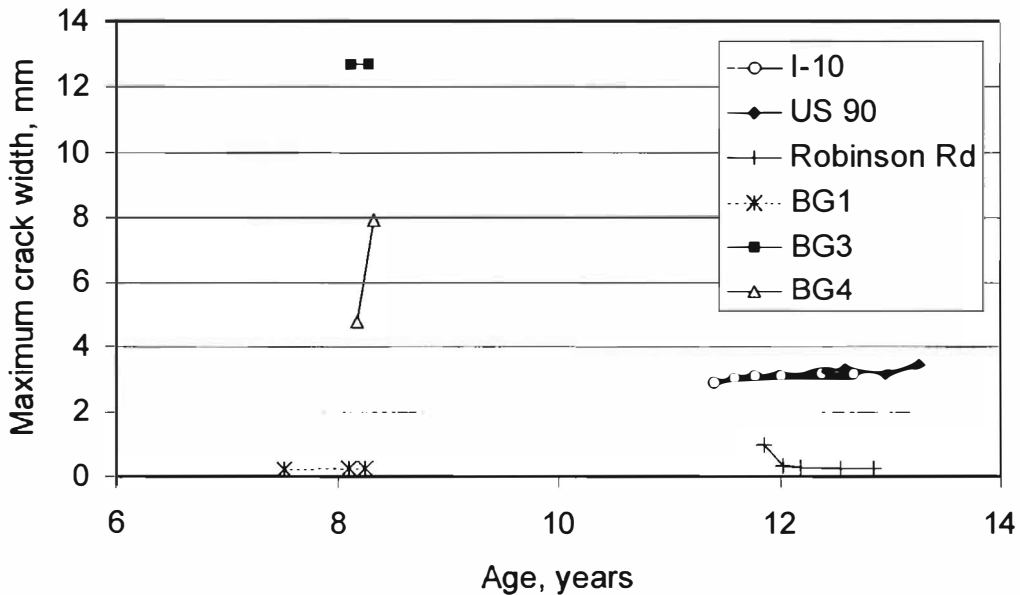
Figure 8.8 Maximum crack width of box and field girders

Figure 8.8 compares the maximum crack widths of box and field girders versus their ages.

This shows similar trends in the structures with mild exposure and low inherent problems (BG1 and Robinson Road). Though the field girders with severe exposure show an increase in maximum crack width, they have lower maximum widths than the younger box girders studied in the laboratory. This

might be explained by lower inherent problems. No structure or girder showed as drastic an increase in maximum crack width as BG4 (wetted). This is consistent with its severity of exposure. Although some field girders may have been located in areas with rainfall as severe as the wetting exposure of BG4, field girders would not generally have as severe exposure, because they would be protected to some degree by overlying slabs.
