RESEARCH REPORT
TR-5-74

**RIGID PAVEMENTS ON INTERSTATE
HIGHWAY USING GLASS FIBER
REINFORCEMENT**

July 26, 1974

PATCHING OF RIGID PAVEMENTS ON INTERSTATE HIGHWAY
USING GLASS FIBER REINFORCEMENT

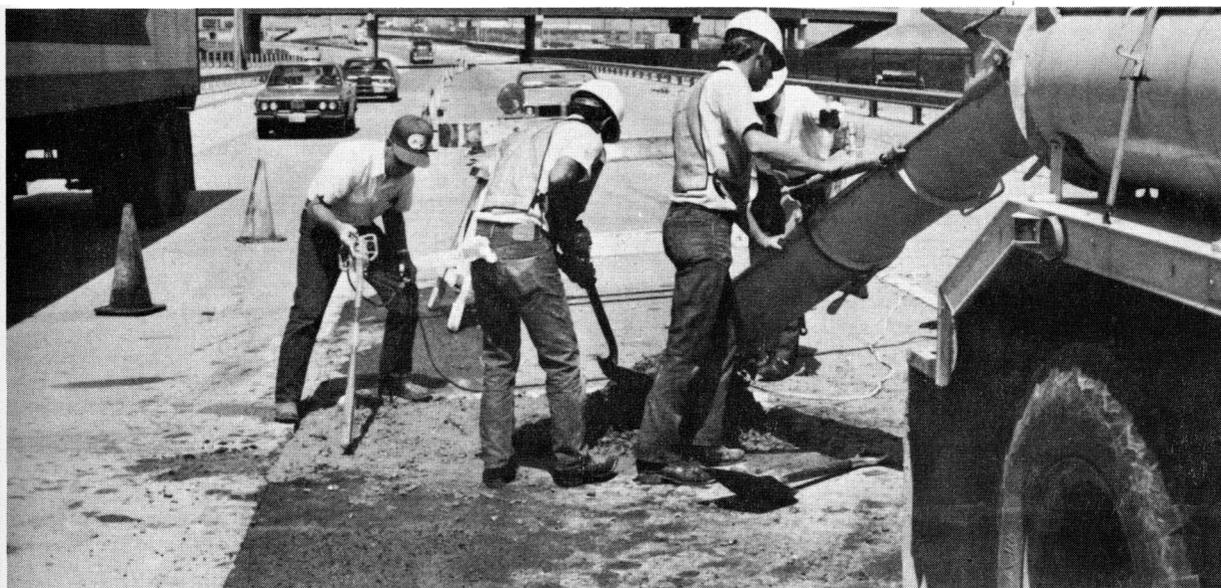
Figure 3: PLACING FIBER REINFORCED CONCRETE IN PATCH #1

Repair patch #1 was of a volume of 0.9 cubic yards. All steel in the patch section was removed as shown by Figure 2. The patch was made without steel reinforcement as shown by Figure 3. The concrete mix was designed for the proportions shown in Table 2.

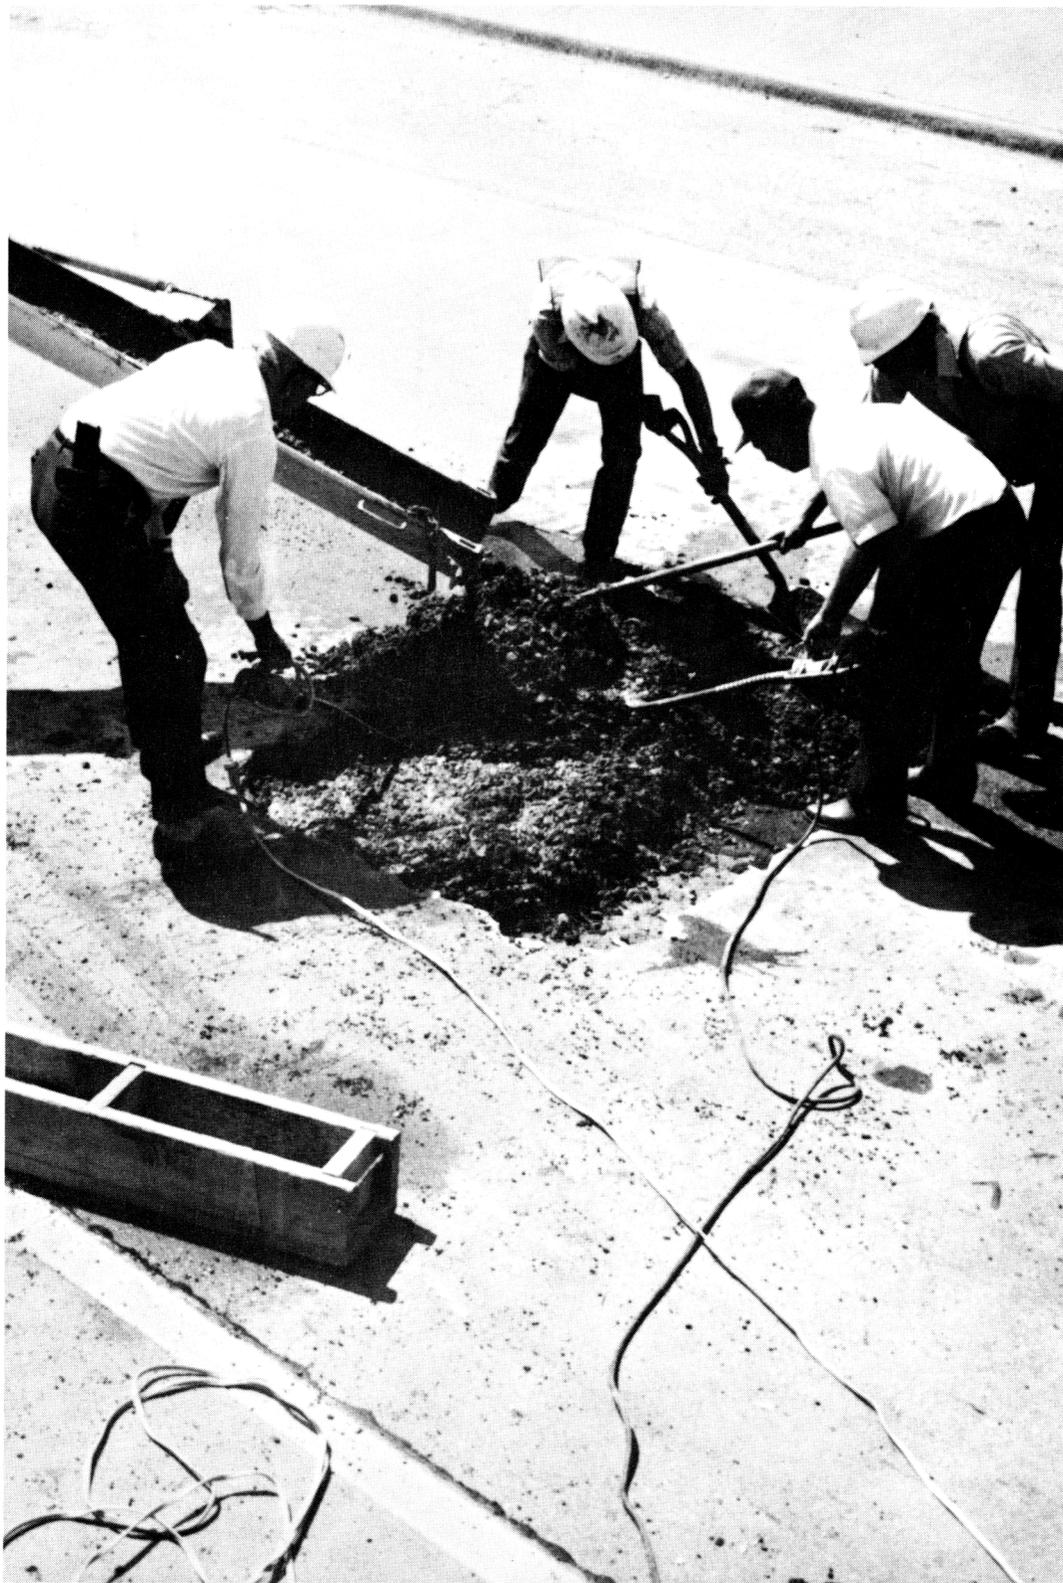
Figure 4: PLACING FIBER REINFORCED CONCRETE IN PATCH #1

The chopped glass fibers, one inch long, were dumped directly from the cardboard shipping container into the hopper of the rotating drum mixer of a ready-mix truck. The truck mixer was then operated at maximum mix speed for three to five minutes. Thorough distribution was achieved, and there was no evidence of any clusters or clumps of glass fibers being formed in the mixture. See Figure 4. The fibrous concrete composite material was readily ejected from the truck-mounted mixer with an apparent slump of about 2 inches. It was placed as shown by Figure 4, internally, and finished without difficulty. See Figure 5.

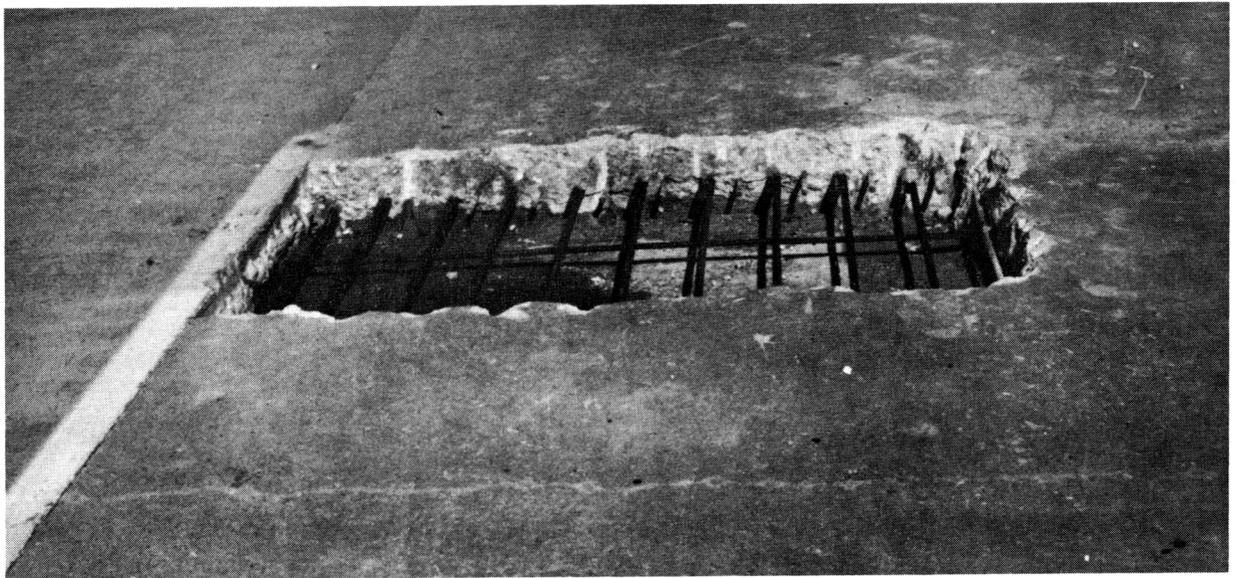
Figure 6: EXCAVATION OF PATCH #2

The approximate concrete requirement, for the second patch to be made with glass fiber reinforcement, was about 0.7 cubic yards. An insufficient amount of glass fibers was available to permit the mixing at a volume content of about 1%. Also, there was less than 0.7 cubic yards remaining in the ready-mix truck. Therefore it was decided to leave the steel reinforcement in place in Patch #2. See Figure 6. It was also decided to place a patch with a mix of high shrinkage potential.

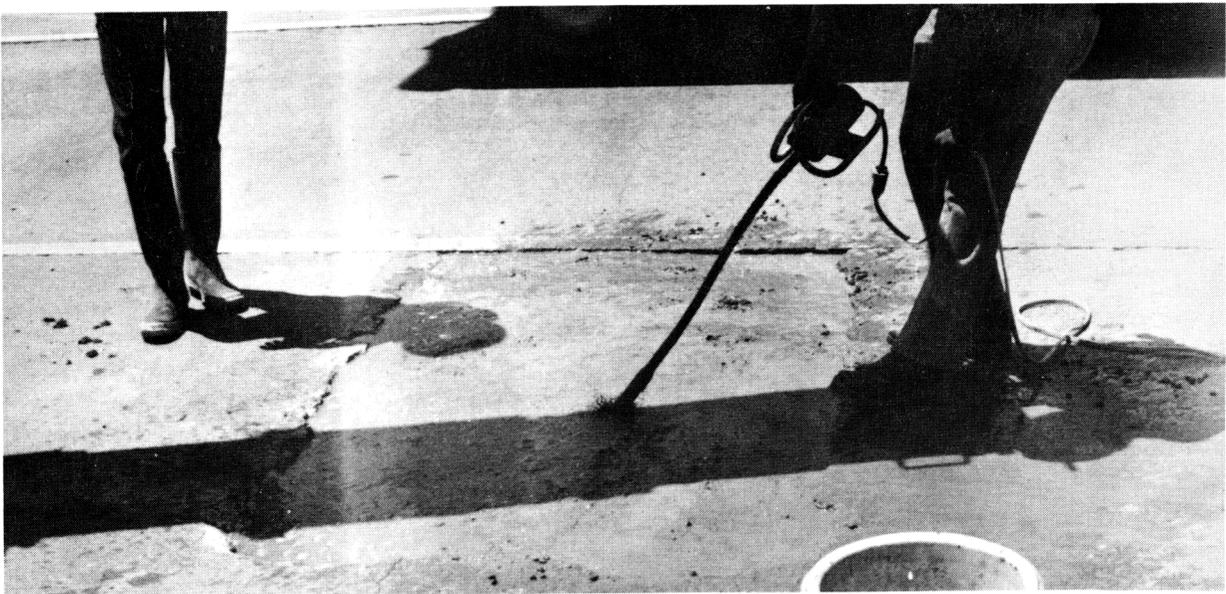
Figure 8: VIBRATING HIGH SLUMP CONCRETE IN PATCH #2

Concrete quantity in the mixer was increased by adding sand (no additional coarse aggregate was available), cement to maintain the eight sack/yd.³ proportion, and water to produce a slump of six inches or more. The glass fiber content was estimated to be about 0.2 percent by volume.

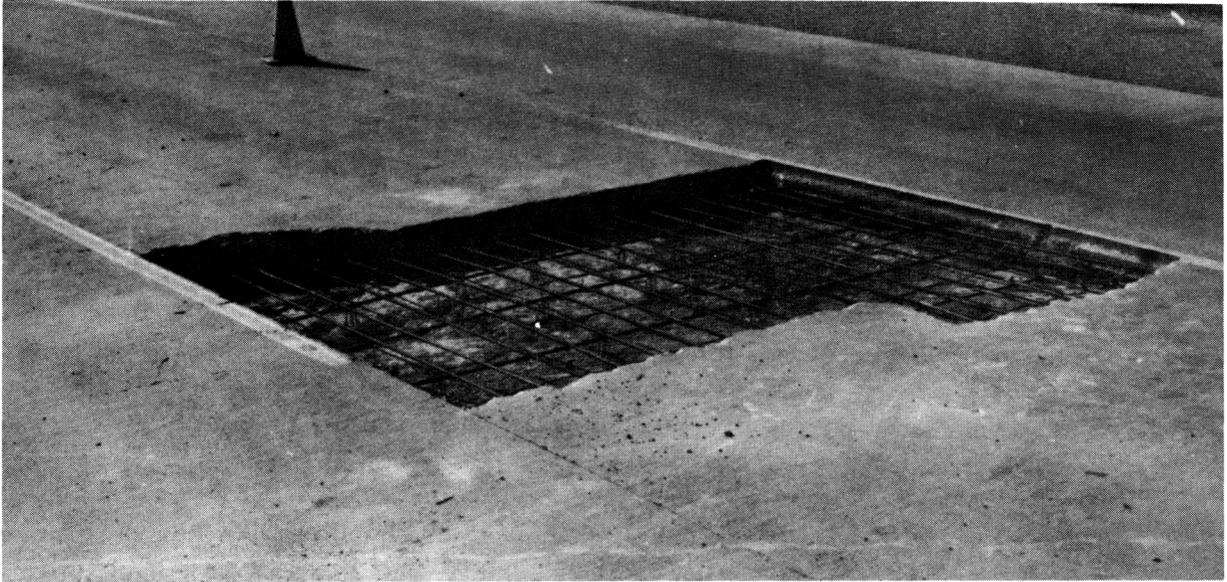
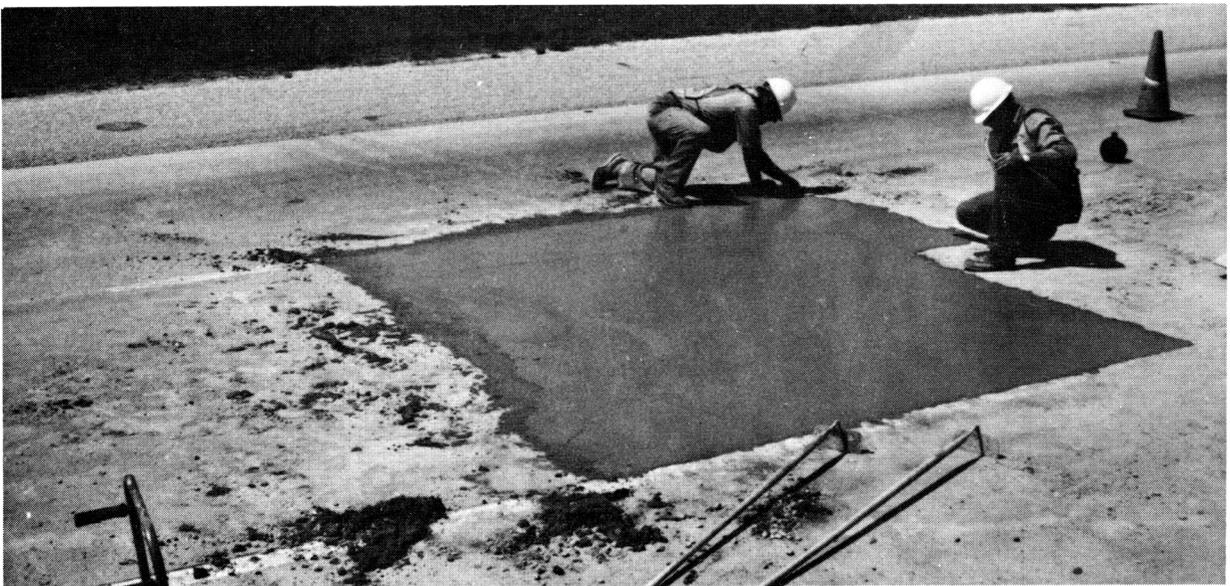
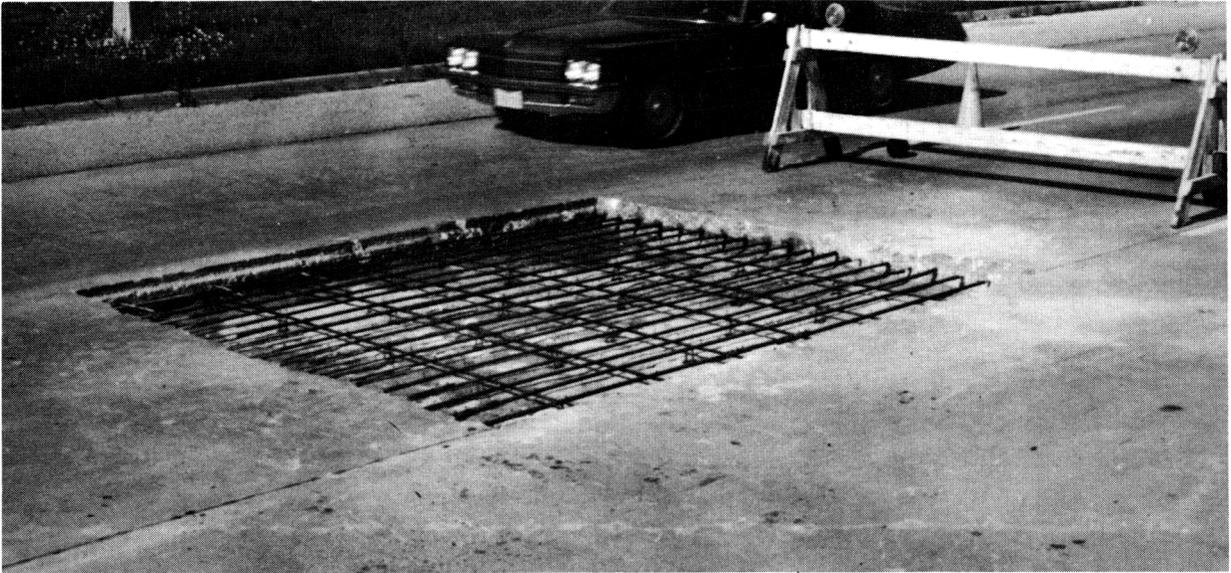
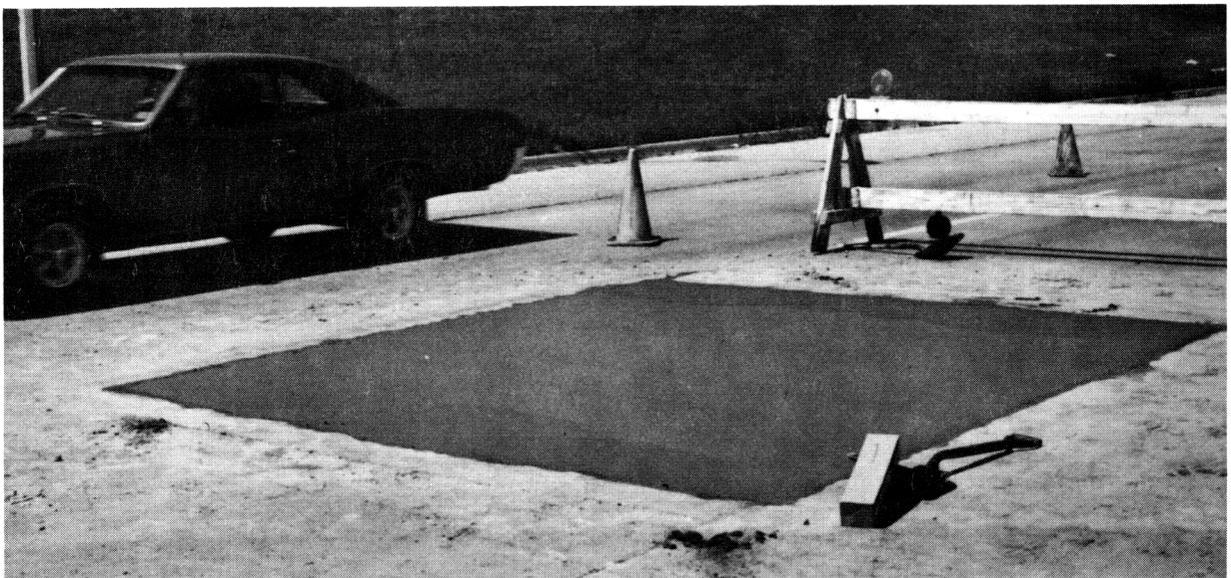
Patch #3 and Patch #4 (see Figures 9 through 12) were each of a volume greater than one cubic yard. The patches were made using concrete mix proportions and placement techniques that are typical of those most frequently used by the Fort Worth District maintenance function of the Texas Highway Department, with the exception that a maximum aggregate size of 3/4-inch was used in lieu of the 1½-inches maximum aggregate size that is normally used.
