"REPORT ON THE STATIC AND DYNAMIC TESTING  
OF FRANKLIN'S U-POST AND EZE-ERECT CONNECTION"

Research Report 3491-1F

Final Report  
on  
Project RF 3491

Texas A & M Research Foundation  
Texas Transportation Institute  
Texas A&M University  
College Station, Texas 77843

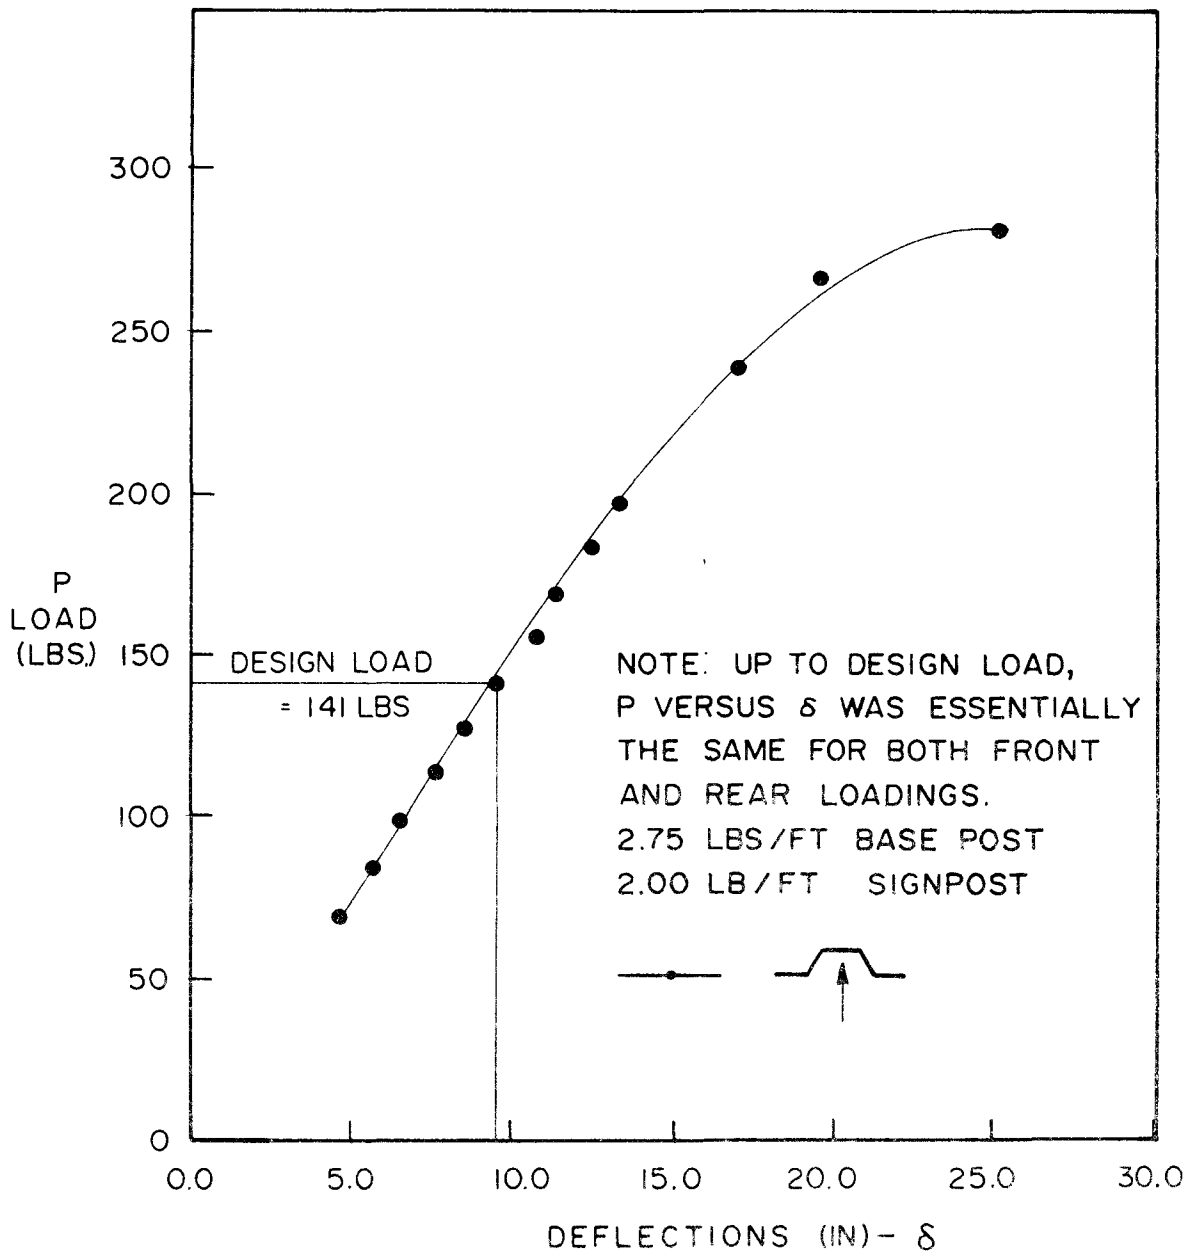
FIGURE 5. LOAD-DEFLECTION CURVE, DESIGN LOAD = 141 LBS.

Results of the static load tests are given in Tables 1 and 2 and Figures 5 and 6. It can be seen that the amount of permanent set and/or slippage was relatively small up to the design load for both loading configurations, for both front and rear loading directions. Although the limited instrumentation precluded an exact determination, it is likely that most if not all of the "permanent" deflections, up to design load, were caused by slippage of the bolted base connection. A structural failure occurred in Configuration II at 136 percent of the design load when the web section of the base post split down the center line of the punched holes. The failure is shown in Figure 7.

- (3) The modulus of elasticity, although believed to be accurate, may not be exact.
- (4) There was some slippage in the bolted connection.
- (5) From Figure 5, some yielding took place above a load of about 200 lb. The theoretical values are based on a linear elastic material.

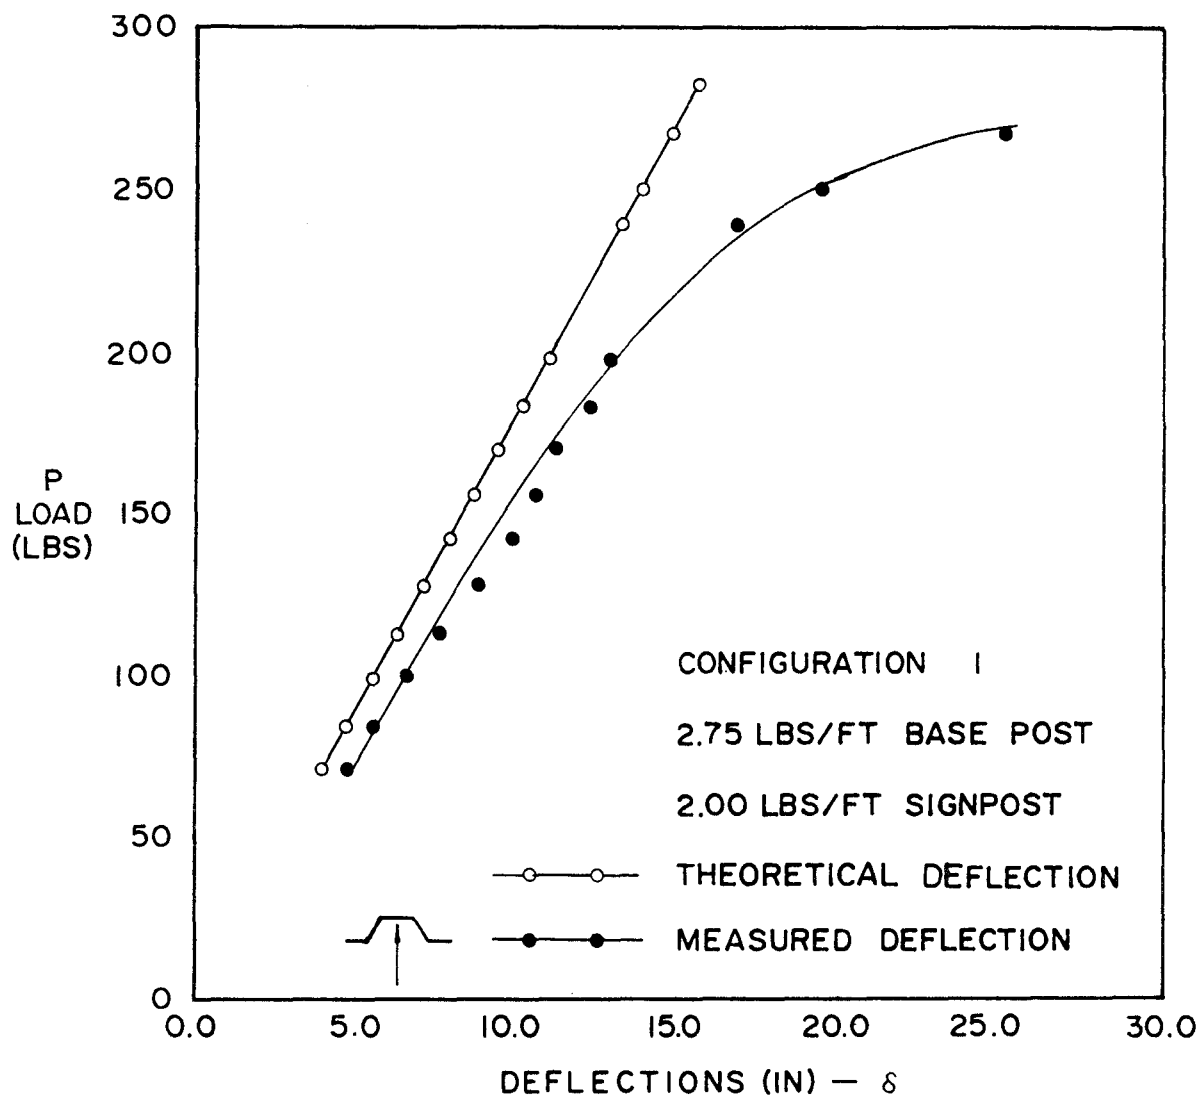
FIGURE 8. THEORETICAL VS. MEASURED DEFLECTIONS, DESIGN LOAD = 141 LBS.

Following the static test, theoretical deflections were calculated and compared with the results from the test. The results are shown in Table 3 and Figures 8 and 9. A percent difference was calculated for the discrepancy that occurred in the measured and calculated deflections. In most cases, the percent difference was about 15-20%.

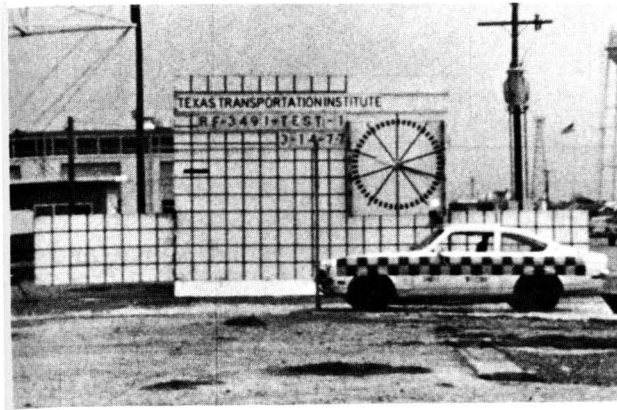
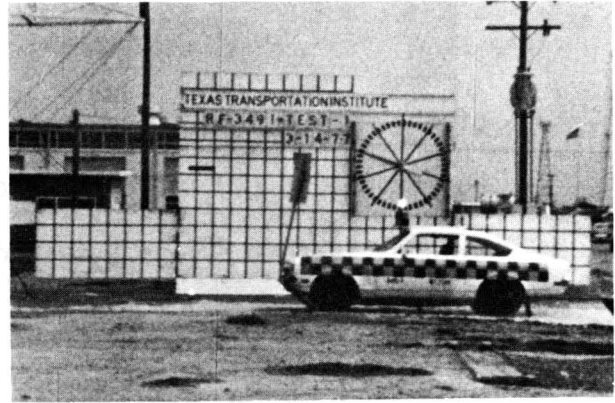
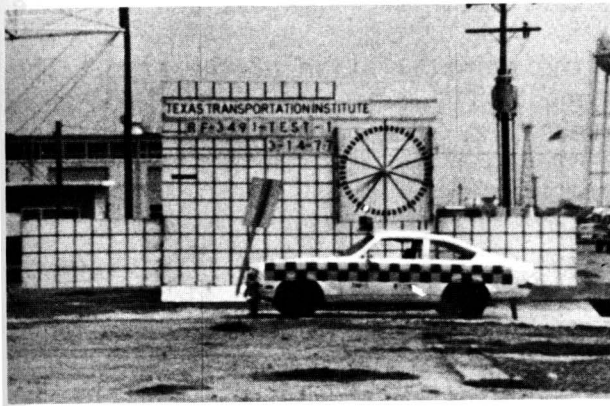
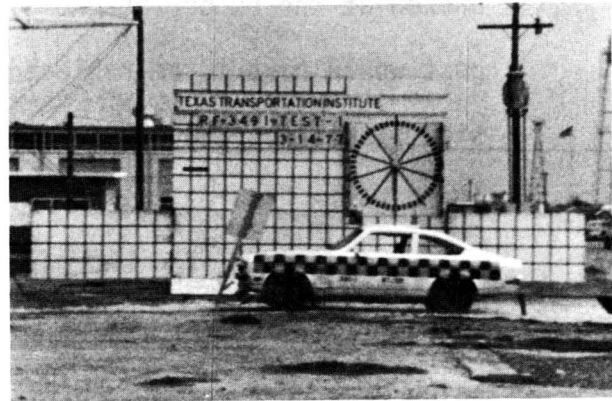
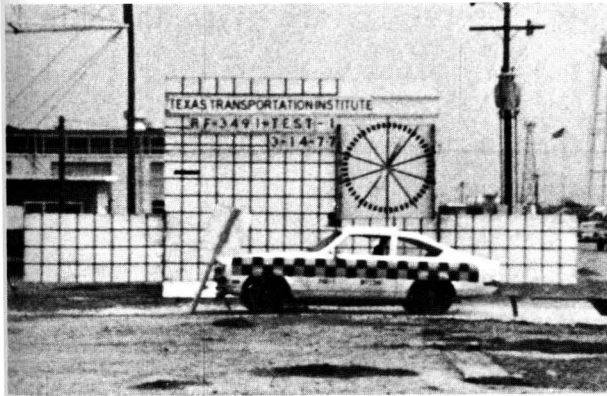
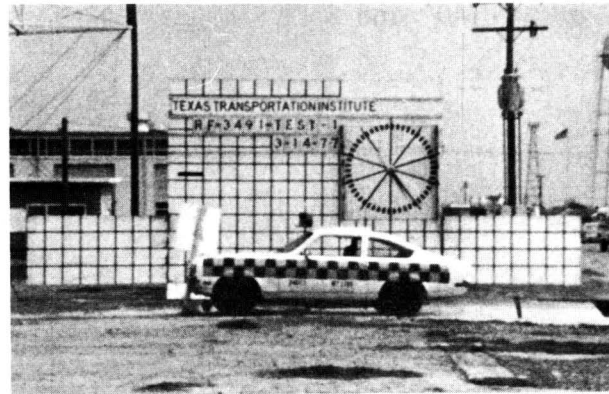
FIGURE 23. SEQUENTIAL PHOTOGRAPHS OF TEST 1.

Sequential photographs of the test from the high-speed film are given in Figure 23. Upon impact, the bolts connecting the base post and the signpost in the Eze-Erect connection broke, with some tearing

of the web section in the base post. The signpost broke also at the bumper height (20 in.) of the car upon impact. The upper part of the signpost with the sign attached flew forward after it broke loose and was rehit by the car.

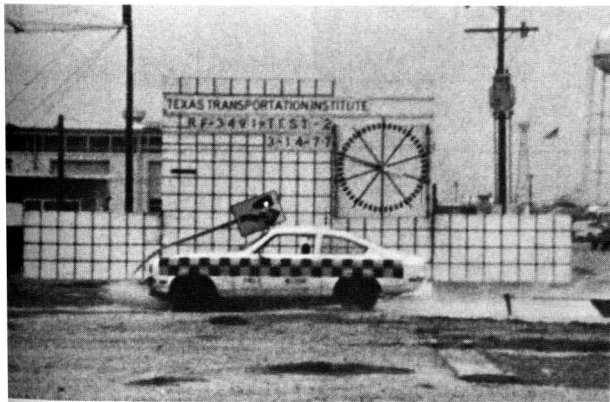
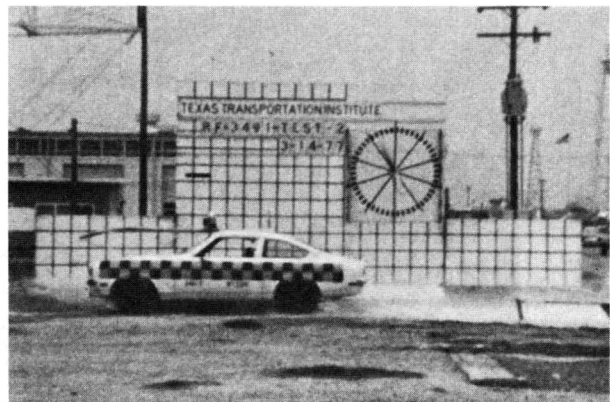
FIGURE 36. SEQUENTIAL PHOTOGRAPHS OF TEST 2.

In Figure 36, sequential photographs from the high-speed film are shown. Upon impact, the signpost was bent by the bumper. Then the signpost and strap broke free from the base post. After the signpost was free, the post flew above the vehicle hitting the top of the car above the windshield but did not crack the glass.

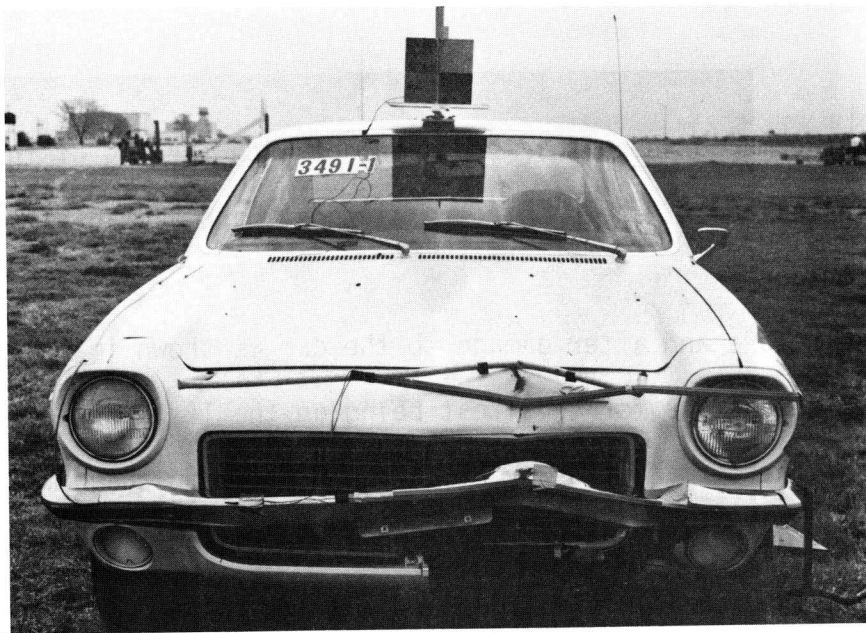
FIGURE 39. CAR BEFORE TEST 2.

The before and after damage to the car is shown in Figures 39 and 40, with the damage for this test being on the left portion of the vehicle. The permanent deformation was minor with the bumper being displaced, damaging the metal section above the grill. The top of the car above the windshield was dented. Damage to the vehicle was assessed using the TAD and SAE systems and is presented in Table 7.

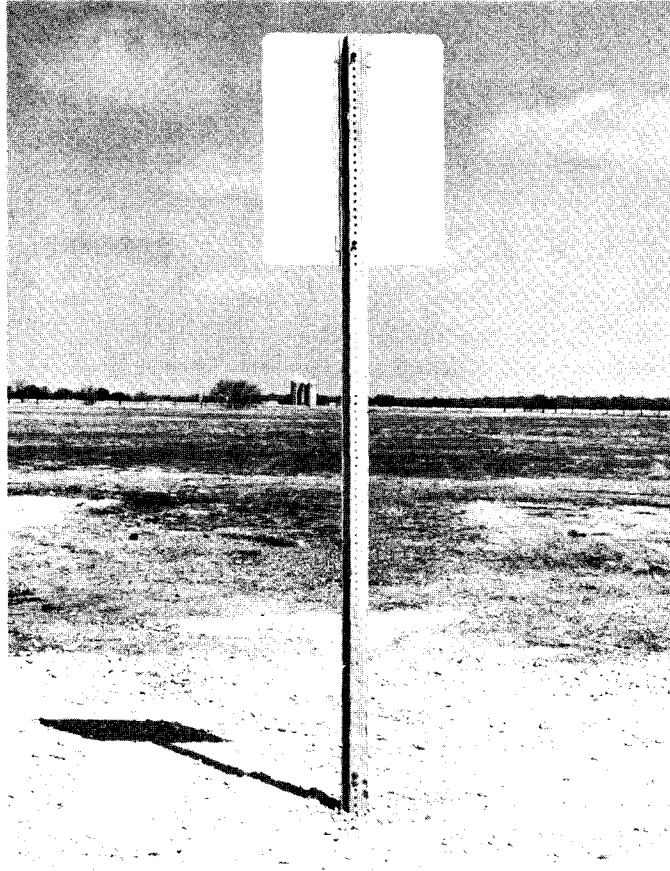
FIGURE 41. DIRECTION OF IMPACT - TEST 3.

The third test was a 20 mph impact with the car towed perpendicular to the back of the sign (Figure 41). The results of this test are summarized in Table 9. The change in momentum of the vehicle computed over the initial time of contact (0.245 sec) was 300 lb-sec for the high-speed film. The maximum change in momentum (Figure 42) during time of contact was 359 lb-sec for the left accelerometer and 376 lb-sec for the right accelerometer. The accelerations are shown in Figure 43. The peak decelerations measured by the two accelerometers were 3.9 g's and 4.3 g's. The time of initial contact was used in calculating the change in momentum because it is less than the free missile travel time (Figure 44).<sup>10</sup> The 50 millisecond average acceleration and the force exerted on the car by the sign are shown in Figures 45 and 46.

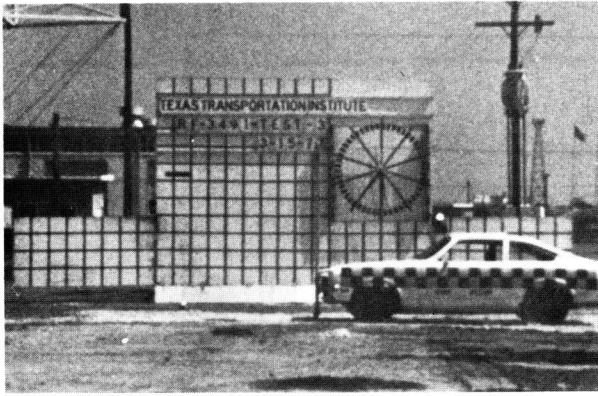
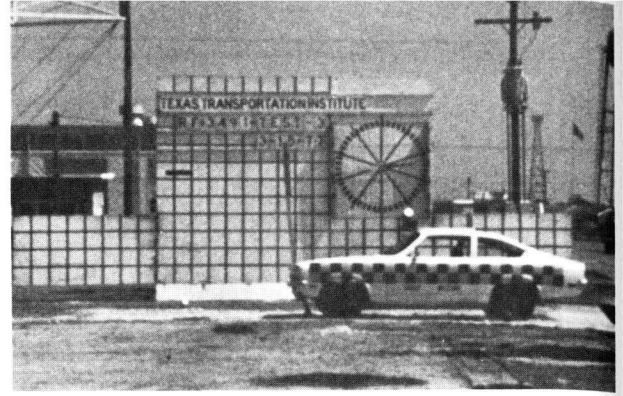
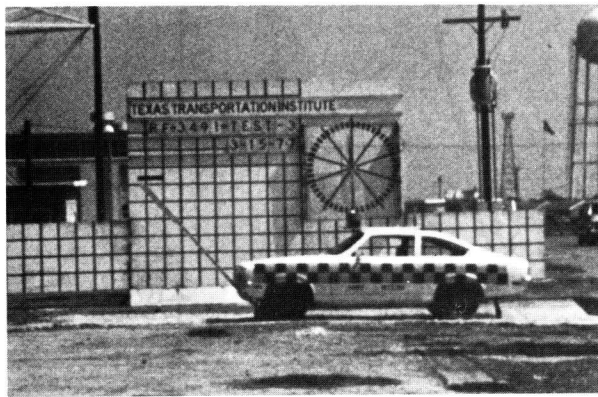
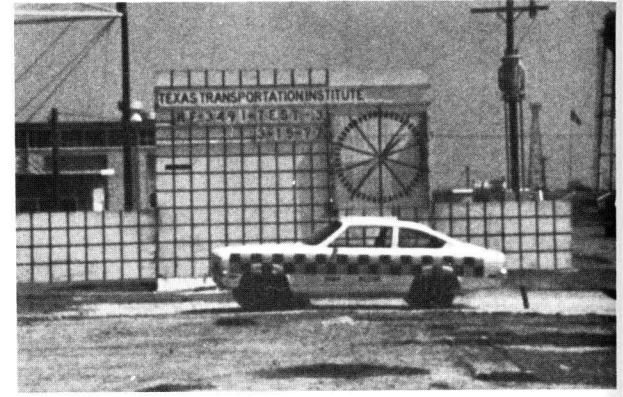
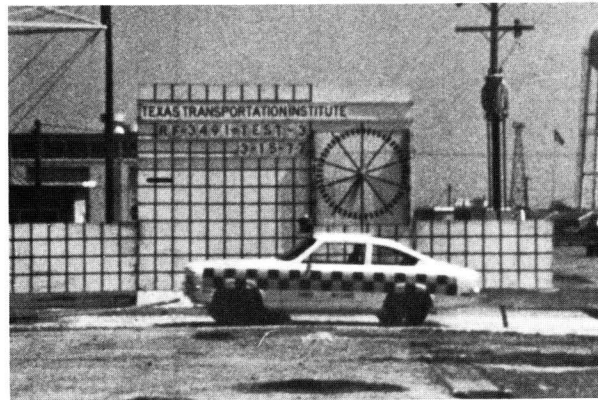
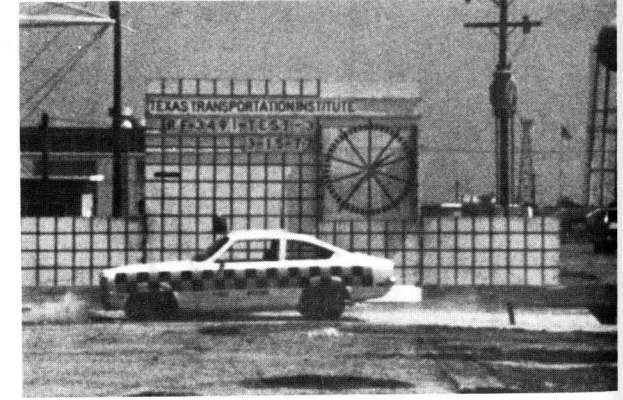
FIGURE 47. SEQUENTIAL PHOTOGRAPHS OF TEST 3.

Sequential photographs from the high-speed film are given in Figure 47. Upon impact, the base post fractured approximately 5 inches below the ground (Figure 48). After the base post broke, the signpost with sign panel attached first flew, then slid along the ground in front of the car.

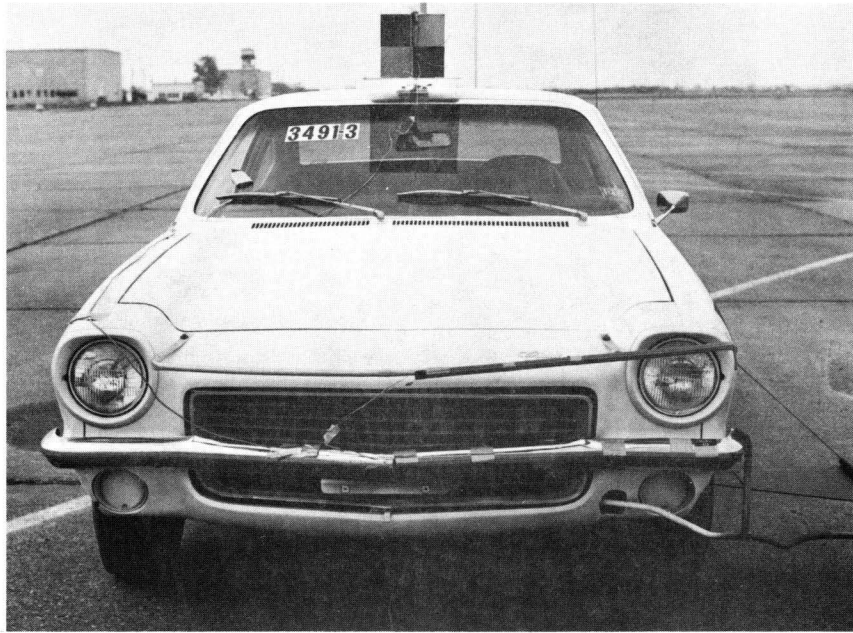
FIGURE 50. CAR BEFORE TEST 3.

Photographs of the car, before and after the test, are shown in Figures 50 and 51. The permanent deformation to the car was minor with the bumper pushed into the grill of the car and the metal above the

grill deformed. The damage to the car was assessed as in previous tests by the TAD and SAE systems. The results are given in Table 9.

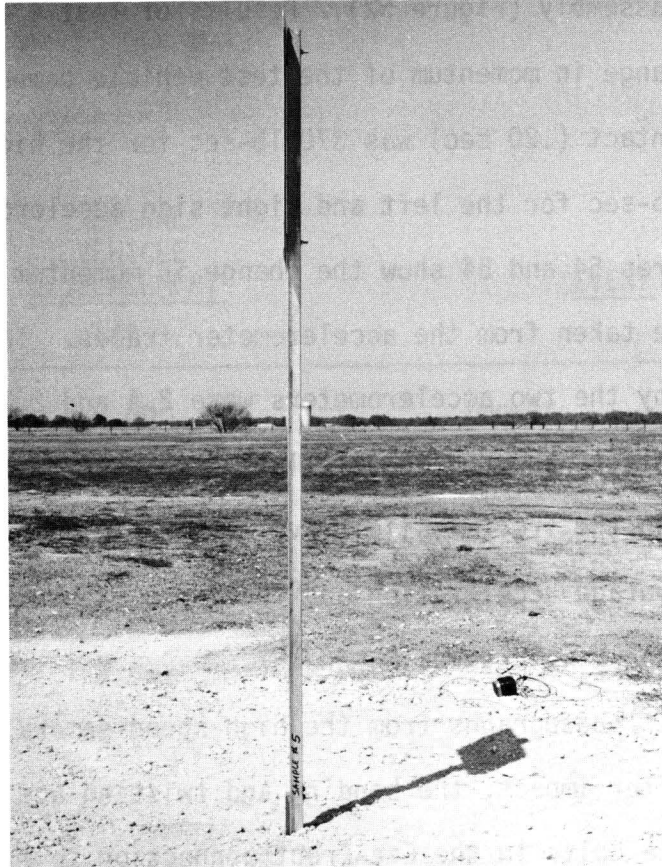
FIGURE 52. DIRECTION OF IMPACT - TEST 4

In Test 4, the car was towed at a speed of 20 mph into the side of the signpost assembly (Figure 52). Results of Test 4 are summarized in Table 11. Change in momentum of the test vehicle computed over the time of initial contact (.20 sec) was 370 lb-sec for the high-speed film and 378 and 337 lb-sec for the left and right side accelerometers, respectively. Figures 54 and 54 show the change in momentum and accelerations of the vehicle taken from the accelerometer traces. The peak measured deceleration by the two accelerometers were 2.4 and 2.7 g's. The time of initial contact was used in calculating the change in momentum because it is less than the free missile travel time (Figure 55).<sup>11</sup> The 50 millisecond average acceleration and the force exerted on the car by the sign are shown in Figures 56 and 57.

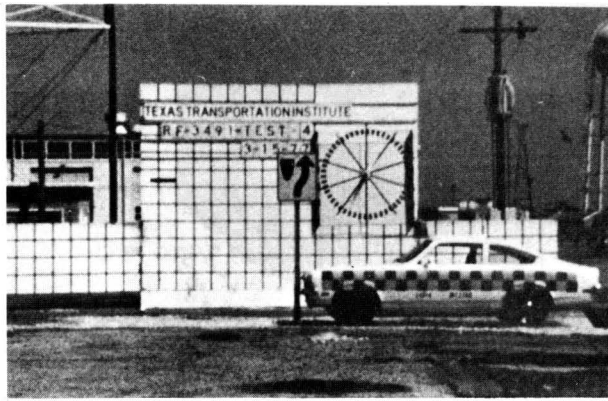
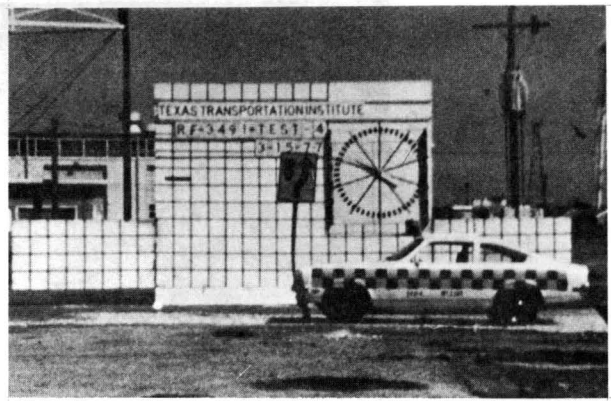
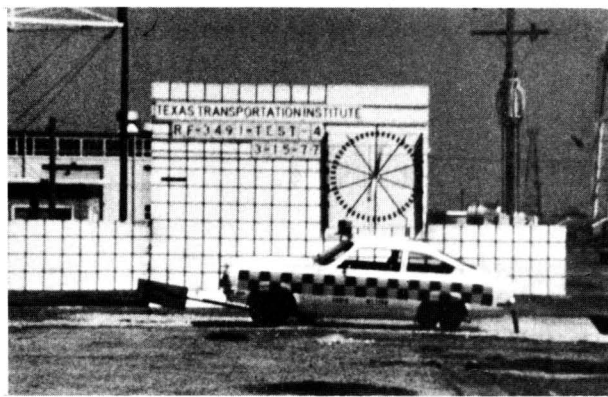
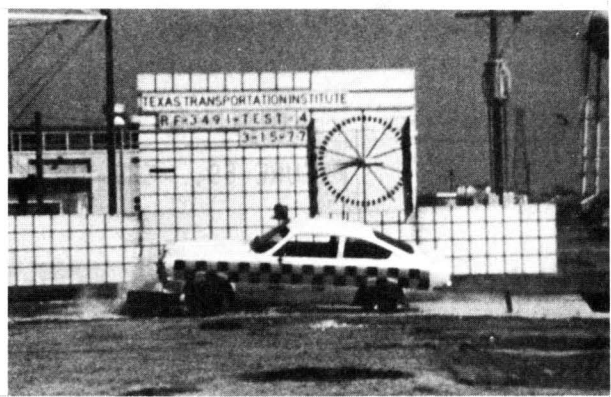
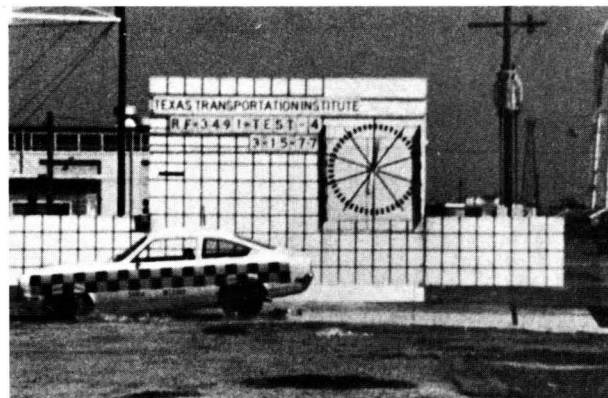
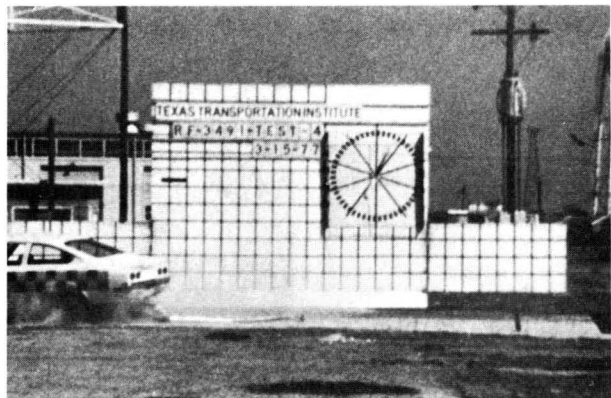
FIGURE 58. SEQUENTIAL PHOTOGRAPHS OF TEST 4.

Sequential photographs from the high-speed cameras are given in Figure 58. After impact, the bending and twisting action of the signpost caused the bolts in the Eze-Erect connection to fail. However, the retainer strap kept the signpost from further travel and the signpost fell to the ground in front of the car. The right front tire contacted the base post causing the car to veer off to the right.

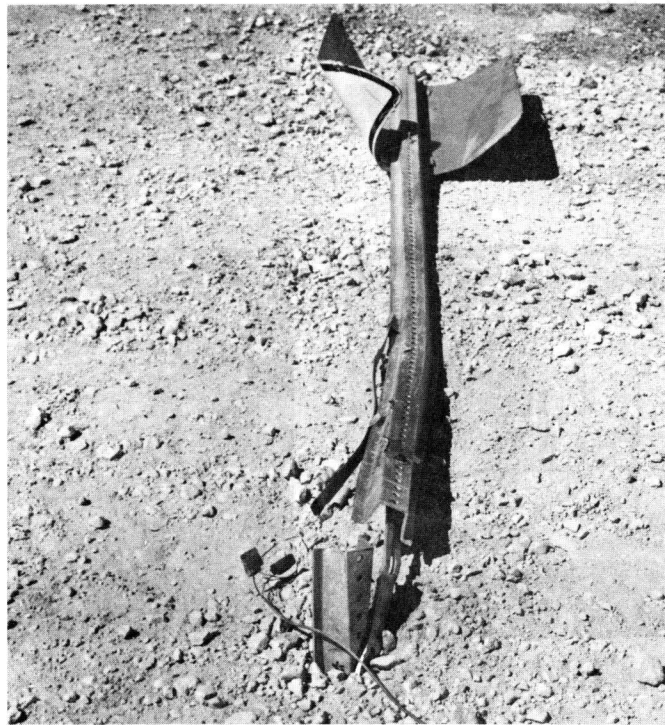
FIGURE 60. POST ASSEMBLY AFTER TEST 4.

The base post was twisted and bent above the ground and the signpost was twisted on the bottom two and a half feet. The sign panel was scratched and bent. (Figures 59 and 60) For reinstallation, the entire assembly would need replacing.

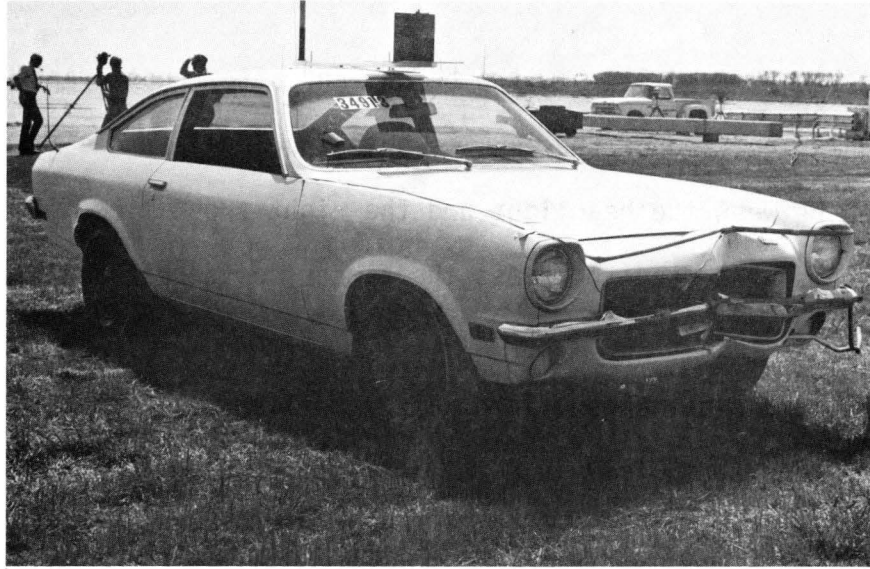
FIGURE 61. CAR BEFORE TEST 4.

Figures 61 and 62 show the before and after photographs of the car. The front right end of the car was pushed up against the tire damaging the area between the headlight and the right front tire. The TAD and SAE systems were used to assess the damage to the car and are presented in Table 11.
