TECHNICAL MEMORANDUM 505-1S

THE MODULAR CRASH CUSHION

A Tentative Progress Memorandum on Contract No. CPR-11-5851

August 1970

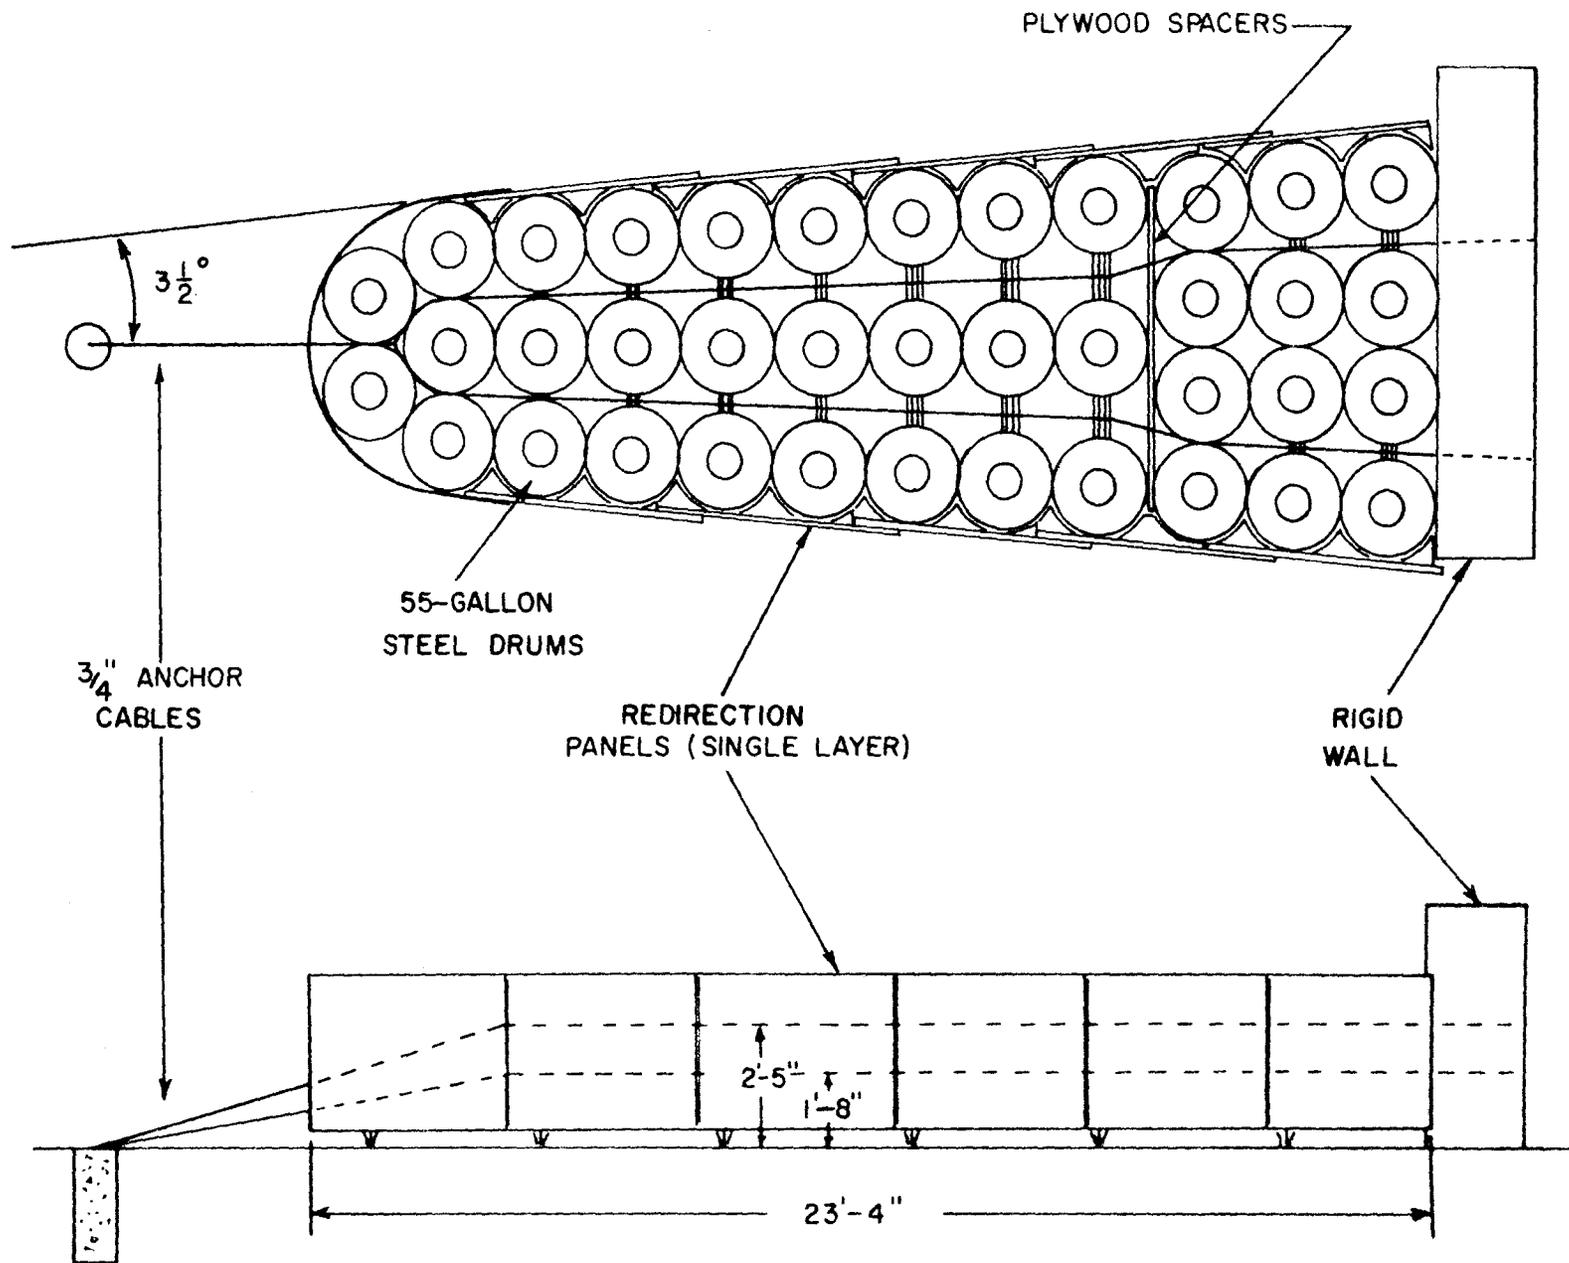
FIGURE 1, CONFIGURATION USED IN TEST 505B-A (BARRIER TYPE 1)

The first configuration is shown in Figure 1. The columns of modules were separated by plywood inserts, and the two support cables ran between the columns of drums in a path as shown in Figure 1. Overlapping redirection panels were attached to the sides of the crash cushion. These panels were made of 3/4" plywood covered with fiber glass which was coated with a polyester resin. This gel coat was used to give more smoothness to the panel surfaces and to improve the appearance of the barrier. The front edges of the panels were hinged so that the back edges could telescope or swing out, allowing free crushing of the barrier during head-on collisions.

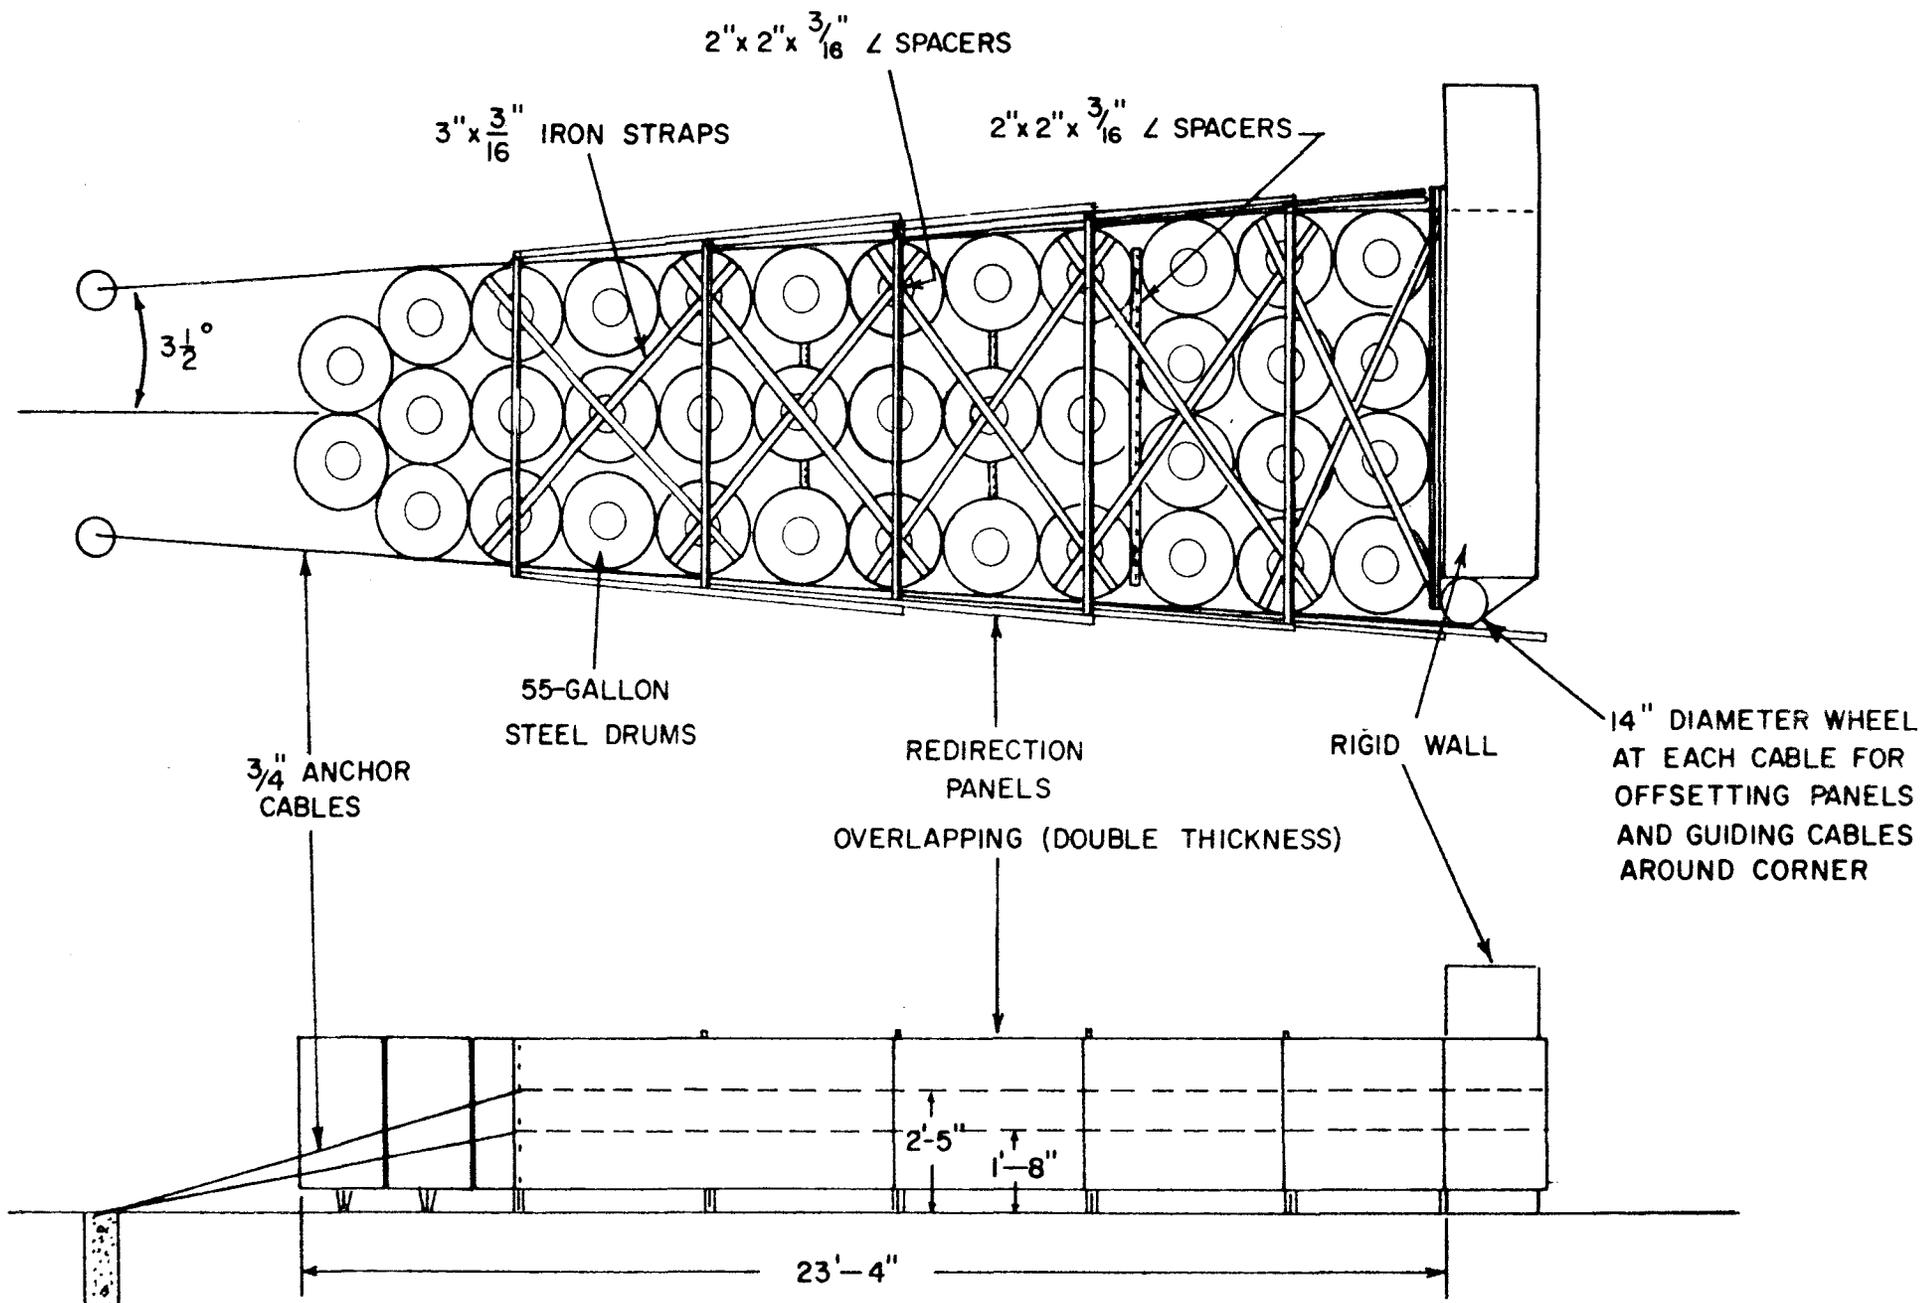
FIGURE 2, CONFIGURATION USED IN TESTS 505B-B AND 505B-C (BARRIER TYPE 2)

The second barrier which was tested is shown in Figure 2. The basic drum arrangement was the same as before, but the support cables were moved to run in a straight line between the outer modules and the redirection panels to reduce vehicle pocketing. A "truss" composed of steel straps was welded to the tops of the modules to increase the lateral strength and stiffness of the crash cushion.

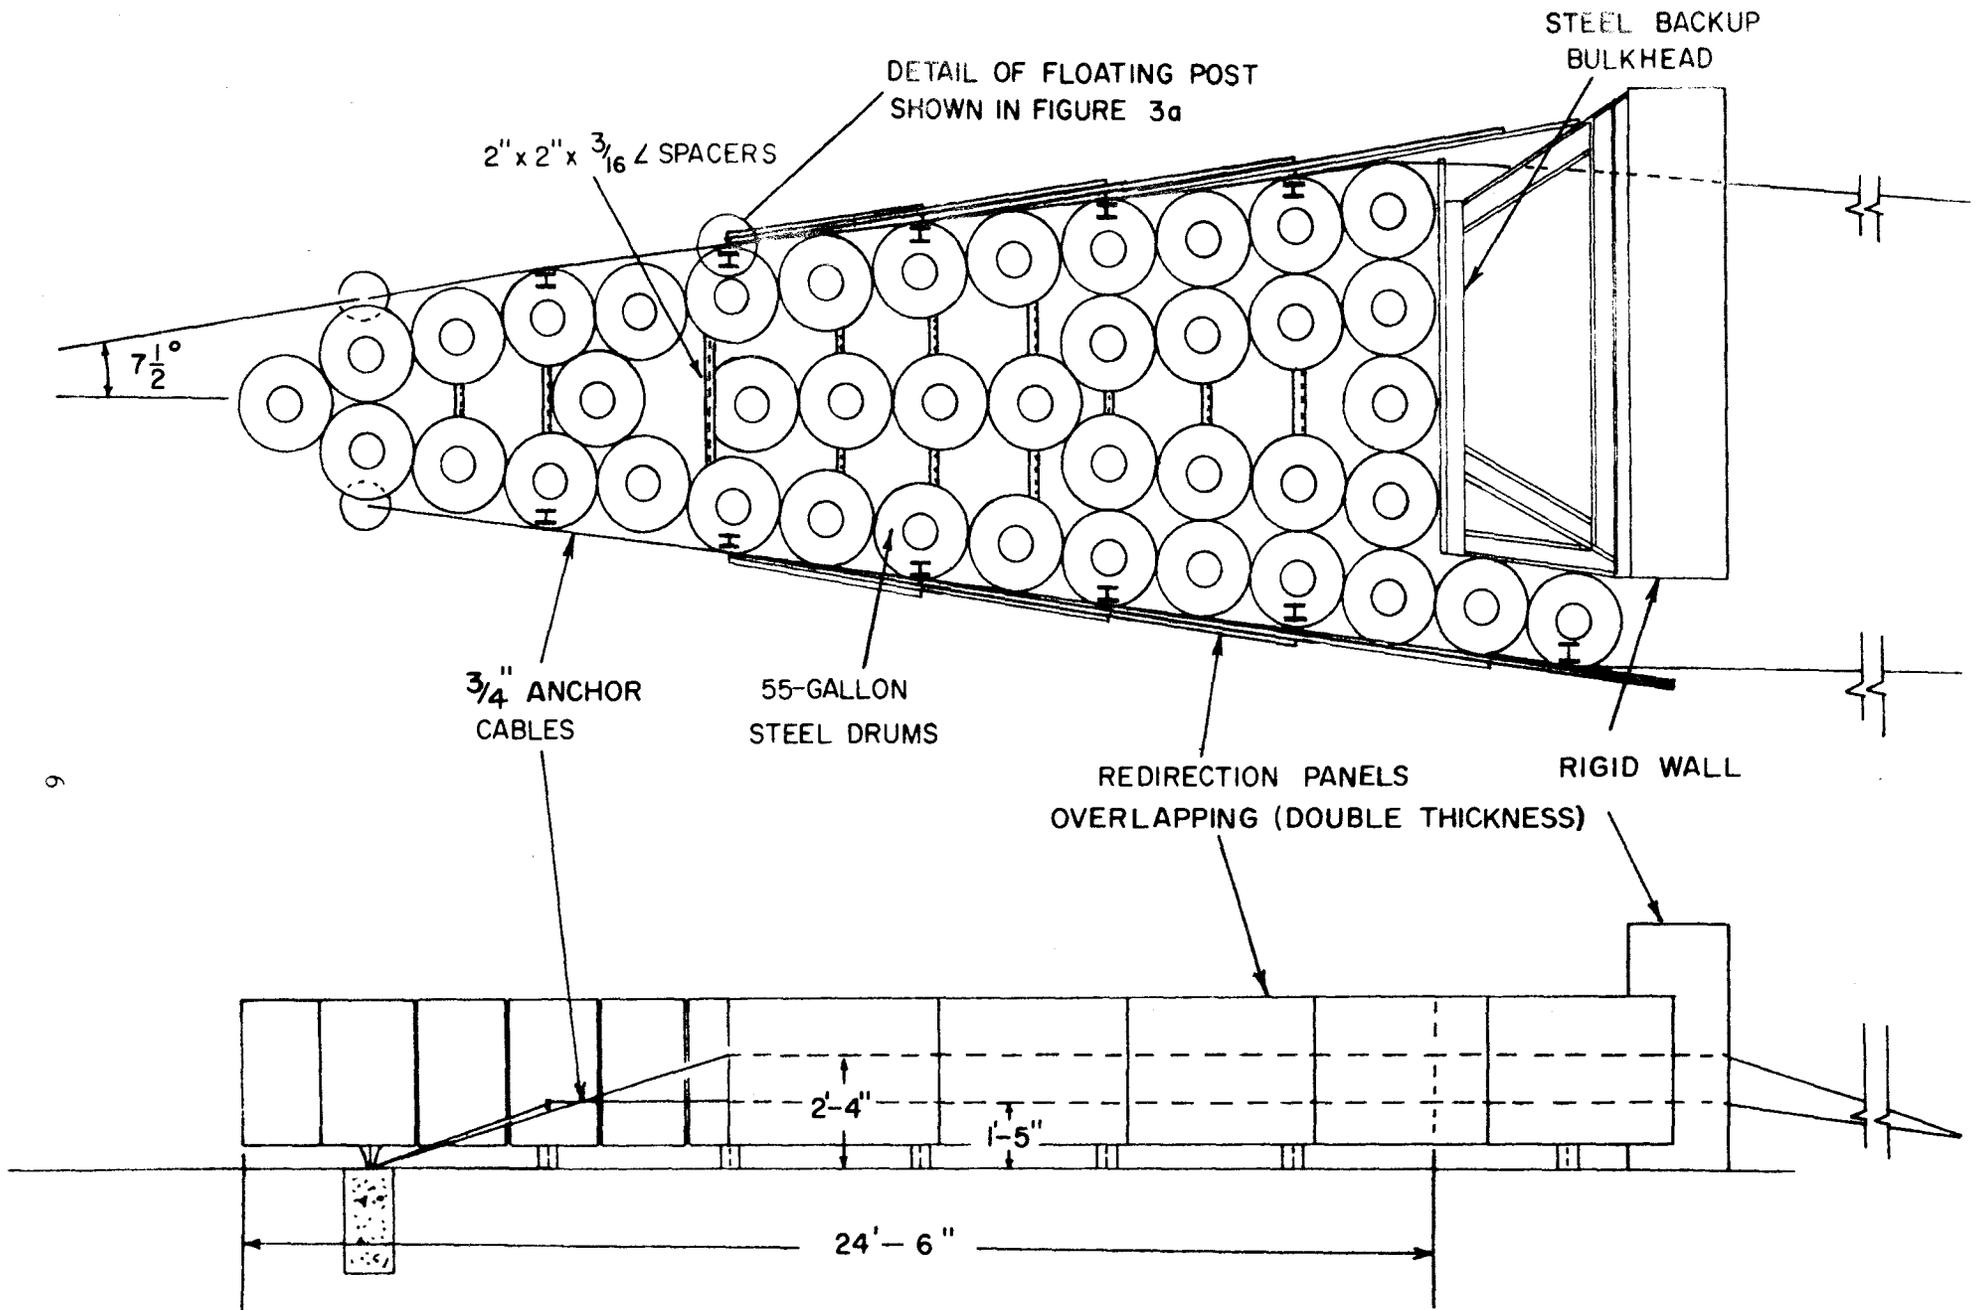
FIGURE 3, CONFIGURATION USED IN TESTS 505B-D AND 505B-E (BARRIER TYPE 3)

The final system constructed for testing is shown in Figure 3. Steel angle spacers were used here, and the module arrangement was modified to reduce the stopping force at the onset of the collision. This modification is especially desirable when the colliding vehicle is small and lightweight. Also, the rear of the barrier was widened to provide a cushion between the end redirection panels and the rigid wall. Again, cables inside the redirection panels were used to give lateral stability without rigidity.

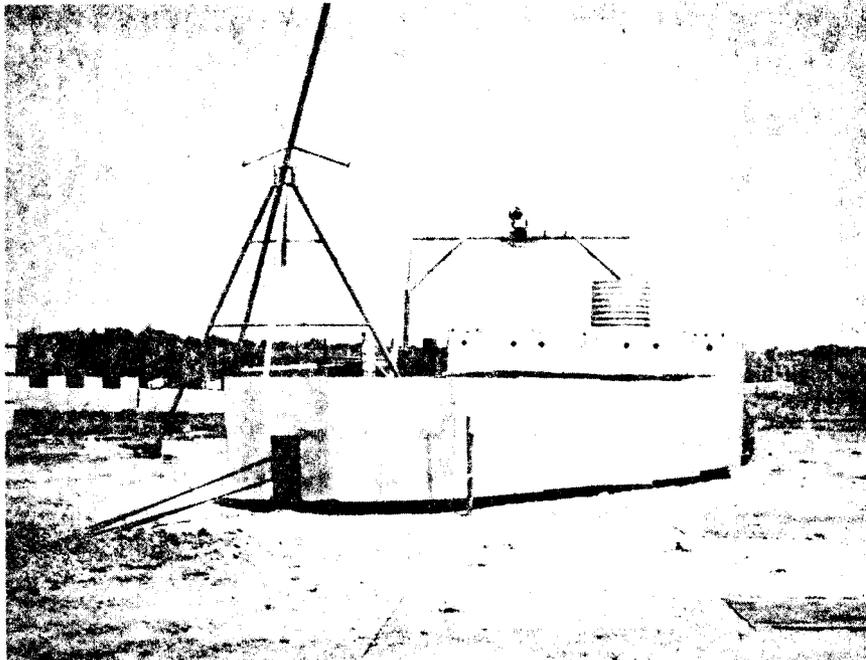
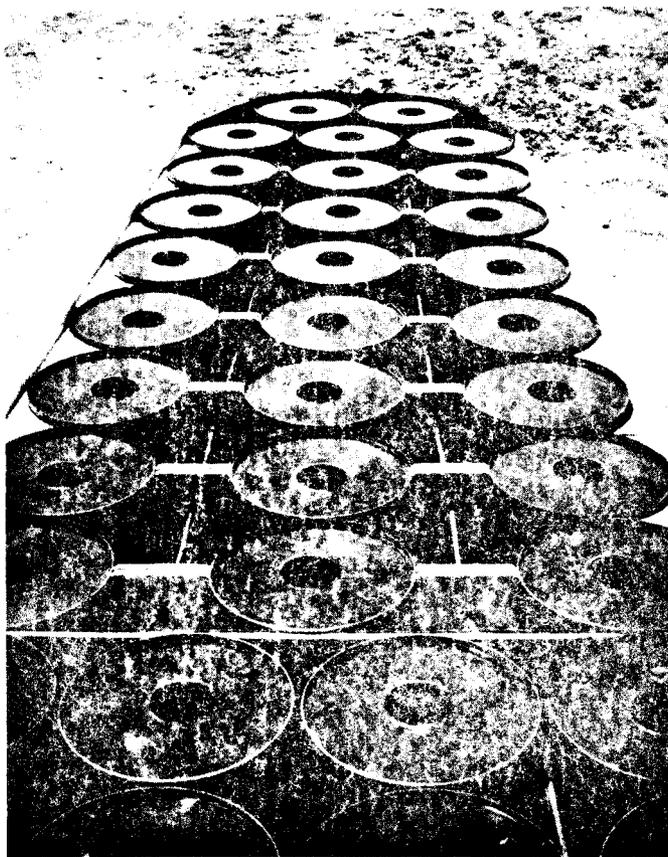
Figure 4, Modular Crash Cushion Before Test 505 B-A.

In this first test, a 1963 Valiant weighing 3000 lbs impacted the Modular Crash Cushion at 56.9 mph. The vehicle centerline made a 20° angle with the centerline of the barrier at impact. The barrier is shown in Figure 4. The redirection panels consisted of 3/4" plywood with two layers of heavy fiber glass roving followed by one layer of gel coat. These panels overlapped approximately 11 inches. Between the columns of barrels were smaller sections of plywood.

This redirection system did not perform as intended. The undesired behavior was attributed to lack of lateral attenuation space at the rear of the barrier adjacent to the edge of the rigid wall. In addition, the barrier had insufficient lateral stability due to the anchor cable positions and to insufficient overlapping of the redirection panels. Subsequent test cushions incorporated design changes which resulted in better redirection capabilities.

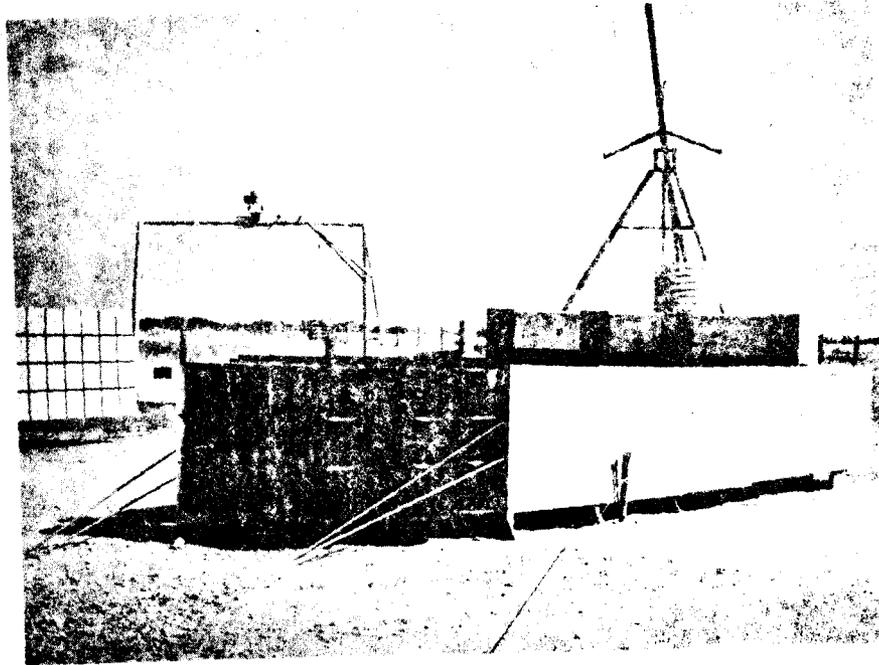
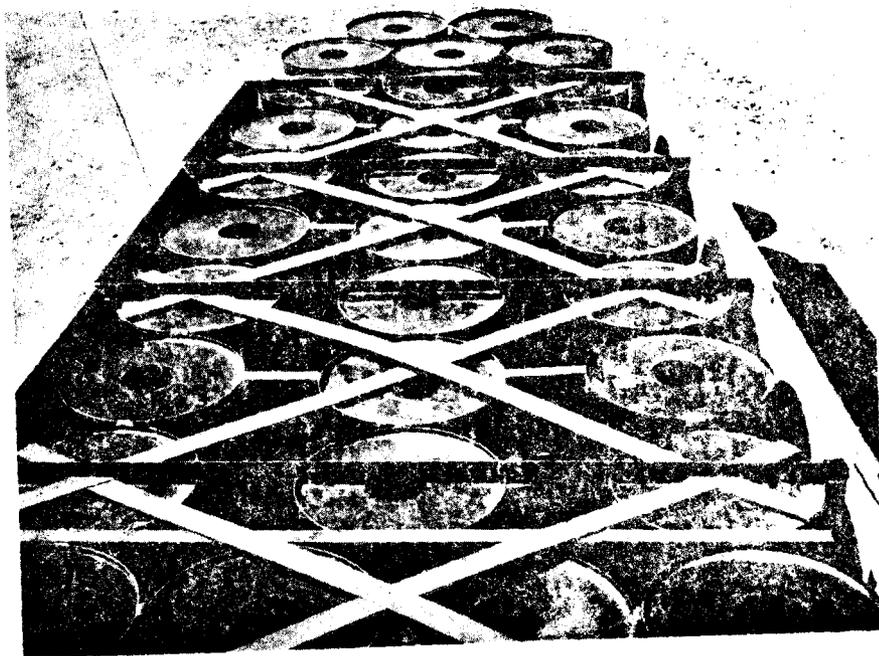
Figure 12, Modular Crash Cushion Before Test 505 B-B.

In order to provide acceptable redirection capabilities, the basic system previously tested was modified. Instead of the plywood spacers between the barrels, metal straps were welded across the top of the barrels as shown in Figure 12. In addition, the anchor cables were placed just inside the deflection panels and were aligned straight and taut. This was done to increase the lateral stability of the system during angle hits for better vehicle redirection. Also, the redirection panels were positioned to overlap each other 4 feet, creating a double thickness of plywood along the impact area.

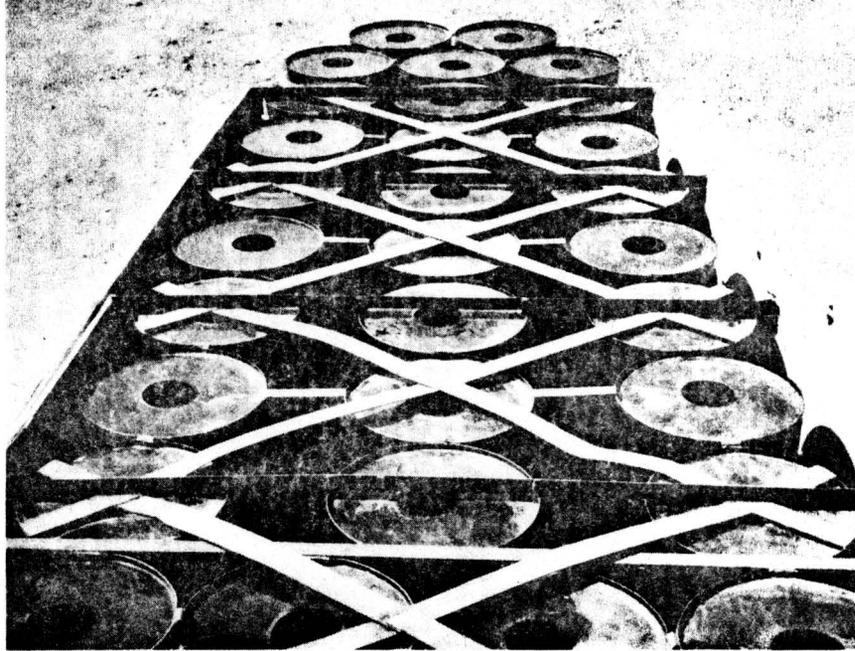
Figure 18, Repaired Modular Crash Cushion  
Before Test 505 B-C.

After a few minor repairs were made, the same crash cushion used in Test B was subjected to a head-on crash test. The purpose of this test was to evaluate the longitudinal response of the modified barrier to a head-on collision. Lateral strength and stiffness had been built into the crash cushion for safe redirection of vehicles impacting at an angle. At the same time, however, this system had been designed to maintain its relatively soft, crushable characteristics for head-on impacts.

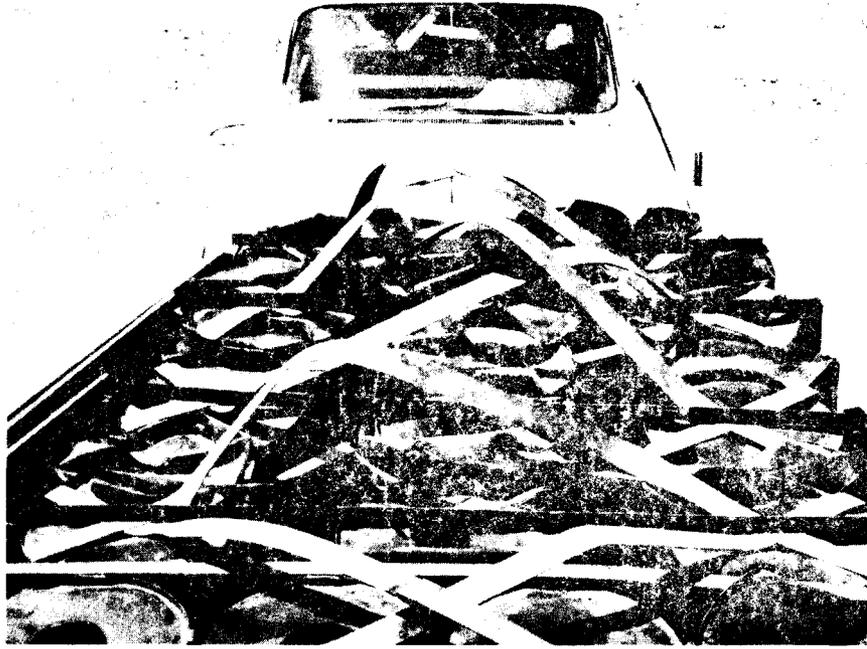
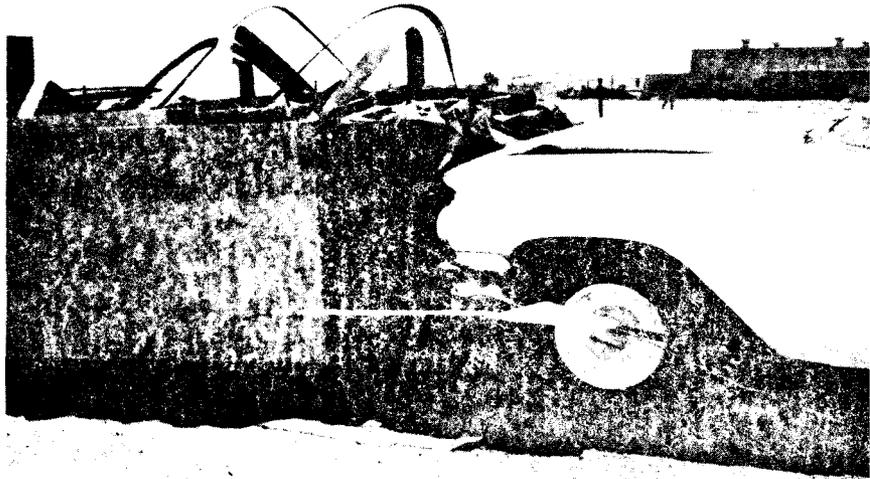
Figure 21, Vehicle and Crash Cushion After Test 505 B-C.

The system performed as designed. The vehicle damage was very minor as shown in Figure 17. Permanent vehicle front end deformation was only 2 inches. The headlights of the vehicle were not broken.

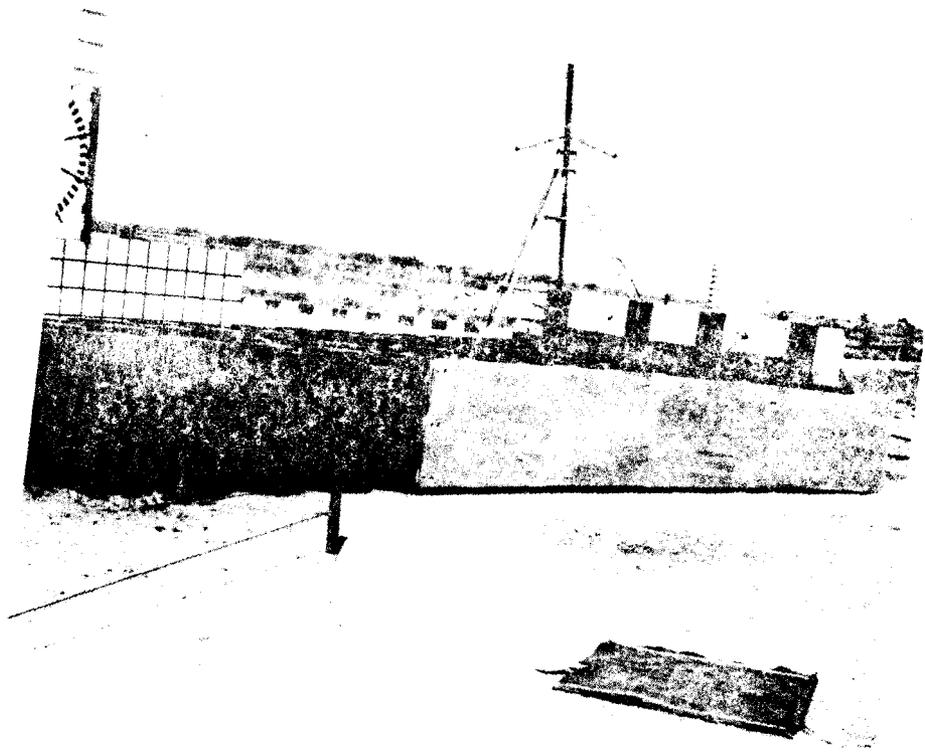
Figure 24, Modular Crash Cushion Before Test 505 B-D.

Two modifications were made in the crash cushion used for this test. The rigid back-up wall was modified to simulate a tapered concrete retaining wall at an elevated freeway gore. This type of retaining wall makes it feasible to extend modules of the crash cushion along its sides. The configuration which was tested had modules extending along only the side which was hit, as modules along the opposite side would have been superfluous for the purposes of these tests. The straight, taut cables and overlapping plywood panels were believed to be sufficient for redirecting a vehicle without the use of the metal "truss" as used in tests B and C. In addition, the barrel modules were arranged in a more triangular shape to provide a softer nose for better head-on attenuation of small, lightweight vehicles.

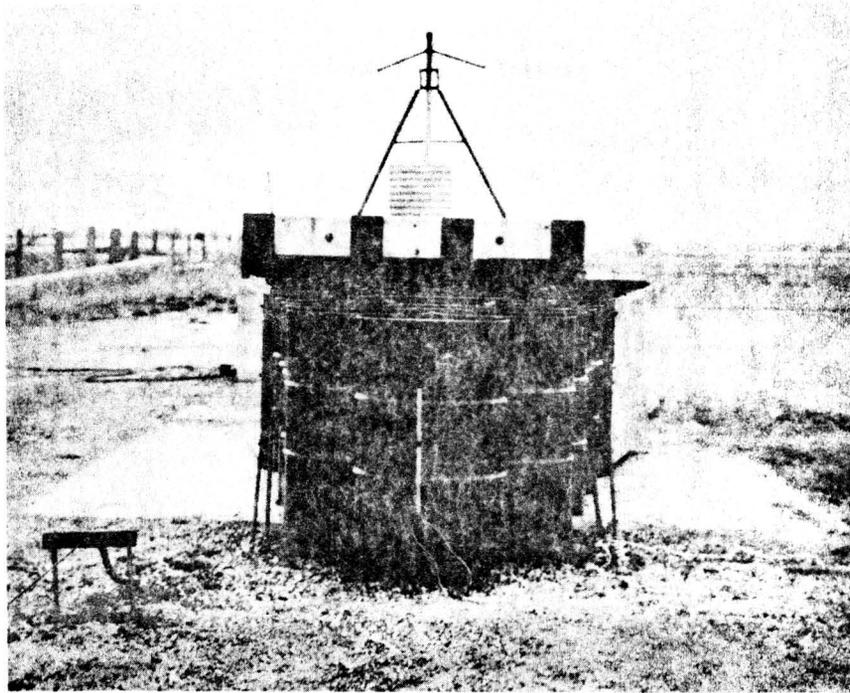
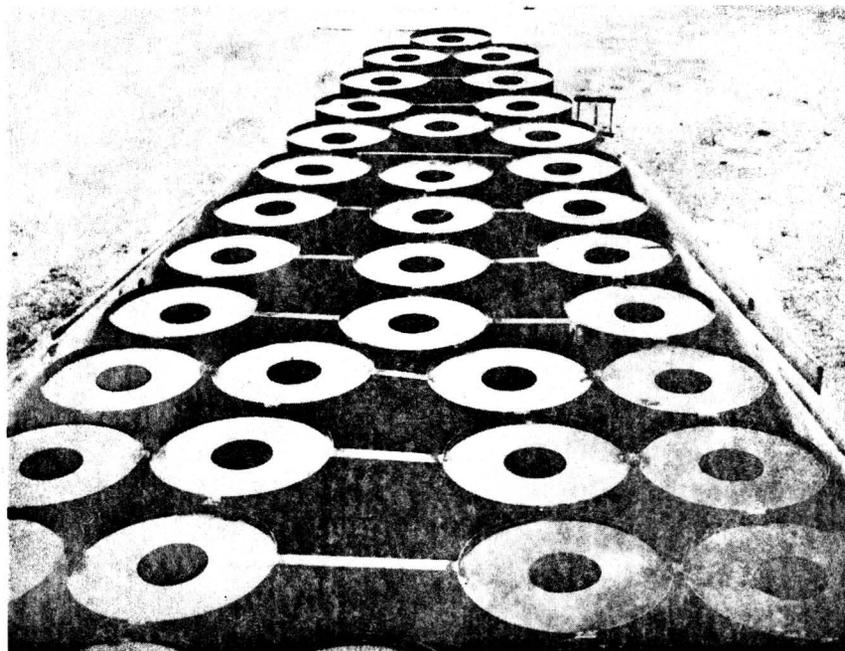
Figure 30, Modular Crash Cushion Before Test 505 B-E.

The purpose of this test was to evaluate the effectiveness of the previous barrier in head-on impacts with small vehicles. After minor repairs, the same cushion used in Test 505 B-D was hit by a 1959 Renault at 58.2 mph. This lightweight vehicle (1500 lbs) was stopped in 12.4 ft with an average longitudinal deceleration of 9.1 g's. The sheet metal portion of the front end of the vehicle was severely buckled, which would be expected in a lightweight, low front profile, rear-engine vehicle. The vehicle was stopped smoothly, without tendency to roll or spin.

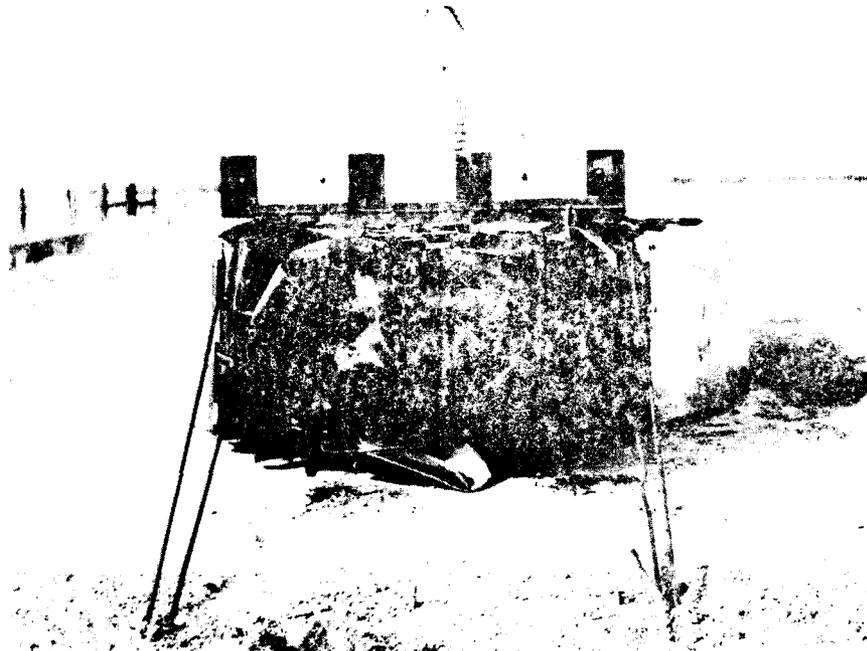
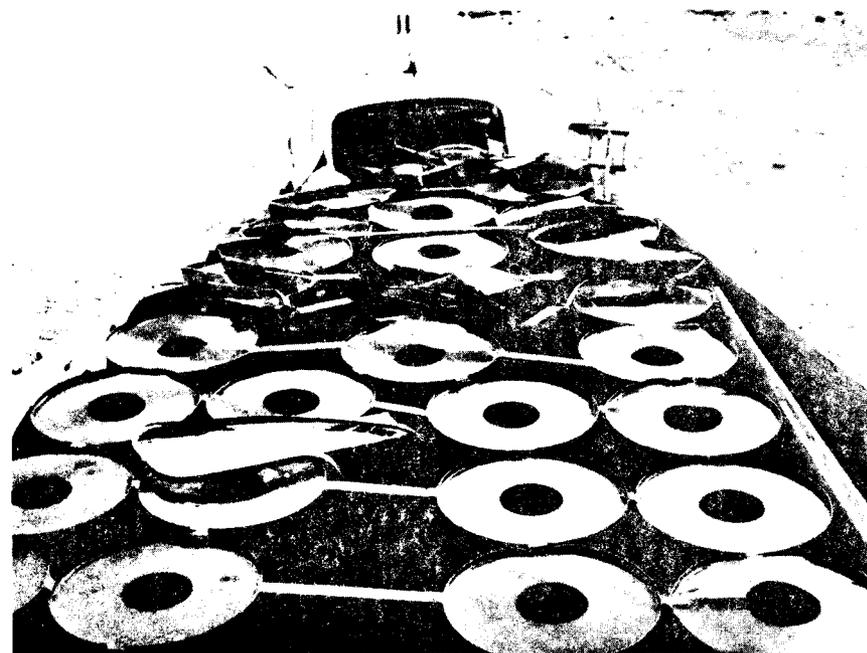
Figure 33, Modular Crash Cushion After Test 505 B-E.

The head-on test of the third crash cushion prototype utilized a lightweight, rear-engine vehicle. Although the damage to the vehicle's front end was severe, it was expected in this case since the engine was in the rear and only a light, sheetmetal luggage compartment protected the front end. Actually, this crushing too is part of the attenuation process. The passenger compartment was not penetrated. The g levels were not excessive considering the weight and speed of the test vehicle. The vehicle maintained a stable posture throughout the impact, with no overturning tendency.
