DETERMINING VIBRATIONAL FORCES  
EXPERIENCED BY HIGH PRESSURE  
SODIUM VAPOR LAMPS IN  
ROADWAY LUMINAIRES

SUPPLEMENT  
TO  
FINAL REPORT  
Research Report Number 273-1F  
Research Project Number 1-8-81-273

August 1988

REPORT A  
ROADWAY LUMINAIRE VIBRATION  
ENVIRONMENTS

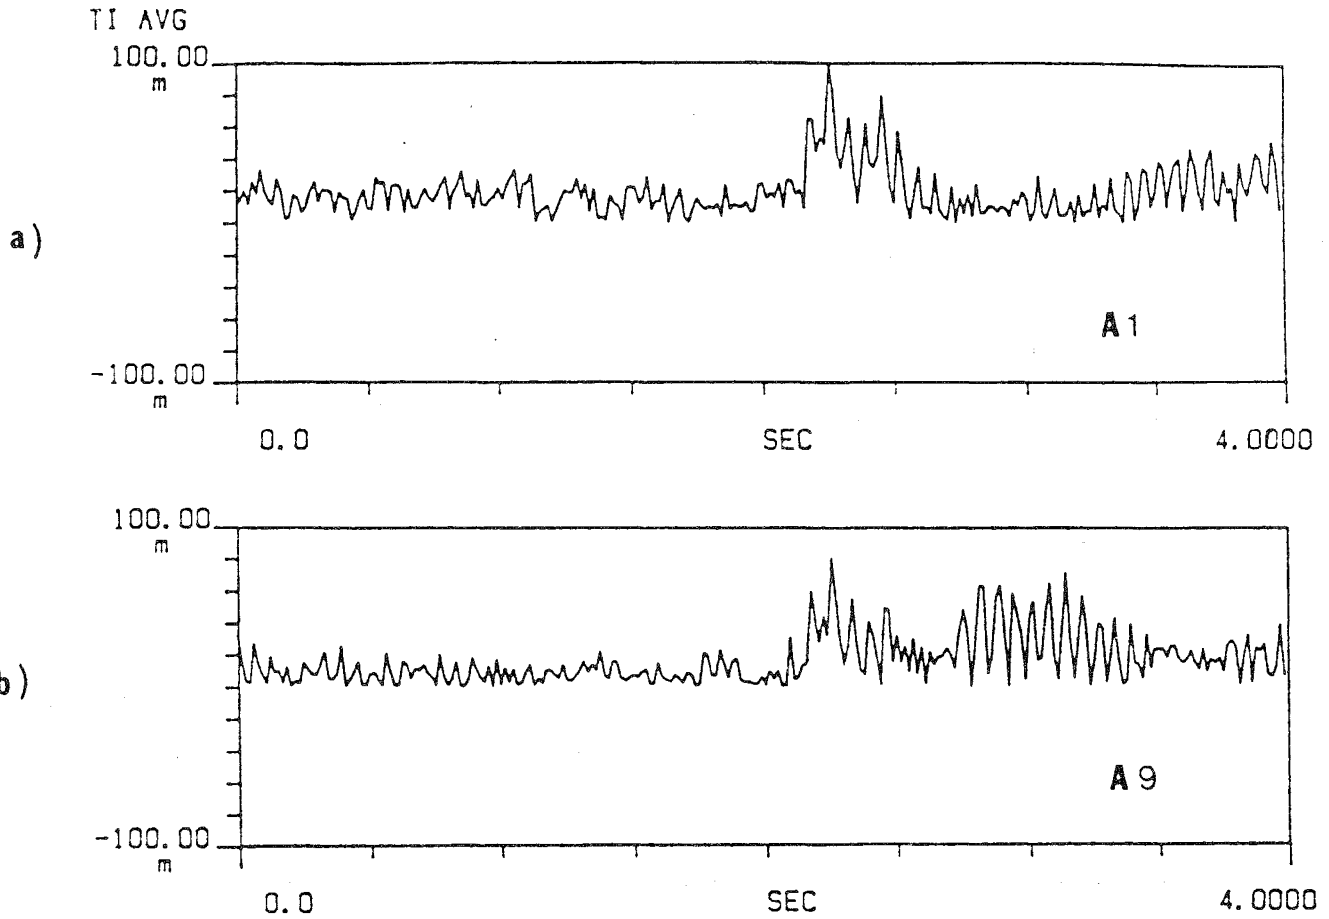
At SITE 4, the luminaire of interest was mounted near midspan of a curved bridge on-ramp. As at SITE 2, vortex induced pulses at the arm end were rather insignificant. More characteristic of this site were highly random, low-level vibration of the luminaire structure as a whole - compare accelerometers 9 and 10 in Figure 4.1.

Figure 4.1 - Typical Time Histories: SITE 4, 6-1-83, Wednesday, 6:49 a.m.  
 a) Accelerometer 1  
 b) Accelerometer 9

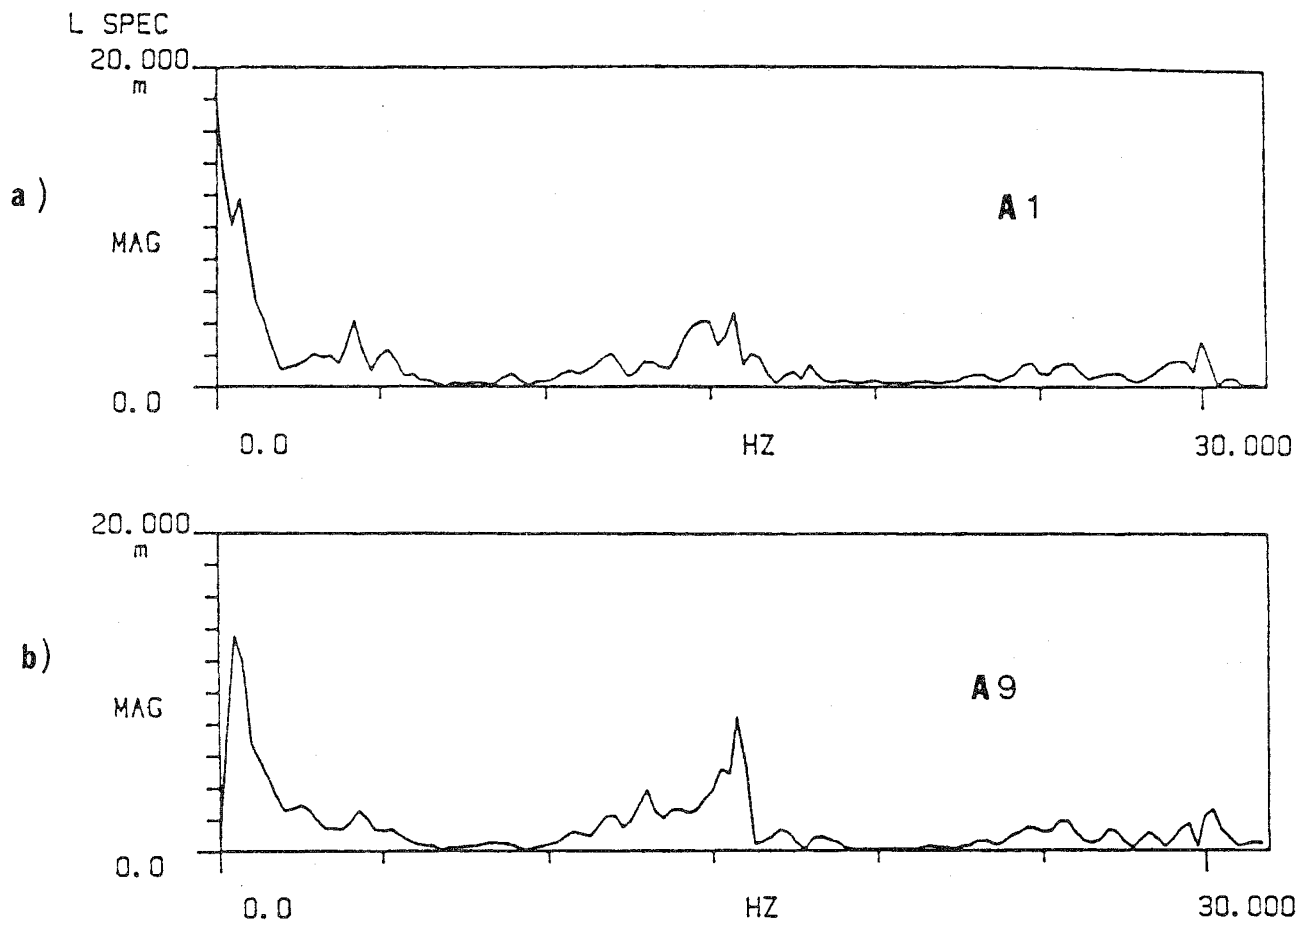
Spectral analyses show the frequency content of the vibration to be broadband - see Figure 4.2.

Figure 4.2 - FFT's: SITE 4, 6-1-83, Wednesday, 6:49 a.m.  
 a) Accelerometer 1  
 b) Accelerometer 9

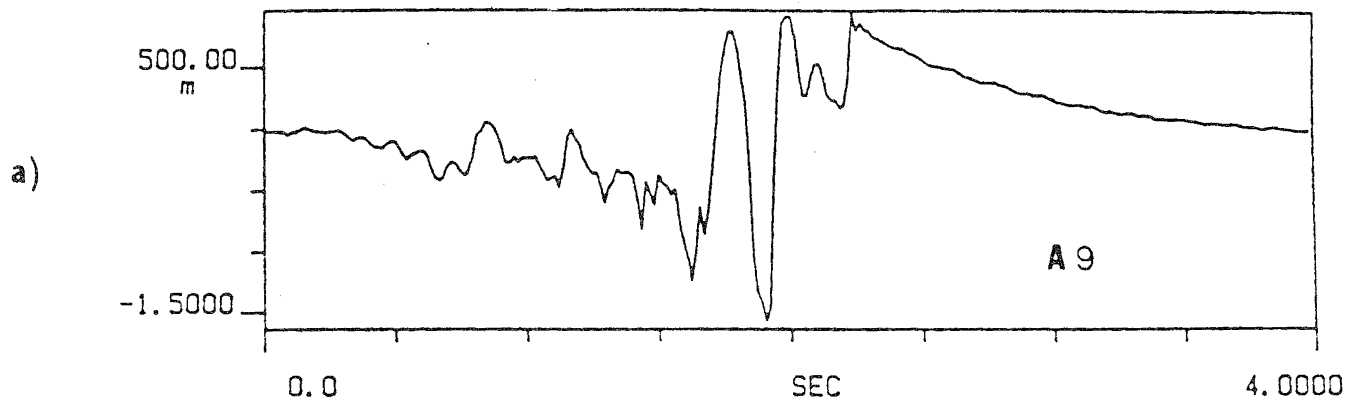
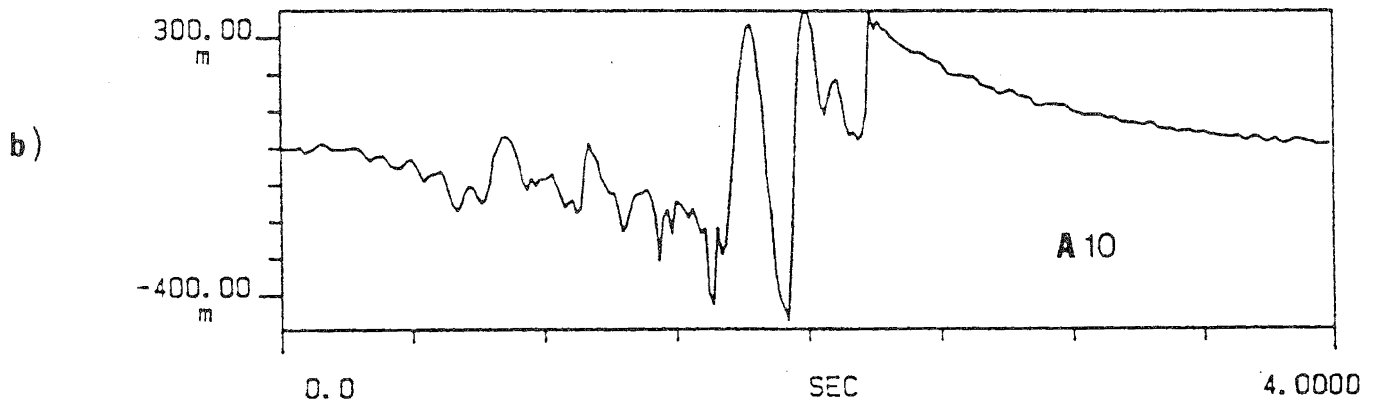
SITE 5 proved to be as dynamically active as SITE 1 - compare the pulse level frequency of occurrence in Tables 2 and 6. Figure 5.1 shows one example of a 3g pulse. The PSD of this pulse in Figure 5.2 shows the localized, low frequency nature of the pulse energy. The absence of modal spikes also indicates the localized nature of the pulse.

Figure 5.1 - Pulses: SITE 5, 7-8-83, Friday, 6:20 a.m.  
a) Accelerometer 9  
b) Accelerometer 10

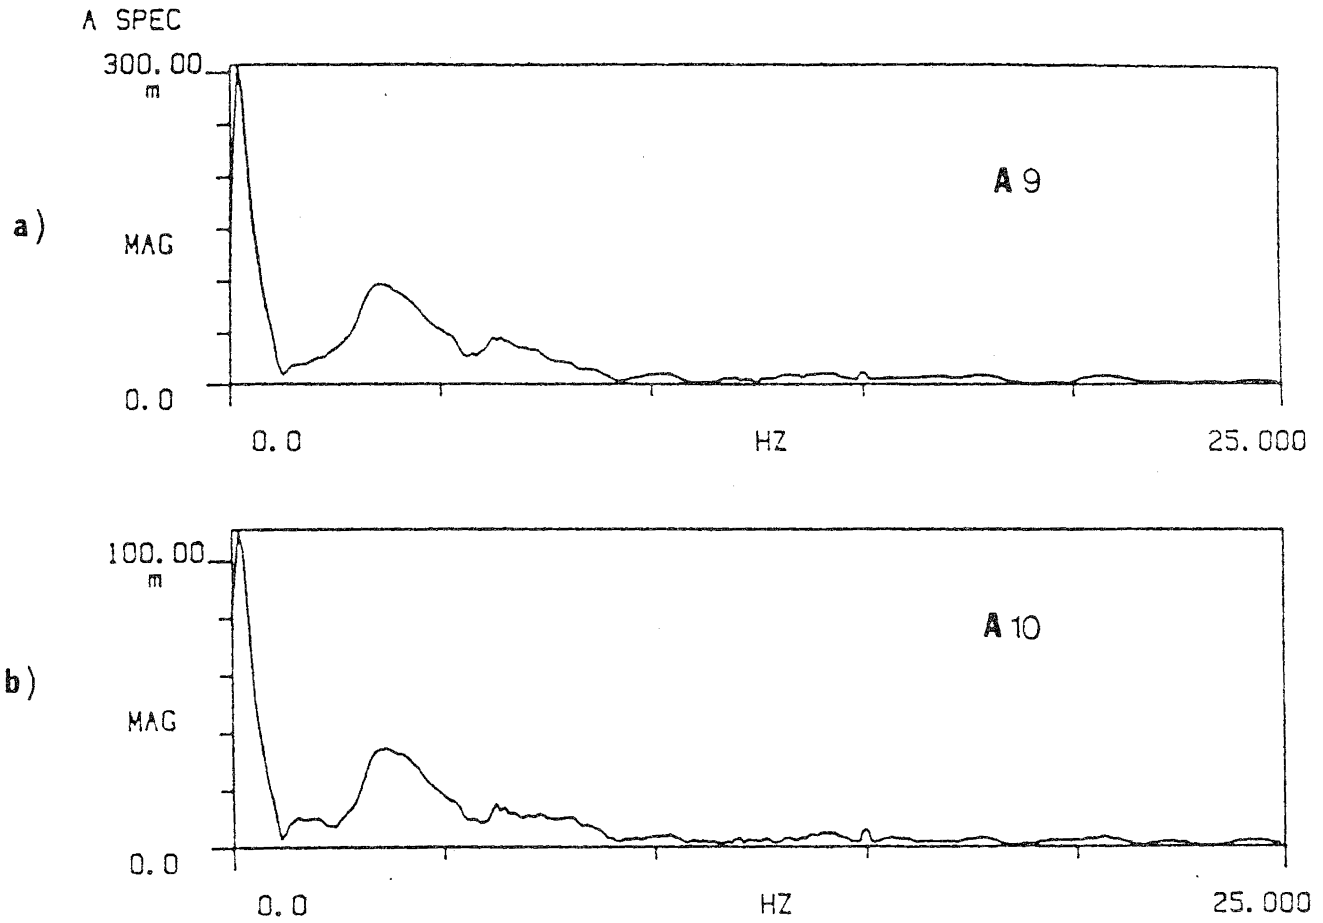
Figure 5.2 - Pulse PSD's: SITE 5, 7-8-83, Friday, 6:20 a.m.  
 a) Accelerometer 9  
 b) Accelerometer 10
