A FIELD SURVEY AND EXPLORATORY EXCAVATION OF TERMINAL ANCHORAGE FAILURES ON JOINTED CONCRETE PAVEMENT

TEXAS HIGHWAY DEPARTMENT

By
B. F. McCullough
Supervising Design Research Engineer

Technical Report No. 39-1
for
Terminal Anchorage Installations
Research Project 1-8-63-39

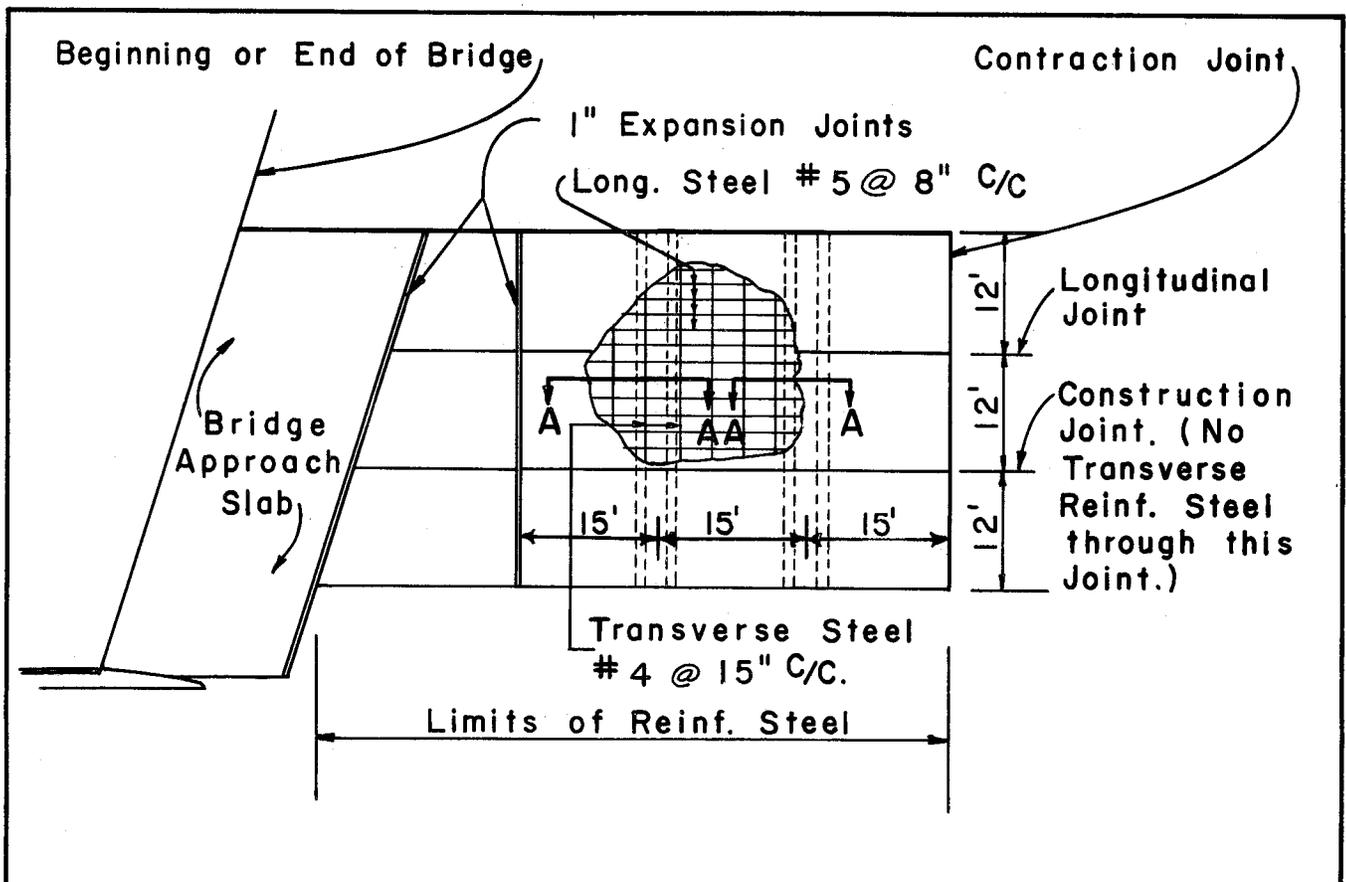
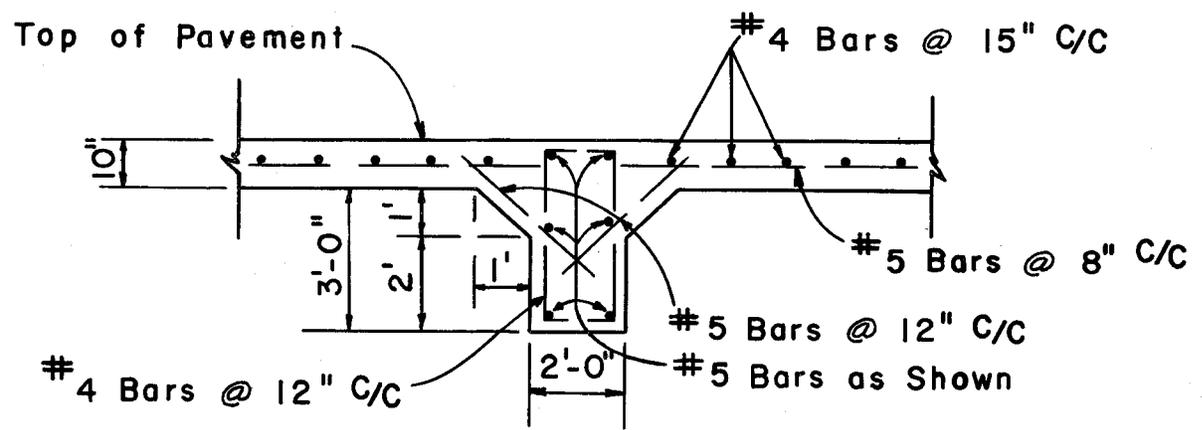
FIGURE I.1 TYPICAL LUG DESIGN- JOINTED PAVEMENT

Referring again to Figure 1.1, the nomenclature of various components of the anchorage system may be enumerated at this point. The slab placed on top of the base or on top of the subsoil is defined as the anchor slab. The members extending vertically into the ground are defined as lugs, with the one nearest the structure being considered as the front lug, the other as the back lug.

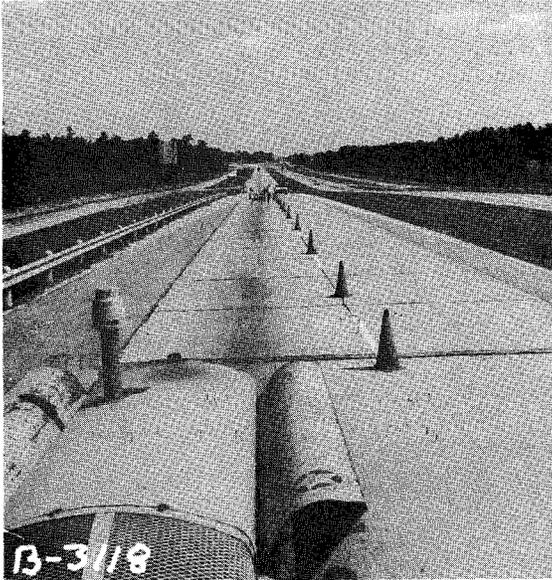
FIGURE 4.2 - General view of an excavation site looking from the structure toward the approach. The generator is sitting on the anchor slab.

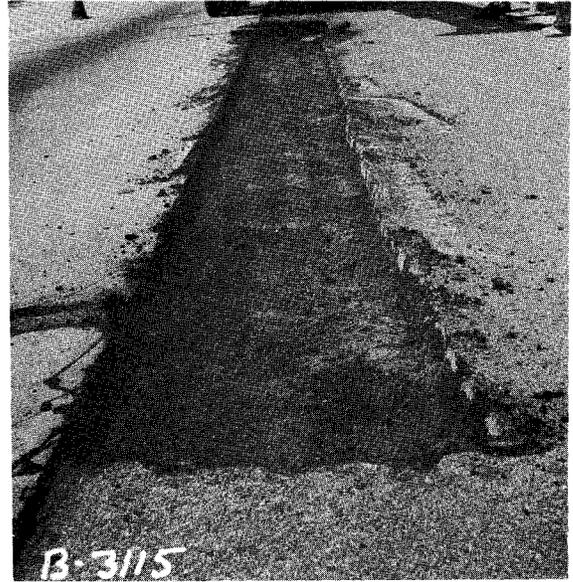
FIGURE 4.3 - Removal of the asphalt shoulder material prior to excavation of the underlying materials.

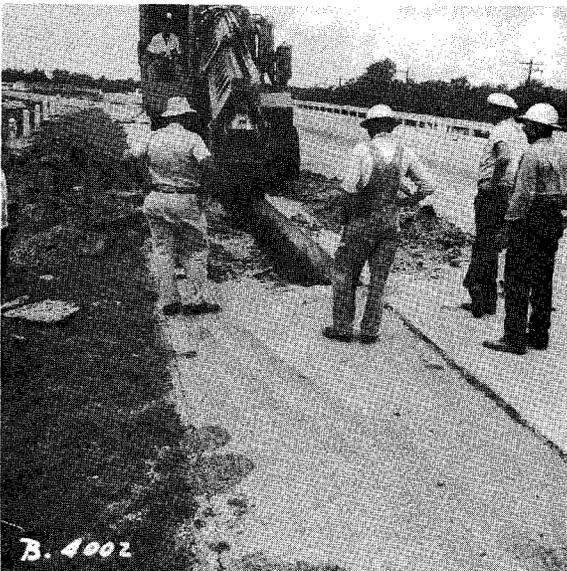
FIGURE 4.4 - Back-hoe digger used in removing the underlying material.

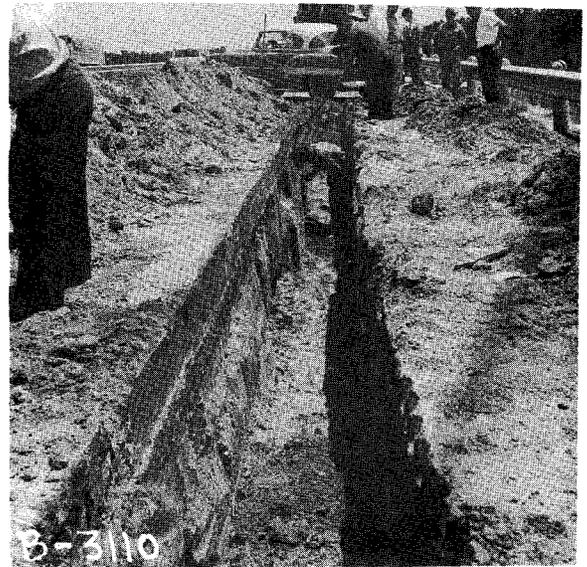
FIGURE 4.5 - Observation trench after completion of the excavation and prior to hand removal of the face adjacent to the lugs.

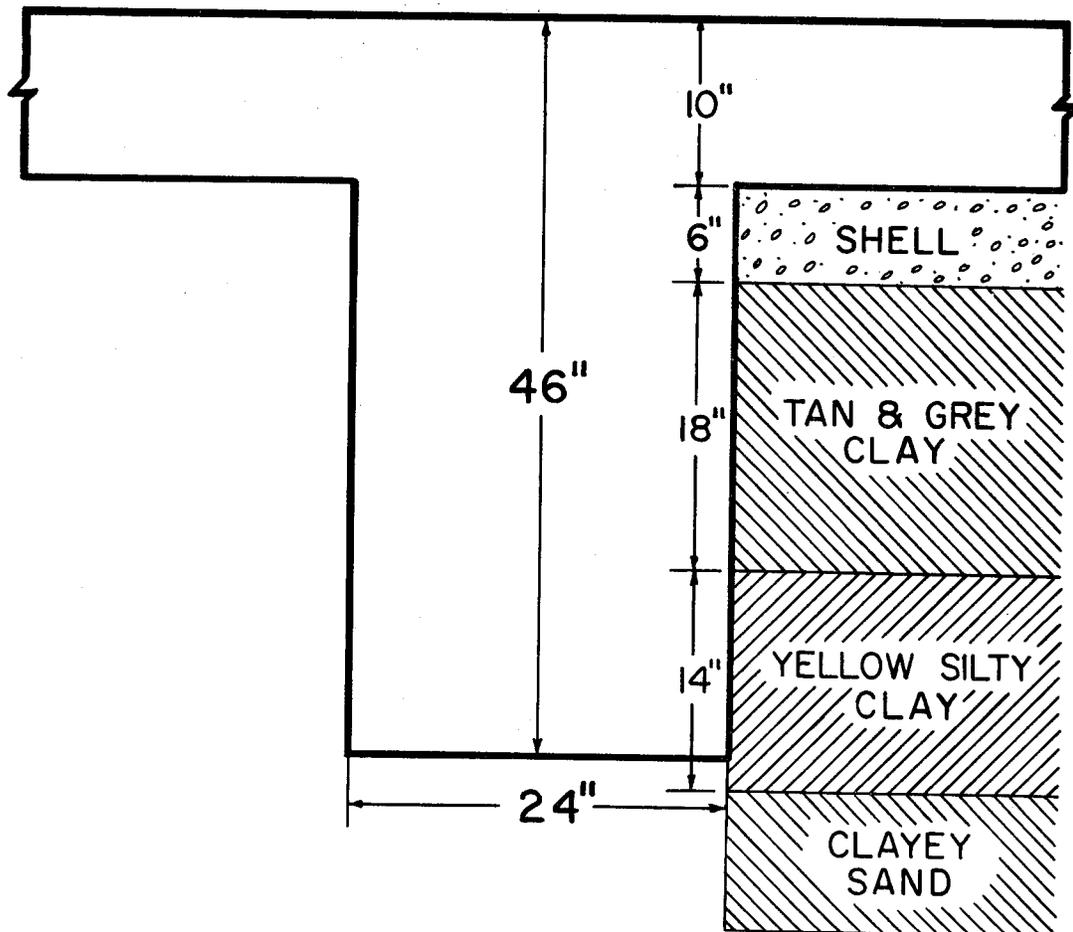
Fig. 4.13

The general observations made in connection with the excavation of the control site are outlined in Table 4.1. Observations in the vicinity of the lug during excavation indicated that only a minute longitudinal movement had occurred at this location. The face of the lugs were against a tan-gray clay, and the bottom of each lug was in a tough silty clay (see Figure 4.13). The silty clay material was hard and quite difficult to dig even with the mechanical equipment. This was borne out by the density test which showed this material to have a considerably higher density than found in connection with the previous excavations (see Figure 4.14). It was readily apparent that

EDGE VIEW OF LUG SHOWING THICKNESS
AND DESCRIPTION OF THE SOIL LAYERS
ENCOUNTERED IN CONTROL EXCAVATION
LEE ROAD O/P

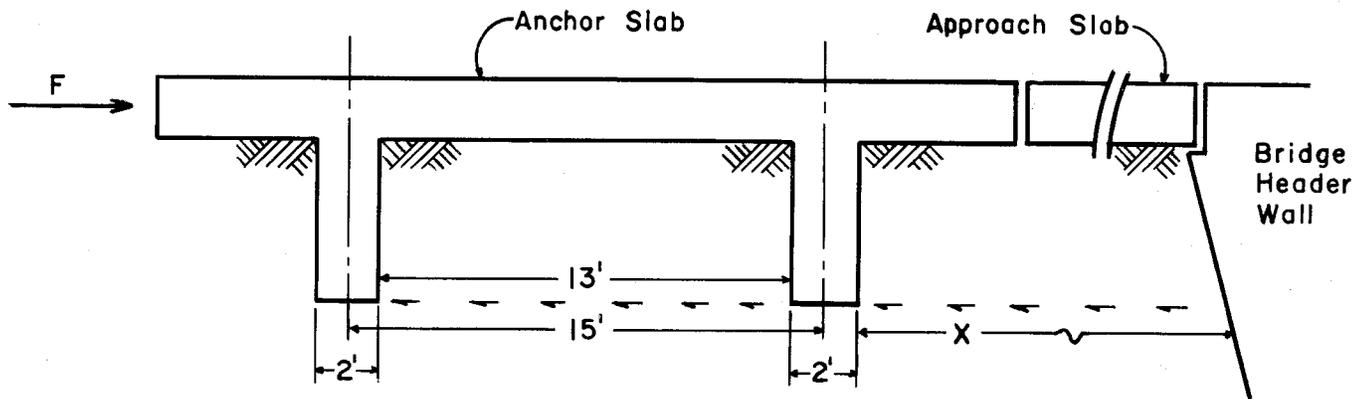
TABLE 5.1
DETERMINATION OF FORCES DEVELOPED
IN ANCHOR SYSTEMS WITH FAILURE CONDITION

Using the soil strength characteristics as outlined in Appendix B, the forces per foot of pavement width present on the three excavated systems were estimated as shown in Table 5.1. The first fact evident from the table is that the Lee Road Overpass which was a satisfactorily performing anchorage system was capable of developing a resistance force of 67,000 pounds per foot of width, whereas the two anchor systems experiencing failure did not exceed 46,000 pounds per foot width. The soil strength characteristics in the Monroe Street Overpass were adequate relative to the Lee Road Overpass, but due to the short distance between the lug and the header wall, the developed resistance forces were insufficient. In contrast, the distance on the Camp Strake Road Overpass was great enough, but the soil strength was completely inadequate.
