1. Report No. DHT-46	2. Government Accession No.	3. Recipient's Catalog No.	
4. Title and Subtitle AN EVALUATION OF FACTORS AFFECTING MOISTURE SUSCEPTIBILITY OF PAVEMENTS IN NORTHEAST TEXAS		5. Report Date October 1998	6. Performing Organization Code

AN EVALUATION OF FACTORS AFFECTING MOISTURE SUSCEPTIBILITY OF PAVEMENTS IN NORTHEAST TEXAS

Prepared by a TxDOT Task Force:

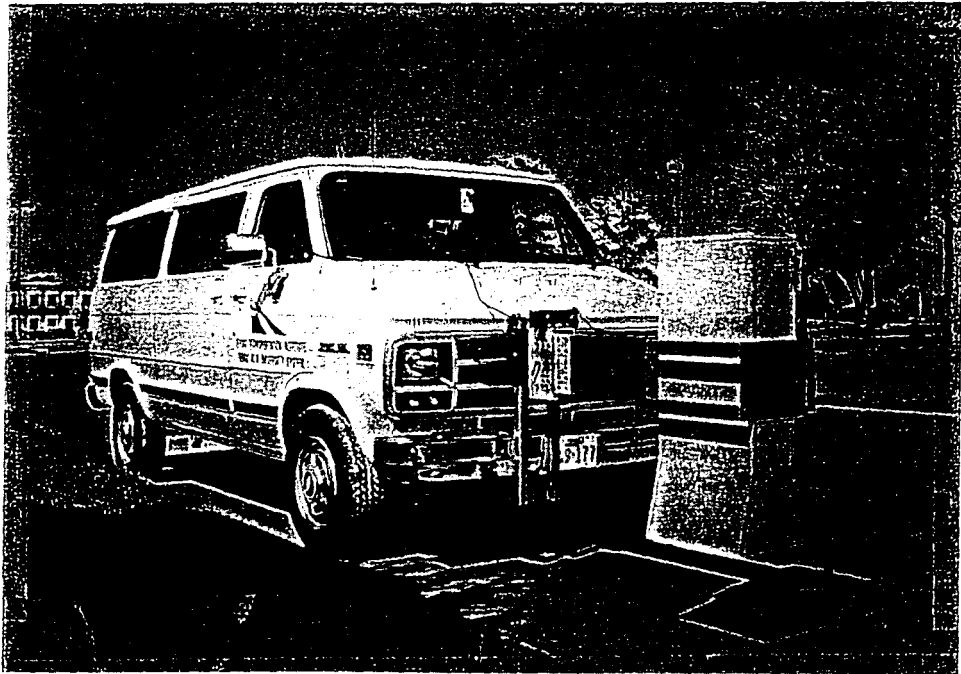
a. TTI GPR Equipment.

Figure 1. GPR Equipment and Principles of Operation.

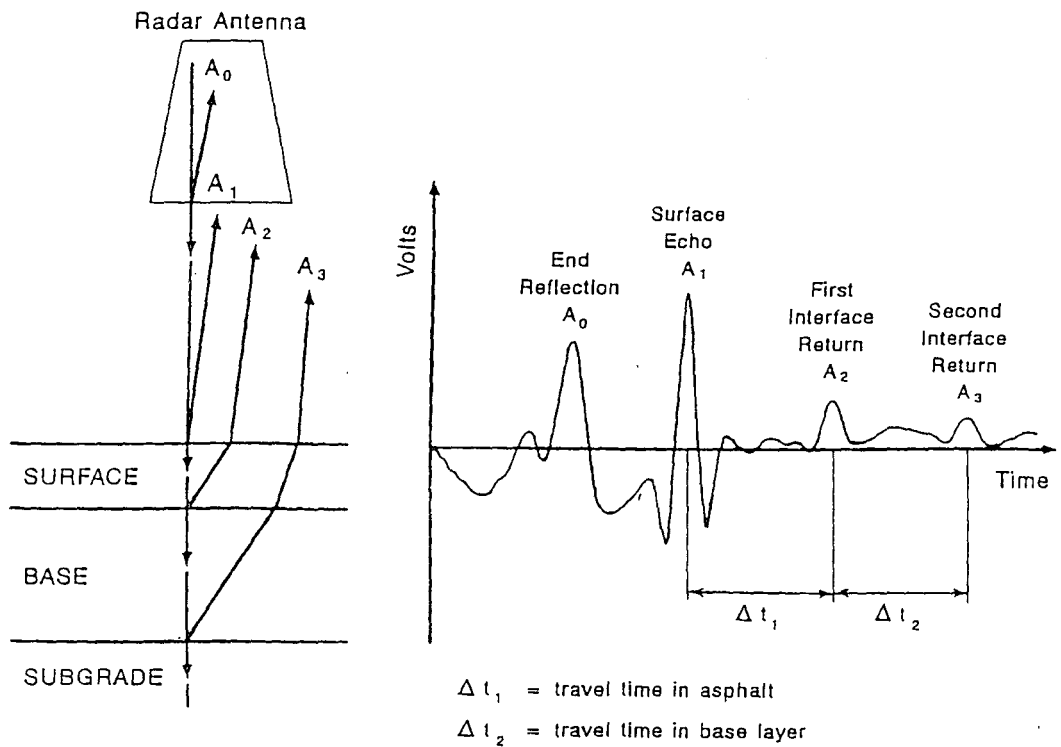
With reference to Figure 1 the reflection A_1 is the energy reflected from the surface of the pavement, A_2 and A_3 are from the top of the base and subgrade respectively. These amplitudes of reflection are used to calculate individual layer dielectrics. These are electrical properties of the pavement materials. The engineering properties which most influence these dielectrics is the moisture content and density of the individual layers. If the moisture content for a layer increases, then the amount of energy reflected from the top of the layer would increase resulting in an increase in calculated layer dielectric. An increase in air voids would have the opposite effect, if the amount of air in a layer increases the energy reflected and resulting dielectric would decrease. TTI has established a range of typical dielectrics for most paving materials, for example HMA layers normally have a dielectric value between 4.5 and 6.5, depending on the coarse aggregate type. Measured values significantly higher than this would indicate the presence of excessive moisture, lower values could indicate a density problem or indicate that an unusual aggregate, such as lightweight, has been used.

The examples below illustrate how changes in materials properties and structure would influence the typical GPR trace shown in Figure 1,

- 1) If the thickness of the surface layer increases then the time interval between A_1 and A_2 would increase,
- 2) If the base layer becomes wetter then the amplitude of reflection from the top of the base A_2 would increase, and
- 3) If there is a significant defect within the surface layer then a reflection will be observed between A_1 and A_2 . This could be either a positive reflection for trapped moisture or a negative reflection for stripping, and
- 4) As the unit travels along the highway it collects traces at regular intervals, therefore GPR has the potential to monitor the uniformity of the surfacing layer. Large changes in the surface reflection A_1 would indicate changes in either the density (decrease in amplitude) or moisture content (increase in amplitude) along the section.

b. Principles of Ground Penetrating Radar. The Incident Wave is Reflected at Each Layer Interface and Plotted as Return Voltage Against Time of Arrival in Nanoseconds.

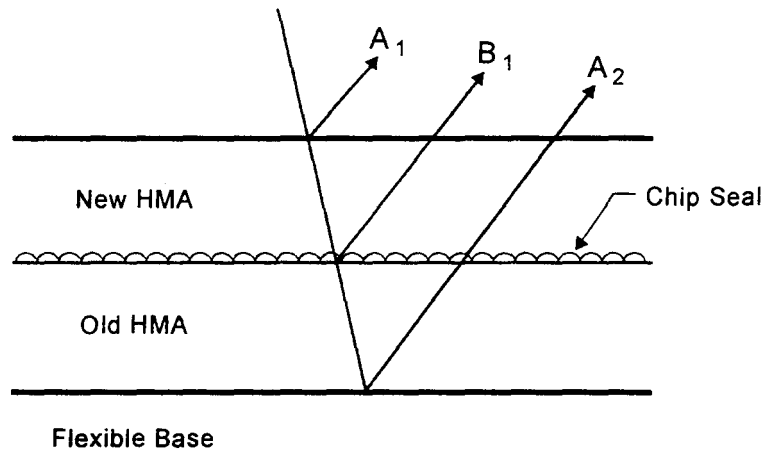
As described above the time since rainfall has a big impact on the GPR signals. The 5 types of reflections found in this study are shown schematically in Figure 4. The "ideal" trace with little contrast between the new and old HMA layers is shown in Figure 2. This is defined as a Case 1 reflection in Figure 4, the other four cases are discussed below;

- Case 3 If a thin layer moisture was trapped on top of a seal coat placed between HMA layers then both the shape and amplitude of reflection B_1 would change. Overlapping signals would be generated with a positive reflection from the top of the moist layer overlapping with a negative reflection as the wave travels from the wet HMA to dry HMA (high dielectric to low dielectric). In this instance the computed dielectric for the lower HMA layer would not increase. (This was encountered frequently in this study particularly with the pavements from the Atlanta District which mostly had a chip seal placed between the old and new HMA layers and the GPR testing was mostly conducted one or two days after significant rainfall. In some instances the seal was made with lightweight (absorptive) aggregates and in these cases the moisture may have been in the seal itself)

- Case 4 If the lower HMA layer contains some deterioration in the form of stripping then a negative reflection would be observed between reflections B_1 and A_2 . Similar negative reflections can also be generated by non defects such as buried lightweight aggregate layers or drainage layers. The key to distinguishing between stripping and unusual aggregates is that with stripping the negative reflection would be intermittent, as the severity of the deterioration varies substantially along the highway.

Case 1 - Normal

- B₁ very small (little dielectric contrast between new and old HMA)

Case 2 - Moisture Trapped in Lower HMA Layer

Case 3 - Thin Layer of Moisture On Top of Seal

Case 4 - Lower HMA Severely Deteriorated-Stripping
