FIBERGLASS PLACEMENT

IH 20, Ector County
Project M-5-13-16
Control 5-13

A NARRATIVE REPORT

September, 1975

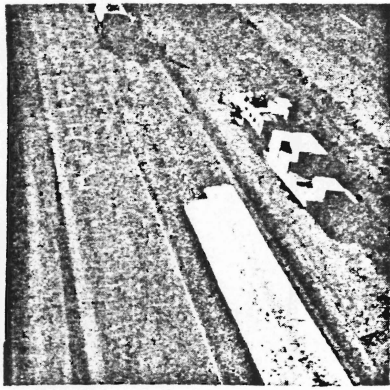
FIGURE 6

Two widths of material have been put down.

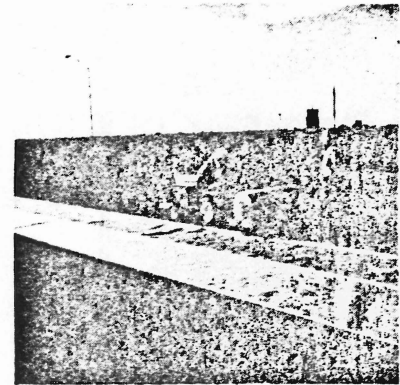
FIGURE 8

The roller has now rolled one half of the material into the tack coat. It is now ready for overlaying with hot mix.

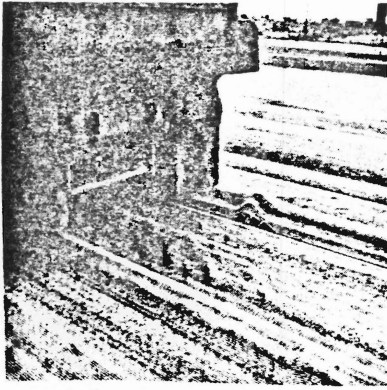
FIGURE 11

It will be noted behind the truck, that there is some wrinkling and pulling up immediately behind the tires.

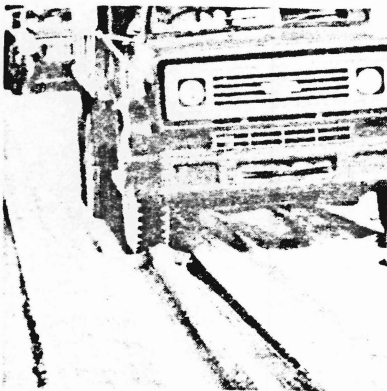
FIGURE 13

This gives an indication as to what was experienced as far as buckling on a portion of the material. The tack coat seemed to stick to the tires and pick up the material. This particular section was tacked a little light and this possibly contributed to the problem.

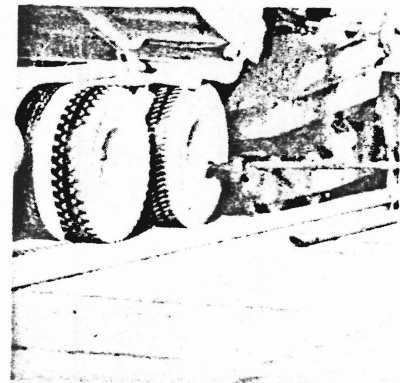
FIGURE 14

When the project was first started, everything was running well. This particular section laid down fairly well and had no wrinkles or buckles.

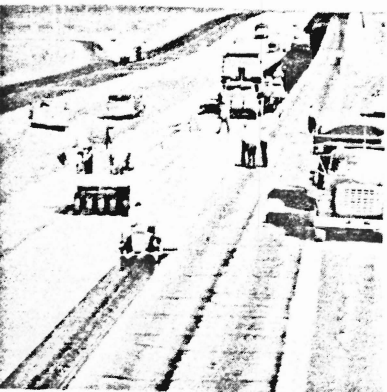
FIGURE 15

This shows the total operation while in progress. The hot mix machine is in the background and the pneumatic roller is on the right hand side. The glass fiber is being rolled out on the left side of the roadway.
