Report Number SS 9.1

## FIBROUS CONCRETE OVERLAY

FIBROUS CONCRETE OVERLAY

Interstate Highway 10

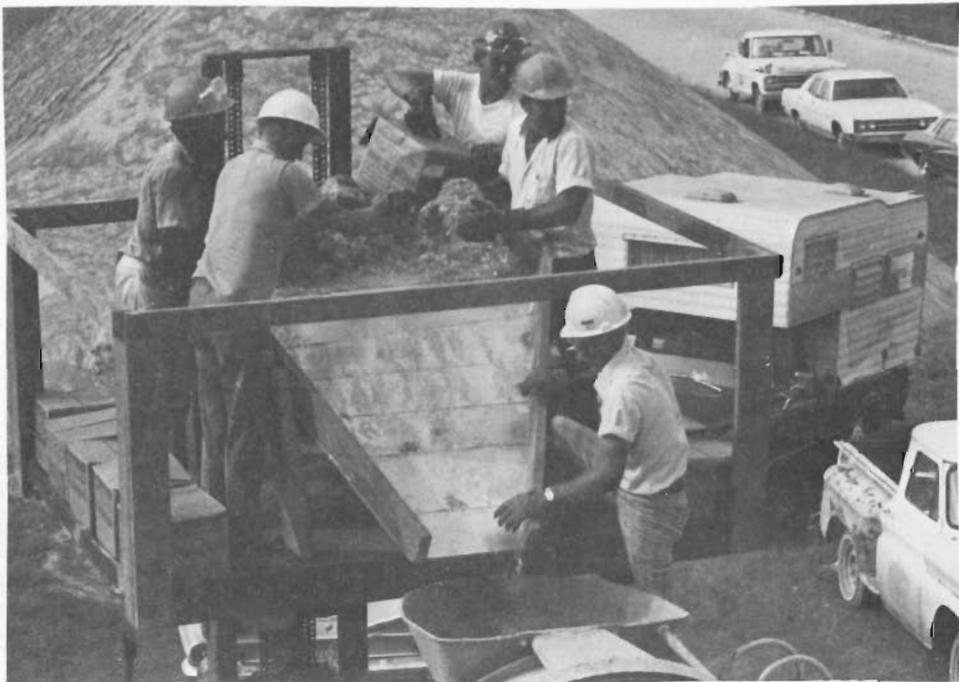
PHOTO NUMBER 2

A problem encountered which caused the most concern was the "balling up" of fibers in the mix. During the placing operation, numerous round concrete coated balls, approximately two to four inches in diameter, were noticed. Several of these balls were broken apart and were found to consist of an inner core of fibers coated with grout on the outside. The fibers were so tightly packed together that it took considerable effort to break them apart. Although the entire quantity of fibers in these balls probably consisted of less than one percent of the total, the balls are undesirable and should be eliminated from the mix.
