CRUSHED SANDSTONE FROM EAST TEXAS STONE COMPANY'S
BLUE MOUNTAIN PIT, FREESTONE COUNTY, TEXAS

Materials and Tests Division
Texas Highway Department

TP 11-70 MR
July 1970

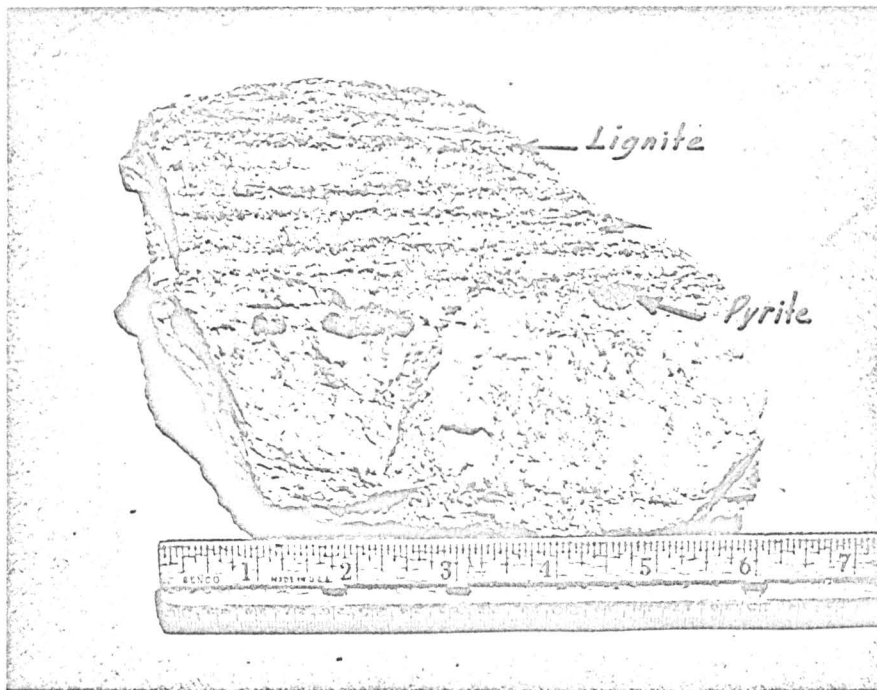
Iron pyrite can be found as rounded nodules (varying in sizes up to about 3 inches), irregular veins replacing carbonized plant remains, or as discrete crystals. Figure 7 shows a hand specimen (taken from pit-run material prior to crushing) containing bands of lignite, which form bedding planes, and plainly visible pyrite nodules.

Figure 7. Hand specimen containing lignite and pyrite.
