Water Intrusion in Base/Subgrade Materials at Bridge Ends: Final Report

Department of Civil Engineering
Texas Tech University

Texas Department of Transportation

Report No. 0-5096-1

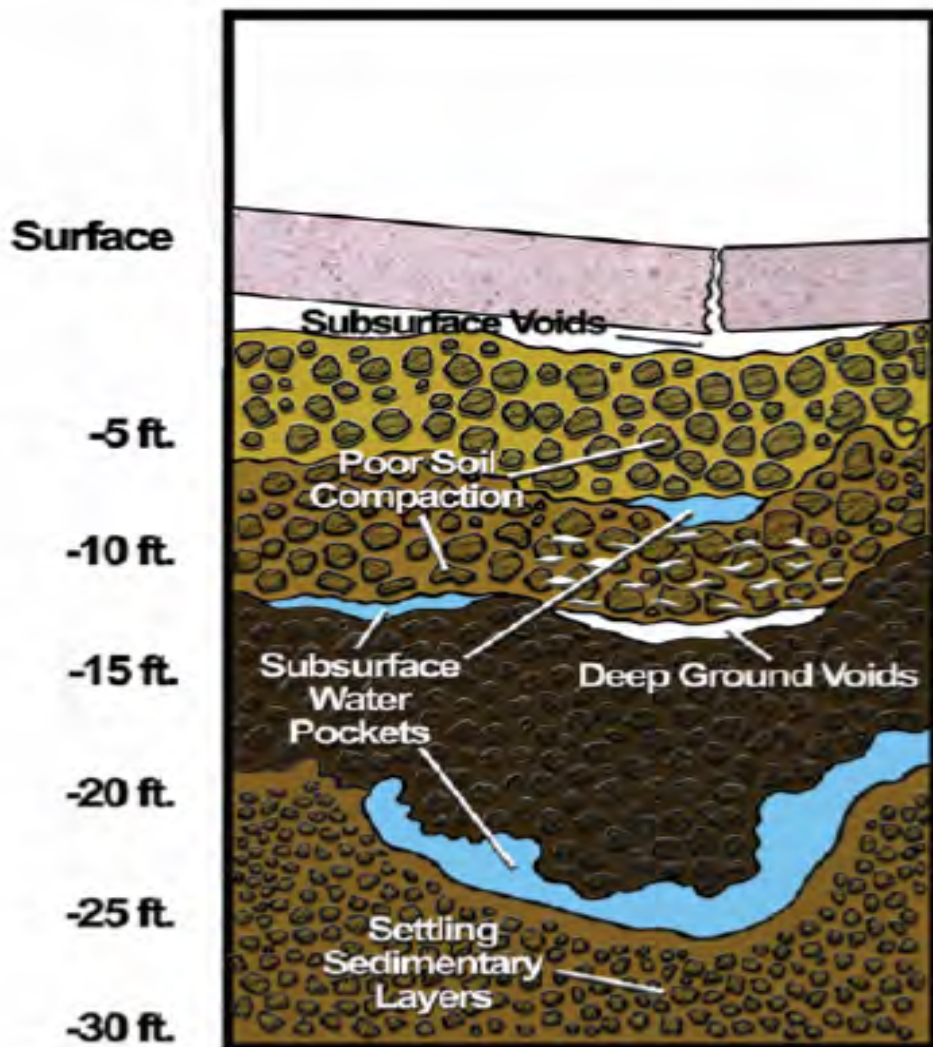
Figure 2.14: Subsurface Defects (from www.uretekusa.com)

The URETEK deep injection method strengthens the underlying foundation on which the road materials lie and hence the pavements/bridge approaches last longer and require less frequent maintenance. Figure 2.14 shows the different elements of a shifting/unstable/damaged underground base.

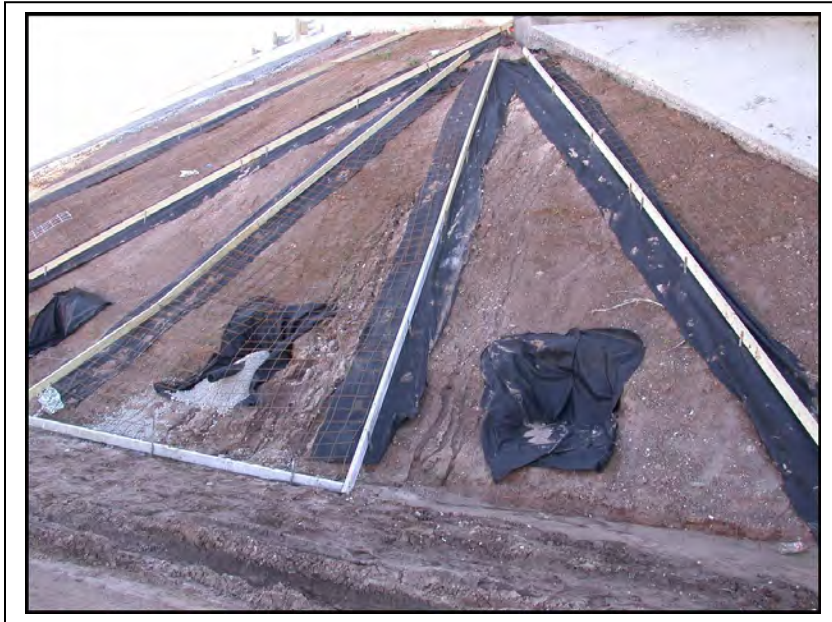
Figure 4.5 Filter Fabric at Joint in Riprap Slab during Construction

The Lubbock District now places filter fabric beneath joints in the riprap slabs to prevent the loss of fines as shown in Figure 4.5. Filter fabric is also placed near any point that might become a location for loss of fine materials (Figure 4.6). Details for the use of the filter fabric are provided in Appendix (Filter Fabric).

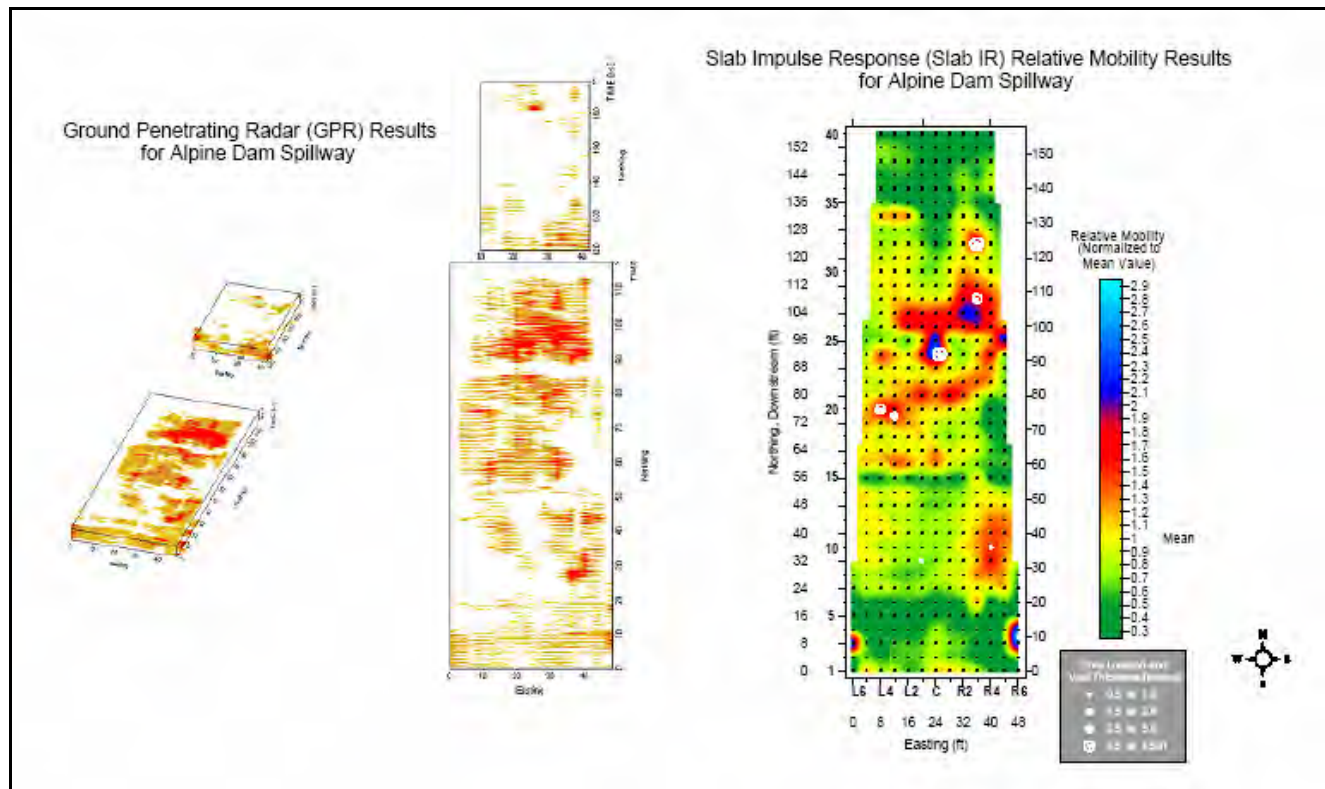
Figure 5.14 Results from GPR and Slab-IR Tests Conducted on Alpine Dam Spillway

- (b) *Three dimensional Ground Penetrating Radar (3D-GPR) and Slab Impulse Response (Slab IR)*: These two techniques have been used in combination by Olson Engineering company to detect subgrade voids underneath Alpine Dam spillway. Figure 5.13 shows the Alpine Dam spillway being tested by Olson Engineering company while Figure 5.14 shows the results from 3D-GPR and Slab IR testing.

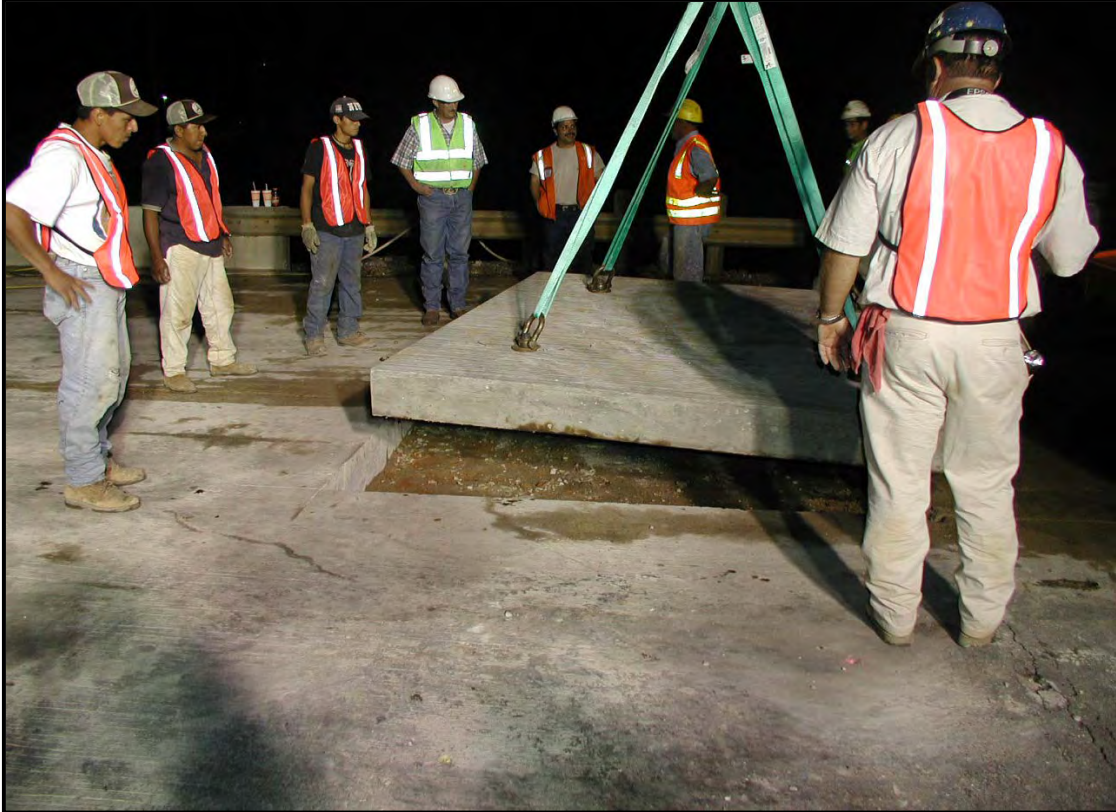
Figure 5.20 Precast Slab being Lowered into Place

(b) *URETEK's Stitch-in-Time*: Uretek Stitch-in-Time technology is another technique that is available to restore load transfer to jointed concrete pavements. The procedure involves cutting a series of 0.5-in wide saw cuts across the joint and then inserting 0.25-in thick polymer composite strips into each slot. Then the inserts are bonded into place by filling the slots with sand and hybrid ultra-dense polymer. The bonding material has very fast curing characteristics and thus, the bridge can be opened to traffic almost immediately after the repair has been completed. Figure 5.20 through 5.22 show a bridge approach slab being repaired with a precast concrete slab and stitched into place using the URETEK Stitch-in-Time method

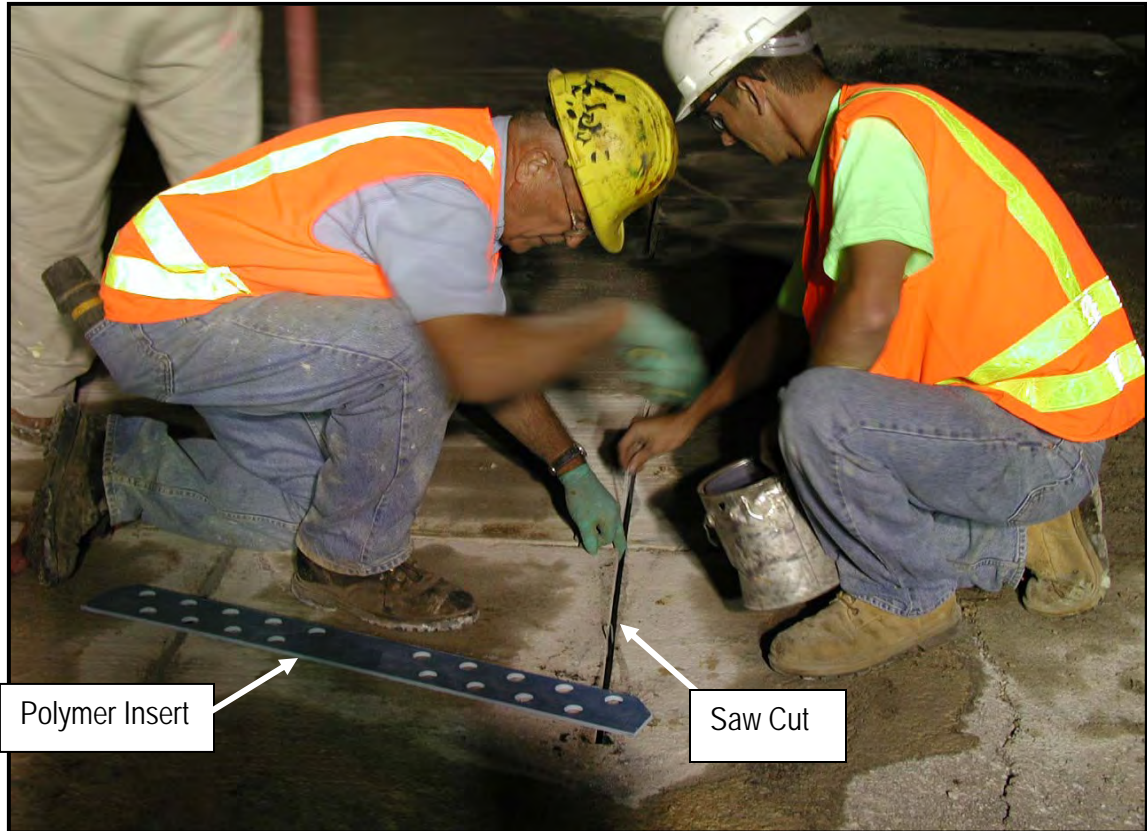
Figure 5.21 Sawcut Prepared to Receive Polymer Insert

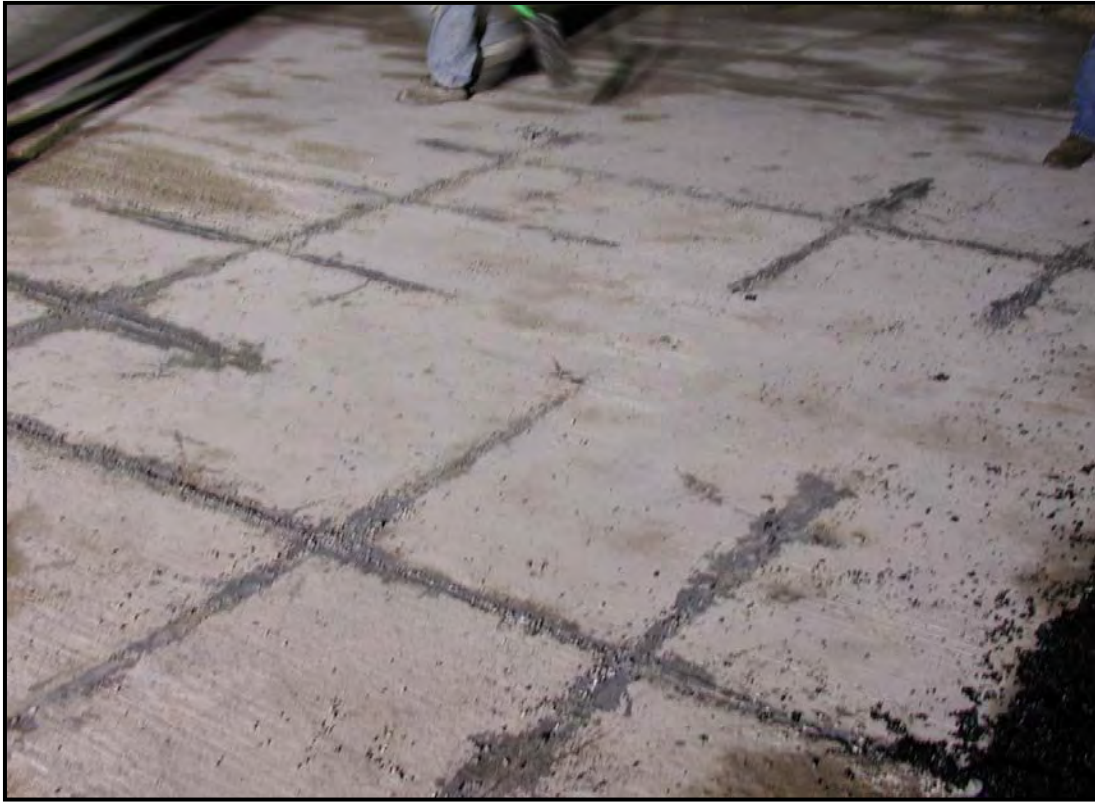
Figure 5.22 Precast Panel after the Repair has been Complete

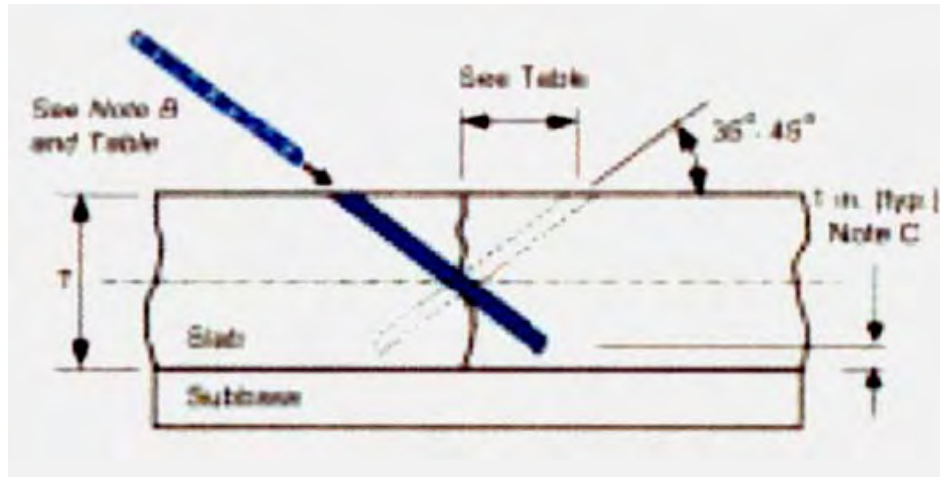
Figure 5.23- Cross-Stitching Across a Crack

(c) *Cross-Stitching*: A third technique that can be used to provide load transfer across joints is called cross-stitching. Cross-stitching uses deformed tie bars inserted into holes drilled across a crack or joint at angles of 35-45 degrees. The steps involved in cross-stitching are as follows: First, holes are drilled at 24 to 36 inch spacings at an angle so

that they intersect the crack or joint at about mid-depth. The angle of inclination of the hole will depend on the thickness of the slab. Then the holes are airblown to remove dust and debris. Next, epoxy is injected into the holes leaving some volume for the bars to occupy inside the holes. Finally, tiebars are inserted into the holes leaving about 1 inch from the top of the bars to the concrete surface. Figure 5.23 illustrates this process.

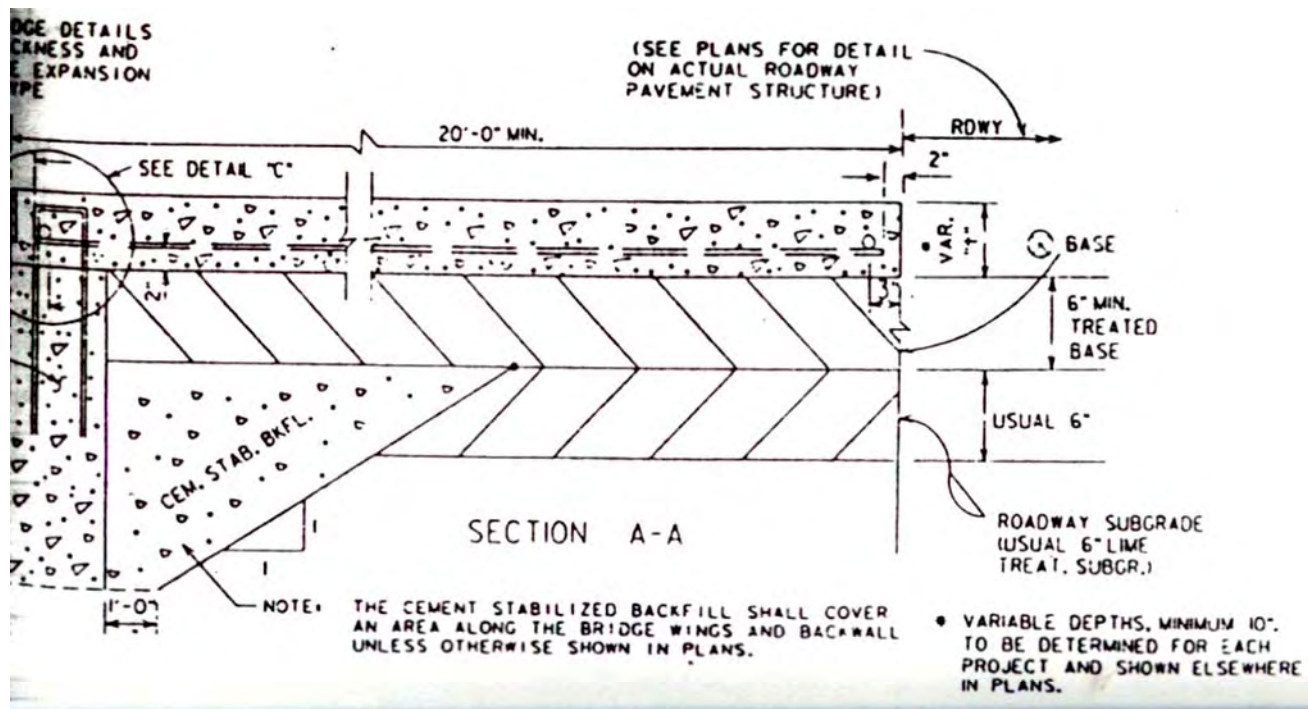
Figure 5.24 Bridge End Detail Showing Cement Stabilized Sand (CSS) Wedge Behind Abutment

Many of the problems commonly encountered in bridge approaches may be overcome by using a wedge of cement stabilized material immediately behind the bridge abutment. Cement stabilized material offers a number of advantages over conventional backfill. First of all, cement stabilized sand backfill has better flowability and therefore, is capable of filling any small void spaces that may be present. Secondly, it does not require compaction to gain necessary strength and thus overcomes the difficulties associated with achieving adequate compaction behind the abutment. Once the cement stabilized material hardens, it will not be sensitive to moisture changes and will not erode. Therefore, the use of a cement stabilized sand (CSS) "wedge" in the zone behind the abutment is encouraged in the TxDOT bridge design manual. Figure 5.24 shows a bridge

approach design with a CSS wedge. In some districts, this has now become the standard practice. The performance of bridge approaches that have been constructed according to this design has been very good.

For the reasons given above, the option of using a CSS wedge behind the abutment should be given serious consideration in new bridge construction and approach reconstruction projects. As mentioned previously, CSS wedge has the potential to overcome many problems experienced at bridge approaches. However, it should be noted that this material does not have the capability to transmit water efficiently, and therefore, CSS will not function as a subdrain system. Therefore, water that enters the approach through joints and cracks in the approach slab and pavements may still cause damage in areas in which CSS material is not present.

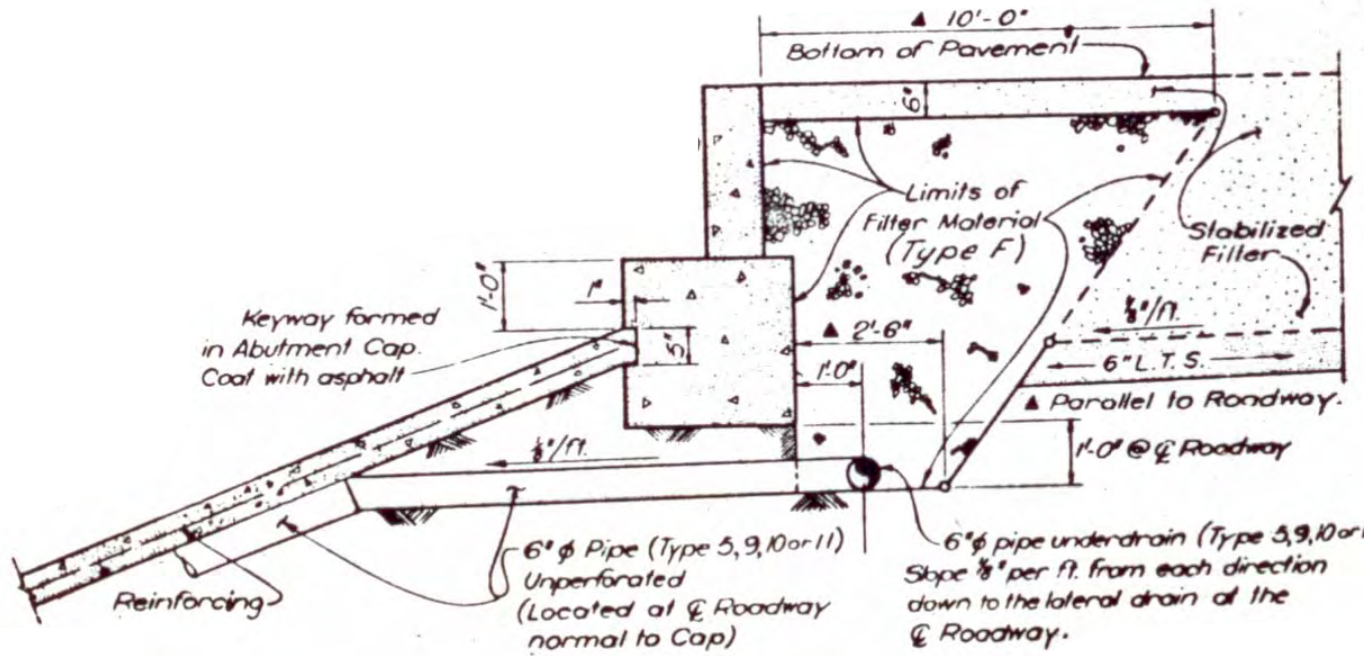
Figure 5.25 Bridge End Detail Showing Subdrain System Used in the Houston District

In Texas, the use of a subdrain system underneath the bridge approach slab is not standard practice at the present time. However, in some TxDOT districts such as Houston, it was common practice many years ago (personal communications with Michael Alford, Director of Maintenance, Houston District, TxDOT). The subdrain system design used by the Houston District previously is shown in Figure 5.25. Other districts, such as Lufkin have also used subdrain systems for some of their bridges. Figure 5.26 shows a drainage detail that was once used in the ABL district (behind an abutment wall). It should be noted that this drainage system is not currently being used in the Abilene District. The purpose of the subdrain (or underdrain) is to collect water that leaks through cracks and joints in the pavement and the approach slab and carry it away from the bridge end so that it would not cause damage by soil erosion and subgrade saturation.

Providing a subdrain system underneath the approach slab and pavement is best accomplished during the initial construction of the bridge approach rather than during repair. Most of the repair strategies discussed in this section would not allow the installation of such a subdrain system. However, this would be possible in many approach reconstruction projects. A more complete collection of different subdrain system designs that may be considered is found in Appendix A.

There are two important points that must be considered when arriving at a decision with regard to the installation of a subdrain system. First, if it becomes necessary to use slab stabilization or slab jacking during future maintenance operations, the grout that is pumped will likely clog the subdrain and make it ineffective. Second, subdrain systems require regular maintenance to ensure that they function properly. Adequate cleanout features or access points should be provided during design and construction.

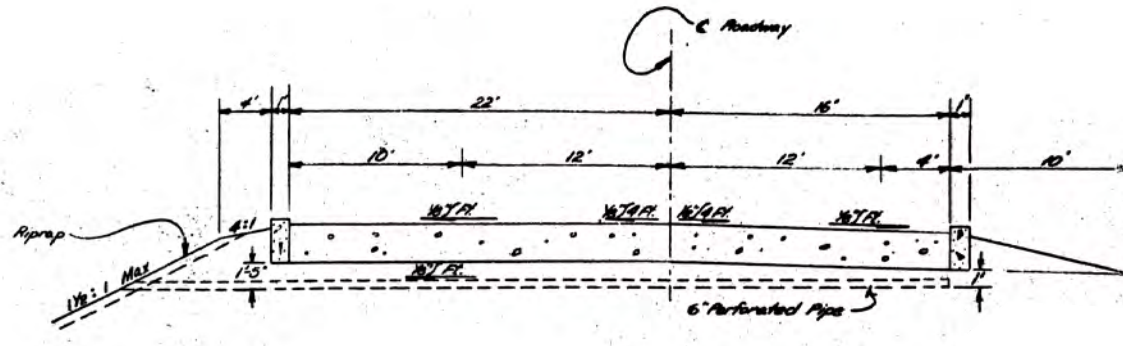
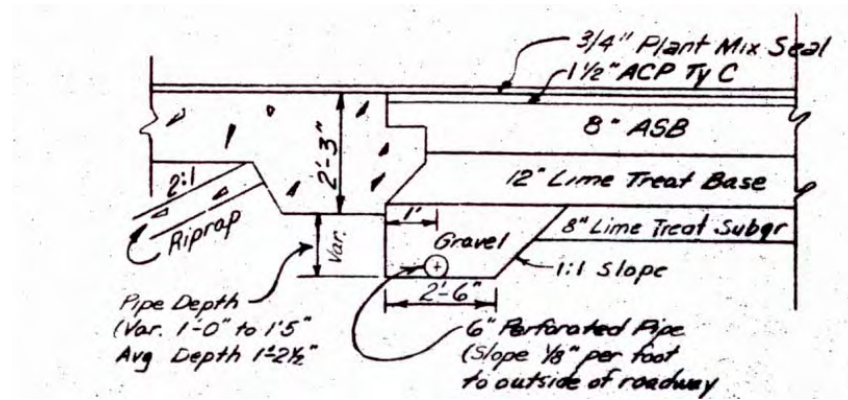
(a) Cross-section of Roadway at Bridge

(b) Section through Riprap and Abutment

Figure 5.26 Bridge End Detail Showing Subdrain System Previously Used in the Abilene District

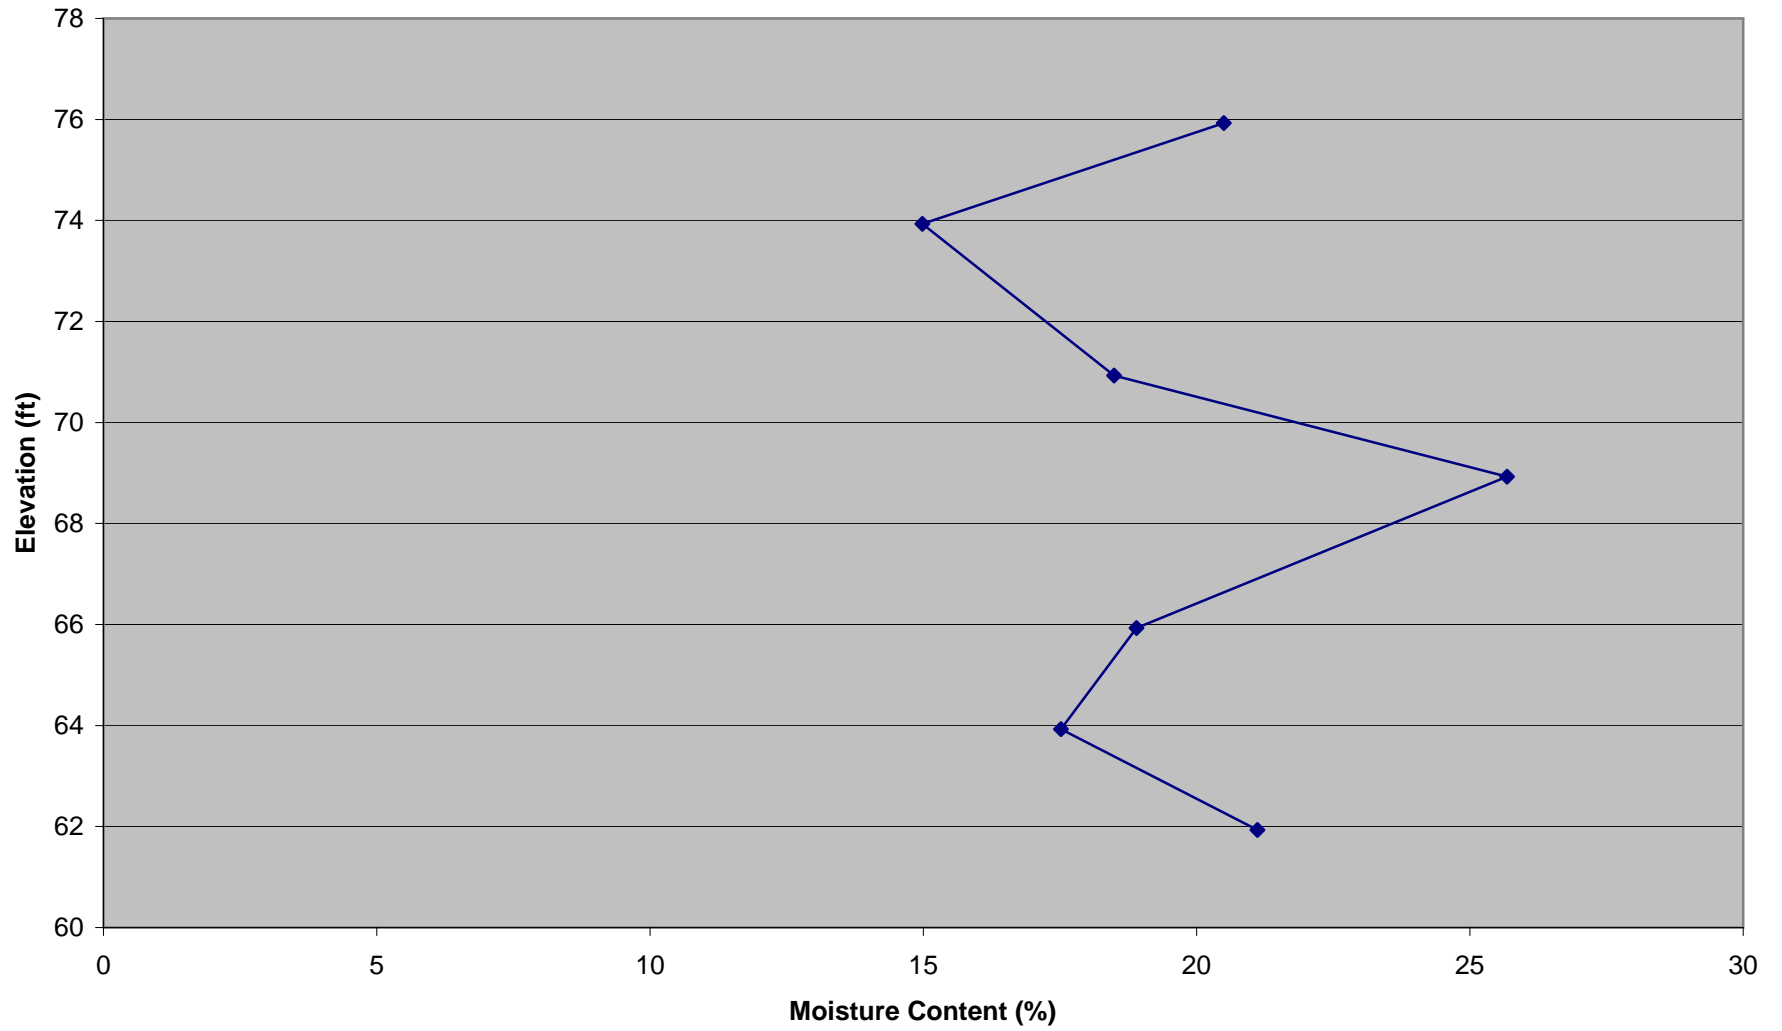
Bridge sites in four TxDOT districts were investigated for possible sources of water intrusion. One site, in the Abilene district, exhibits a continuing seepage problem indicative of water beneath the pavement surface. Researchers performed thorough field and laboratory investigations to determine the source of the water intrusion. The major source of the water intrusion was found to be inflow from surface water, although capillary action at the site keeps fill material in the embankment in a near saturated condition.

**US Highway 83 over Antilley Road, Abilene, TX
Moisture Content Profile with Depth for B3**

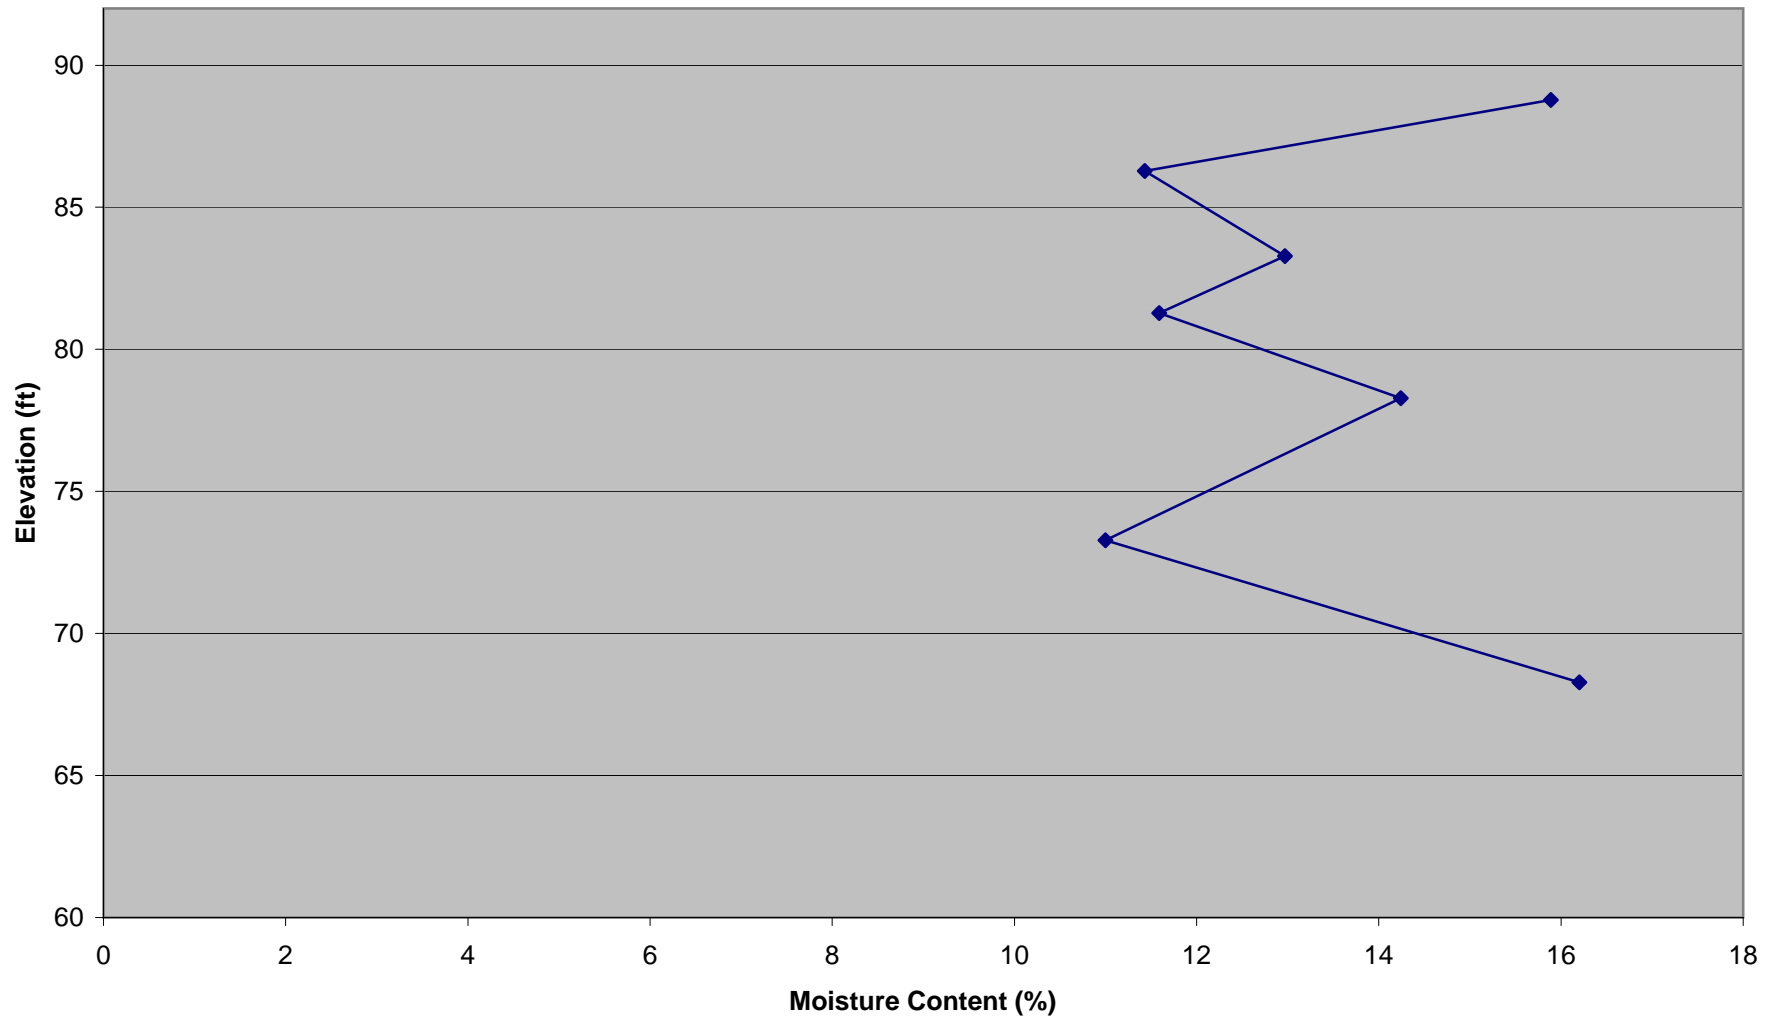
**US Highway 83 over Antilley Road, Abilene, TX
Moisture Content Profile for B2**

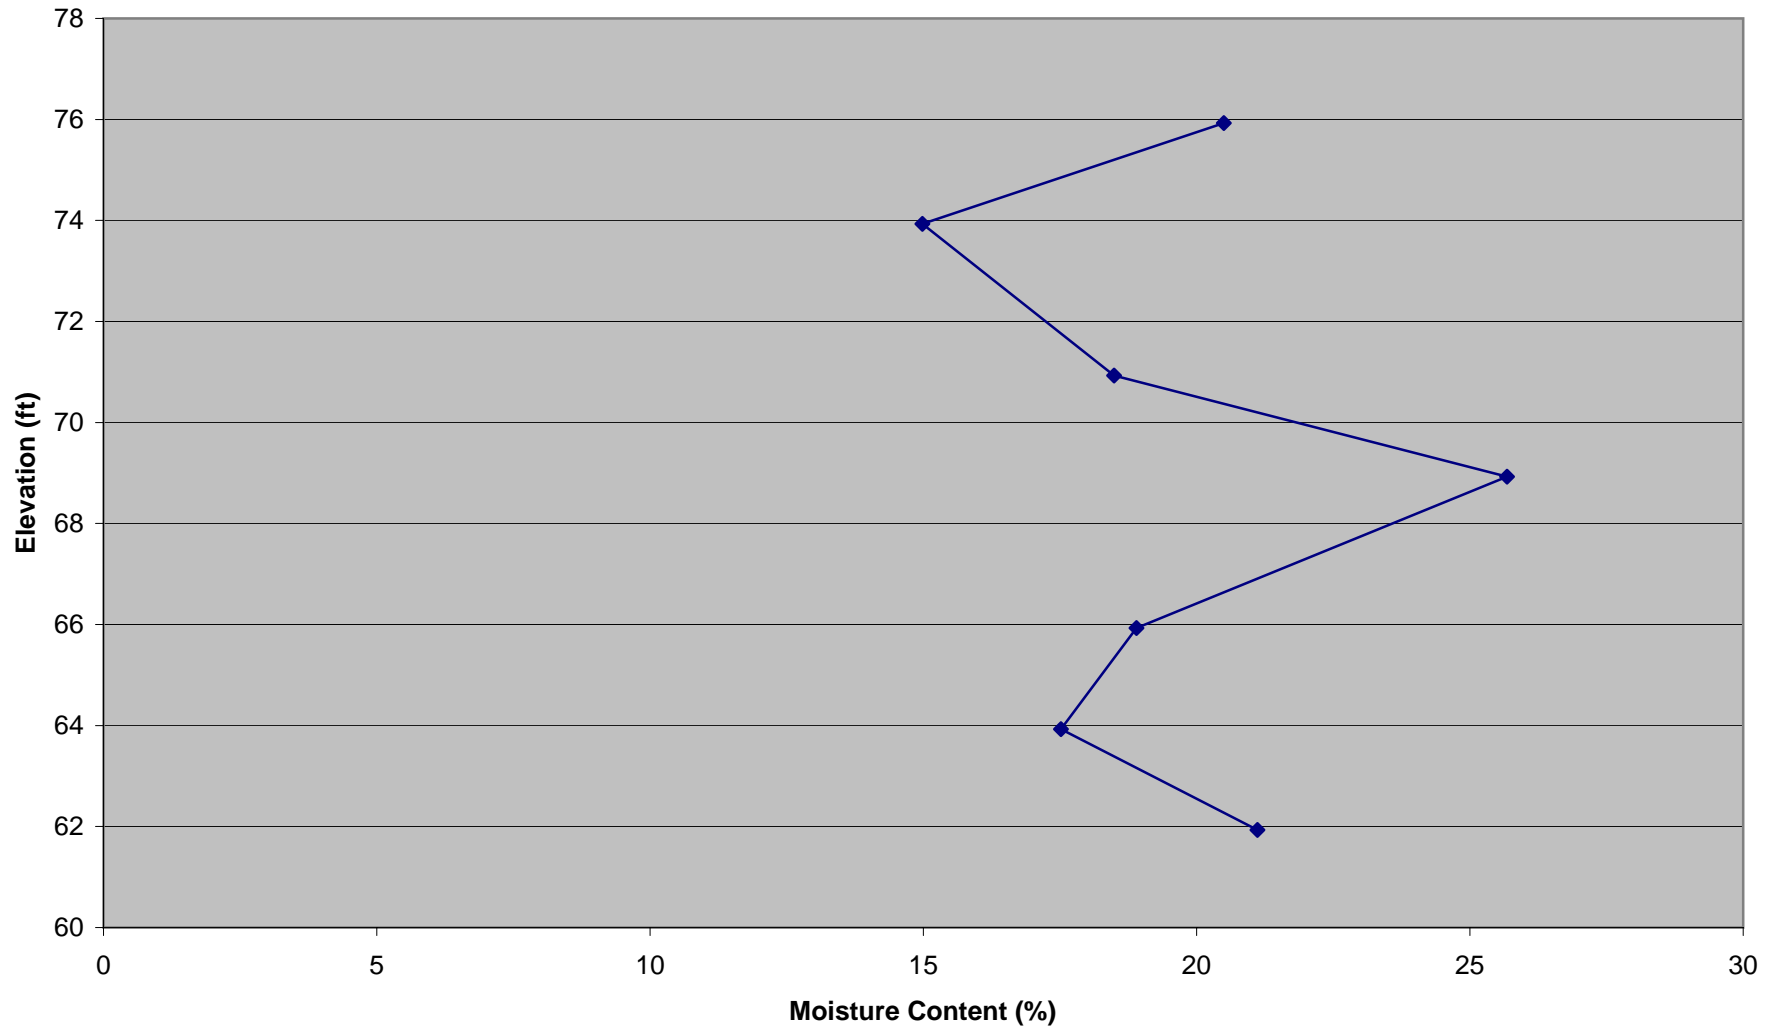
**US Highway 83 over Antilley Road, Abilene, TX
Moisture Content Profile with Depth for B3**
