TEXAS TECH UNIVERSITY

Implementing the Ultra-High Pressure Water Cutter for Roadway Maintenance Applications: Interim Report

Report #: 5-5230-01-1
www.techmrt.ttu.edu/reports.php

June 2012

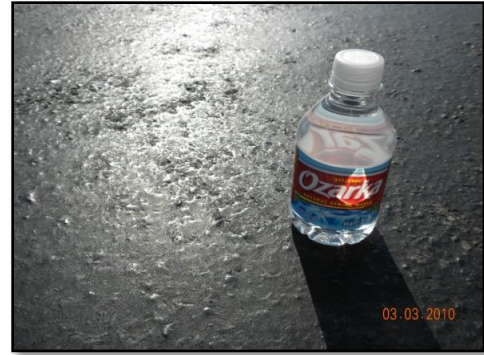
As can be seen in Figure 1.3, the section of FM 2562 selected for treatment was very heavily flushed. The contractor made five passes with the UHP water cutter, varying the rate of advance to accomplish different degrees of asphalt removal. One finding of the demonstration was that Rampart's technology is actually superior, or more advanced, than the New Zealand/Australia technology. Rampart's UHP water cutter truck uses a *fixed* deck blaster rather than an umbilical-mounted deck blaster, eliminating the need to have a person walk behind the truck and operate the unit. Further, Rampart's truck relies on a hydrodynamic transmission to better control the rate of advance of the water cutter unit. The result is improved control of the asphalt surface treatment, and a safer maintenance process.

(b) Heavily flushed seal coat, pre-treatment

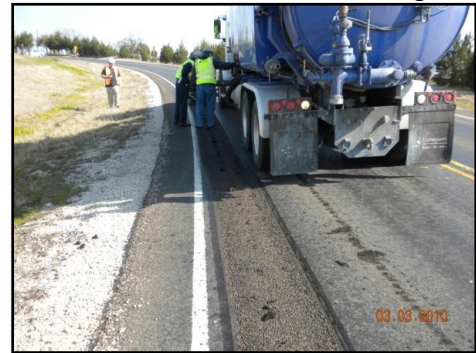
(f) Results from first treatment pass

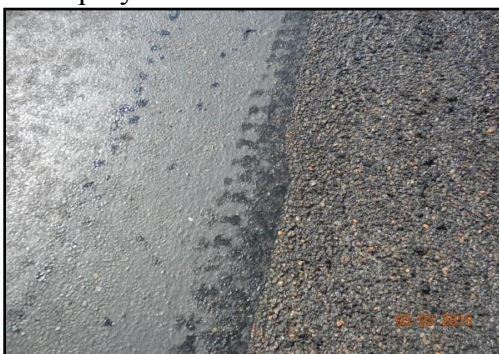
(g) Comparison of pre- vs. post-treatment

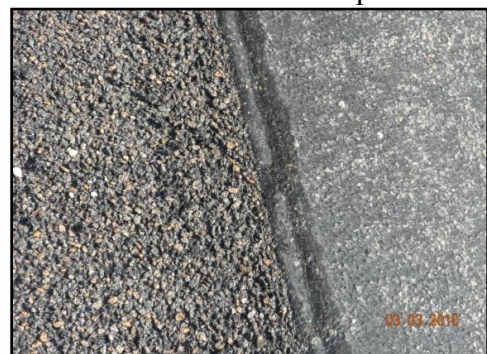
(h) Close-up of treated road surface

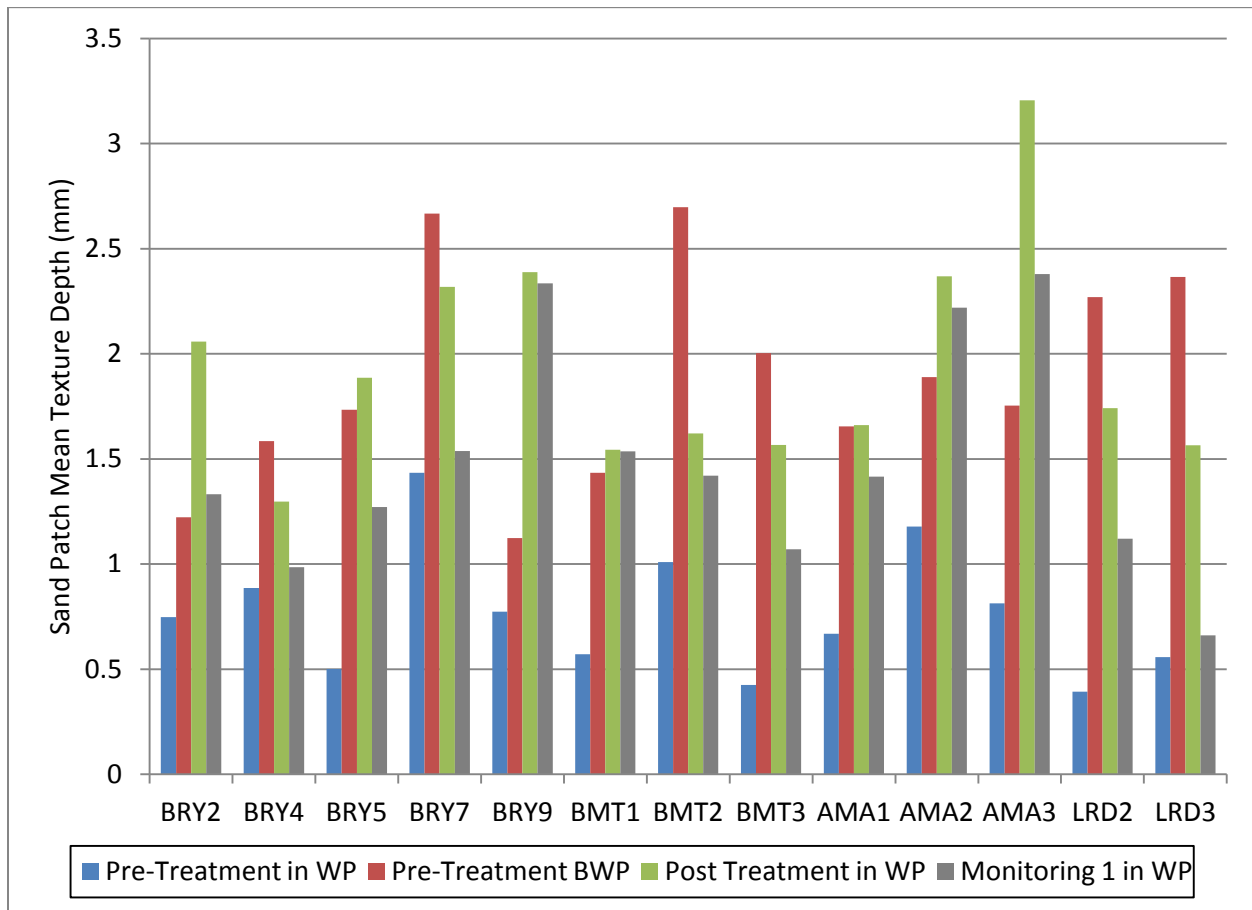
Figure 3.1 shows the Sand Patch mean texture depth for all 13 test sites both before and immediately after the water cutter treatment. The mean texture depth in the area between the two wheel paths at the test points is also shown for comparison purposes as a benchmark of the pavement macrotexture prior to the development of flushing in the pavement. These results show that water cutter treatment resulted in remarkable improvement in the sand patch mean texture depth. Research suggests average texture depths of approximately 0.8mm to 1mm are desirable for satisfactory wet weather skid resistance. The sand patch mean texture depth prior to the treatment showed three of the 13 sites with macrotexture values equal to or greater than 1mm, with the range of values being 0.4 to 1.2mm. After the treatment, the mean texture depths ranged from 1.3 to 3.2mm. Five months after the treatment, the range was 0.7 to 2.3mm with

one of the 13 sections showing texture depth below 1mm. This one section happened to be the heavily trafficked interstate highway section just north of Laredo.

FIGURE 3.1. Sand patch mean texture depth for all test sites before and immediately after UHP treatment and at first follow-up monitoring cycle

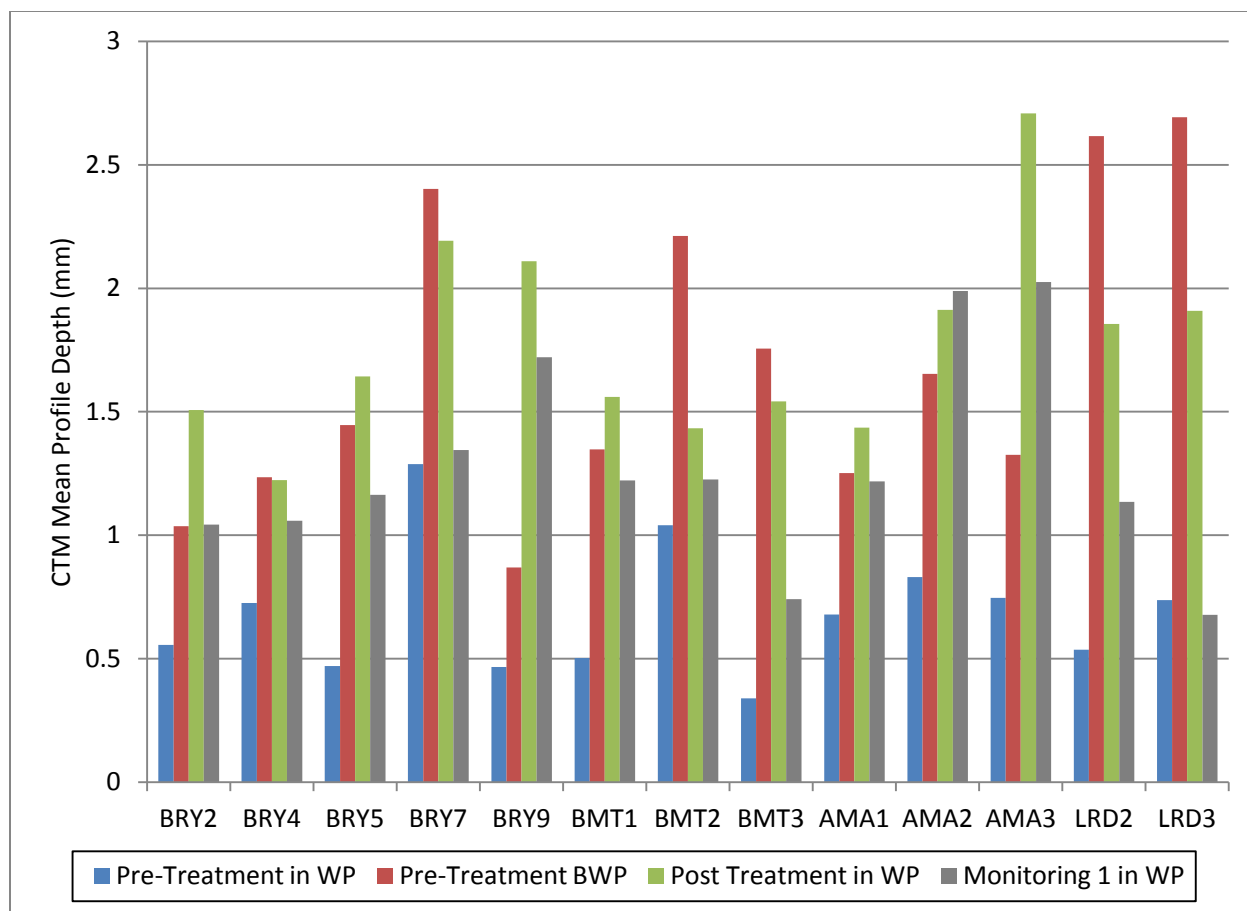
Similar observations can also be made from Figure 3.2, which shows the macrotexture represented by the CTM mean profile depth. The range of CTM mean profile depth values before treatment was 0.3 to 1.3mm, which increased to 1.2mm to 2.7mm after treatment. Five months after treatment, the range was at 0.7 to 2.0mm, with only two of the 13 sections with values lower than 1mm.

FIGURE 3.2. CTM mean profile depth for all test sites before and immediately after UHP treatment and at first follow-up monitoring cycle

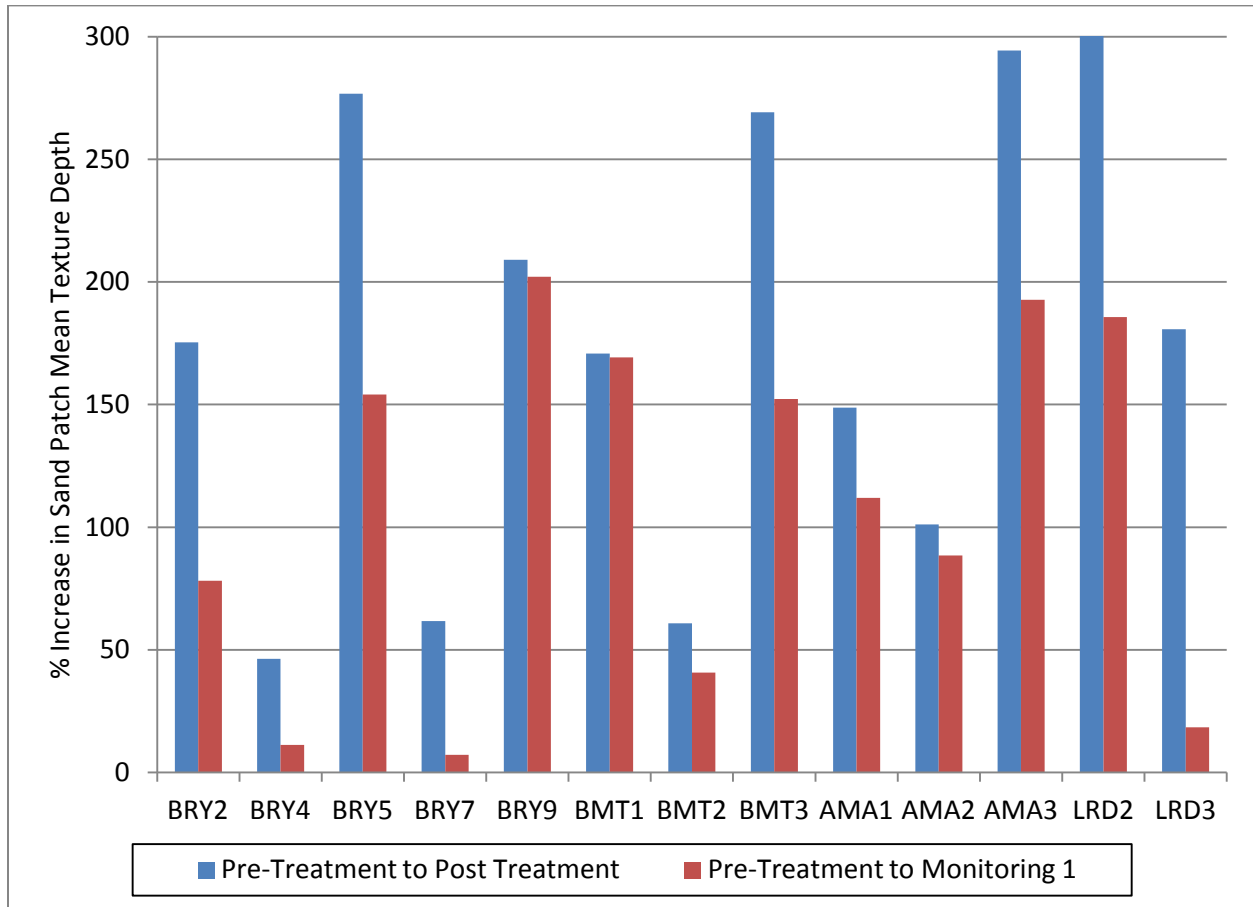
Figure 3.3 shows the percent improvement in sand patch mean texture depth as a result of water cutter treatment. The results show remarkable improvement with all 13 sites showing 50 percent or higher increases in macrotexture, with 10 of the 13 projects showing improvements of 100 percent or more. The three sites with around 50 percent increase in macrotexture were all sites with non-uniform flushing levels along the section. Five months after treatment, nine of the 13 sites still had increases over 100 percent, with one section showing a drop from a 180 percent increase in texture depth to about 20 percent. Once again, this was the interstate highway section north of Laredo.

FIGURE 3.3. Percent increase in sand patch mean texture depth for all test sites from pre-treatment to post-treatment, and from pre-treatment to monitoring cycle #1

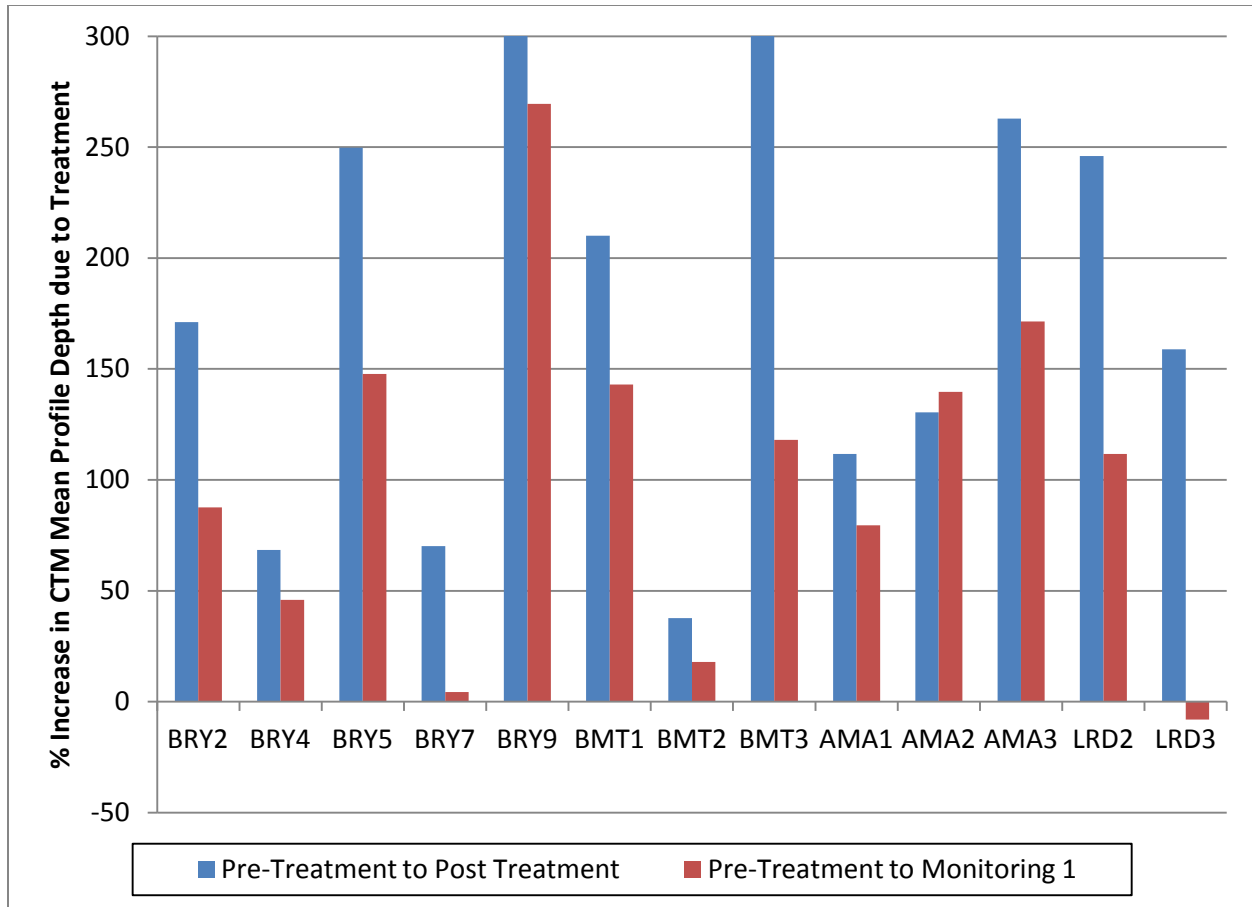
Figure 3.4 shows a similar trend in the CTM mean profile depth (macrotexture) values. It is important to note that improvement in texture could perhaps lead to raveling as an unintended consequence. The research team will continue to monitor the performance of these test sections over the next 12 months to assess such developments. In the roadway sections that were treated with the UHP water cutter, some raveling was observed during treatment. However, this was the result of experimenting with different nozzle configurations and travel speeds, and once a suitable nozzle configuration and a travel speed was decided upon, the treatment appeared to be

FIGURE 3.4. Percent increase in CTM mean profile depth for all test sites from pre-treatment to post-treatment, and from pre-treatment to monitoring cycle #1

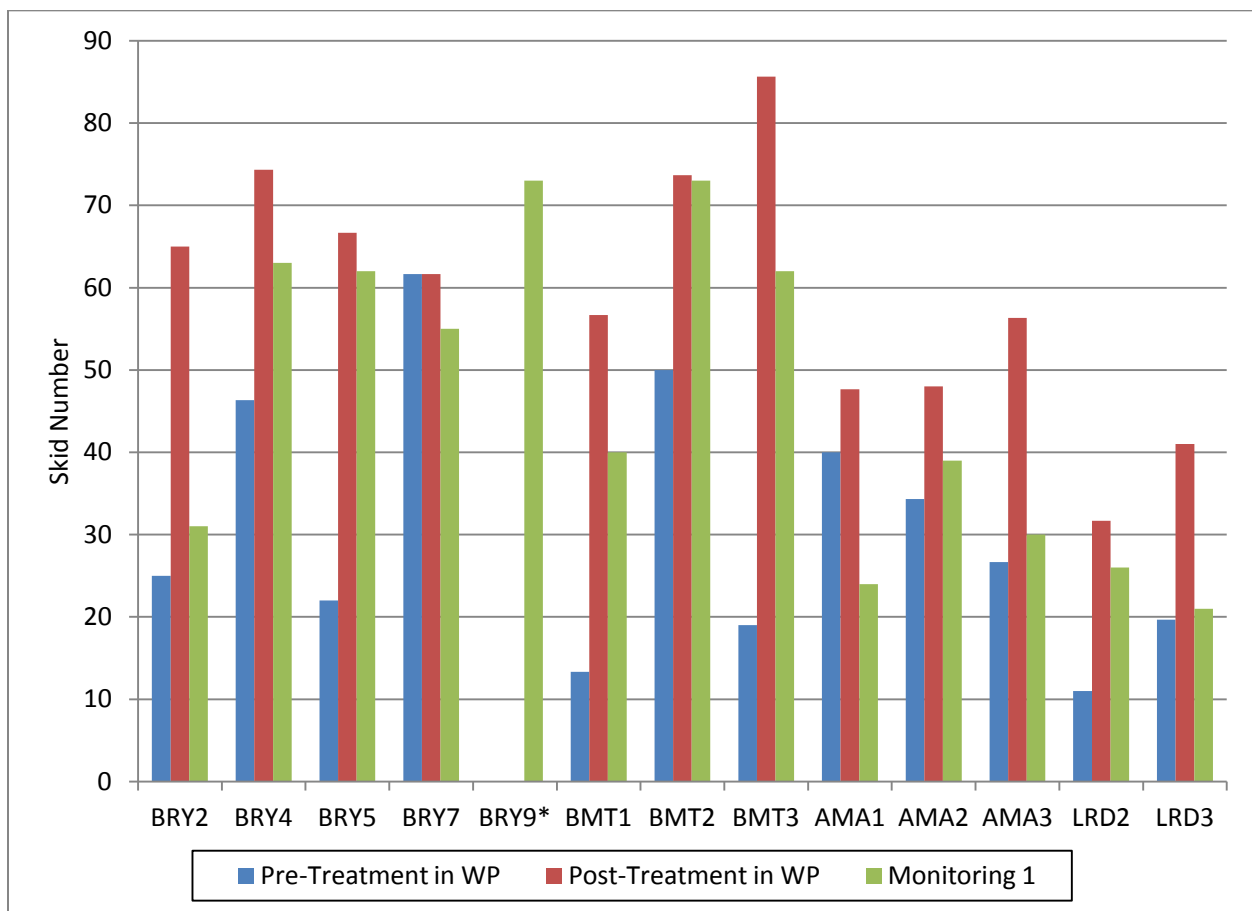
Figures 3.7 and 3.8 illustrate the effectiveness of the treatment in terms of improved friction. Two pavement friction parameters were measured using the skid truck and the DFT before and immediately after the treatment, as well as during the first monitoring event. Here again, the improvements are very significant and even dramatic for many of the sites. The BRY9 site was added later to the test matrix, and as a result, a skid test was not conducted for that site prior to treatment. However, the DFT values are available for both before and after treatment for all test sites including BRY9. Results presented in Figure 3.7 show very high increases in the skid number, indicating the success of this treatment method to improve pavement skid resistance. Prior to the treatment, four of the 13 sections had a skid number greater than 35, one between 30 and 35, and seven below 30. A skid number of 30 is generally considered to be the acceptability threshold for any type of pavement. After the treatment, eleven of the 13 sections had skid numbers over 40, which is well above the generally considered threshold minimum of 35 for high traffic pavements. The remaining section showed a skid number of 31.

Four of the thirteen test sites showed skid number increase in excess of 40, and five showed increases in excess of 20. The BRY7 site showed no change in the skid number after the treatment, and it is possible that due to the non-uniformity and sporadic nature of flushing in this section, the skid truck was not able to test the same location when testing before and after the treatment. Two of the sections that had the lowest increases in the skid number (approximately 8 and 13) used low microtexture, low-friction siliceous gravel aggregate. The two sites LRD2 and LRD3 showed the lowest post-treatment skid numbers (31 and 41 respectively), and this may be attributed to the type of limestone used in these two sites and other factors. The skid number and the DFT friction number are both functions of the macrotexture as well as microtexture. Therefore, the aggregate used in the surface has a significant influence in the final value of the friction parameter value.

FIGURE 3.7. Skid Number values in the wheel path for all test sites before and immediately after UHP treatment and at first follow-up monitoring cycle

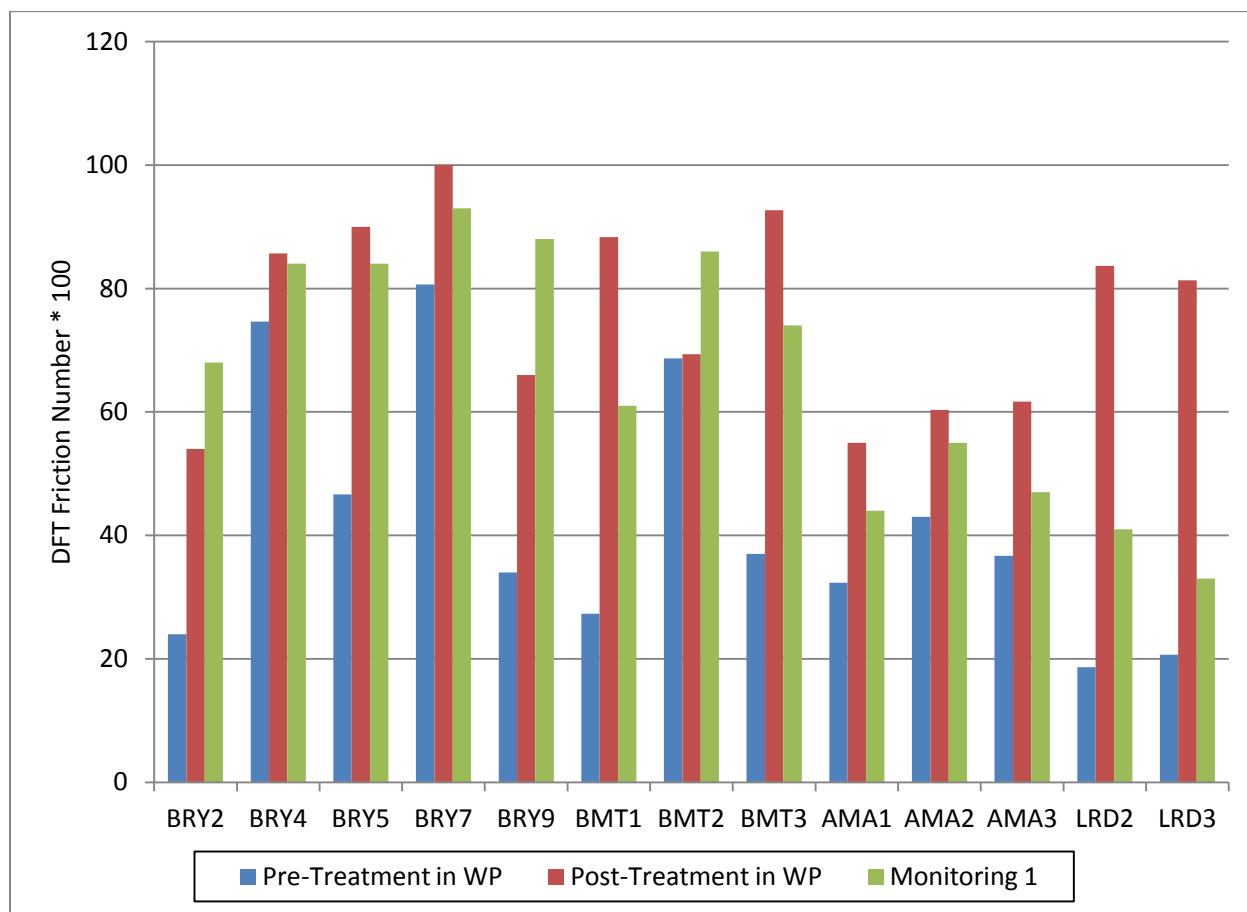
The DFT friction numbers showed trends similar to those of the skid number (Figure 3.8). Prior to treatment, seven of the 13 section had DFT friction numbers over 0.35 and six were below. After the treatment, all thirteen sections had friction numbers above 0.35. After five months, all except one of the 13 sections had friction numbers above 0.35, with the lone exception being the interstate highway section north of Laredo which had a value of 0.32. In Figure 3.8, the results

from the DFT show mostly similar trends in friction values compared to the skid numbers. All sections showed remarkably high increases in the DFT friction value with the lowest increases in the siliceous gravel sections. It is interesting to note that the two sections LRD2 and LRD3, which used the weak limestone, had high post-treatment friction values and also three-fold increases. However, the DFT friction values for these two sections dropped sharply to one-half or more of the post-treatment value, from the time of treatment to the first monitoring event five months later. There appears to be a general correlation between the skid truck and DFT results.

FIGURE 3.8. DFT Friction Number values (x100) for all test sites before and immediately after UHP treatment and at first follow-up monitoring cycle

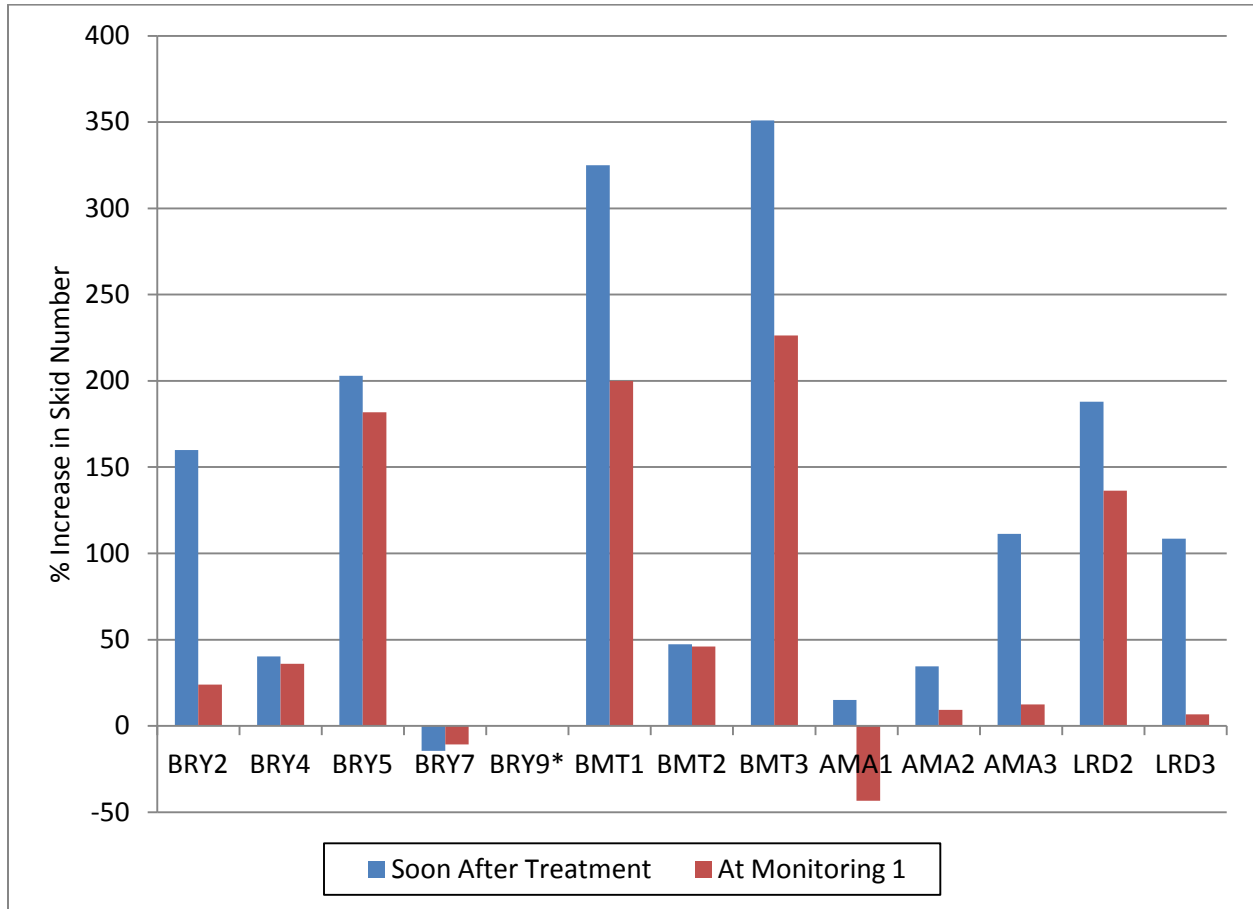
Figures 3.9 and 3.10 show the percent increase in friction due to the water cutter treatment measured using the skid truck. Six of the thirteen sites showed at least a 100 percent increase in the skid number and five sites showed similar trends for the DFT friction number. A few sites showed unexpectedly low increases. This may be attributable to factors not related to the general effectiveness of the treatment. The sites that showed low increases either used low friction siliceous gravel aggregate (AMA1, AMA2 and AMA3) or had uneven flushing along the length of the highway section (in BRY4 and BRY7). The trends were similar for both the skid number and DFT friction number values.

FIGURE 3.9. Percent increase in skid number in the inside wheel path for all test sites from pre-treatment to post-treatment, and from pre-treatment to monitoring cycle #1

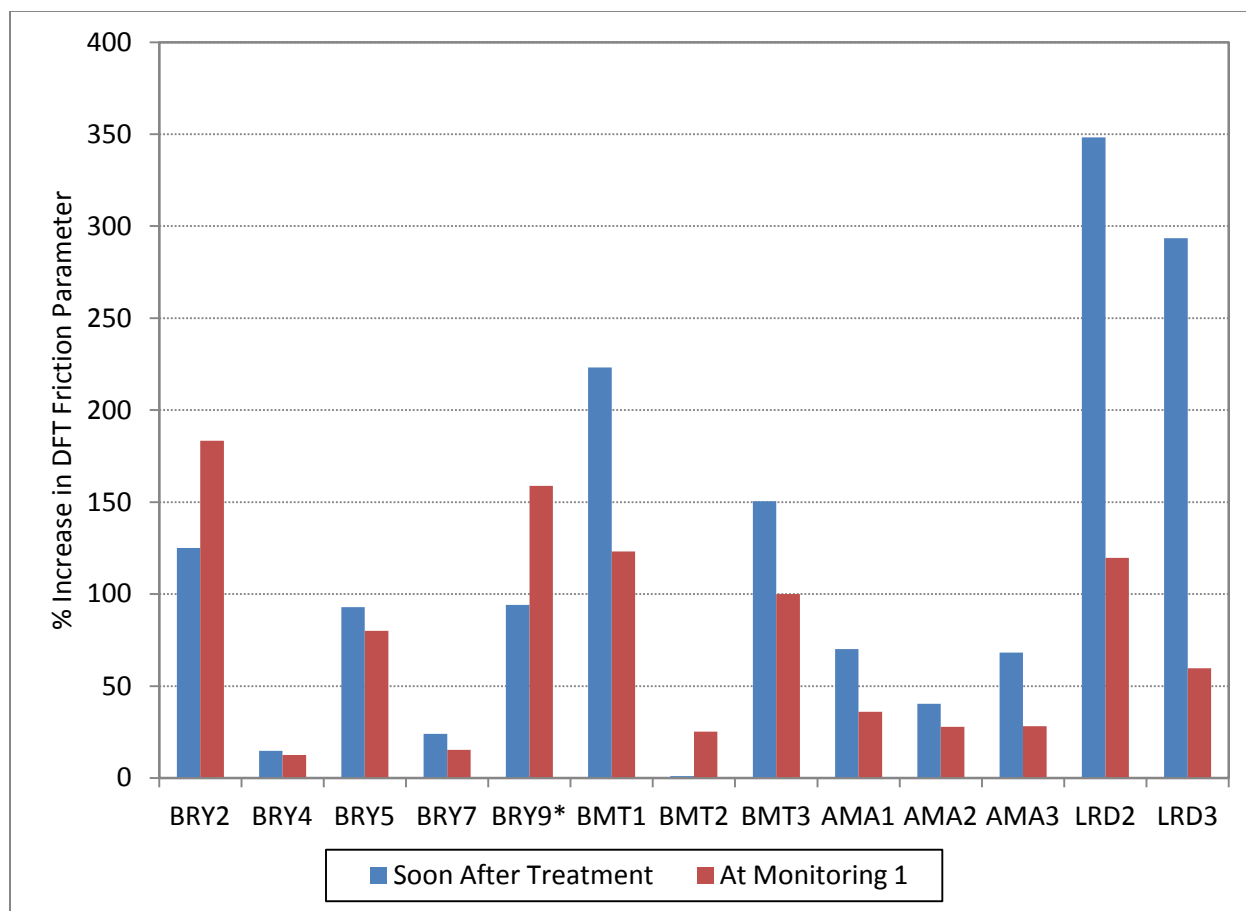
FIGURE 3.10. Percent increase in DFT friction number in the inside wheel path for all test sites from pre-treatment to post-treatment, and from pre-treatment to monitoring cycle #1

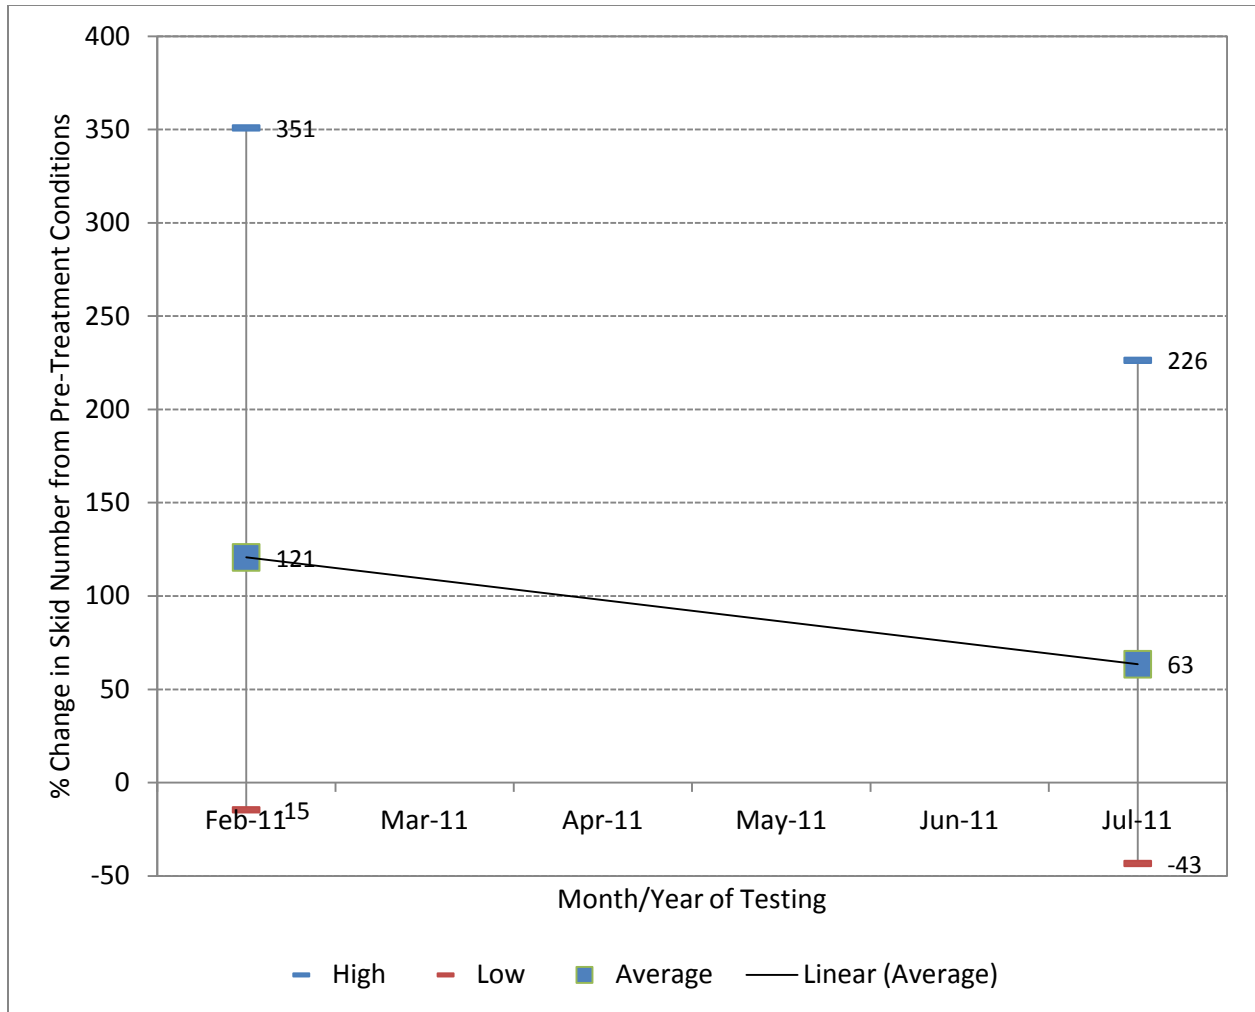
Figures 3.11 and 3.12 illustrate the durability of the friction improvement; *i.e.*, how well the treatment holds up under continued use. The trend in the percent change in surface friction from the time of treatment to the first monitoring cycle five months later is shown here. For better interpretation of results, the range of values for percent increase in friction (with minimum and maximum values) is also presented. Figure 3.11 shows that the average skid number for all sections was above 60 percent at the time the first monitoring event was conducted in July 2011. The same can be said for the CTM mean profile depth (see Figure 3.12).

FIGURE 3.11. Trend for percent increase in skid number for all test sites relative to pre-treatment levels

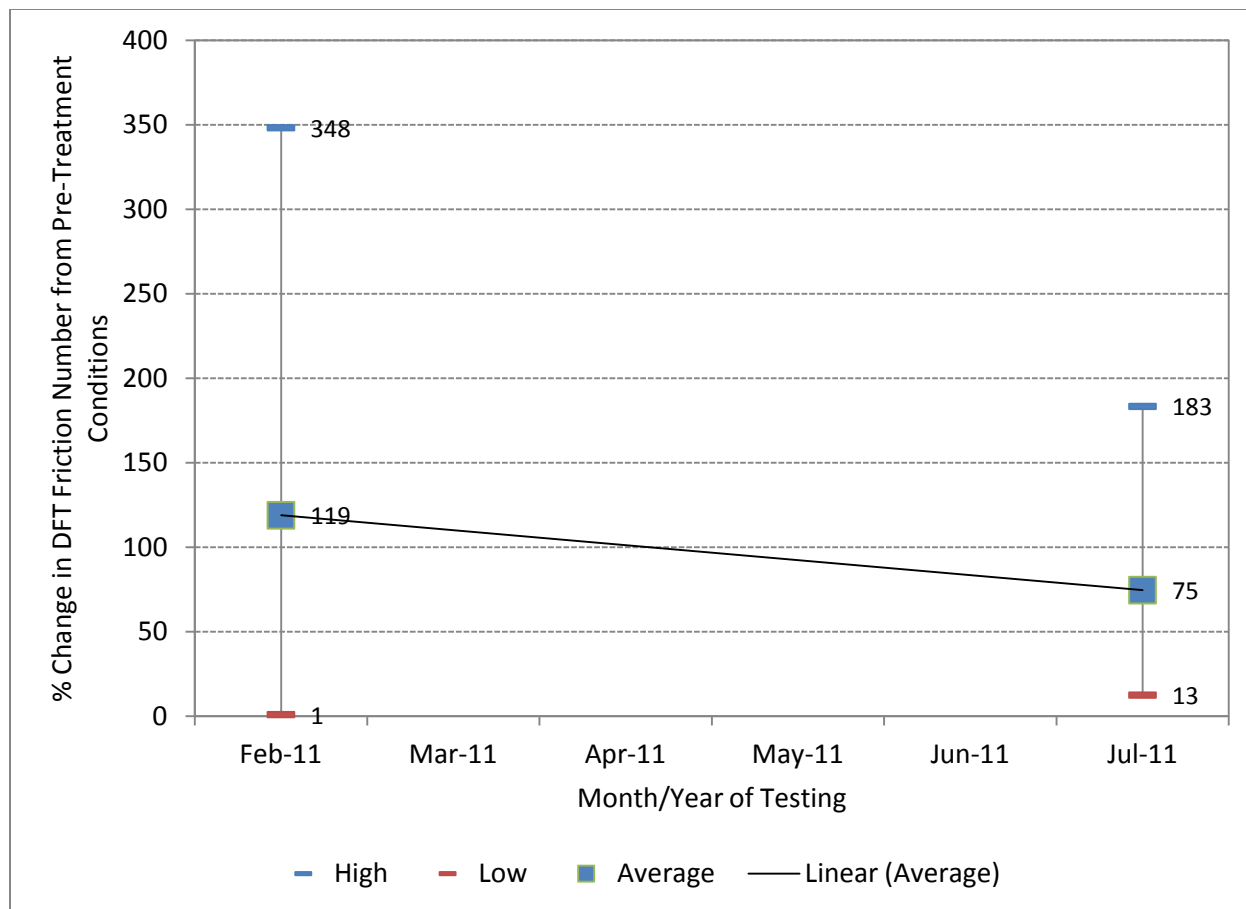
FIGURE 3.12. Trend for percent increase in DFT Friction Number for all test sites relative to pre-treatment levels

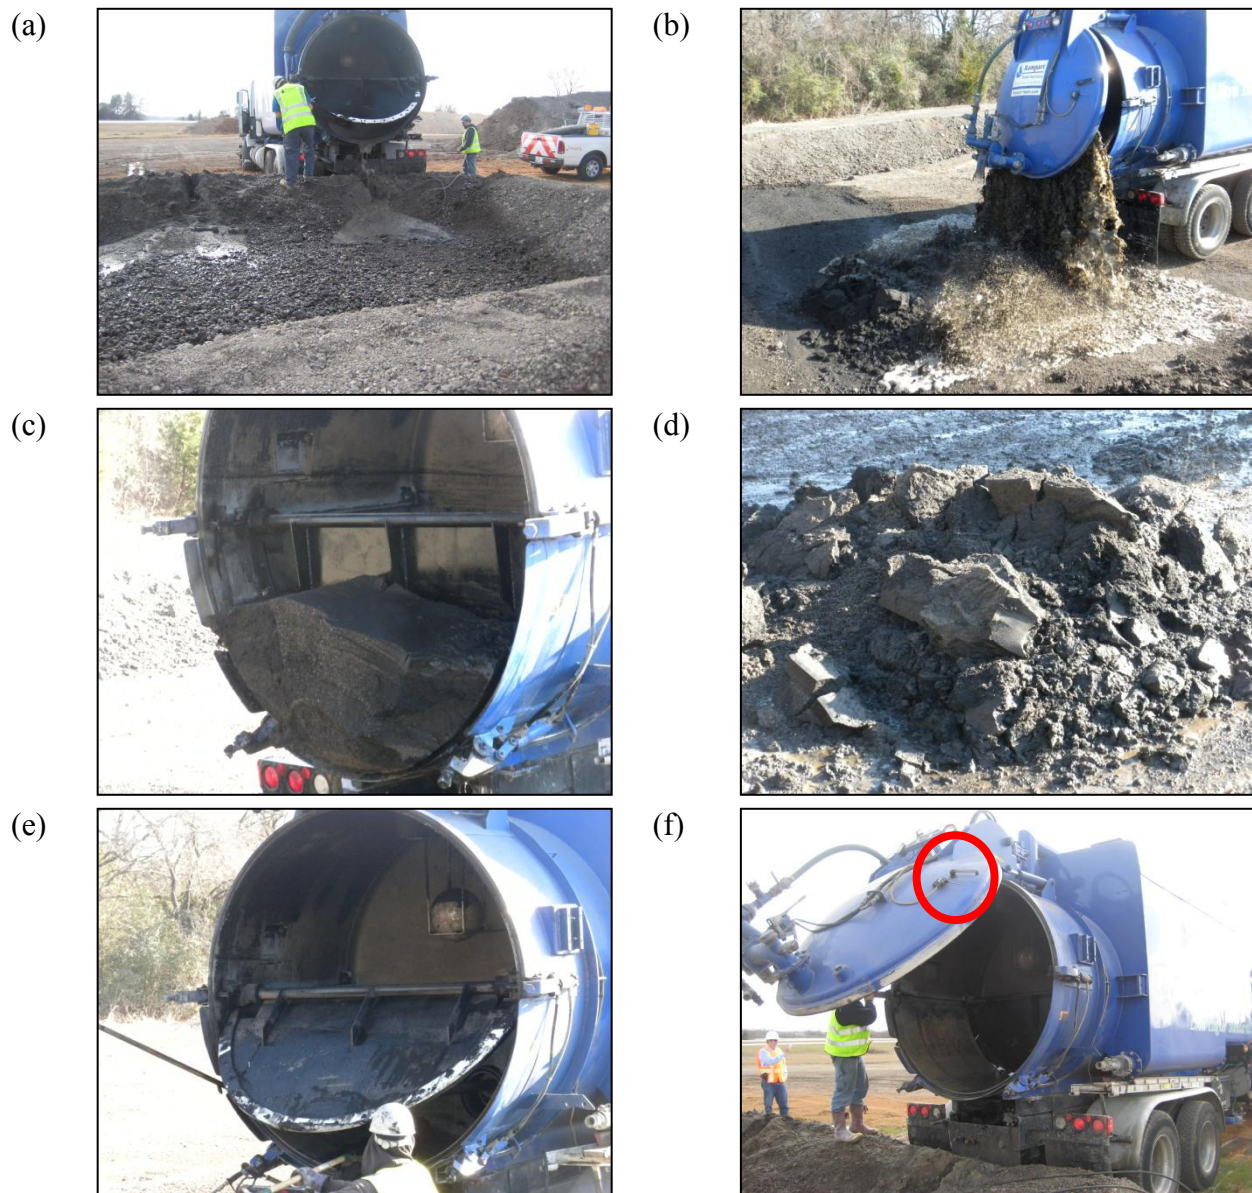
Because the debris tank has only 1,000 gallon capacity and the water supply tank has 4,000 gallon capacity, the location of an approved dump site will significantly impact the rate of production. Figure 4.3 illustrates the key steps involved in the waste disposal process. The back gate of the truck has a gage that indicates the material level in the waste tank [see the circled area in Figure 4.3(f)]. The truck is able to directly back into the disposal area and open the rear gate as shown. This operation requires that the disposal area is firm enough to carry the laden truck that is at least partially filled with water. Once the gate is opened, water spills out of the truck, but the solid material must be pushed out using a hydraulic ram inside the waste tank.

FIGURE 4.3. Disposal of excess flushed asphalt removed by the treatment; (a) A bermed area chosen by the TxDOT maintenance yard used to dispose the material without run-off; (b) Opening of rear gate spills out the water among the waste; (c) lump of asphalt and sand waste pushed out using hydraulic system; (d) lump of asphalt and sand waste on the ground; (e) cleaning of waste tank using high-pressure water jet; (f) cleaning of waste tank solid material – the circle highlights the gage on the rear gate that indicates the material level in the waste tank.

The maintenance supervisor must ensure that the waste material is disposed according to guidelines stipulated by the TxDOT Environmental Division. The waste material consists of ground asphalt, sand, and water. When the temperature of the pavement is relatively high, evidence of some emulsification of the asphalt could be observed. Ideally, the disposal area is to be bermed around to prevent immediate run-off of the material.

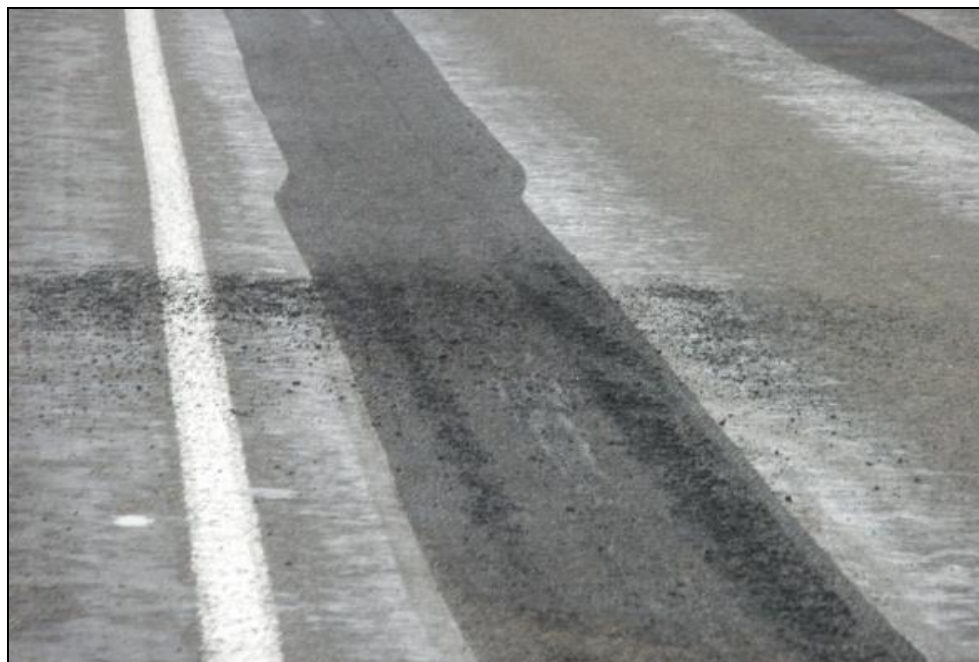
Figure 4.5 illustrates some situations we observed during the treatment process. The UHP water cutter removes a significant amount of excess asphalt material from the pavement surface. The actual quantity removed will depend on the travel speed, rotational speed of the spray bar, the nozzle configuration in the bar, extent of flushing on the road and the asphalt and aggregate material characteristics. Figure 4.5 (a) shows the removed asphalt left on the road when the vacuum system is not operating. Under conditions that can be labeled as "typical," the vacuum system in the machine is capable of sucking up all the material. Typical conditions would mean desirably cool temperatures and modified binders. However, there can be situations where the vacuum system is unable to remove all the cut asphalt as shown in Figure 4.5 (b). Figure 4.5(c) shows a power broom following the water cutter to ensure that all material is removed from the roadway before traffic is allowed back.

FIGURE 4.6. Traces of removed asphalt left on treatment path

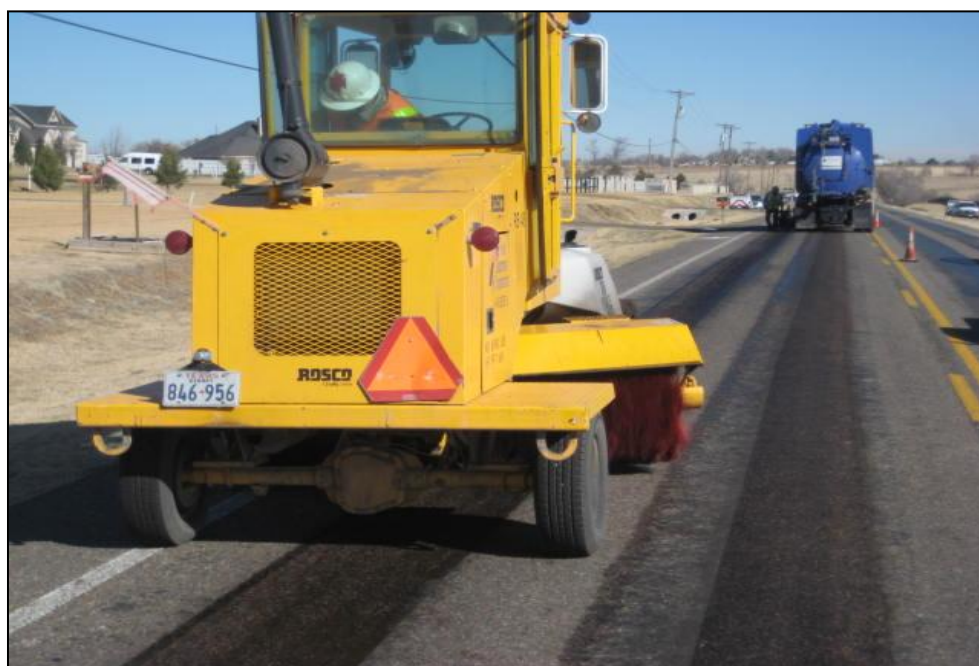
FIGURE 4.7. Power broom used to sweep remaining asphalt left after treatment head vacuum system

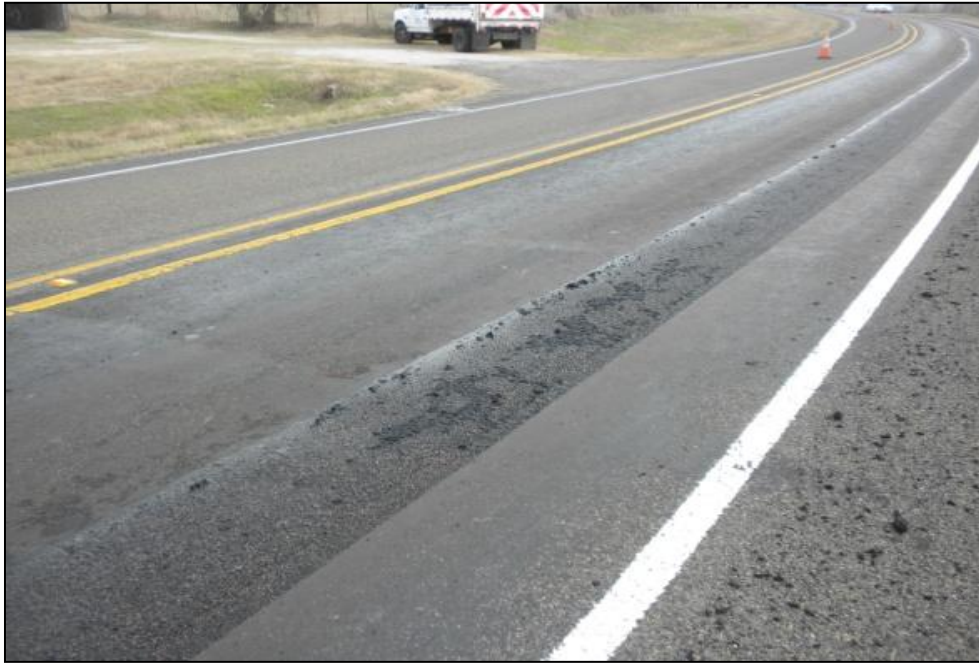
Figure 4.5(d) also illustrates a phenomenon where the treatment process may leave a sharp shallow drop along the edge of the treated strip. This drop is not deep enough to cause traffic to lose control if caught on the edge. This issue can be alleviated by changing the nozzle configuration to gradually taper-off the treatment depth towards the outside of the treated strip. Another outcome that is influenced by the nozzle configuration is not having sufficient nozzle coverage in a certain part of the treatment trip. Figure 4.5(e) shows a narrow strip along the center of the treated strip where all excess asphalt was not removed. This results in a lightly-scored pattern on the surface.

FIGURE 4.8. Treated wheel patch showing small amounts of asphalt not vacuumed and then pressed back into the lane by tires of the water cutter truck – this picture also shows the sharp edge sometimes left by the treatment at the edge of the strip

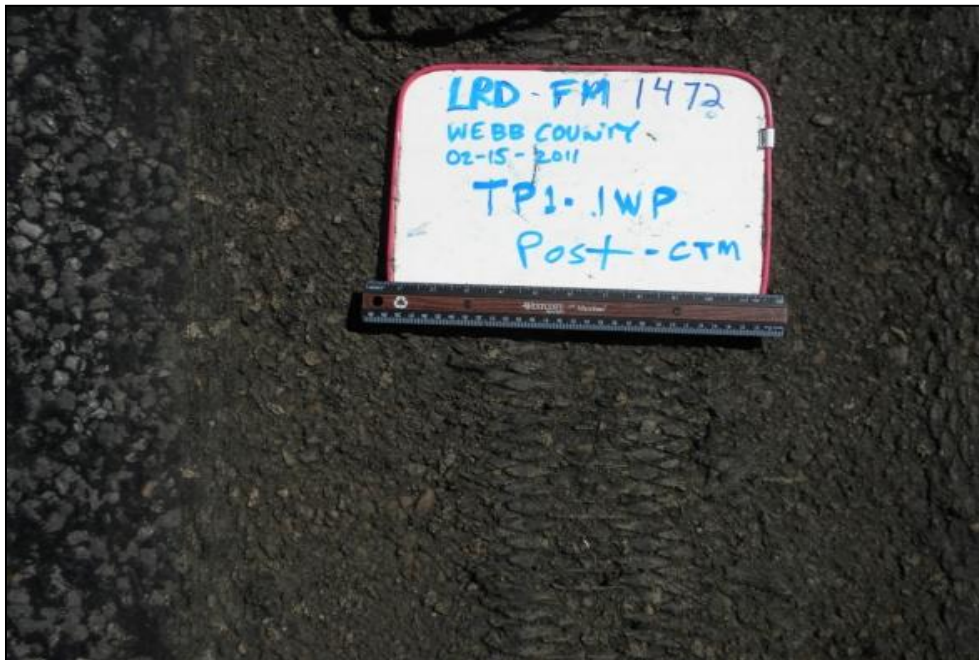
FIGURE 4.9. "Holiday" areas not subjected to treatment due to ineffective nozzle coverage, in this case along the center of the treatment path

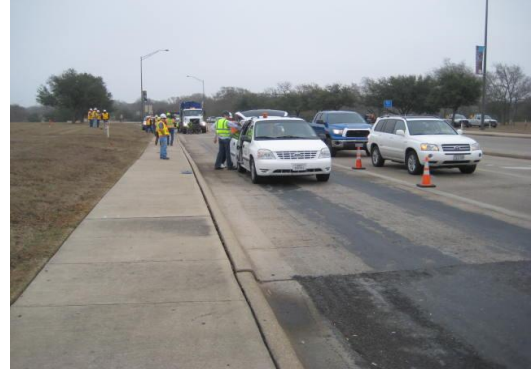
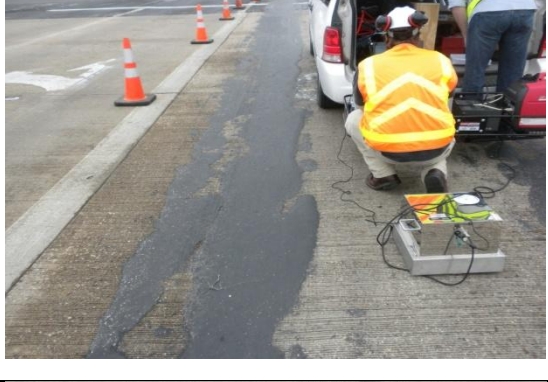
<p>Figure XX. BRY2 Pictures (a) highway and location; (b) roadway surface before treatment; (c) close-up of flushed surface before treatment; (d) roadway surface after treatment; (e) close-up of flushed surface immediately after treatment; (f) roadway surface at first follow-up; (g) close-up of surface at first follow-up</p>
