TEXAS TECH UNIVERSITY

Implementing the Ultra-High Pressure Water Cutter for Roadway Maintenance Applications: Interim Report

Report #: 5-5230-01-1
www.techmrt.ttu.edu/reports.php

June 2012

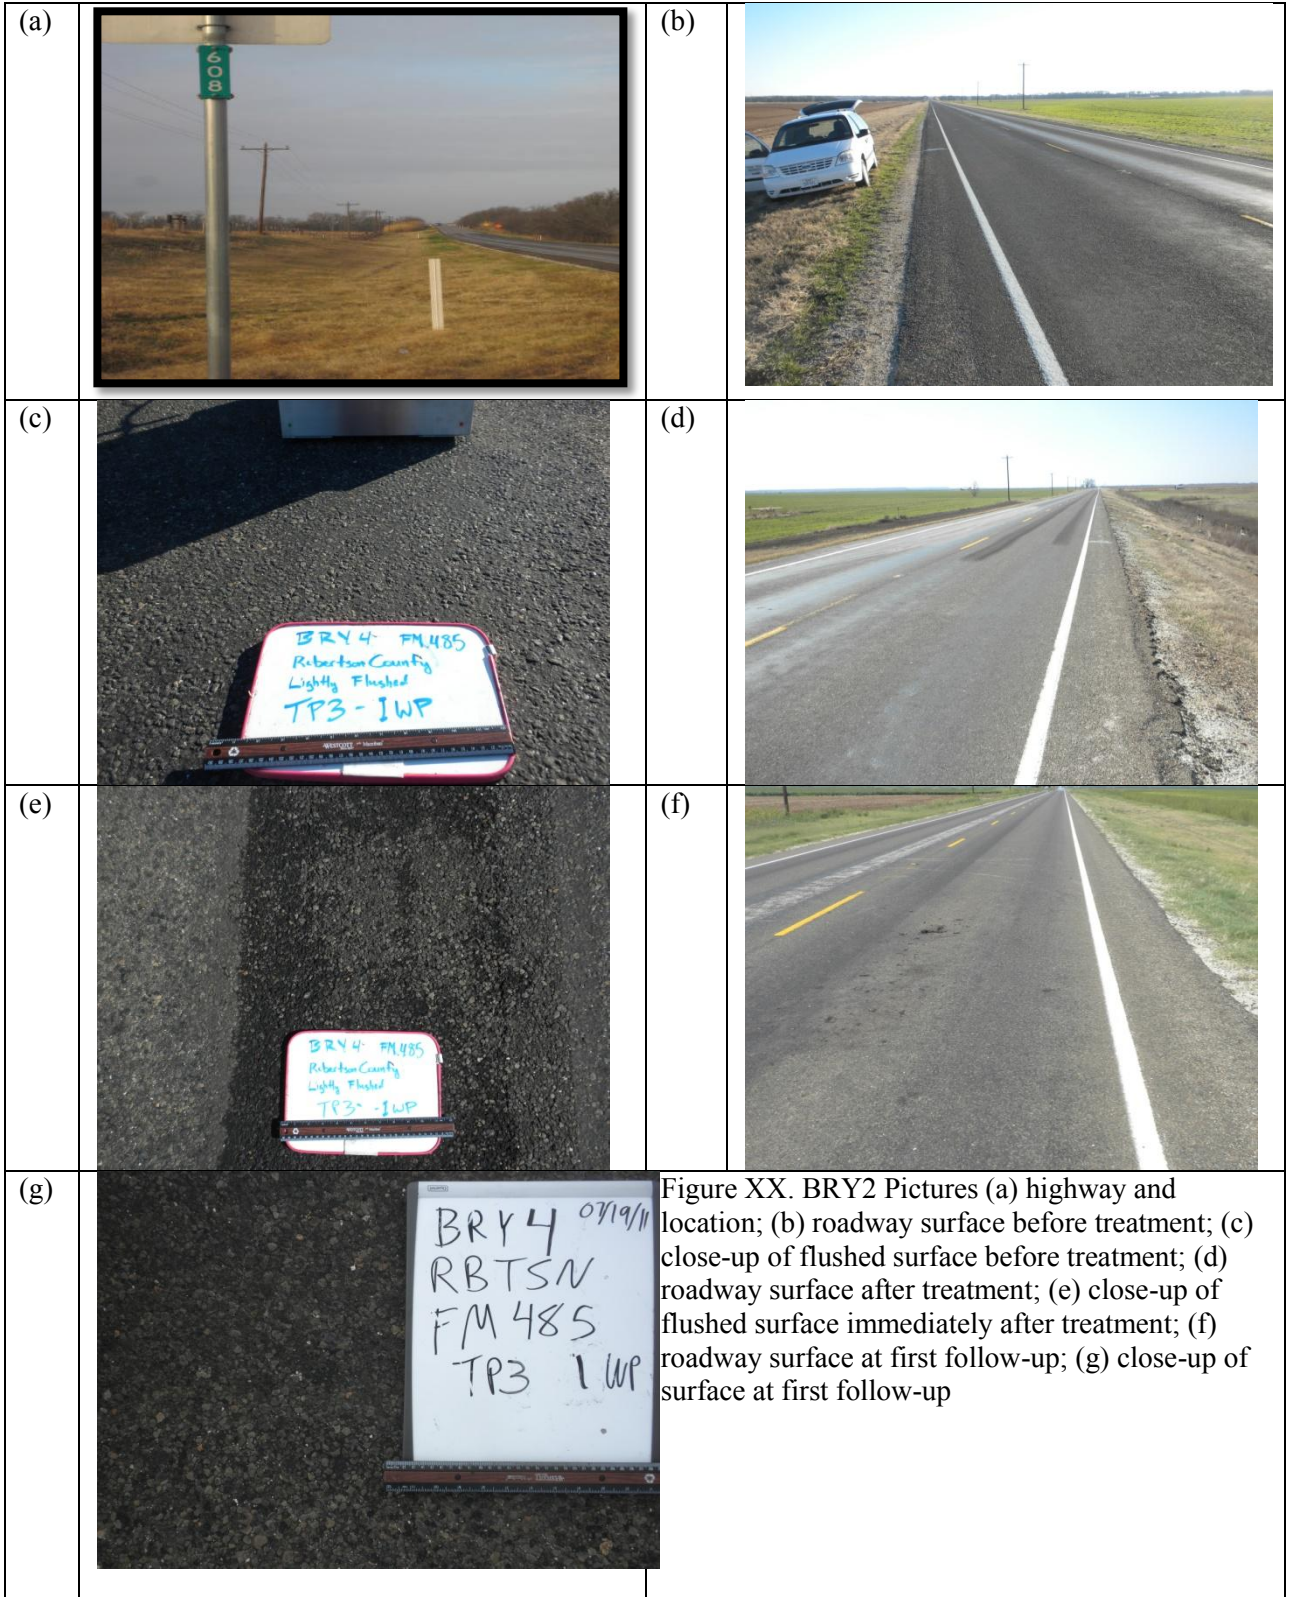
Site Photographs

<p>The TechMRT team ran the speed trial CTM from 12:20PM till 12:50PM. After completing the CTMs, TechMRT took a short lunch break.</p> <p>Along some of the sections there appeared to be a powdery black residue left on the road way. A conversation between TechMRT, Rampart and TxDOT's Neil Munn and James Robins failed to identify a probably cause. A pressure washer was used to remove the materials. The black powder was easily washed away. TxDOT has a broom truck on the site. They used the truck to attempt to remove some of the powder. Though it did remove a significant portion of the powder, it did not completely clean the surface. During CTM and latter DFT and SP testing, the wire brush and blower to remove more of the powder before testing.</p> <p>At 3:15PM TechMRT began the post treatment CTM, DFT and SP tests at TP1,2 and 3. These tests were only run in the wheel path. Testing was completed at 4:00PM. The vehicle was packed, including the weather station by 4:30. The TechMRT team returned to the hotel by way of the TxDOT Area office where the DFT water jugs were refilled.</p> <p>A teleconference was held from 8:00PM till 9:05PM between all members of the TechMRT team. The conversation discussed the day's work and importance of carefully collecting and recording all meaningful data.</p>

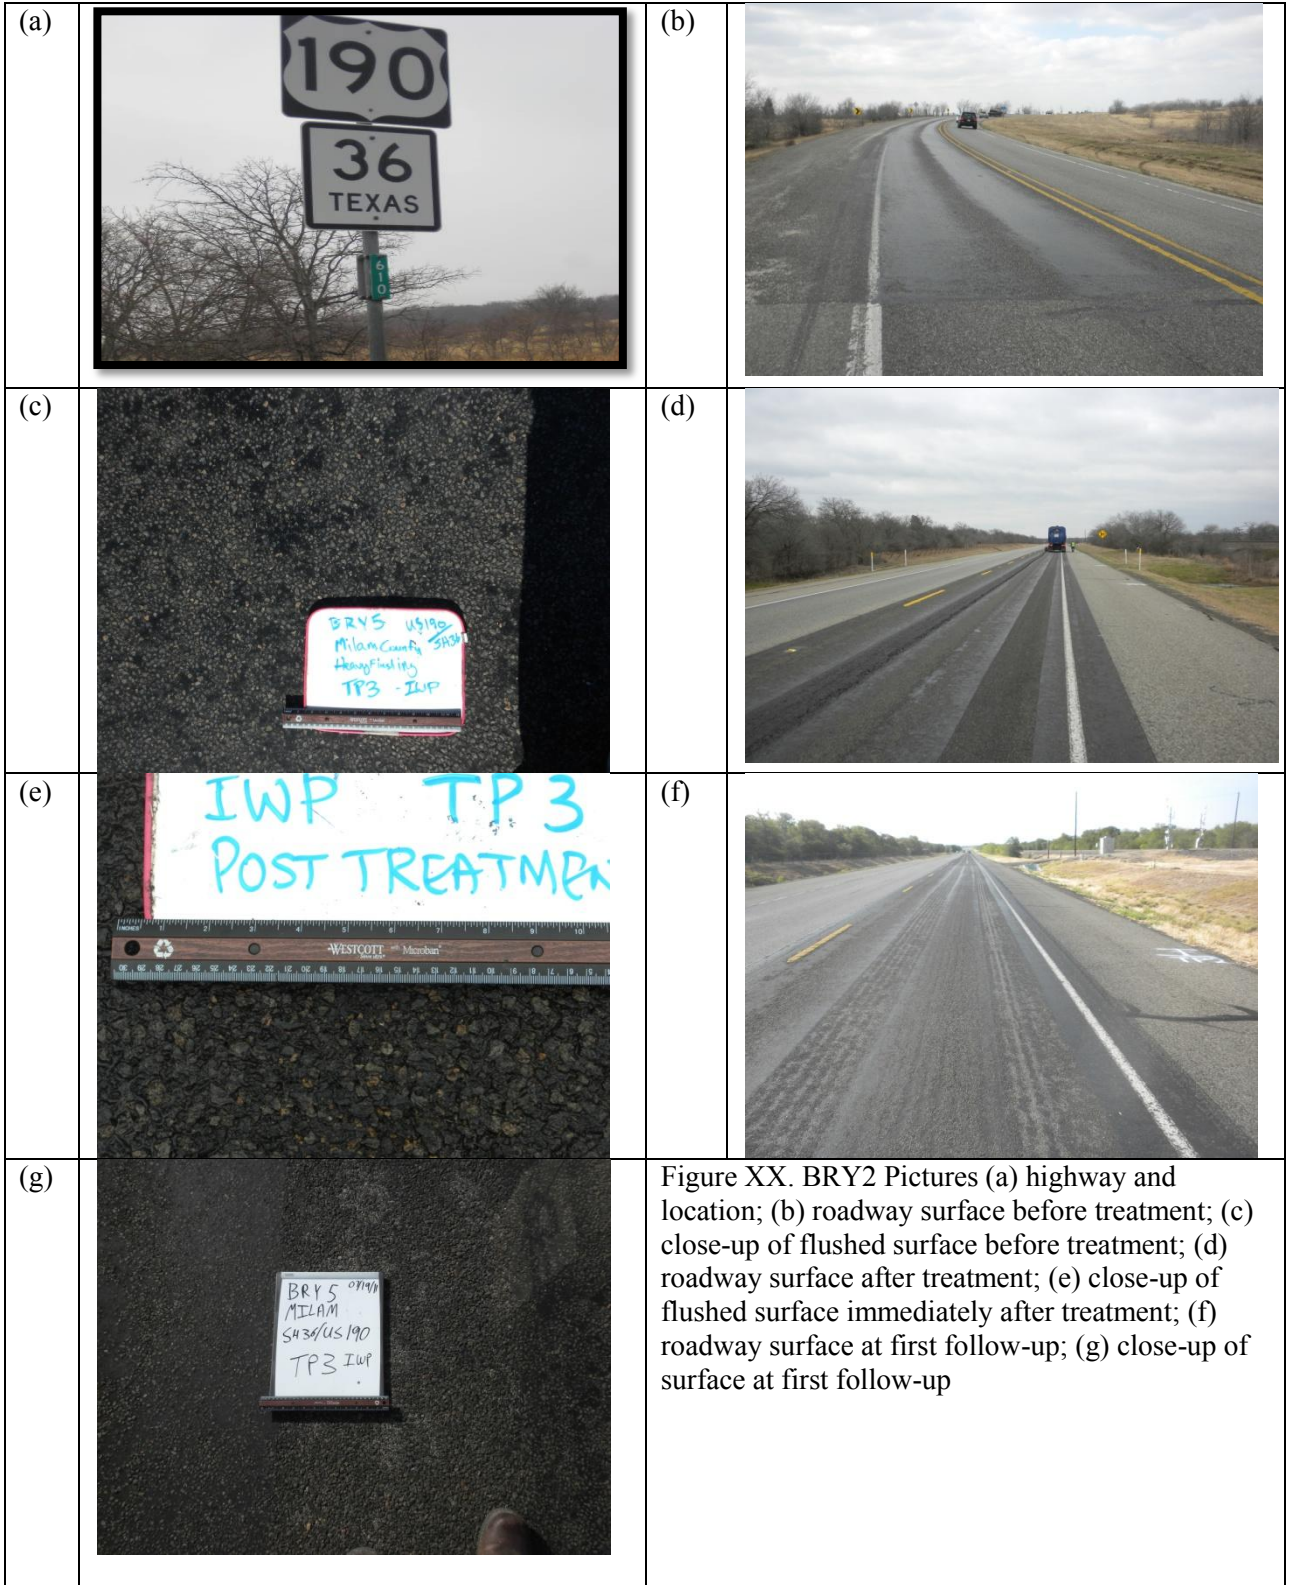
Site Photographs

<p>sprayer bar stopped spinning. Therefore Rampart stopped treating the roadway at 1:15PM. Rampart then worked to find and repair an electrical short which led them to identify a failed hydraulic actuator. They worked from 1:15PM till 3:30PM on the road. They then moved to the local maintenance yard to continue the work. They were able to repair the truck by 6:00PM. TechMRT did the post CTM testing on the treated speed sections, namely the outside wheel path in speed section 3 through 8. This took place from 3:00PM to 3:30PM. At 3:30PM TechMRT loaded the weather station and followed Rampart to the maintenance yard. After a short conference, TechMRT returned to the hotel. Once Rampart confirmed that the truck was operational, Darlene was informed that TechMRT would be ready for work on Friday morning.</p>	
Comments	
Follow-On Testing Summary	
Date:	Comments:
Date:	Comments:
Date	Comments:

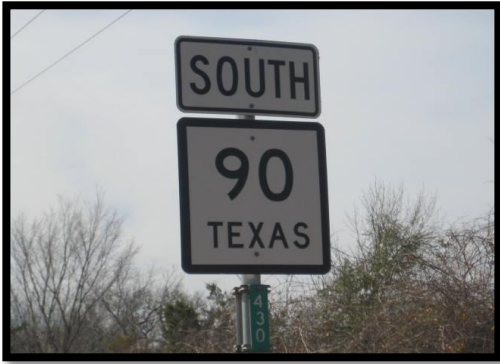
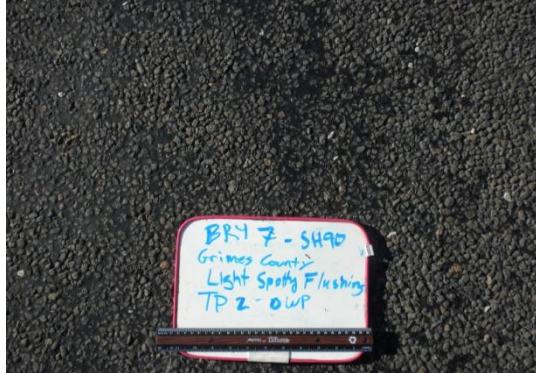
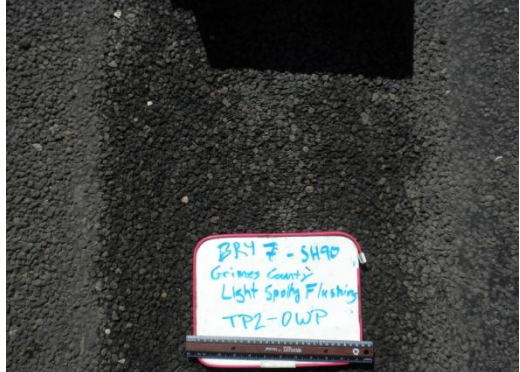
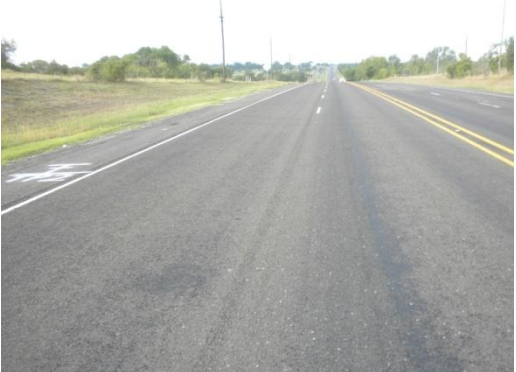
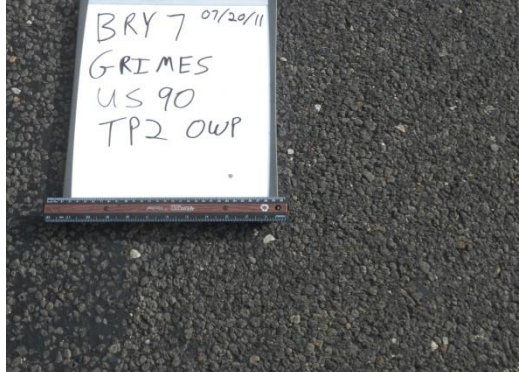
<p>Figure XX. BRY2 Pictures (a) highway and location; (b) roadway surface before treatment; (c) close-up of flushed surface before treatment; (d) roadway surface after treatment; (e) close-up of flushed surface immediately after treatment; (f) roadway surface at first follow-up; (g) close-up of surface at first follow-up</p>

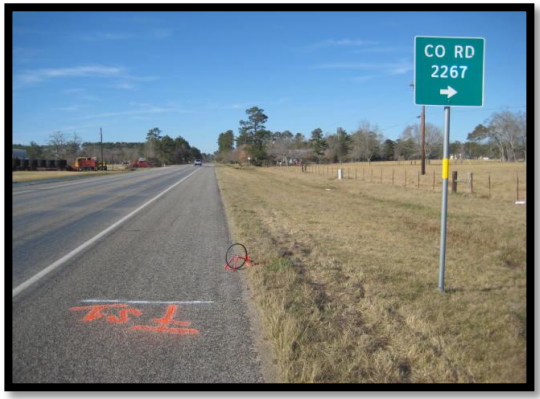
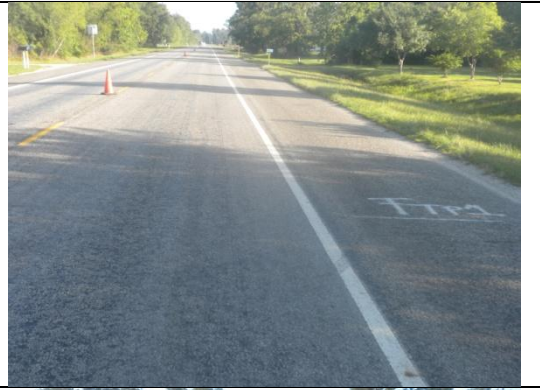
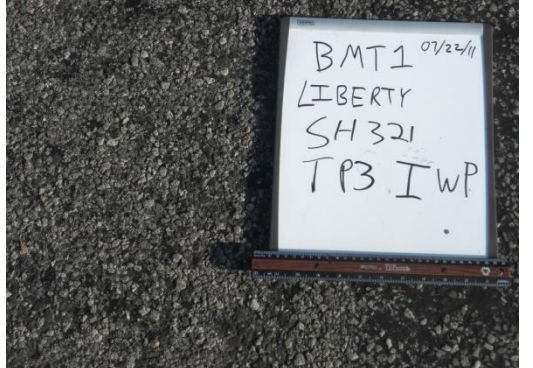
<p>Figure XX. BRY2 Pictures (a) highway and location; (b) roadway surface before treatment; (c) close-up of flushed surface before treatment; (d) roadway surface after treatment; (e) close-up of flushed surface immediately after treatment; (f) roadway surface at first follow-up; (g) close-up of surface at first follow-up</p>

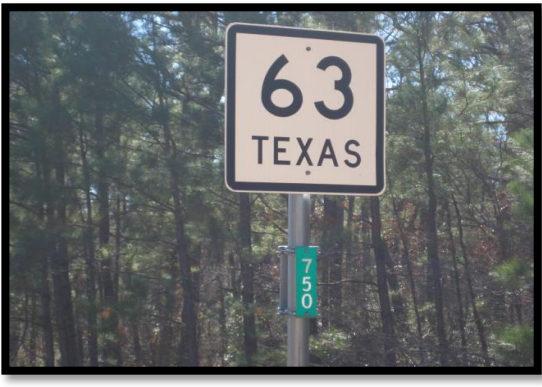
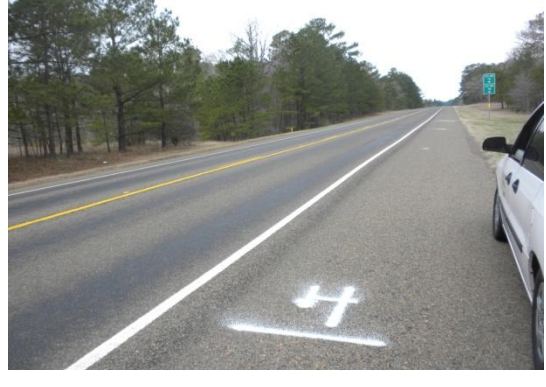
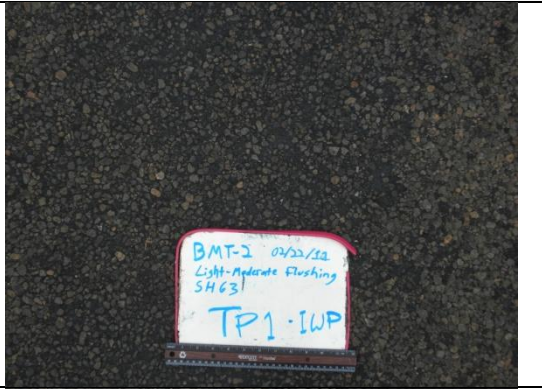
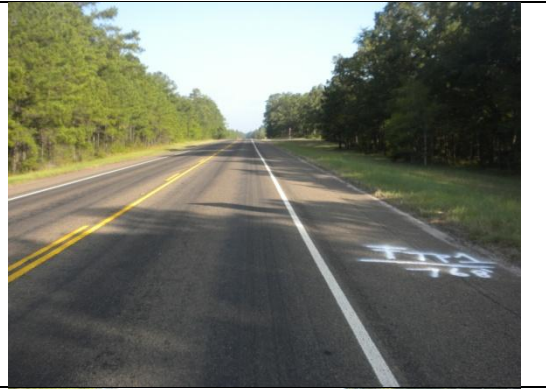
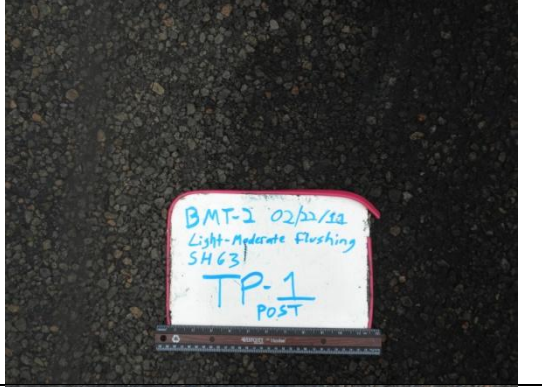
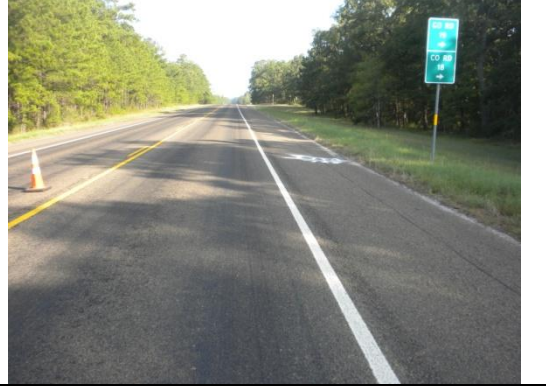
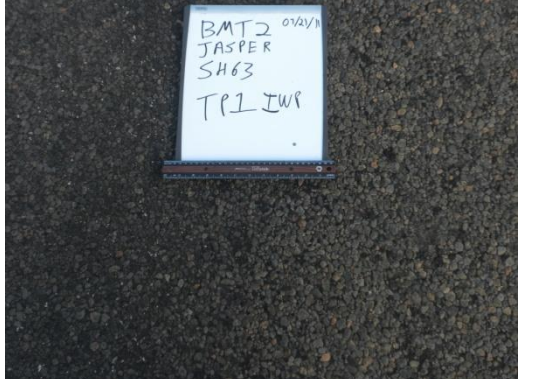
<p>Figure XX. BRY2 Pictures (a) highway and location; (b) roadway surface before treatment; (c) close-up of flushed surface before treatment; (d) roadway surface after treatment; (e) close-up of flushed surface immediately after treatment; (f) roadway surface at first follow-up; (g) close-up of surface at first follow-up</p>

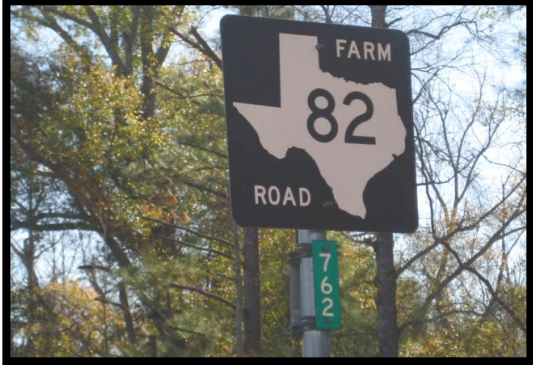
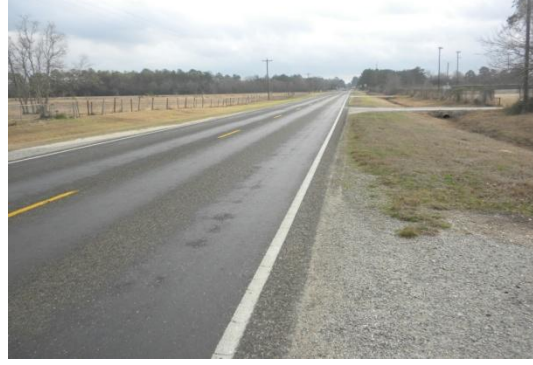
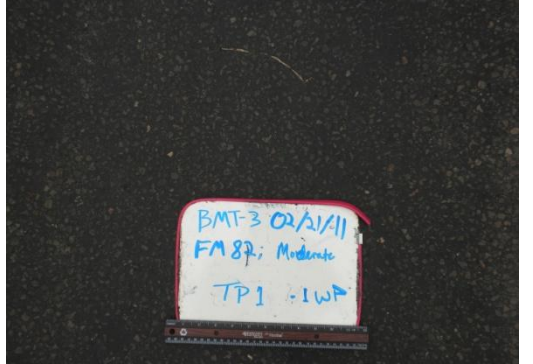
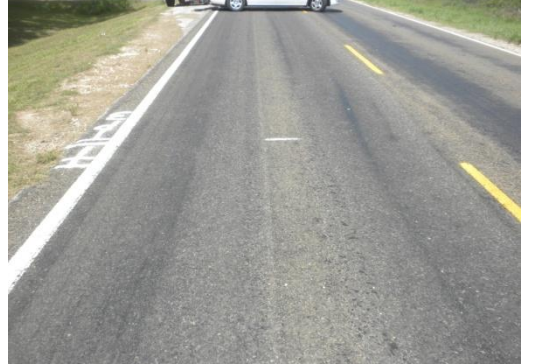
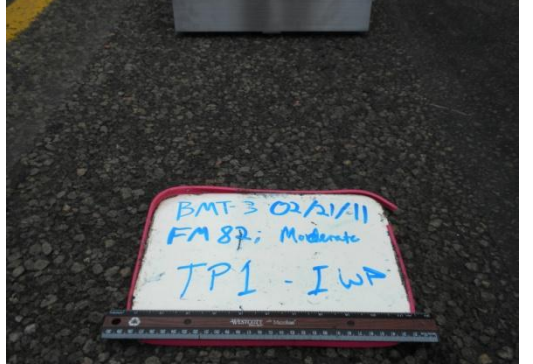
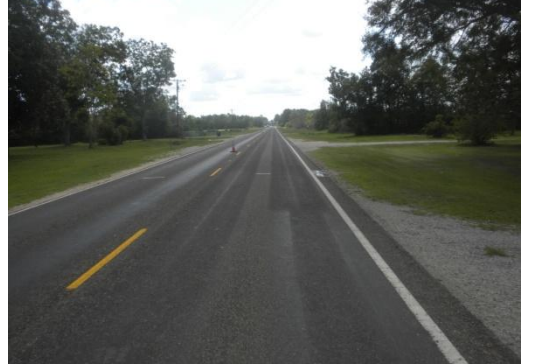
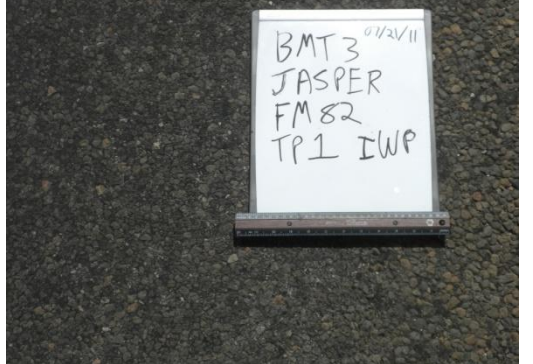
<p>Figure XX. BRY2 Pictures (a) highway and location; (b) roadway surface before treatment; (c) close-up of flushed surface before treatment; (d) roadway surface after treatment; (e) close-up of flushed surface immediately after treatment; (f) roadway surface at first follow-up; (g) close-up of surface at first follow-up</p>
