1. Report No. FHWA/TX-03/0-4138-3		2. Government Accession No.		3. Recipient's Catalog No.	
4. Title and Subtitle PERFORMANCE OF THE TXDOT T202 (MOD) BRIDGE RAIL REINFORCED WITH FIBER REINFORCED POLYMER BARS				5. Report Date October 2002 Resubmitted: November 2003

11. Contract or Grant No. Project No. 0-4138	
12. Sponsoring Agency Name and Address Texas Department of Transportation Research and Technology Implementation Office P.O. Box 5080 Austin, Texas 78763-5080				13. Type of Report and Period Covered Research: September 2000 - August 2002

**PERFORMANCE OF THE
TxDOT T202 (MOD) BRIDGE RAIL
REINFORCED WITH FIBER REINFORCED POLYMER BARS**

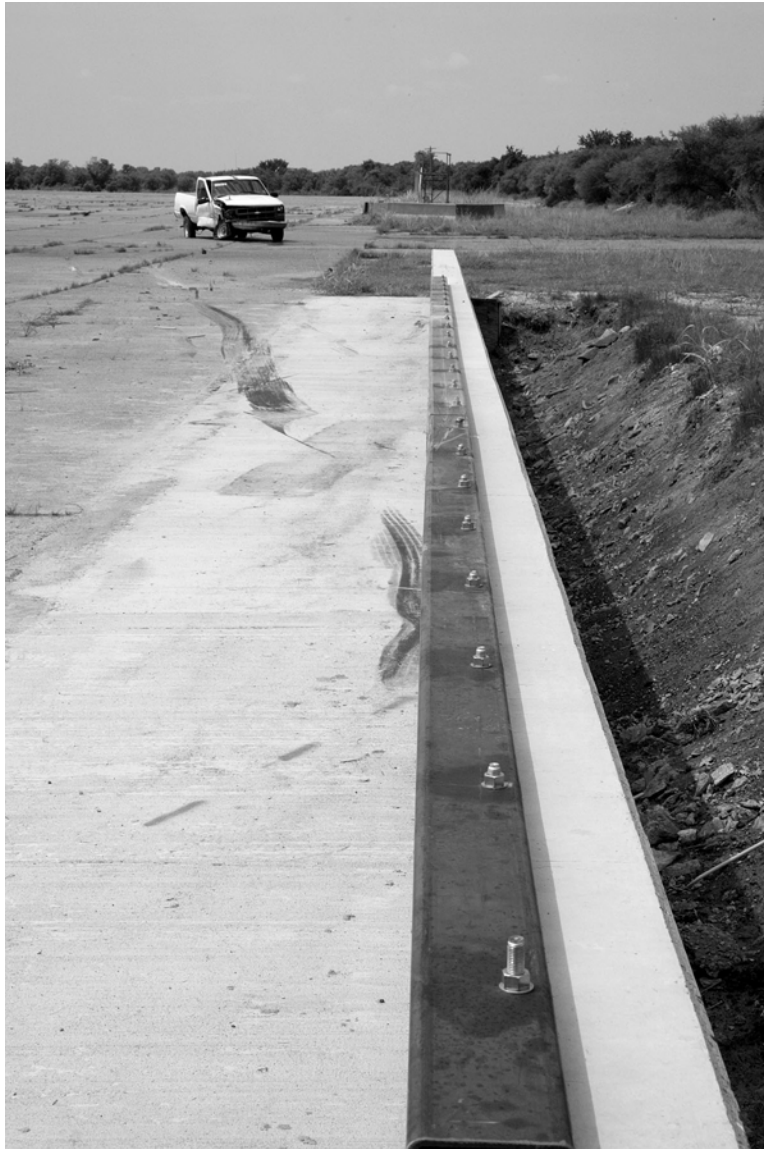
Figure B-8. After Impact Trajectory for Test 441382-2.

K.	<i>After collision it is preferable that the vehicle's trajectory not intrude into adjacent traffic lanes.</i>	The vehicle subsequently came to rest on the left side, 52.6 m downstream of impact and 9.5 m forward of the traffic face of the rail.	Fail*

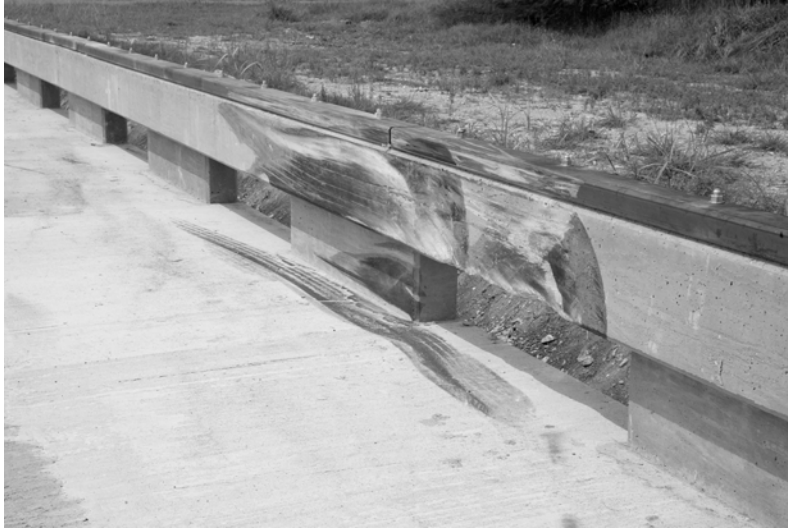
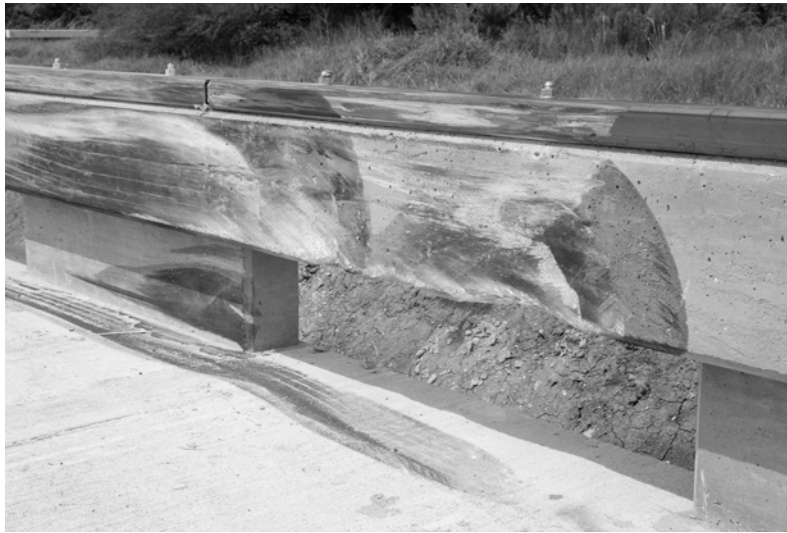
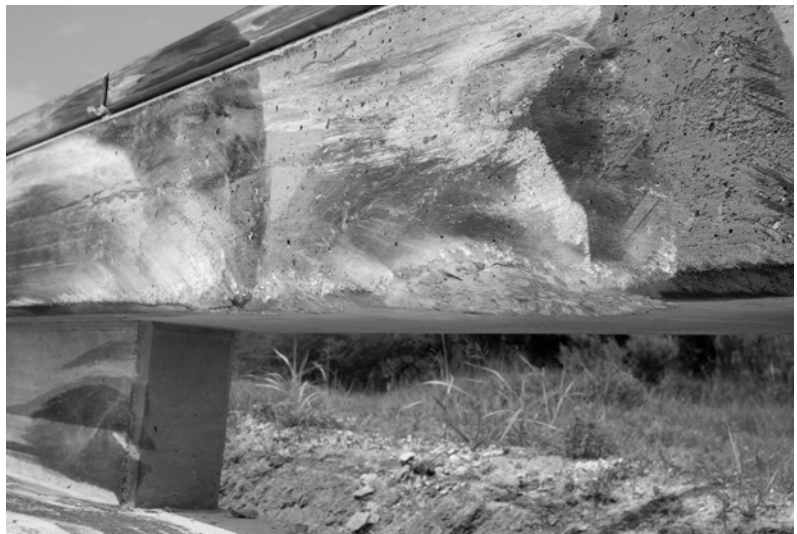
Figure B-9. Installation after Test 441382-2.

Tire marks were located on the face of post 8 and small pieces of concrete were chipped out of the underside of lower edge of the beam rail between posts 8 and 9 where the vehicle's tire/wheel contacted it. The upper beam experienced hairline cracks 14.2 inches (360 mm) and 33.9 inches (860 mm) upstream of post 8. No cracks were evident in the deck. The vehicle was in contact with the bridge rail for a distance of 13.03 ft (3.97 m). Figures B-8 and B-9 show photographs of the damage to the bridge rail. There was no indication of significant structural damage to the rail or the deck. There was no indication that the GFRP exhibited any undesirable traits.

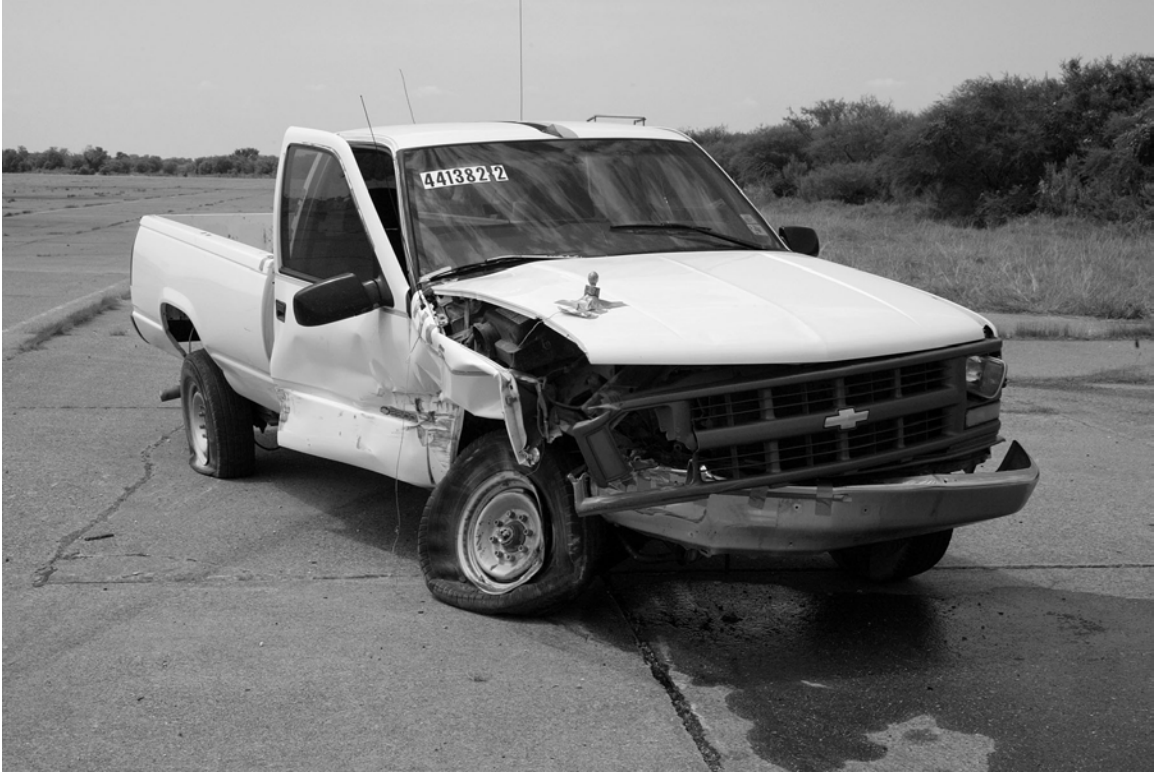
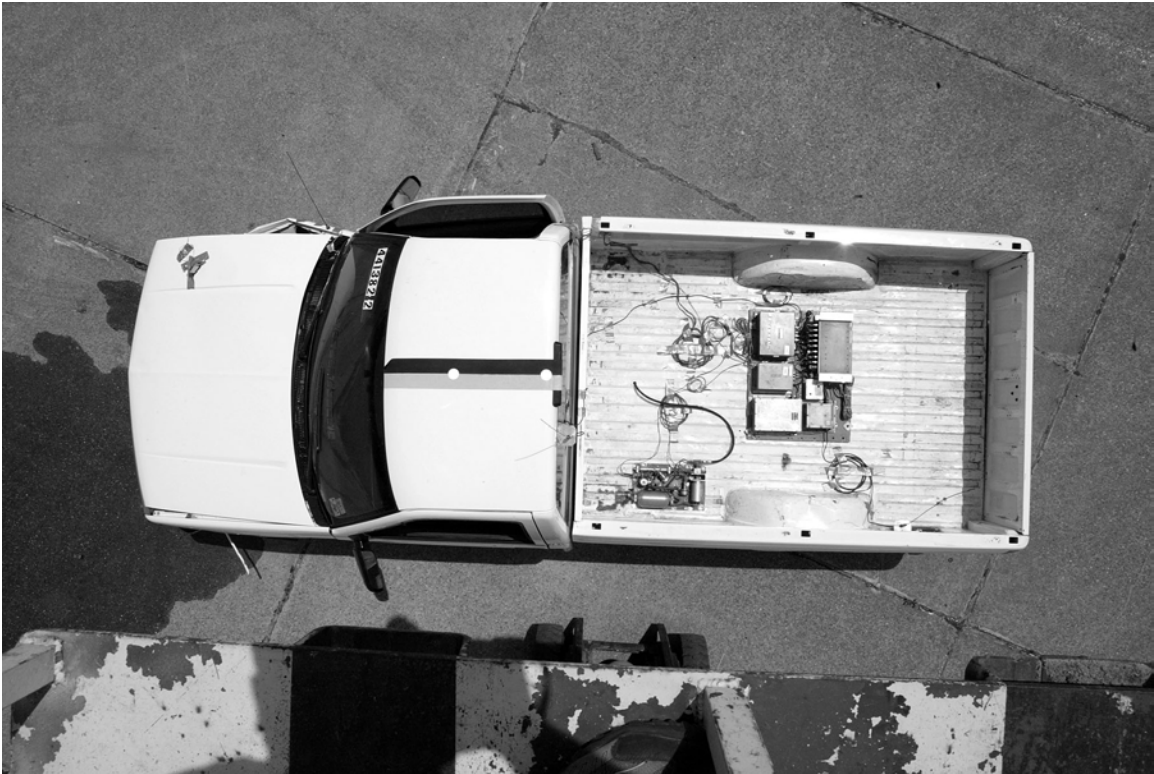
Figure B-10. Vehicle after Test 441382-2.

Figure B-10 shows damage to the vehicle. Structural damage was imparted to the stabilizer bar, right upper and lower A-arms, right spindle, right rod ends, right front frame member, firewall, and floor pan. Also damaged were the front bumper, hood, radiator, fan, right front tire and wheel rim, right front quarter panel, right door, right rear exterior bed and right rear tire and wheel rim. The windshield sustained stress cracks. Maximum exterior crush to the exterior of the vehicle was 23.6 inches (600 mm) in the front plane at the right front corner near bumper height. Maximum occupant compartment deformation was 5.6 inches (143 mm) in the kick panel area on the passenger's side. Figure B-11 shows photographs of the interior of the vehicle. Tables B-1 and B-2 show exterior vehicle crush and occupant compartment measurements.

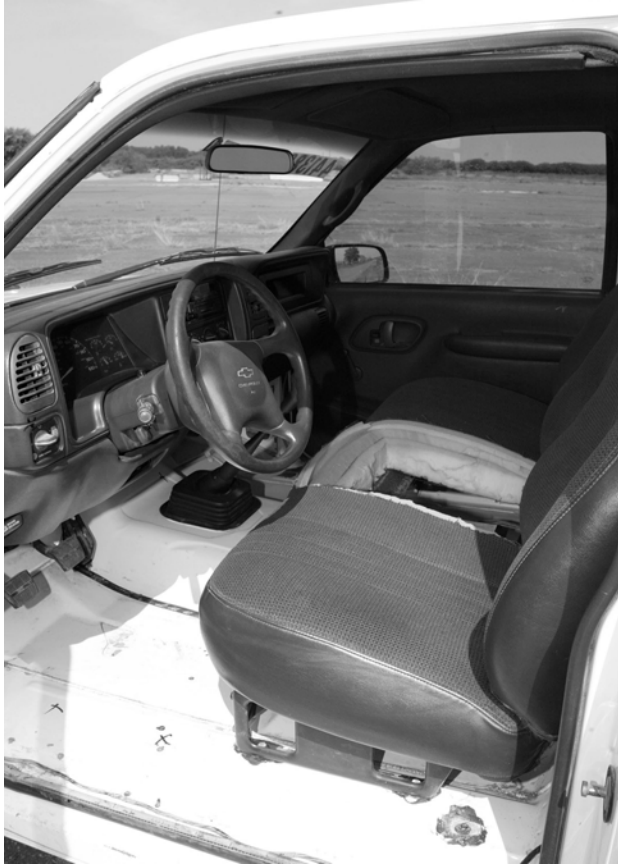
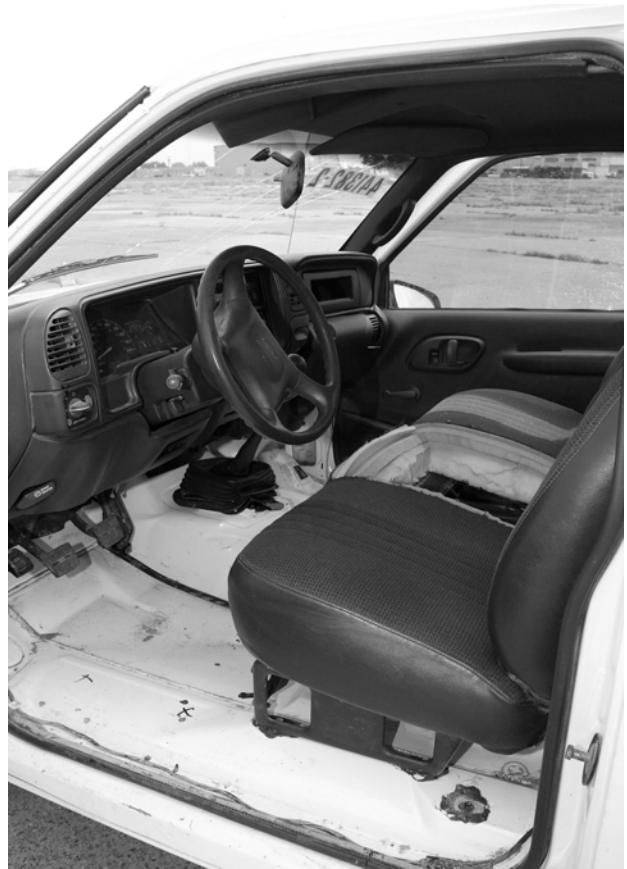
Figure B-11. Interior of Vehicle for Test 441382-2.

Results: No detached elements, fragments, or other debris were present to penetrate or to show potential for penetrating the occupant compartment, or to present undue hazard to others in the area. Maximum occupant compartment deformation was 5.6 inches (143 mm) in the floor pan to instrument panel on the right side near the driver's feet.
