1. Report No. FHWA/TX-06/0-4240-4		2. Government Accession No.		3. Recipient's Catalog No.	
4. Title and Subtitle DATABASE OF SULFATE STABILIZATION PROJECTS IN TEXAS				5. Report Date November 2005 Resubmitted: February 2006

DATABASE OF SULFATE STABILIZATION PROJECTS IN TEXAS

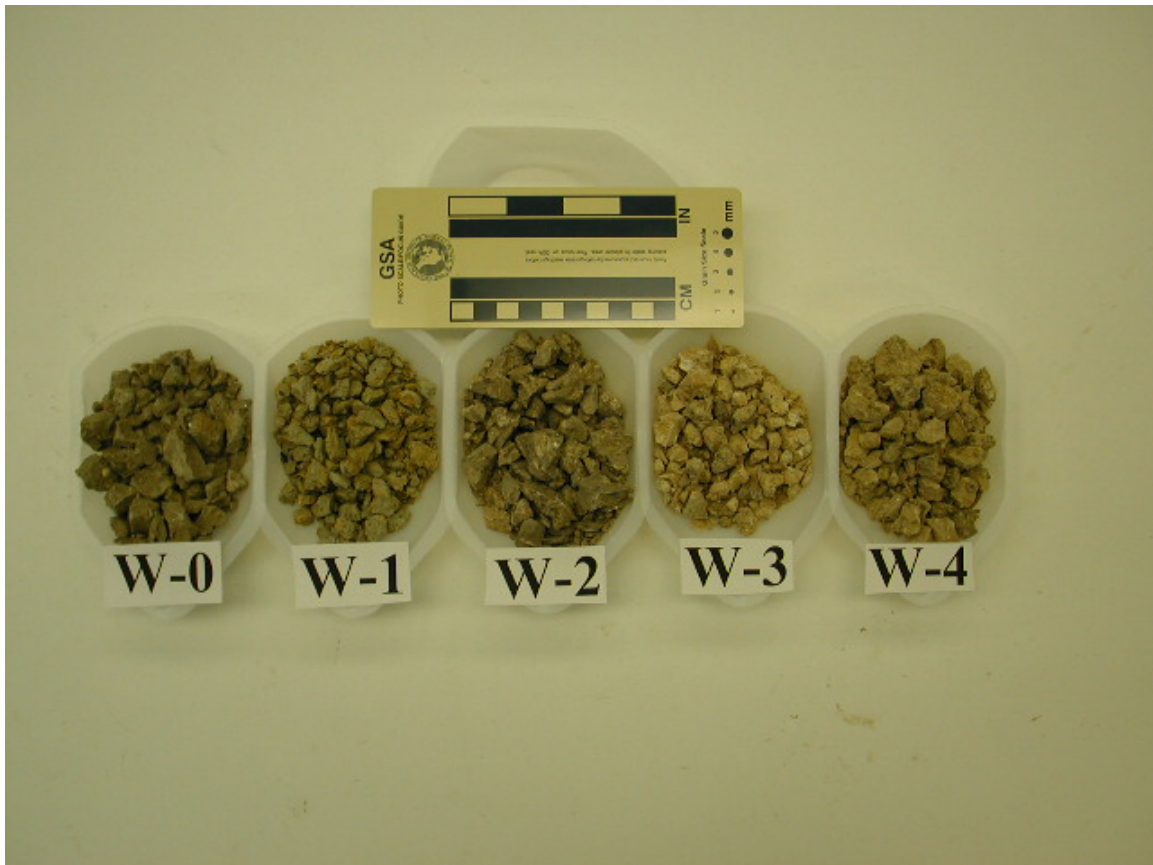
Representative samples (Figure 7) were taken from each bag delivered to TTI and allowed to air-dry overnight. Five grams of material was taken from each sample and mixed with 100 mL of double-distilled water on a mechanical shaker. The conductivity and pH of each sample were measured at different time intervals with an Accumet AR50 pH/Conductivity meter. These samples were not pulverized.

Figure 7. Representative Samples Taken from Each Bag That TxDOT Delivered to TTI.

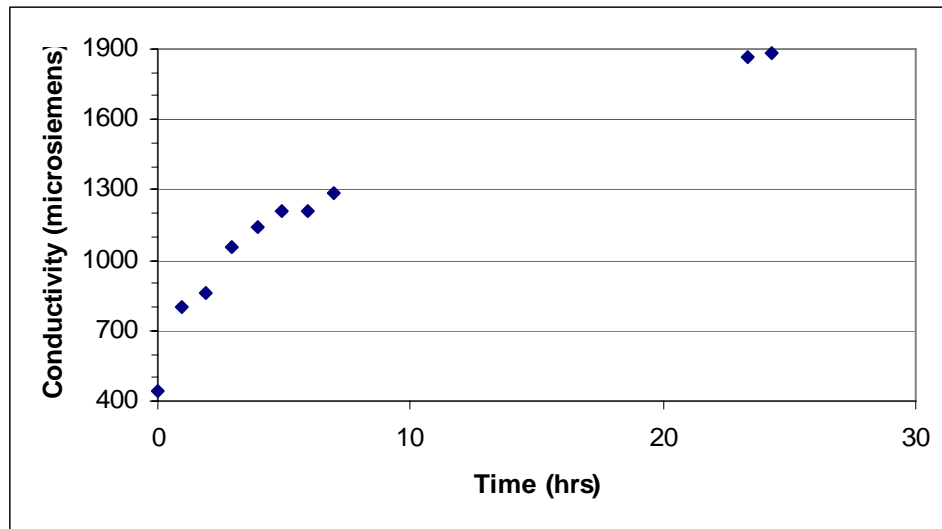
A valuable approach is to monitor conductivity over time to determine how quickly sulfates react with lime. Figure 8 shows a graph of conductivity over a time period of approximately 24 hours for an unpulverized soil sample. It is evident from this graph that there is a range of grain sizes because samples on the east side have a fairly high initial conductivity reading. The conductivity increases over time, indicating dissolution of coarser grained constituents. Coarse-grained samples take longer to dissolve, so the conductivity increases more slowly as these crystals dissolve.

Figure 8. Conductivity Measurements for Sample E-0 Shows How Sulfate Grain Size Affects Readings.

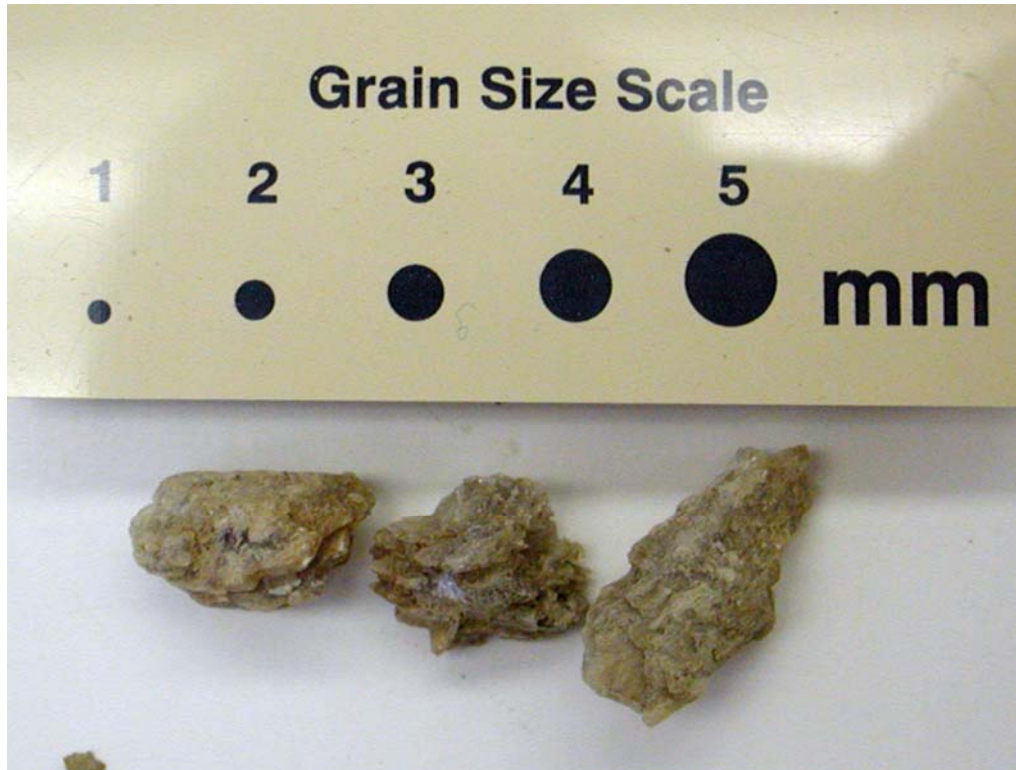
Figure 9 shows some gypsum crystals removed from Sample E-1B. These crystals increase to more than a centimeter across. Crystals several centimeters in size

have been observed from this formation. The crystals have a muddy appearance because they grew in the soil, and some of the soil is trapped in the crystal structure.

Figure 9. Individual Gypsum Crystals Extracted from Sample E-1B.

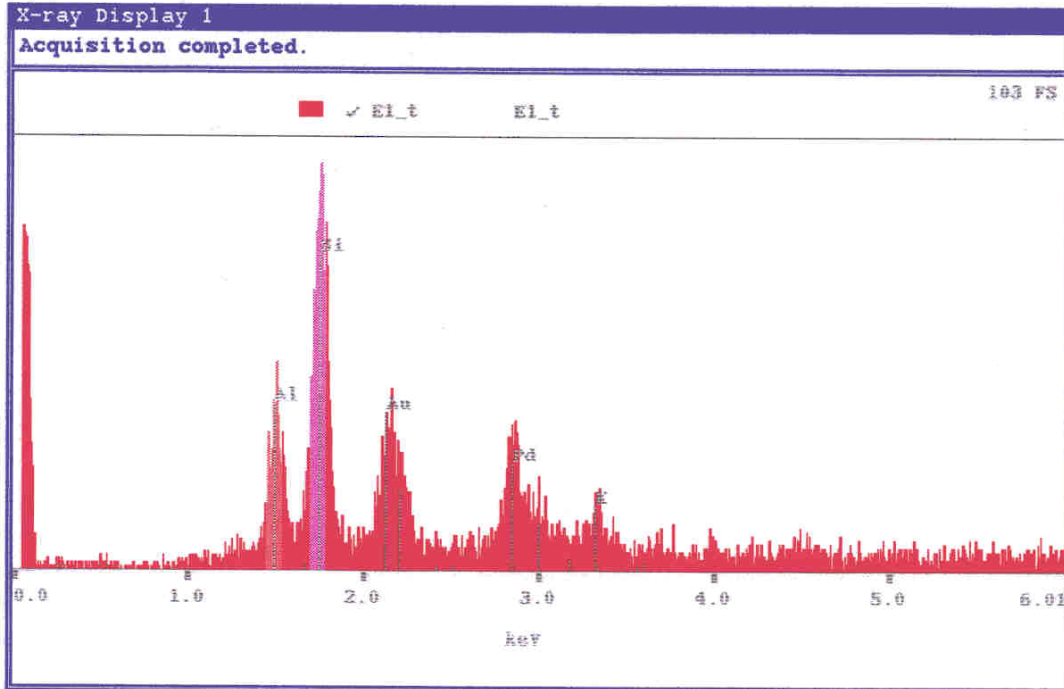
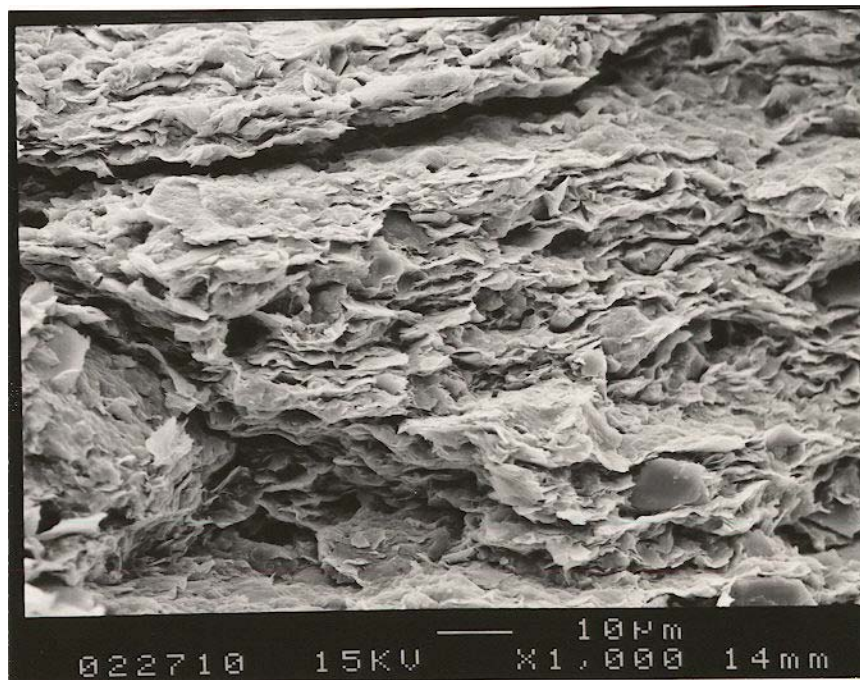
Scanning electron microscopy was used to examine samples for deleterious reaction products. Two lime-treated samples and two raw subgrade samples were analyzed. It is obvious from comparing images from the stabilized and unstabilized samples that lime reacted with gypsum to form ettringite (Figures 10-14) in the stabilized material. Figure 10A shows the absence of calcium (Ca) in this untreated sample. Figure 10B is an untreated subgrade sample that shows unaltered smectite crystallites in a subparallel arrangement due to compaction.

Figure 10A. EDS Pattern from Sample E-1T Which Is an Untreated Subgrade Sample. (These elements are typical of smectite and other clay minerals from image 10B. Note absence of calcium.)

Figure 10B. SEM Image of Natural Clay Rich Soil. (The crinkly masses are smectite grains. Note the absence of long needle-shaped crystals.)

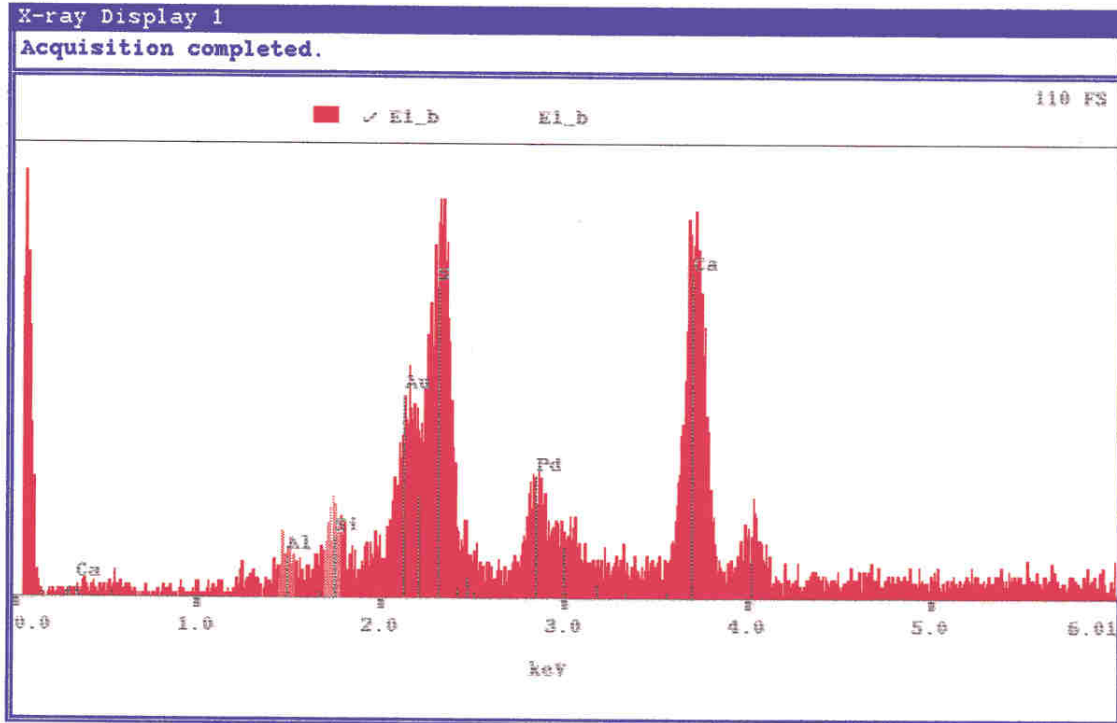
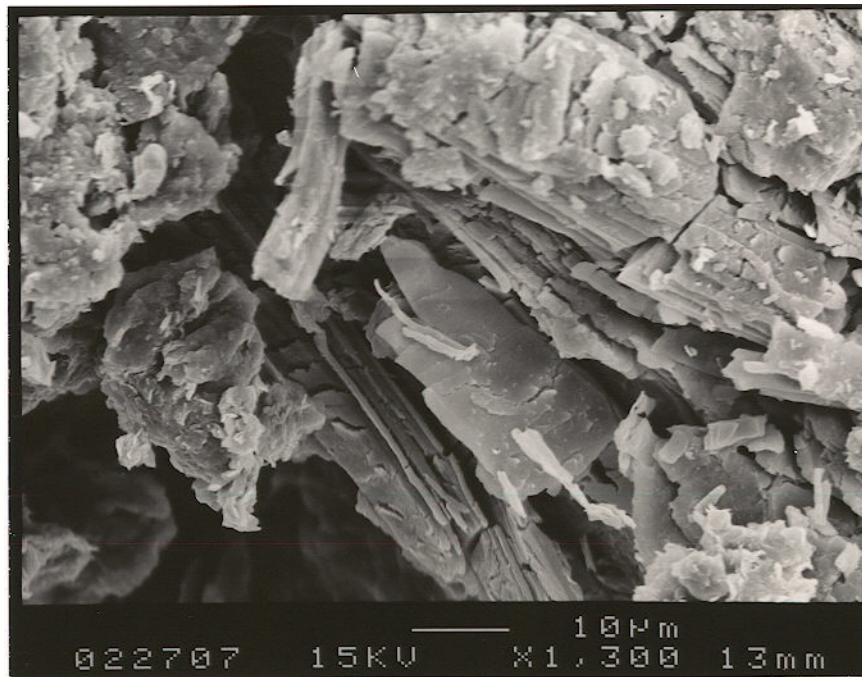
Figures 11A and 11B are from the untreated subgrade as well. The EDS pattern is of the gypsum crystals in Figure 11B. Note the absence of aluminum (Al). Figure 11B shows small gypsum crystals (~50 μm) that were observed in some of the untreated samples.

Figure 11A. EDS Pattern of Gypsum Crystals Shown in 11B.
 (Note the ratio of the calcium to sulfur peaks and the absence of an aluminum peak.)

Figure 11B. SEM Image from Sample E-1B Showing Gypsum Crystals in the Untreated Subgrade.

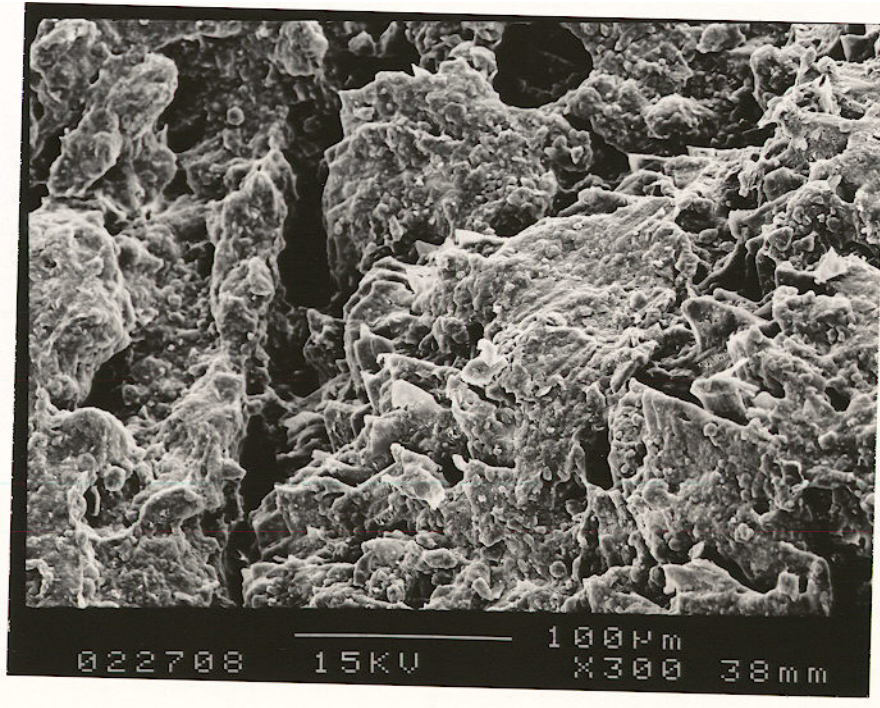
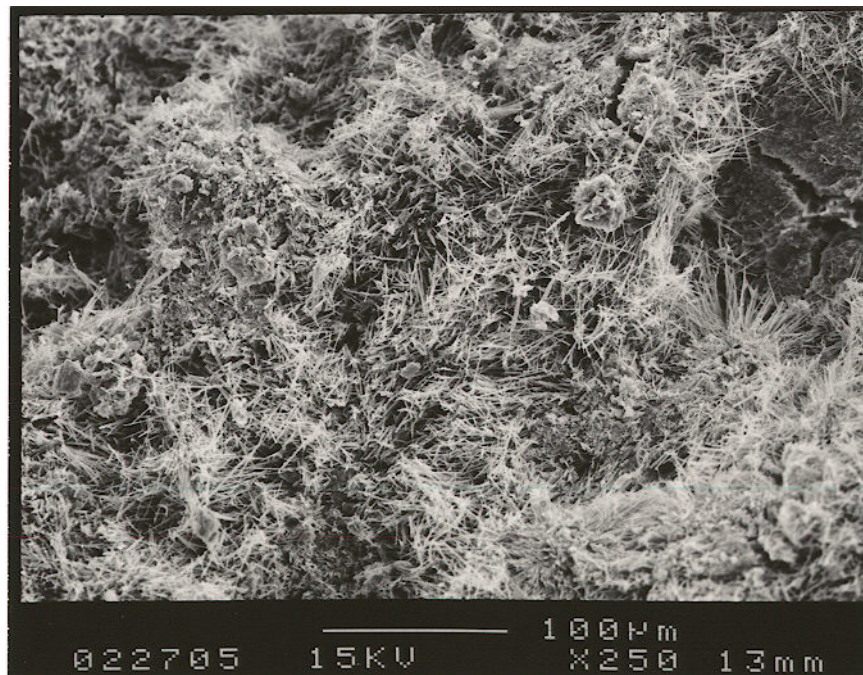
All of the untreated samples show an absence of the long acicular crystals observed in [Figure 12A](#). [Figure 12B](#) was taken at about the same magnification as 12A and shows the marked contrast between the treated and untreated samples. There are abundant long, fibrous crystals in the lime-treated subgrade that are absent in the untreated samples. This crystal morphology is typical of ettringite. The EDS pattern in [Figure 13A](#) confirms that the long, fibrous crystals are indeed ettringite.

Figure 12A. SEM Image Illustrates What the Untreated Soil Looks Like.
(Note absence of reaction products.)

Figure 12B. SEM Image from Sample E-1 LTSa Showing What the Lime Treated Subgrade Samples Look Like. (Note the abundant long needle-like crystals everywhere.)

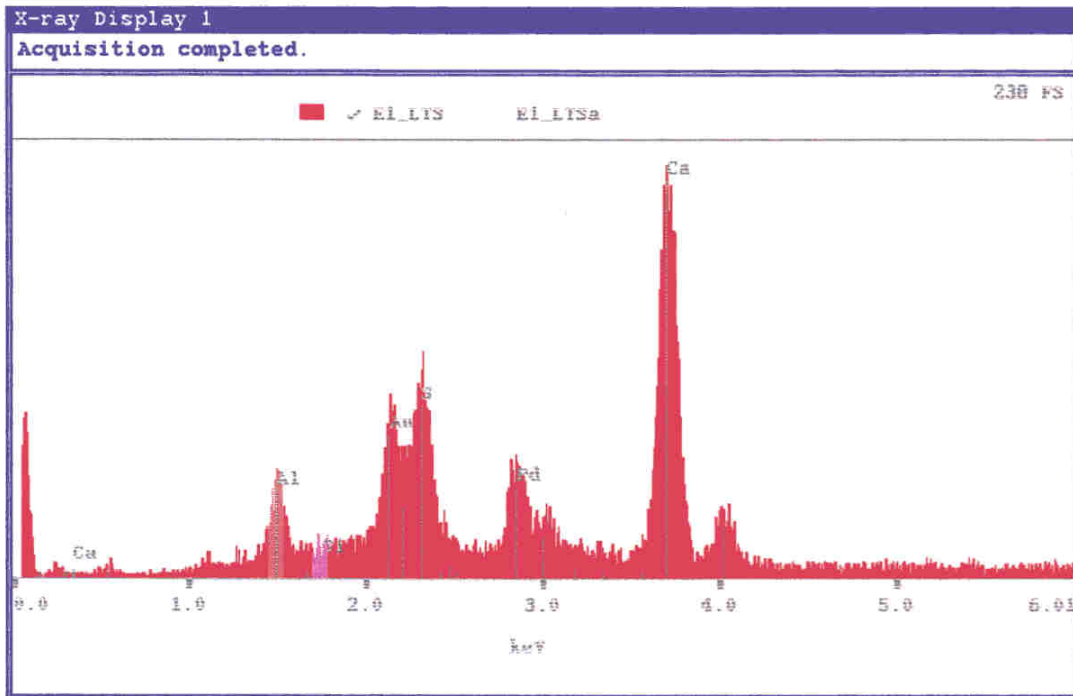
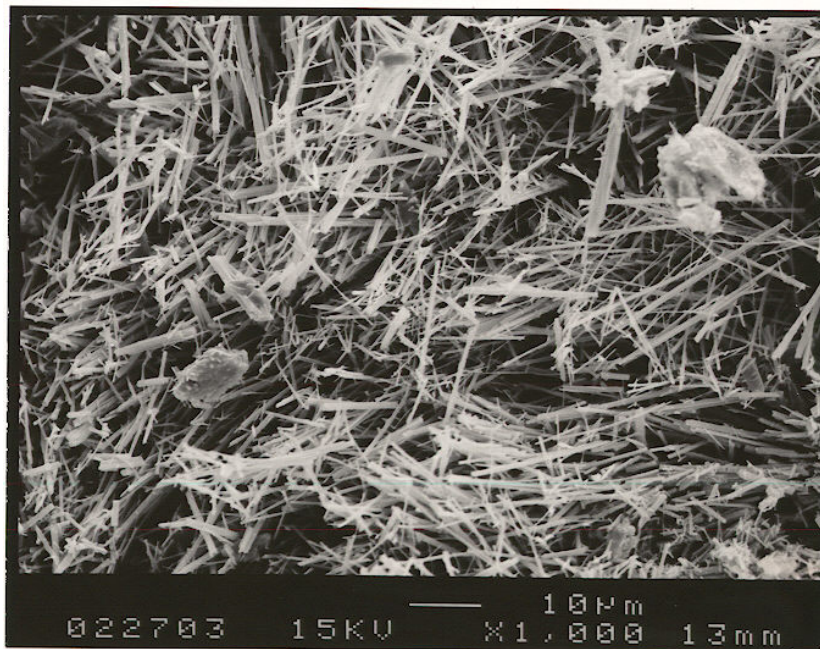
Figure 13A. EDS Pattern from the SEM Image Below.
(Note the high calcium peak and the sulfur and aluminum peaks. This pattern is typical of ettringite.)

Figure 13B. SEM Image from Sample E-1 LTSa Shows Acicular Prismatic Crystals Which Are Typical of Ettringite. (This is an expansive reaction product of lime and gypsum.)

- The formation of ettringite can be blamed for the heaving observed on US 82 in the Paris District.
- From the samples analyzed at TTI, the sulfate problem appears to be concentrated on the eastern side of the project.
- TxDOT needs to be careful if there is any **cut and fill work because sulfates tend to be more concentrated at depth** in the soil profile, which is evident from samples taken from site E-1.
- There is a need to analyze for sulfides in this particular case since sections are being cut, because the Eagle Ford Formation is rich in pyrite at depth. Pyrite is the ultimate source of the gypsum crystals observed in the soils developed in the Eagle Ford Formation.⁶

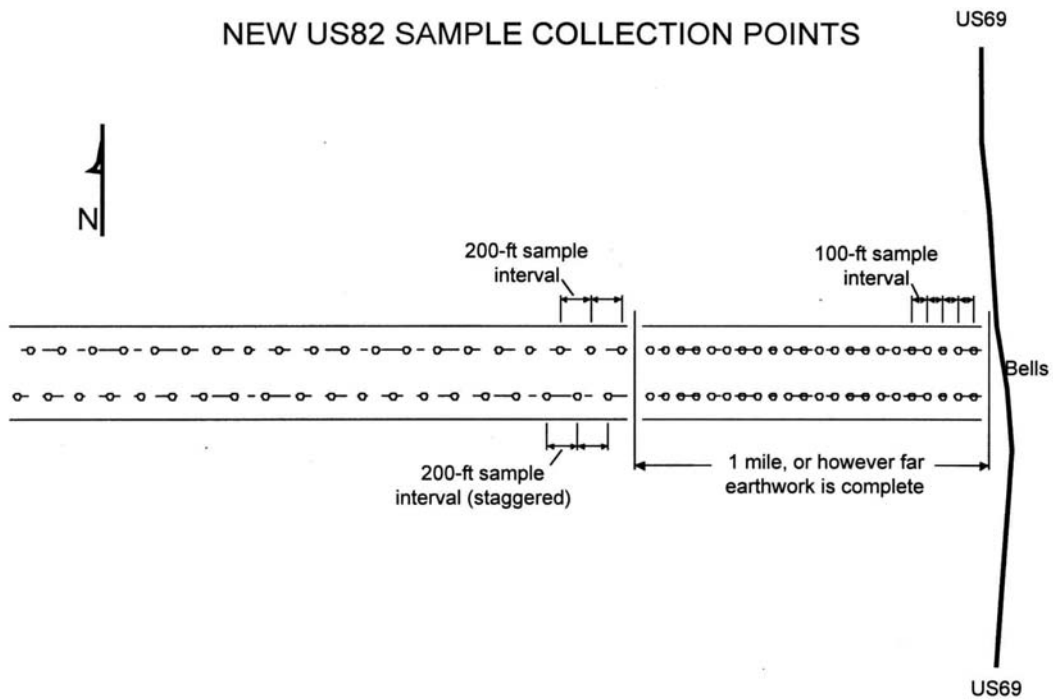
Conductivity measurements were made in two parallel passes separated by 12 feet, with measurements taken at intervals of 100 feet in the westbound direction of US 82 (Figure 14). Samples were not collected east of US 69 because that is where the lime stabilized subgrade heaved (Figure 15). Due to the cut and fill operations, samples were not collected in areas where earthwork was not complete, because sulfates could be

Figure 14. Sample Collection Sites along US 82. Samples Were Only Collected along the First Mile of the Project. (Map courtesy Dar-Hao Chen of TxDOT)

Conductivity measurements were taken at 102 stations as illustrated in [Figure 14](#). Based on the initial and final conductivity measurements (time = 0, 10 hrs.), 12 locations were chosen to collect samples for extended laboratory testing ([Table 2](#)).

- The sulfate concentrations on the part of the project analyzed by TTI ([Figure 14](#)) are apparently low with a couple of exceptions where higher concentrations of gypsum were detected.
- The conductivity test did an excellent job of detecting the higher sulfate soils.

- As illustrated in [Figure 16](#), and from the field testing, these sulfate seams can be quite localized.
- The researchers recommend stabilization with lime on the western section that has been tested because the sulfate concentrations are low enough to stabilize with lime. However, they need to continue sulfate testing as areas are filled to grade and prior to stabilization on the remainder of the project.

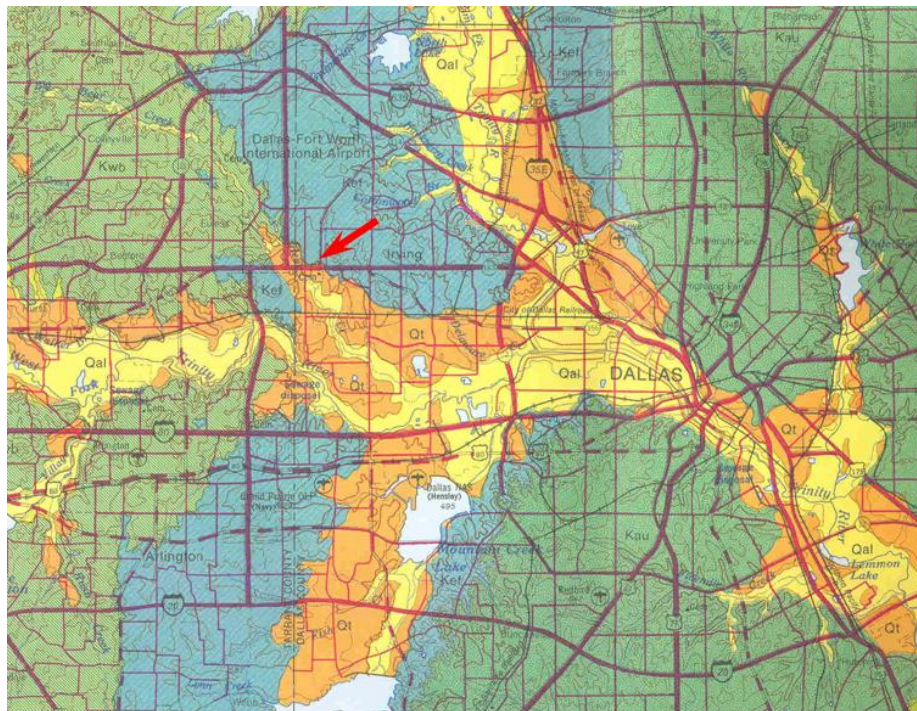
The soil on this project is developed on the Eagle Ford Formation ([Figure 17](#)). Sulfate concentrations range from 21,000 to 27,000 ppm. This project is part of an interchange being constructed on SH 161 and SH 183.

Figure 17. Portion of Geologic Atlas of Texas Showing SH 161 (red arrow) Located on the Eagle Ford Formation.

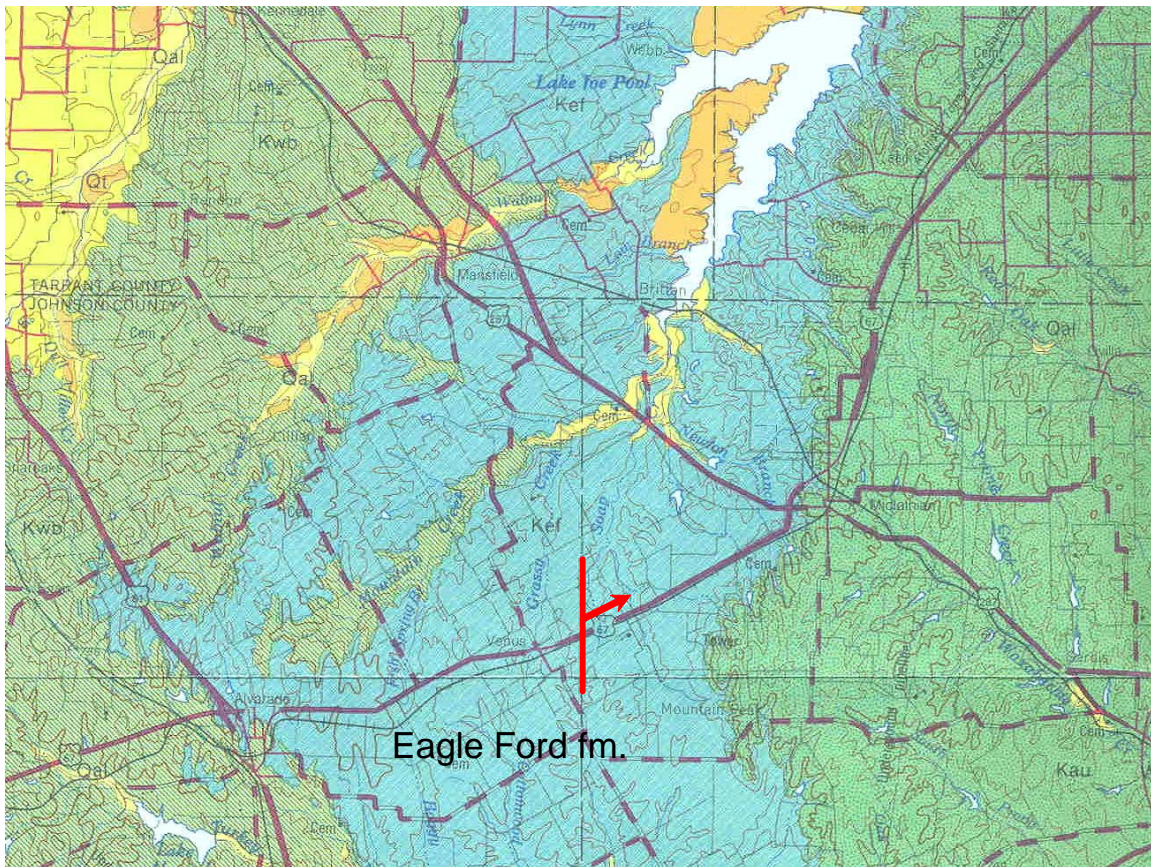
The Geologic Atlas of Texas may give a good indication of what minerals are in a soil. It shows the rock formations in an area. In this case, the widening project runs east-west, right across the Eagle Ford Formation (Figure 19, lower third of map), the same rock formation that caused problems on US 82. The red vertical line on Figure 19 marks the western boundary of the project, and the red arrow points in the direction of the project. The legend of the Eagle Ford (Kef) describes it as being *selenitic*. Selenite is another name for gypsum ($\text{CaSO}_4 \cdot 2\text{H}_2\text{O}$), which supplies the sulfate needed for the heaves. Samples of the stabilized and unstabilized soil were collected for analysis at TTI. The following figures show evidence of ettringite formation in the lime-stabilized soil. The formation of ettringite generates a volume increase double its original volume.

Figure 19. Portion of Geologic Atlas of Texas Showing US 67 West of Midlothian Passing through the Eagle Ford Formation (in blue).

The safest thing is to remove all of the sulfate-bearing soil from the site and replace it with a material free of sulfates or sulfides. The existing lime-stabilized material still has about 1% unreacted gypsum, which could cause the swelling problem to recur.

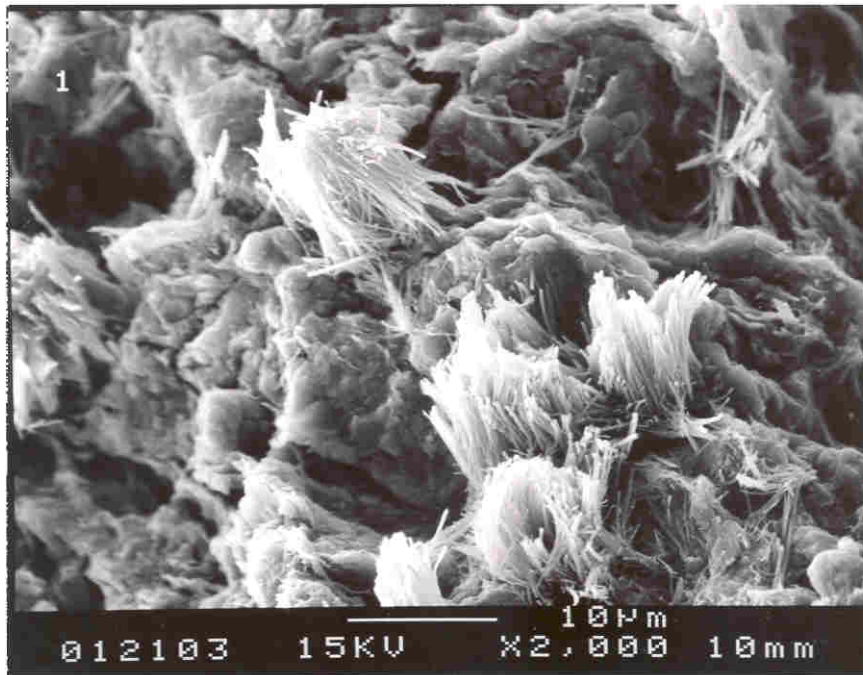
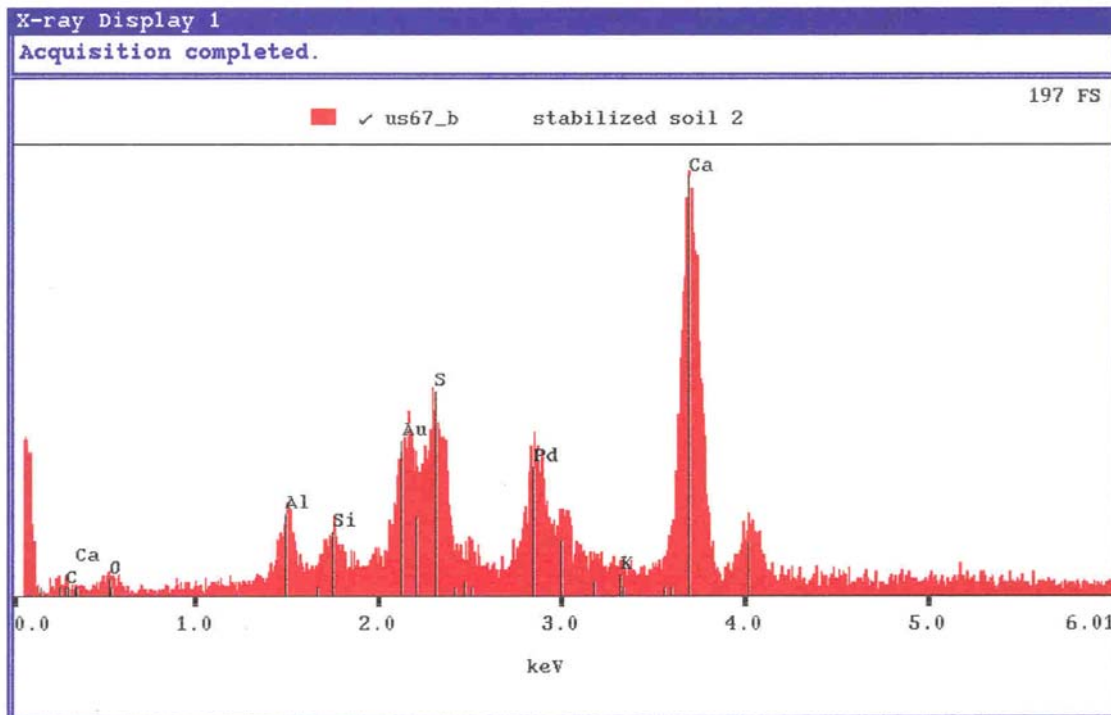
Ettringite was identified in the lime-stabilized soil by X-ray diffraction and SEM analysis. The ettringite crystals are the white needle-like crystals shown in the image in [Figure 20A](#). The EDS attached to the SEM gives the elemental composition of the crystals. [Figure 20B](#) is an EDS pattern of the needle-like crystals, which confirms the presence of sulfur (S), aluminum (Al), and silicon (Si) in a concentration typical of ettringite. Gypsum crystals abound in the unstabilized soil as both large crystals in excess of 2 mm and as exceptionally small crystals less than 1 μm ([Figure 21A](#) and [B](#)).

Figure 20A. SEM Image of Ettringite Crystals in Lime-Stabilized Subgrade.

Figure 20B. EDS Pattern of Ettringite Crystals Shown in the SEM Image in 20A.

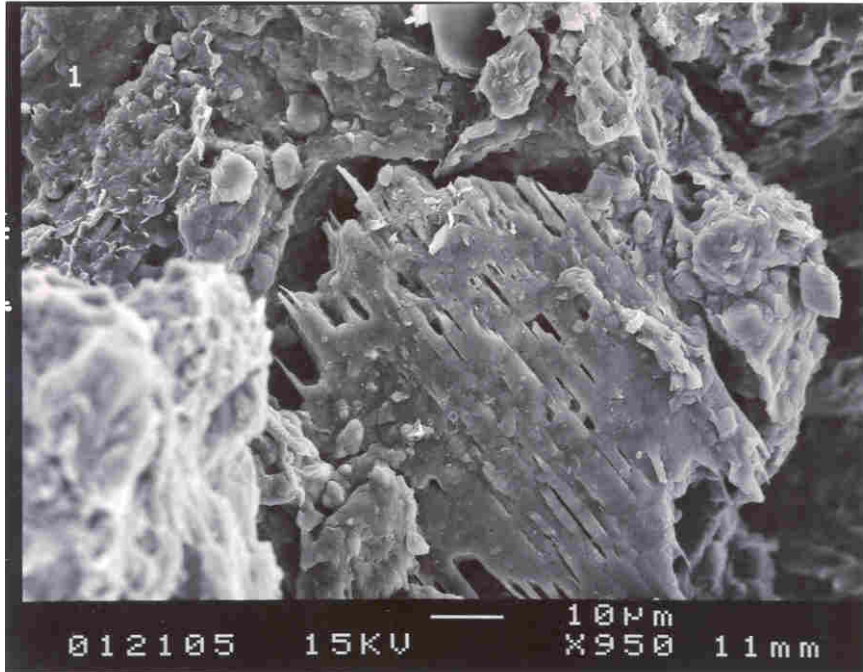
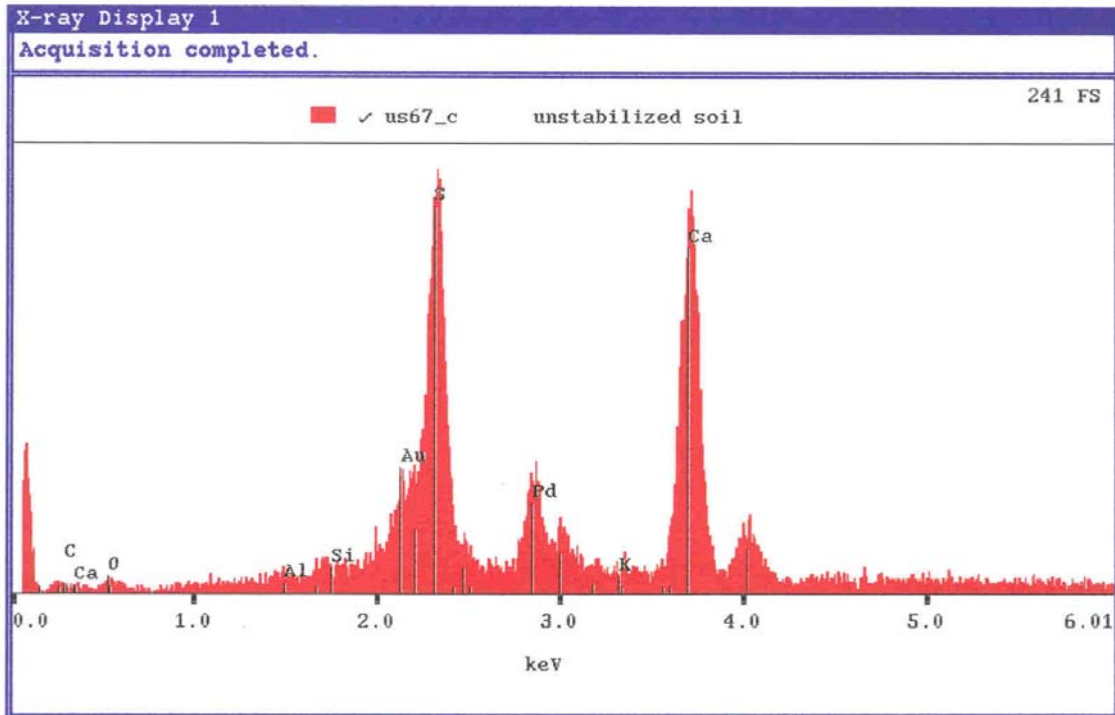
Figure 21A. SEM Image of a Gypsum Crystal in the Unstabilized Soil.

Figure 21B. EDS Pattern of the Gypsum Crystal Shown in SEM Image Above.

No, the gypsum is still present in the lime-treated soil. Large gypsum (up to 2 mm) crystals were observed in the lime-treated soil by visual inspection under a binocular microscope. X-ray diffraction of the lime-treated soil confirmed the presence of ettringite as well as unreacted gypsum. As discussed above, the gypsum crystals are large, and it appears that they were not all consumed in the original reaction with the lime.

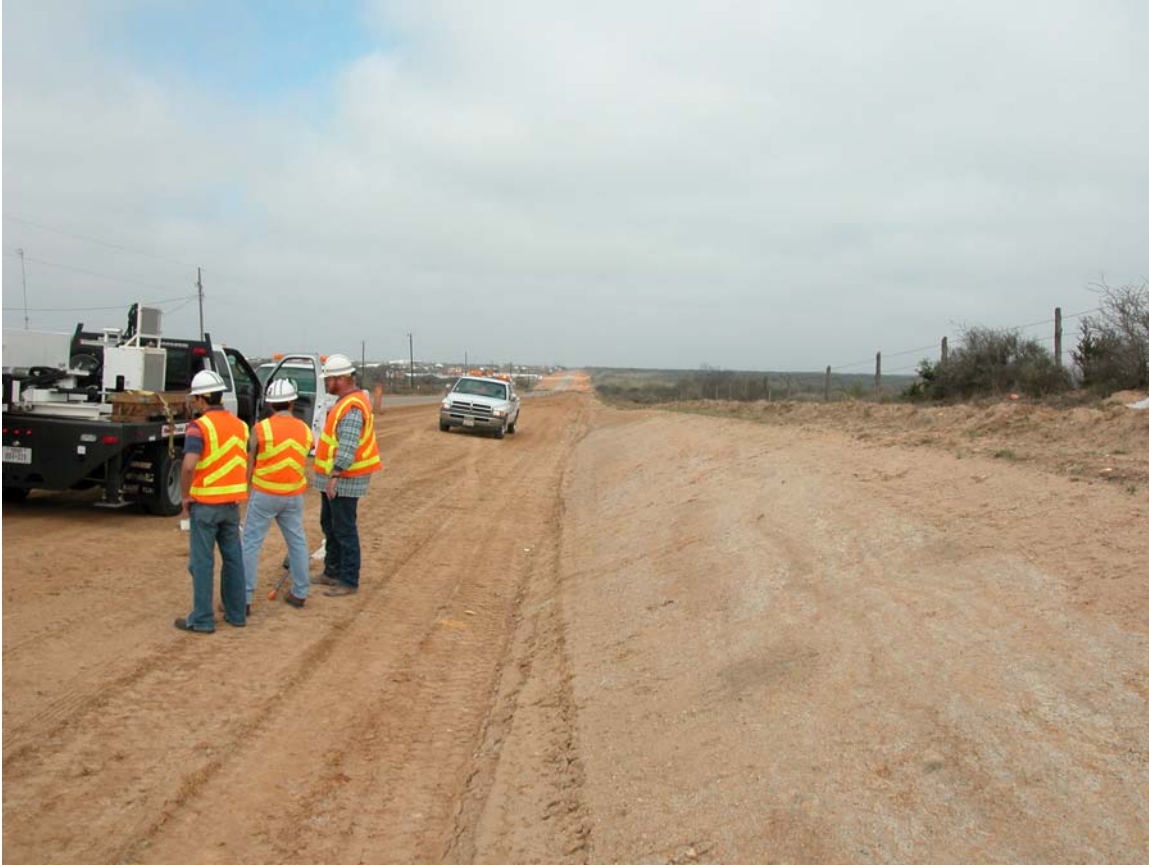
FM 3338 is an 8 mile widening project (Figure 22) that had sulfate contents measured below 2000 ppm across the entire project initially and was scheduled to be lime

stabilized. But the laboratory performed proctor tests and measured soil samples for sulfates a second time. They found a short section where the sulfates measured in excess of 40,000 ppm.

Figure 22. FM 3338 is an 8-Mile Long Widening Project in the Laredo District.

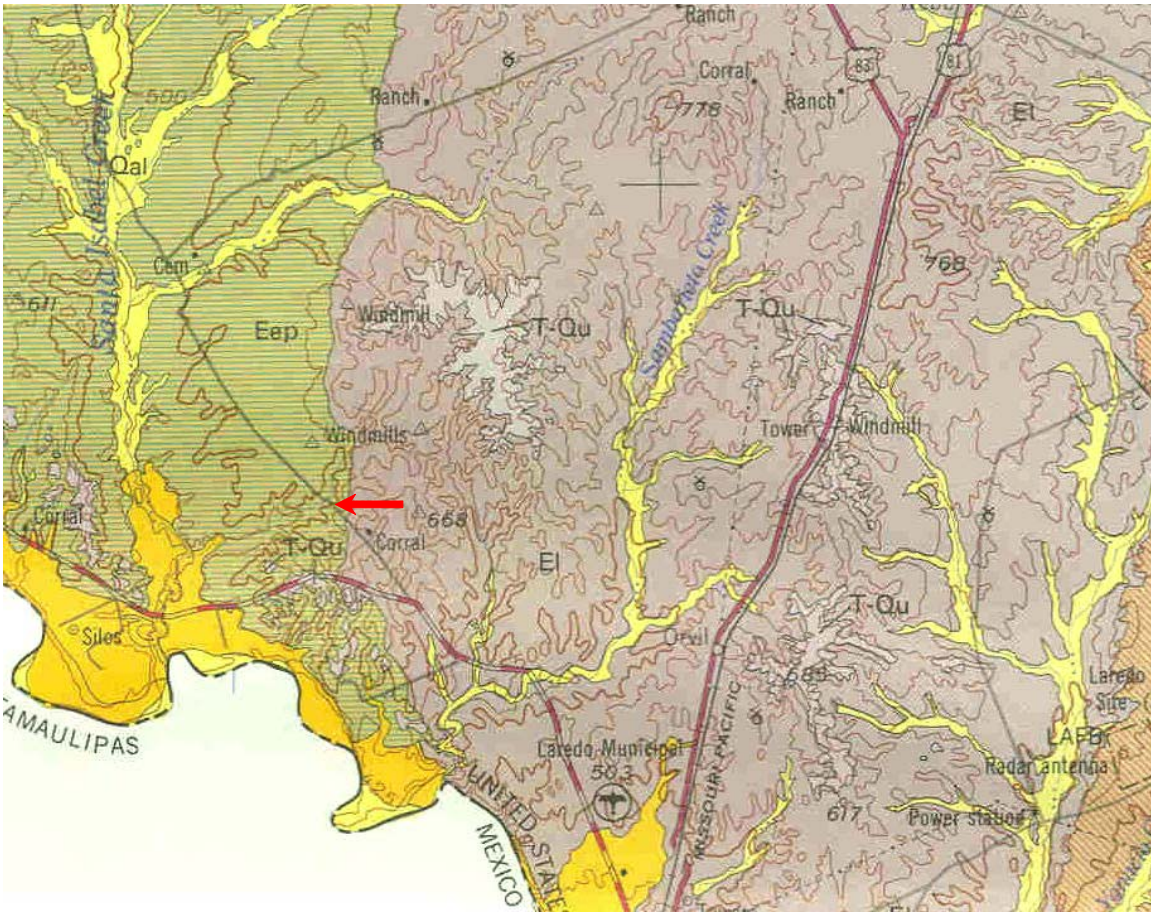
A review of the Laredo Sheet (Figure 24) from the Geologic Atlas of Texas at a scale of 1:250,000 showed that the FM 3338 project (red arrow) is on the El Pico Clay Formation (Eep, left hand side of map), which is *gypsiferous* as explained in the legend. Gypsiferous is another name for gypsum ($\text{CaSO}_4 \cdot 2\text{H}_2\text{O}$), which illustrates how important these maps can be in locating areas with potential sulfate problems.

Figure 24. Geologic Atlas of Texas Showing FM 3338 Passing through the El Pico Clay (Eep) Which is Gypsiferous.

Based on three-dimensional (3-D) swell and strength testing of the high sulfate soils from FM 3338 in Laredo, the decision was made to change the stabilizer from lime to a mixture of GGBFS and lime only in areas where high sulfates were detected. Lime was used to stabilize parts of the project where sulfates were less than 3000 ppm. There is a more detailed account of the procedures used to select the stabilizers for FM 3338 in [Chapter 3](#) and [Appendix B](#).

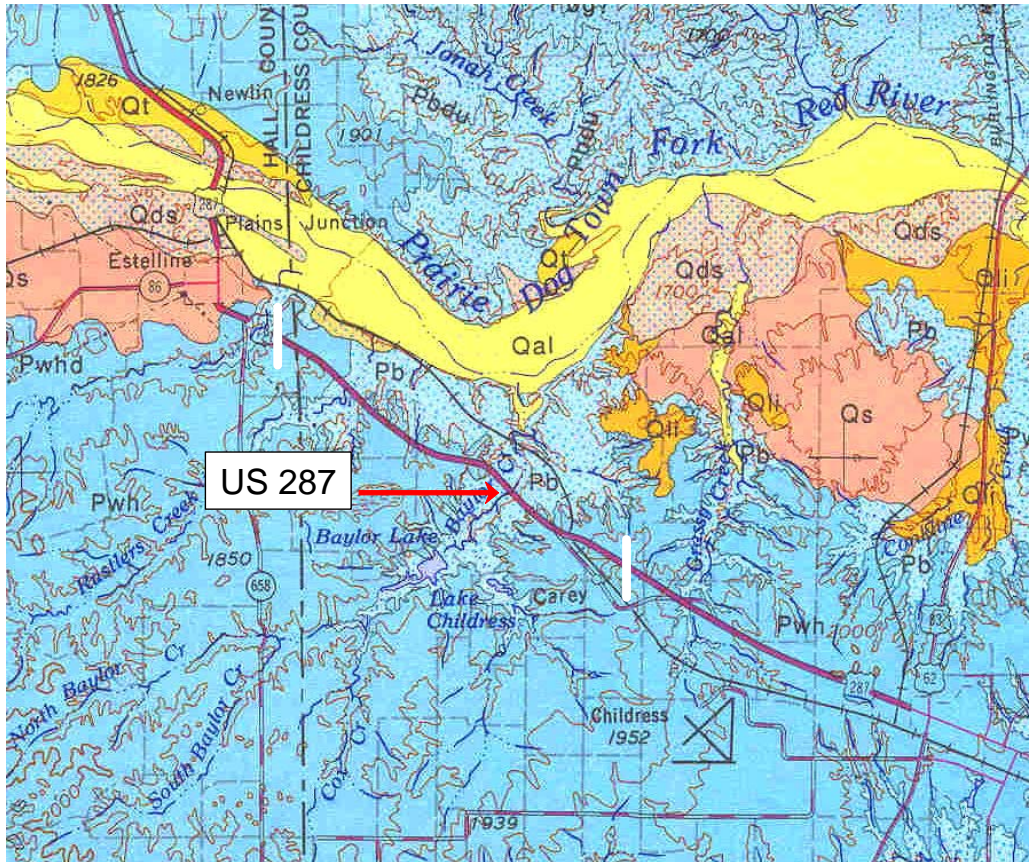
[Figure 26](#) is a portion of the Plainview Sheet of the Geologic Atlas of Texas, and it shows the limits of the premature failure (white lines across road) on US 287. The solid blue portion of the map labeled Pwh consists of the Cloud Chief Gypsum and Whitehorse Sandstone units deposited in the Permian period. A geologic description of these rocks includes interbedded sandstone, shale, gypsum, and dolomite. The sandstone is described as fine-grained orange to orange-brown quartz. The gypsum is white to gray and pink up to 20 feet thick. The term *gypsum* in the name of the unit should raise a red flag regarding sulfates in the soil.

Figure 26. Geologic Map Showing Limits of US 287 Reconstruction (white bars) Project where Premature Failure Occurred.

Analysis of the Plainview Sheet shows US 287 in the vicinity of Baylor Creek (Figure 26, red arrow) is constructed on rocks of the Blaine Formation (Pb, light blue stippled). The description of the Blaine Formation in the legend states “shale, siltstone, sandstone, gypsum, and dolomite interbedded.” Figure 27 is from a ditch adjacent to the northbound outside shoulder of US 287 south of the Baylor Creek Bridge. The rocks exposed in the ditch illustrate the interbedded nature of the gypsum with the shale, siltstone, and dolomite. An interbed is defined as a bed, typically thin, of one kind of rock material occurring between or alternating with beds of another kind.⁷

The cause of the repeated failure on US 287 is sulfate-induced heave generated from the lime reacting with the gypsum present in the underlying rocks (Figures 26 and 27). TxDOT tested different stabilizer options with this soil and determined that a combination of lime and fly ash was the best option for this high sulfate soil.

TxDOT made four recommendations addressing the problems on US 287. The first recommendation was that the existing soil be removed and replaced with a select fill. Secondly, they suggested reworking the existing subgrade with a lime and fly ash combination. The third recommendation was to use a mechanical stabilizer like Geogrid® in lieu of chemical stabilization. The last option was to mill the surface and apply a thin overlay and apply compost to the shoulders to stabilize moisture movement.

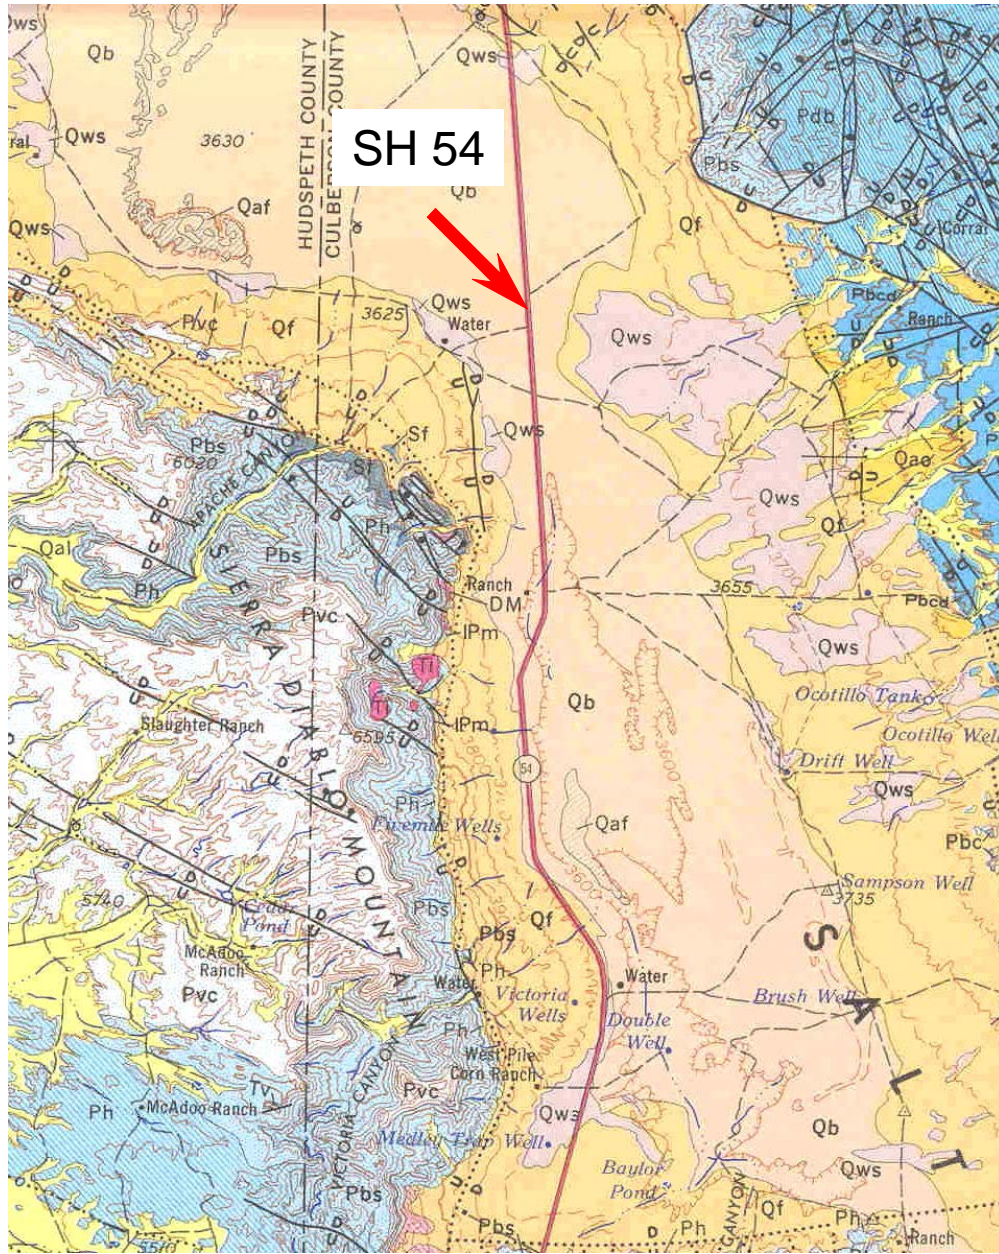
A review of the Van Horn-El Paso Sheet of the Geologic Atlas of Texas showed that most of this highway sits on Quaternary lacustrine and fluvial deposits of clay, silt, sand, and gypsum in bolsons (Figure 32). Lacustrine means lake deposits and fluvial means river or stream deposits. A bolson is a term applied in desert regions where there is an extensive, flat basin with drainage flowing into it from the surrounding mountains.

The geologic map again indicates gypsum in the rocks. The sand used in the backfill was full of gypsum, which reacted with the cement to form ettringite. The ettringite caused expansion, which deformed the culverts and broke the headwalls. TxDOT replaced the deformed culverts and used an untreated backfill around the culverts.

Figure 32. Geologic Map of SH 54 Showing That the Highway Is Constructed on Quaternary Bolson (Qb) Deposits.

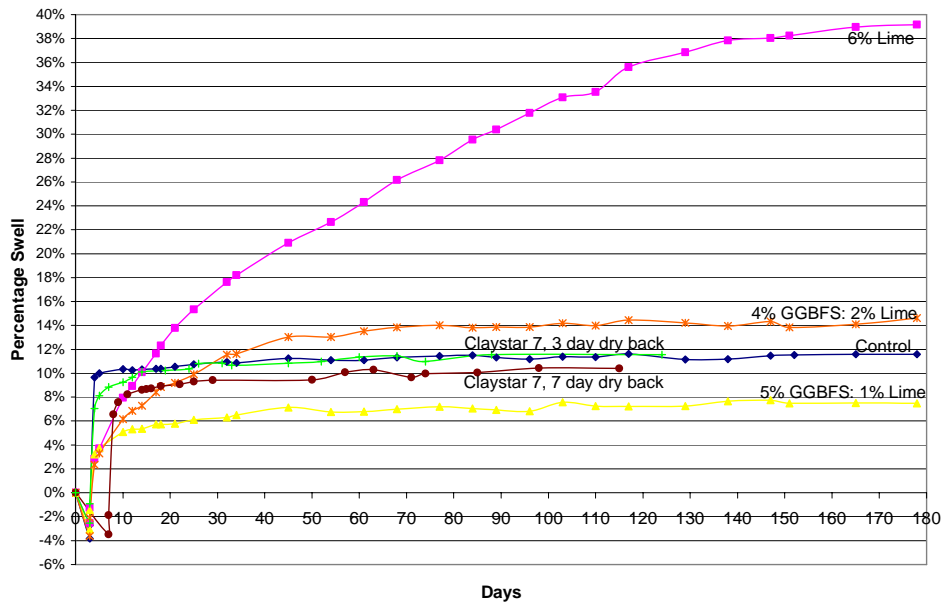
The consequences of stabilizing this soil with lime were illustrated by the 6% lime sample swelling to just below 40%, about 4 times as much as the unstabilized soil (Figure 33). The 5% by weight GGBFS and 1% by weight lime combination showed a reduction in swell of almost 4% compared with the unstabilized sample. A combination of 4% GGBFS and 2% lime was also tested, but this showed an increase in swell compared to the unstabilized sample. ClayStar samples were tested after a 3-day dry back and another set of samples after a 7-day dry back. The 3-day dry back showed no improvement in swell compared to the control sample. The 7-day dry back showed a slight decrease in swell of <2%. The reason the 7-day dry back performed better than the 3-day dry back remains unclear. However, the committee felt that the 7-day dry back was excessive and would not be realistic in the field.

Figure 33. Three-Dimensional Swell Results for a High Sulfate Soil from SH 161.
