**INVESTIGATION OF MAINTENANCE BASE REPAIRS OVER
EXPANSIVE SOILS: YEAR 1 REPORT**

Report 0-4395-1

Research Project Title: Optimum Spot Base/Subgrade Repair Techniques for Moderate to High
Traffic Highways over Highly Expansive Subgrade Soils

October 2002

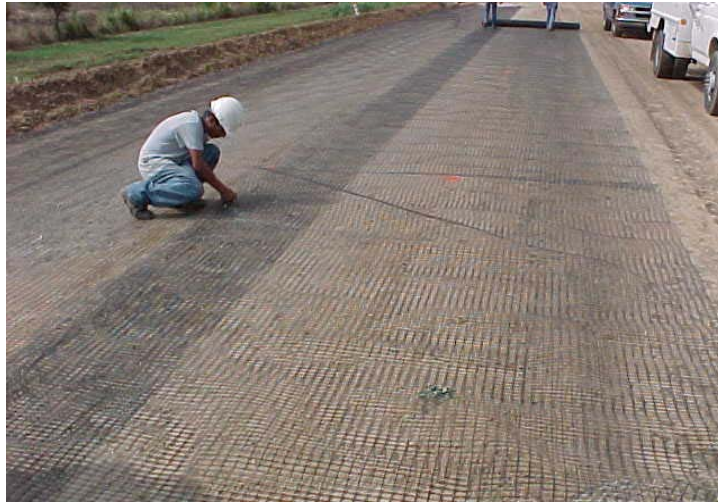
Geotextiles and geogrids have been used and promoted for use in numerous pavement applications over the years. One major issue with pavements over expansive soils is dealing with the longitudinal cracks, or “dry-land” cracks, that typically develop. An example of this type of cracking is shown in [Figure 1](#). Cracking in the highly plastic subgrade reflects through the pavement structure, creating an inlet for water into the pavement and a headache for maintenance forces. Typical treatments are filling and sealing the cracks or reworking the base, and possibly raising up the side slopes to reduce edge drying in the section. Neither of the first two treatments deals with the source of the problem, the subgrade. In efforts to minimize the longitudinal cracking from highly plastic subgrades, the Bryan District has been using geogrids beneath a layer of flex base on FM roads to provide a barrier to keep cracks from coming through the surface. Results have been promising. [Figure 2](#) shows the geogrid being placed, and [Figure 3](#) shows a representative reworked section utilizing the geogrid after approximately 2 years of service. [Chapter 4](#) of this report contains a complete summary of the design and construction process used in the Bryan District.

Figure 1. Example of Longitudinal Cracking.

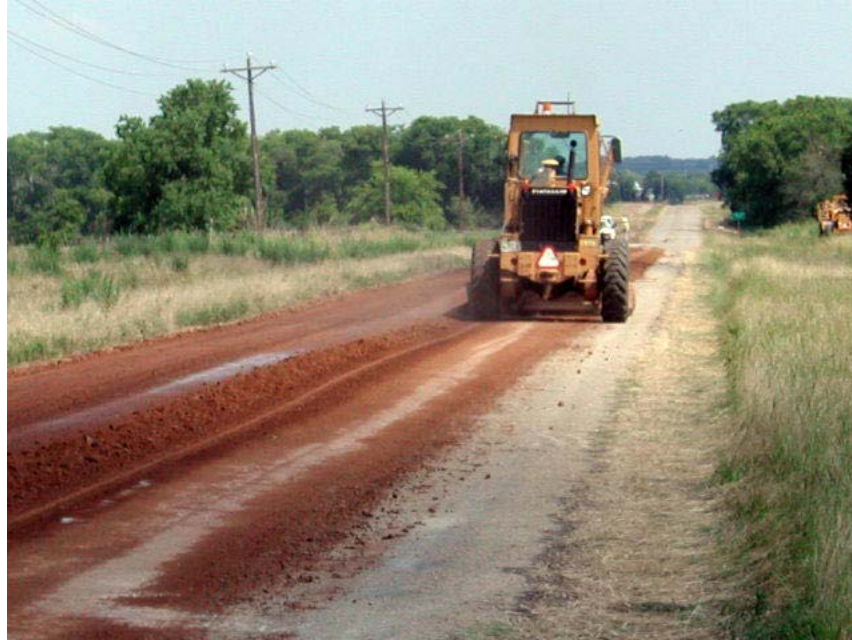
Primary Distress(es) before Treatment: Rutting.

Treatment(s) Applied: Maintenance forces recycled the existing base/seal coat with cement in June 2002. [Figure 19](#) shows the treated base being placed.

Figure 19. Placement of Recycled Base on FM 2967.

Field Observations: This project was constructed at the time researchers were visiting the Lufkin District in June 2002; thus, no performance history is available yet. Maintenance personnel indicated that an increase in truck traffic resulted in the rutting. USDA soils maps indicate this road is on Woodtell and Lacerda soils, with low strength and shrink-swell being the main limitations for suitability for roadways (42).

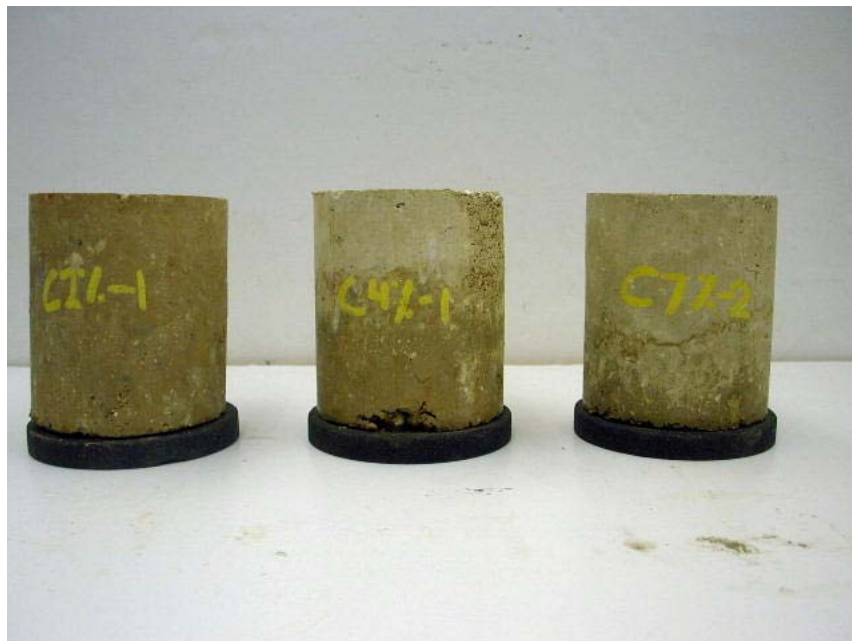
As shown previously in Table 6, neither of the untreated materials had a final dielectric value below 10 after the TST, meaning personnel should consider some type of treatment to improve base performance if moisture is available in field conditions. Thus, TTI tested the cement-treated materials in the TST. Figure 33 presents the results from the TST on the cement-treated specimens. The Colorado Materials aggregate required 4 percent cement before a final dielectric value less than 10 was achieved, whereas the Vulcan aggregate with only 2 percent cement had a final dielectric below 10. The greater degree of moisture susceptibility of the Colorado Materials aggregate is visually evident when contrasting Figures 34 and 35. Figure 34 shows how the height of water rise progressed all the way through the Colorado aggregate with 2 percent cement. Figure 35 illustrates that the height of water rise is only about one-half that of the sample in the Vulcan aggregate with 2 percent cement.

Figure 34. Representative Colorado Cement-Treated Base after the TST.
L to R: 2 percent, 4 percent, and 7 percent Type 1 Cement.

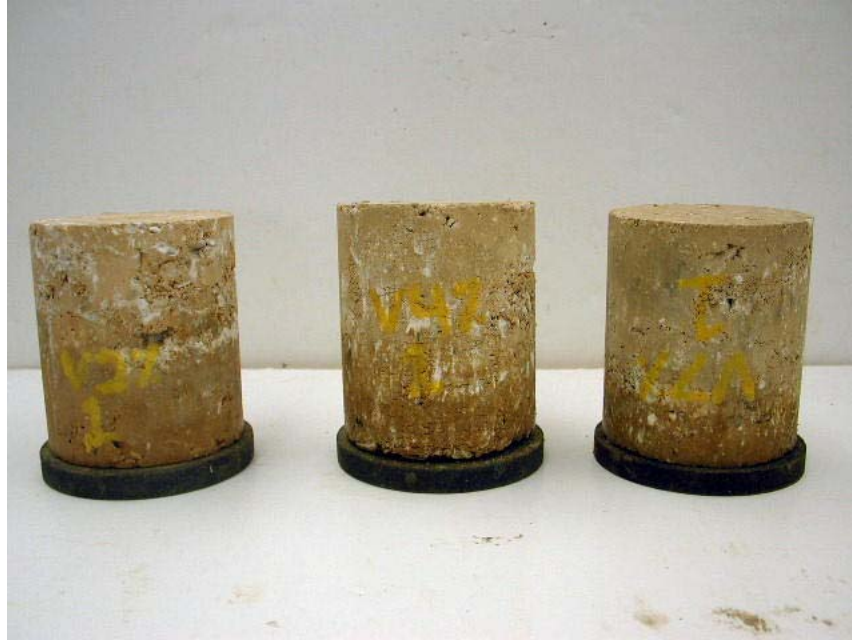
Figure 35. Representative Vulcan Cement-Treated Base after the TST.
L to R: 2 percent, 4 percent, and 7 percent Type 1 Cement.

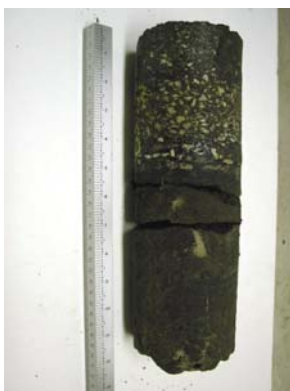
FM 1818 Hole #3

Depth (in.)	PI	General description
0-2	---	Surface
2-5	---	black base
5-11.5	---	Subgrade
11.5-16	8	tan clayey sand
16-20	8	tan clayey sand

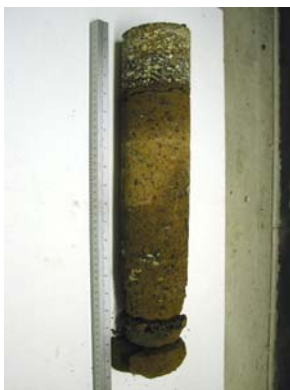
FM 226 Hole #3

Depth (in.)	PI	General description
0-2	---	new surface
2-4	---	old surface
4-17	---	CTB
17-21	---	old road surface
21-29	13	reddish sandy clay with gravel
29-33	18	reddish sandy clay
33-36	15	reddish sandy clay

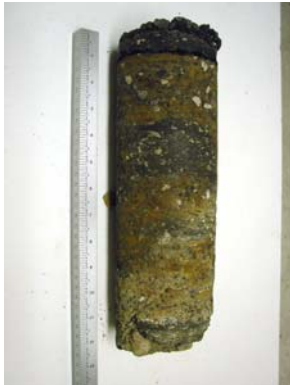
FM 2076 Hole #2

Depth (in.)	PI	General description
0-1	---	Surface
1-11	---	CTB
11-18	---	Subgrade
18-24	48	tan clay

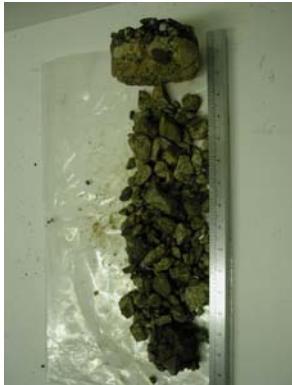
FM 20 Hole #4

Depth (in.)	PI	General description
0-1	---	Surface
1-11	---	Base
11-17	26	brown and gray clay
17-22	24	dark gray clay
22-24	13	tan sandy clay with limestone rocks
24-26	12	tan sandy clay with limestone rocks
26-29	14	tan sandy clay with limestone rocks
29-32	21	tan and brown sandy clay

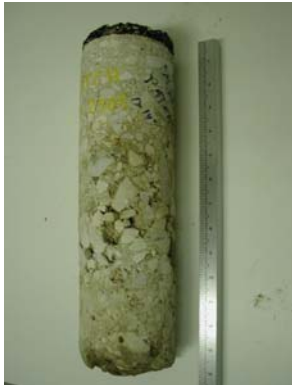
FM 2505 SB Patch

Depth (in.)	PI	General description
0-2	---	Surface
2-7	---	CTB
7-14.5	---	Subgrade
14.5-20	7	reddish tan clayey sand
20-25	12	tan clayey sand
25-30	16	brown and tan sandy clay
30-35	14	dark gray and tan sandy clay

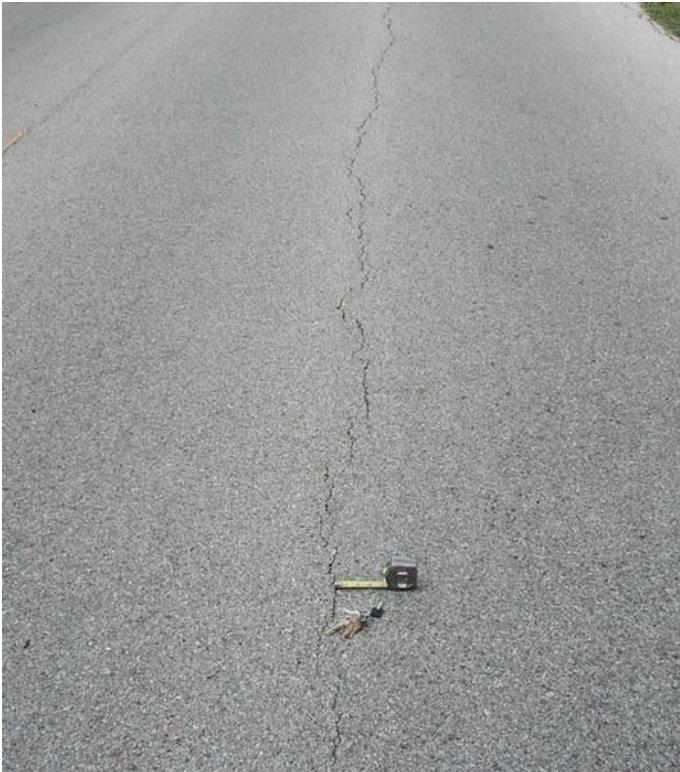
Low Severity Longitudinal Cracking

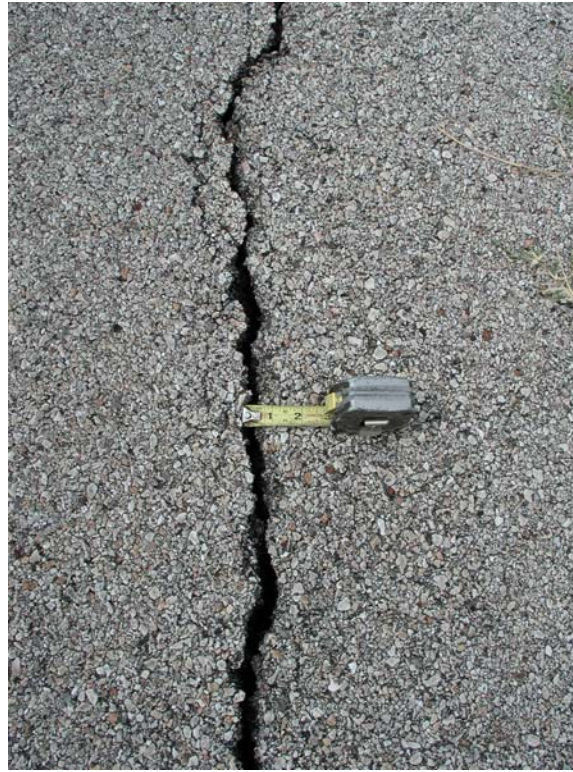
Medium Severity Longitudinal Cracking

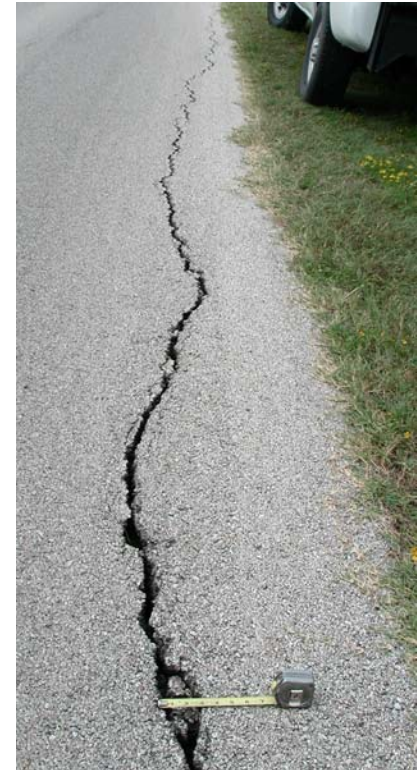
**High Severity
Longitudinal Cracking**

Likely Causes: Longitudinal cracks can be load or non-load related. Load-related cracks are in the wheel paths and are early signs of fatigue cracking. Non-load related cracks typically result from highly plastic subgrade material. These cracks meander and often occur near the pavement edge in expansive soil environments. In some cases a lack of edge support and/or weak and wet subgrades result in faulting of these cracks.

General Maintenance Treatment Options: Crack seal, crack fill and seal, blade-on patch (when faulting is present), seal coat or overlay, reconstruct or recycle utilizing geogrid reinforcement. The geogrid reinforcement method utilizes a synthetic grid placed between a layer of stabilized base and a thin layer of flexible base as shown in the figure on the next page. A thin surfacing placed on top of the flex base seals the pavement. The geogrid has shown promising results for effectively stopping dry land cracks from reflecting through the pavement surface.

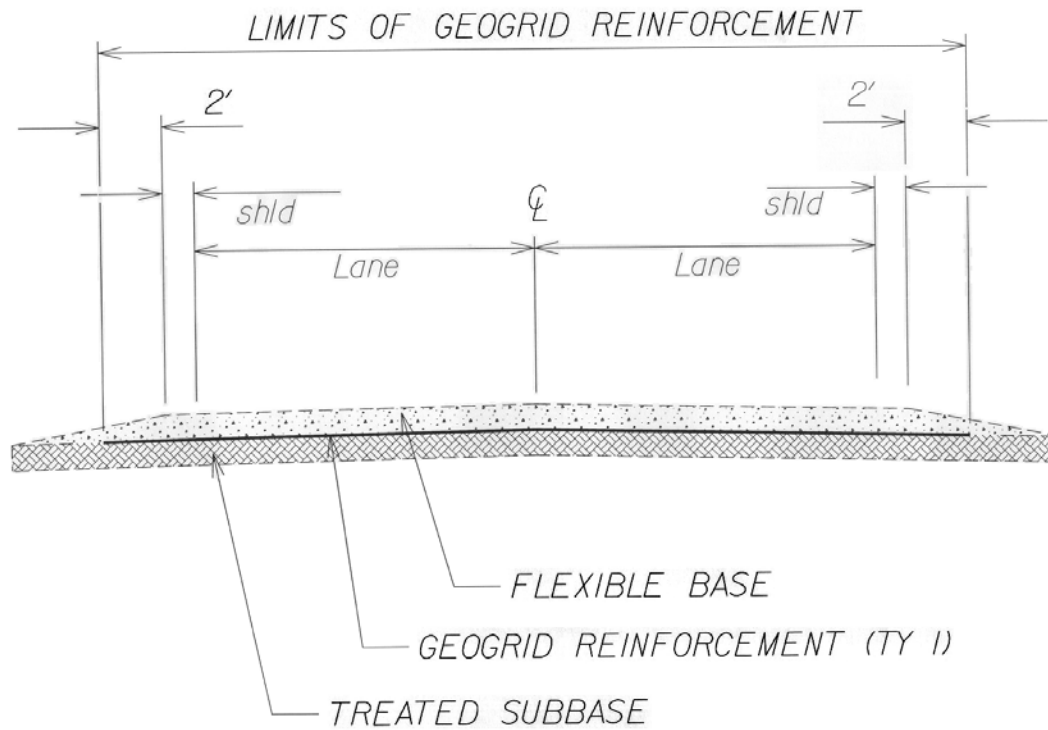
Geogrid Reinforcement for Reducing Longitudinal Cracking through the Pavement Surface
Schematic courtesy of Darlene Goehl, P.E.

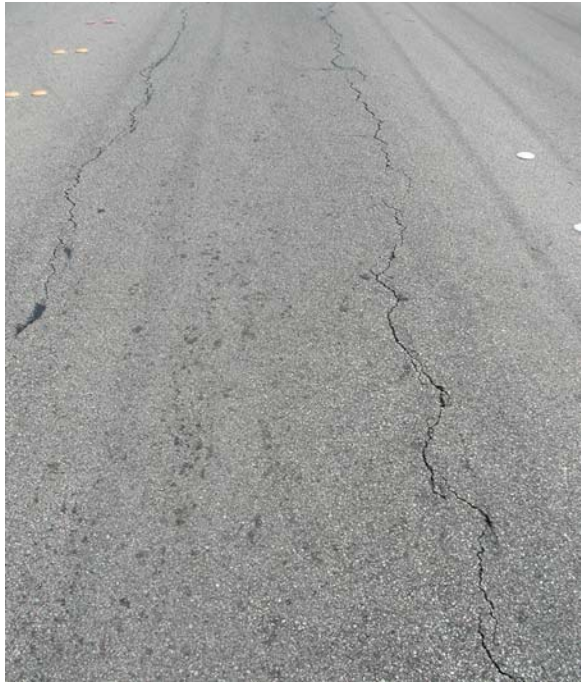
Low Severity Fatigue Cracking

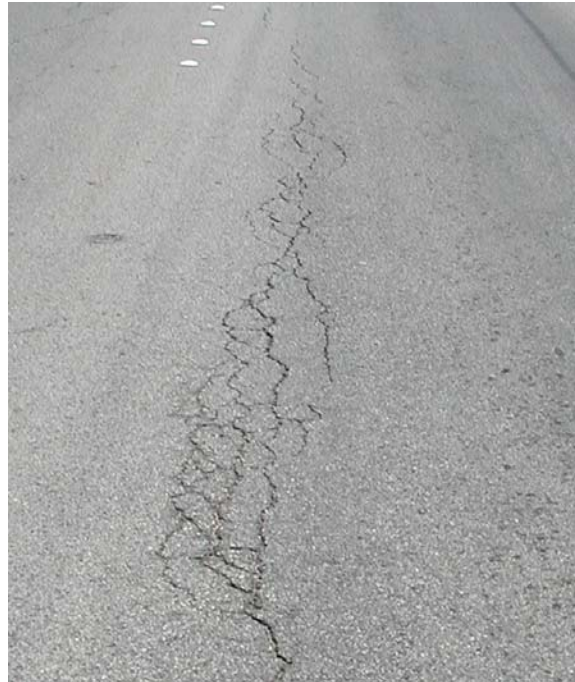
Medium Severity Fatigue Cracking

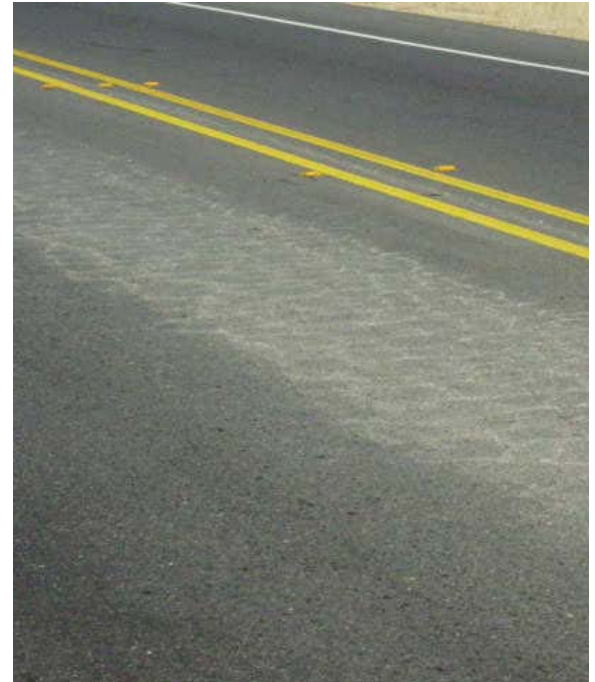
High Severity Fatigue Cracking

Likely Causes: Typically fatigue cracking is load related and results from structural problems such as a weak base or subgrade or inadequate surface structure. Occasionally situations are encountered where fatigue cracking is not load related but caused by problems with the HMA surfacing, such as asphalt cement properties, segregation of the HMA, or debonding of layers.

General Maintenance Treatment Options: A wide assortment of treatments can be used on fatigue cracking, ranging from seal coats to reconstruction, depending on the severity of the distress and whether the cracking is a structural problem. A full-depth repair is needed for fatigue cracking when structural deterioration exists, possibly with an increase of the base thickness.

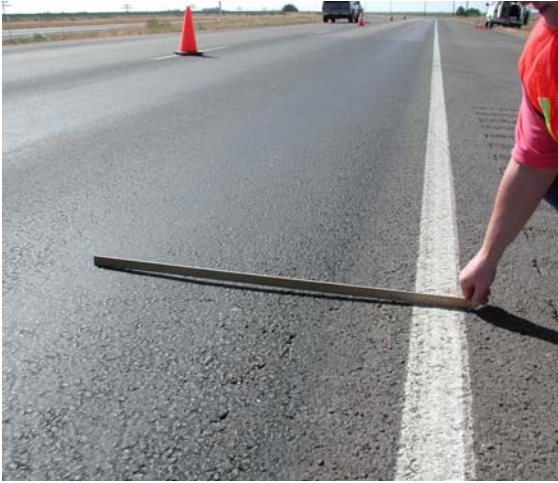
Low Severity Rutting

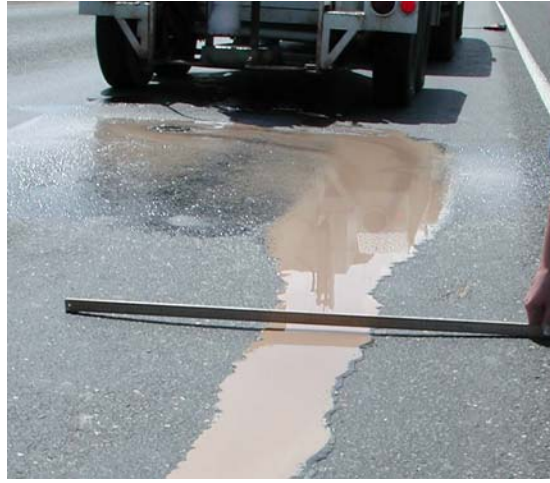
Medium Severity Rutting

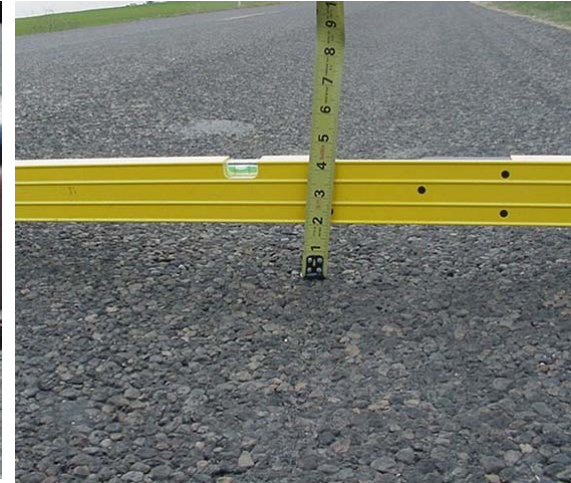
High Severity Rutting

Likely Causes: Rutting can result from densification of pavement layers; rutting may be caused by problems with the surfacing and thus limited only to the HMA layer, or rutting may be the result of a structural deficiency.

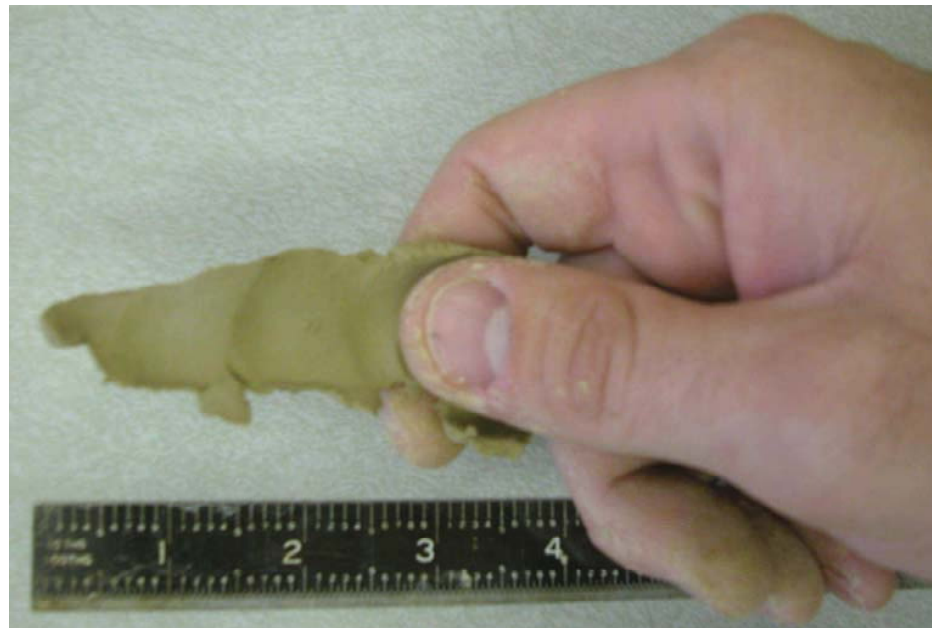
“Ribboning” of soil Illustrating High Plasticity (scale in inches)

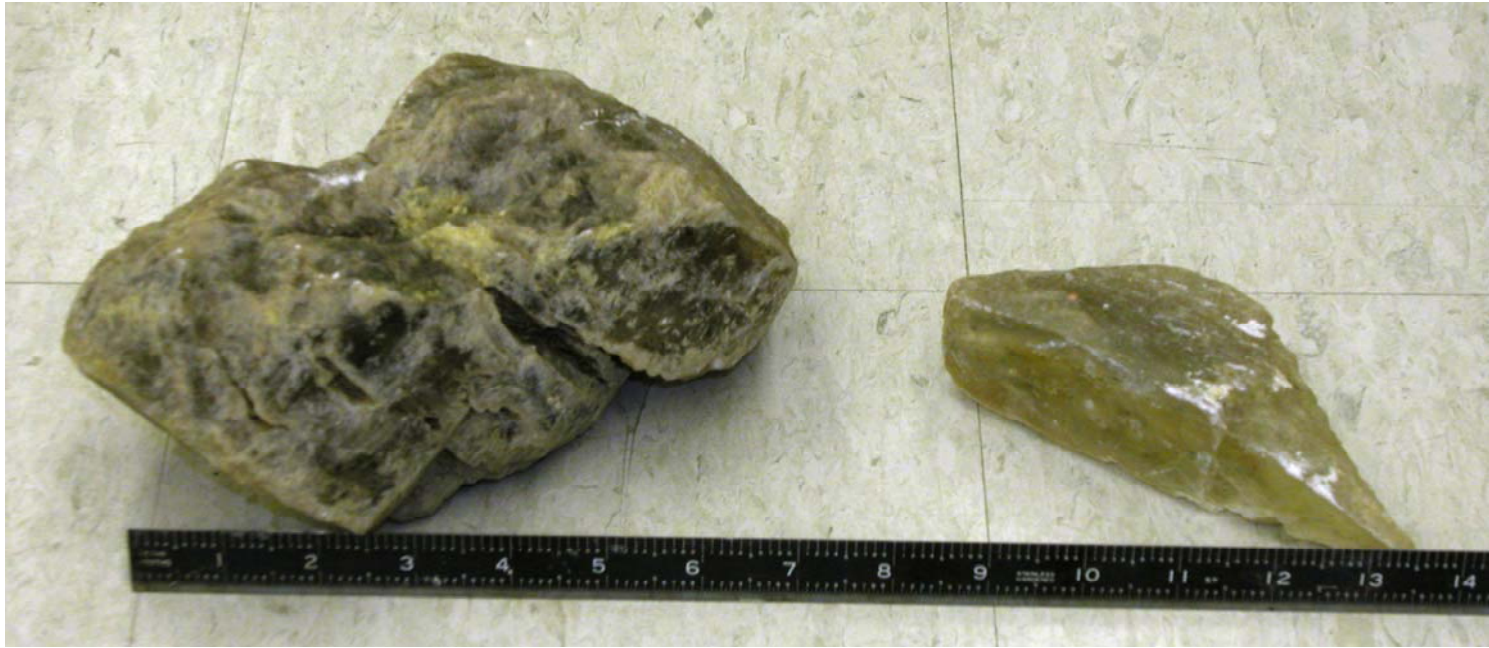
- The soil should have a soluble sulfate content below 3000 parts per million. Sometimes sulfates can be visually identified in soils in the form of gypsum crystals, which typically are shiny, glass-like crystals as shown in the photo on page 107. These crystals can vary greatly in size, as evidenced by contrasting the crystals shown on page 107 to the crystals on page 108.

Large Gypsum Crystals (scale in inches)
