1. Report No. FHWA/TX-05/0-4395-2		2. Government Accession No.		3. Recipient's Catalog No.	
4. Title and Subtitle FINALIZATION OF GUIDELINES FOR MAINTENANCE TREATMENTS OF PAVEMENT DISTRESS				5. Report Date August 2004

FINALIZATION OF GUIDELINES FOR MAINTENANCE TREATMENTS OF PAVEMENT DISTRESS

Report 0-4395-2
Project Number 0-4395
Project Title: Optimum Spot Base/Subgrade Repair Techniques for Moderate to High Traffic
Highways over Highly Expansive Subgrade Soils

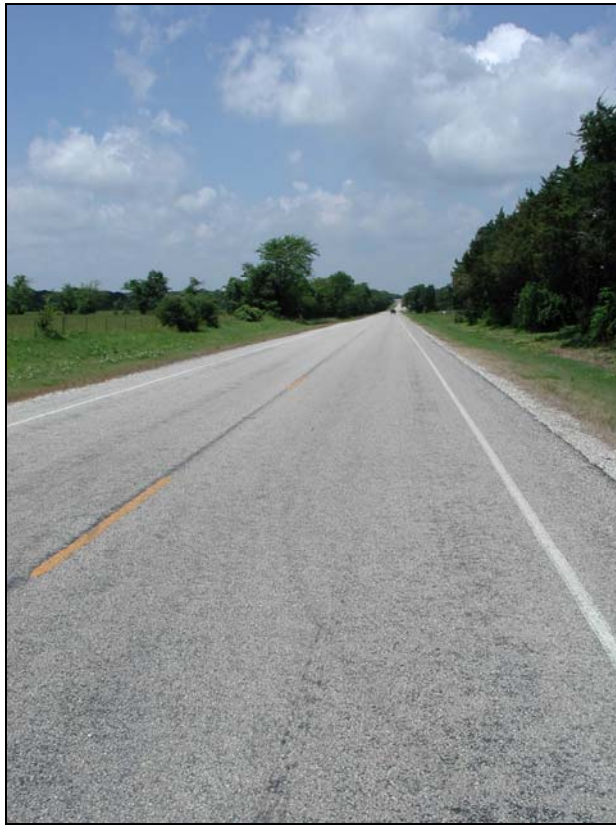
Figure 3.3. OSR in July 2004.

Reported treatments for longitudinal cracking included CTB, cold-mix surface patch, or asphalt base. The expected time per station to construct each was between 3.5 and 6 hours. [Figure 3.2](#) shows the distribution of life expectancies for these treatments. Overall the reported repairs with asphalt base had the longest expected life. Since longitudinal cracking typically results from subgrade shrinkage, it is no surprise that the CTB repairs typically have the shortest life since the stiff CTB cracks when the subgrade moves. Despite the reported results of the asphalt base repairs for longitudinal cracking, the research team believes if a full-depth repair is going to be made, the best method is to use the geogrid reinforcement method described in the first report from this project (0-4395-1). The Bryan District rehabilitated approximately 3.6 miles of OSR in 2000 using this technique. [Figure 3.3](#) shows the section in July of 2004; there are no visible longitudinal cracks in the section.
