**PERFORMANCE REPORT ON JOINTED CONCRETE PAVEMENT
REPAIR STRATEGIES IN TEXAS**

Report 0-4517-1

Project 0-4517

Project Title: Develop Statewide Recommendations for Application of PCC Joint Reflective
Cracking Rehabilitation Strategies Considering Lufkin District Experience

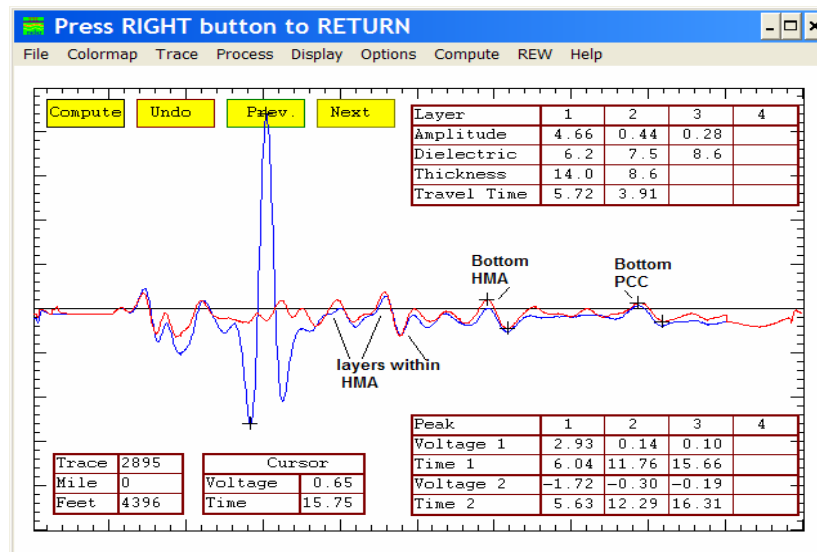
Figure 12. Typical Trace from Section R4.

Figure 11 shows the GPR data from section 4. This display is complex because there are many different layers within the HMA layer. The total HMA thickness is between 14 and 16 inches. The reflections from the bottom of the PCC are still visible but fainter than in the earlier figures. The complex nature of the reflections from section R4 is shown in Figure 12, which shows a single reflection. There are multiple reflections from within the structure, and it would have been difficult to estimate layer thickness without prior knowledge of the existing structure.

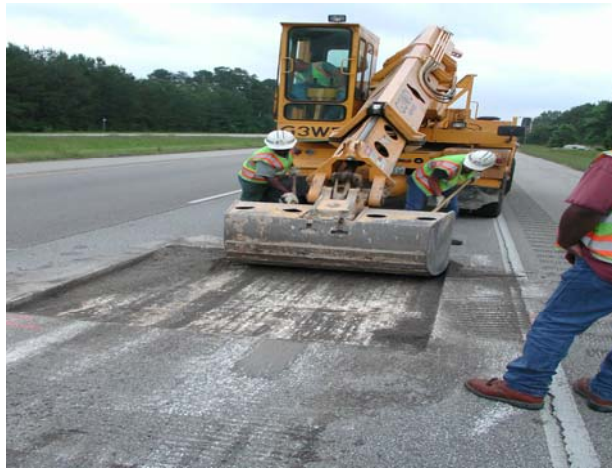
Figure 14. Sampling Materials from Section R3 on US 59.

In order to further evaluate this material, researchers decided to sample material from the roadway and return this material to TTI for laboratory testing. The sampling operation is shown in [Figure 14](#). The major engineering property of interest for the base material is its moisture susceptibility. This property was measured by a new TxDOT test (Draft method 144E), the Tube Suction Test (TST). The samples of the Lufkin material under test are shown in [Figure 15](#).

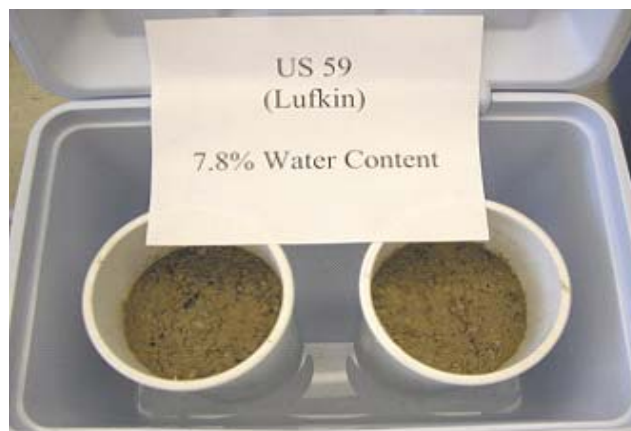
Figure 15. Samples of Base in TST Test.

Details of the tube suction procedure can be found elsewhere (4). In summary the test measures the capillarity of base samples compacted at optimal moisture content. The sample is dried back, and then moisture is introduced at the bottom of the sample. The top of the sample is monitored with a Percometer, which measures the surface dielectric. The dielectric is an electrical property, which is an indication of the amount of unbound moisture reaching the

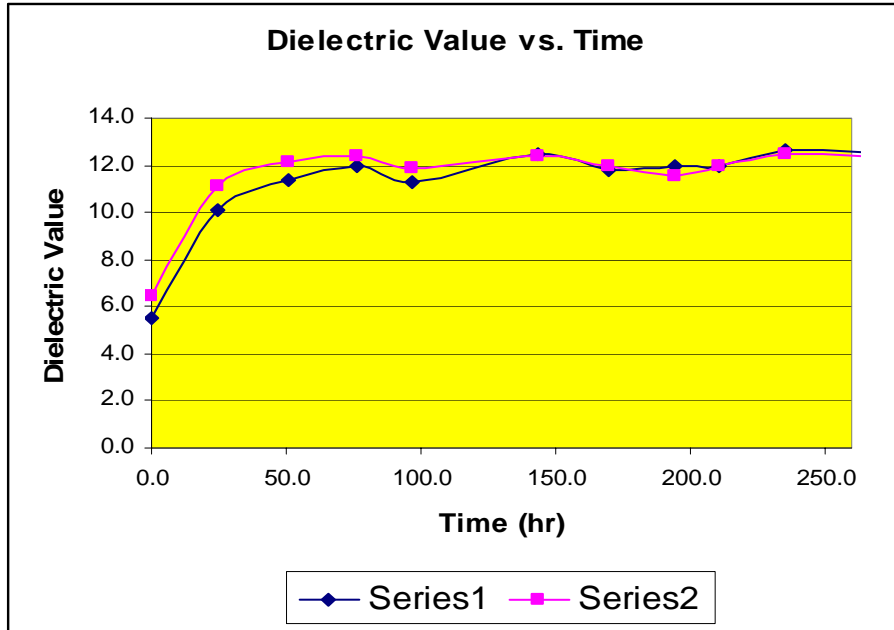
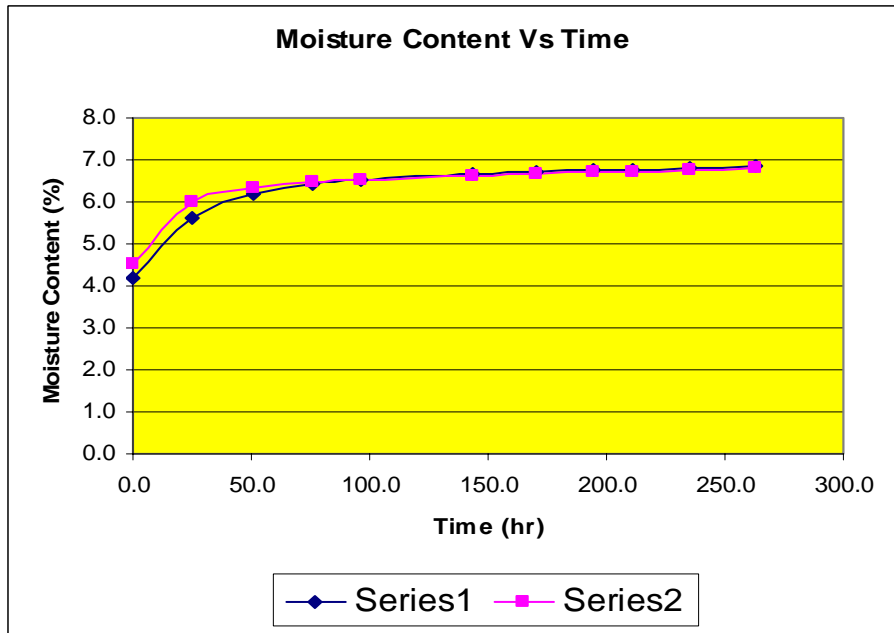
Figure 16. Detailed Results from the Tube Suction Test on the Section R3 Base Material.

The results for the Lufkin material are shown in [Table 5](#) and [Figure 16](#). The final dielectric for this material was found to be 12.5, which from the classification shown in [Table 4](#) was judged to be “good.” The final moisture content after 10 days capillary rise was found to be 6.8 percent, which is below the optimum moisture content of 7.8 percent. In summary, if flexible base overlays are to be used on future JCP projects in Texas the base material uses should have equal or better properties to the material, which performed well on US 59. This included:

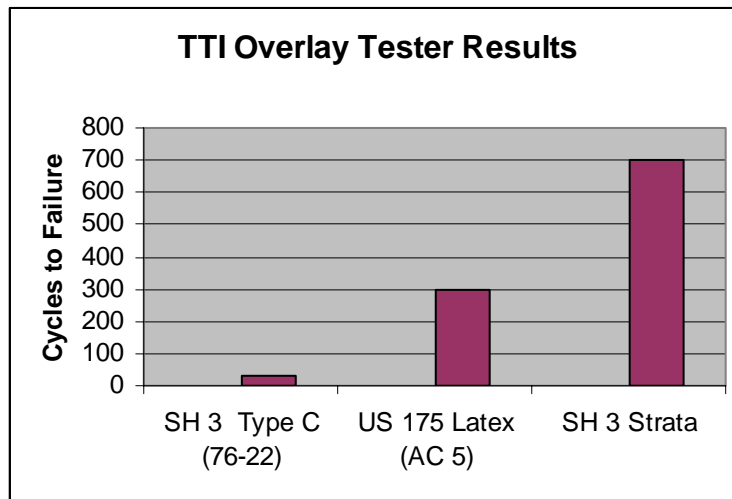
Figure 23. Overlay Tester Results from SH 3 Materials (Average of Two Tests).

The results obtained for the two mixes used on SH 3 are shown in [Figure 23](#). The Type C material failed after 30 cycles, whereas the Strata® material lasted more than 700 cycles. The test was stopped after 700 cycles, and the Strata® material had not cracked. These results are to be compared with the results obtained on a good performing latex modified mix from the Dallas District. The mix on US 175 was placed over 10 years ago on a cracked cement treated base, and after 10 years of service very few cracks were found in the surface. From the overlay tester results the Strata® material has superior crack retarding properties. Similar tests were conducted at a reduced temperature of 50 ° F, and the Strata® material still performed very well.

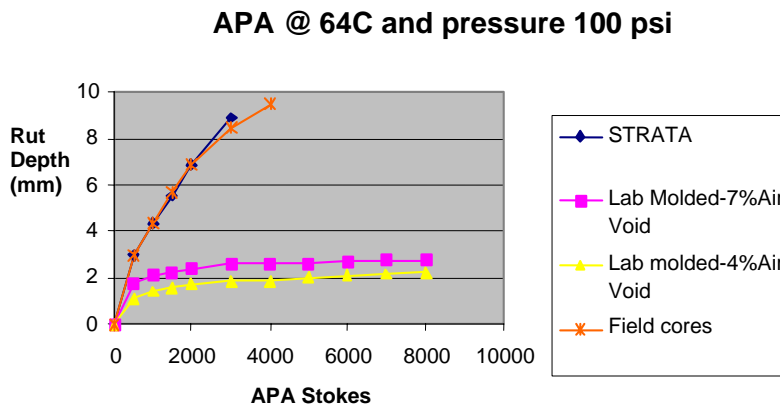
Figure 24. APA Results Evaluating the Rutting Potential of the Strata® Material.

As shown in [Figure 24](#) the Strata® material did poorly in the rutting test. The deformations shown in the specimen after less than 3000 load repetitions are shown in [Figure 25](#). In [Figure 24](#) the Strata® performance is compared to the following three mixes:

These data show the Strata® has a very similar rutting curve to the failed Texas mix. The results raise a concern that it may be a problem to drive on the Strata® product for extended periods during construction; this would be a concern if the construction was occurring in the middle of a Texas summer.

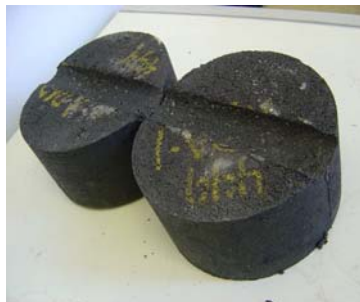
Figure 25. Strata® Samples after 300 Load Repetitions.

The test results presented above show both the strengths and the weaknesses of the Strata® system. Firstly, it demonstrates superior resistance to reflection cracks. This material should perform excellently in the field. The weakness is that it is a soft mix with a flushed appearance. The Houston District expressed concerns about its skid resistance in wet conditions. In general traffic should not drive on the mix for extended periods during construction. The manufacturer recommends no more than five days, but that could be a problem in mid summer in Texas. Houston placed the overlay on top of Strata® within 72 hrs. The potential for the mix to rut also governs the amount of cover material required in high traffic load situations. For example the Strata® manufacturer material usually recommends a minimum of 3 inches of HMA over the Strata®. That means that the minimum application thickness will be on the order of 4 inches.

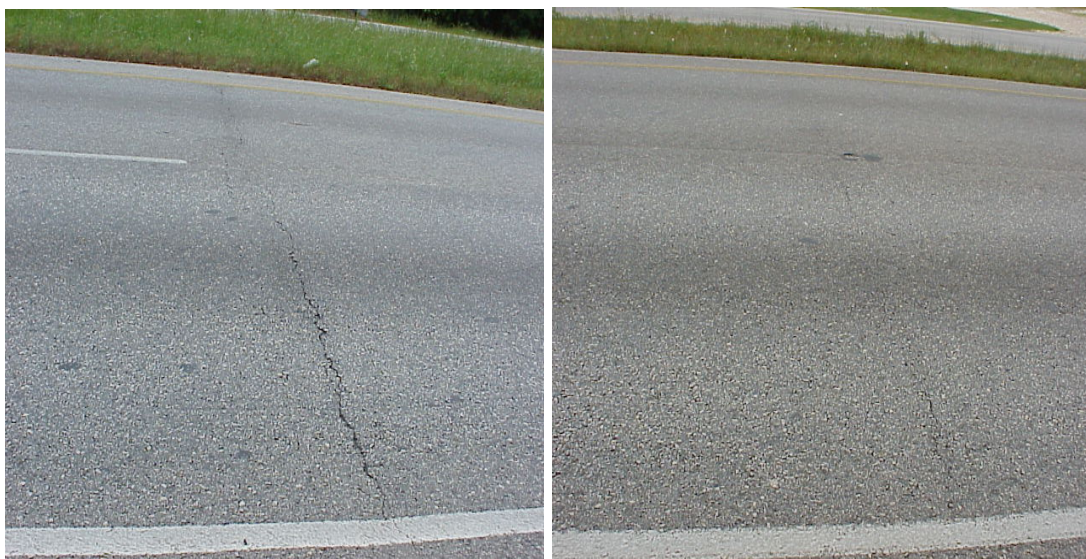
Figure 26. US 59 GlasGrid® Evaluation Site.

GlasGrid®, followed by a 2 inch CMHB level up. The only problem noted by Ron Evers, the district pavement engineer at the time, was that because of the low (45 °F) air temperature during construction, the GlasGrid® did not adhere well to the leveling course at the beginning of the operation. A control section was placed adjacent to the grid section with 4 inches of HMA without the grid. Visual inspections were first conducted in August 2002. At that time all of the cracks had reflected through the control section, and the first reflection cracks were observed in the grid section. This is shown in [Figure 26](#) where the reflection cracks are clear in the control section. The cracks were observed in about 20 percent of the joints in the GlasGrid® section but they were less severe than the control section. Ron Evers commented that the grid had retarded the reflection cracking by about 1 year.

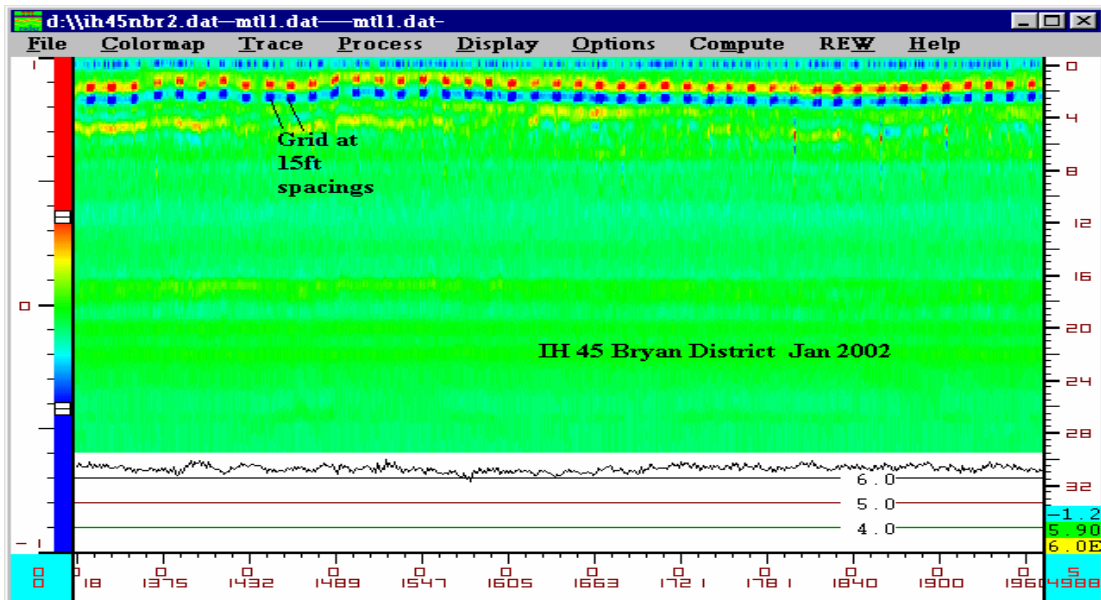
Figure 36. GPR Data Collected on the GlasGrid® Section on IH 45.

strips, and that the joints were every 15 ft. Figure 36 shows about 700 ft of the section. The distance scale in miles and feet is at the bottom of the figure. From the GPR there is a clear signature from each strip of grid. This is the red/blue interface at a depth of approximately 2 inches (depth scale on right of figure). This reflection shows that there is a discontinuity in the mat at each grid location. If the two asphalt layers were fully bonded together, only minor reflections would be observed at the interface between the CMHB and Type C mix. The GPR signature is similar to that observed in the Houston sections. The pattern indicates the presence of moisture at the level of the grid. This pattern is most probably associated with debonding of the HMA layers at grid, allowing moisture to concentrate at this level.

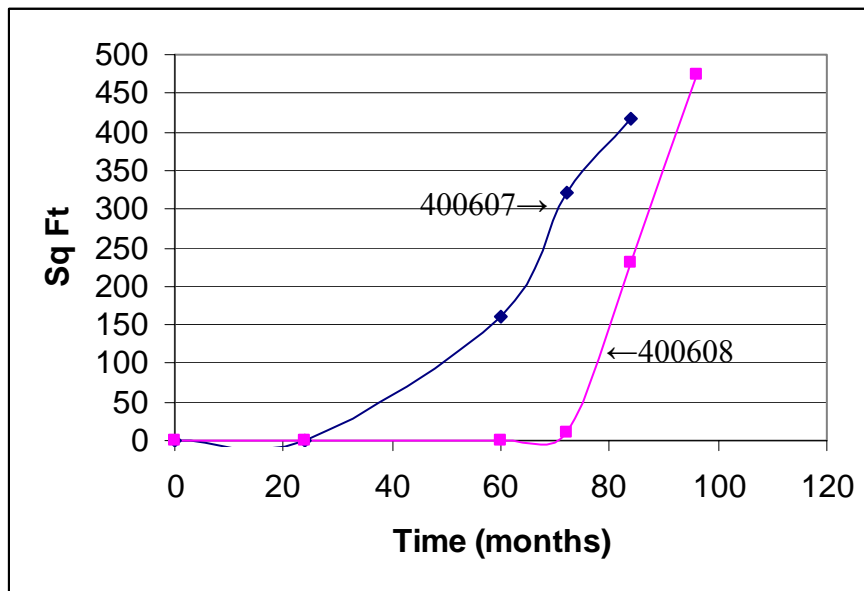
Figure 39. Growth in Alligator Cracking from Rubblized Concrete Sections in Oklahoma.

In section 400607 substantial alligator cracking was found in the section after five years in service. This was the section with the low PCC modulus. Both sections received substantial patching and maintenance in year 2001, nine years after construction. The poor performance is

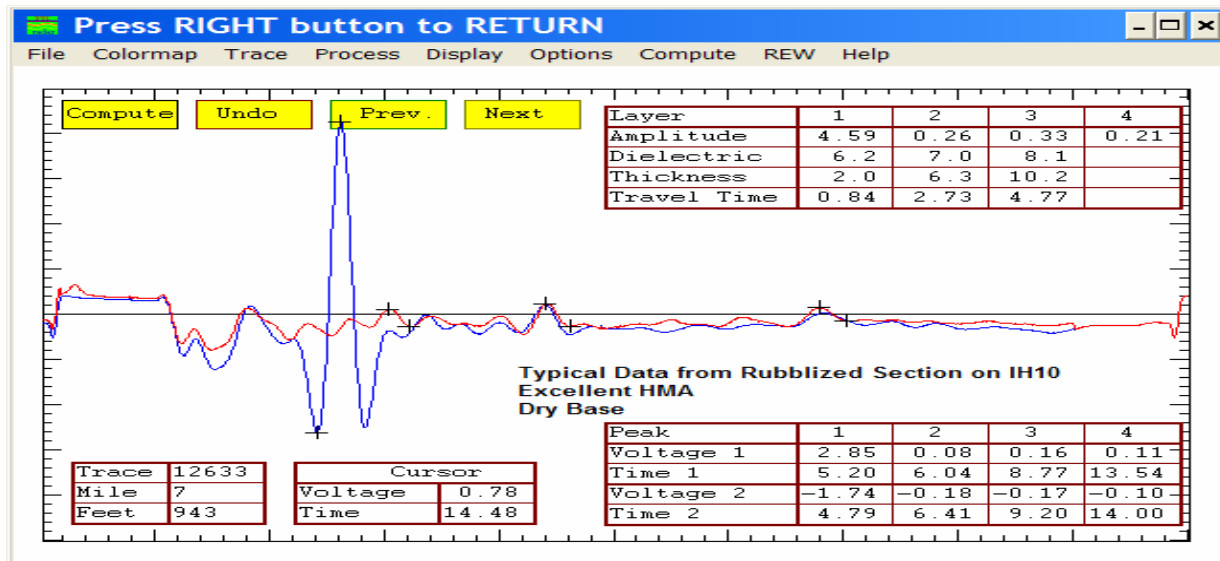
Figure 41. Typical Trace Obtained on IH 10 Rubblization Project (Ideal Case - No Defects).

[Figure 41](#) shows typical data from Job 2 (east of MP 93). These data are judged as ideal. The blue line in [Figure 41](#) is the raw data collected at this location. The distance from the start of the run (7 miles and 943 feet) is shown in the box at the lower left-hand corner. The red line superimposed on the blue line in [Figure 42](#) is the resulting trace once the large surface reflection has been removed by the COLORMAP software package ([13](#)). This “surface removal” technique is useful in exposing small near surface reflections, which are typically from the bottom of the last overlay placed. In this case, a small peak is detected just to the left of the surface reflection; this is the bottom of the wearing course.

The numbers in the box in the upper right part of [Figure 41](#) are the results of the calculations made on this trace. The amplitudes and travel times between peaks are listed together with the computed layer dielectrics and thicknesses. In this particular case the trace was analyzed to show 2 inches of wearing course, 6.3 inches of HMA base and 10.2 inches of rubblized concrete. The individual layer dielectrics are 6.2, 7.0 and 8.1. The dielectric for the rubblized concrete is low at 8.1; this is very dry. This number for a granular base is judged to be ideal if it is less than 10, and it would be a cause for concern if it was greater than 16.

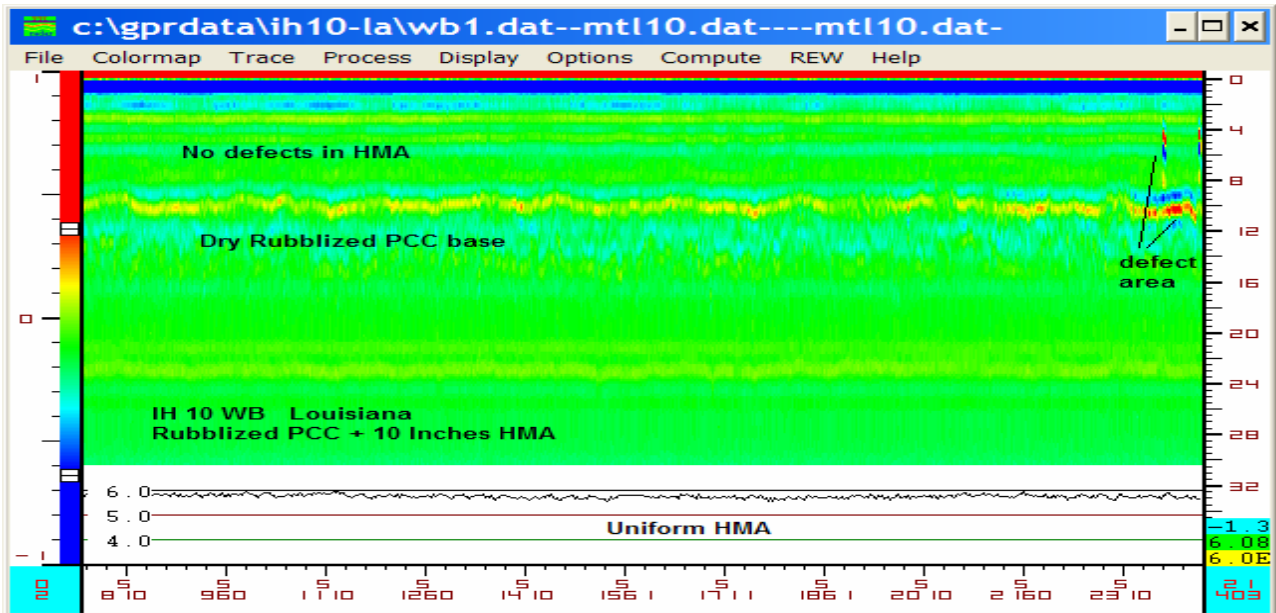
Figure 42. Typical Colormap Display for Job 2 (Ideal Case), Small Defect Area at Right.

Using the COLORMAP color coding scheme, 1500 ft of IH 10 is shown in [Figure 42](#). The scale at the bottom is the distance scale from 5 miles and 810 feet to 5 miles and 2310 feet. In this case, the surface has been moved to the top of the screen. The only significant reflection is a faint yellow line at a depth of approximately 10 inches. This is the top of the rubblized concrete layer. No defects are apparent in either the HMA or base layers. The line at the bottom of the [figure](#) is the surface dielectric plot. This is an indicator of the uniformity of the surfacing, and sudden localized dips would indicate areas of segregation. No significant segregation was found on either job. There is one small defect area to the far right of [Figure 42](#). There is a localized strong red/blue reflection at approximately mid depth in the HMA layer.

The results from Job 2 are judged as ideal and provide clear evidence that this is a well compacted, top quality, defect free HMA layer. For the entire project the surface dielectric was extremely uniform, and the base was dry. However, a few localized problems were detected. These are illustrated in [Figure 42](#). All of the defects in Job 2 were detected at either on or off ramps.

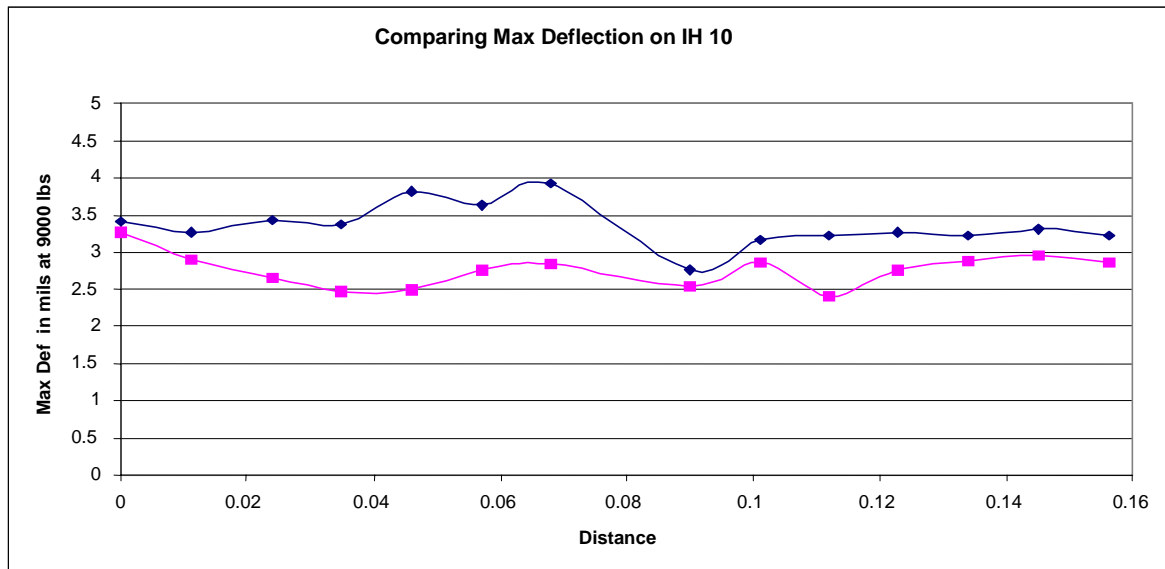
Figure 46. Comparing Deflection from the Rubblized Section (Job 2) with an Uncracked Concrete Slab.

A second set of deflection data were also collected mid-slab on a section of jointed concrete on IH 10, which was about to be rubblized. This was an intact 10 inch thick PCC slab made with gravel aggregates. Figure 46 compares the normalized maximum deflection data from the rubblized section on Job 2 to the unbroken concrete section. In both cases the data were normalized to 9000 lbs, and both sets of data were collected with a pavement temperature close to 67 ° F. It is interesting to note that the deflections from the rubblized pavement are very similar to the deflections from the concrete slab. In fact, the rubblized section has slightly lower deflections than the uncracked slab.

In summary, the structural strength of the rubblized section looks very good. The rubblized concrete base modulus of almost 850 ksi is well above that traditionally found with Class 1 flexible bases of 70 to 80 ksi. This indicates that the rubblized base is not being reduced to a flexible base. It is still retaining many features of a fractured slab. It was commented that the rubblization process rubblizes the upper layers but only introduces diagonal cracks in the lower part of the slab. These very high moduli values would support that observation.

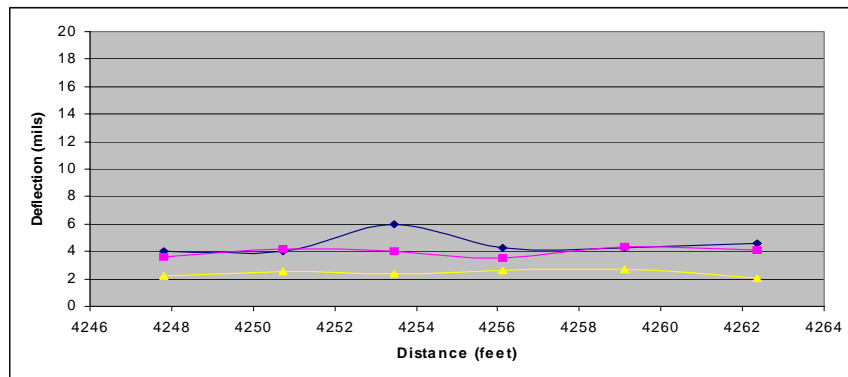
Figure 49. RDD Deflection for One Joint (Ideal Case).

With the RDD, deflections are continually monitored at all three rolling geophones. These data are processed to provide an average surface deflection for every 2 feet of pavement. A typical deflection profile for a single joint in the pavement is shown in [Figure 49](#). The blue line is the sensor directly between the loading wheels; the red and yellow lines are sensors 2 and 3.

The deflection pattern from the joint shown in [Figure 49](#) is judged to be the ideal case. At this location the pavement condition was excellent; the joints had zero faulting and the load transfer test with the FWD indicated that the LTE was between 95 and 100 percent. For US 82 the majority of the section gave joint deflection profiles similar to that shown in [Figure 49](#). However, as shown in [Figure 50](#), significantly different deflection patterns were also observed in other sections on US 82.

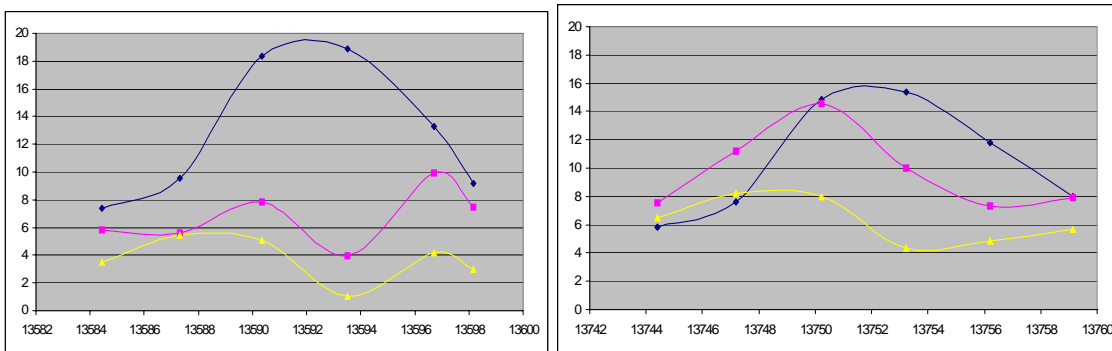
c) RDD Deflection Patterns over Typical Joints in the Distressed and Non-distressed Area

The upper plot in [Figure 49](#) shows the RDD deflection profile for a 700 ft section of US 82. The left of the [figure](#) shows that the pavement condition was poor with several broken slabs and some slab faulting. The right of the [figure](#) shows that the slab condition was good with no apparent surface distress. However, in both cases the two deflection patterns shown in [Figure 50c](#) are clearly different from the ideal case shown in [Figure 49](#).

As part of this evaluation a tentative interpretation was made of the deflection patterns shown in [Figure 50c](#). The deflection pattern on the left of [Figure 50c](#) is for the distressed area. It shows a large increase in sensor 1 deflections and some variations in sensors 2 and 3. However, the main characteristic is that there is a large difference in deflections between sensors 1 and 2 as the loaded wheel passes over the joint. The interpretation is that this area has poor load transfer and low subgrade support. The deflection pattern for the non-distressed section at the right of [Figure 50c](#) is very different from either the ideal case or the distressed case. In this area, large variations in all three sensors are occurring. In particular sensor 2 deflections are similar in amplitude as sensor 1. The interpretation here is that the subgrade support is poor, but the load transfer efficiency on the joint is good.

In an attempt to validate the subgrade support and load transfer efficiency classifications a limited number of DCP and FWD tests were conducted. The poor subgrade area was confirmed with the DCP. In the problem areas it was found that approximately 2 feet of very weak soil exists beneath the slab.

district could reduce the overlay thickness design. In zone 2 it is recommended that the district consider thickening the overlay required. In zone 3 some full-depth repair would be required but this would be problematic as the sub slab support is very poor, therefore substantial undercutting would be required. More work was suggested to define rehabilitation options for the zone 3 areas. These full-depth repair areas could be a candidate for a flexible base overlay similar to that used in the Lufkin experimental sections described in [Chapter 2](#) of this report.

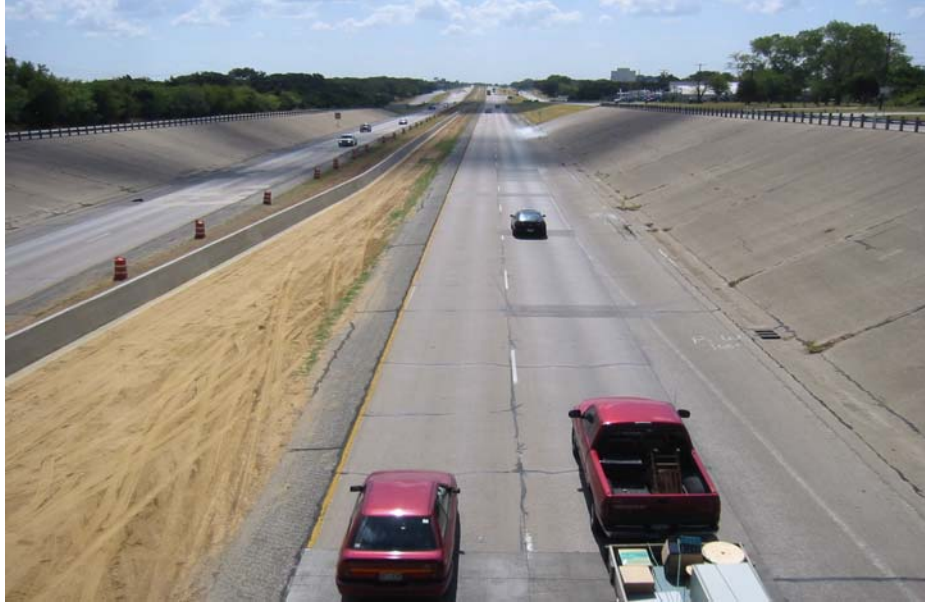
Figure 51. View of the Section of US 175 that Received Both the GlasGrid® and Strata® Treatment in December 2003.

In November of 2003 the Dallas District constructed a major experimental section to evaluate the ability of both GlasGrid® and Strata® to retard reflection cracking. The original pavement condition is shown in [Figure 51](#). The original structure consisted of a 45 year old JCP pavement, which had performed well. The pavement had variable joint spacings; in some areas the joints were at 50 ft spacing whereas in others a 15 ft joint spacing was found. The project length was almost 3 miles. In both directions a 1 inch level-up layer was placed on top of the JCP; in the southbound direction the GlasGrid® product was placed followed by a 2 inch surface layer. In the northbound direction the Strata® product was used with a 3 inch overlay. Both sections were completed in December 2003. It is recommended that this section be included in the monitoring in the second year of Project 0-4517.

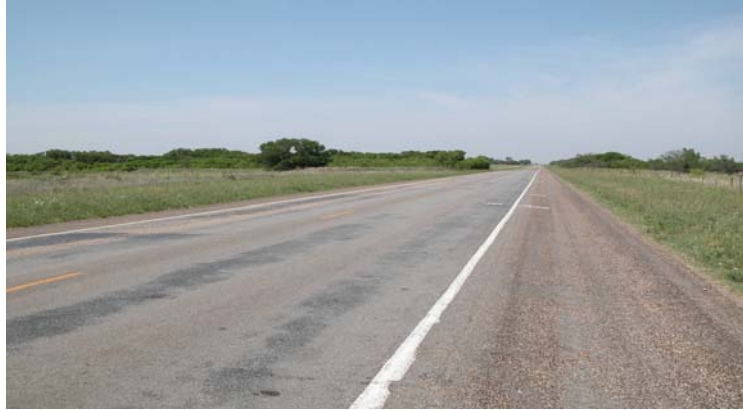
Figure 52. Rubblization Site on US 83 South of Childress.

Nondestructive testing data were collected on the site prior to construction. The view of the project is shown in [Figure 52](#). This is a relatively low volume roadway. The subgrades in the test area are good and the climate is dry, with some freeze/thaw cycling in winter.

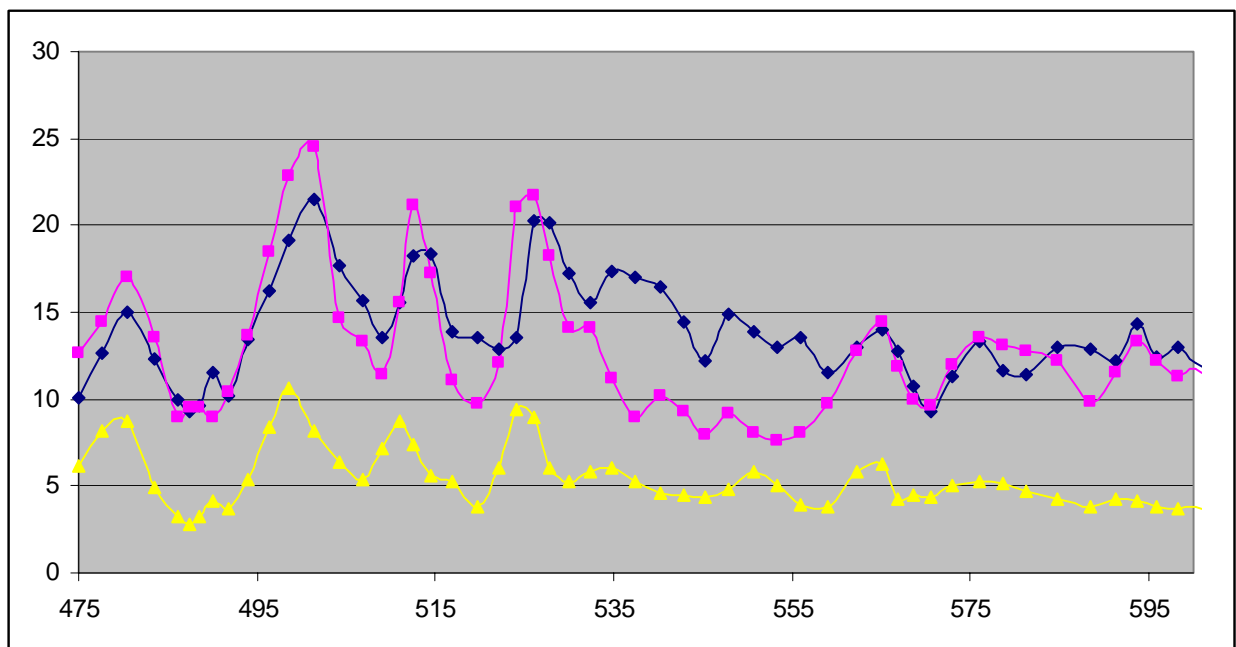
Figure 53. Rolling Deflectometer Data from Candidate Rubblization Site on US 83.

The NDT testing consisted of rolling deflectometer, FWD and GPR. In a few cases dynamic cone penetrometer data were also collected. In this test program, three different segments, which were to be rubblized, were tested. A sample of the RDD data collected is shown in [Figure 53](#). In all of the sections tested, the deflections were substantially higher than previously encountered on JCP pavement in other parts of Texas. The RDD maximum deflections were over 20 mils, and in several locations the sensor 2 deflections were higher than sensor 1. Based on previous experience on US 82, this would be classified as an area of good load transfer but very poor sub-slab support. The three adjacent joints starting at 495 feet have very high deflections.

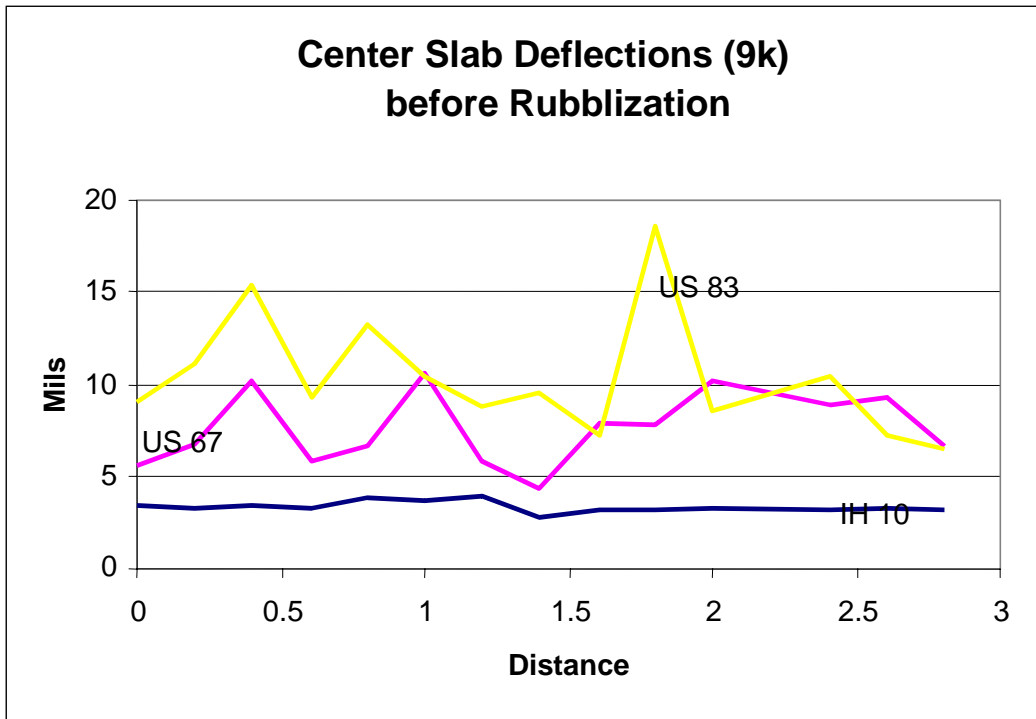
Figure 55. Comparison of Center Slab Deflections on Three Candidate Rubblization Projects.

The high deflections on the US 83 project are also shown in [Figure 55](#). These are maximum deflection values normalized to 9000 lb load. The US 83 results are compared with those from two other rubblization projects. The IH 10 results are from Louisiana where rubblization has been documented to be working very well. The US 67 project is from the Atlanta District of Texas where rubblization was a problem. These data were collected center slab before attempting rubblization. One concern about the US 83 project is that the initial deflections were substantially higher than on the other two projects, one of which was judged to be a failure.

The conclusion from this evaluation is that the slab on US 83 is resting on a weak dry sand layer. If deflection is a good criteria for determining if US 83 is a good candidate for rubblization, then based on the results in Figure 55 it could be assumed that US 83 is not a good candidate. If the selection criteria should be based on the presence of sub-slab moisture, then US 83 would be judged to be a good candidate. It will be critical to follow the construction of US 83 in the spring of 2004, to determine if the slab can be effectively rubblized and if the resulting

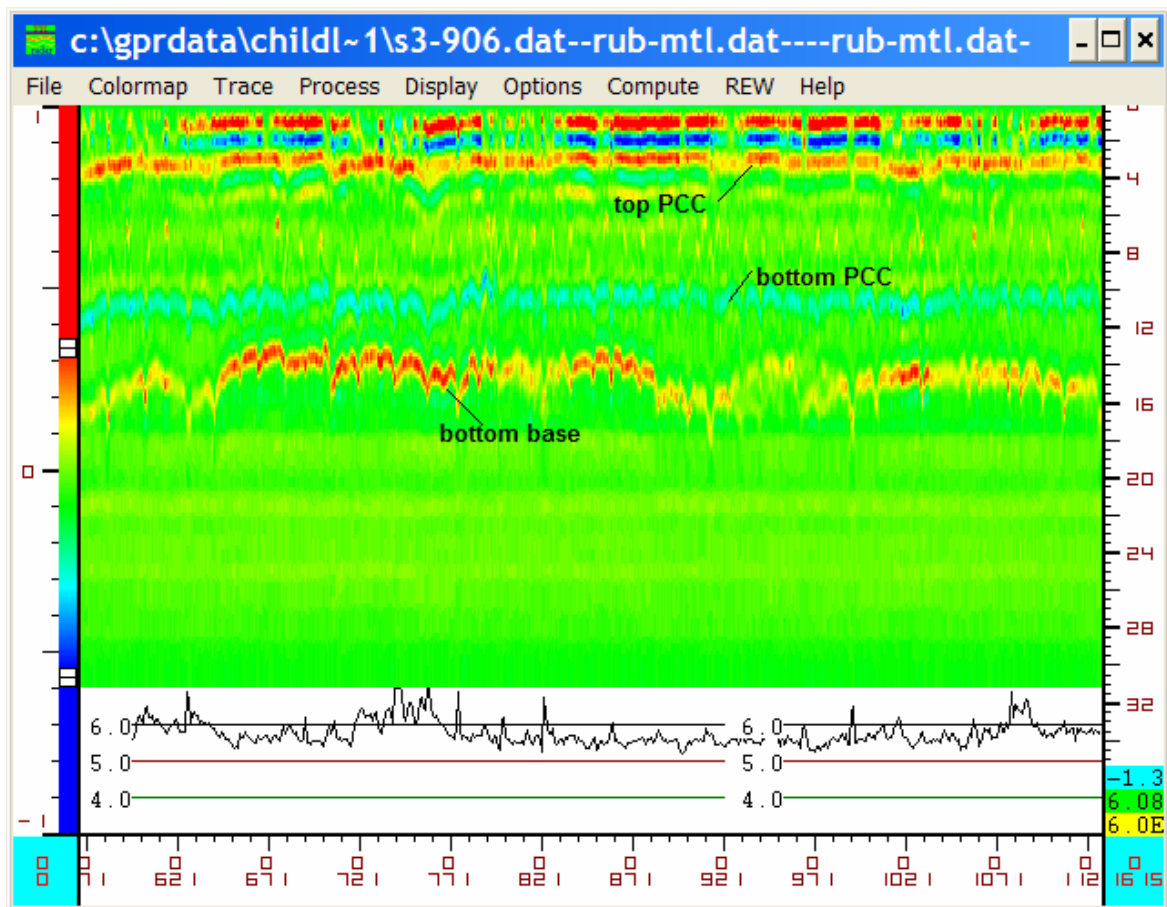
Figure 56. GPR Data on Candidate Rubblization Site on US 83.

To complete the NDT testing on US 83, ground penetrating radar data were collected on all the candidate rubblization projects. The data collected on site 3 are shown in Figure 56; this is the project with the extremely low moduli values shown in Figure 54. The key feature of this figure is the strong negative reflection (blue line) at the bottom of the slab. This is an indication that the select fill may be of low density or have eroded in several places. The select fill material is also very dry. The fill appears to be 4 to 5 inches thick, and then the GPR wave encounters a higher dielectric soil layer, marked as the bottom of the base in Figure 56.
