METHODS OF REDUCING JOINT REFLECTION CRACKING: FIELD PERFORMANCE STUDIES

Report 0-4517-3
Project 0-4517

Project Title: Develop Statewide Recommendations for Application of PCC Joint Reflective Cracking Rehabilitation Strategies Considering Lufkin District Experience

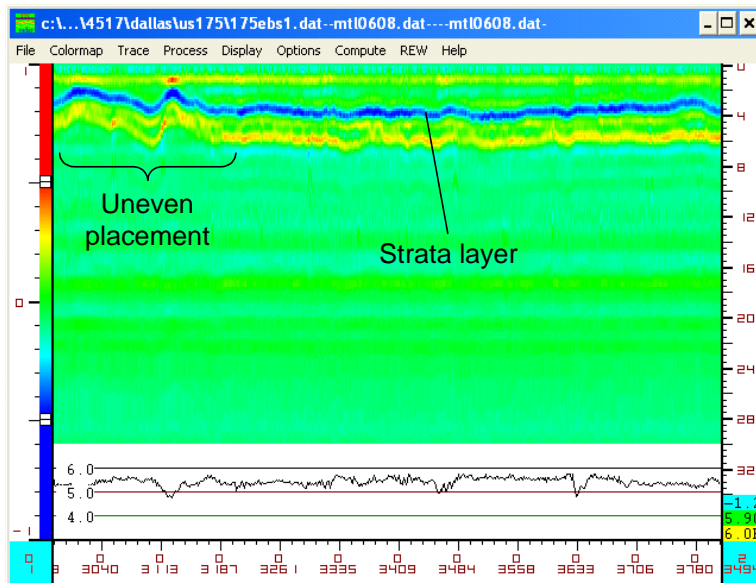
Figure 19. GPR Data Collected on Eastbound US 175.

A GPR survey of the outside wheel path of both lanes was conducted. The data show strong reflections at the Strata layer, which is expected due to the difference in material types. Inconsistent surface thickness, which indicates some construction problems, is the only problem noted from the GPR data. Typical GPR data are shown in [Figure 19](#).

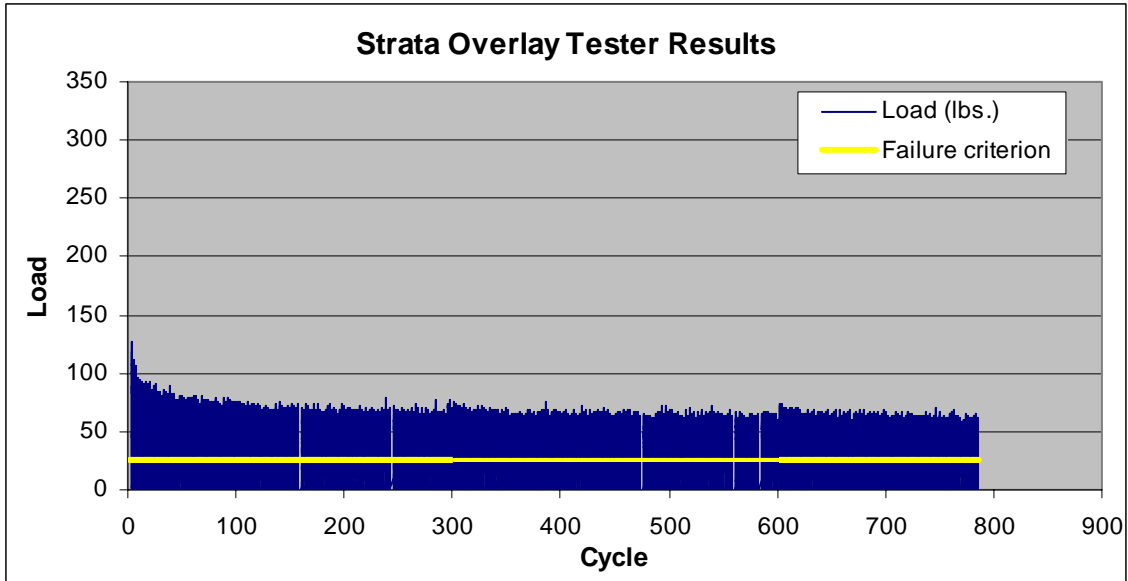
Figure 21. Strata Overlay Tester Results.

The Strata performed well on the test and passed the design criteria for crack resistant materials by exceeding 750 cycles of the test. The results of the test are shown in Figure 21. The yellow line in the figure shows the failure load level based on the criteria given above.

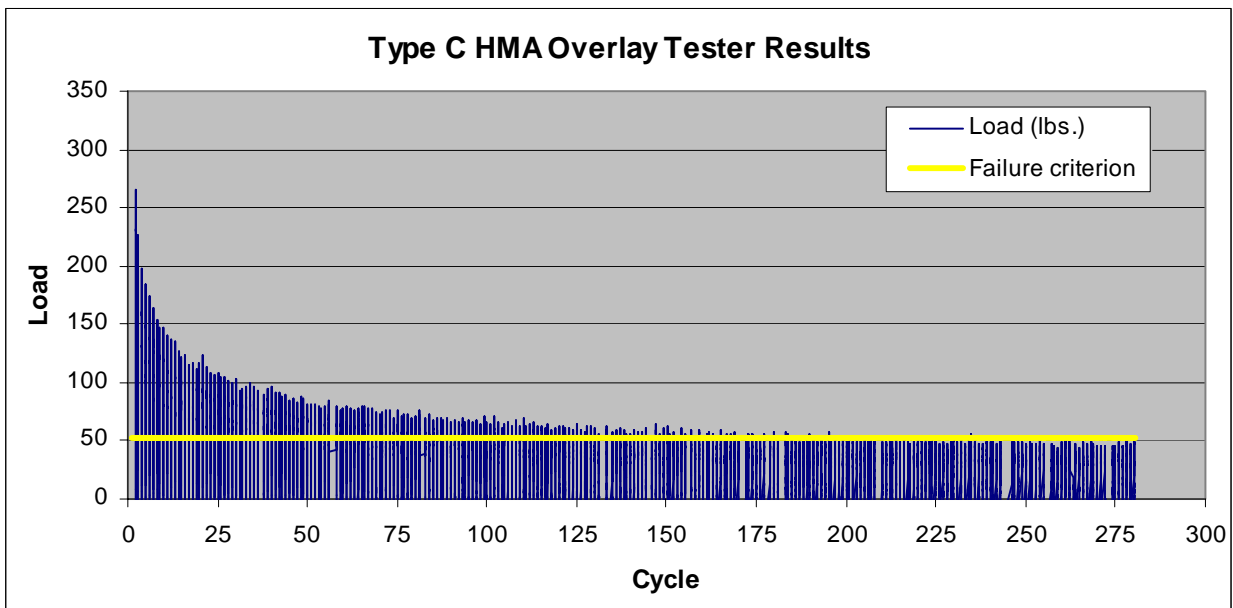
Figure 22. Type C HMA Overlay Tester Results.

The Type C HMA mix did not pass the design criteria for Types C and D mixes. Failure occurred at 169 cycles, which is below the design criterion of 300 cycles for this type of mix. The results of the test are shown in [Figure 22](#).

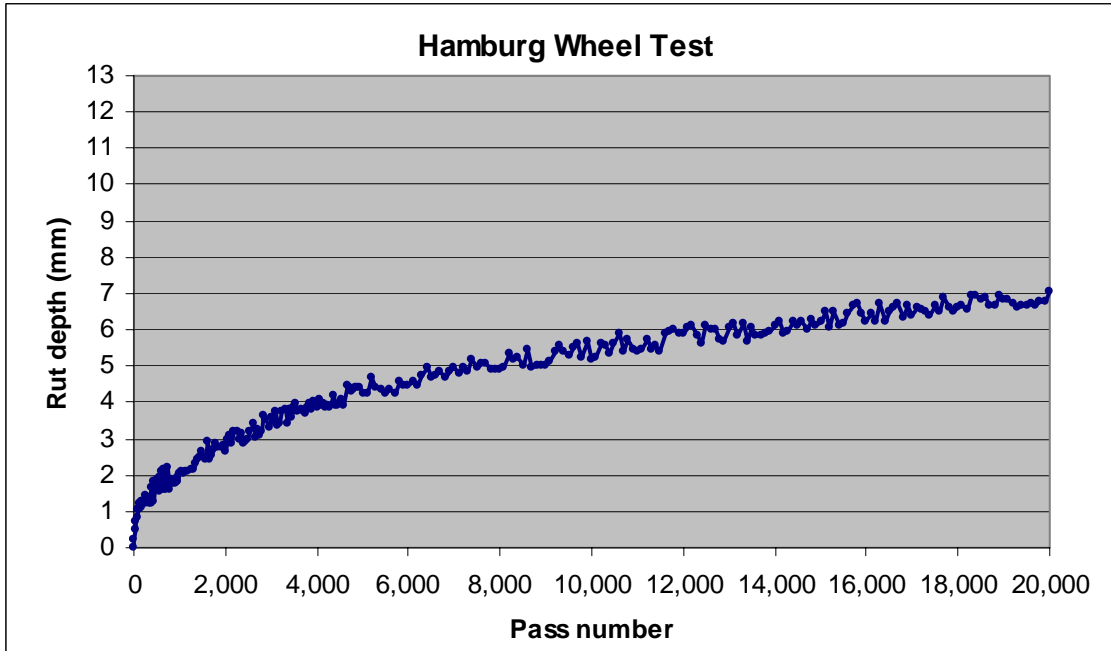
Figure 24. Hamburg Wheel Test Results for the US 175 Material.

The Strata and Type C HMA combination performed well on the test and passed the design criteria by not failing within 20,000 passes. The final rut depth was 7-mm after 20,000 passes. The results of the test are shown in [Figure 24](#).

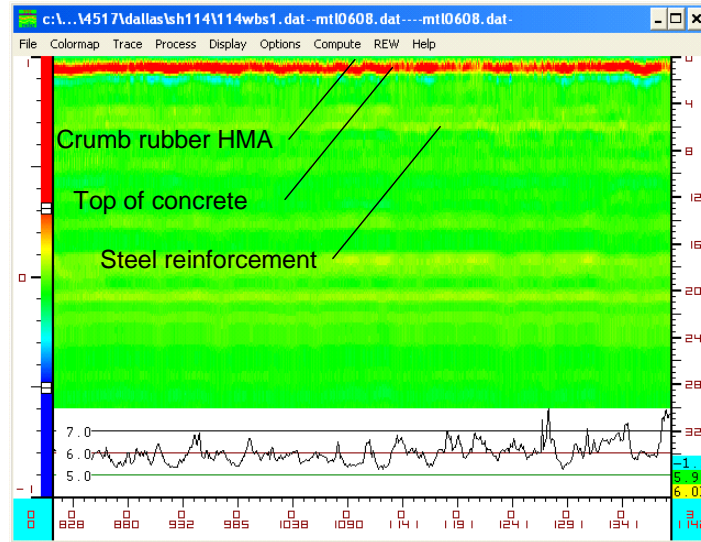
Figure 27. GPR Data Collected on SH 114.

A GPR survey of the outside wheel path of both lanes was conducted. The data clearly show the consistent thickness of the crumb rubber layer on the concrete. No major moisture problems were noted in the pavement structure. Typical GPR data are shown in [Figure 27](#).

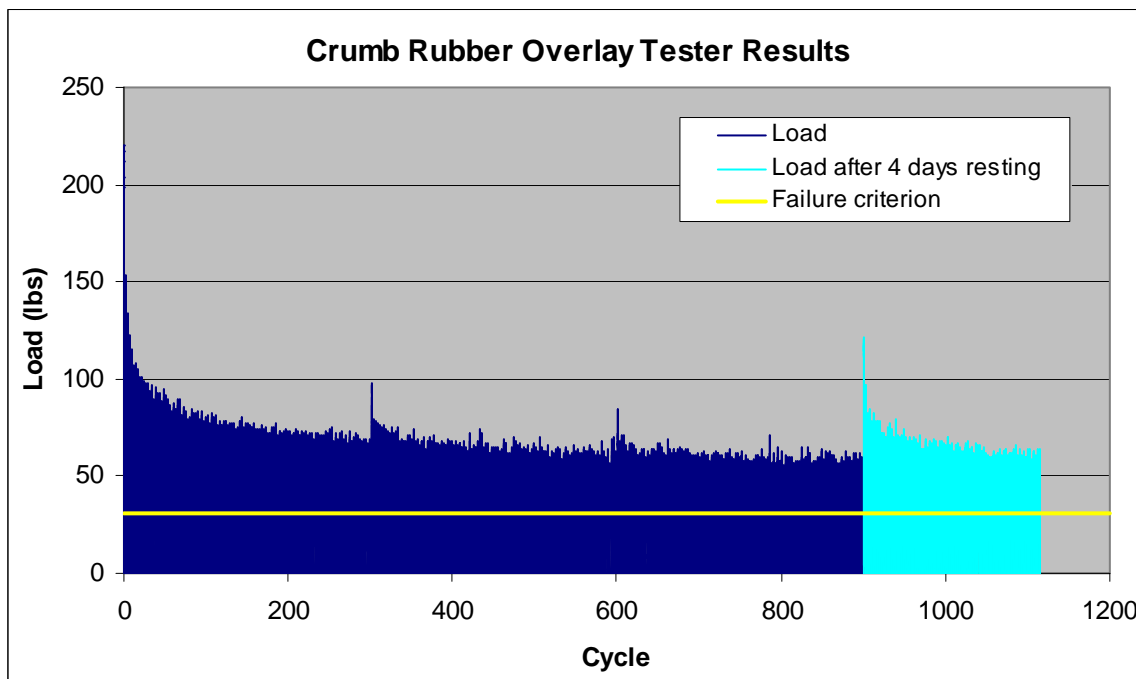
Figure 29. Crumb Rubber Overlay Test Results.

The crumb rubber performed well on the overlay test and passed the design criteria for crack resistant materials by exceeding 750 cycles of the test. The results of the test are shown in [Figure 29](#).

Since it was suspected that some healing of the crumb rubber layer may have been taking place in the field, it was decided to retest the sample after completion of the usual test. The sample was retested 4 days after the initial test. The secondary test showed a noticeable increase in the resistance to the strain in the secondary test when compared to the state of the sample at the end of the first test. This may be evidence of healing of the sample, but further investigation will be needed to provide conclusive proof of healing.

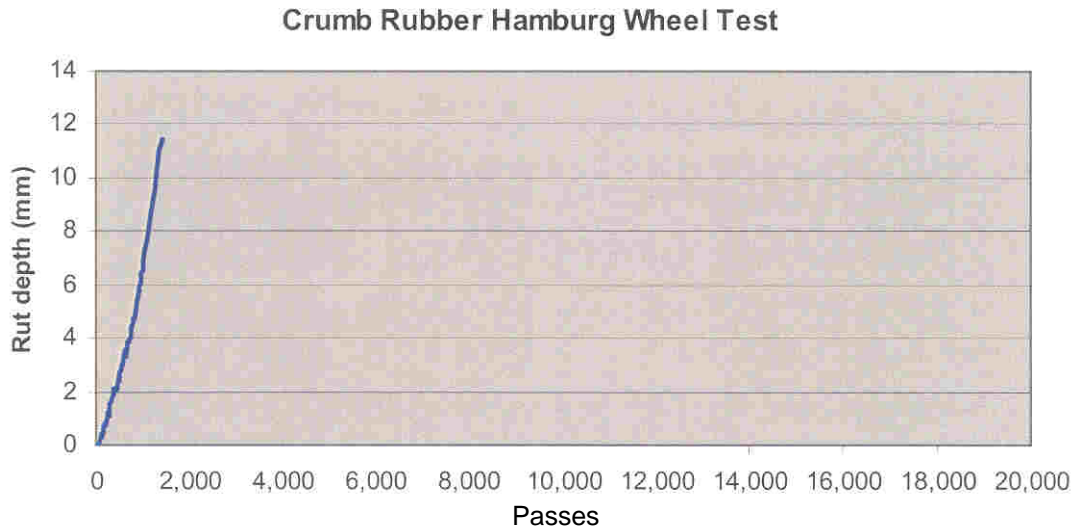
Figure 31. Hamburg Wheel Test Results on Crumb Rubber.

The crumb rubber performed very poorly on the Hamburg test. The sample was approaching failure within 2000 passes. The binder used in this sample was AC-10, which is judged to be equivalent to the current PG 64-22, which has a Hamburg requirement of 10,000 passes. The results of the test are shown in [Figure 31](#).

The results show that the crumb rubber layer is very susceptible to rutting and permanent deformation. No severe rutting was noted in the field, but the traffic on the frontage road is very light and of low volume. The frontage roads provide access to office complexes off SH 114. Some evidence of permanent deformation was noted in the braking areas on the frontage roads, but this was not widespread.

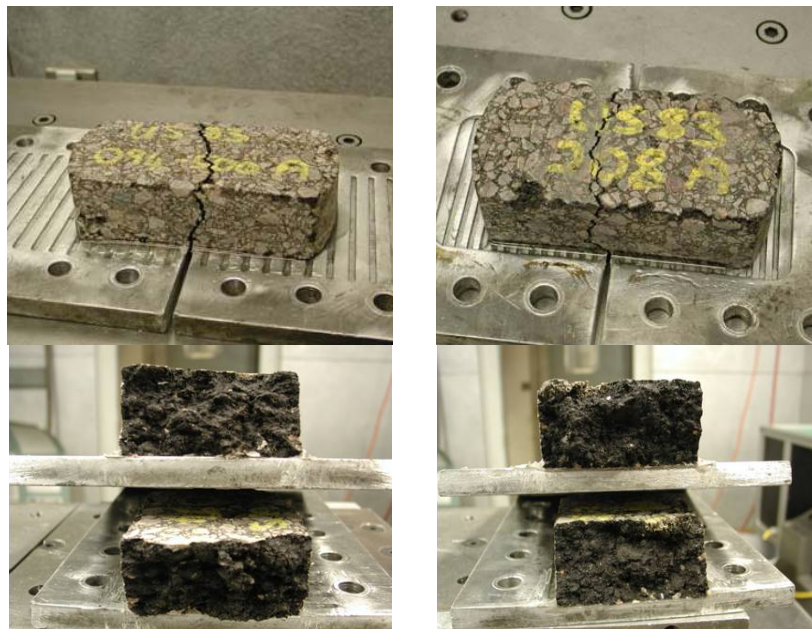
Figure 33. US 83 HMA Specimens Cracked in the Overlay Tester.

The specimens failed within 10 cycles of the overlay tester, which is far below the tentative design criterion of 300 cycles for Types C and D mixes. This early failure indicates that the asphalt mixes that were used on US 83 are susceptible to reflection cracking. A visual inspection of the crack surfaces of these mixes indicated that the mixes were dry and that the asphalt surface was dull.

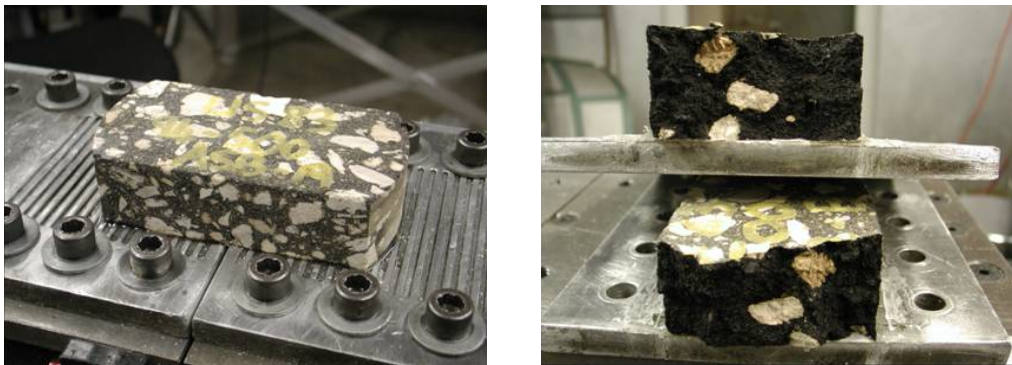
Figure 34. US 83 Stabilized Base Specimens Cracked in the Overlay Tester.

The specimens failed within 10 cycles of the overlay tester. This indicates that the asphalt stabilized base also has a poor resistance to reflection cracking.

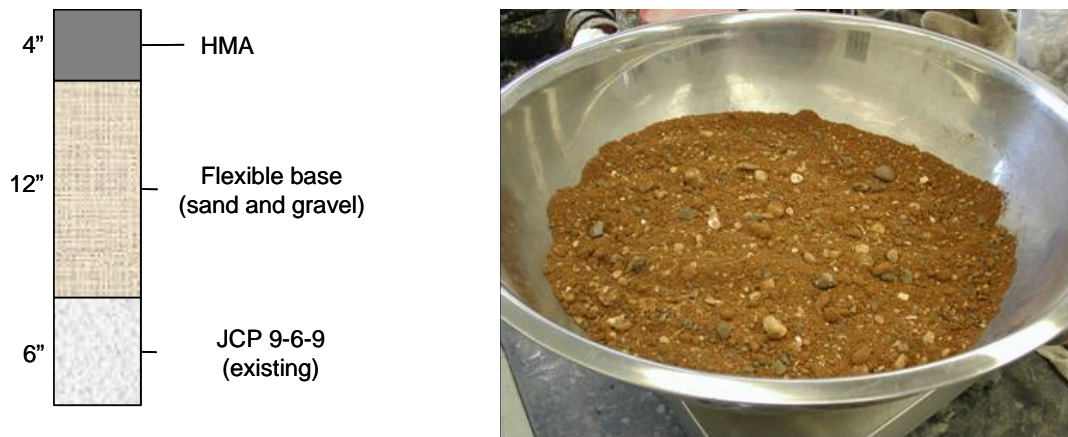
Figure 35. Flexible Base Overlay Section on US 83.

In Report 0-4517-1, it was found that the best performing section on the Lufkin project was the use of untreated gravel base and a thin asphalt surfacing placed directly over the jointed concrete pavement. In 1963, a similar rehabilitation strategy was used on a short section of US 83 just south of Paducah. A $\frac{3}{4}$ -mile jointed concrete pavement section was overlaid with 12-inches of flexible base (sand and gravel) and a 2-inch HMA surface course. This section has provided 40+ years of excellent service with no transverse cracks reflecting through from the bottom layers and no other major distresses. Adjacent sections, where the jointed concrete was overlaid with HMA, have experienced reflection cracking problems. A 2-inch HMA overlay and surface seal was applied to the entire road section in 2003, so no distresses were visible on the surface at the time of evaluation. However, the ride was excellent and maintenance forces had mentioned that the base overlay section had little distress at the time of overlay. A typical pavement section and a photograph of the base retrieved are shown in [Figure 35](#) below.

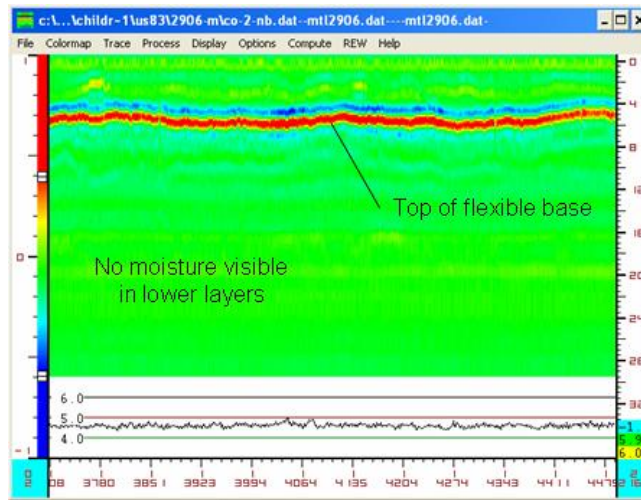
Figure 37. GPR Data on US 83, Thick Flexible Base.

A GPR survey of the outside wheel path of both directions was conducted. Details of GPR data analysis can be found elsewhere (Scullion and Chen, 1999). The purpose of this evaluation was to check the moisture condition in the base layer. High dielectric values are associated with wet base areas. Typical GPR data for this section are shown in Figure 37.

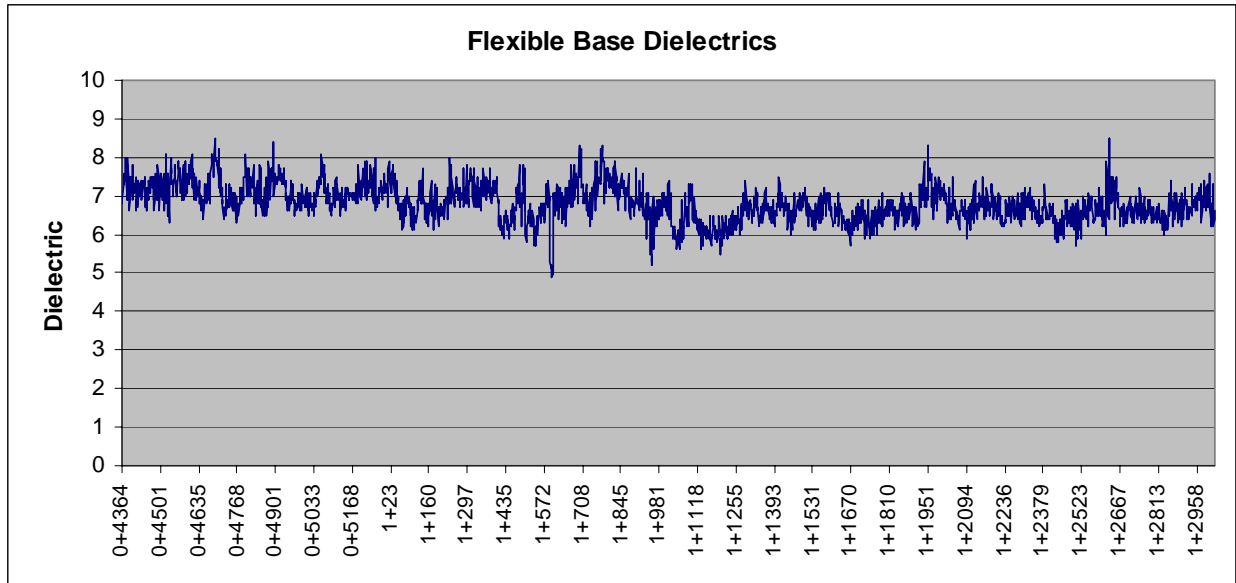
Figure 38. Dielectrics of Flexible Base Overlay on US 83.

The dielectrics of the flexible base layer for the northbound direction are shown in Figure 38. The average dielectric for this layer is in the 7 to 9 range, which is judged to be low, indicating a dry base. Experience has shown that bases with dielectrics in the 10 to 12 range indicate moderate moisture levels and values above 16 indicate wet/saturated. The base on this section is very dry.

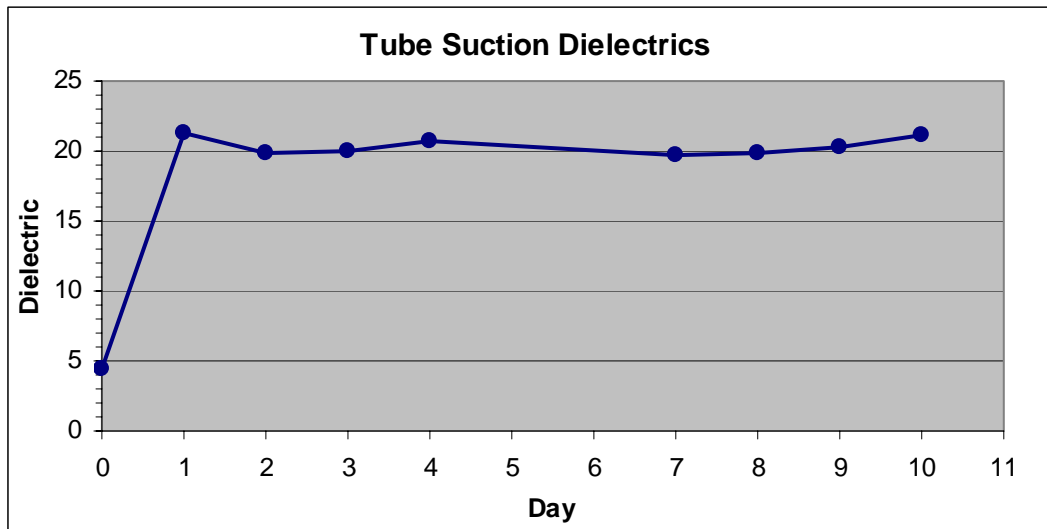
Figure 39. Tube Suction Test Dielectric Results.

The results of the test show a rapid increase in moisture at the surface of the sample and a high final dielectric of 20.5. The final moisture content of the base was 11 percent, which is much higher than the optimum moisture content of 4 percent. This test indicates that this base is very susceptible to moisture.

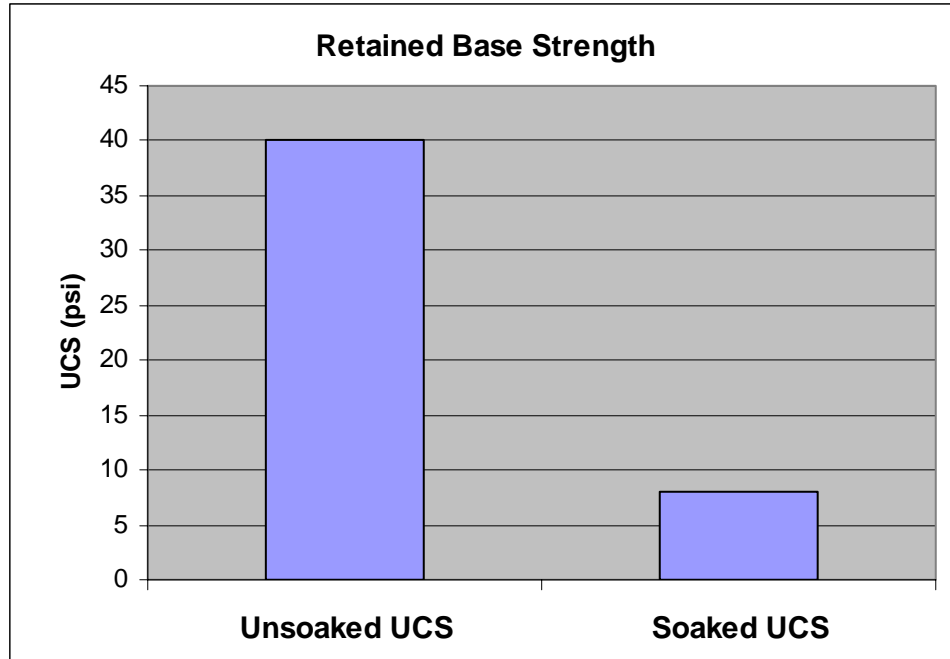
Figure 40. Unconfined Compressive Strength of Base.

The retained strength is, therefore only 20 percent of the unsoaked strength. This is considerably below the requirement of 75 percent retained strength. This indicates that this is a highly moisture susceptible base.

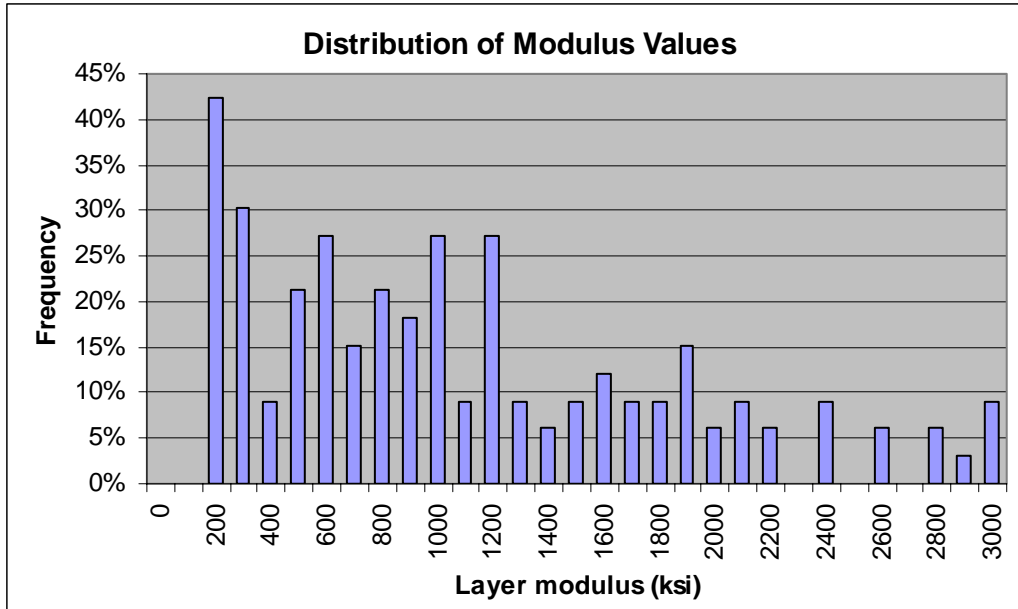
Figure 41. Distribution of Modulus of Cracked Layer.

From the distribution above, it is evident that the resultant modulus values of the crack and seat layer are highly variable. The values greater than 2000 ksi are suspected to be areas where the concrete has not been cracked. Over 10 percent of the tested locations had modulus values of greater than 2000 ksi. With such highly variable results, it is not possible to recommend a single modulus value for design. Further investigation may be needed to derive a design value. Detailed FWD analysis results can be found in [Appendix A](#).

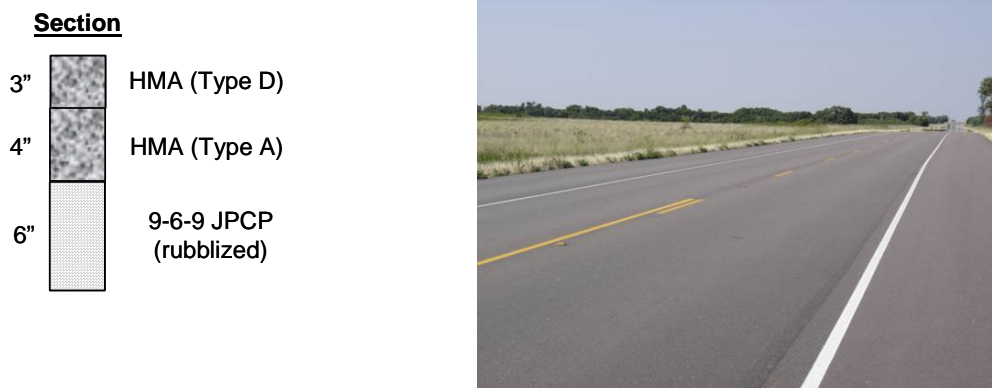
Figure 42. Structure on US 83.

The Childress District has rubblized a section of US 83. A continuous section 0.9 mile long, from FM 3256 northward, was evaluated. This section is 2 years old and is still performing excellently. The pavement section and a photograph of the section are shown in [Figure 42](#).

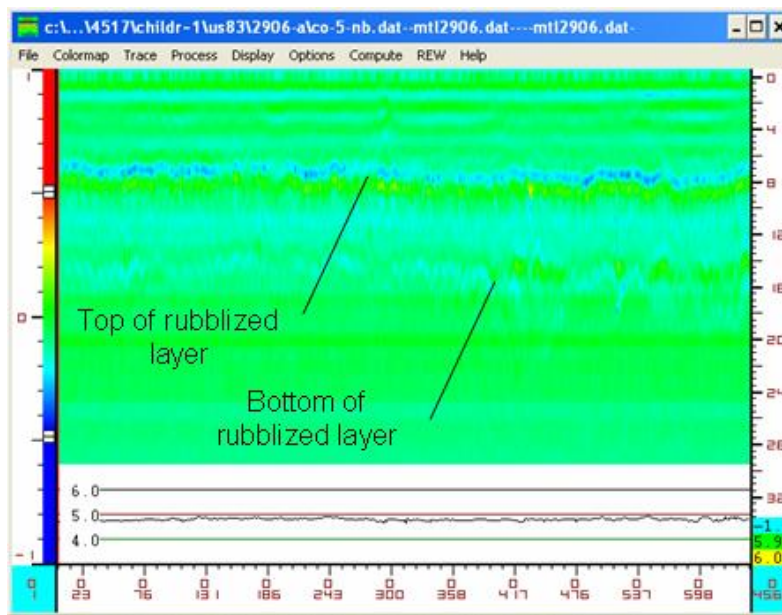
Figure 43. GPR Data on US 83, Rubblized Section.

GPR survey was conducted on this section, and no moisture was found in the rubblized layer. Typical GPR data are shown below in [Figure 43](#).

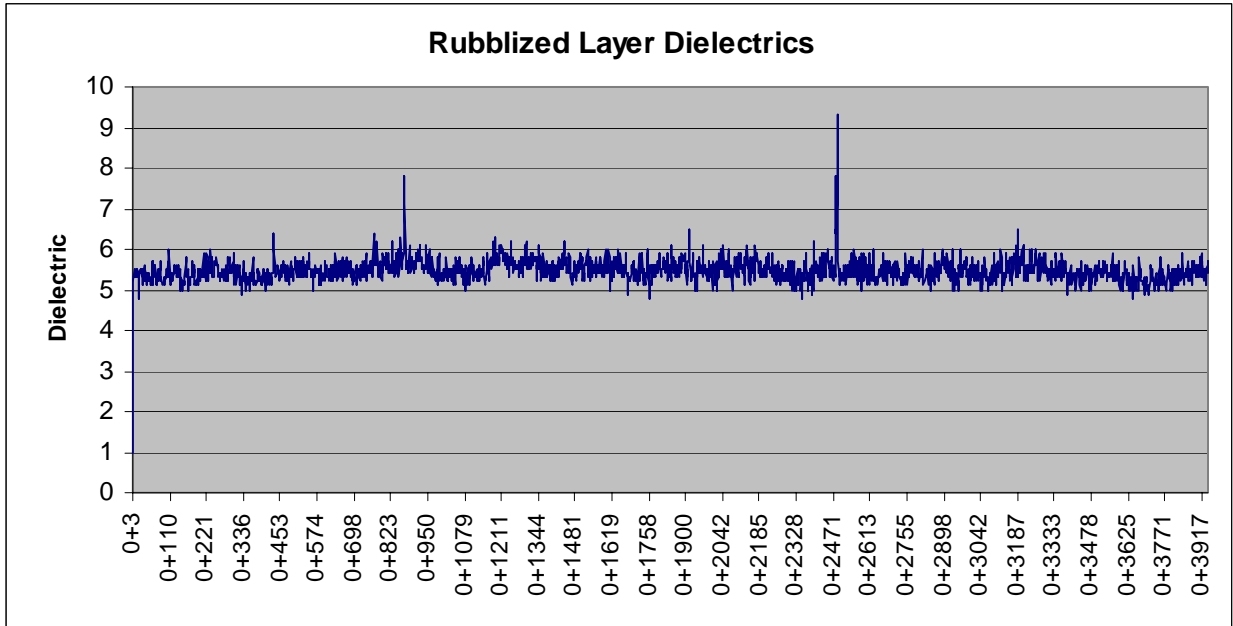
Figure 44. Dielectrics of a Rubblized Section on US 83.

The dielectrics show a consistent low moisture level within the rubblized section. There are two low spikes in the dielectric values, which may reflect moisture or other discontinuities in the layer.

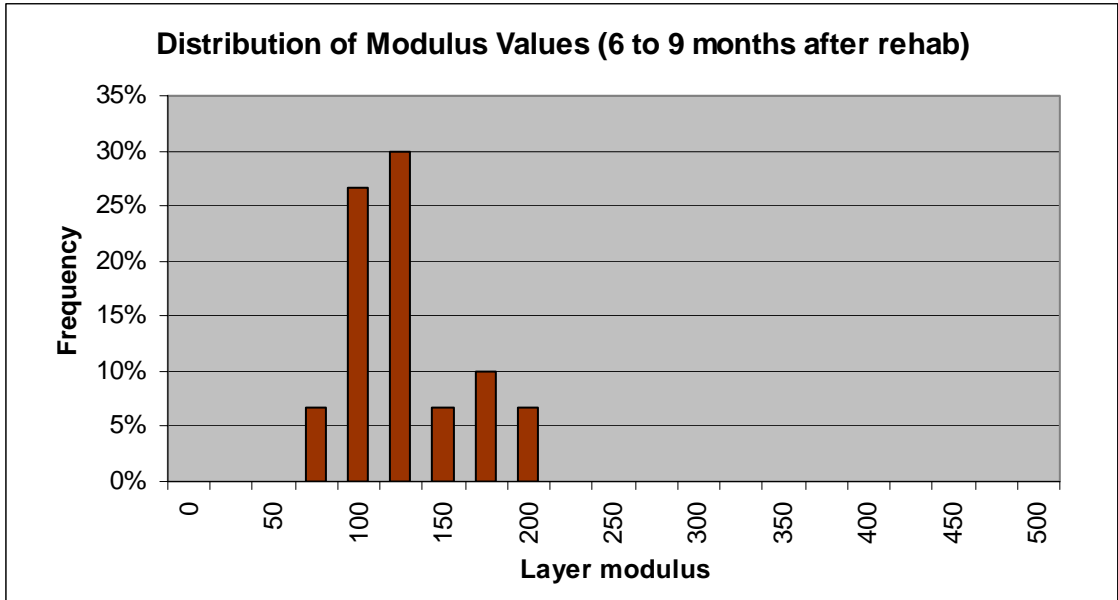
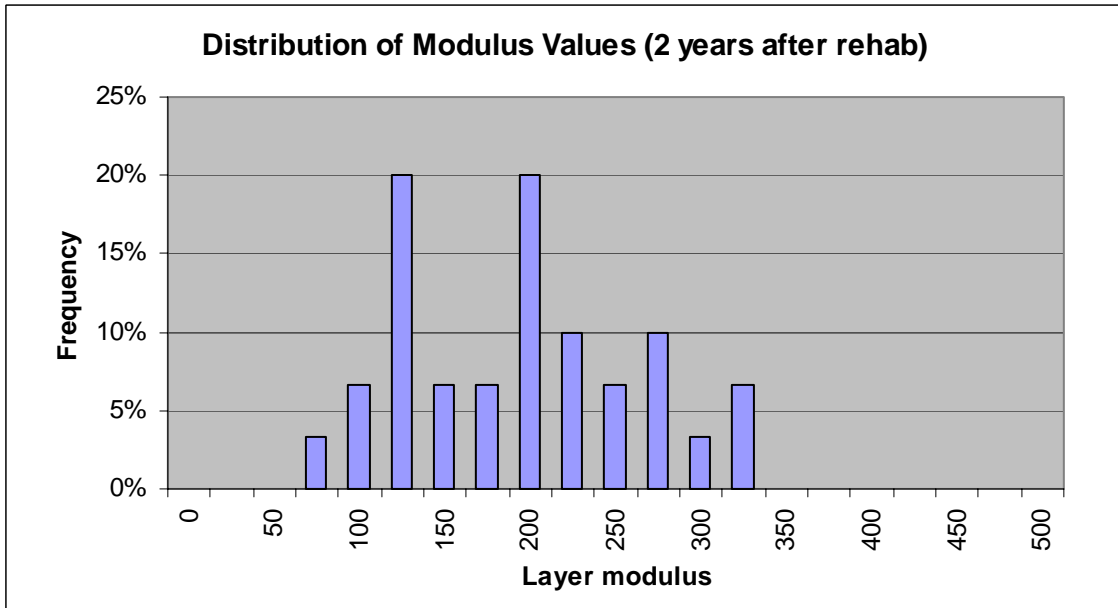
Figure 45. Distributions of Modulus of the Rubblized Layer.

The results show that the concrete layer has increased in stiffness after the rubblization from 115 ksi to 200 ksi. The variance of the layer modulus has remained fairly constant over all stages of the rehabilitation, and the subgrade modulus has also remained fairly constant. The distributions of the modulus values soon after the rubblization and 18 months after the rubblization are shown in [Figure 45](#).

When the rubblized concrete modulus values are compared to the crack and seat modulus distributions, it is clear that the variance of the rubblized modulus values are considerably less than the crack and seat modulus values. There are no tests with modulus values greater than 2000 ksi in the rubblized section. This indicates that the rubblization was effective in breaking up the slabs. It should be noted that the sample size of the rubblization tests is much smaller than the crack and seat tests with 30 drops and 123 drops, respectively. However, the results described above are very similar to the moduli distributions reported by [Witczak and Rada \(1992\)](#).

More FWD data should be collected on the rubblized monitor section on US 83. The increase in base modulus with time should be studied further; if confirmed, it could indicate that the rubblized base is “self-cementing.” The Childress District is planning to use rubblization on three more projects in 2006. These projects will also be monitored in the future.
