1. Report No. FHWA/TX-08/0-4687-2		2. Government Accession No.		3. Recipient's Catalog No.	
4. Title and Subtitle FIELD EVALUATIONS AND GUIDELINES FOR RUBBLIZATION IN TEXAS				5. Report Date September 2007 Published: December 2007

FIELD EVALUATIONS AND GUIDELINES FOR RUBBLIZATION IN TEXAS

Report 0-4687-2
Project 0-4687
Project Title: Rubblization and Crack and Seat
as Major Rehabilitation for Concrete Pavements

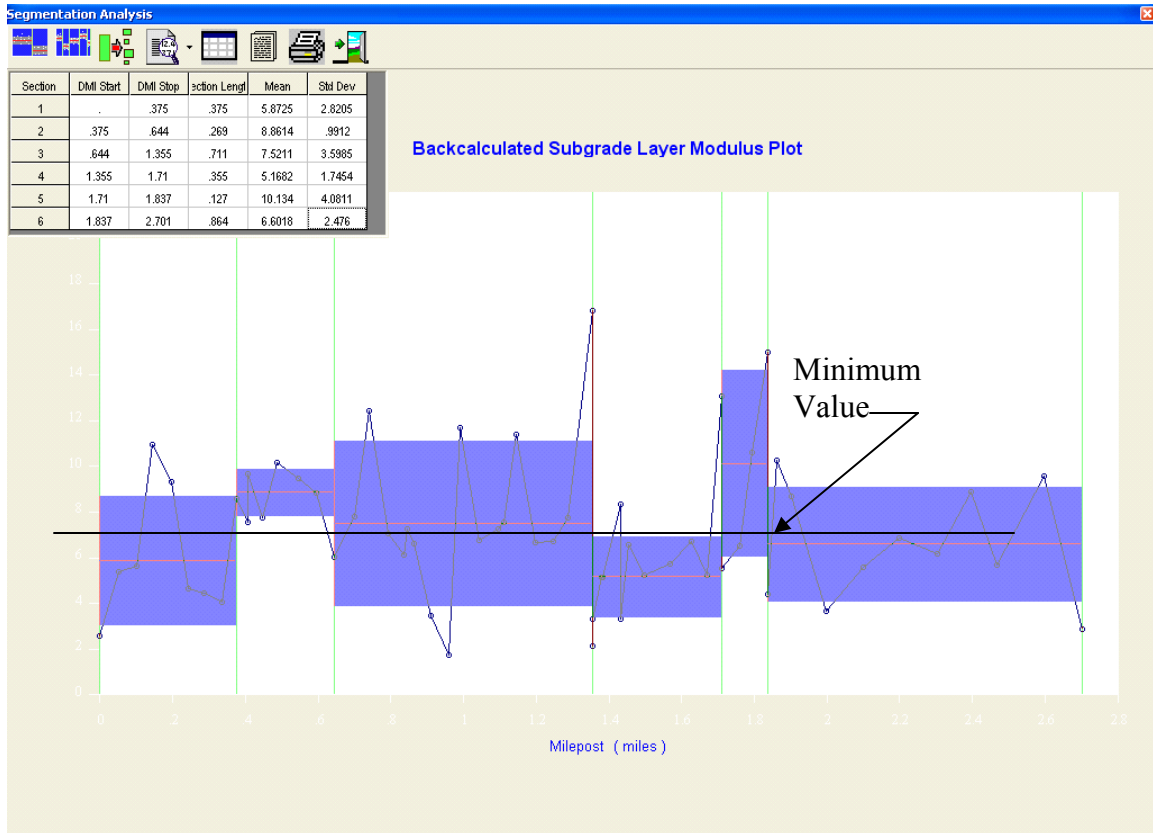
**Figure 1.6. FM 912 Backcalculated Subgrade Modulus with Distance (SB direction).
Note: Milepost Zero is at RM 628 + 0.182**

To segment the project, the backcalculated subgrade modulus with distance is graphed in Figure 1.6. Segments 2 and 6 are marginally suited for rubblization. The average subgrade value exceeds (segment 2) or nearly meets (segment 6) the required minimum value. The DCP data from within these sections indicate they are marginally suitable for rubblization. The limits of these sections are from RM 628.557 to 628.826 and 630.019 to 630.658.

The first segment is not suitable for rubblization because the subgrade modulus is less than the required minimum value. Segments 3 through 5 should not be rubblized due to their proximity to locations where voids have occurred beneath the slabs.

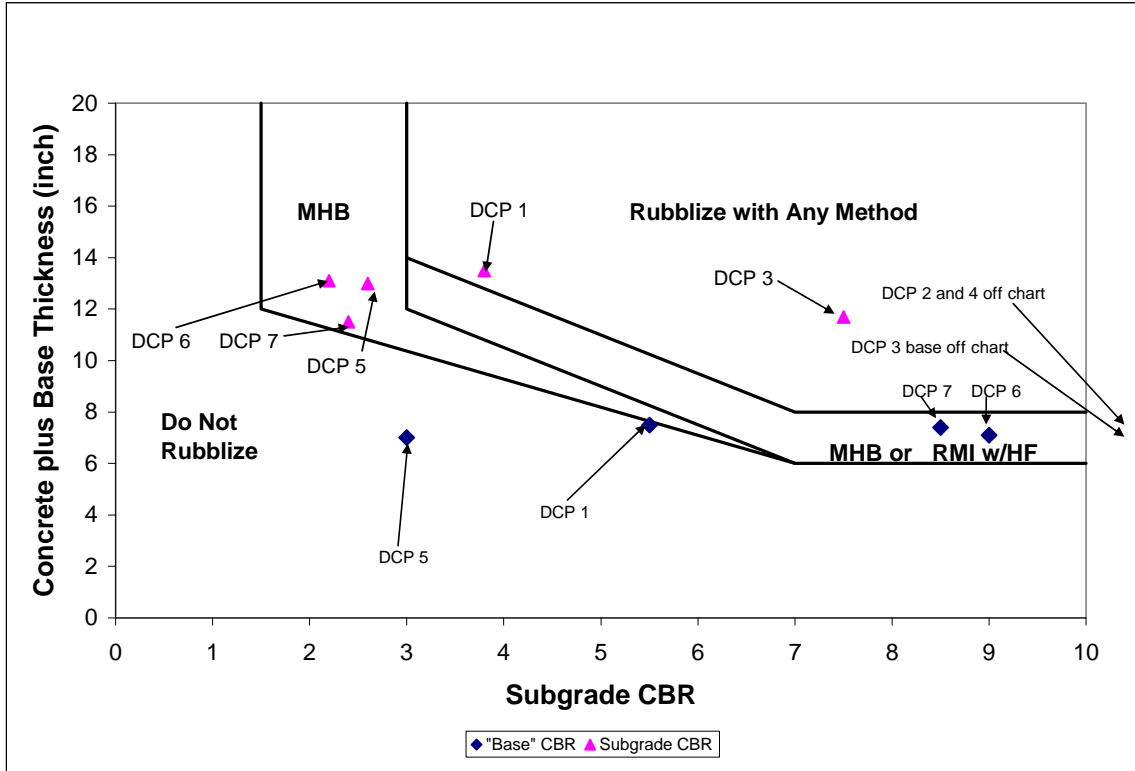
Figure 2.4. DCP Results from FM 1155 on IDOT Rubblization Selection Chart.

- The location at DCP 1 is of questionable suitability for rubblization due to marginal support immediately beneath the slab.
- The locations represented by DCP tests 2, 3, and 4 are suitable for rubblization.
- At the location of DCP 5, support is inadequate for rubblization; the concrete may not break. Additionally, due to the poor support, even if the concrete does break, if the resonant breaker was used, the multiple passes may result in shear failure of the subgrade.
- At the locations of DPC 6 and 7, the project is marginally suitable for rubblization. This is because although reasonable support exists immediately beneath the slab, the subgrade quality quickly deteriorates with depth. Again, depending on equipment used, shear failure in the subgrade could occur from loading stresses from the construction equipment.

- The first 1000 feet are of questionable suitability for rubblization.
- From 1000 to 4550 feet, the project should be suitable for rubblization.
- From 4550 to 5250 feet, the subgrade support is likely too poor to support rubblization operations. A core should be taken at 5000 feet to verify the pavement structure.
- From 5250 feet to the end of the JCP, the project is marginally suitable for rubblization.
- Given the soil conditions, the multi-head breaker likely is the safest equipment to use if rubblization is attempted.

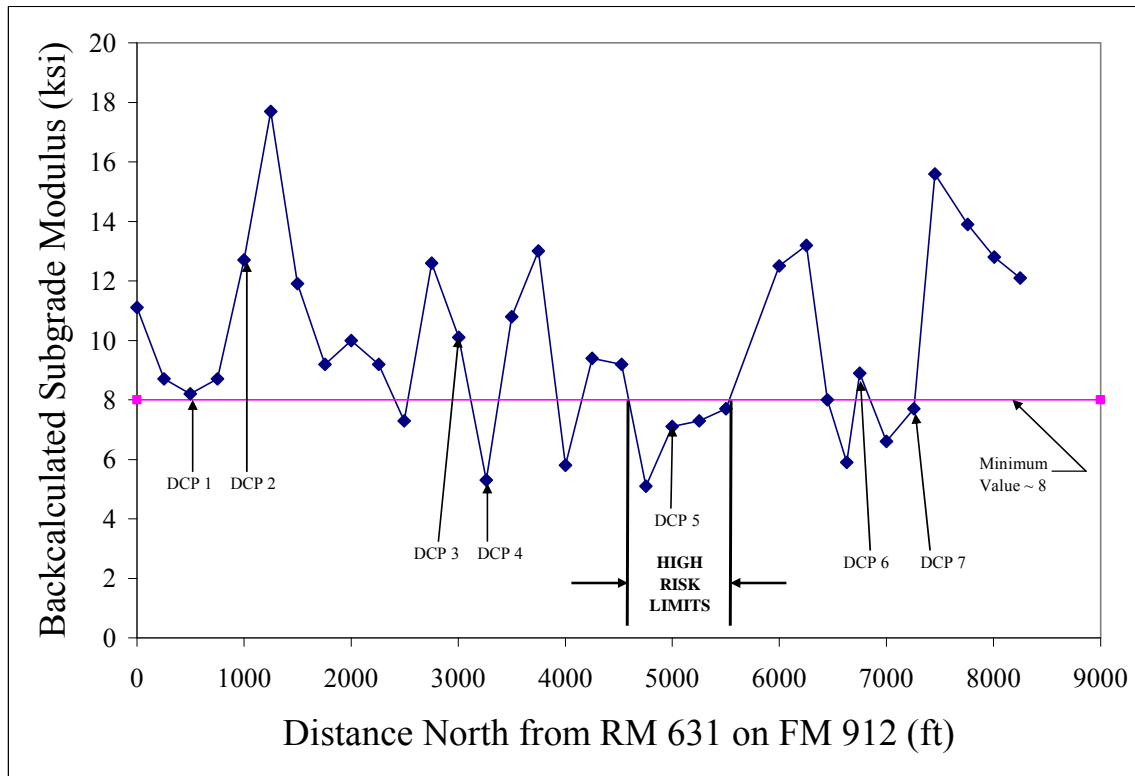
**Figure 2.7. FM 1155 Backcalculated Subgrade Modulus with Distance (NB direction).
Note: Zero Distance is at RM 631 on FM 912.**

Figure 2.7 shows the backcalculated subgrade modulus with distance for the project. Using the approximate minimum subgrade CBR of 8, rubblization may not be feasible for approximately one third of the project. With the FWD analysis in conjunction with the DCP analysis, the greatest risk of encountering problems if rubblization is attempted exists between 4580 to 5250 feet north of RM 631 on FM 912.

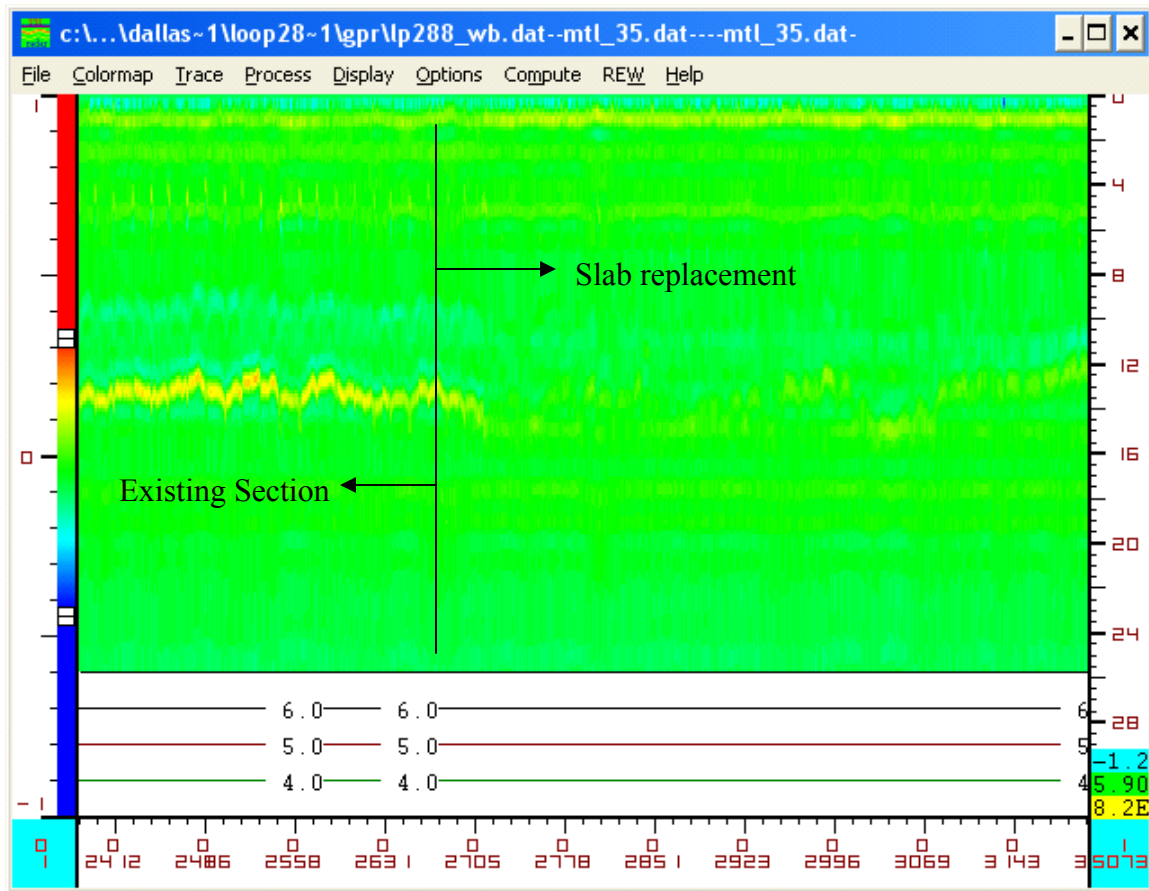
Figure 3.3. Section Break at Location of Slab Replacement in Westbound Travel Direction.

The GPR survey serves two primary purposes. First, the survey can identify section breaks. Second, the GPR survey can identify locations of excessively wet subgrade or trapped water, both of which hinder the rubblization process. In the survey, the signal from the LTS was lost at locations of slab replacement. From discussions with area office personnel, it is believed the change in signal is due to undercutting the subgrade and placement of hot-mix asphalt beneath the new slabs. [Figure 3.3](#) shows one of the section breaks at a location of slab replacement. No non-typical GPR traces were seen other than at locations of slab replacements. The GPR data did not indicate any locations of excessive moisture, which, if present, can hinder rubblization activities.

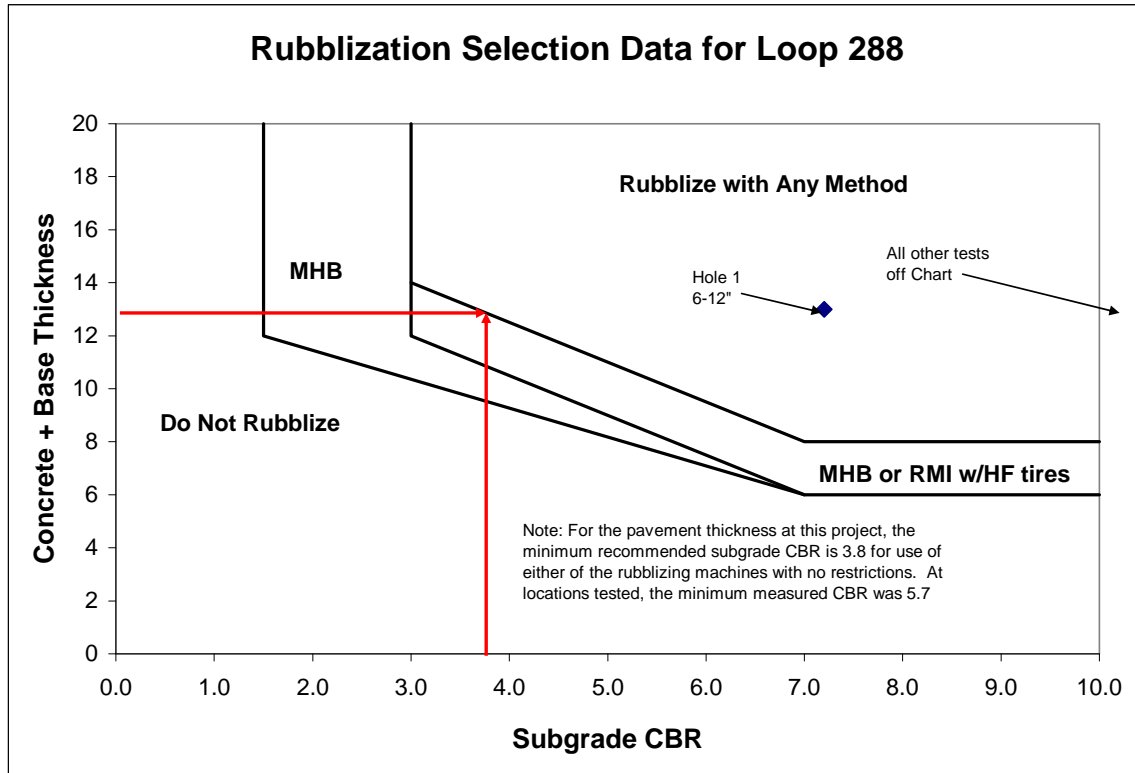
Figure 3.4. DCP Results from Loop 288 on IDOT Rubblization Selection Chart.

Tables 3.1 and 3.2 show the FWD backcalculation results for the Loop 288 project. Current thinking suggests a minimum value of 10 ksi for the subgrade modulus in order for rubblization to be an option. As evidenced by the data in Tables 3.1 and 3.2, nearly all the backcalculated subgrade moduli values exceed this minimum. However, verification with DCP testing is still necessary to ensure adequate soil support exists. After studying FWD results in the field, TTI selected several locations to perform DCP tests at the project site. Researchers performed DCP tests only conducted in the eastbound (EB) travel direction. Table 3.3 summarizes the DCP results. The results show the condition of the lime layer was excellent, and the untreated embankment and native subgrade soil were good. The Illinois DOT developed a rubblization selection chart to aid in evaluating a project's suitability for rubblization. This chart uses the CBR of the top 12 inches of subgrade (divided into two 6 inch layers) along with the combined concrete and base thickness as an indicator of the project's suitability for rubblization. Figure 3.4 shows this chart, and as evidenced by the data in Table 3.3, the CBR values of the subgrade were typically greater than 10, off the scale of the IDOT chart. Therefore, based on existing guidelines, this project is suitable for rubblization.

Based upon the results presented and discussed above, the Loop 288 project between FM 428 and US 380 is suitable for rubblization. Due to the pavement structure, the resonant machine may be a better method to rubblize this pavement. A forensic investigation revealed the primary cause of distress in the pavement is due to construction problems: the pavement did not crack at the saw-cut joints as designed, resulting in uncontrolled cracking in the concrete layer.

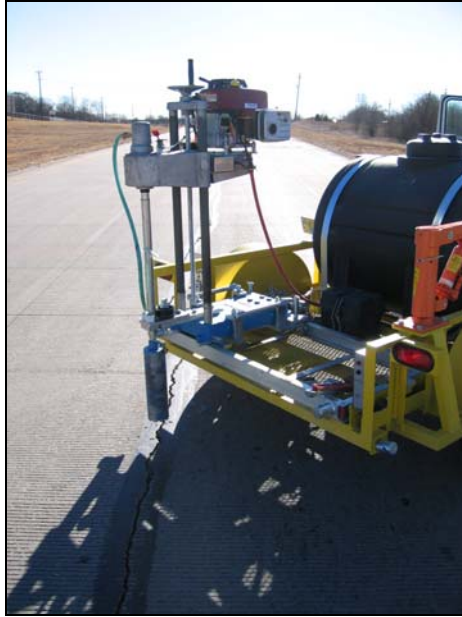
Figure 3.5. Preparing to Core over Longitudinal Crack on Loop 288.

In an effort to determine the cause of the distress on Loop 288, a forensic investigation was conducted in January 2006. Two cores were taken as illustrated in Figure 3.5. The first core, shown in Figure 3.6, was collected 4230 feet east of FM 428 and was taken directly over the sawcut at the outside shoulder. This core revealed the concrete did not crack as intended at the sawcut. The second core, collected 4320 feet east of FM 428 and taken from directly over a longitudinal crack, revealed that the cracking is confined to the concrete layer. Figures 3.7 and 3.8 show that the ASB is not cracked where there is a longitudinal crack in the concrete. Therefore, based upon this investigation, researchers concluded the primary cause of distress on Loop 288 is due to a construction problem: the concrete did not crack at the sawcuts as designed.

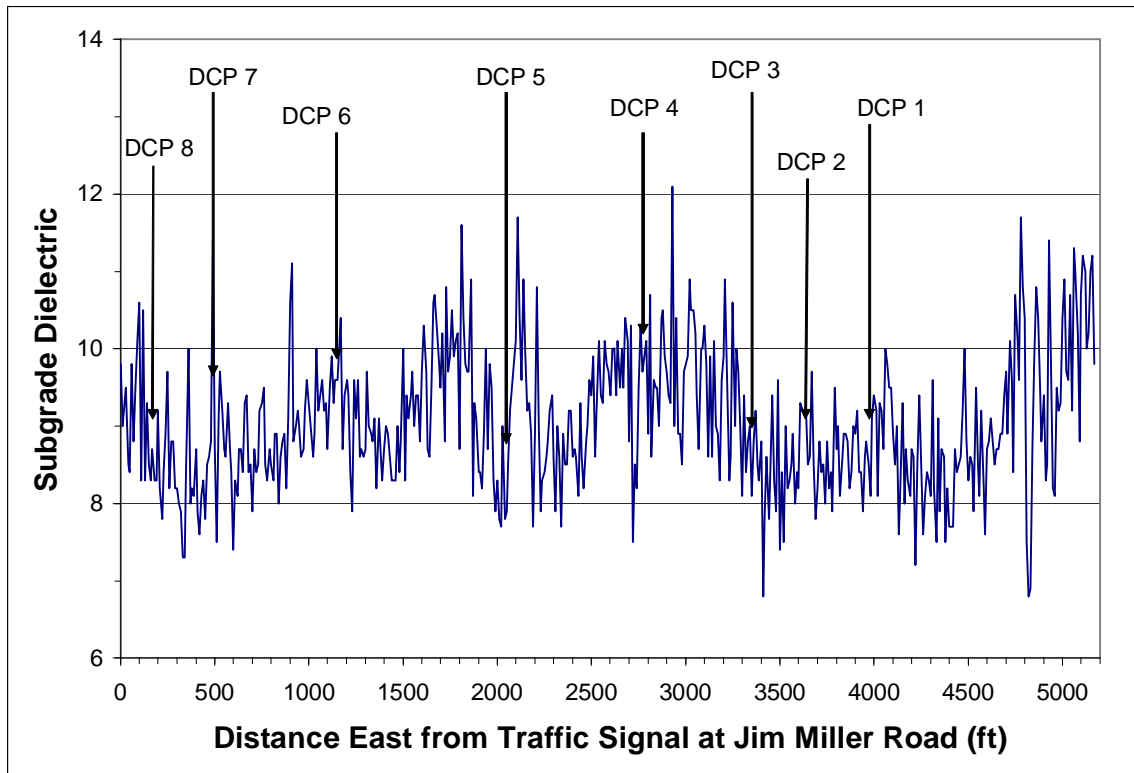
Figure 4.4. Subgrade Dielectric Value on Loop 12 Project.

The GPR survey serves two primary purposes. First, the GPR survey can identify section breaks or changes in structure. Second, the survey can identify locations of excessively wet subgrade or trapped water, both of which hinder the rubblization process. As [Figure 4.2](#) shows, the structure appears consistent throughout the project limits. In the GPR data, the subgrade dielectric values ranged from 6.8 to 12.1 with an average value of 9.0. Values greater than 10 typically indicate excessively wet material. The subgrade dielectric value exceeded 10 in a few sections of the project, as [Figure 4.4](#) illustrates. DCP at selected locations verified the existence of wet subgrade beneath the JCP as [Figure 4.5](#) illustrates. Although the GPR data were collected in August 2004 and the DCP testing performed in February 2006, there appears to be reasonable agreement between the locations of high dielectric values and the observance of wet soil in the DCP tests.

Note: Soil at DCP 4 and DCP 6 visibly wet on DCP rod when tested with DCP.

Based upon the results presented and discussed above, the Loop 12 project between Jim Miller Road and US 175 is suitable for rubblization with either the resonant machines or multi-head breaker equipment. The only potential concern observed was a few locations of wet subgrade. Testing at these locations still revealed suitable subgrade support exists. However, it is possible that the vibrating action of the RMI machine could pump water; therefore, if rubblization is pursued using the RMI equipment, consideration should be given to installing edge drains prior to rubblization.

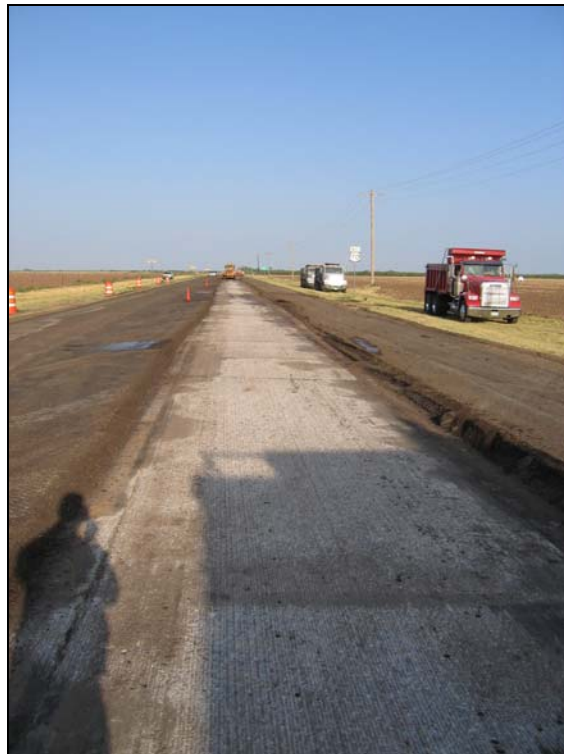
Figure 6.4. Existing Concrete Slabs on US 70 in Foard County.

In August 2006, the contractor initiated rubblization, and the TTI research team visited the construction site to observe operations. The existing slab length was 40 feet, and most slabs contained two to four transverse cracks in them. [Figure 6.4](#) shows the existing concrete slabs after removal of the HMA by milling.

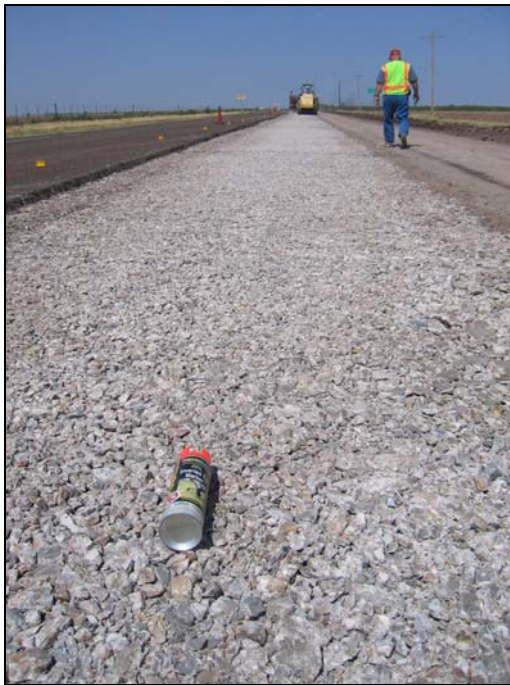
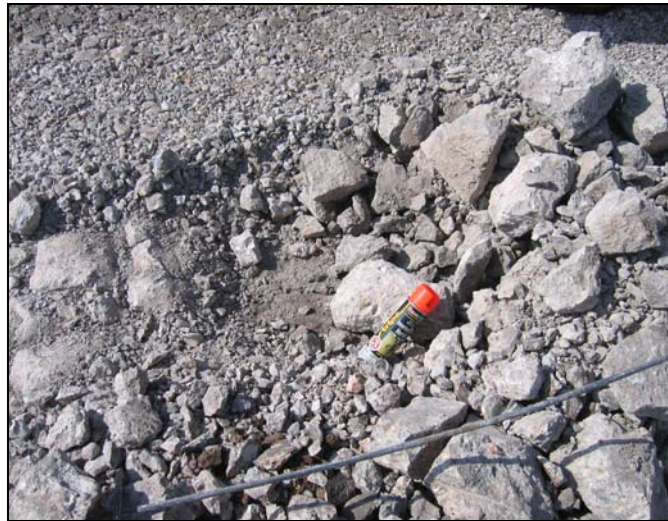
Figure 6.6. Surface and Cross Section Views of Rubblized JCP on US 83.

The multiple head breaker machine rubblized the existing JCP, as [Figure 6.5](#) shows. [Figure 6.6](#) illustrates the typical surface view and cross section of the rubblized layer. [Figure 6.6](#) shows how the multiple head breakage pattern produced a layer of small particles, typically less than 3 inches, overlaying a layer of fractured concrete with larger particle sizes, typically around 8 to 15 inches in size.

At the project startup, the only problem noted was that the longitudinal reinforcing steel was not being consistently debonded, and the particle sizes at the reinforced edge were larger than specifications allow. The contractor and the engineer worked together until both were satisfied with the rubblizer's operation.

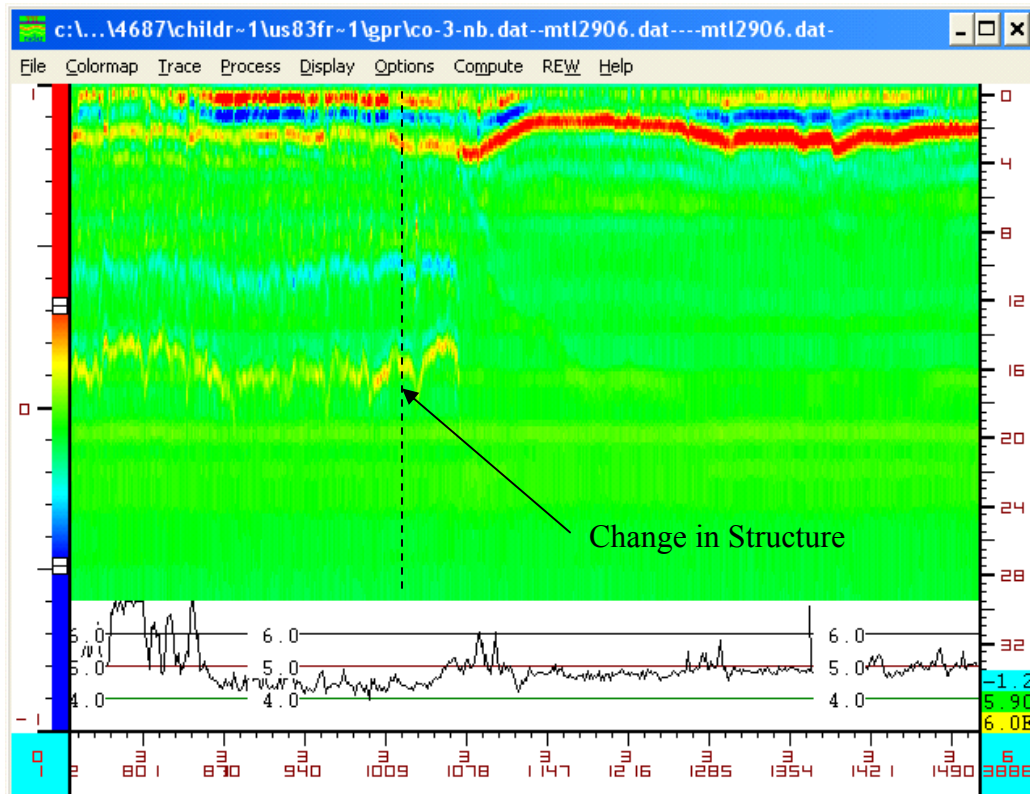
Figure 7.2. Representative Section Break in GPR Data on US 83 Northbound.

In the GPR data, two clear section breaks are evident. These sections of different structure are from 3.18 to 3.44 miles and from 4.22 to 4.82 miles north of the King/Cottle County line. [Figure 7.2](#) shows an example of one of the section breaks.

- The FWD data confirm the existence of different structures seen in the GPR data. Based on GPR, these sections are from 3.18 to 3.44 and 4.22 to 4.82 miles north of the King/Cottle County lines. In these sections, the FWD backcalculations have high errors per sensor, and the backcalculated base moduli are in the range of a flexible base as illustrated in Figure 7.3. In the GPR data, only the bottom of the surfacing could be seen in these sections, so other records or coring may be necessary to identify the structure of these sections.

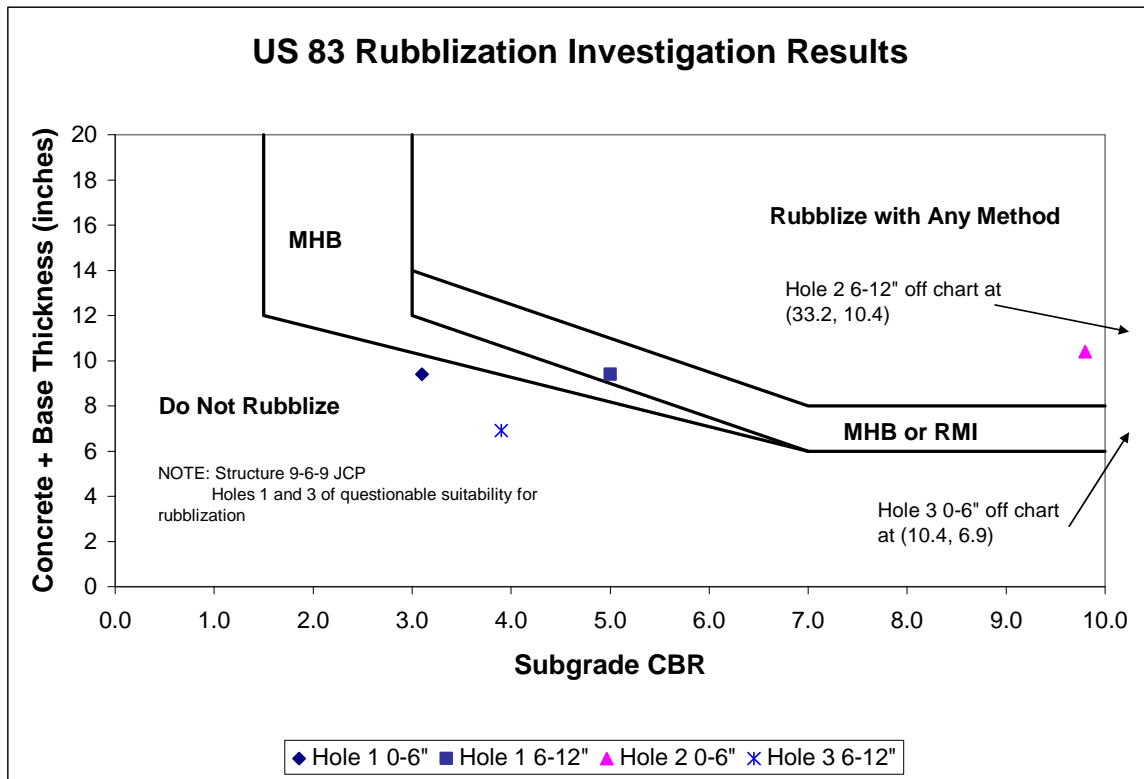
Figure 7.4. DCP Results from US 83 on IDOT Rubblization Selection Chart.

- The DCP data, when plotted on the IDOT rubblization selection chart, indicate the project is of marginal suitability for rubblization. The data are plotted on the IDOT chart in Figure 7.4. These data show that the locations represented by Holes 1 and 3 are in the "gray area" of suitability. At Hole 1, the top 6 inches of subgrade are outside the rubblization zone, but the next 6 inches are in the suitability zone. Hole 3 shows the top 6 inches of subgrade are very good, but the next 6 inches of subgrade are poor. Problems rubblizing may occur at these locations and locations with similar soil properties.

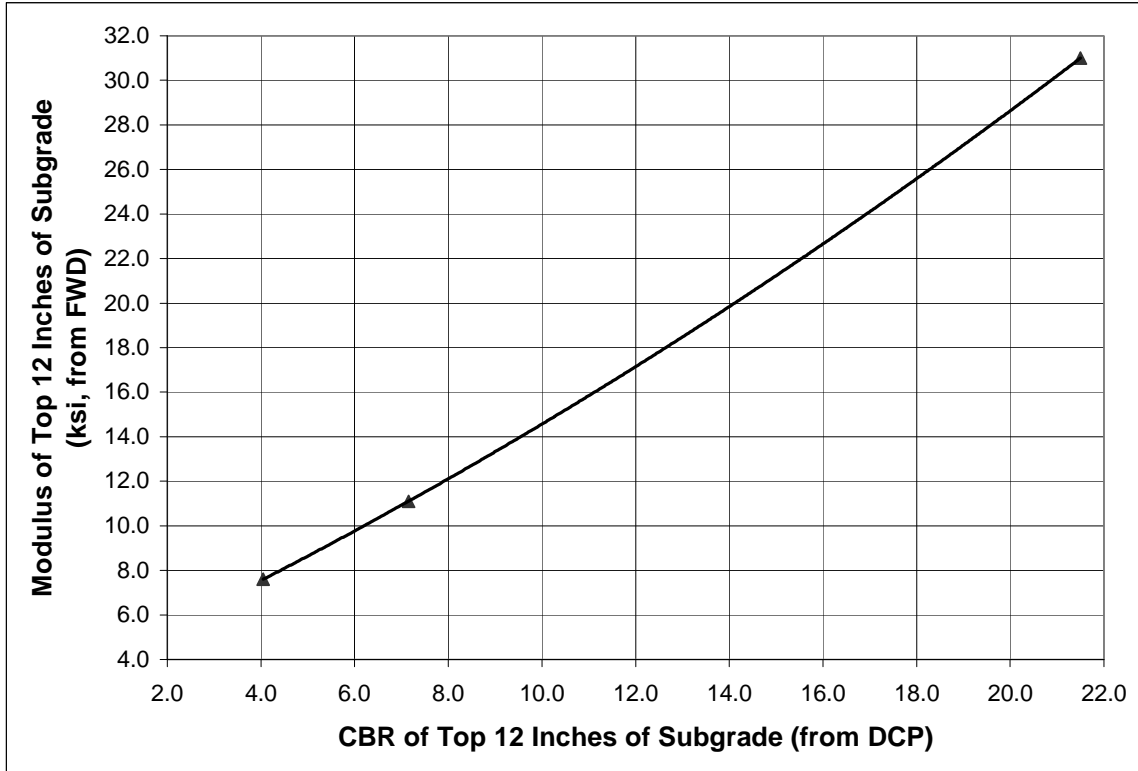
Figure 7.5. Relationship between Subgrade Modulus and CBR on US 83.

- Figure 7.5 shows the relationship between the subgrade CBR and backcalculated subgrade modulus for the top 12 inches of soil for this project. From this relationship, the subgrade modulus should be 10 or higher to confidently pursue rubblization of the entire project with either rubblization method. A review of the FWD data reveals 57 percent of the observations for the first 12 inches of subgrade are below 10 ksi.

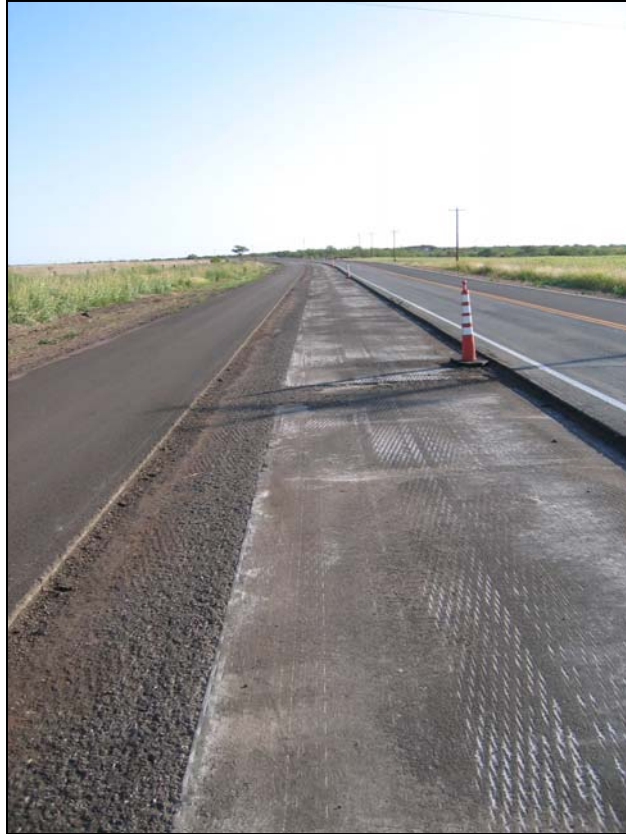
In July 2006, the TTI research team visited the construction site to observe operations. The existing slab length was 40 feet, and most slabs contained two to four transverse cracks in them. [Figure 7.6](#) shows a typical existing concrete slab.

Figure 7.6. Existing Concrete Slabs on US 83 from King/Cottle County Line.

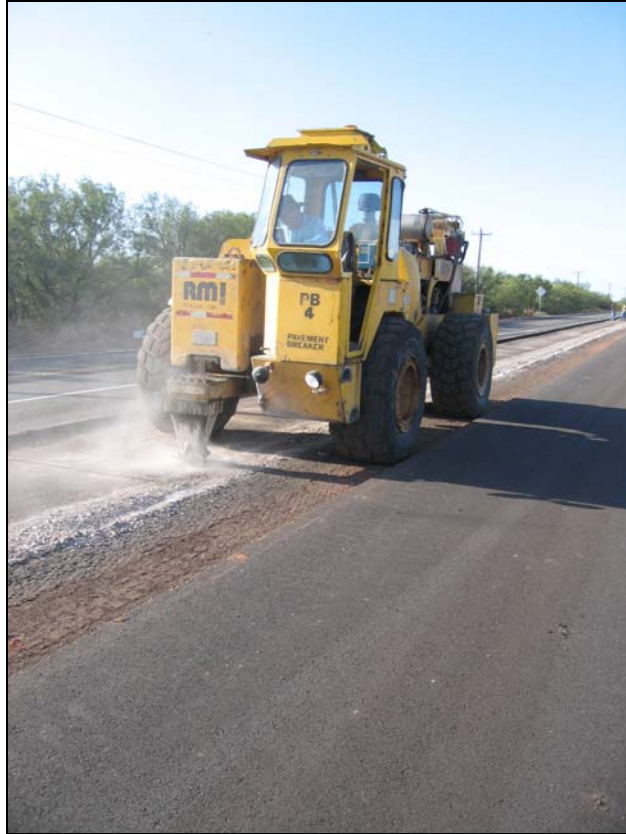
The resonant machine device rubblized the existing JCP, as [Figure 7.7](#) shows. [Figure 7.8](#) illustrates the typical surface view and cross section of the rubblized layer. Proof rolling, as [Figure 7.9](#) shows, aided the inspector in determining limits of instability for removal. Although the rubblizer successfully fractured the concrete on the entire project, locations requiring removal typically exhibited abnormally large particle sizes, as [Figure 7.10](#) illustrates. In some cases, the rubblizer created large ruts in the pavement, serving as its own proof roller and indicating the need for removal and replacement. [Figure 7.11](#) shows one such location of significant rutting in the rubblized layer from the RMI machine.

Figure 7.7. Resonant Breaker on US 83 from King/Cottle County Line.

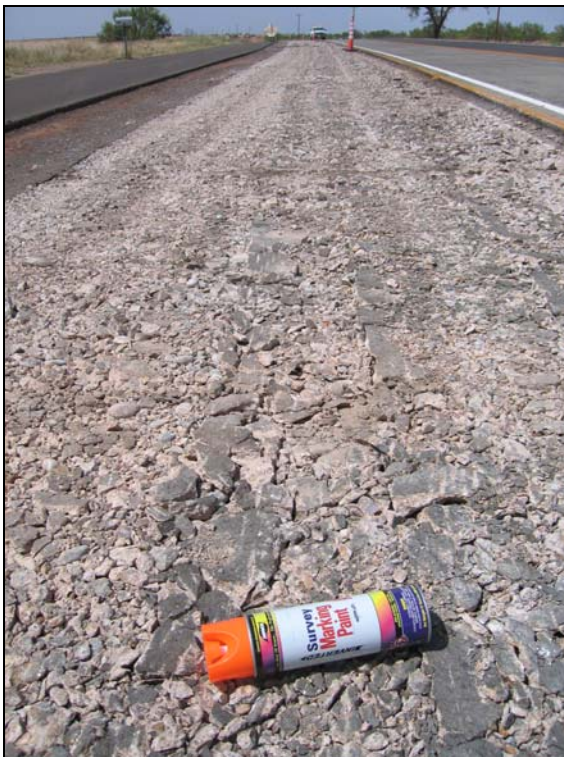
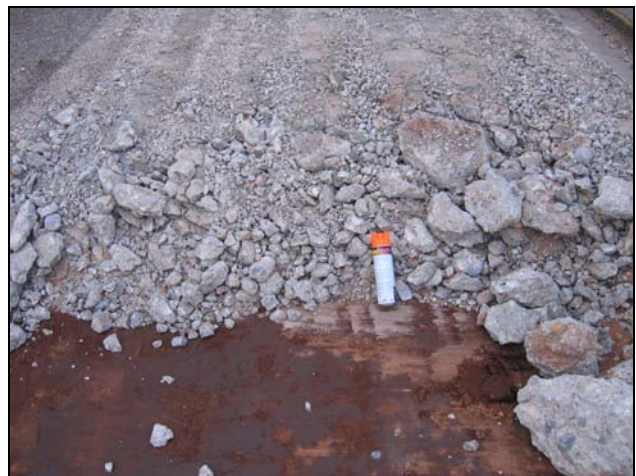
Figure 7.8. Surface and Cross Section Views of Rubblized JCP on US 83.

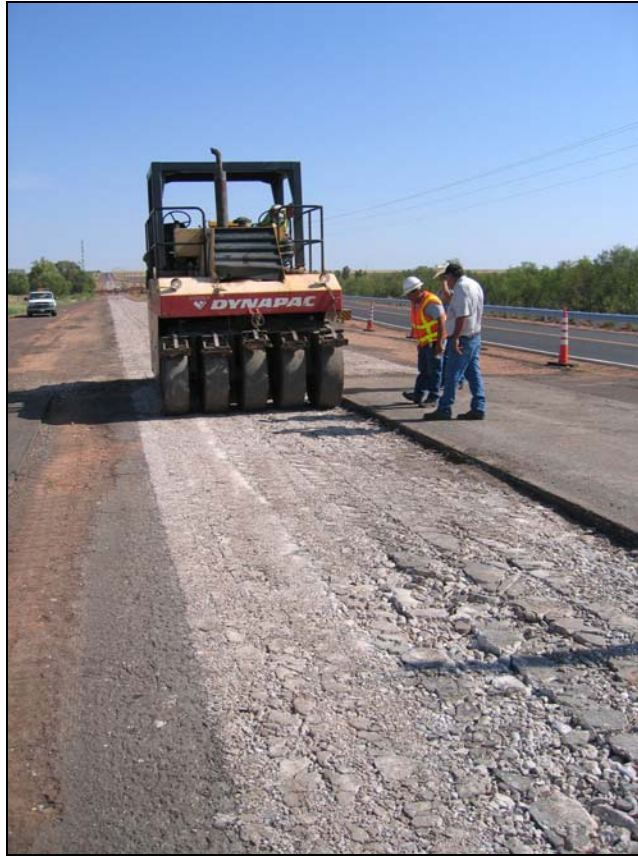
Figure 7.9. Proof Rolling on US 83 from King / Cottle County Line.

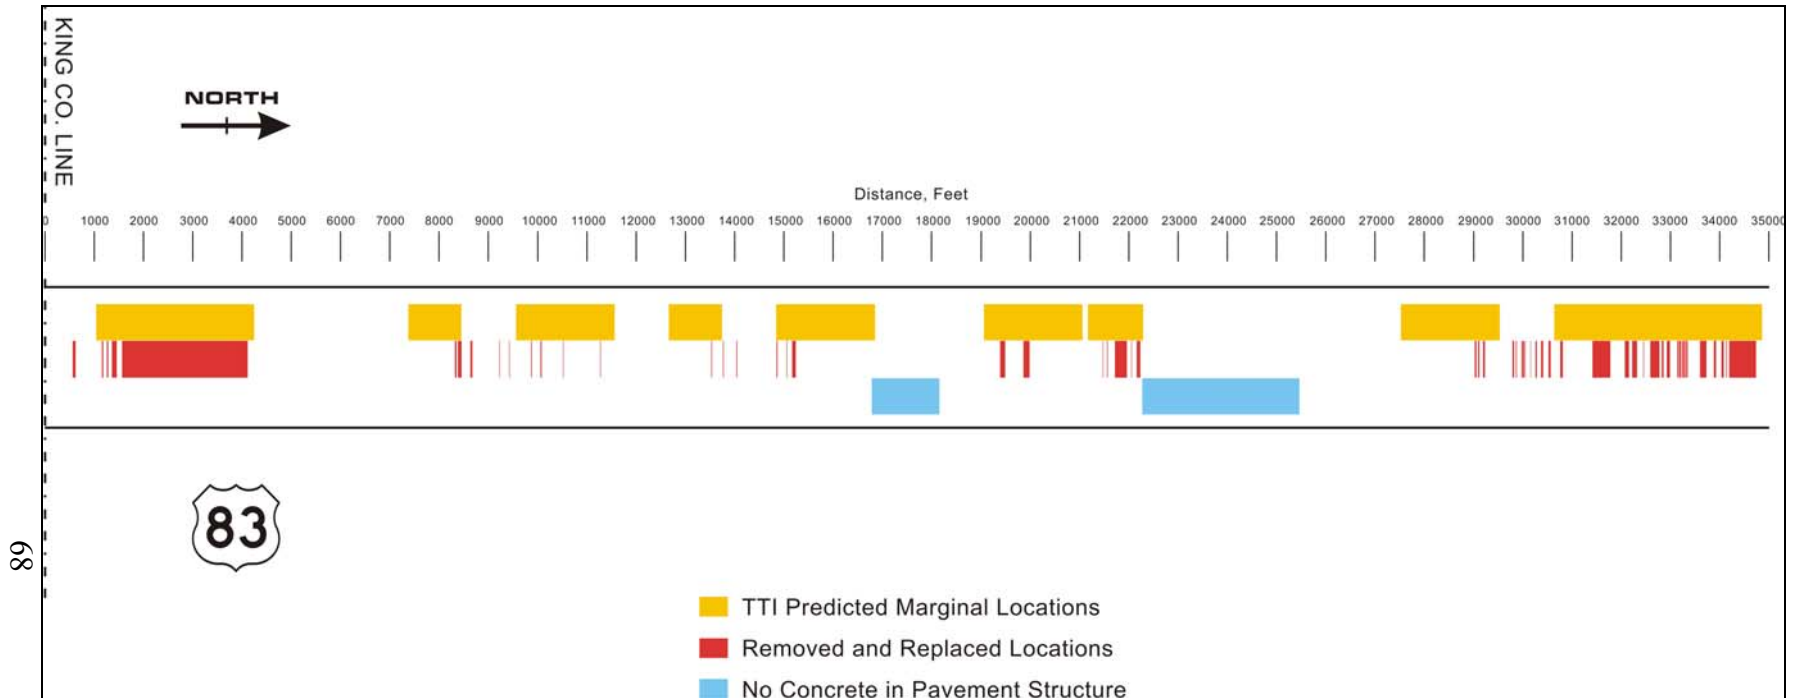
The survey of the site by TTI prior to construction highlighted two locations where the concrete pavement appeared to have already been replaced. Additionally, at several locations non-destructive test (NDT) data suggested rubblization likely would encounter problems due to the subgrade. Milling off the old HMA overlay revealed that the concrete indeed had been previously removed in two sections. [Figure 7.12](#) shows one of these locations. Additionally, [Figure 7.13](#) shows how the predictions of marginal locations in the pre-construction evaluation matched quite well with the locations that were removed and replaced due to instability.

Figure 7.13. Comparison of NDT Predictions and Field Construction.

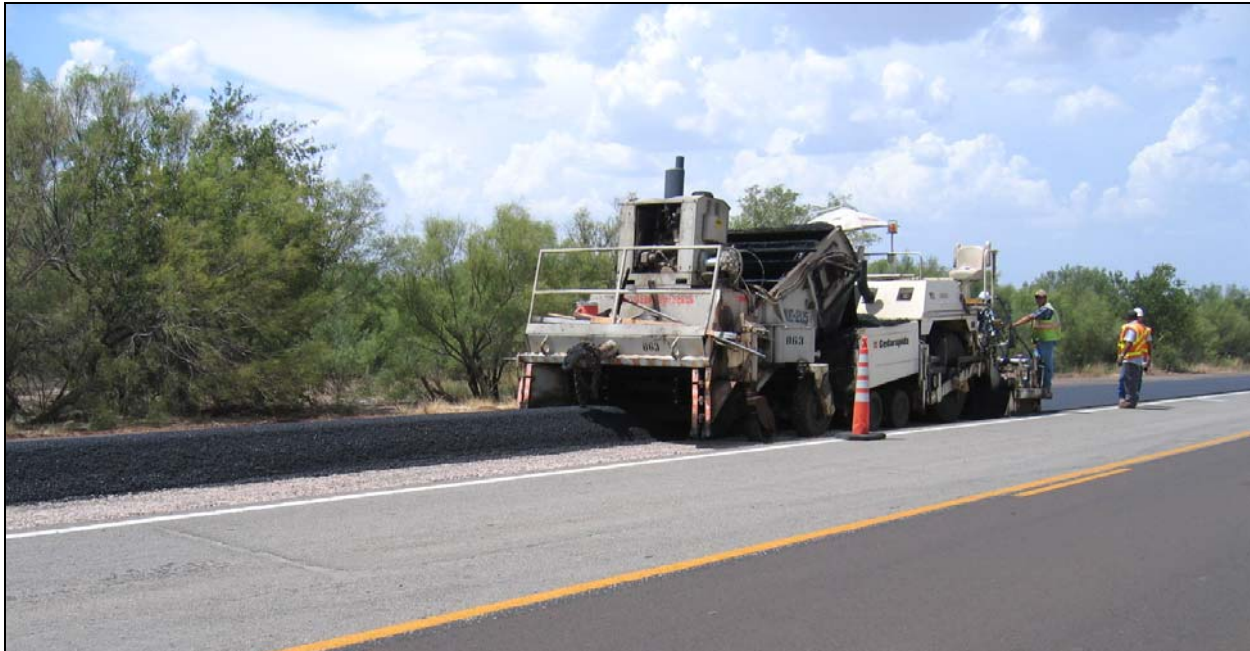
Jordan Paving constructed the HMA overlays on top of the rubblized pavement. According to their personnel, they did not encounter any problems placing the mix on top of the rubblized JCP. [Figure 7.14](#) shows the paving operation.

Figure 7.14. Paving Operation on US 83 from King / Cottle County Line.

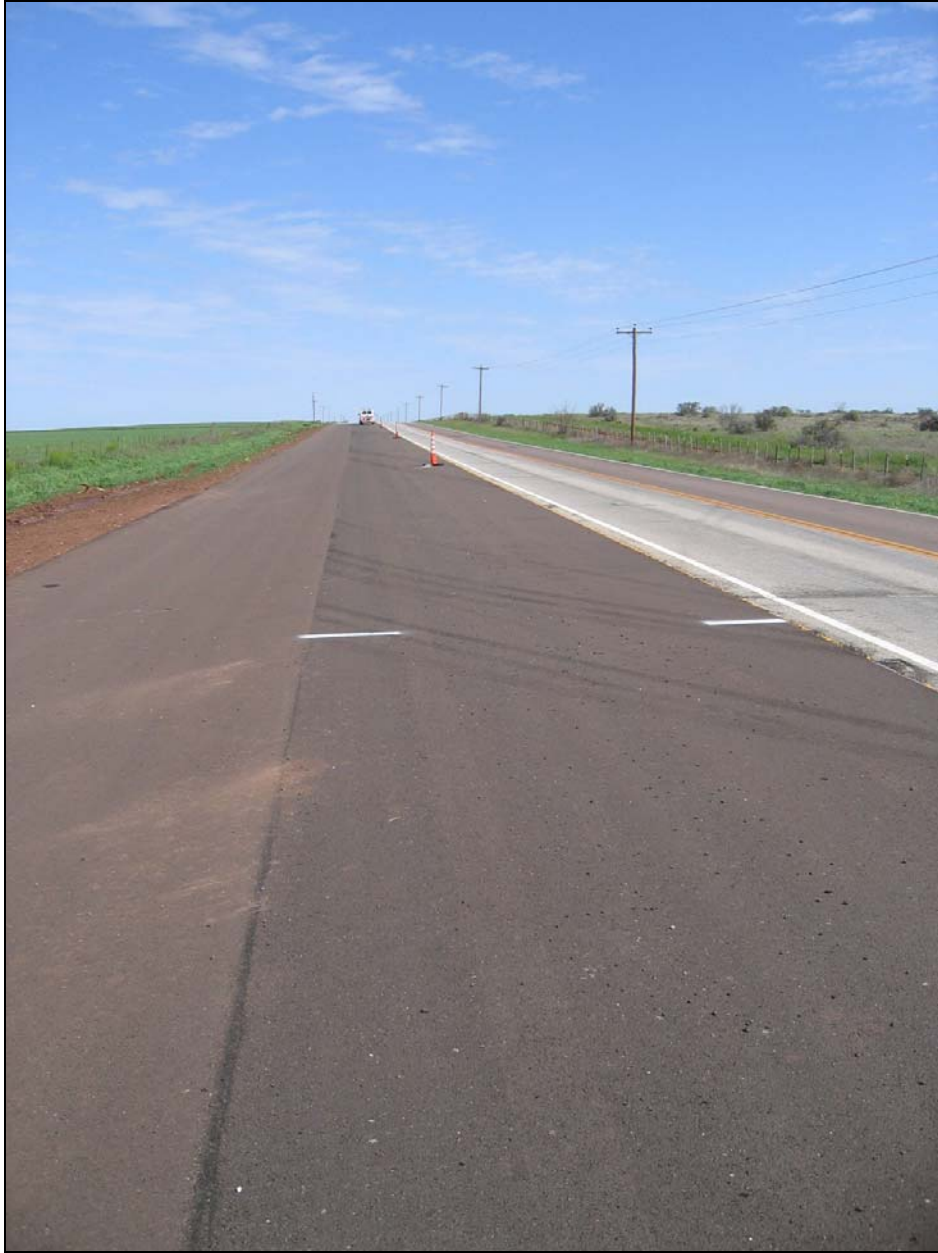
Figure 7.15. Looking North on US 83 SB from STA 1743.

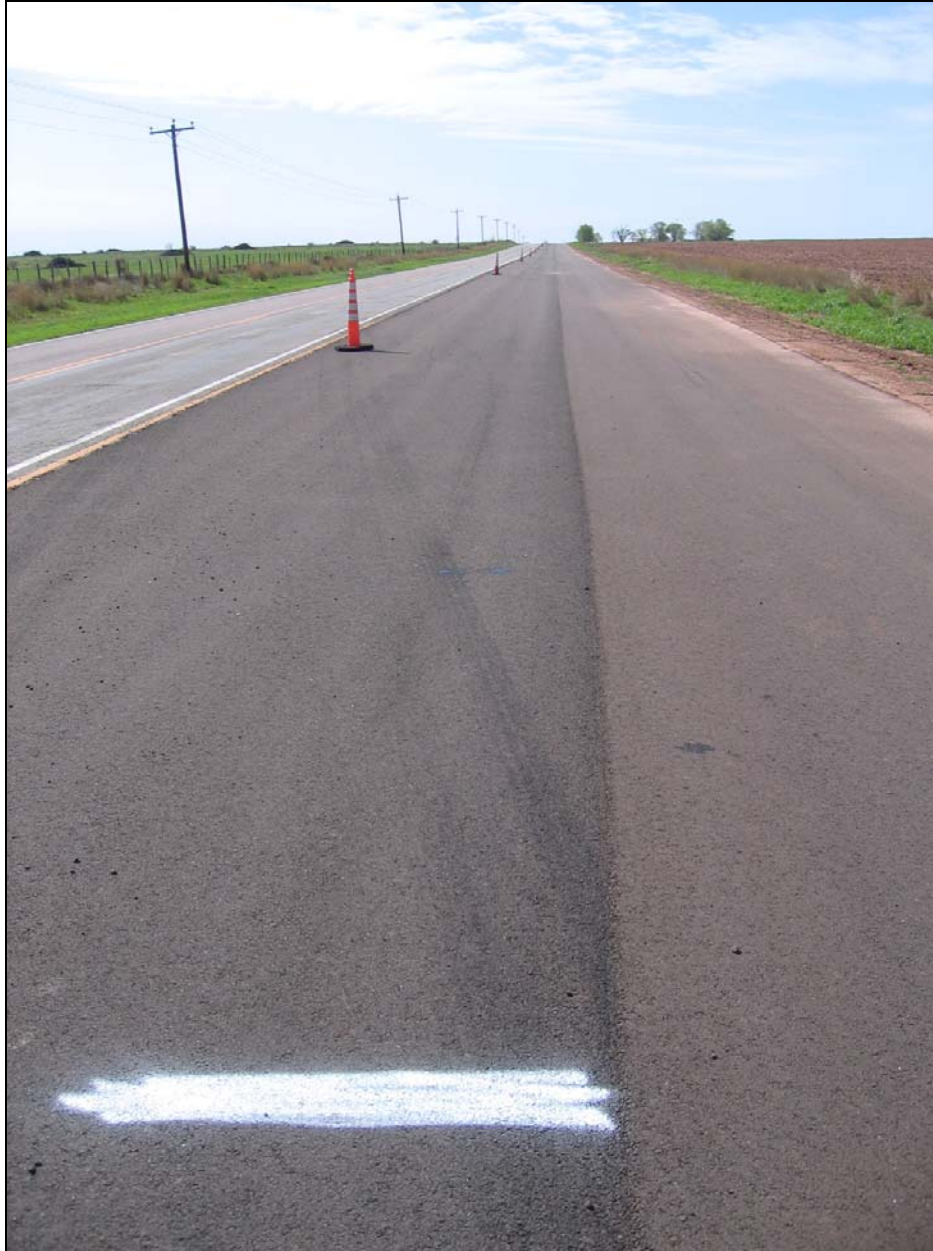
Figure 7.16. Looking South on US 83 SB from STA 1653.

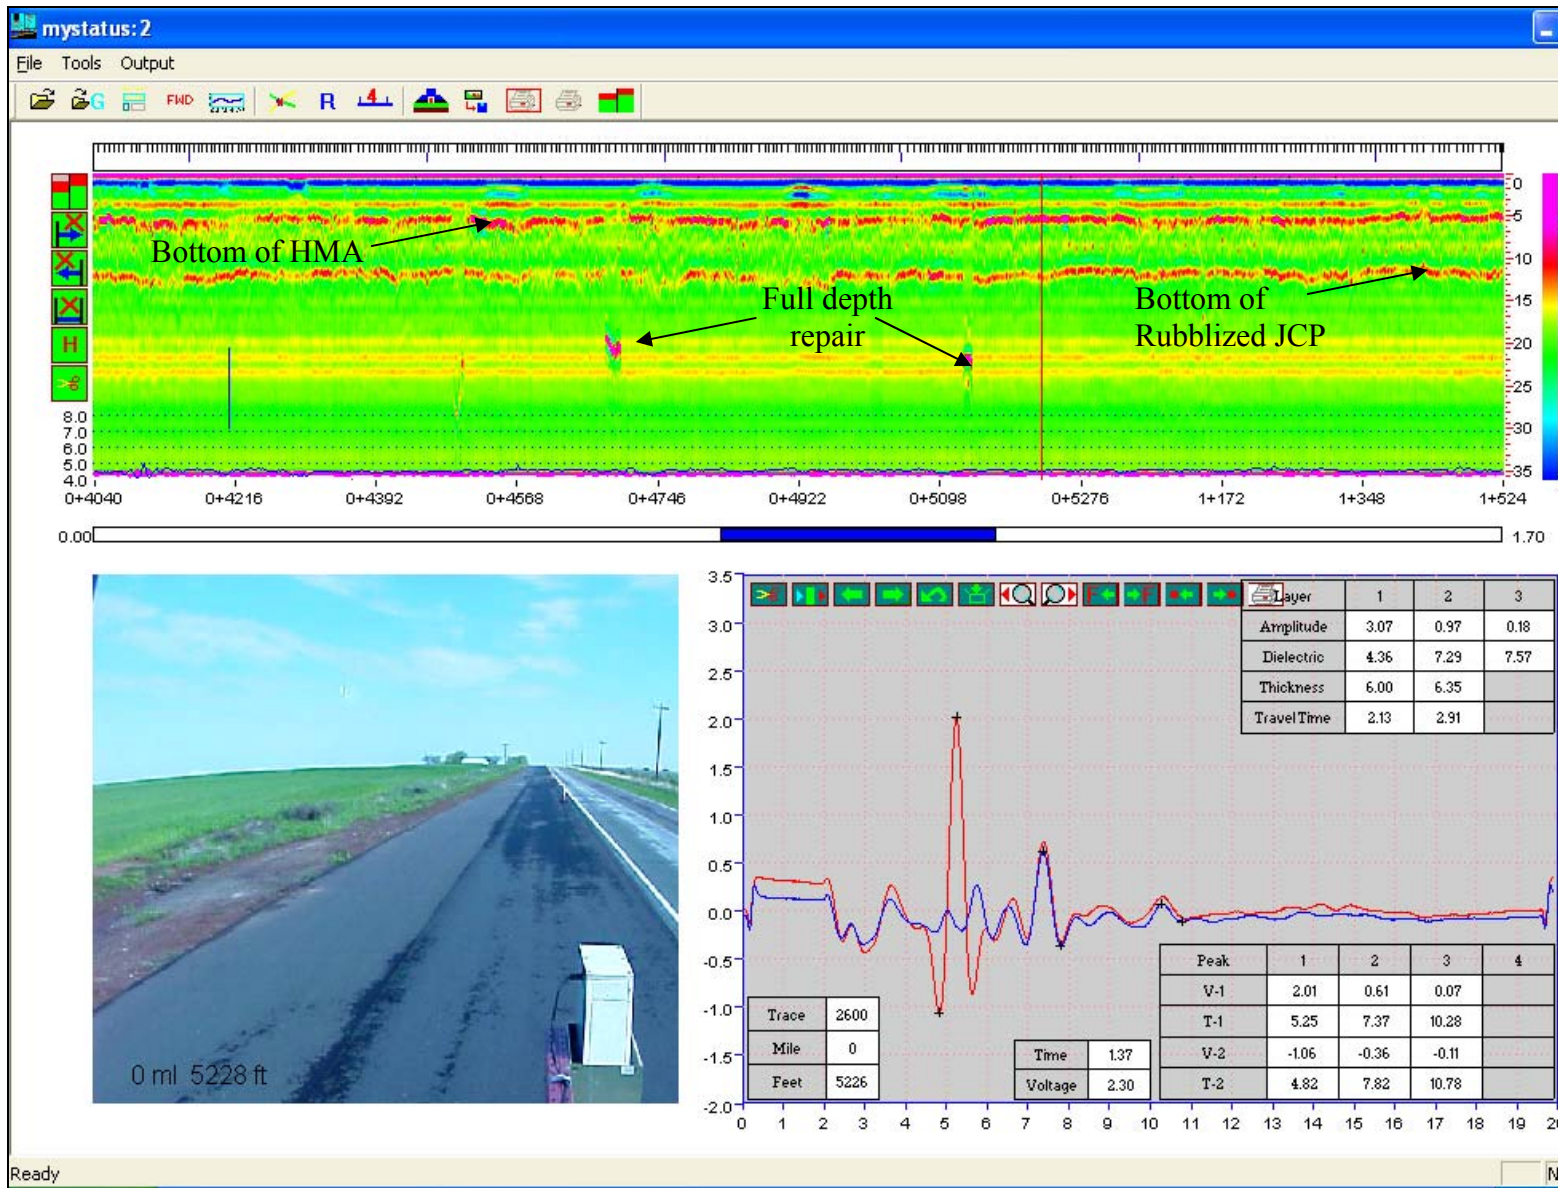
Figure 7.17. Example GPR on US 83 from King / Cottle County Line.

Figure 7.17 shows example GPR data from the section. From the GPR data the typical HMA thickness ranges between 6 and 7 inches. Likewise, the rubblized layer thickness also ranges between approximately 6 and 7 inches. Additionally, Figure 7.17 shows two short full depth repair locations. Based on the measured layer thicknesses with GPR, Modulus 6.0 performed FWD backcalculations using 6.5 inches for both the HMA and rubblized layer thicknesses. Table 7.3 shows the output. At the time of testing, the age of the section was approximately nine months, and the average rubblized PCC modulus was 154 ksi, or 7 percent of the pre-fractured PCC modulus. The standard deviation of the rubblized layer modulus was 83 ksi, which results in a coefficient of variation of approximately 54 percent.
