1. Report No. FHWA/TX-08/0-4687-2		2. Government Accession No.		3. Recipient's Catalog No.	
4. Title and Subtitle FIELD EVALUATIONS AND GUIDELINES FOR RUBBLIZATION IN TEXAS				5. Report Date September 2007 Published: December 2007

FIELD EVALUATIONS AND GUIDELINES FOR RUBBLIZATION IN TEXAS

Report 0-4687-2
Project 0-4687
Project Title: Rubblization and Crack and Seat
as Major Rehabilitation for Concrete Pavements

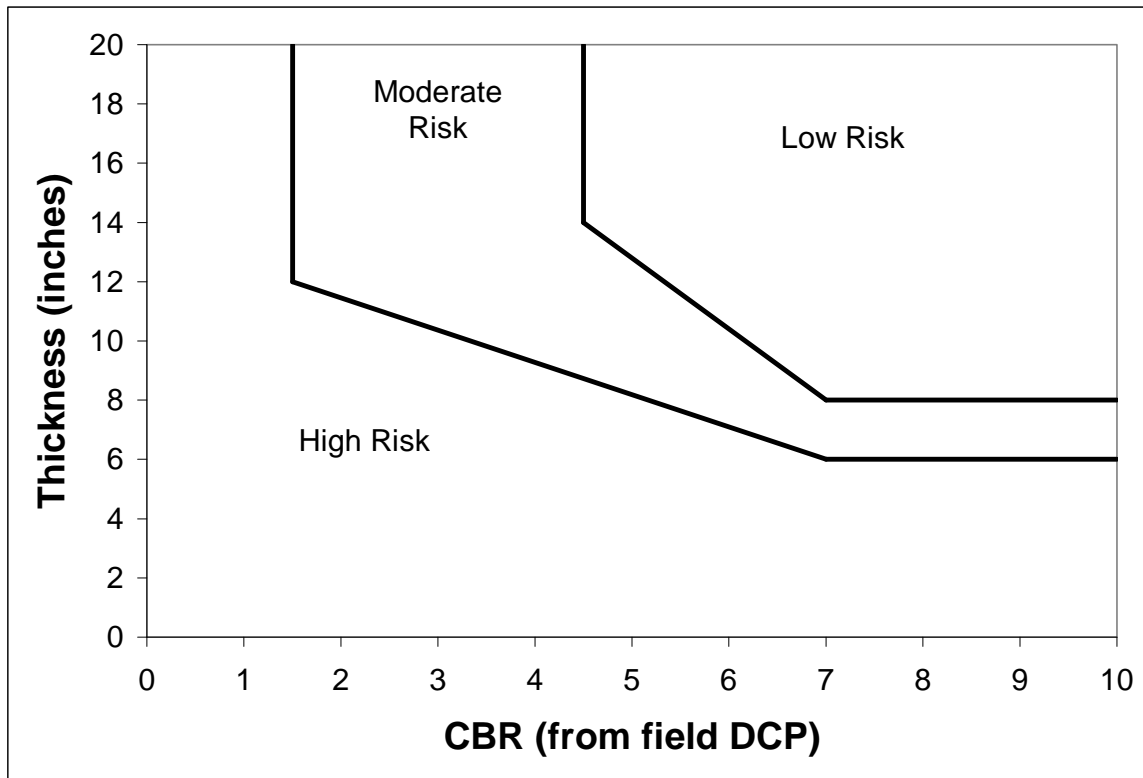
Figure 8.1. Proposed Rubblization Selection Chart.

“rubblize with any method” zone using the original IDOT boundaries. However, during field construction this location required full depth removal and replacement. [Figure 8.1](#) shows the proposed rubblization selection chart incorporating the recommended modifications for use with the procedure described above.

The original IDOT selection chart, used in the project screenings presented in Chapters 1 through 4 of this report, worked reasonably well for evaluating projects and matching field construction experiences. However, from the experiences on the US 70 and US 83 projects, the researchers concluded that the distinction between rubblization equipment should be eliminated from the chart. The original philosophy behind the equipment distinction is the fact that the load from the MHB equipment stays on the unbroken concrete; therefore, this machine could be used to rubblize in poorer soil conditions. Field experience in Texas showed, however, that because of the nature of operation of the MHB, soft spots may be missed, which then fail under construction traffic during paving. The RMI, on the other hand, serves well as its own proof roller, and one would much rather discover weak foundation areas during rubblization rather than during paving. Because of these experiences, the researchers recommend the chart use risk rather than equipment for the various zones.

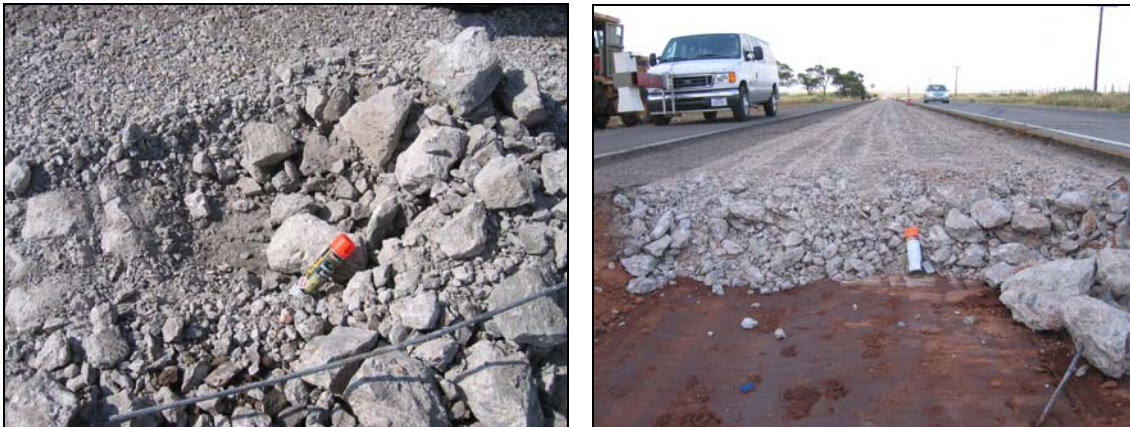
The break patterns produced by the two machines differ. The MHB produces larger particle sizes deeper in the concrete layer and flat, elongated particles at the top. These top particles are then broken down with the special Z-grid roller. In contrast the RMI process appears to produce a relatively uniform break pattern through the depth profile of the concrete layer. [Figure 9.1](#) shows cross sections of the rubblized layer produced by each machine.

Figure 9.1. Cross Section of Rubblized Layer from MHB (left) and RMI (right).
