1. Report No. FHWA/TX-04/0-4852-1		2. Government Accession No.		3. Recipient's Catalog No.	
4. Title and Subtitle CRASH TESTING AND EVALUATION OF THE MODIFIED T77 BRIDGE RAIL				5. Report Date September 2003

CRASH TESTING AND EVALUATION OF THE MODIFIED T77 BRIDGE RAIL

Report 4852-1
Project Number 0-4852
Research Project Title: Development of the T77 Bridge Rail

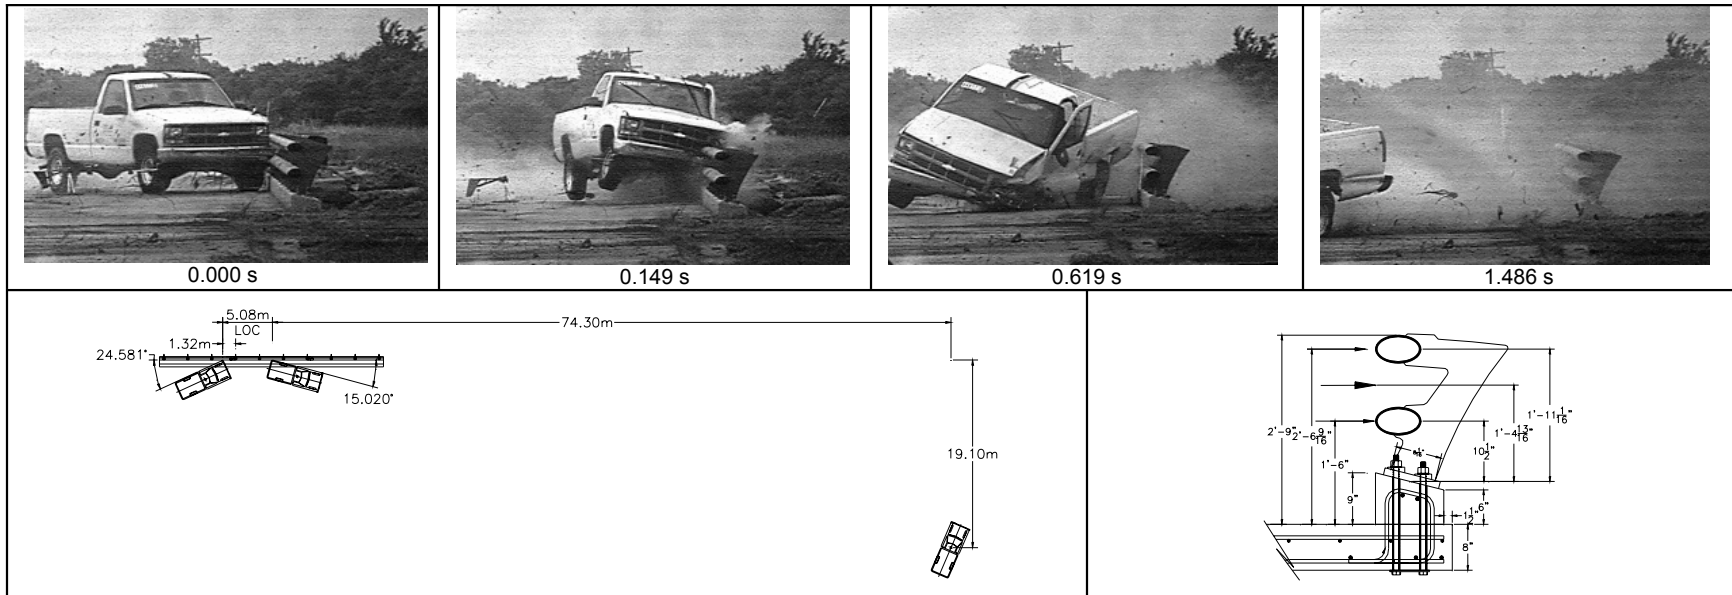
General Information		Impact Conditions		Test Article Deflections (in)	
Test Agency	Texas Transportation Institute	Speed (mi/h)	62.5 (100.6 km/h)	Dynamic	1.1 (28 mm)
Test No.	448523-1	Angle (deg)	24.6	Permanent	0.8 (21 mm)
Date	05/27/03	Exit Conditions		Working Width	24.9 (638 mm)
Test Article		Speed (mi/h)	46.4 (74.7 km/h)	Vehicle Damage	
Type	Bridge Rail	Angle (deg)	15.0	Exterior	
Name	Modified T77 Bridge Rail	Occupant Risk Values		VDS	
Installation Length (ft)	75 (22.7 m)	Impact Velocity (ft/s)		CDC	
Material or Key Elements	Steel Elliptical Rails And Steel '7'-Shaped Posts	x-direction	21.3 (6.5 m/s)	Maximum Exterior	
Soil Type and Condition	Concrete Footing, Dry	y-direction	24.6 (7.5 m/s)	Vehicle Crush (in)	
Test Vehicle		THIV (mi/h)	21.5 (34.7 km/h)	Interior	
Type	Production	Ridedown Accelerations (g's)		OCDI	
Designation	2000P	x-direction	-4.3	Max. Occ. Compartment	
Model	1999 Chevrolet Cheyenne 2500 Pickup	y-direction	10.4	Deformation (in)

Results: No detached elements, fragments, or other debris were present to penetrate or to show potential for penetrating the occupant compartment, or to present undue hazard to others in the area. Maximum occupant compartment deformation was 6.9 inches (174 mm) in the left kick panel laterally across the cab. (FAIL)

Results: The vehicle yawed counterclockwise and came to rest 243.8 ft (74.3 m) downstream of impact and 62.5 ft (1.9 m) forward of the traffic face of the rail after the brakes were set. (FAIL)

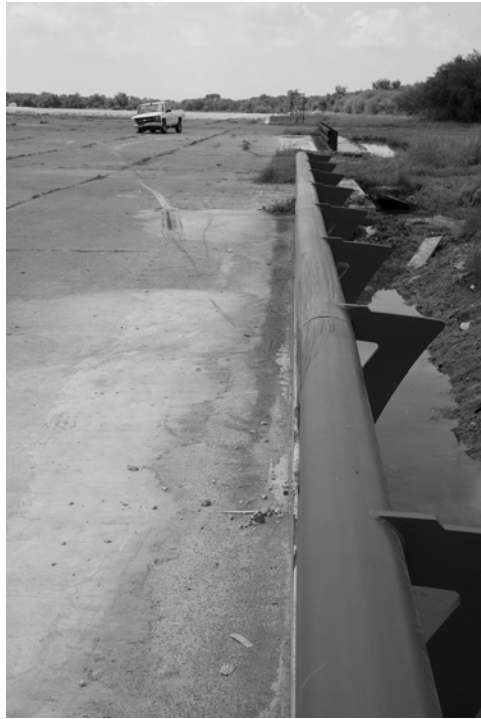
Figure 17. After Impact Trajectory Path for Test 409260-1.

Results: The vehicle yawed clockwise and came to rest 217.5 ft (66.3 m) downstream of impact and 25.0 ft (7.6 m) forward of the traffic face of the rail after the brakes were set. (FAIL)

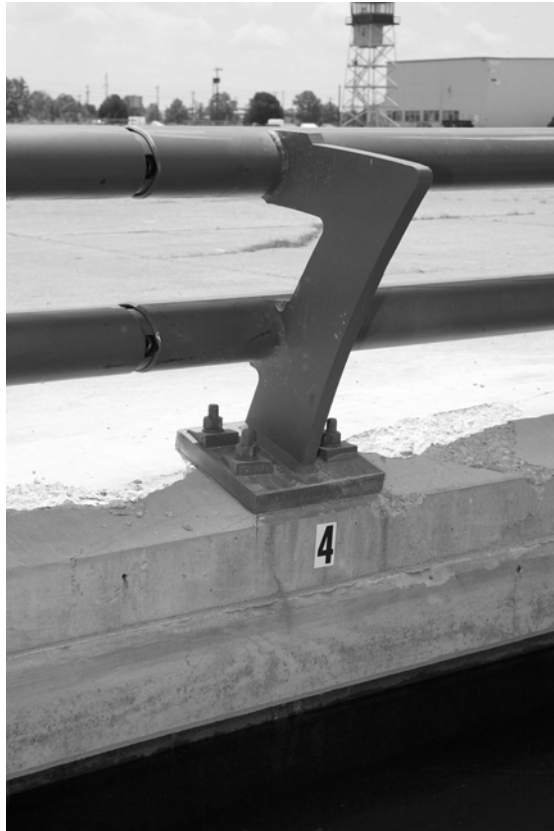
Figure 18. Installation After Test 409260-1 (Continued).

Damage to the T77 bridge rail is shown in Figures 17 and 18. Cracks radiated out of the front and rear anchor bolts of post 3 and 4 and extended toward and down the rear side of the curb and into the deck. The traffic face of the curb was also fractured below the baseplate of post 4. Total length of contact of the vehicle with the bridge rail was 12.4 ft (3.8 m). Maximum dynamic deflection of the rail element was not attainable and maximum permanent deformation was 0.7 inch (18 mm).

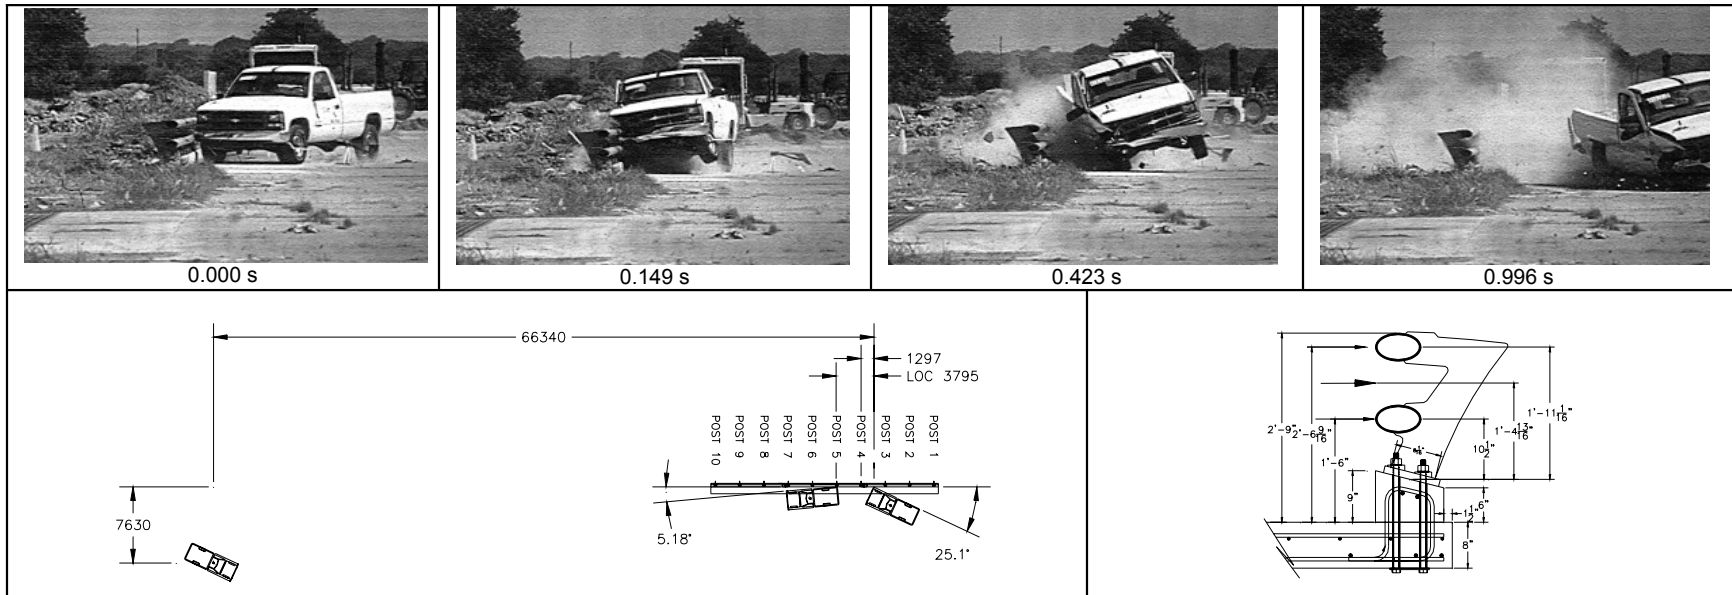
General Information		Impact Conditions		Test Article Deflections (in)	
Test Agency	Texas Transportation Institute	Speed (mi/h)	62.1 (99.9 km/h)	Dynamic	Not attainable
Test No.	409260-1	Angle (deg)	25.1	Permanent	0.7 (18 mm)
Date	07/17/03	Exit Conditions		Working Width	Not attainable
Test Article		Speed (mi/h)	55.1 (88.6 km/h)	Vehicle Damage	
Type	Bridge Rail	Angle (deg)	5.2	Exterior	
Name	Modified T77 Bridge Rail	Occupant Risk Values		VDS	01FR2
Installation Length (ft)	75 (22.7 m)	Impact Velocity (ft/s)		CDC	01FREW2
Material or Key Elements	Steel Elliptical Rails And Steel '7'-Shaped Posts	x-direction	18.0 (5.5 m/s)	Maximum Exterior	
Soil Type and Condition		y-direction	23.3 (7.1 m/s)	Vehicle Crush (in)	17.7 (450 mm)
Test Vehicle		THIV (mi/h)	19.5 (31.4 km/h)	Interior	
Type	Production	Ridedown Accelerations (g's)		OCDI	RF0103000
Designation	2000P	x-direction	-3.7	Max. Occ. Compartment	
Model	2000 Chevrolet Cheyenne 2500 Pickup	y-direction	-9.2	Deformation (in)	3.0 (76 mm)

Results: No detached elements, fragments, or other debris were present to penetrate or to show potential for penetrating the occupant compartment, or to present undue hazard to others in the area. Maximum occupant compartment deformation was 3.0 inches (76 mm) in the center front floor pan area over the transmission tunnel and in the left kick panel laterally across the cab. (PASS)
