# **PERFORMANCE MONITORING PAVEMENTS WITH THERMAL SEGREGATION IN TEXAS**

Report 0-6080-1

Project Title: Performance Histories of Thermally Segregated HMA

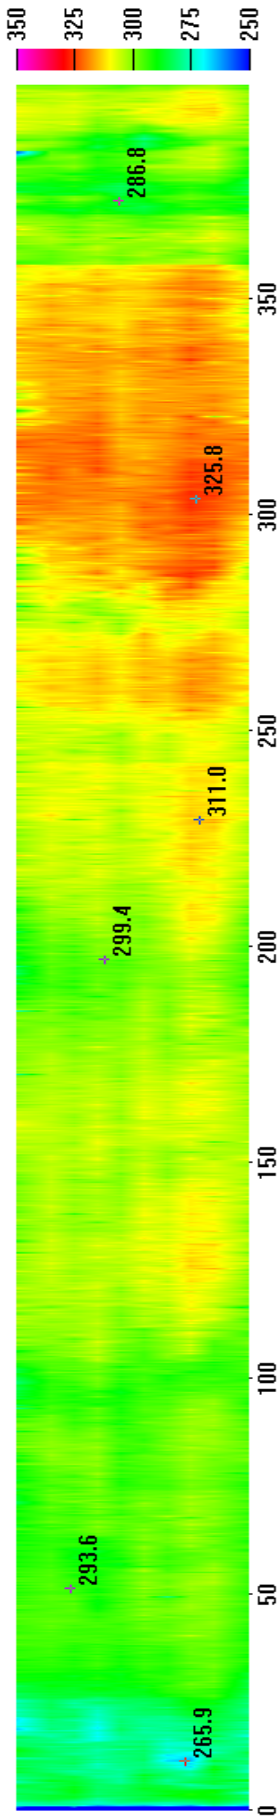
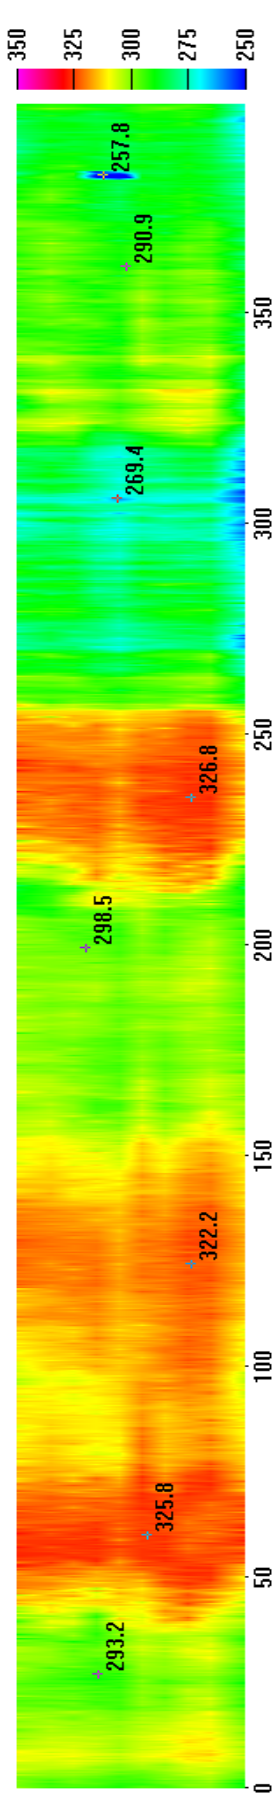
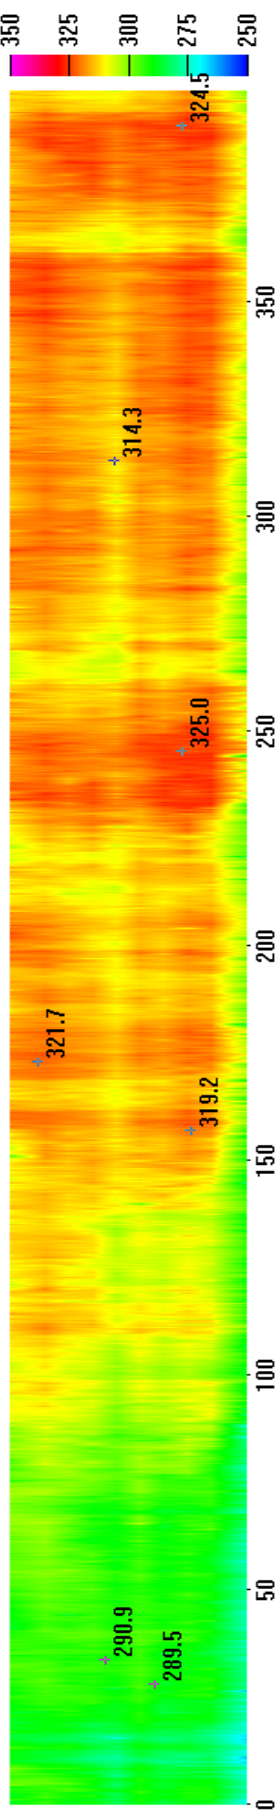
Figure 2. Infrared Data on IH 20 Starting at Station 578 -29.

Figure 2 presents the thermal profile results. Due to the breaking up of the data files, the distance scale starts over at zero for each plot. The top plot is 0 to 400 ft, the middle plot is 400 to 800 ft, and the bottom plot is 800 to 1200 ft. When paving started, the ambient air temperature by the paver was 95°F and winds were calm. The thermal profile shows the following:

- There is some noticeable variability in temperatures between trucks, but overall temperature uniformity is good. Temperatures across each transverse scan are very uniform, typically ranging less than 15°F from the min. to max. temperature. Recommendations from prior work suggest temperature uniformity should be within 25°F.
- The 257.8°F cold spot at 780 ft (380 ft into middle plot) is not due to segregation, but resulted from cold water spilling onto the mat when a worker got water from a cooler.

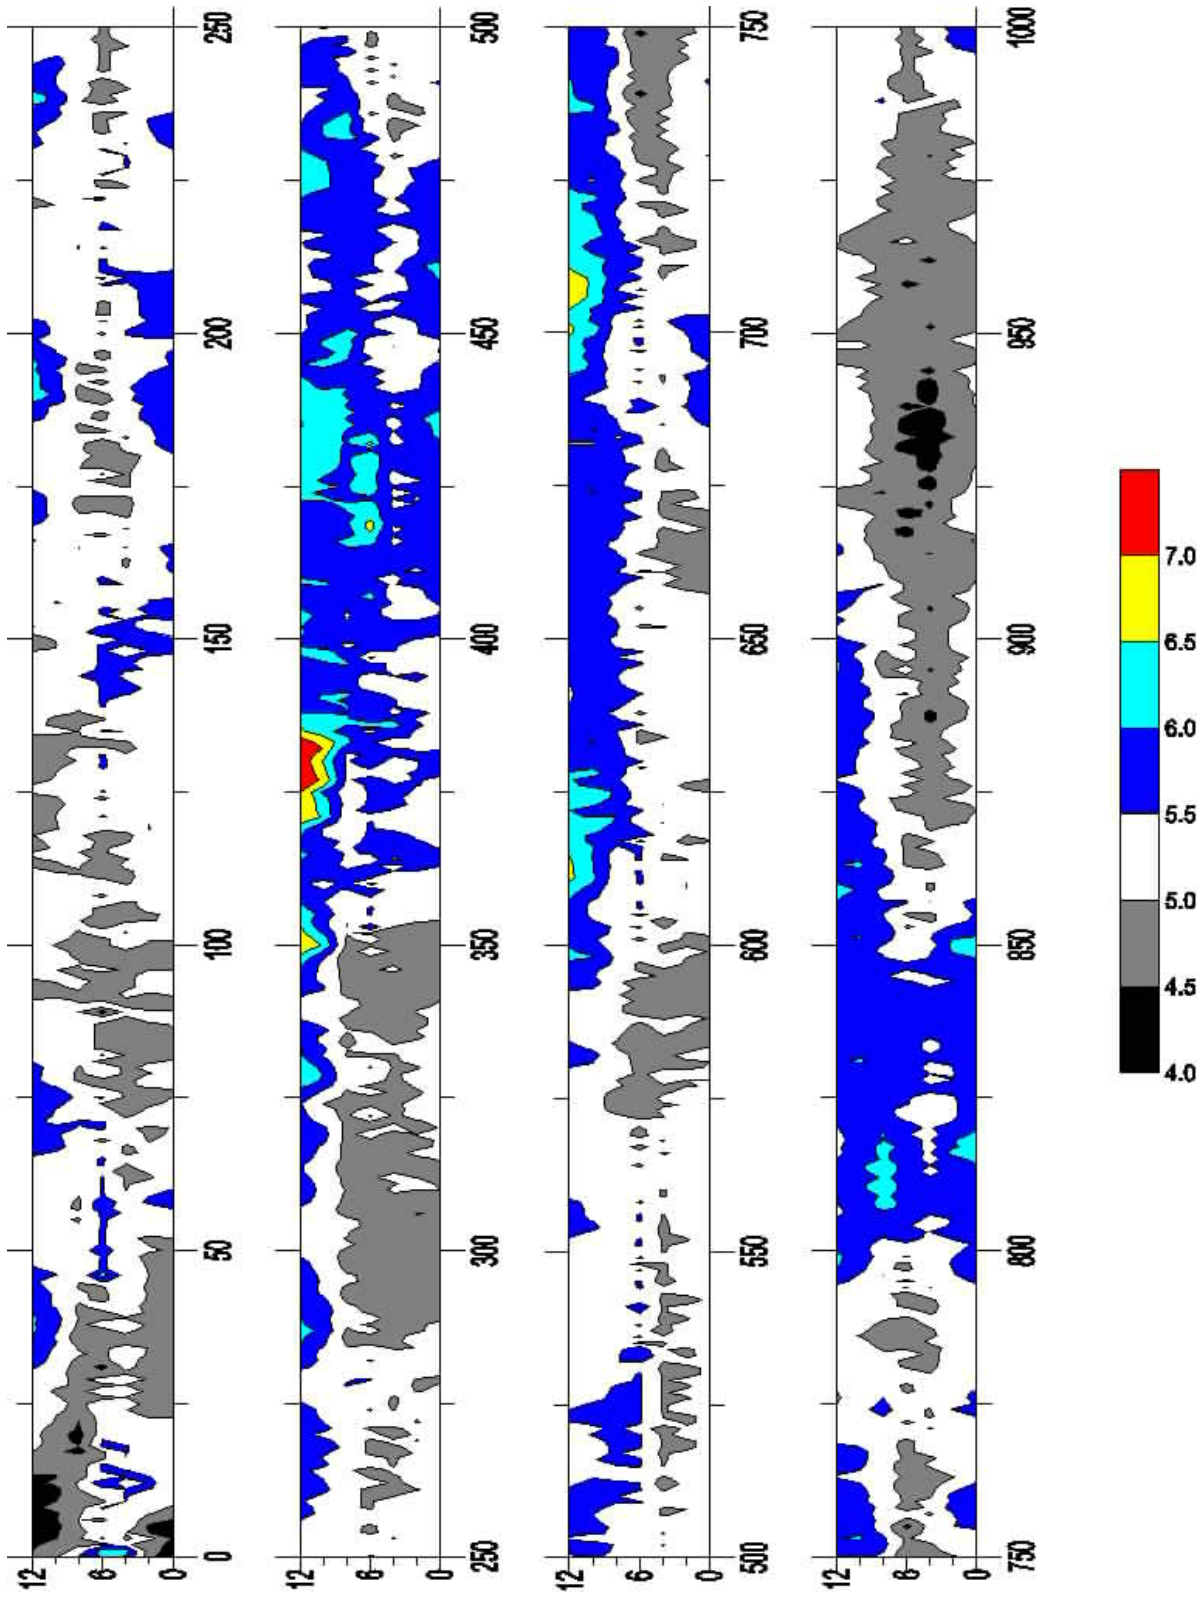
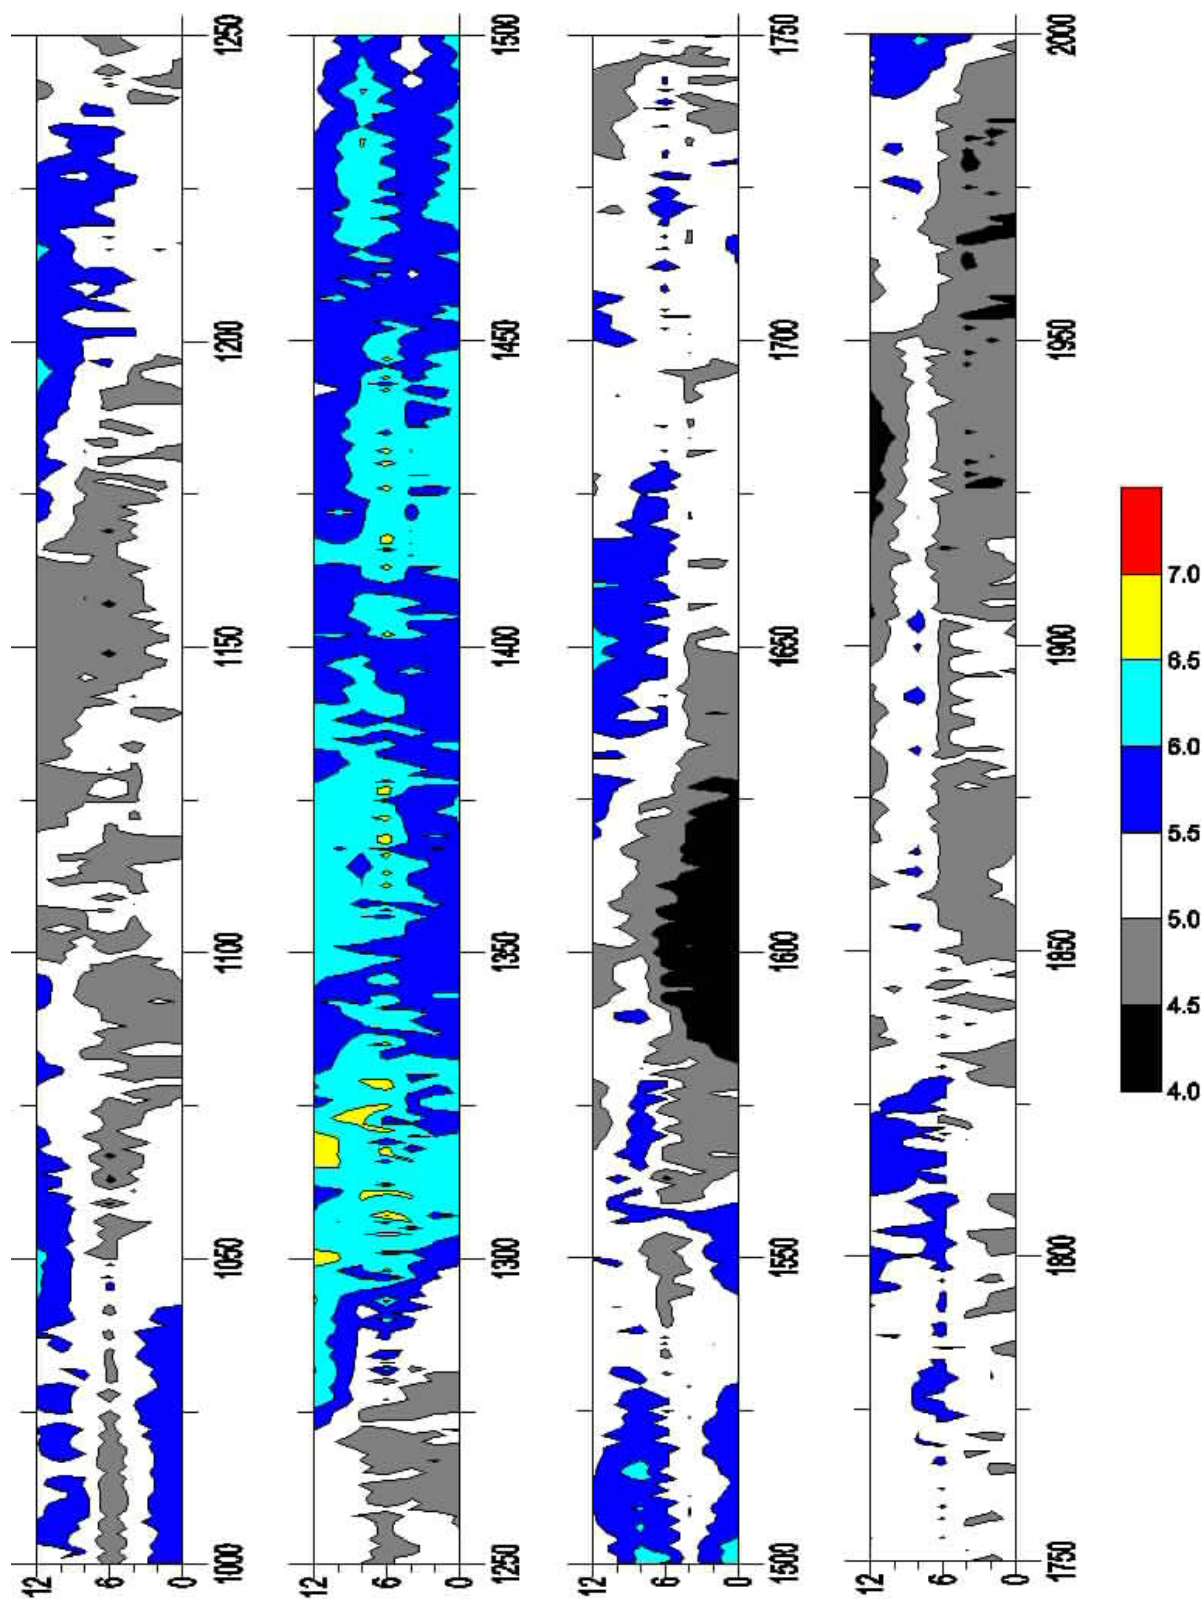
Figure 4. Predicted Air Voids for IH 20 Test Section.

Table 2 summarizes the coring results used to calibrate the relationship between dielectric and air voids. Figure 3 graphically shows the calibration. Based upon the determined relationship, the data from the five GPR runs were converted into a plot of predicted in-place air voids. Figure 4 shows this plot. Additionally the GPR data, with about 10,000 data points, can be used to estimate the percent of the section with air voids within a given range. Figure 5 shows this distribution. Based on the results, 95 percent of the test section is expected to have air voids between 4.6 and 6.2 percent. The minimum predicted air void content is 3.6 percent and the maximum predicted air void content is 7.5 percent.

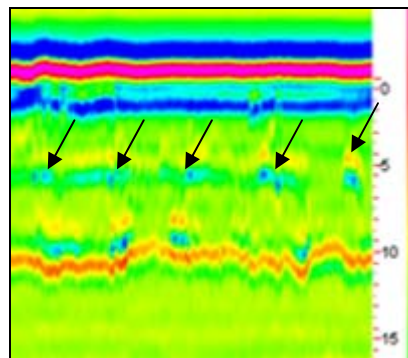
**Figure 6. Example GPR on IH 20 after Seven Years of Service.**

In late 2009, TxDOT reported that this project had some leveling work performed by maintenance forces due to rutting. In 2011, TTI conducted a radar survey over the section; [Figure 6](#) presents an example from these radar data. The data show the surface mix appears good; however, the GPR indicates possible localized problem areas in the subsurface mixture. These areas may be cyclical segregation that could result in distress occurring over time.

Data collected during construction on the IH 20 paving project showed good placement and density uniformity. After seven years of service, some problems have occurred throughout the project. Current GPR indicates that some portions of the project may have subsurface defects, which could have contributed to the problem. The performance suggests ensuring quality on lower-layer mixes is just as important as ensuring quality and uniformity on the final surfacing.

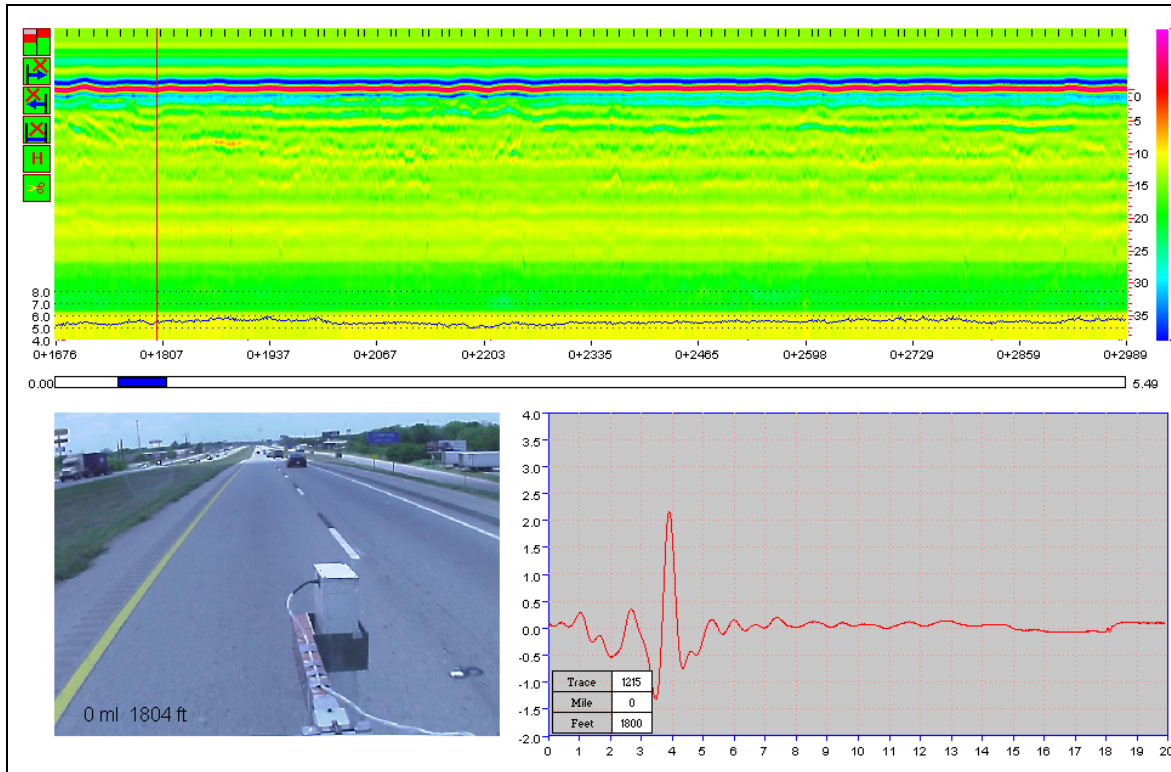
**Figure 9. Example GPR on IH 10 in July 2011.**

In July 2011, TTI conducted a visual and GPR survey of this project. The only distresses noted were occasional transverse cracks, as [Figure 8](#) illustrates, and occasional longitudinal cracking on the shoulder. The longitudinal cracking was likely due to the subgrade and dry weather pattern that existed at the time of the survey. The GPR survey did not reveal any items of concern, with clean, uniform traces and uniform surface dielectric values. [Figure 9](#) presents an example excerpt from the GPR data collected over the westbound inside lane.

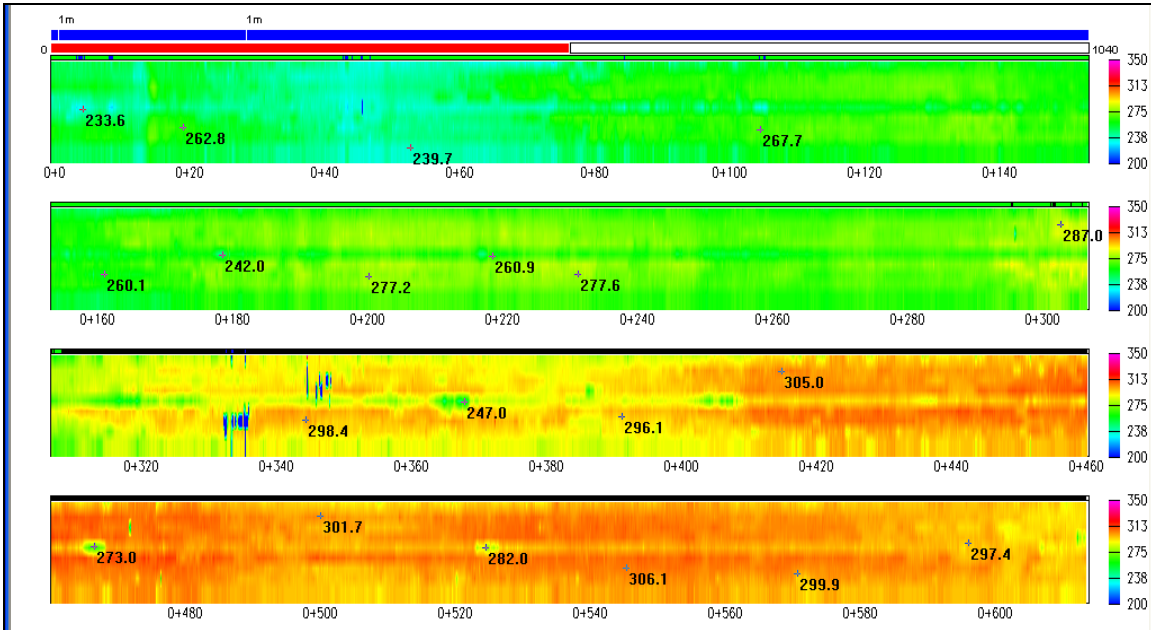
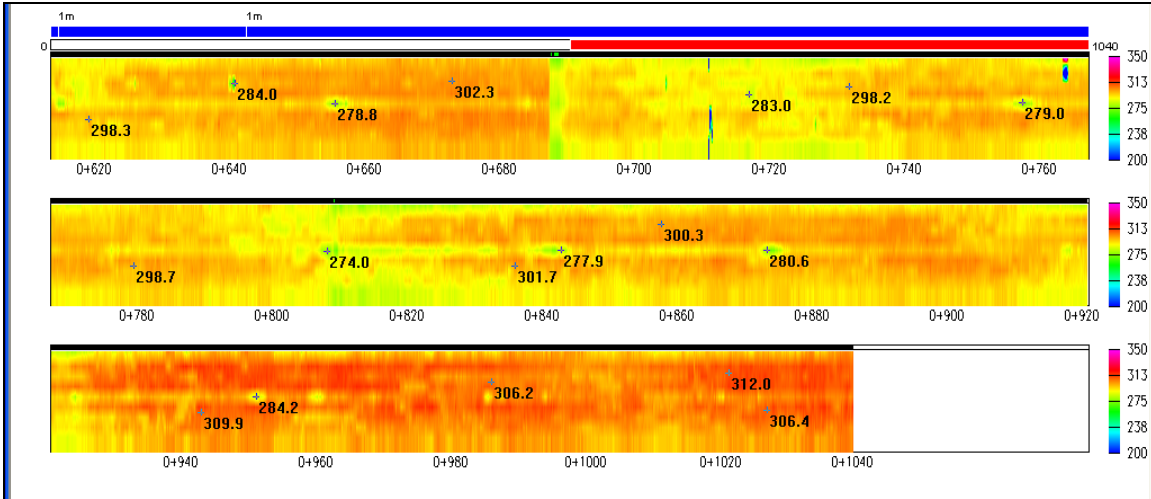
**Figure 12. Thermal Profile at Start of US 75 Paving on 12-3-08.**

Figure 11 shows a Pave-IR system collecting project data on US 75. In the thermal survey, the “zero” distance point is approximately 15 ft north of the northern end of the bridge deck over Center Road. Figure 12 shows the IR data collected on the first approximately 1000 ft of paving. The data show that the first two truckloads of mix were somewhat cooler than the rest of the loads, with placement temperatures between approximately 230 and 275°F. After those first initial truckloads, the mix placement temperatures appeared to stabilize within a narrow temperature window of approximately 280° to 310°F. Although the thermal profile also shows recurring thermal differentials at approximately 40-ft intervals in the lane centerline, after the first two truckloads the magnitude of these differentials was only between approximately 20° and 30°F, which should not cause concern.

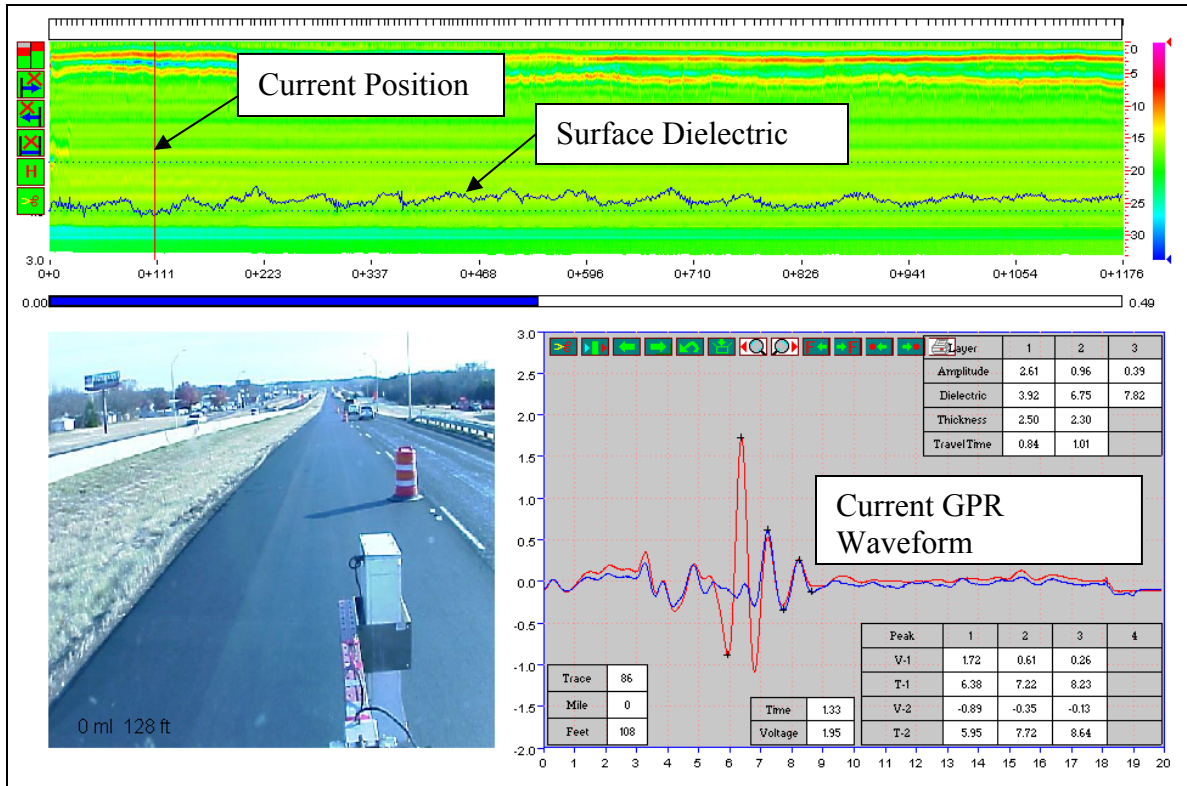
**Figure 17. Excerpt from GPR Survey on US 75.**

Figure 17 shows an excerpt from one of the GPR runs. At the location shown, the surface dielectric is rather low compared to the rest of the data. Based upon data review in the field, TTI selected four core locations to calibrate the GPR to density. TxDOT collected and tested the cores for air void content. Table 3 shows these data, and Figure 18 shows the calibration between the GPR data and HMA density. Although the air voids are typically predicted from the dielectric value using an exponential function, with this data set a much better fit exists by using a linear function.

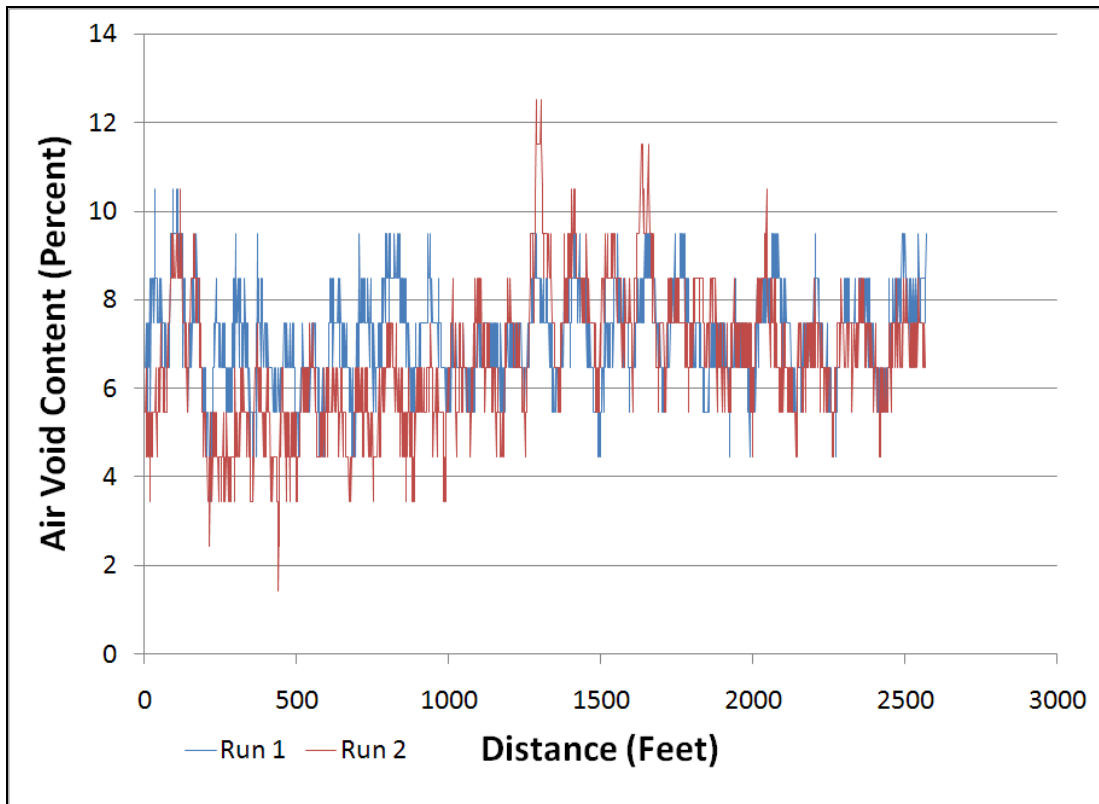
**Figure 20. Predicted Air Voids with Distance from GPR Runs on US 75.**

According to the governing TxDOT specification on this project, the contractor receives a placement pay factor of 1.00 or greater for air voids between 4.7 and 8.5 percent. From [Figure 19](#), the GPR data suggest approximately 77 percent of the section would qualify for a pay factor of 1.00 or greater. The data also suggest approximately 3.5 percent of the section has air voids greater than or equal to 10 percent. [Figure 20](#) shows the air void predictions with distance for both GPR runs, which suggest the locations with unacceptable air void content exist primarily at distances between 95 and 121 ft, 1288 to 1310 ft, 1407 to 1418 ft, and 1632 to 1661 ft into the GPR runs.

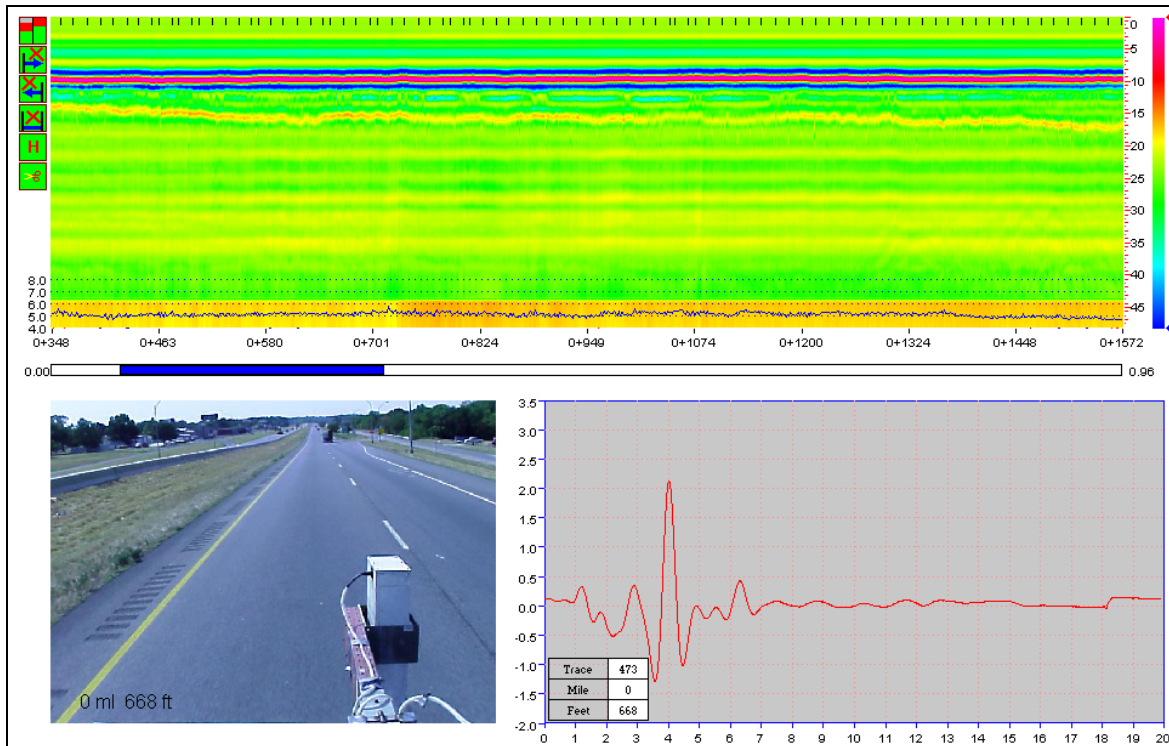
**Figure 21. Example GPR Data on US 75 in August 2011.**

In August 2011, TTI conducted a visual and GPR survey of this US 75 project and noted no distresses. The GPR data similarly look good, with no odd reflections and a uniform surface dielectric. [Figure 21](#) presents an excerpt of the GPR data from the section.

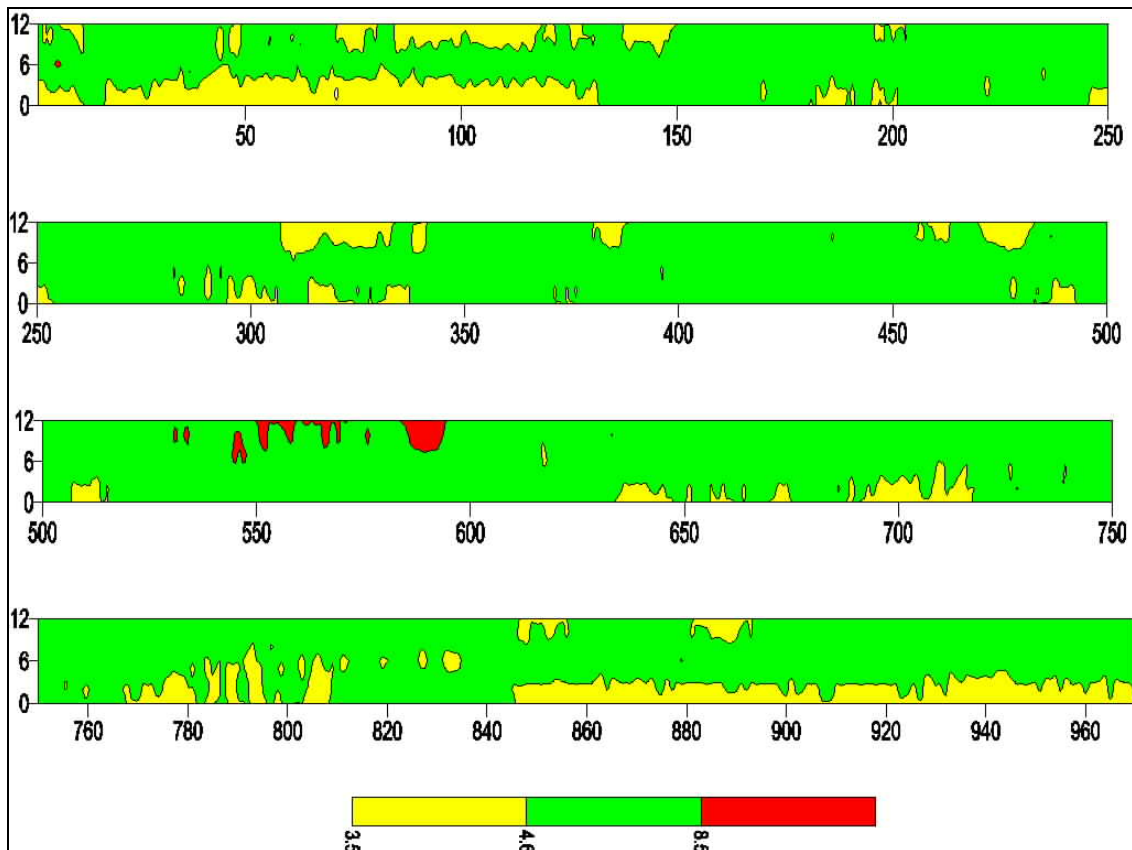
**Figure 30. Expected Air Void Content on IH 40 Type C HMA.**

Using the calibration from [Figure 28](#), each radar trace was converted to an air void measurement, yielding over 2100 measurements spatially over the HMA mat with summary statistics, as shown in [Table 5](#), and distribution frequency as illustrated in [Figure 29](#). The data show approximately 87 percent of the mat area is within the placement bonus region between 4.7 and 8.5 percent air voids. The individual air void predictions at known spatial locations on the mat also allow development of the contour map, as [Figure 30](#) illustrates. In the location in [Figure 30](#) with air voids exceeding 8.5 percent, the thermal data did not show any noticeable anomalies. It is, therefore, suspected that the higher air voids (from 550 to 600 ft) may have been the result of issues with the rolling operation.

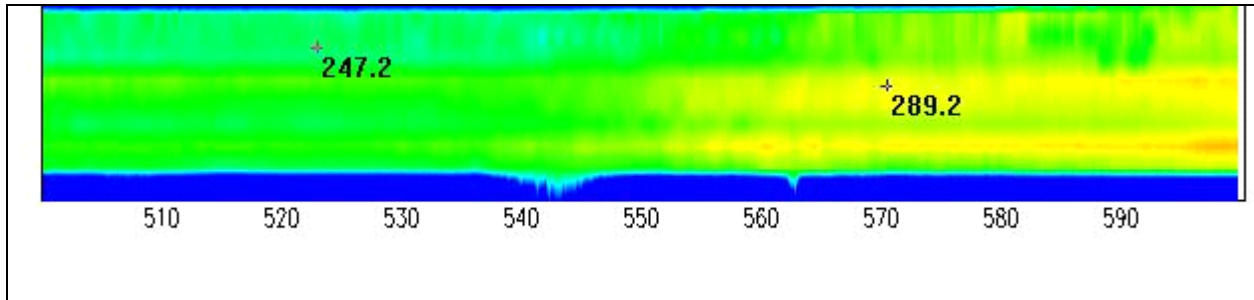
**Figure 38. Example Infrared Data on BU 290 Type D.**  
*Note: blue cold regions at edge of mat are from IR sensors off the mat.*

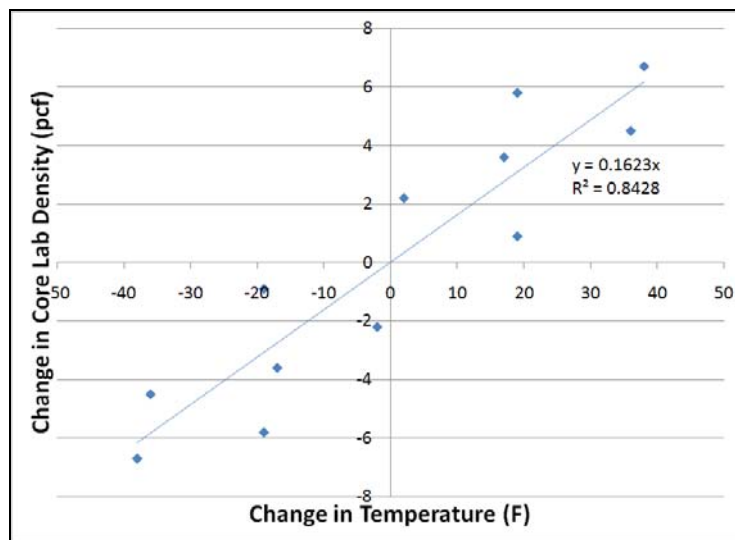
**Figure 39. Relationship between Infrared and Air Voids on BU 290 Type D.**

[Figure 38](#) shows an excerpt from the IR data, and [Table 6](#) presents results from cores collected on the project at the time of construction. [Figures 39](#) and [40](#) illustrate that both IR and GPR correlated well with the compacted mat density.

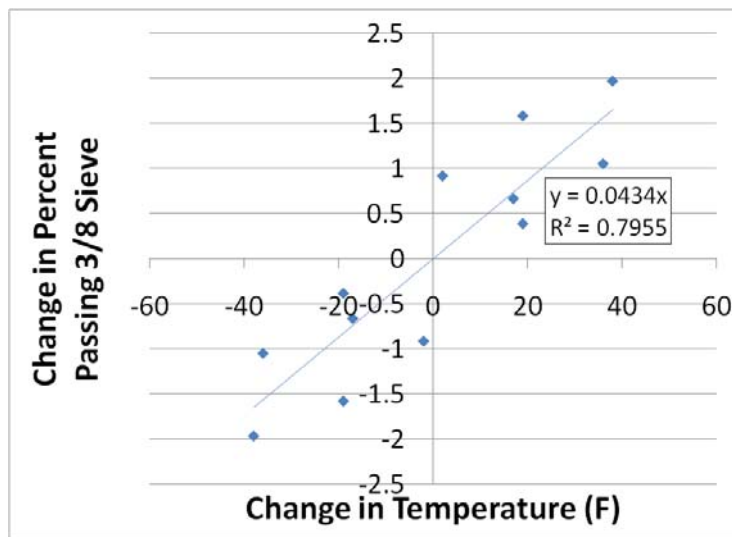
**Figure 41. Change in Temperature and Percent Passing 3/8 in. on BU 290 Type D.**

Table 7 presents the gradation results obtained on the field cores. Figures 41 and 42 illustrate that both the infrared and GPR correlated with gradation. As temperature and dielectric values increased, the mix became finer.

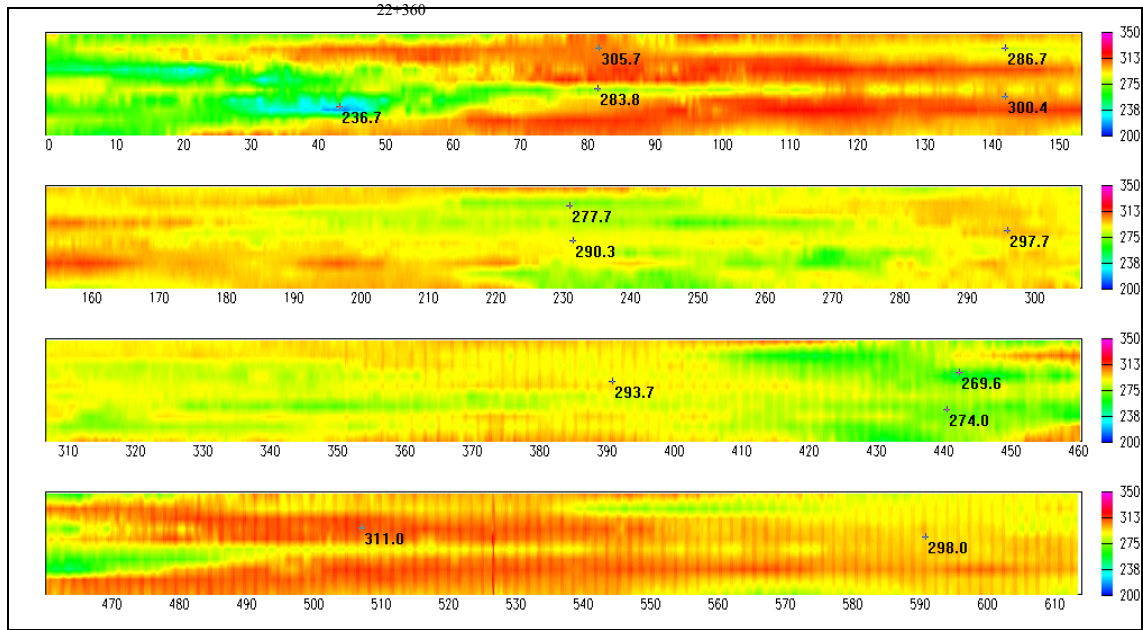
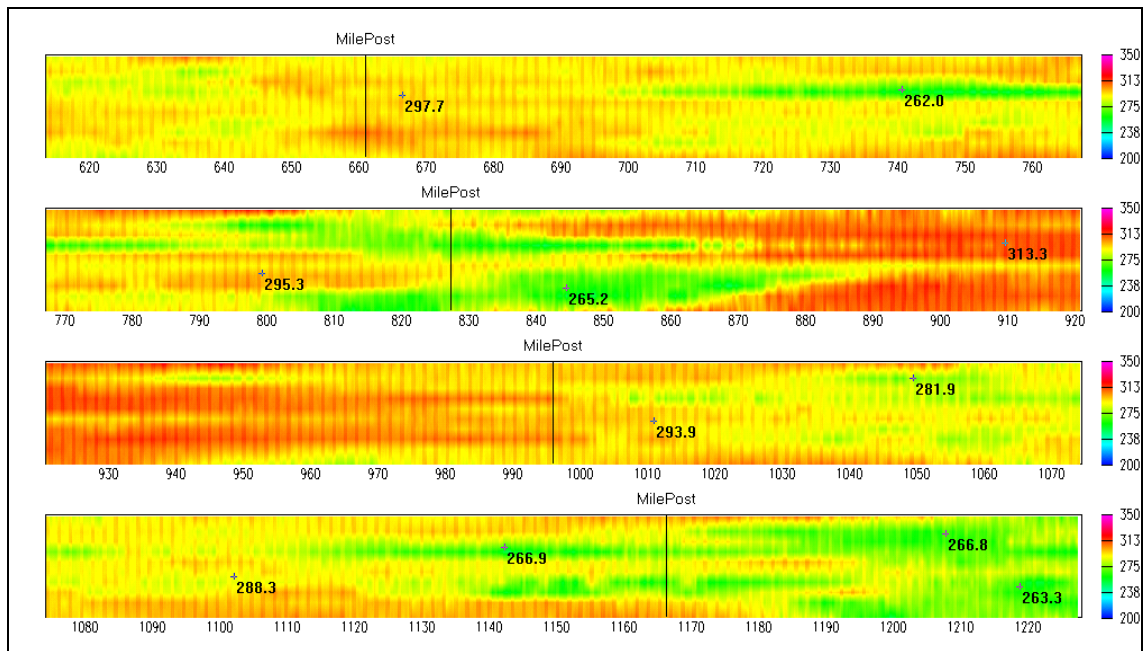
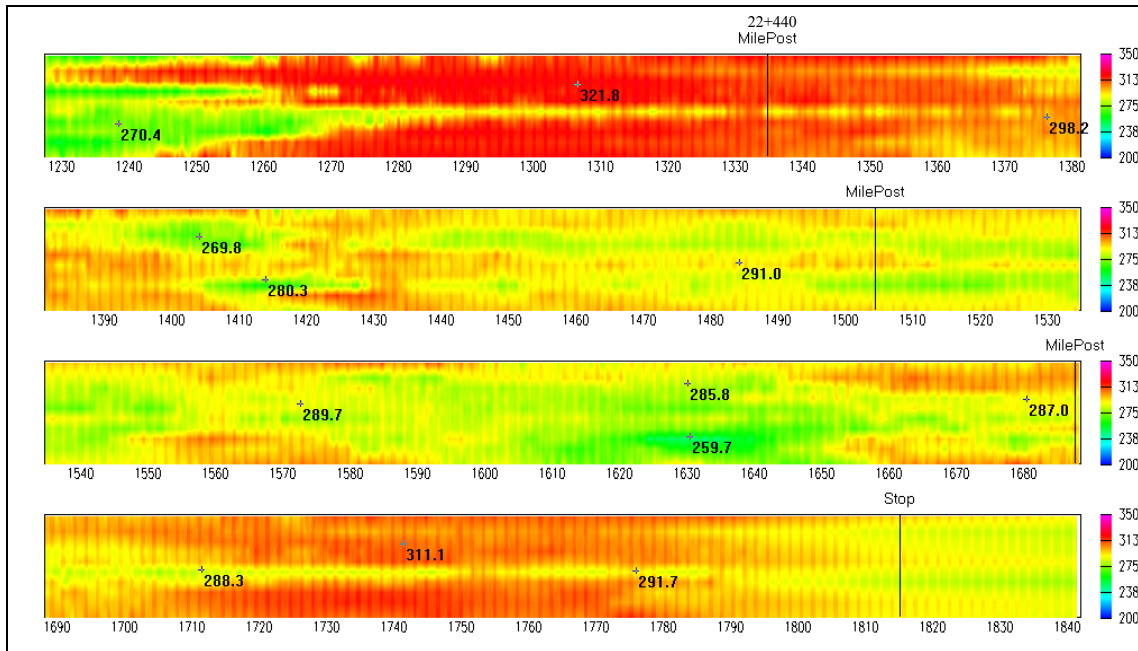
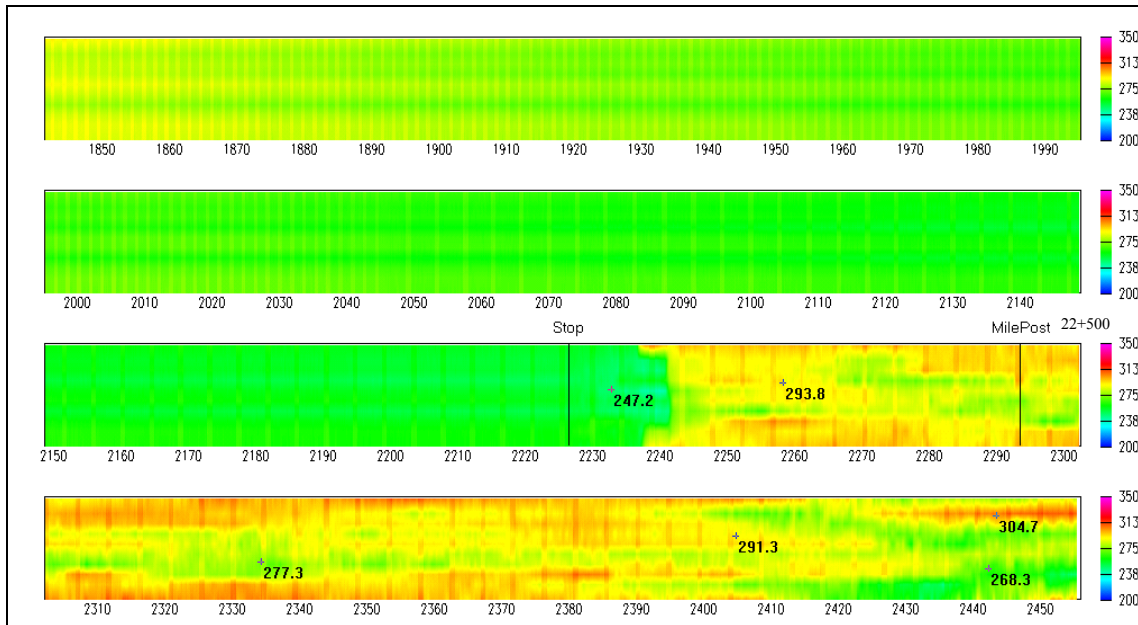
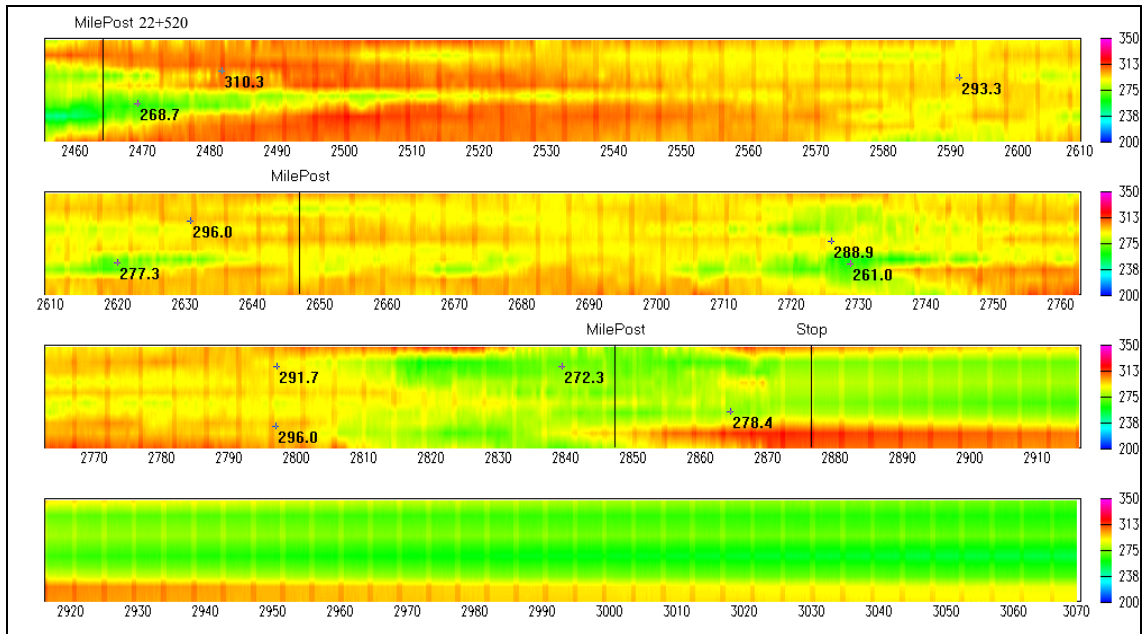
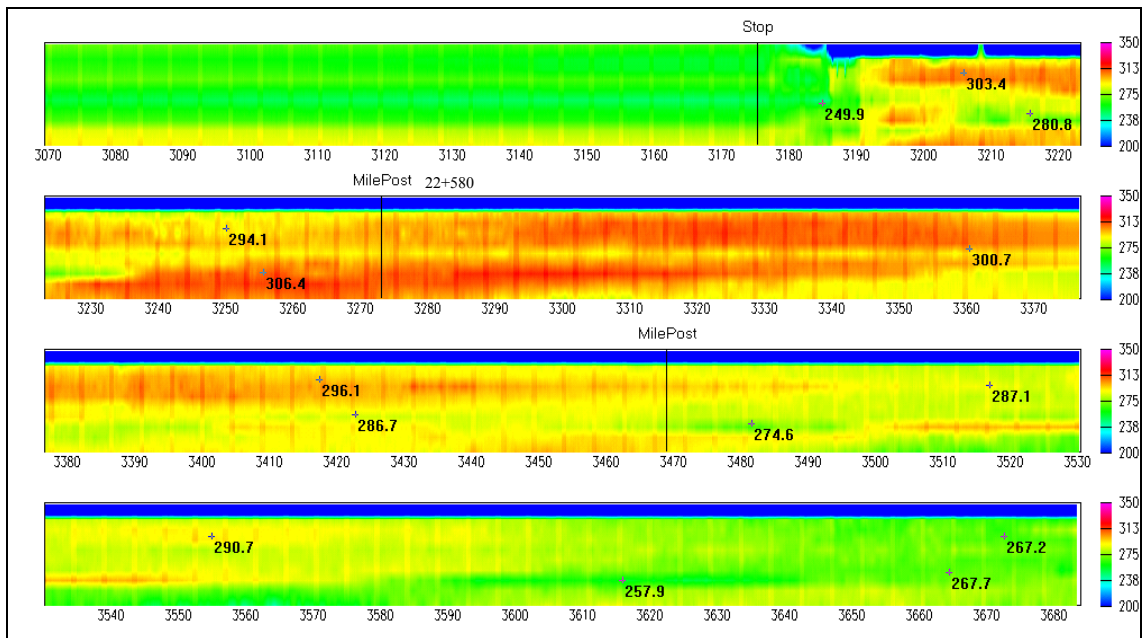
**Figure 47. Thermal Plot of US 77.**

[Figure 47](#) shows the thermal plot for the project. Due to problems with the distance measuring device, the thermal data were collected in the time mode. To reference the data to the project, markers were inserted in the data at the stations. Additionally, locations of paver stops and starts were denoted by a marker labeled “stop.” Examination of the thermal data show:

- Thermal uniformity of the mix within each truckload was very good.
- Truck arrival temperatures were consistent, with placement temperatures (excluding truck-end cold spots) typically between 280° and 310°F.
- Clear patterns of truck-end temperature differentials exist from STA 22+360 to STA 22+560. The temperature differentials at these truck-end locations were typically between 25° and 40°F. It is unknown if these trucks were insulated or not.

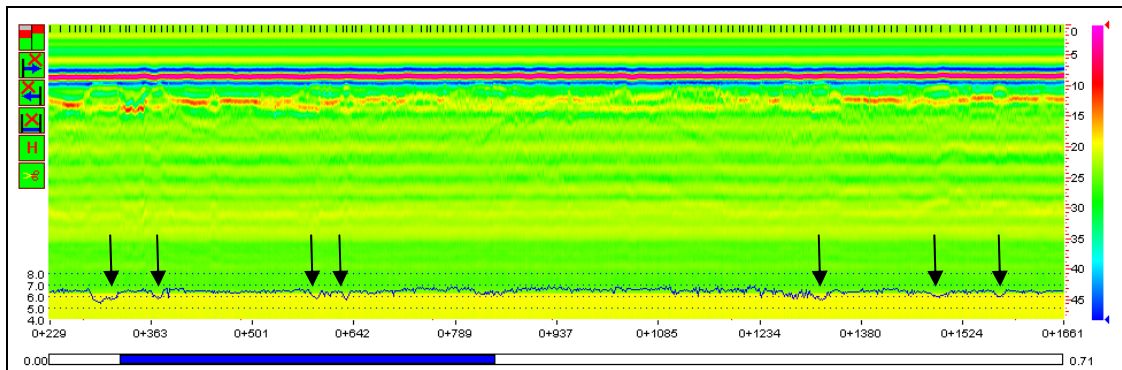
**Figure 52. GPR on US 77 after Five Years of Service.**

TTI conducted a visual and GPR survey on this section of US 77 in July 2011, approximately five years after construction. The pavement exhibited some longitudinal and transverse cracking, as [Figure 51](#) illustrates. Additionally, the visual and GPR survey shows clear signs of truck-end segregation. [Figure 52](#) presents the GPR data, which show cyclical dips in the surface dielectric value. Many of these cyclical dips correspond to locations of high air voids shown in [Figure 49](#) identified at the time of construction.

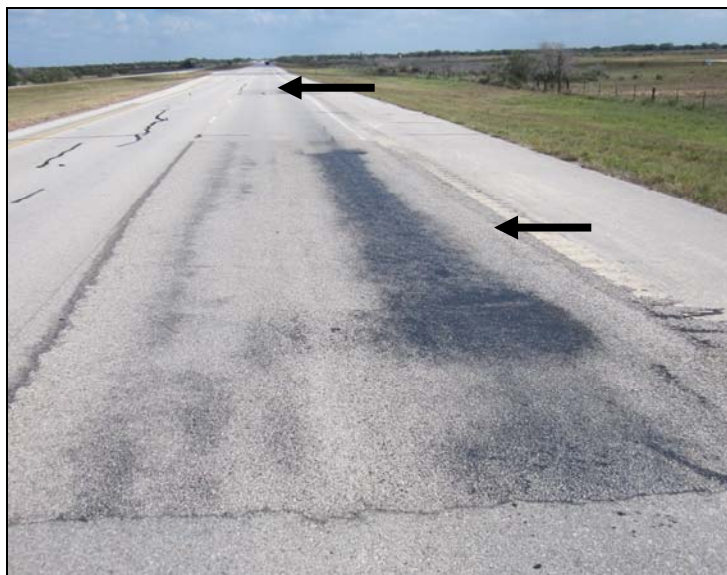
**Figure 55. Patching on US 77.**

Elsewhere on the US 77 project, other locations of segregation were observed, as [Figure 54](#) illustrates. Although these locations were not surveyed at the time of construction, [Figure 54](#) illustrates classic cases of cyclical segregation, exhibiting a coarser surface texture, raveling, and cracking. Additionally, some locations of patching exist on the project, and at one location, these patches were centered about 150 ft apart, typically the distance between truckloads. [Figure 55](#) shows this location.

After five years of service, evidence of the cyclical segregation still exists—both visually and through the radar survey. While no significant distress due to segregation was positively identified in the section surveyed at the time of construction, elsewhere in the project some locations did exist where cracking was clearly initiating in a segregated zone. One location of patching exists where the distance between patches was consistent with the distance between truckloads, so it is possible some failures may have occurred and been patched due to segregation.

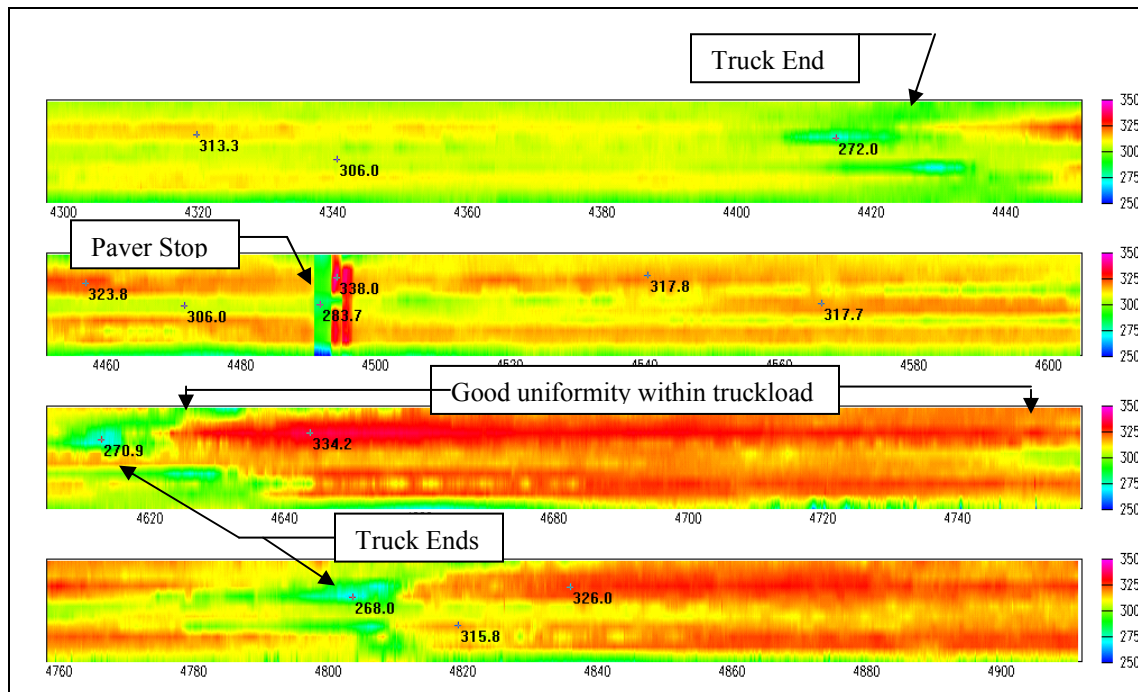
**Figure 58. Representative Temperature Surface Plot.**

Figure 58 shows a representative surface plot of mat placement temperatures and illustrates good uniformity within truckloads, a location where the paver stopped, and locations of truck-end thermal segregation. Figure 58 shows a hot spot immediately following the location of a paver stop. This pattern is due to burners on the paver operating while the paving train was stationary.

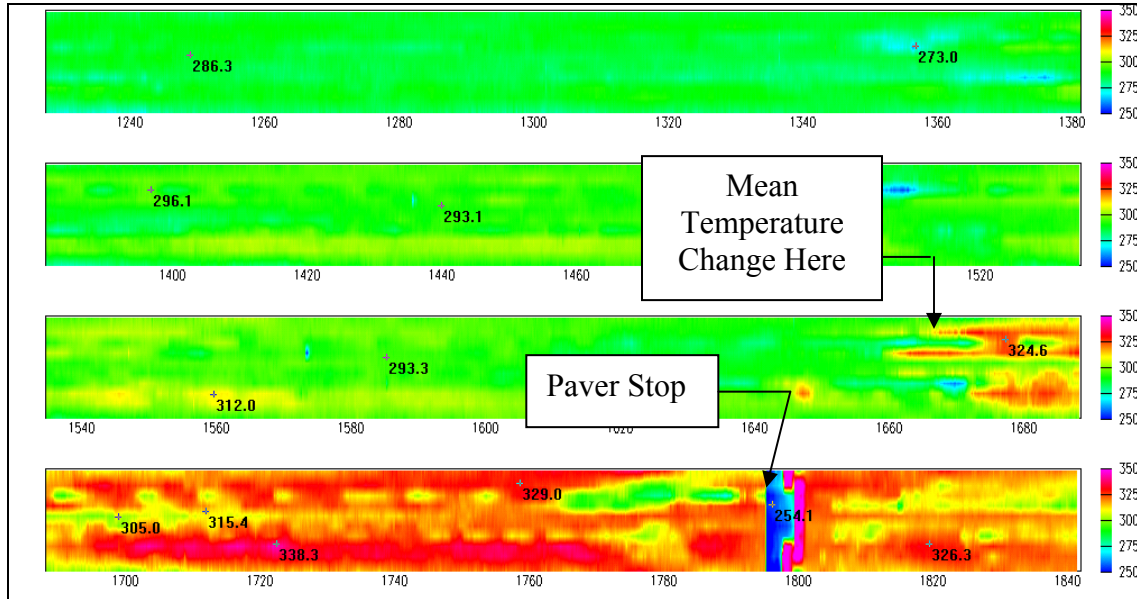
**Figure 59. Transition Point in Mean Truckload Temperatures.**  
*Note: data from Lot 1.*

Figure 59 illustrates a location where a shift in the mean truckload temperatures occurred. The green areas are in the range 280° to 300°F, whereas in the last segments the temperatures are

generally above 320°F. This figure also shows a location of a paver stop; the short blue area represents cooling mix under the paver; the adjacent strong red strips across the mat probably represent the area beneath the burners.
