# **PERFORMANCE MONITORING PAVEMENTS WITH THERMAL SEGREGATION IN TEXAS**

Report 0-6080-1

Project Title: Performance Histories of Thermally Segregated HMA

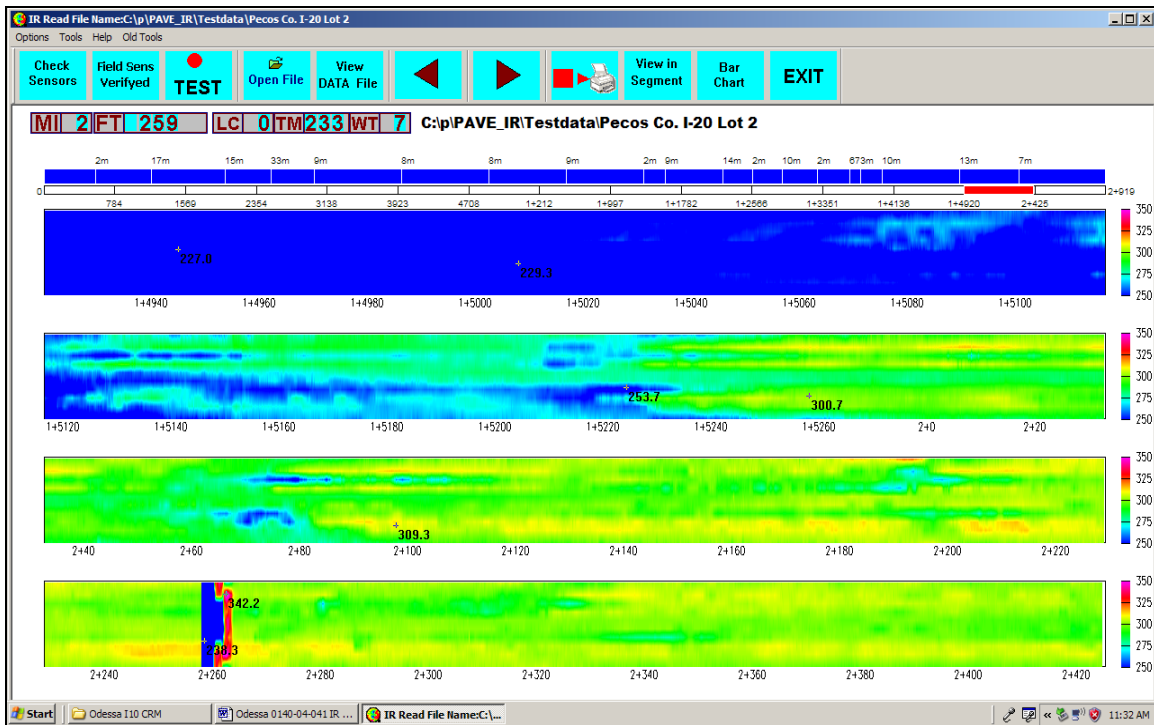
**Figure 62. End of Cold Truckloads in Lot 2 on IH 10 CRM.**

Figure 62 shows the end of the cold section where normal surface temperatures were restored after 1 mi. and 5220 ft. Lot 2 was by far the most extreme lot from all the data collected. Most of the other lots showed reasonably uniform placement temperatures. The most obvious temperature issue with the other lots was caused by frequent paver stops.

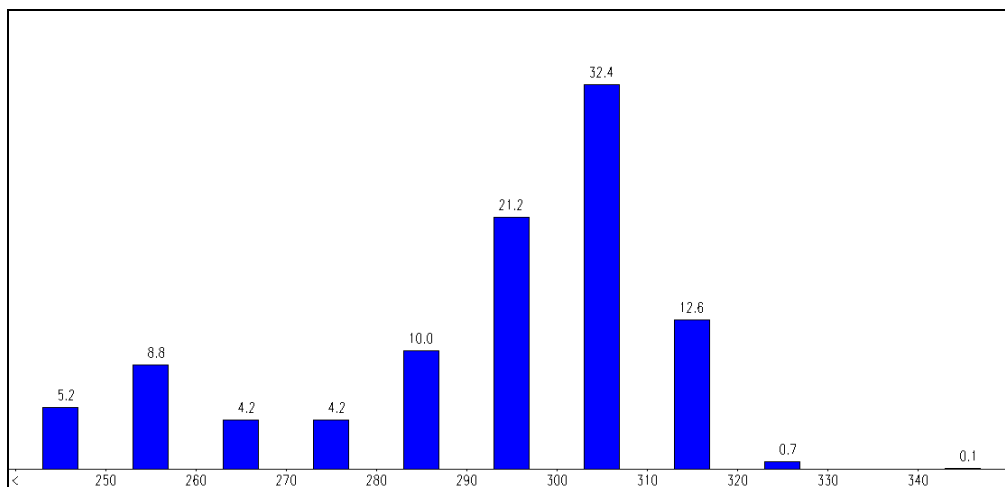
**Figure 63. Histogram of IH 10 CRM Lot 2 Placement Temperatures.**

Figure 63 shows the distribution of temperature for the entire Lot 2. This distribution is considerably different from the distribution for Lot 1 shown earlier in Figure 60. In Lot 1, only 2 percent of the mat was less than 280°F; in Lot 2, over 22 percent of the mat was placed at less than 280°F.

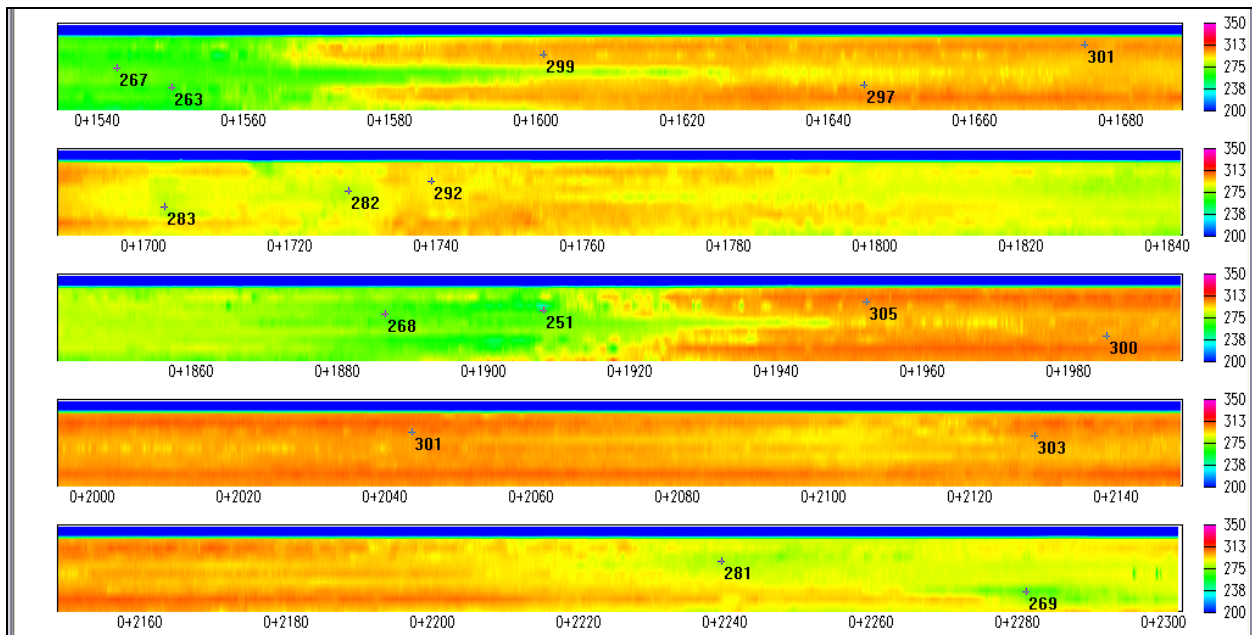
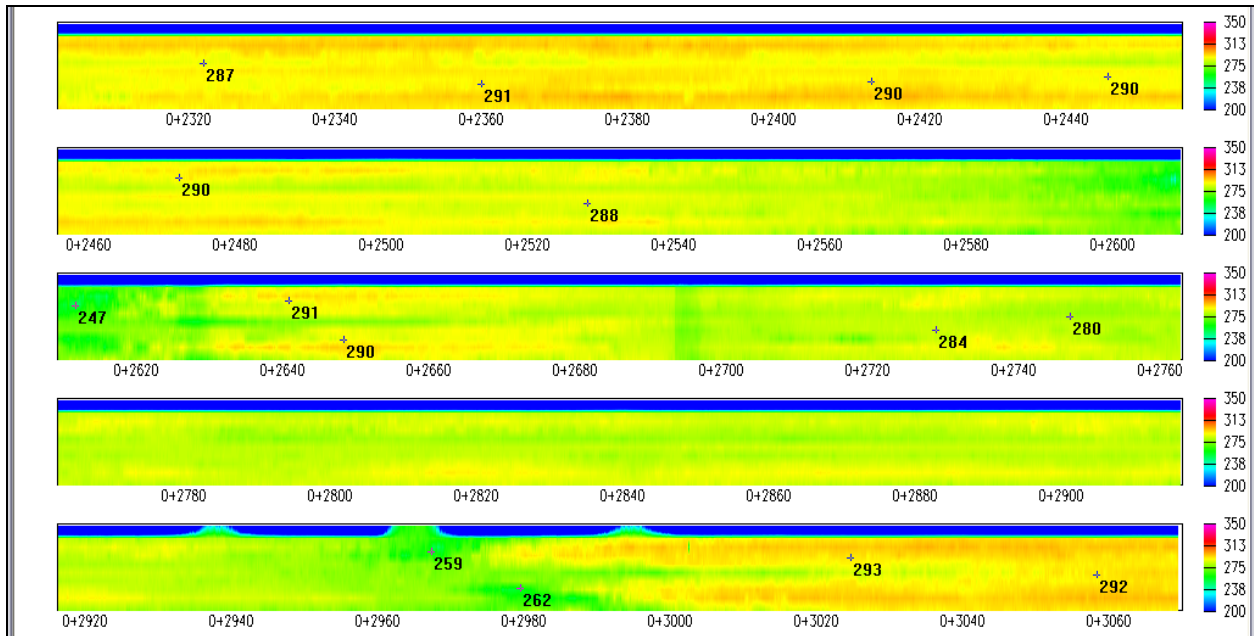
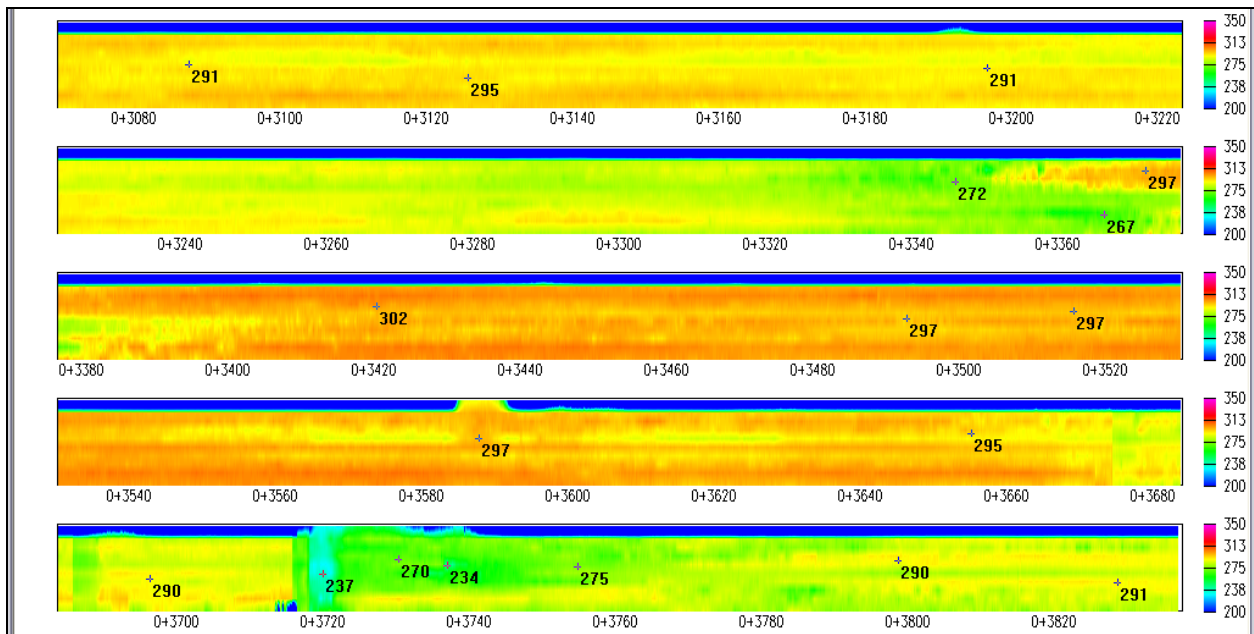
**Figure 66. Thermal Profile of CAM on US 59 Southbound Inside Lane.**

TTI performed a thermal survey on the southbound inside lane, beginning at the northern project limit and continuing to station 45+09. [Figure 66](#) shows excerpts from the thermal profile, which revealed good uniformity within truckloads, some variations in the mean placement temperature from individual trucks, and some truck-end thermal differentials typically around 30°F.

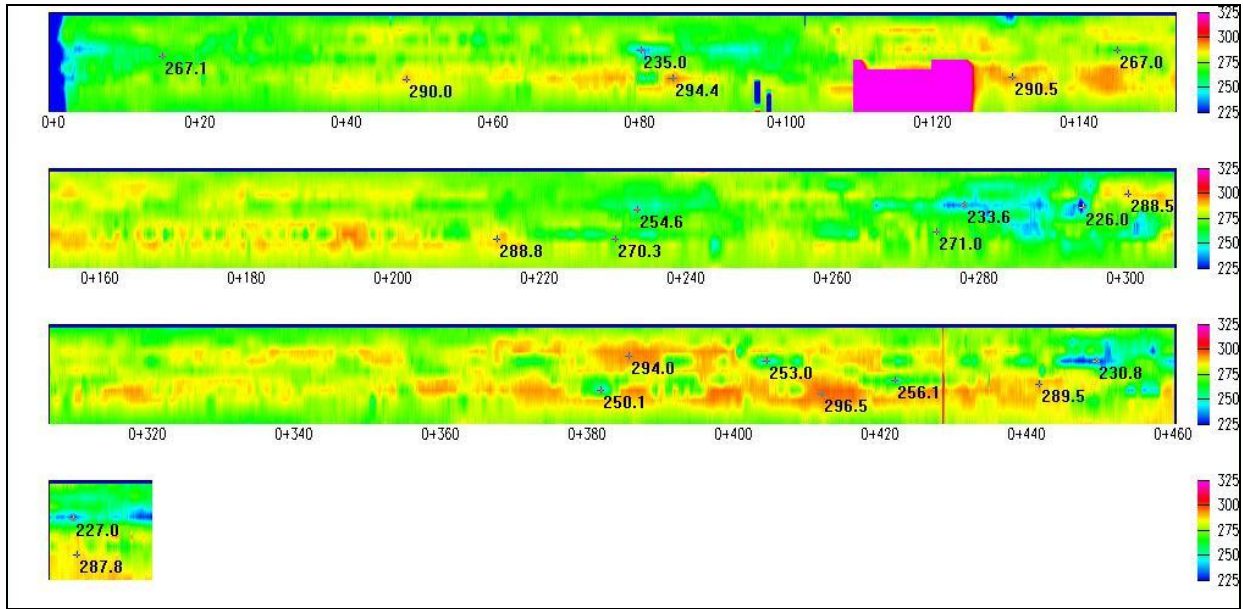
**Figure 70. Thermal Profile from US 90 CAM.**

TTI collected a thermal profile beginning at N 29 12.820, W 99 55.612; and ending at N 29 12.751, W 99 55.425. On this project, numerous locations of thermal segregation were observed with temperature differentials around 50°F. [Figures 70](#) and [71](#) show the thermal profile. Oftentimes these cold locations were also visibly evident, as [Figure 72](#) illustrates.

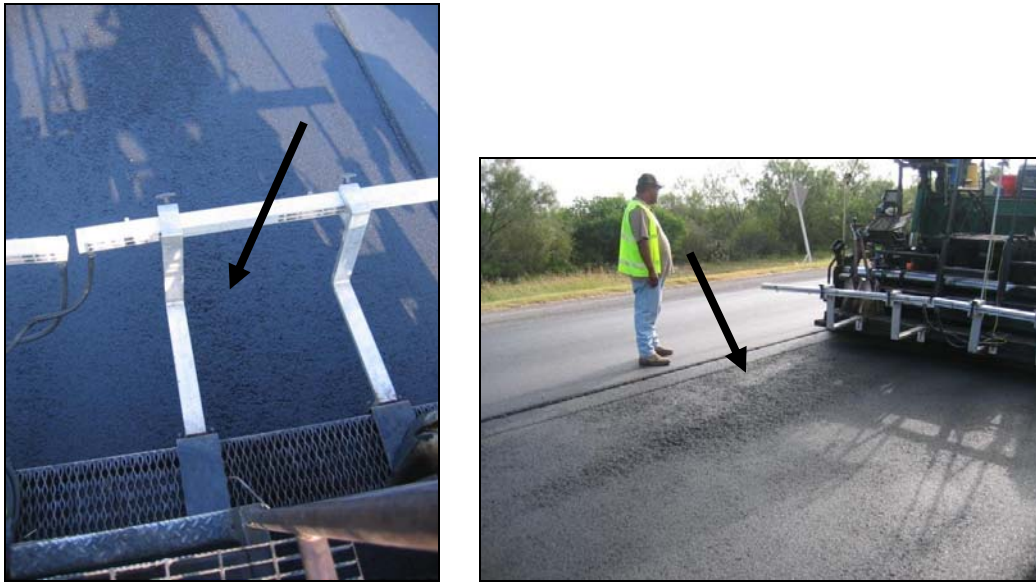
**Figure 72. View of Cold Spot on US 90 CAM.**  
*Note: corresponds with 520 ft in Figure 57.*

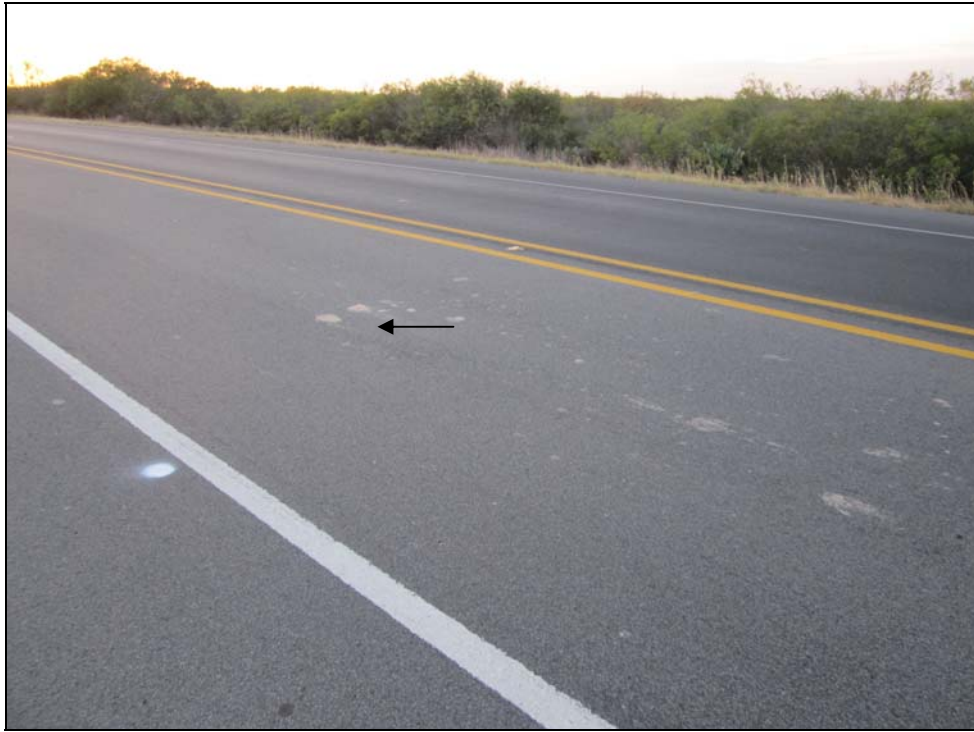
In July 2011, TTI conducted a follow-up visual and GPR survey. Figure 73 shows the GPR data, which show a significant drop in the dielectric in the middle and at the end of the evaluated section. Visually, some locations of coarser surface texture, and some corrugations, were observed. Figures 74 and 75 show the thermally segregated locations selected for coring.

**Figure 74. US 90 Thermally Segregated Locations.**  
*Note: corresponds to ~450 ft in [Figure 70](#).*

In addition to the cores selected from the thermally segregated areas, coring also was performed at a normal location corresponding with approximately 355 ft in [Figure 70](#). [Table 10](#) presents these core results. The core results show some significant changes in density at the most severely thermally segregated location, but poor performance in all cases in the overlay test.

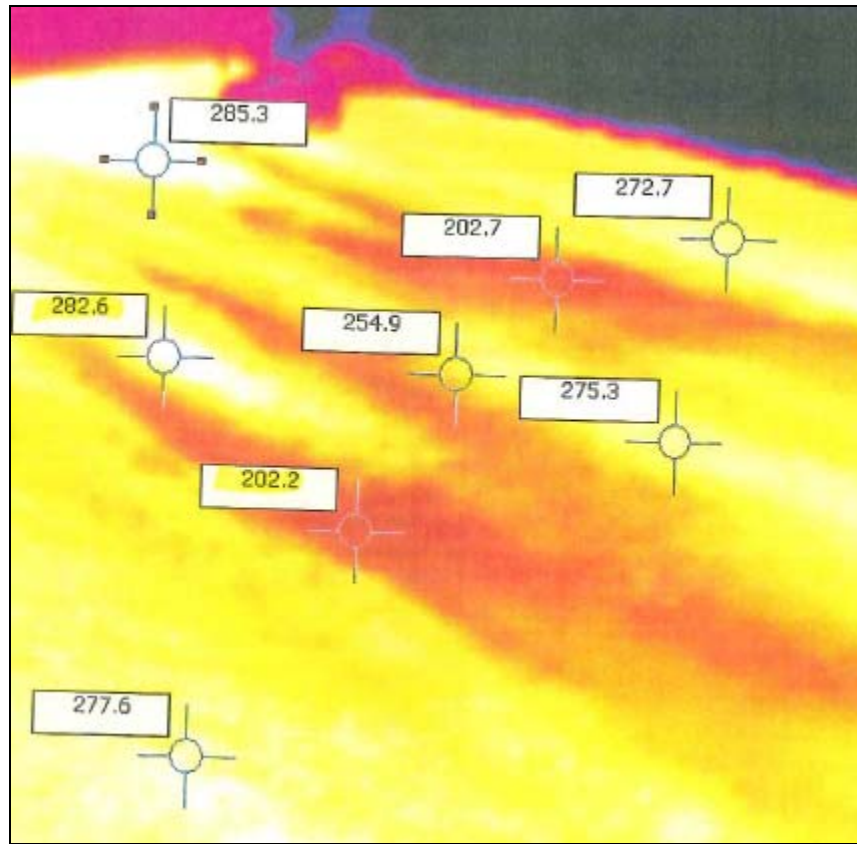
**Figure 76. Example Thermal Picture on FM 2440.**

TxDOT's Austin District staff performed thermal profiling on this project with an infrared camera. The results indicating thermal segregation and failing density profiles prompted a request for follow-up radar and coring surveys. [Figure 76](#) shows an example thermal picture from the project.

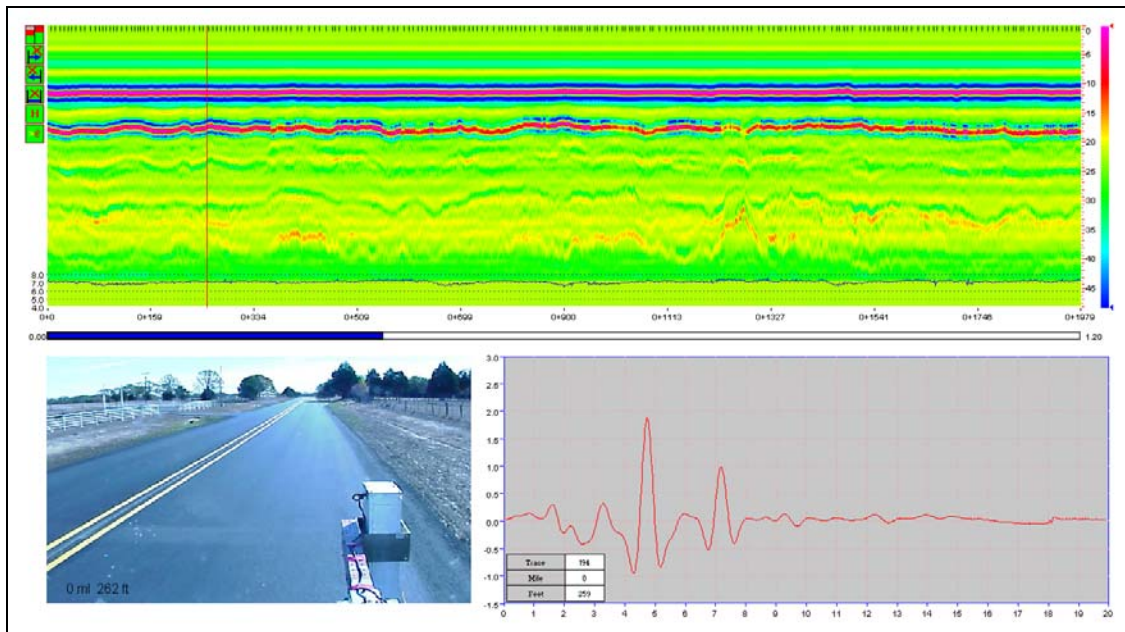
**Figure 77. Example GPR on FM 2440 Shortly after Construction.**

The GPR survey employed four passes each at a different transverse offset on a section approximately 1.2 miles long. The beginning and ending GPS coordinates were 30.20290495 N -96.96591655 W, and 30.19522483 N -96.94862899 W, respectively. The survey covered approximately from station 237 to 299. [Figure 77](#) presents an excerpt of the GPR survey data.

TTI performed a follow-up visual and GPR survey on this section in July 2011. Longitudinal cracking, likely due to the subgrade, was the only distress noted. Figure 84 shows example GPR data from the section evaluation. Contrasting Figure 84 with Figure 77 indicates the dielectric plot in the current data does not vary as much as the dielectric plot observed shortly after construction. This may mean traffic action has smoothed out some of the density irregularities that existed immediately after construction.

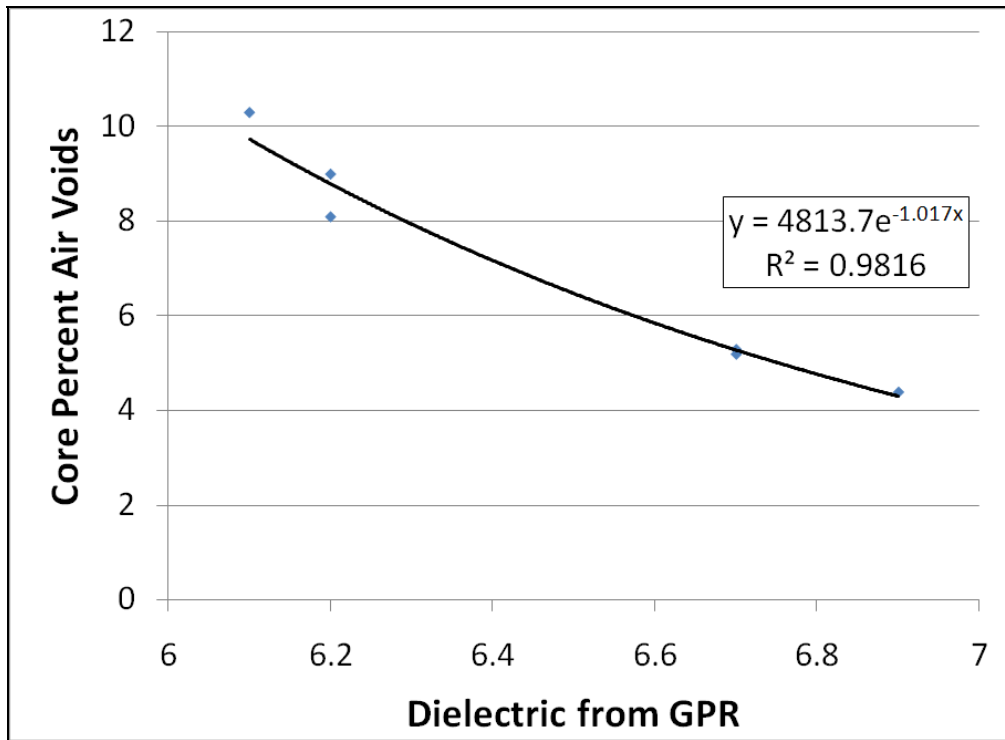
Figure 78. Calibrating GPR to Air Voids on FM 2440.

The core testing allowed correlation of the GPR to the air void content, as [Figure 78](#) illustrates. Using this correlation, researchers converted the trace from each GPR reading to an air void prediction, and used that data to generate predicted air void distributions for the section surveyed. [Figure 79](#) shows this distribution in the cumulative frequency format, encompassing information from over 11,000 data points collected spatially over the mat area surveyed.

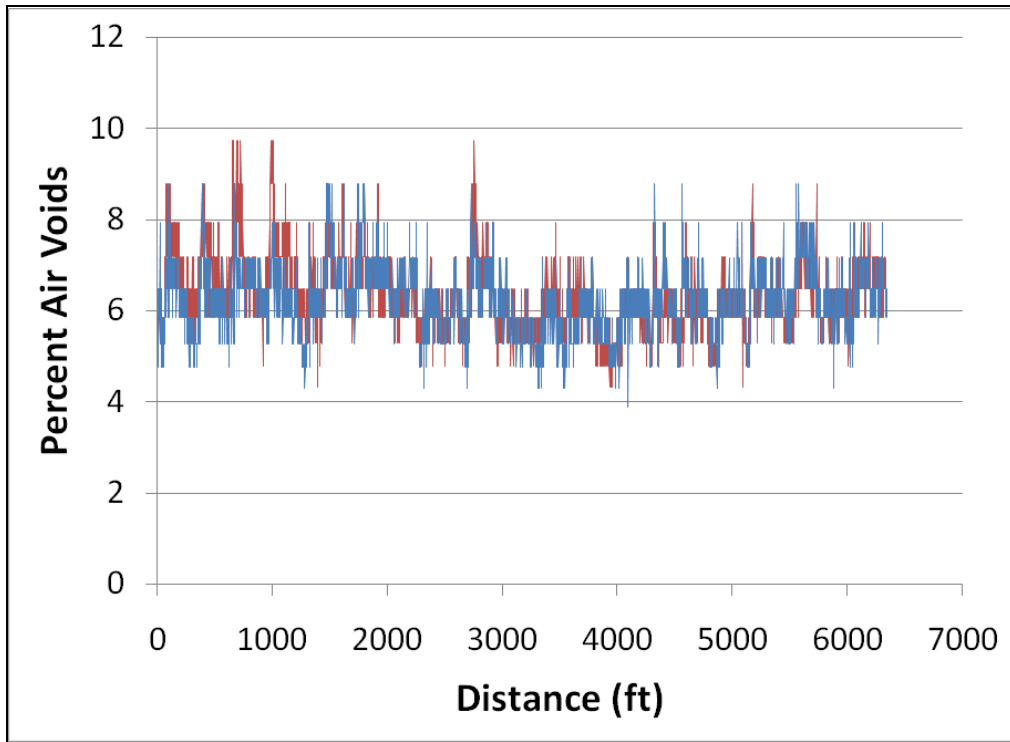
Figure 81. Predicted Air Voids with Distance for GPR Runs 2 and 3 on FM 2440.

Although the expected distribution of air voids shown in [Figure 78](#) does not raise many concerns, visual localized segregation was observed at many locations throughout the project, as [Figure 80](#) shows. Although these cyclic segregated areas will not make up a large portion of the mat area, they can result in maintenance headaches for TxDOT due to the early failure that may occur at these locations. Therefore, the GPR data were further examined for evidence of cyclic spikes in air void content. The GPR data do show noticeable patterns. For example, [Figure 81](#) graphs predicted air void content with distance for both the second and third GPR runs. Noticeable peaks in air void content exist at approximately 300-ft intervals over the first 1000 ft, then at an average spacing of 150 ft from 1450 to 2000 ft. [Figure 82](#) zooms in on the first 2000 ft and further illustrates these patterns using data from the second GPR run. Also, [Figure 82](#) combines the information from all the GPR runs into a surface contour plot of the predicted in-place air void content with thresholds in the color scale chosen from critical points in the Item 341 Placement Pay Adjustment Factors table. [Figure 83](#) illustrates the cyclical low-density areas spatially on the pavement mat from station 237 to 257.

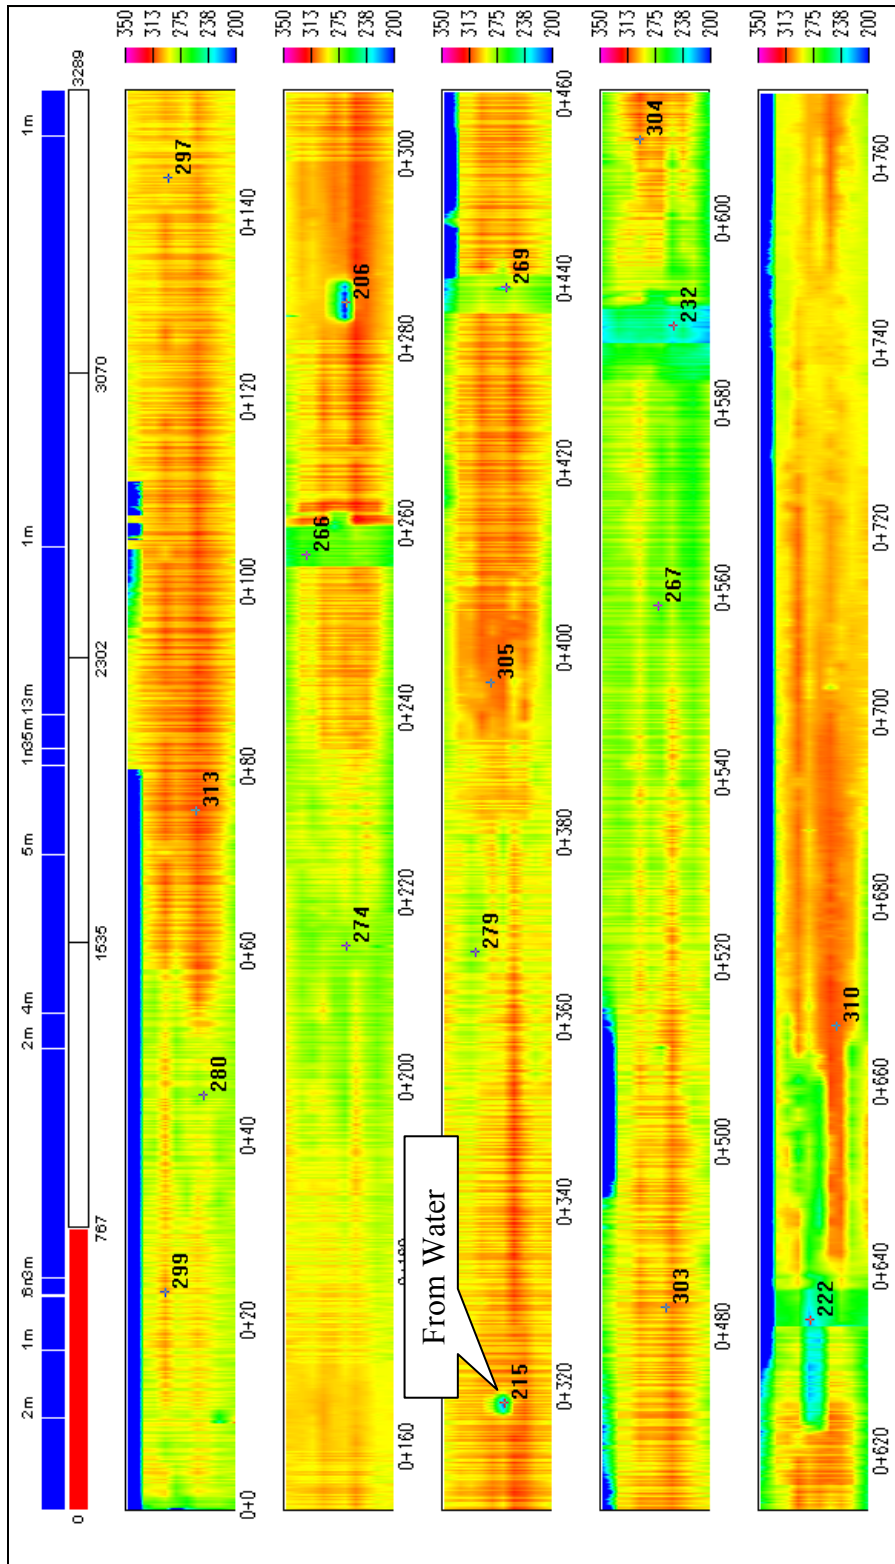
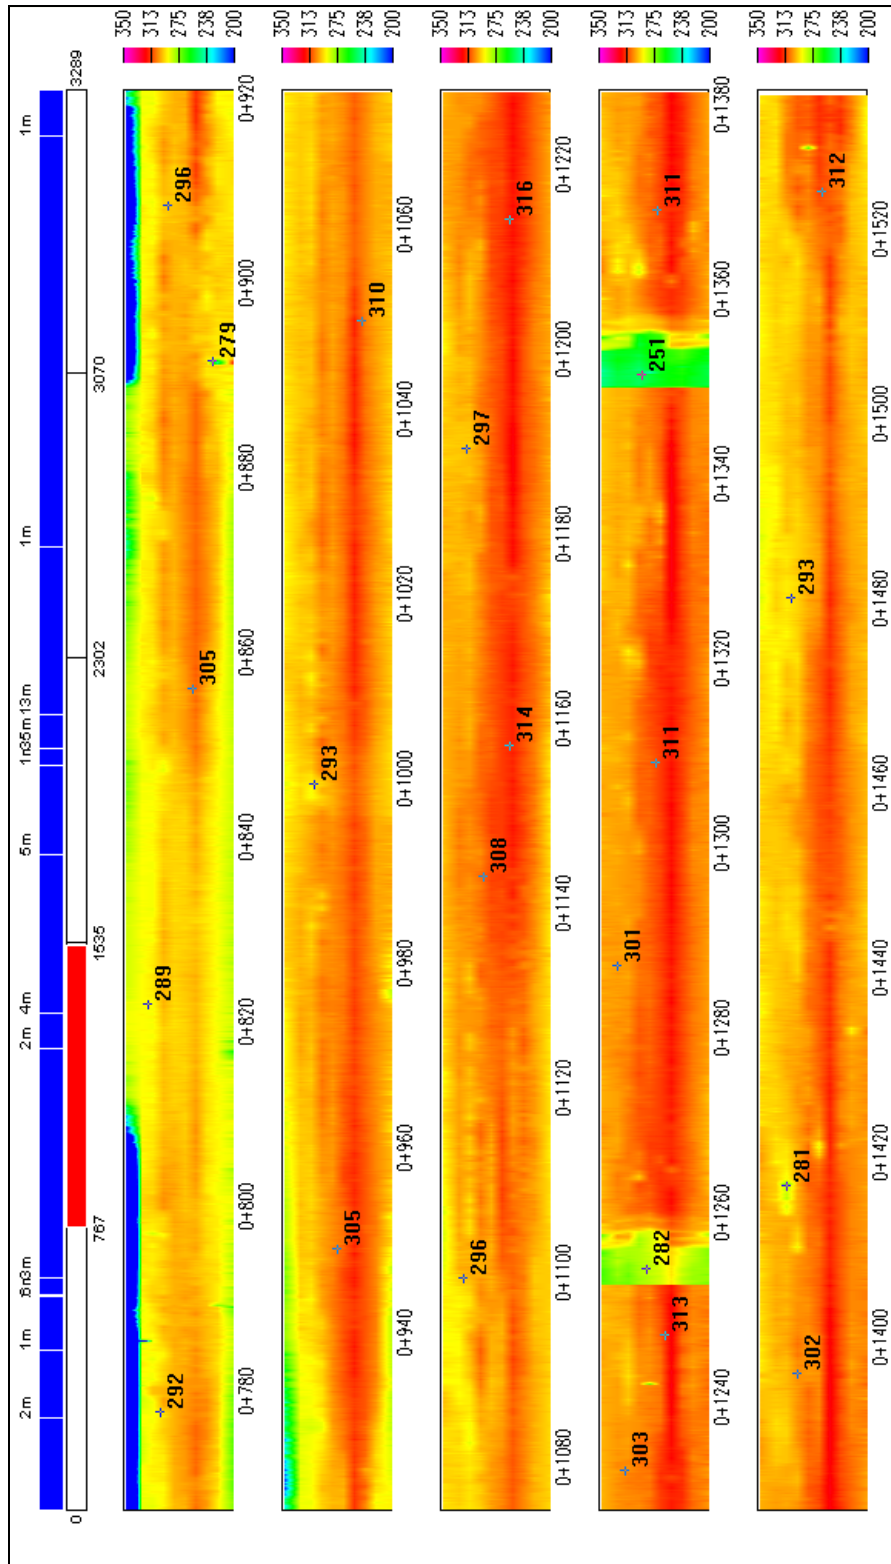
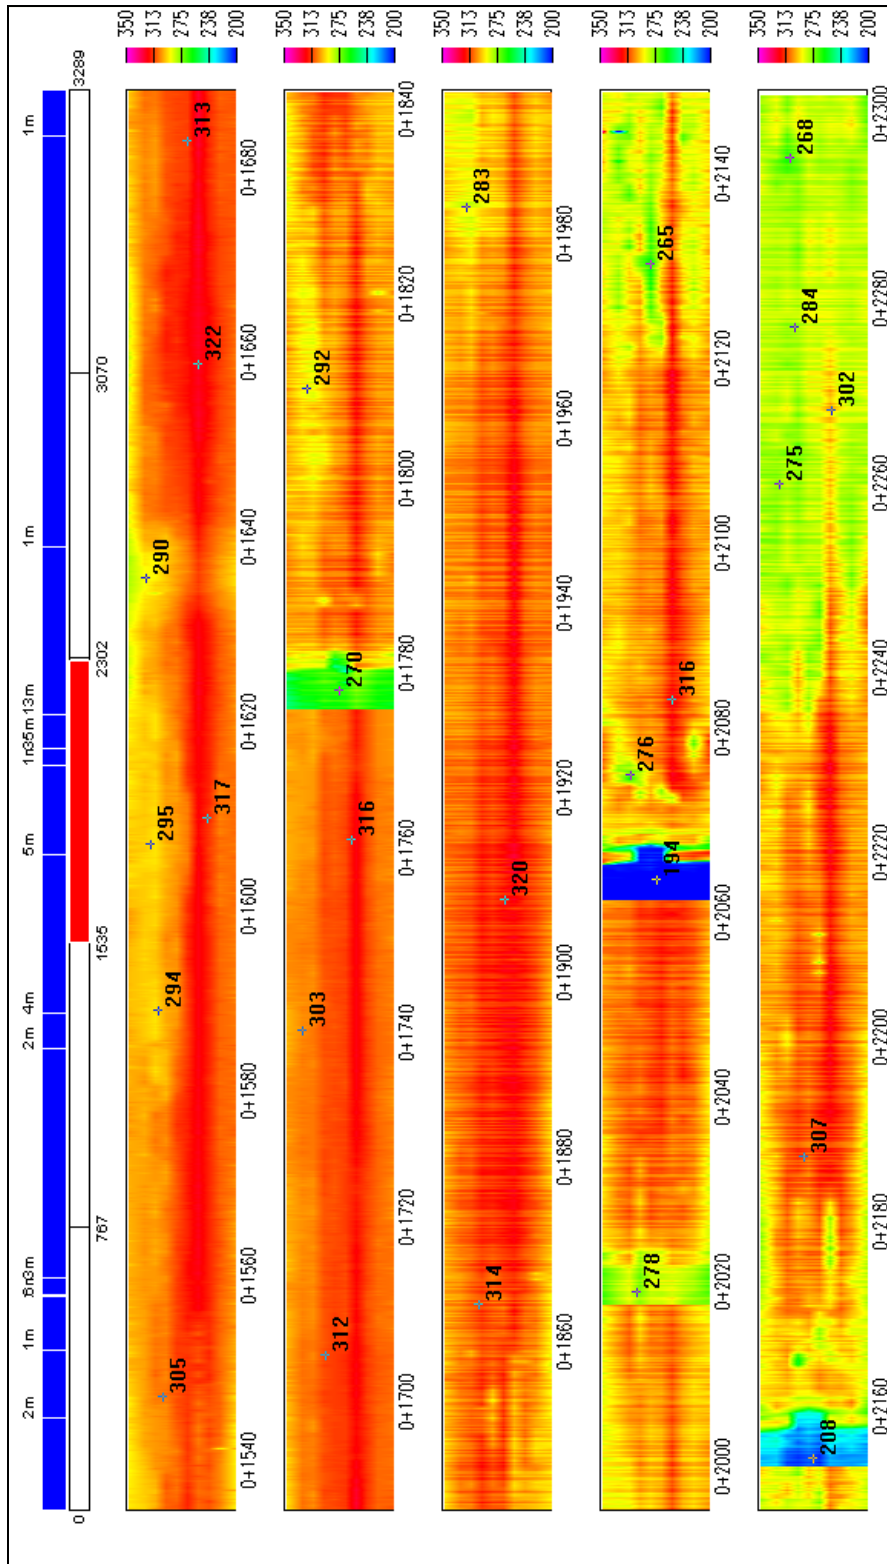
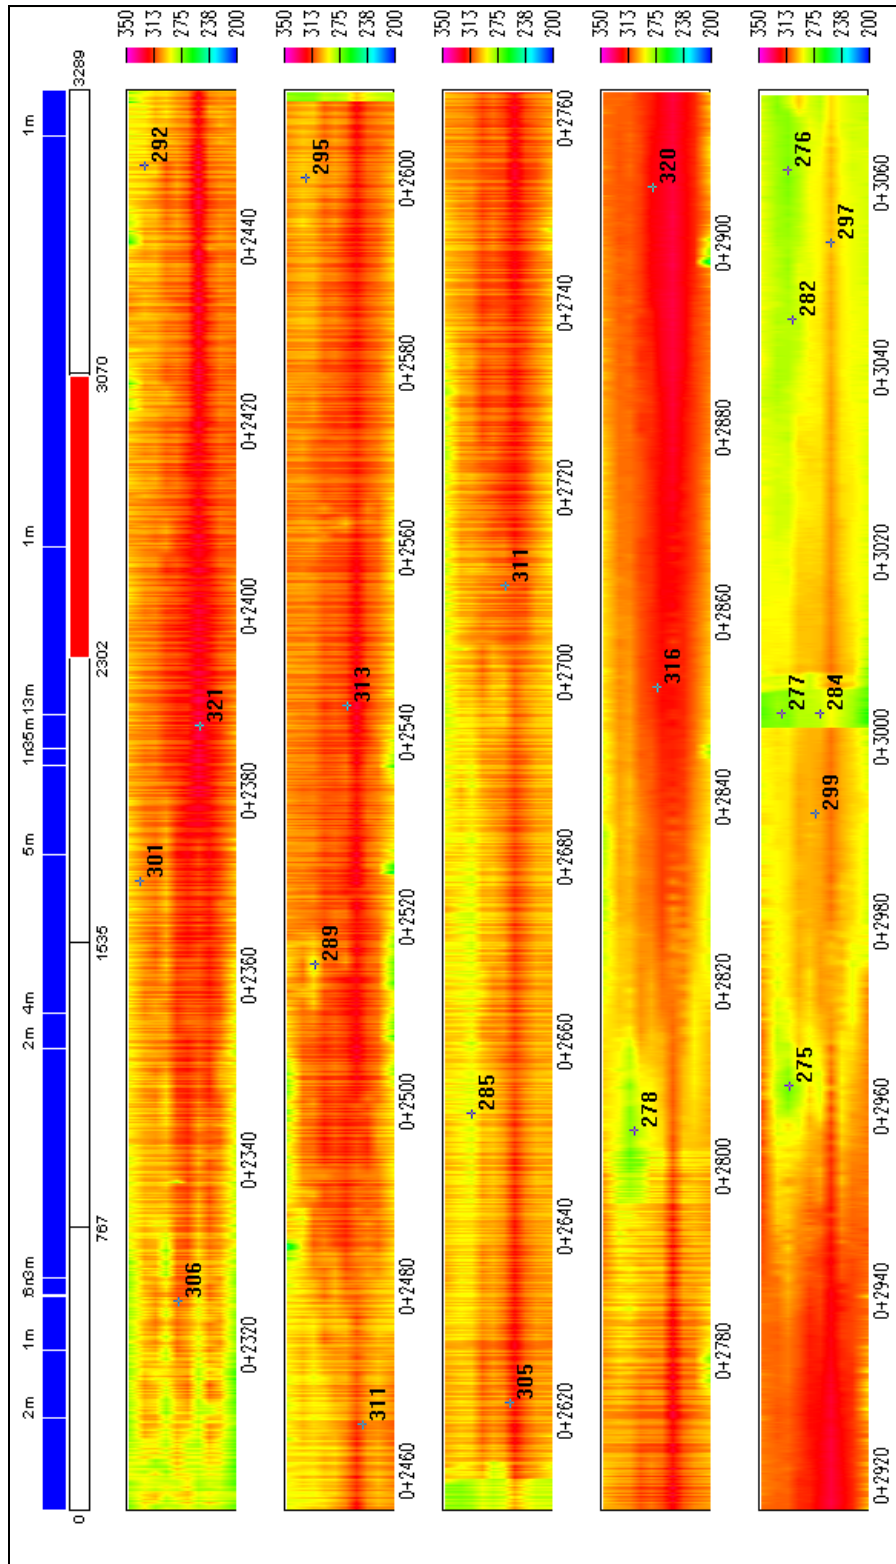
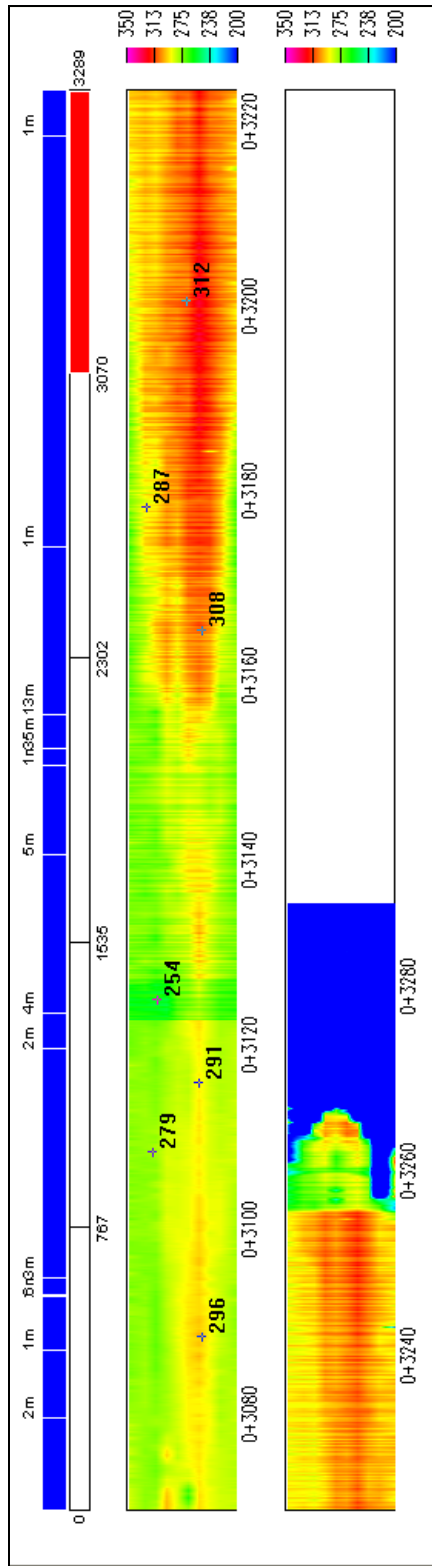
Figure 86. Thermal Profile on Parmer Lane.

- Noise exists in the data when the computer was plugged into the paver generator. The impact of the noise on the profile can be seen by comparing the first 770 ft in [Figure 86](#) to the data from 770–1530 ft.

- With the exception of locations of paver stops and a few other anomalous spots, temperature differentials in the longitudinal direction are typically around 30°F or less.

In July 2011, TTI performed a follow-up visual and GPR survey on the section. The section appears in good condition with no distress noted. The only observations noted were locations of coarser surface texture between 625 and 680 ft. The location at 625 ft matches the centerline thermal streak in Figure 86. Patterns of paver stops at 2060 and 2154 ft also were observed and match paver stops observed in the thermal profile. Figures 89 and 90 show these

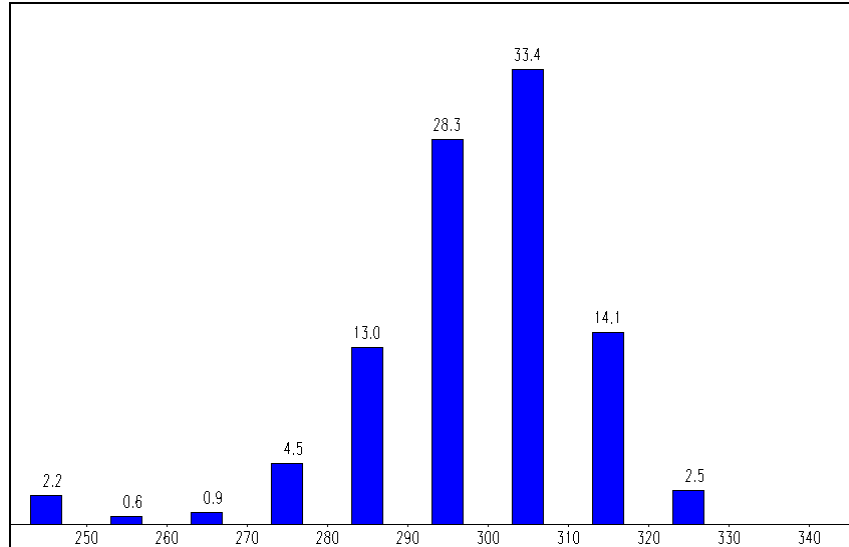
**Figure 87. Histogram of Measured Temperatures on Parmer Lane.**

- Approximately 95 percent of the mat surveyed had placement temperatures between 270° and 320°F, as [Figure 87](#) shows. However, the noise in the data from the method of powering the laptop likely inflated this range; the actual 95 percent interval of placement temperatures is more likely within a 40°F range.

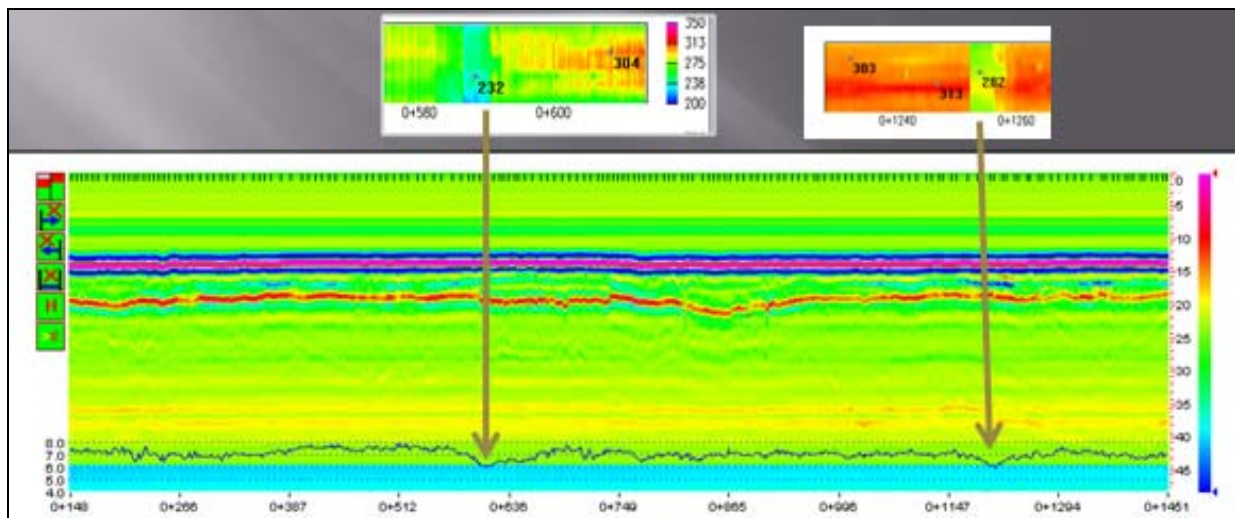
**Figure 88. Low Dielectric Locations at Paver Stops on Parmer Lane.**

On April 23, 2009, TTI collected GPR over the section. An initial review of the data showed some sizeable dips in the GPR-measure surface dielectric value. Some of these low dielectric locations occurred at locations of paver stops. However, not all paver stops showed up in the GPR data as low dielectric locations. Figure 88 shows an example of two paver stops and corresponding low surface dielectric values.

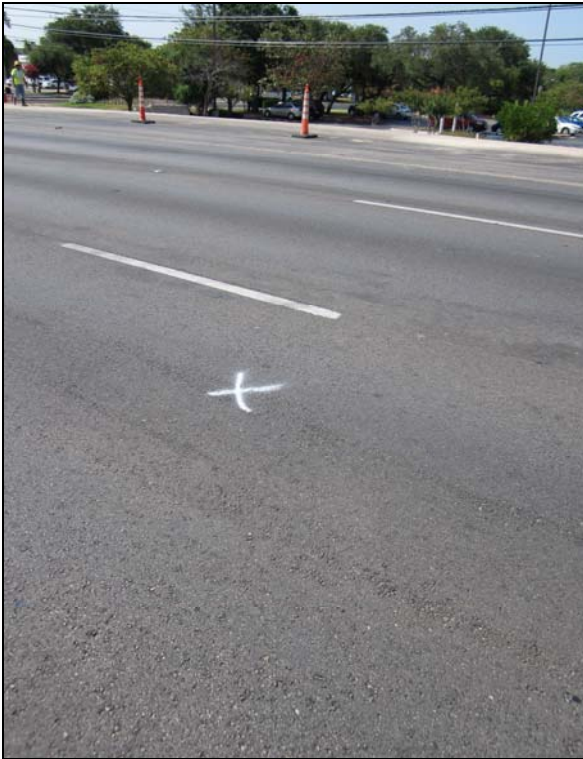
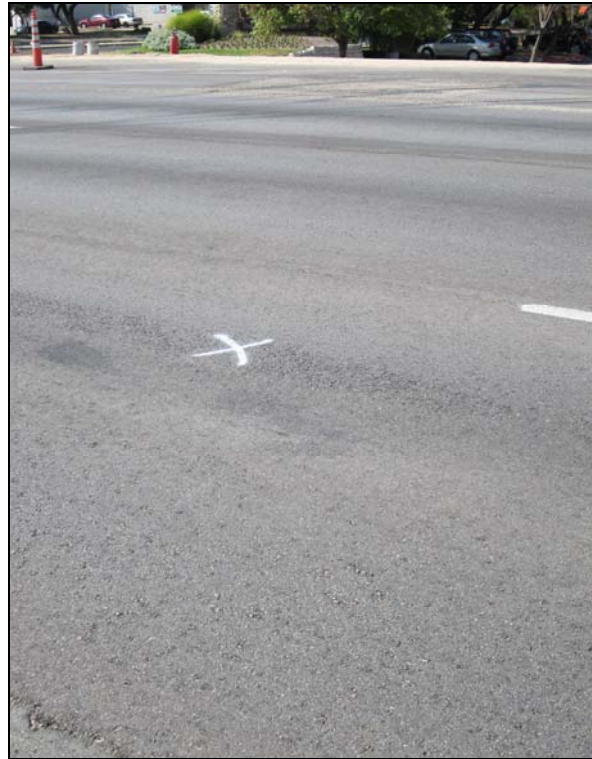
**Figure 89. Streak on Parmer Lane after Two Years of Service.**

streak and paver stop locations. At the streaks, only a coarser surface texture was noted. At the locations of the paver stops, the outline of the paver bull plate was still visible in the pavement.

To evaluate in the lab the performance measures of the anomalous locations against a normal location, the spots marked in Figures 89 and 90 were cored for laboratory density, overlay, and Hamburg tests. Two additional cores at 1079 and 1779 ft into the pull were cored. The location at 1079 represents a normal location, and the location at 1779 ft was another paver stop region. Table 12 presents the results from these cores. In general, the locations observed as thermally segregated at the time of construction had higher air voids. All the samples passed the

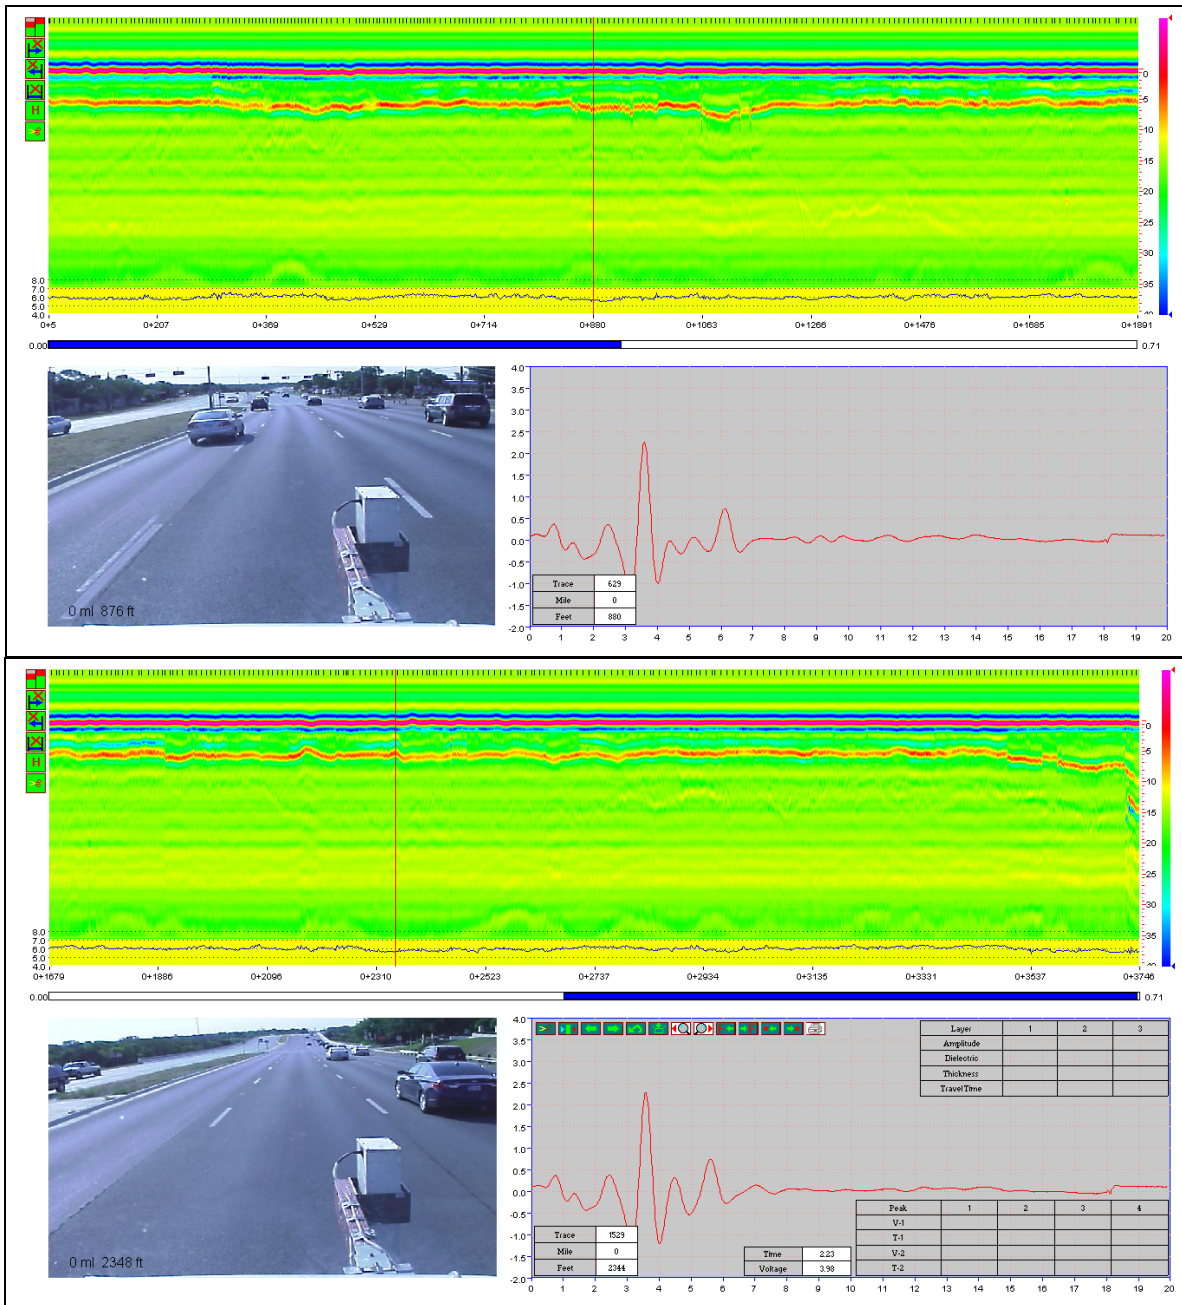
**Figure 91. GPR on Parmer Lane after Two Years of Service.**  
*Note: start of pull is at 292 ft in this GPR file.*

Figure 91 shows GPR data on Parmer Lane after two years of service. As compared to Figure 77, the surface dielectric does not vary as much as was observed immediately after construction.
