# **PERFORMANCE MONITORING PAVEMENTS WITH THERMAL SEGREGATION IN TEXAS**

Report 0-6080-1

Project Title: Performance Histories of Thermally Segregated HMA

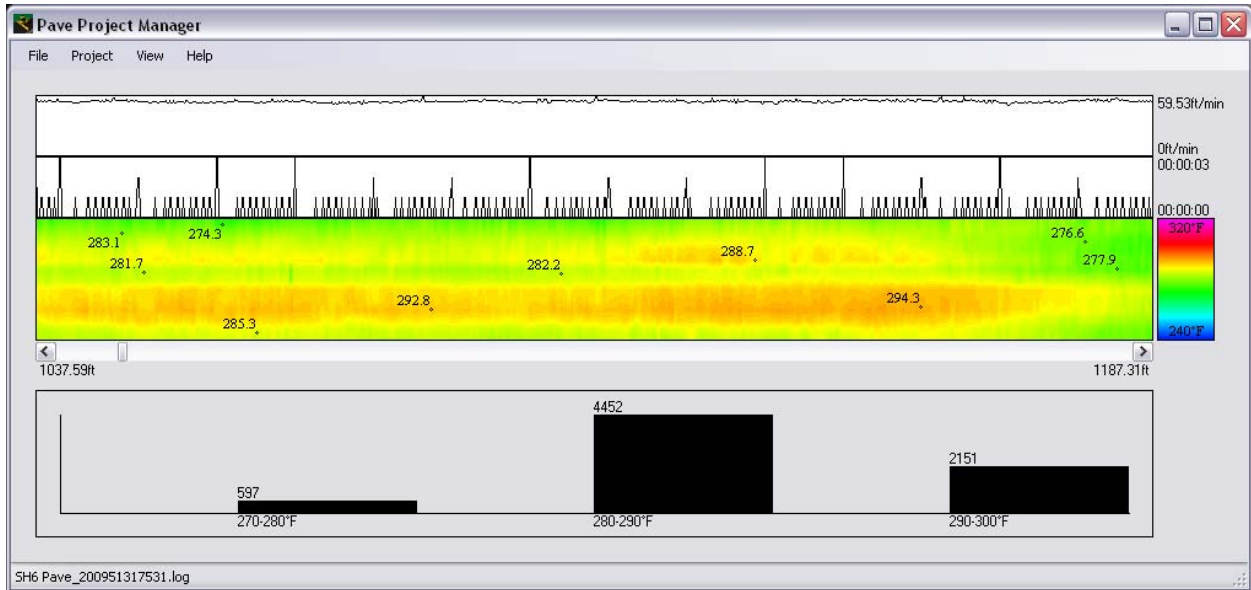
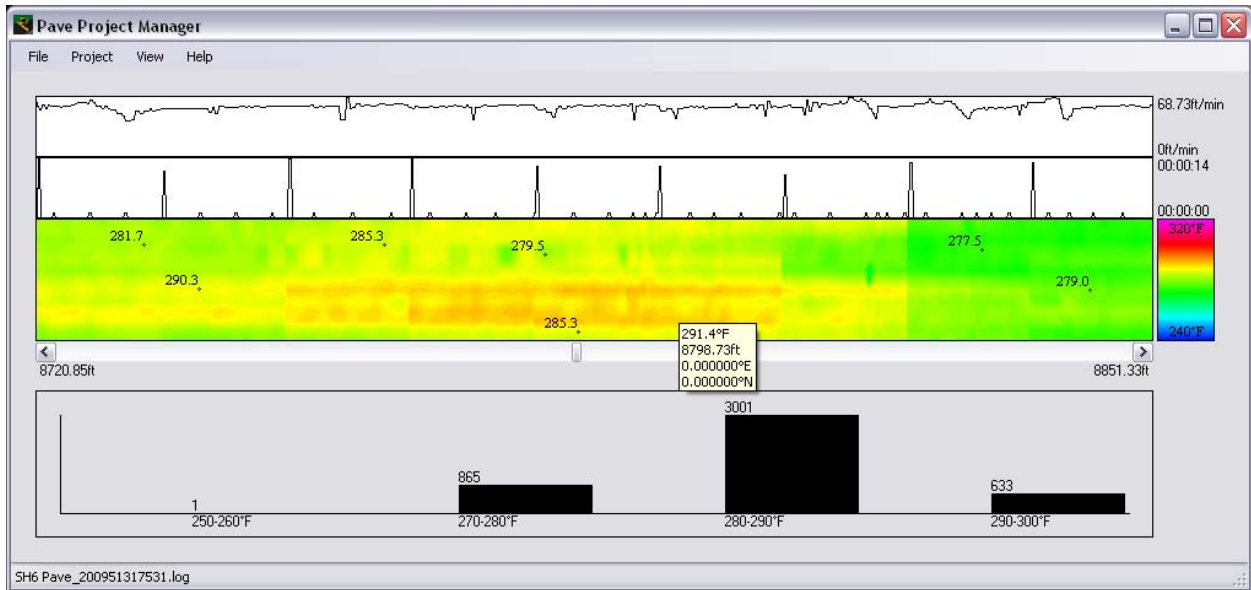
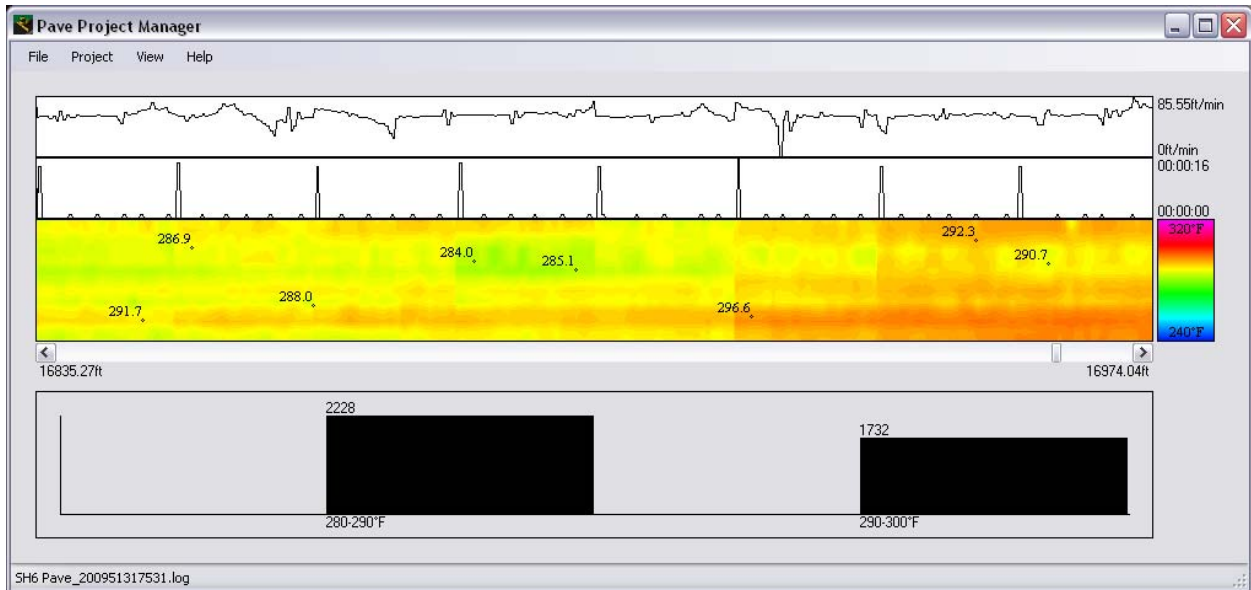
**Figure 94. Example Thermal Profile on SH 6 PFC.**

[Figure 93](#) shows the Pave-IR unit used to collect the thermal profile. This unit employs 12 sensors spaced approximately 1 ft apart and was set to collect data at 3-in. distance intervals. Within 150-ft. segments, the thermal differentials typically ranged from 20° to 30°F, as [Figure 94](#) illustrates; with occasional segments with differentials within 40°F, as [Figure 95](#) shows. The cumulative distribution frequency of placement temperatures, presented in [Figure 96](#), shows approximately 90 percent of placement temperatures were between 250° and 295°F.

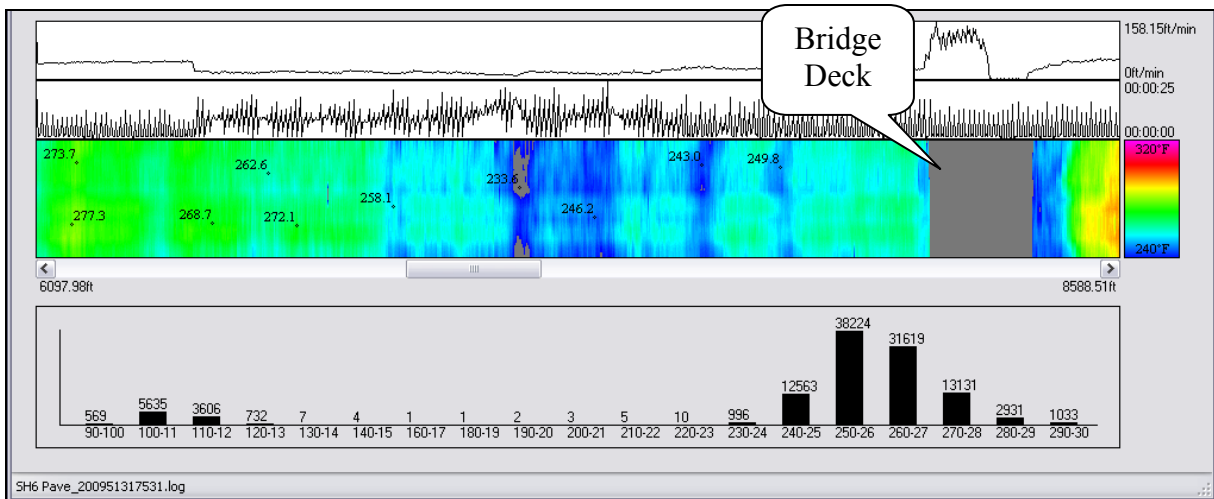
Figure 97. SH 6 Thermal Problems as Approaching First Bridge Deck.

The most anomalous location occurred as the paving train approached the first (northernmost) bridge deck. Figure 97 shows these data. Reportedly, the plant experienced some problems that resulted in this anomalous location. Figure 97 shows mix from approximately 1047 ft north of the bridge deck to the bridge deck not meeting the minimum desired placement temperature of 260°F. This location was from approximately Station 488.86 to the bridge deck. Additionally, the first approximately 67 ft south of the bridge deck did not exceed 260°F.

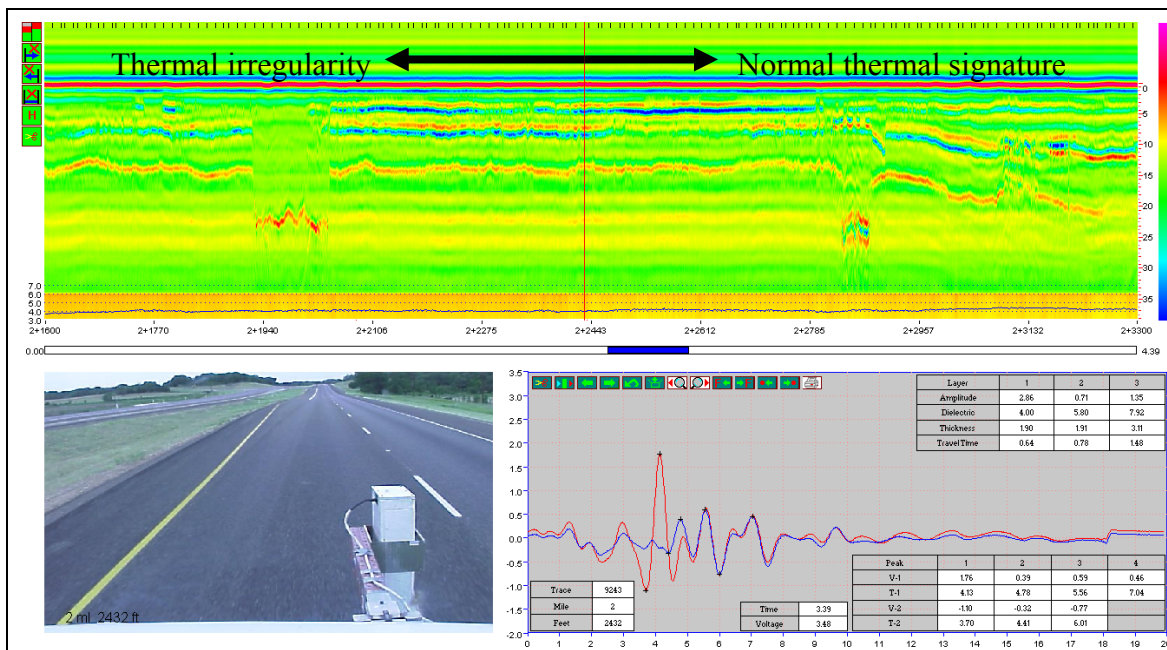
Figure 98. Representative GPR from SH 6 after Two Years of Service.

Although TxDOT does not currently apply thermal profiling to PFC mixtures, TTI performed a follow-up survey in July 2011. In particular, this survey focused on examining whether any problems existed at the location shown in Figure 97 with the thermal irregularities. Figure 98 contrasts the current GPR data from a representative portion of the project with the section of thermal irregularity at the time of placement. No visual or GPR indicators exist to suggest the zone with the thermal irregularity is substantially different than the normal section. Visually, no distress was observed, and the GPR shows no difference in surface dielectrics between the two zones.

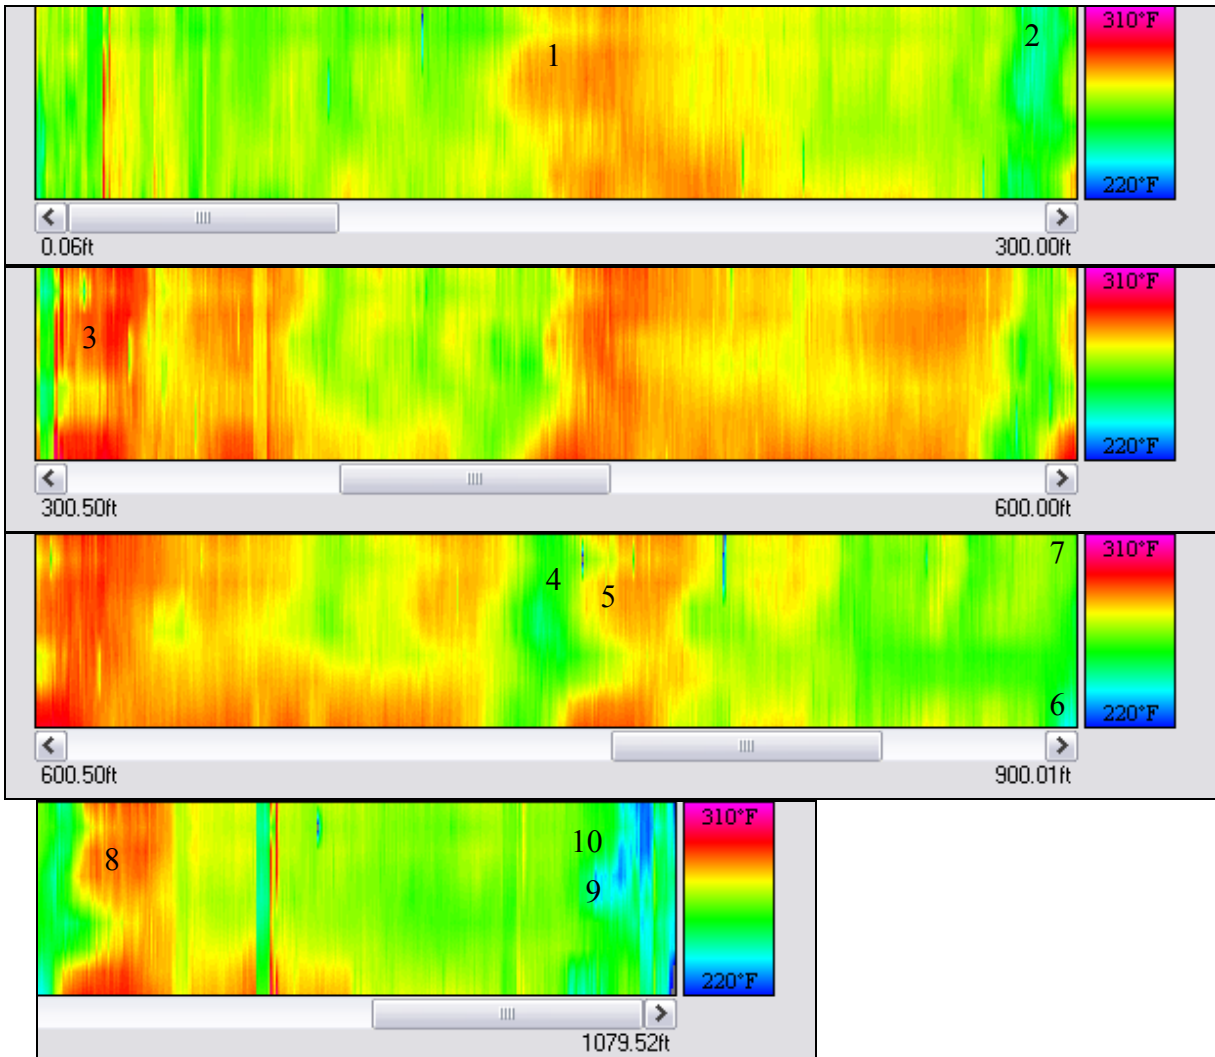
**Figure 100. US 190 Thermal Profile.**

[Figure 100](#) shows the thermal profiles from the project. The thermal data show reduced temperatures at the truck ends with temperature differentials typically around 30°F. Ten locations were marked for further investigation, as annotated in [Figure 100](#).

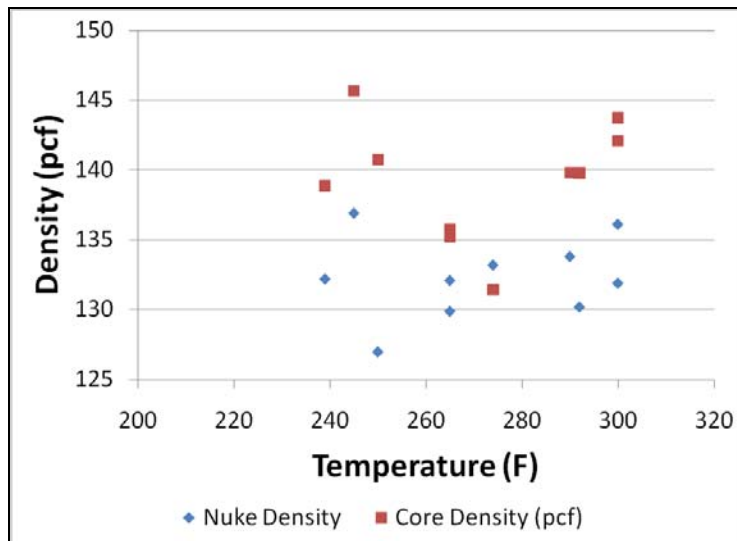
**Figure 102. Lack of Correlation between Temperature and Density on US 190.**

With the core data complete, researchers analyzed the IR and GPR data in conjunction with the core results to investigate the significance of the NDT readings. Historically, thermal cold spots typically show up as low density locations in the mat. However, [Figure 102](#) illustrates that on this project the temperature data did not correlate to the in-place density.

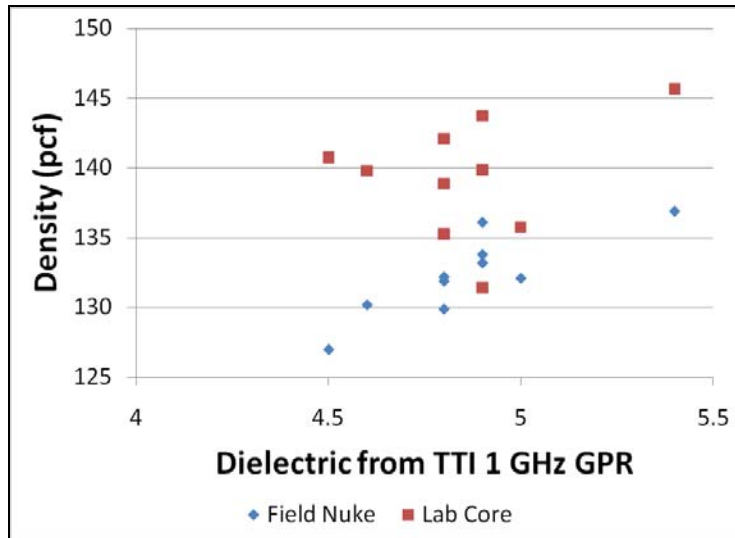
Figure 103. Lack of Correlation between GPR and Lab Density on US 190.

[Figure 103](#) illustrates that on this project, although the GPR-measured surface dielectric correlated well with field nuclear density readings, neither the GPR nor the nuclear gauge correlated with the laboratory-measured core densities. More research needs to be conducted to determine why the GPR did not correlate with the lab densities. It is unknown if the mix type, the presence of fibers, or the rain at the plant contributed to the lack of tracking between the GPR and core densities.

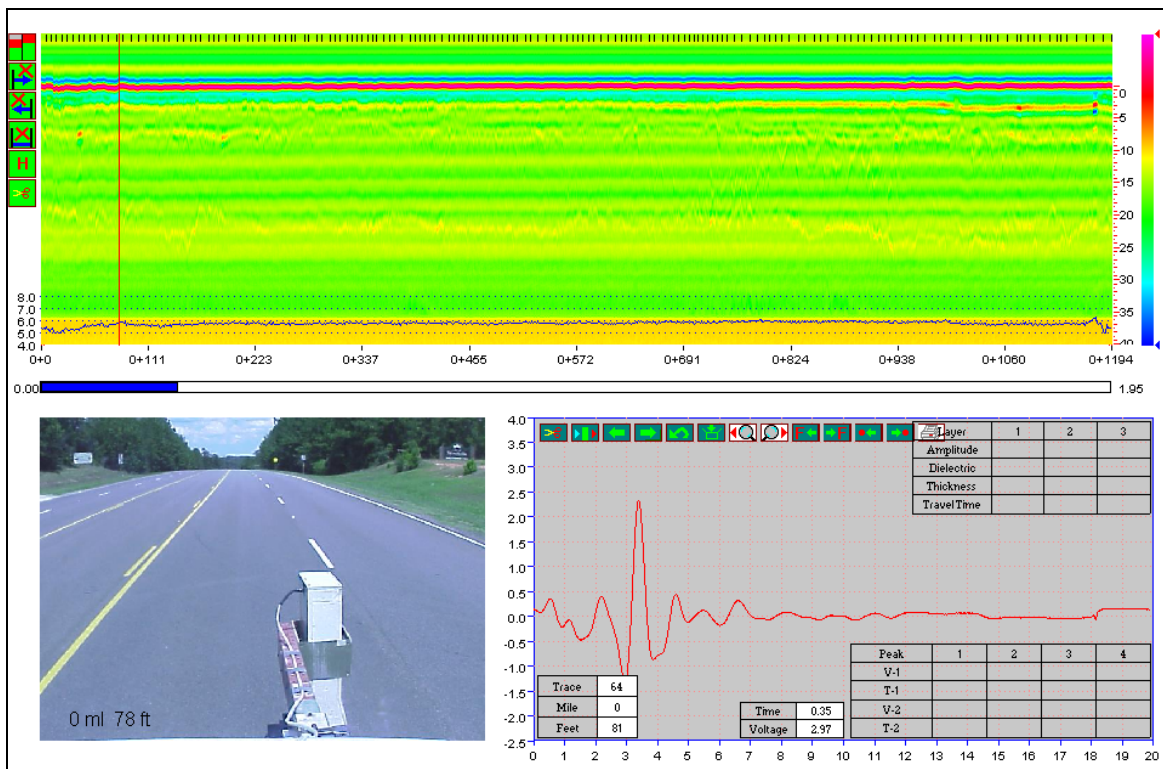
Figure 104. US 190 GPR after Two Years of Service.

In July 2011, TTI conducted a follow-up visual and GPR survey on this section. Visually, no distress was noted. Figure 104 presents the GPR data over the section approximately two years after construction. With the exception of the first 70 ft, and the location in the immediate vicinity of the construction joint at the end of the pull, the GPR data are uniform with no indication of concerns.

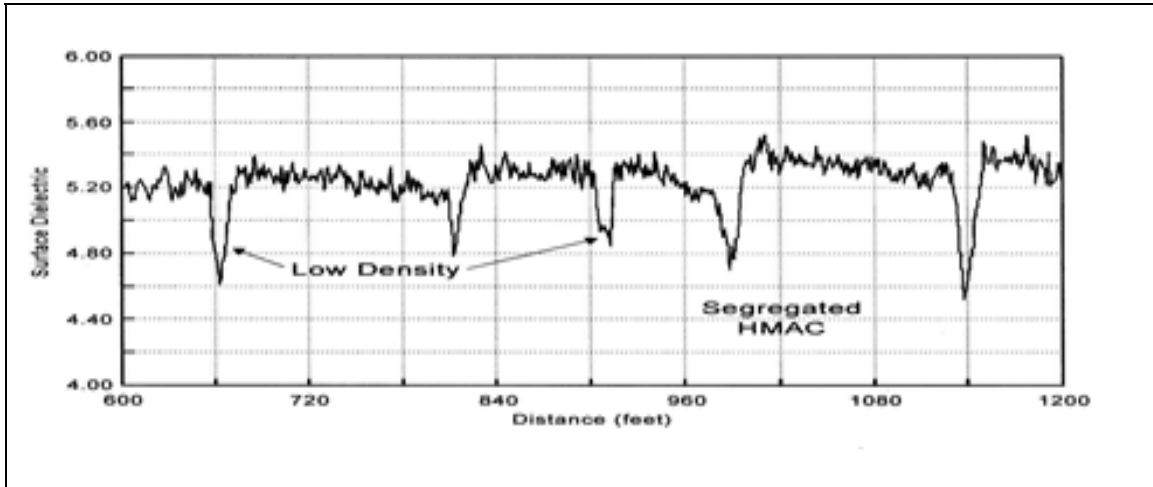
**Figure 113. Surface Dielectric for a Section of HMA Base Material on IH 20.**

One of the first demonstrations using GPR to identify thermal segregation was on a section of asphalt base material on IH 20 west of Odessa in 2002. [Figure 113](#) shows the surface dielectric from the GPR data, clearly showing cyclical zones of low density in the mat.

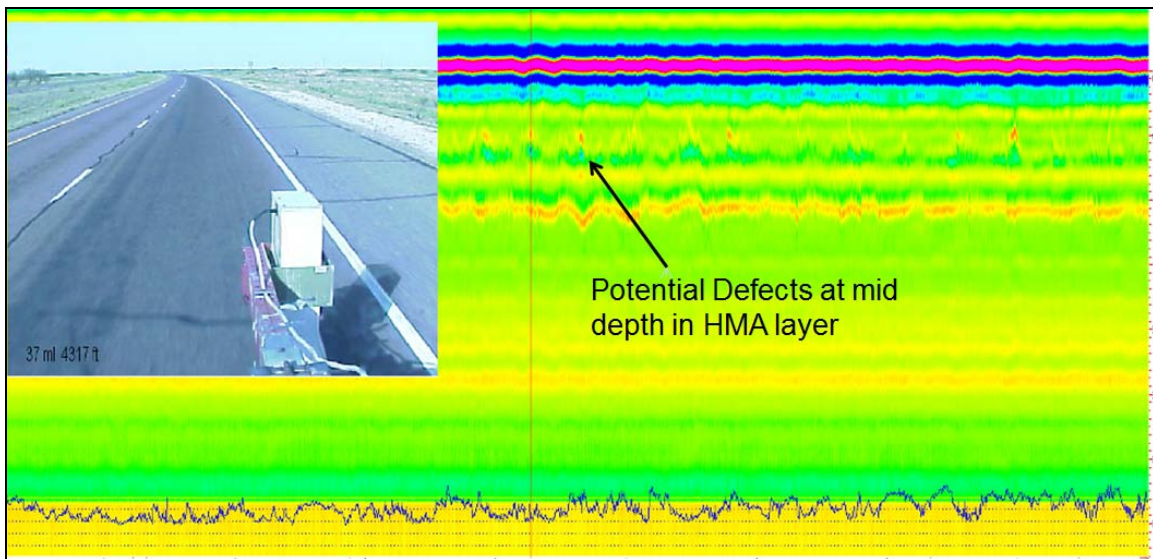
**Figure 114. GPR Data from IH 20 near Reference Marker 87.**

At the time of construction, the segregated layer was not an immediate concern since it was to be overlaid with at least 4 inches of additional HMA. This section of highway has performed well for 10 years, and it was resurveyed in 2011 as part of the IH 20 corridor analysis that TTI conducted. Currently, this section has periodic transverse cracking and some longitudinal cracking. [Figure 114](#) presents example GPR data from the section, which show some periodic negative reflections from mid-depth in the HMA layer. In most cases, the surface cracks coincided with the defects observed in the GPR data at mid-depth in the HMA layer.

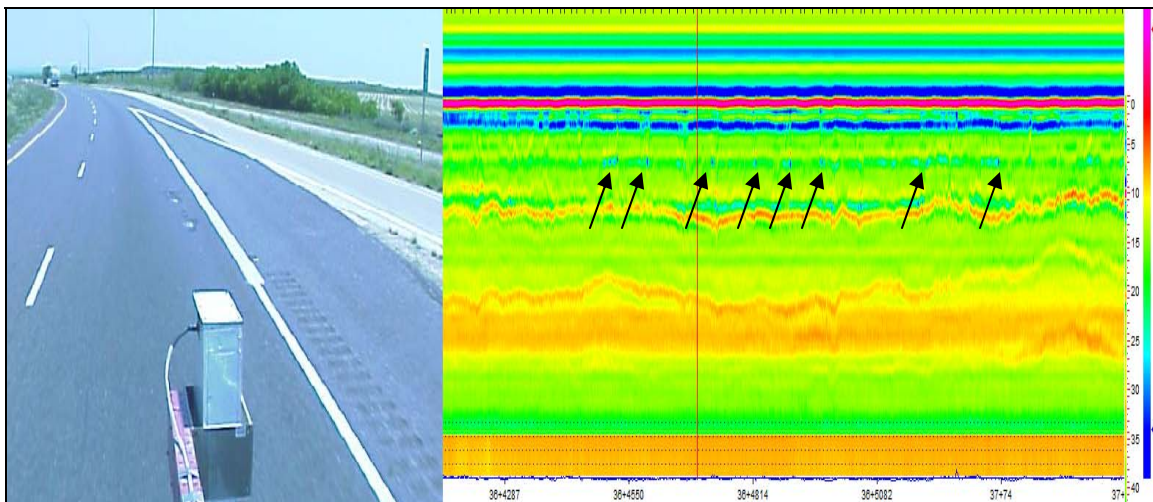
**Figure 116. IH 20 near TRM 157 Eastbound.**

The GPR signature shown in [Figure 114](#) was also observed in other locations of IH 20. [Figure 116](#) shows an excerpt of radar data from TRM 148 to 159, which also exhibited periodic areas with a similar GPR display. This section has received a seal and a PFC surfacing, but as [Figure 116](#) shows, localized suspect areas at mid depth exist in the HMA layer about 6 inches below the surface.

*Note: areas highlight zones of suspected segregation in subsurface HMA.*

Based on these observations, field performance of these pavements suggests that buried thermal segregation may be a more significant problem than originally thought. With time and the probable ingress of moisture, these areas could continue to deteriorate. These localized

failure zones will become a major maintenance problem, since repairs to only the upper surface layers will not address the defect buried at mid-depth in the HMA layer. In the worst-case scenario, the problem in the lower HMA layers could continue to deteriorate to such a stage that rehabilitation of the section will require the complete replacement of all the HMA layers.
