1. Report No. FHWA/TX-11/0-6120-1		2. Government Accession No.		3. Recipient's Catalog No.	
4. Title and Subtitle TREATMENTS TO REDUCE THE FREQUENCY OF FREEWAY EXIT SIGN HITS				5. Report Date January 2011 Published: June 2011

9. Performing Organization Name and Address Texas Transportation Institute The Texas A&M University System College Station, Texas 77843-3135				10. Work Unit No. (TRAIS)

# **TREATMENTS TO REDUCE THE FREQUENCY OF FREEWAY EXIT SIGN HITS**

Report 0-6120-1

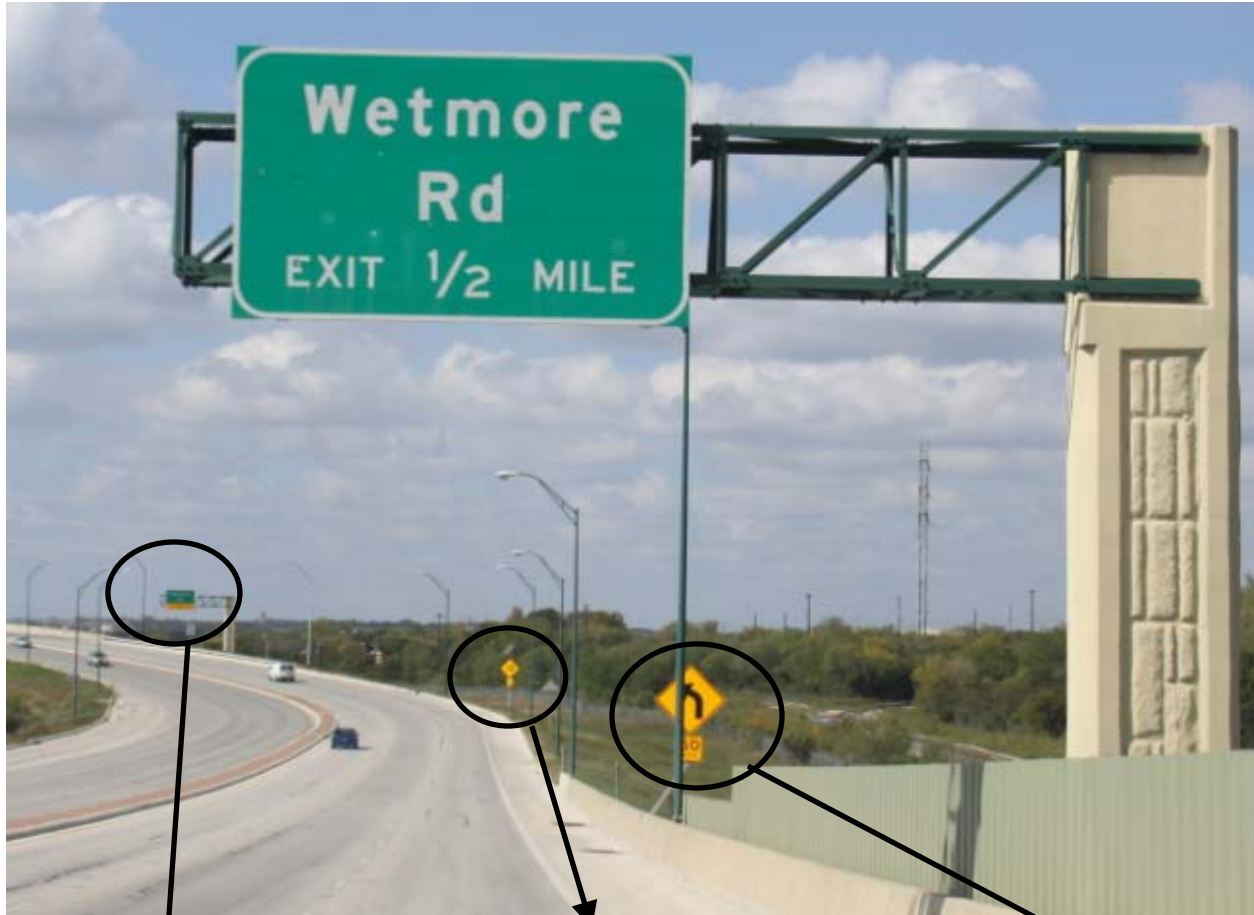
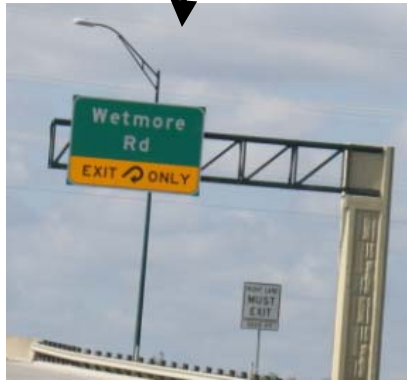
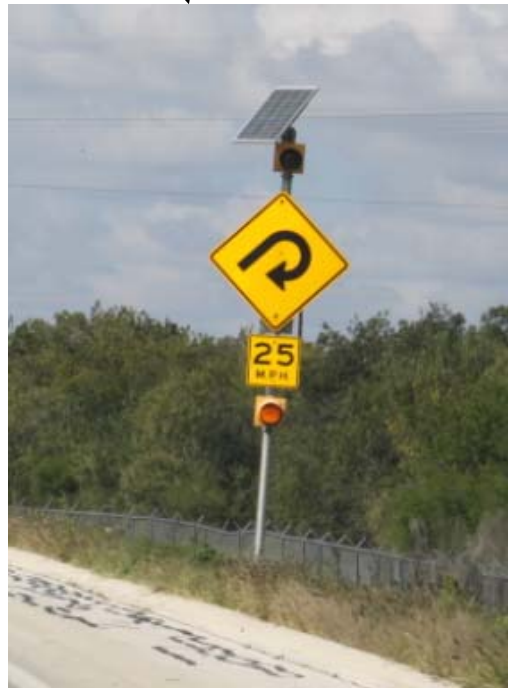
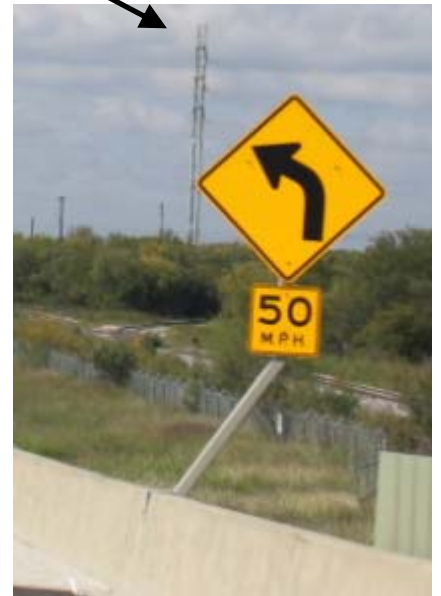
**Figure 42. Sequence of Signing on Approach to Wetmore Exit on Westbound Wurzbach Parkway.**

- Vertical and horizontal curves were observed on approach to exit.
- Steep grade on approach to the exit reduces sight distance significantly.
- Relatively high speeds were observed on approach to the exit.

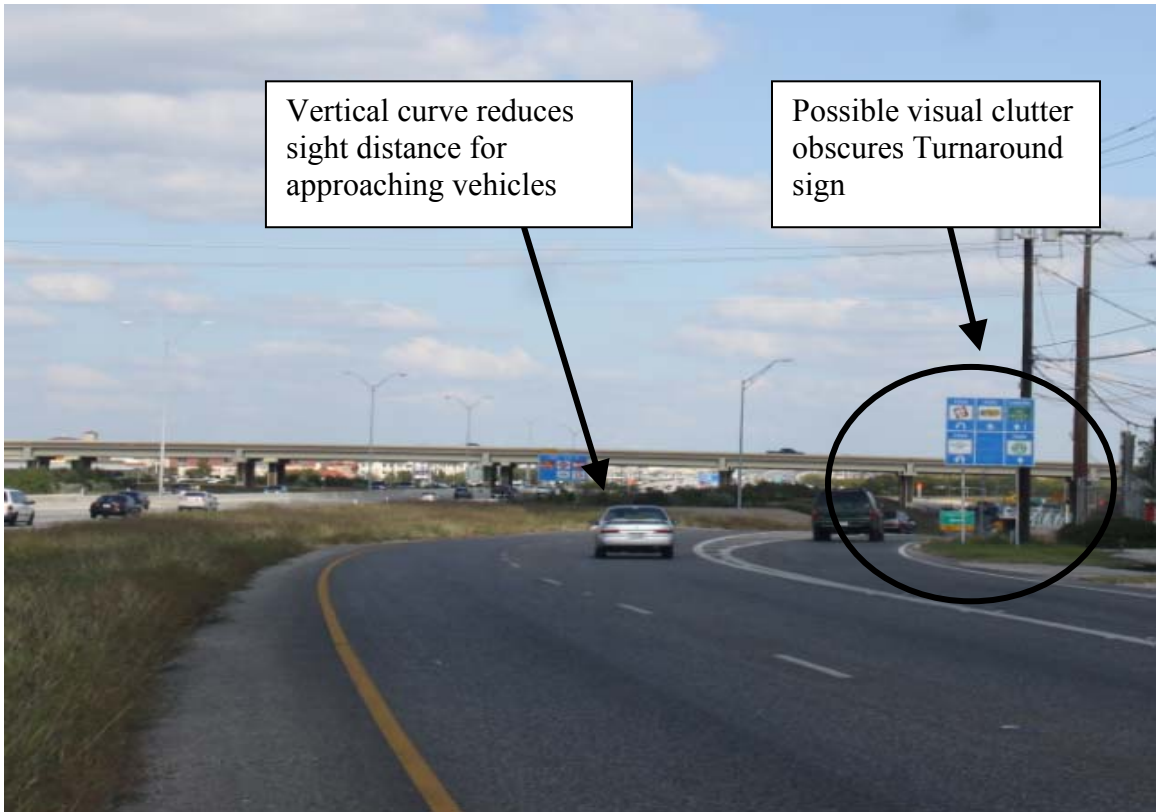
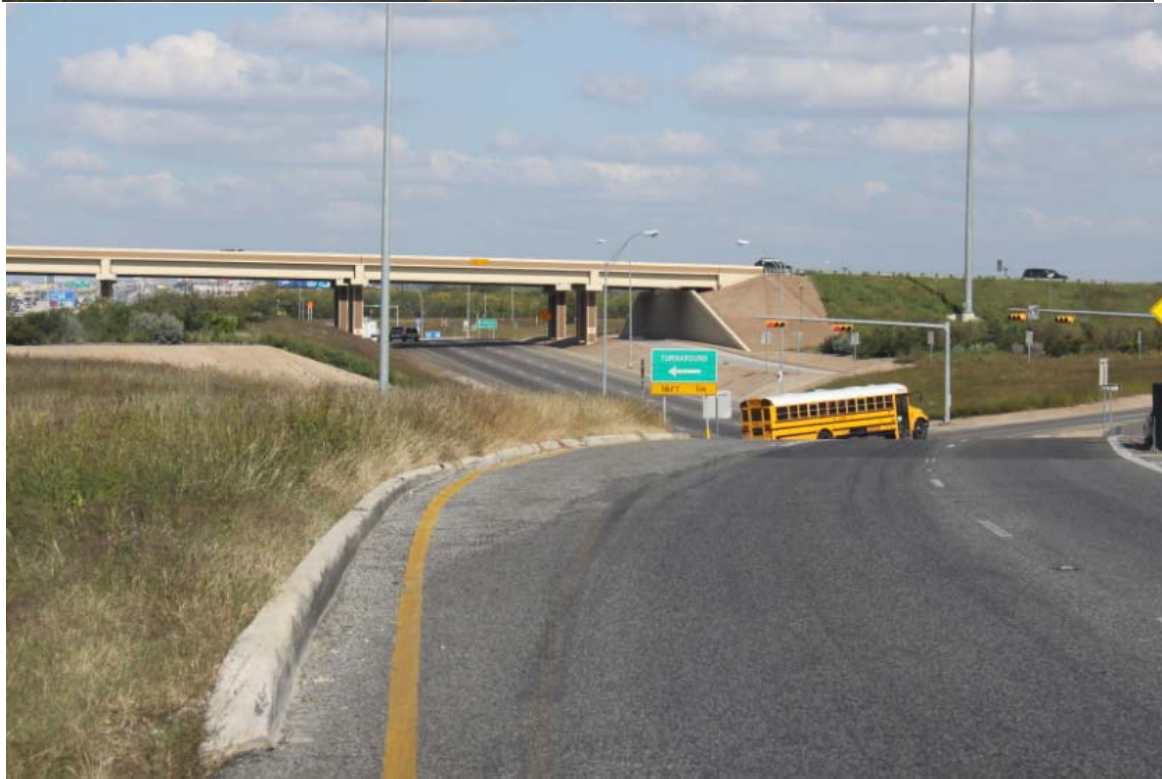
**Figure 46. Northbound IH 410 Frontage Road Approach to U-Turn at SH 151.**

- Vertical curve on approach to the frontage road intersection inhibits sight distance significantly, thus increasing driver response time to the sudden turnaround lane.
- It was easily observed from curb marks that drivers frequently overshoot the turnaround curve and jump the curb.

No existing measures were observed to have been taken at this location. However in the other direction, the U-turn sign had been completely removed after several hits.
