## TEMPORARY LARGE GUIDE SIGNS

**Test Report 0-6782-1**

**TEXAS A&M TRANSPORTATION INSTITUTE  
COLLEGE STATION, TEXAS**

**TEXAS DEPARTMENT OF TRANSPORTATION**

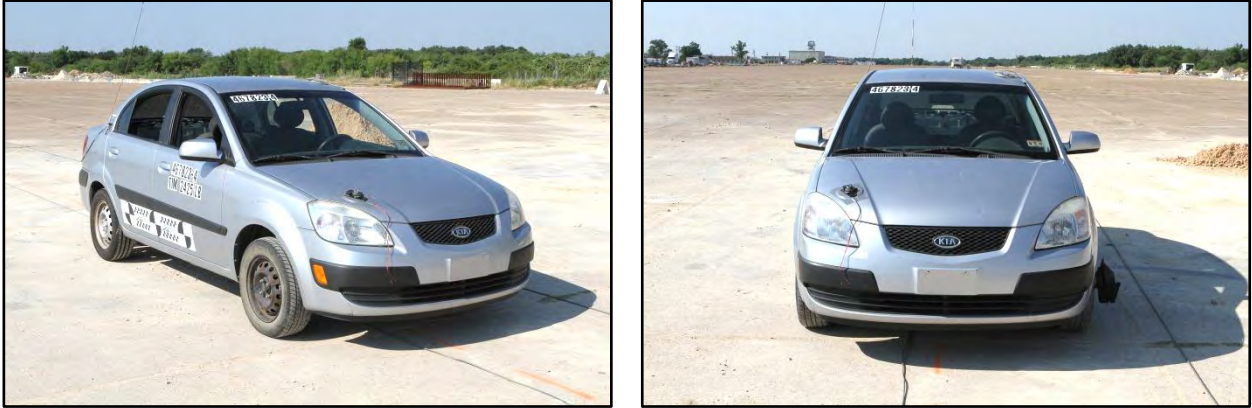
**Figure 5.4. Vehicle before Test No. 467823-4.**

Figure 5.4 shows the 2007 Kia Rio used for the crash test. Test inertia weight of the vehicle was 2425 lb, and its gross static weight was 2608 lb. The height to the lower edge of the vehicle bumper was 7.12 inches, and the height to the upper edge of the bumper was 21.0 inches. Table H1 in Appendix H gives additional dimensions and information on the vehicle. The vehicle was directed into the installation using the cable reverse tow and guidance system and was released to be free-wheeling and unrestrained just prior to impact.

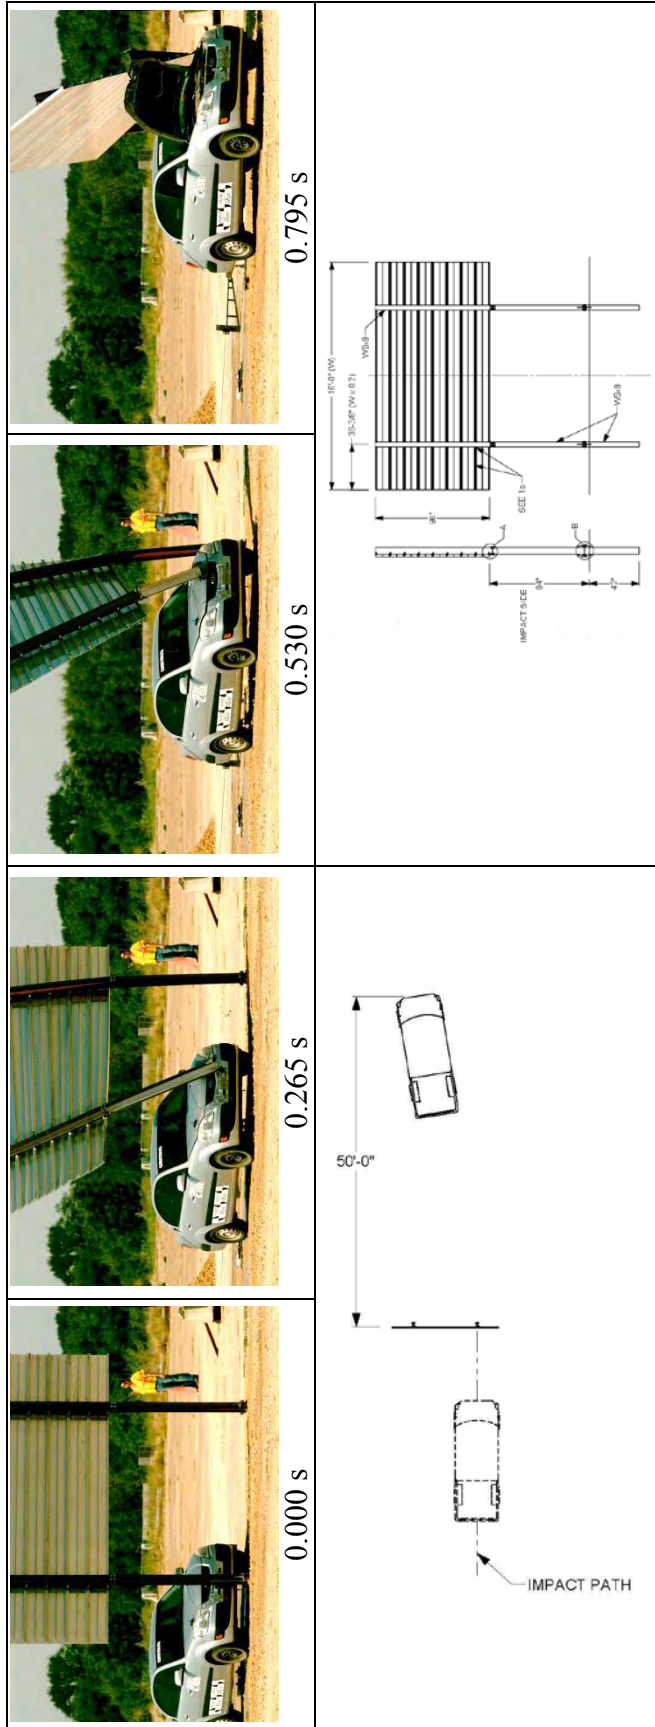
**Results:** The direct embedded steel post support system for temporary guide signs activated readily by releasing at the slip base, fracturing the front fuse plate, and rotating about the back fuse plate as designed. (PASS)

<p><b>General Information</b></p> <p>Test Agency ..... Texas A&amp;M Transportation Institute (TTI)          Test Standard Test No. .... MASH Test 3-60          TTI Test No. .... 467823-4          Test Date ..... 2013-07-02</p> <p><b>Test Article</b></p> <p>Type..... Sign Support          Name ..... TxDOT Direct Embedded Steel Support          Temporary Guide Sign System          7 ft          8-ft x 16-ft extruded aluminum sign panel          on by two W6x9 steel posts with fuse          plates and slip base connections          Standard Soil of Crushed Limestone</p> <p><b>Soil Type</b></p> <p>Type/Designation..... 1100C          Make and Model..... 2007 Kia Rio          Curb ..... 2348 lb          Test Inertial ..... 2425 lb          Dummy..... 183 lb          Gross Static..... 2608 lb</p>	<p><b>Impact Conditions</b></p> <p>Speed..... 19.5 mi/h          Angle ..... 0 degrees          Location/Orientation ..... Right support</p> <p><b>Exit Conditions</b></p> <p>Speed..... Not attainable          Angle ..... 0 degrees</p> <p><b>Occupant Risk Values</b></p> <p>Impact Velocity          Longitudinal..... 6.2 ft/s          Lateral..... 1.3 ft/s</p> <p>Ridedown Accelerations          Longitudinal..... 0.6 G          Lateral..... 0.6 G</p> <p>THIV ..... 2.0 m/s          PHD ..... 0.8 G          ASI..... 0.04          Max. 0.050-s Average          Longitudinal..... -0.8 G          Lateral..... -0.4 G          Vertical..... -0.4 G</p>	<p><b>Post-Impact Trajectory</b></p> <p>Stopping Distance ..... 50 ft downstrm</p> <p><b>Vehicle Stability</b></p> <p>Maximum Yaw Angle..... 10 degrees          Maximum Pitch Angle..... 1 degrees          Maximum Roll Angle..... 4 degrees          Vehicle Snagging ..... NA          Vehicle Pocketing..... NA</p> <p><b>Test Article Debris Pattern</b></p> <p>Longitudinal..... 20 ft          Lateral..... 10 ft</p> <p><b>Vehicle Damage</b></p> <p>VDS..... 12FC1          CDC ..... 12FCEN2          Max. Exterior Deformation..... Hood damage only          OCDI..... FS0000000          Max. Occupant Compartment          Deformation..... None</p>

Results: The right support detached from its base as designed but remained attached to the sign panel. It did not penetrate or show potential for penetrating the occupant compartment nor to present an undue hazard to others. (PASS)
