# CRASH TEST AND EVALUATION OF TL-2 SHORT RADIUS GUARDRAIL TREATMENT

**Test Report 0-6913-R1**

**TEXAS A&M TRANSPORTATION INSTITUTE  
COLLEGE STATION, TEXAS**

**TEXAS DEPARTMENT OF TRANSPORTATION**

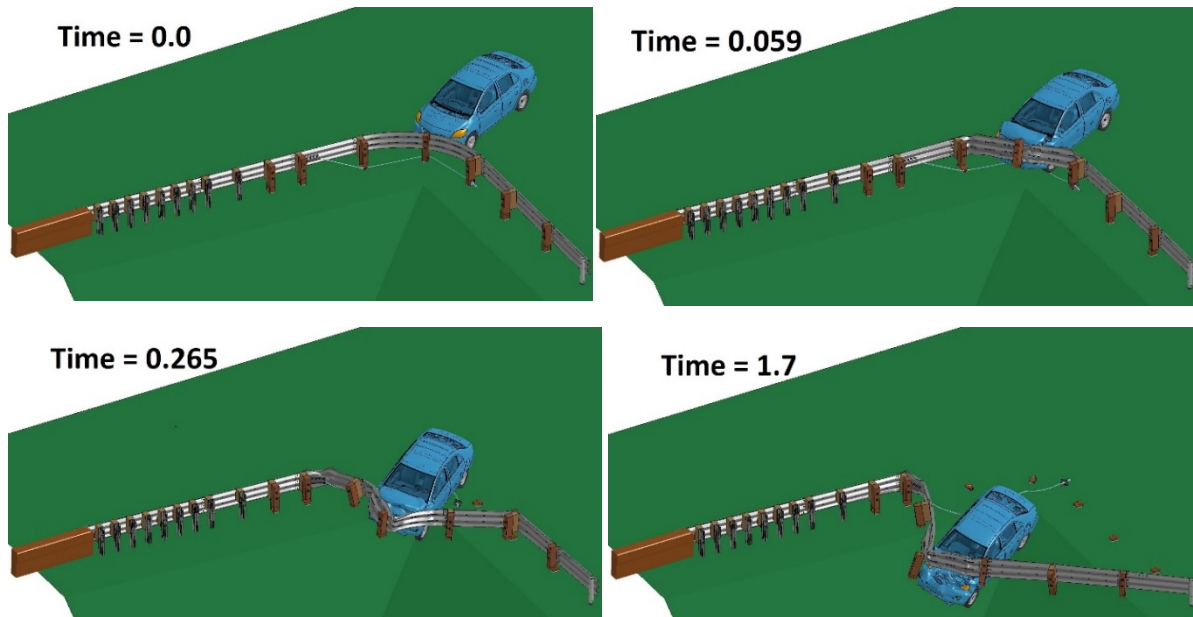
**Figure 2.5. Sequential Images of Car Simulation with Cable.**

Figure 2.5 presents the progression of the small car in this simulation. Upon impact, the rail and deformation of the front of the car progress into the windshield of the car, which is an undesirable behavior for the system.

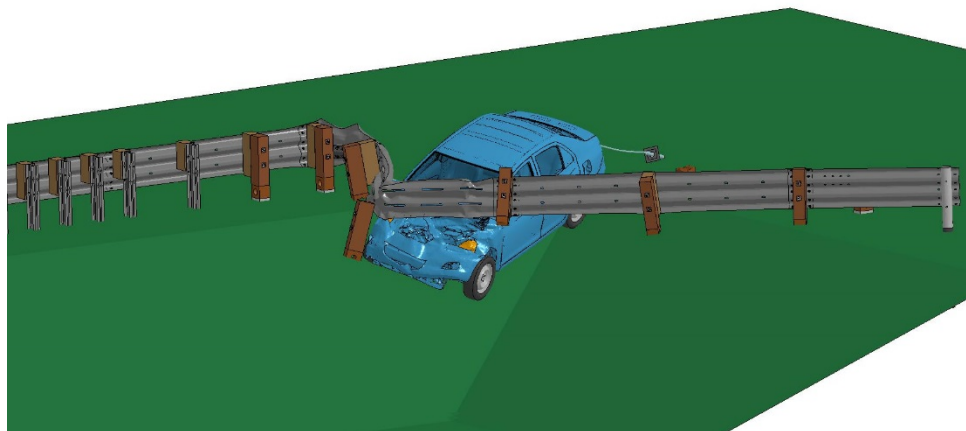
**Figure 2.7. Final State of the Simulation.**

Figures 2.6 and 2.7 show images of the initial and end state of the simulation, respectively. Figure 2.7 shows a close up image of the car going under the guardrail damaging the front of the car and windshield. It is also noticed that the tires rolled over the cable without much effect.

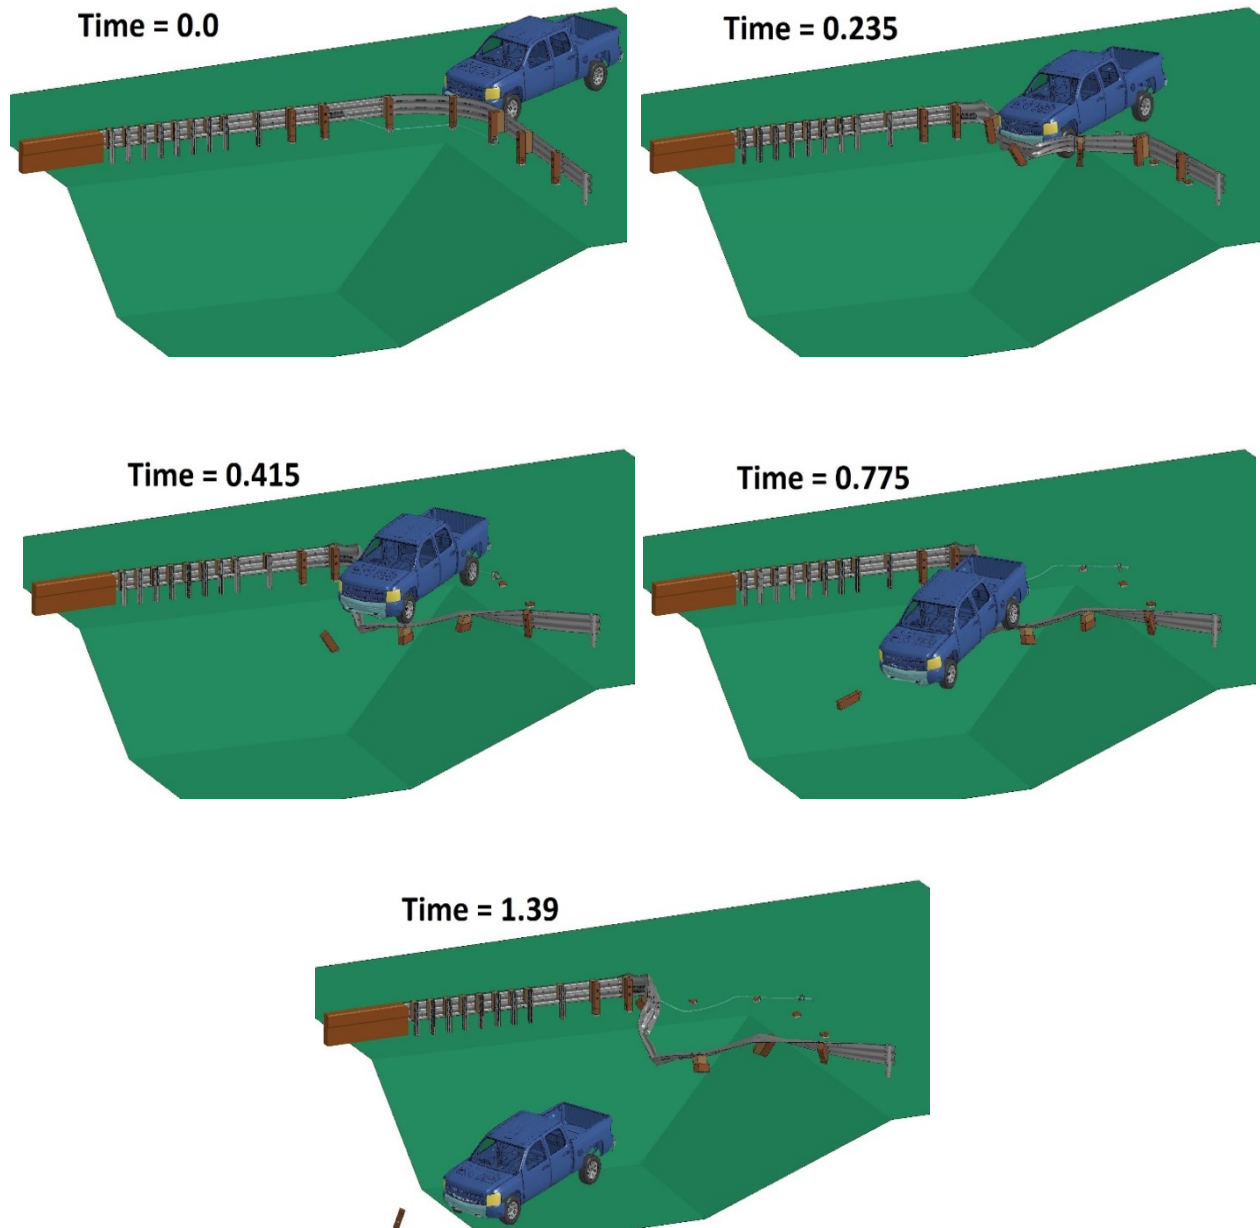
**Figure 2.8. Sequential Images of Truck Simulation with Flare.**

Figure 2.8 shows sequential images of the simulation of the truck upon impact. The first image shows the initial position of the system and is followed by three images of the truck interacting with the rail. The guardrail system is already deforming by the time of 0.235 s. At time 0.415 s, the truck begins to override the guardrail system, and by 0.775 s, the truck has completely overridden the system. The truck was not contained by the guardrail system.

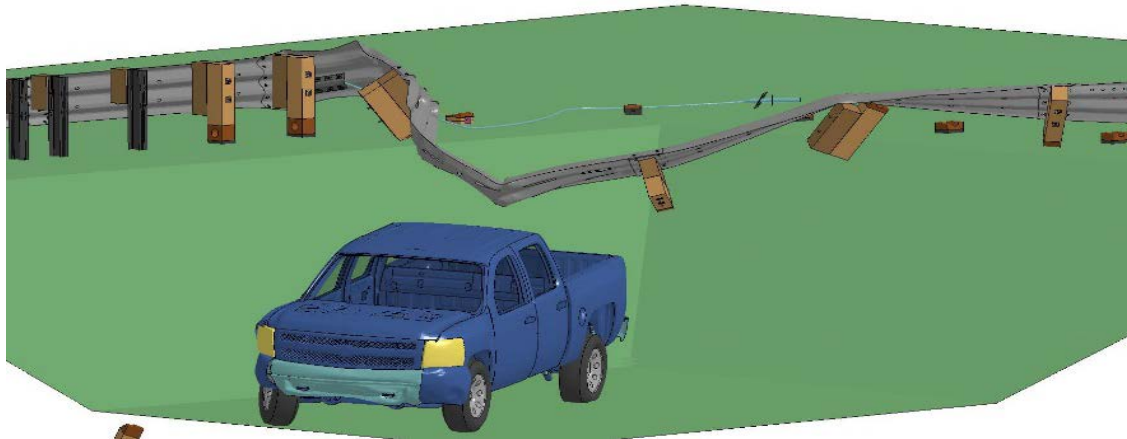
**Figure 2.10. Final State of Simulation.**

Figures 2.9 and 2.10 show the initial and final state images of the simulation of the truck with cable, respectively. Figure 2.10 shows the deformation of the guardrail system and the truck. Five posts from the system broke while the remaining posts stayed intact. The truck was bent from the front, and the right front tire was deformed as well.

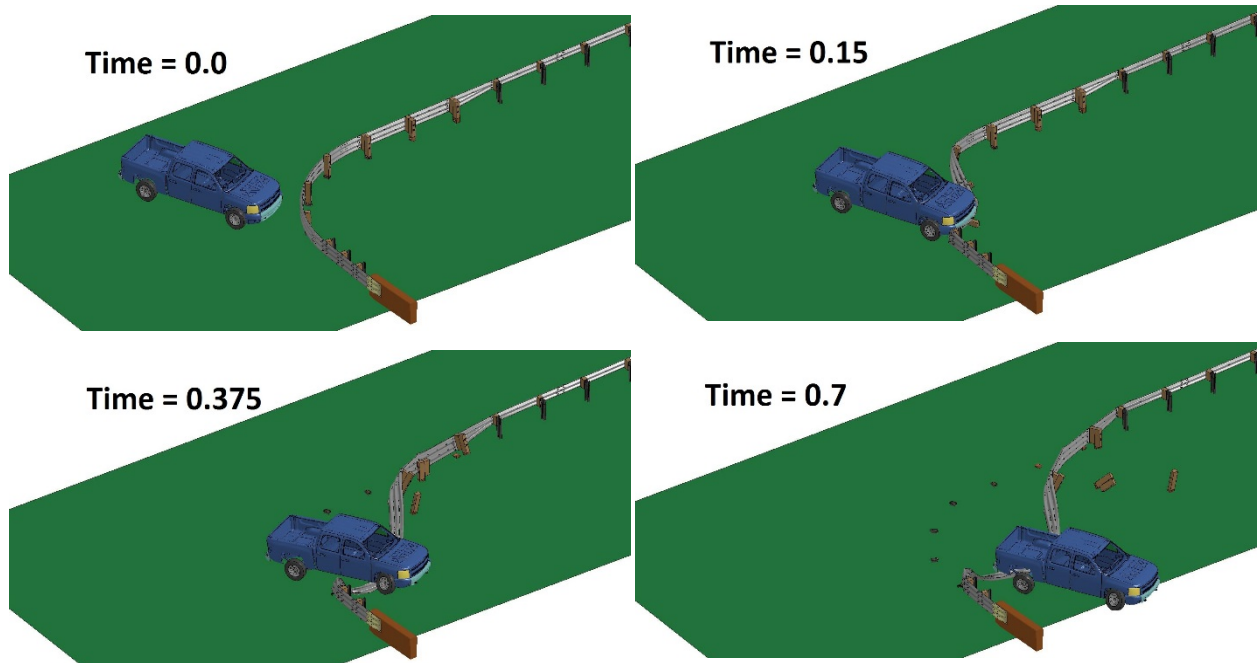
**Figure 2.14. Sequential Images of Simulation with No Cable.**

Figure 2.14 presents the sequential images of the motion of the truck as it impacts the nose section of the system. The truck remains stable during the simulation. The first image shows the initial position of the system and is followed by three images of the truck interacting with the rail. At time 0.375 s, the truck has overridden the system. The last image displays the end state of the simulation and shows that the truck has completely gone over the system. The simulation of the system shows that the system is not adequate to contain the truck.

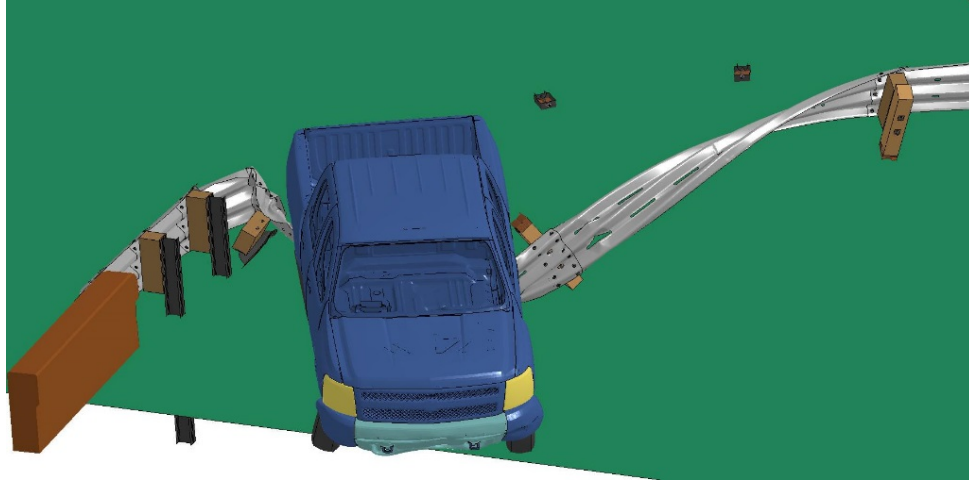
**Figure 2.16. Final State of Simulation.**

Figures 2.15 and 2.16 show the initial and final state of the simulation of the truck, respectively. In the final frame of the simulation, the guardrail system has deformed and seven of the posts broke while two steel posts to the right of the thrie beam end shoe appear to remain intact.

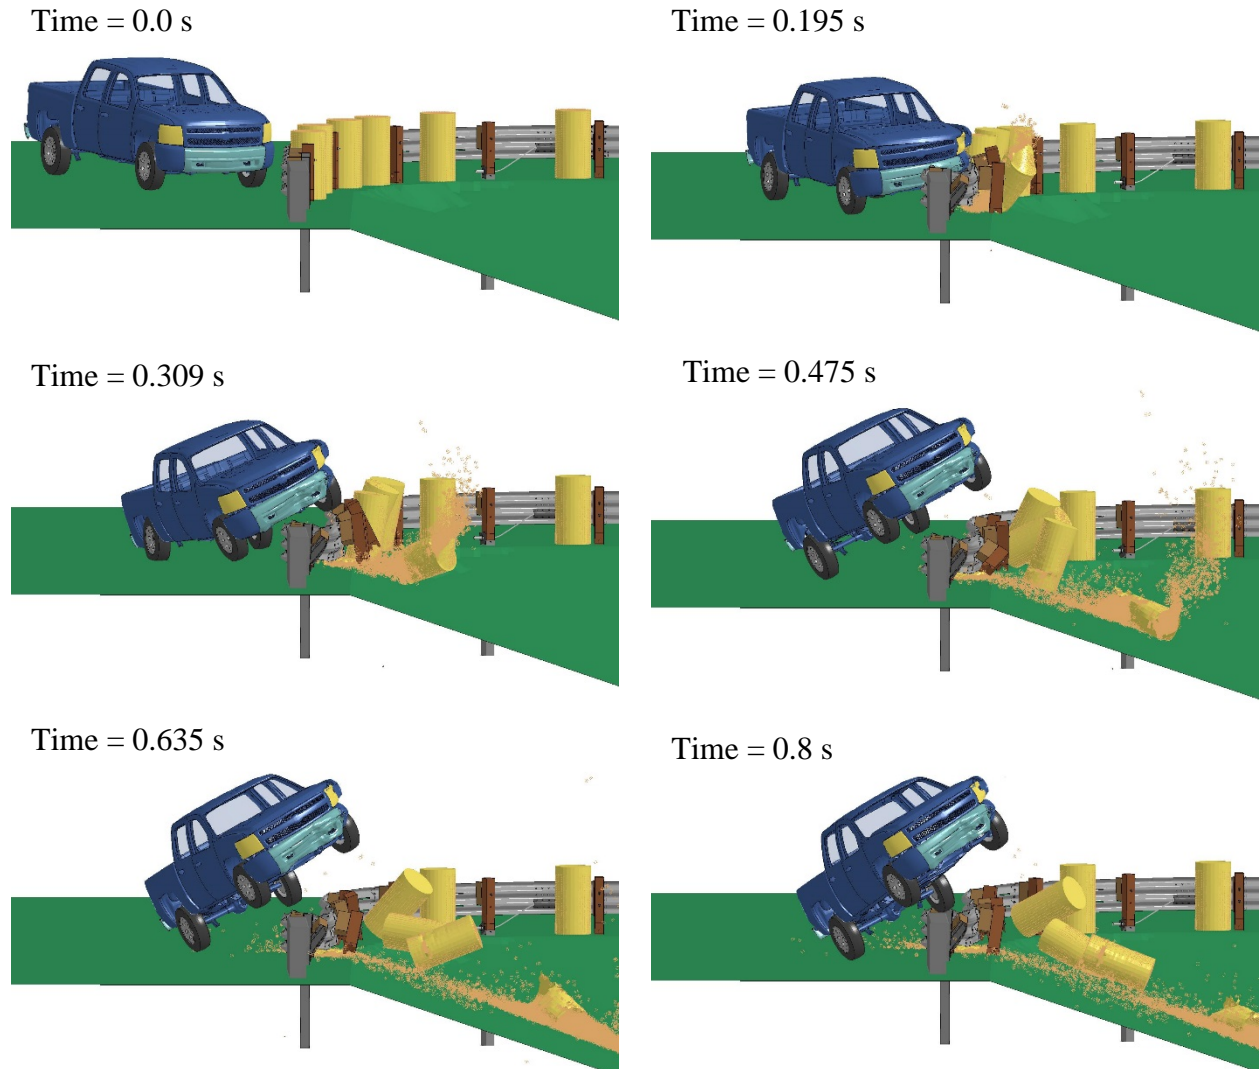
**Figure 3.20. Sequential Images of Truck Simulation with Tension Cable and Six 700-lb Sand Drums.**

Figure 3.20 presents the simulation of the truck. The first CRT post along the primary roadway broke, and by the end of the simulation three CRT posts were broken, one steel post was deformed, and the other stayed stable through the simulation. By 0.309 s, the driver side front wheel of the truck began to ride up onto the rail. The truck becomes unstable as early as 0.35 s.

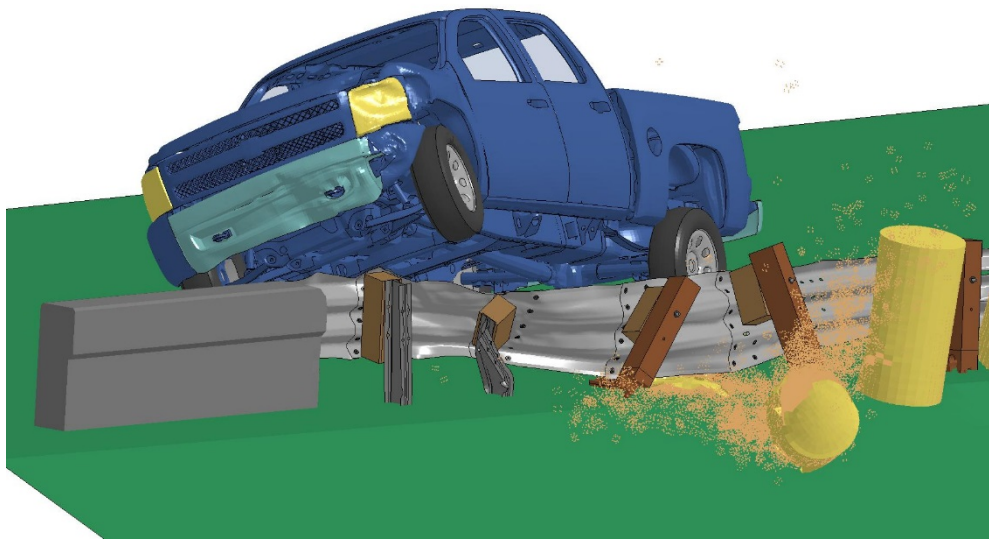
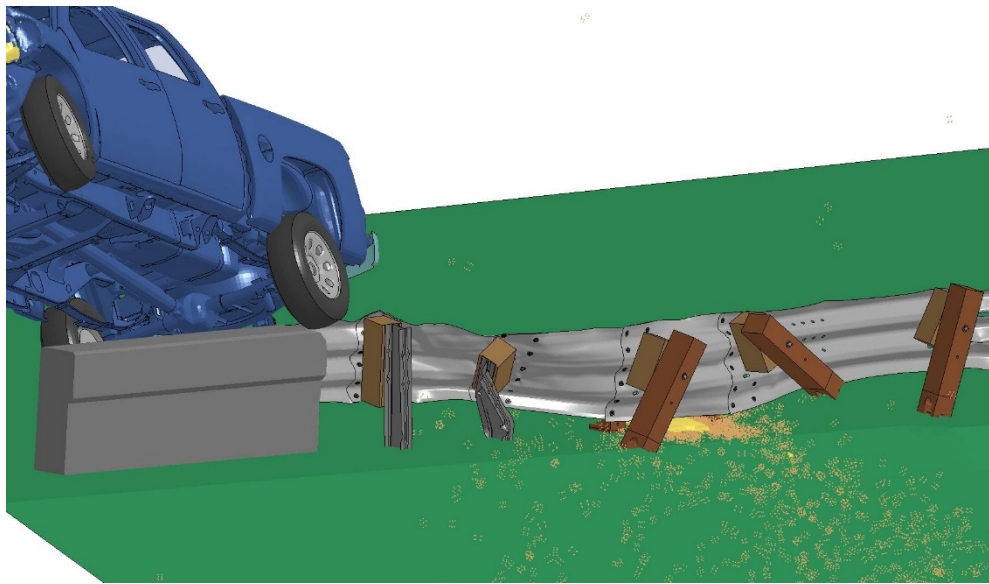
Figures 3.21 and 3.22 display a closer view of the interaction. The drums were removed to show the deformation between the car and the rail.

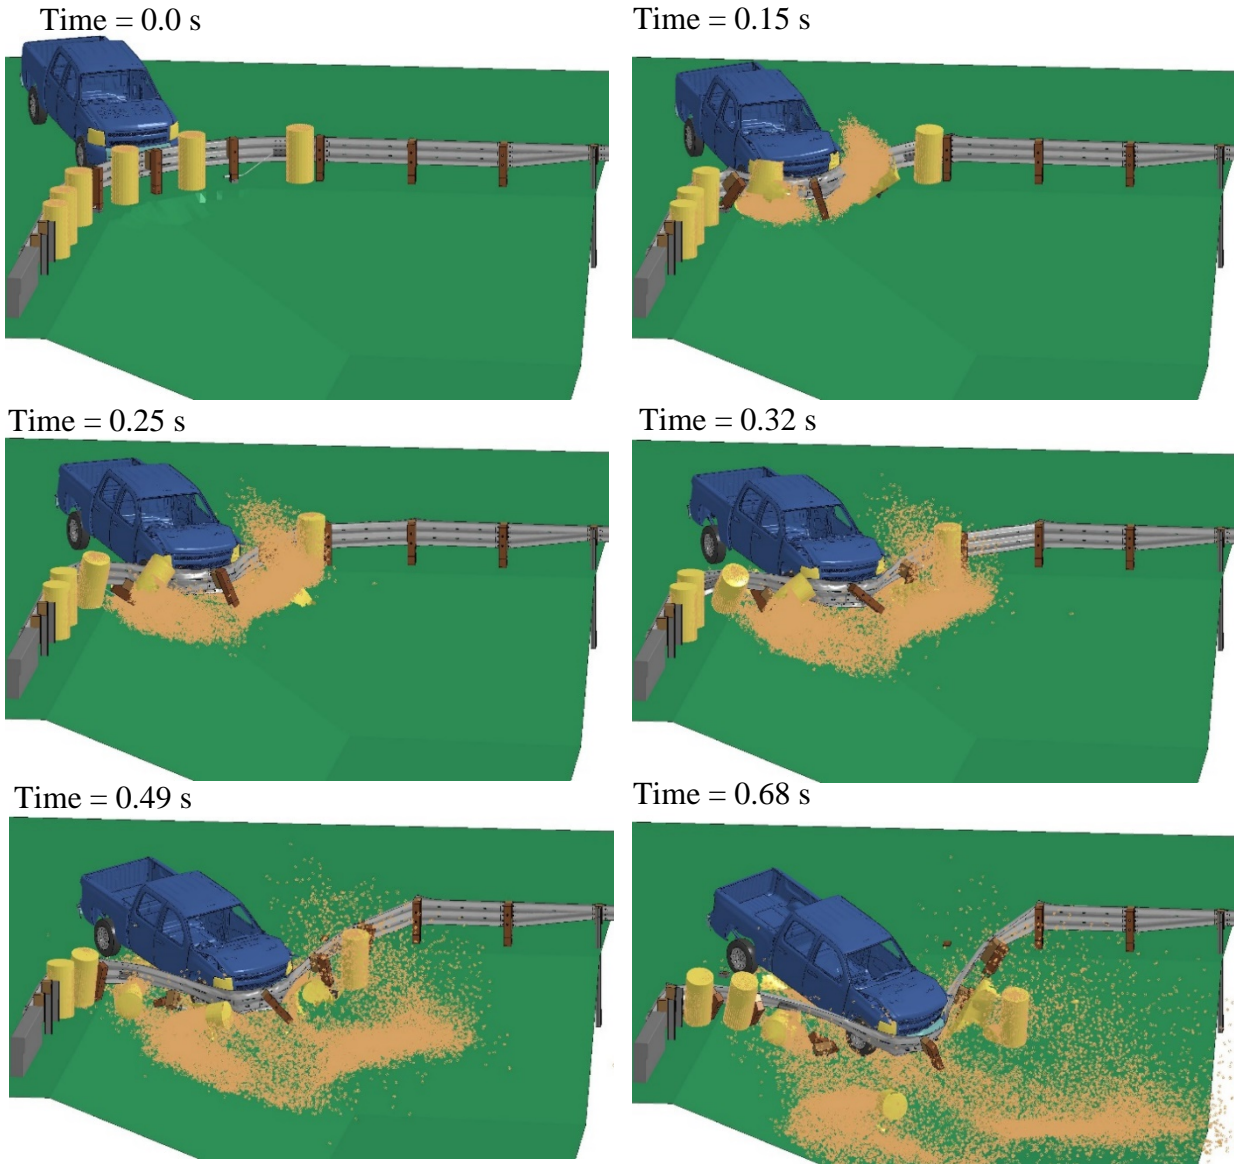
**Figure 3.24. Sequential Images of Truck Simulation with Two Tension Cables and Six 700-lb Sand Drums.**

Figure 3.24 shows the sequential images of the simulation. In this simulation, the truck did not override the system. At 0.68 s, six of the wood posts broke and most of the drums dispersed the sand they were containing.

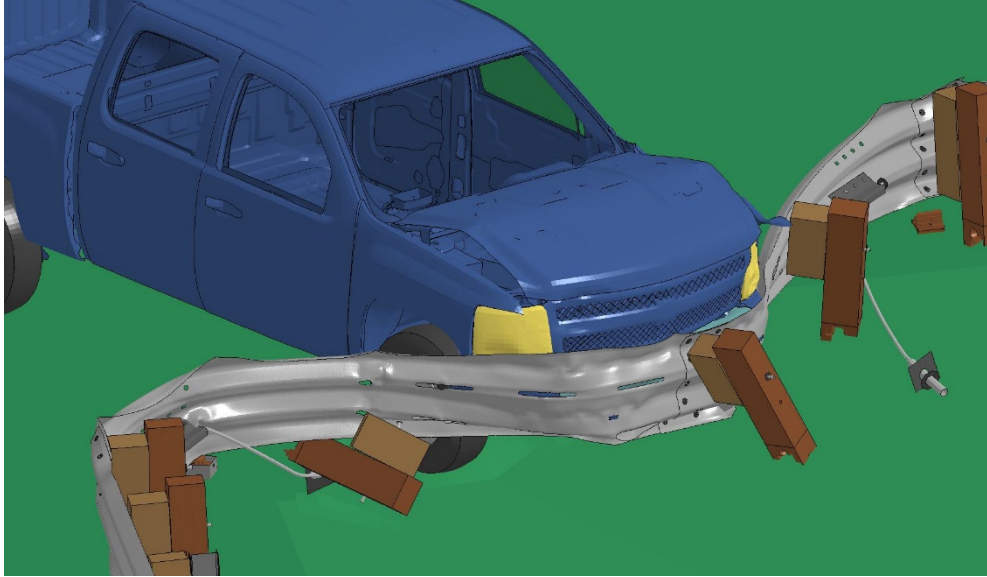
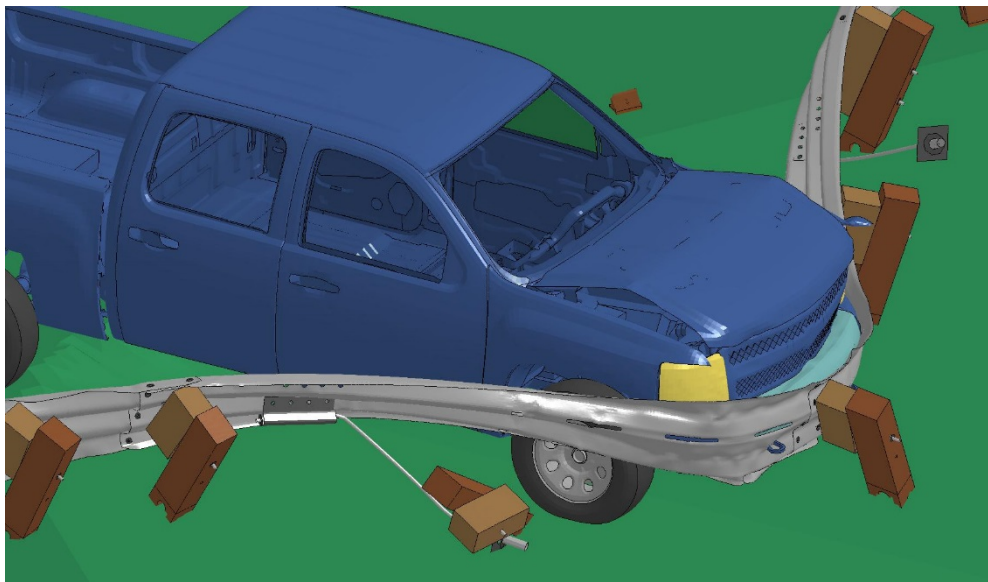
Figures 3.25 and 3.26 are a closer view of the simulation. The drums were removed to show the deformation of the car and guardrail.

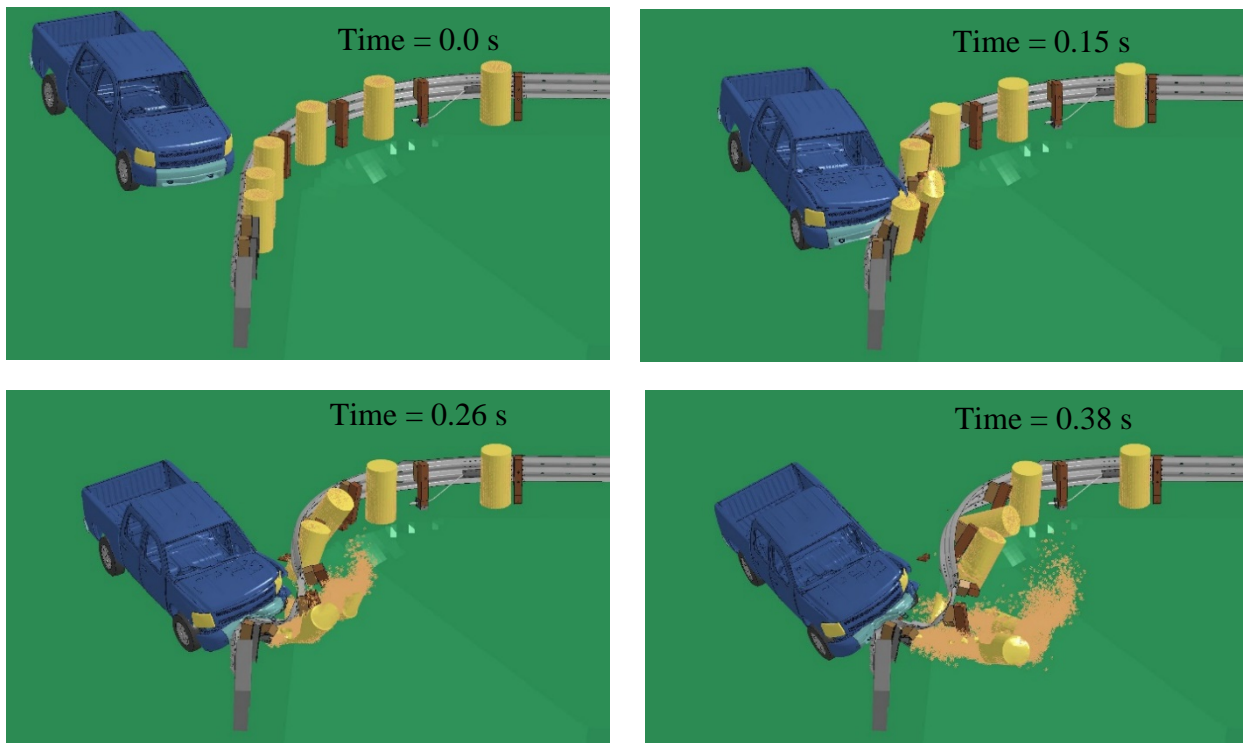
**Figure 3.28. Sequential Images of Truck Simulation with Tension Cable and Six 700-lb Sand Drums.**

Figure 3.28 shows the sequential images of the simulation. At 0.15 s, the truck has impacted the rail. The last image shows that the truck was not redirected away from the system. Instead, the front of the truck began to override the rail.

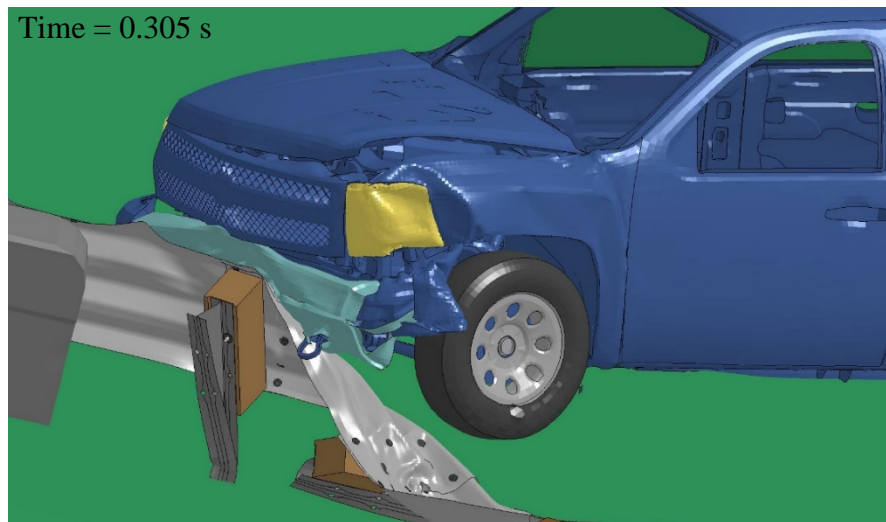
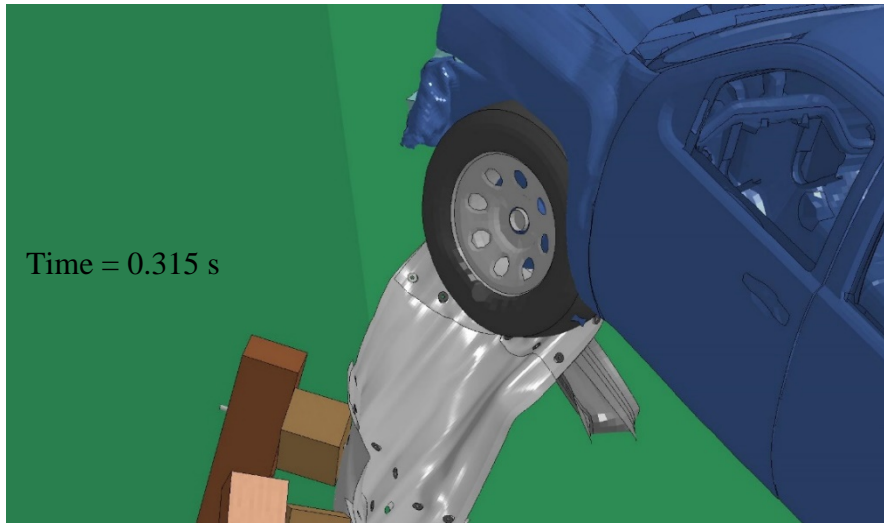
Figures 3.29 and 3.30 show a close view of the deformation between the truck and the guardrail system. These two figures show different views of the truck at certain points in the simulation. As seen below, at approximately 0.3 s the front of the truck is lifted up. The drums were removed for clarity.

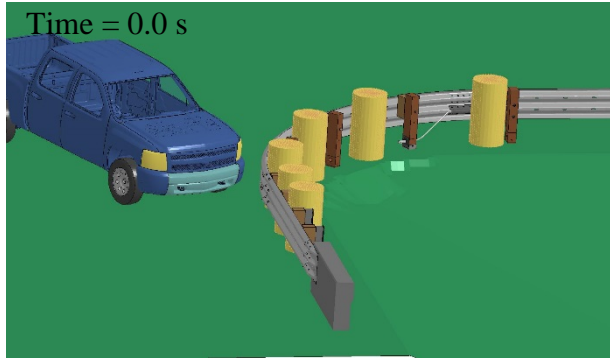
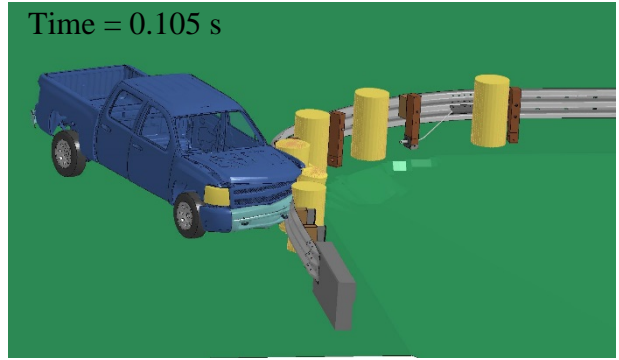
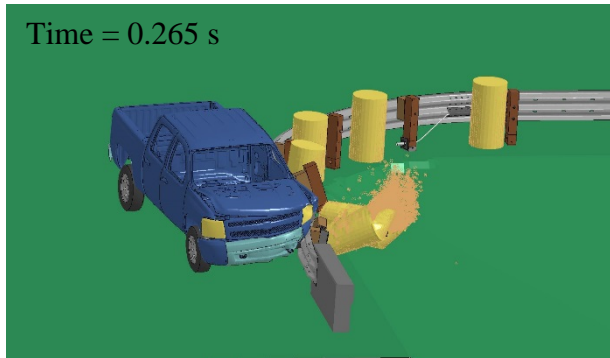
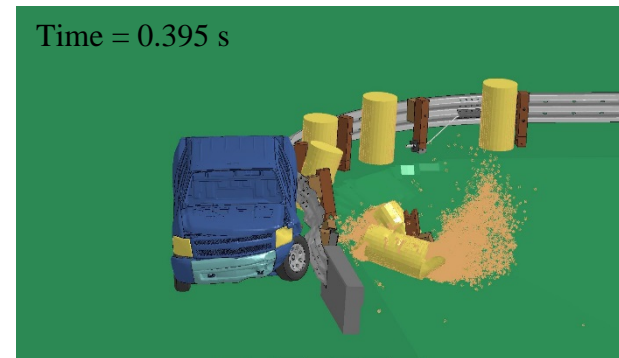
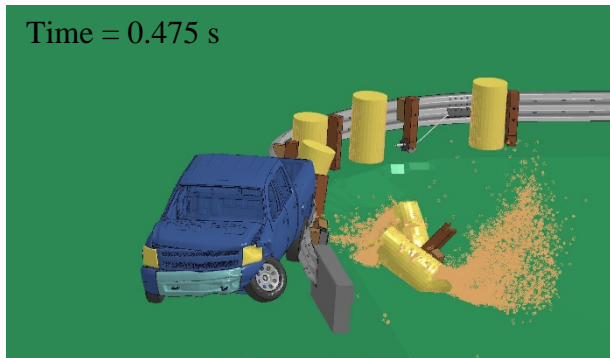
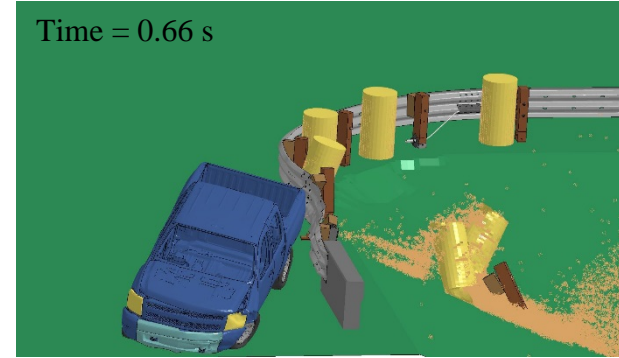
**Figure 3.32. Sequential Images of Truck Simulation with Two Tension Cables and Six 700-lb Sand Drums.**

Figure 3.32 shows the sequential images of this simulation. At 0.105 s, the truck pushed the rail into the interior of the system and the front left side of the truck deformed. The cable maintained tension capacity. By 0.4 s, the truck had been redirected. At 0.475 s, the left side corner of the truck interacted with the system. The last image displays the redirected truck after its interaction with the system was complete.

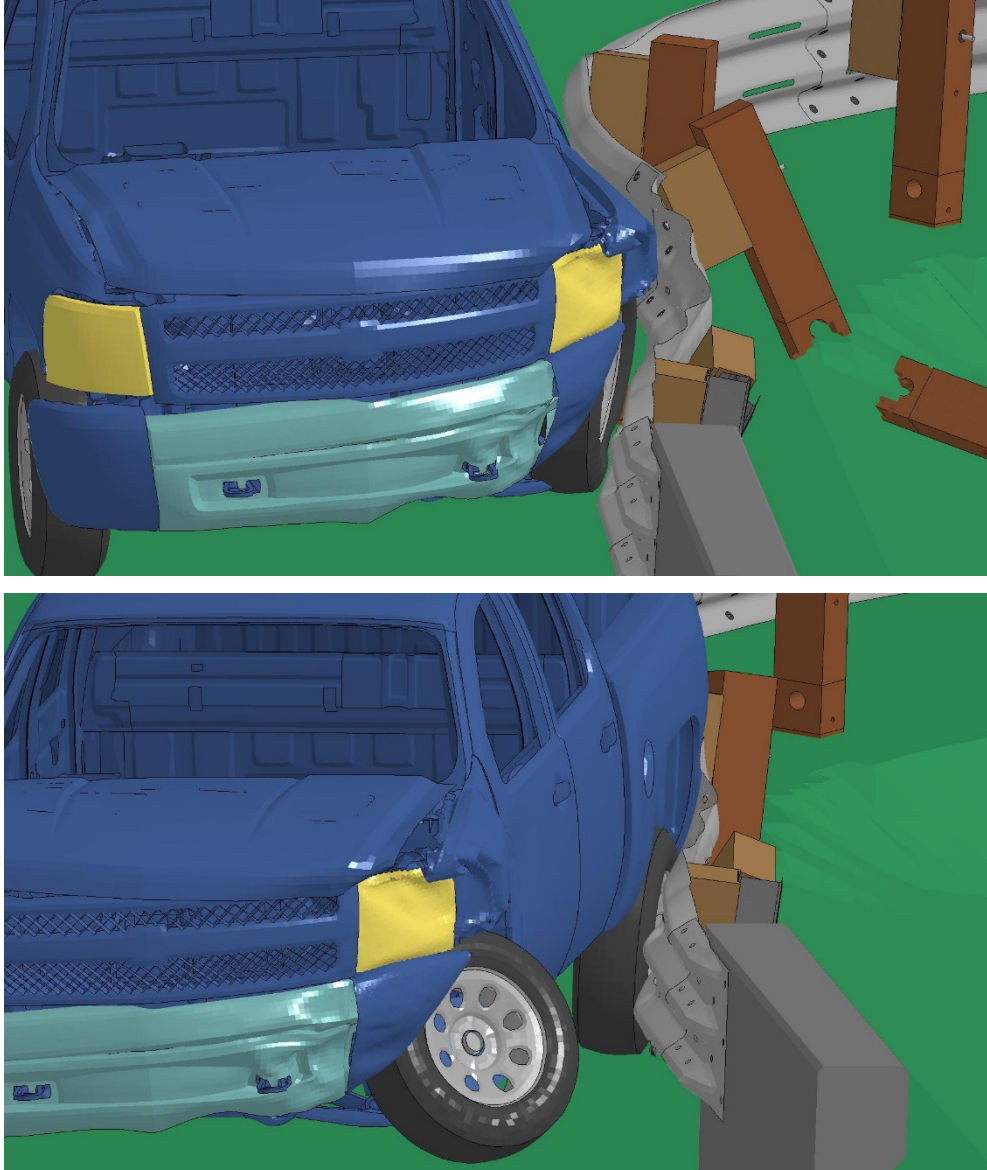
**Figure 3.33. Interaction of Truck with System (No Drums Visible).**

Figure 3.33 presents a closer view of the interaction. Deformation has occurred for both the truck and rail, leaving two broken CRT posts and one deformed steel post. The sand has been hidden from these images to better see the rail and truck.

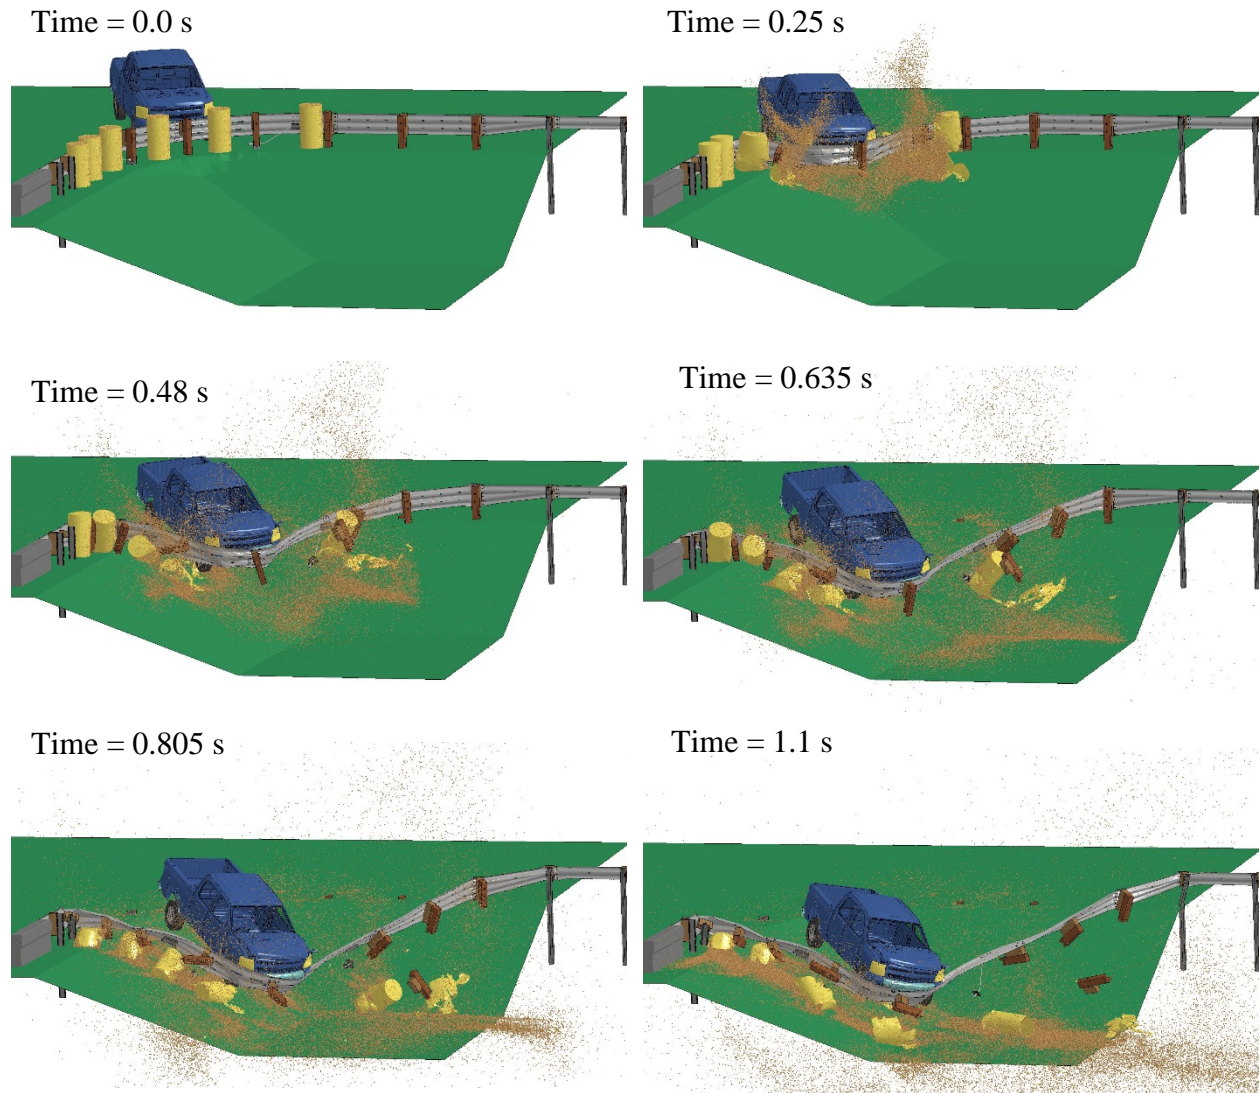
**Figure 3.34. Sequential Images of Truck Simulation with Two Tension Cables and Six 700-lb Sand Drums.**

Figure 3.34 presents the sequential images depicting the performance of the system. The first image shows the initial position of the system. At 0.25 s, four wood posts surrounding the impact area broke. The wood posts continued to break consecutively. By the end of the simulation, all of the wood posts broke and one of steel posts had significant bending while the other one still remained intact.

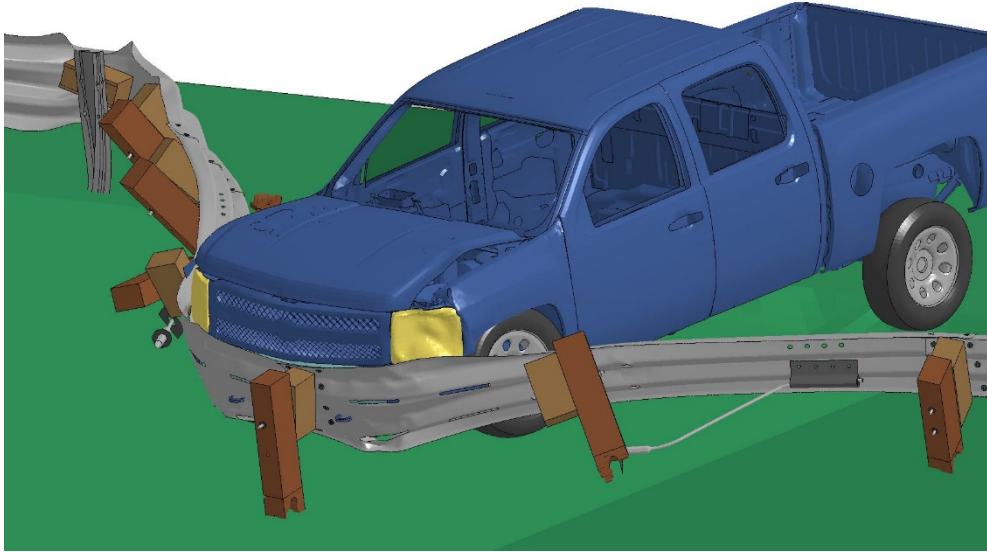
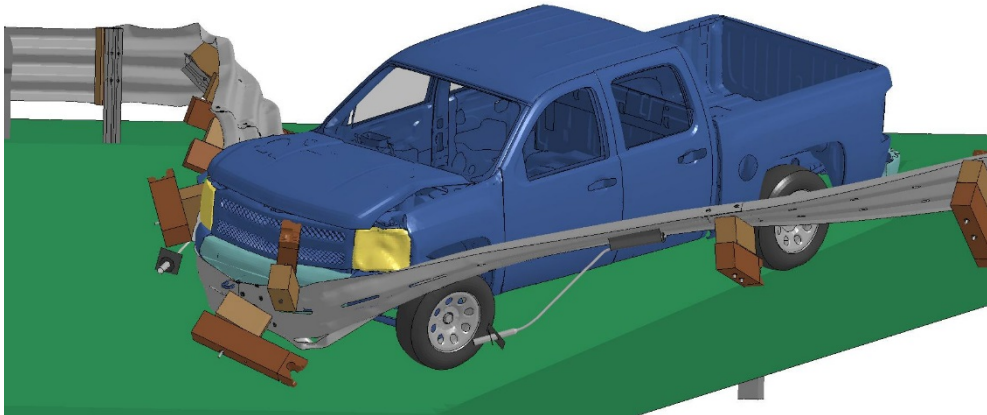
Figures 3.36 and 3.36 show a closer view of the impact during the simulation and at the final state of the simulation. The drums were removed to have a clear view. Figure 3.36 displays a clear view of how the rail started to go under the front of the truck.

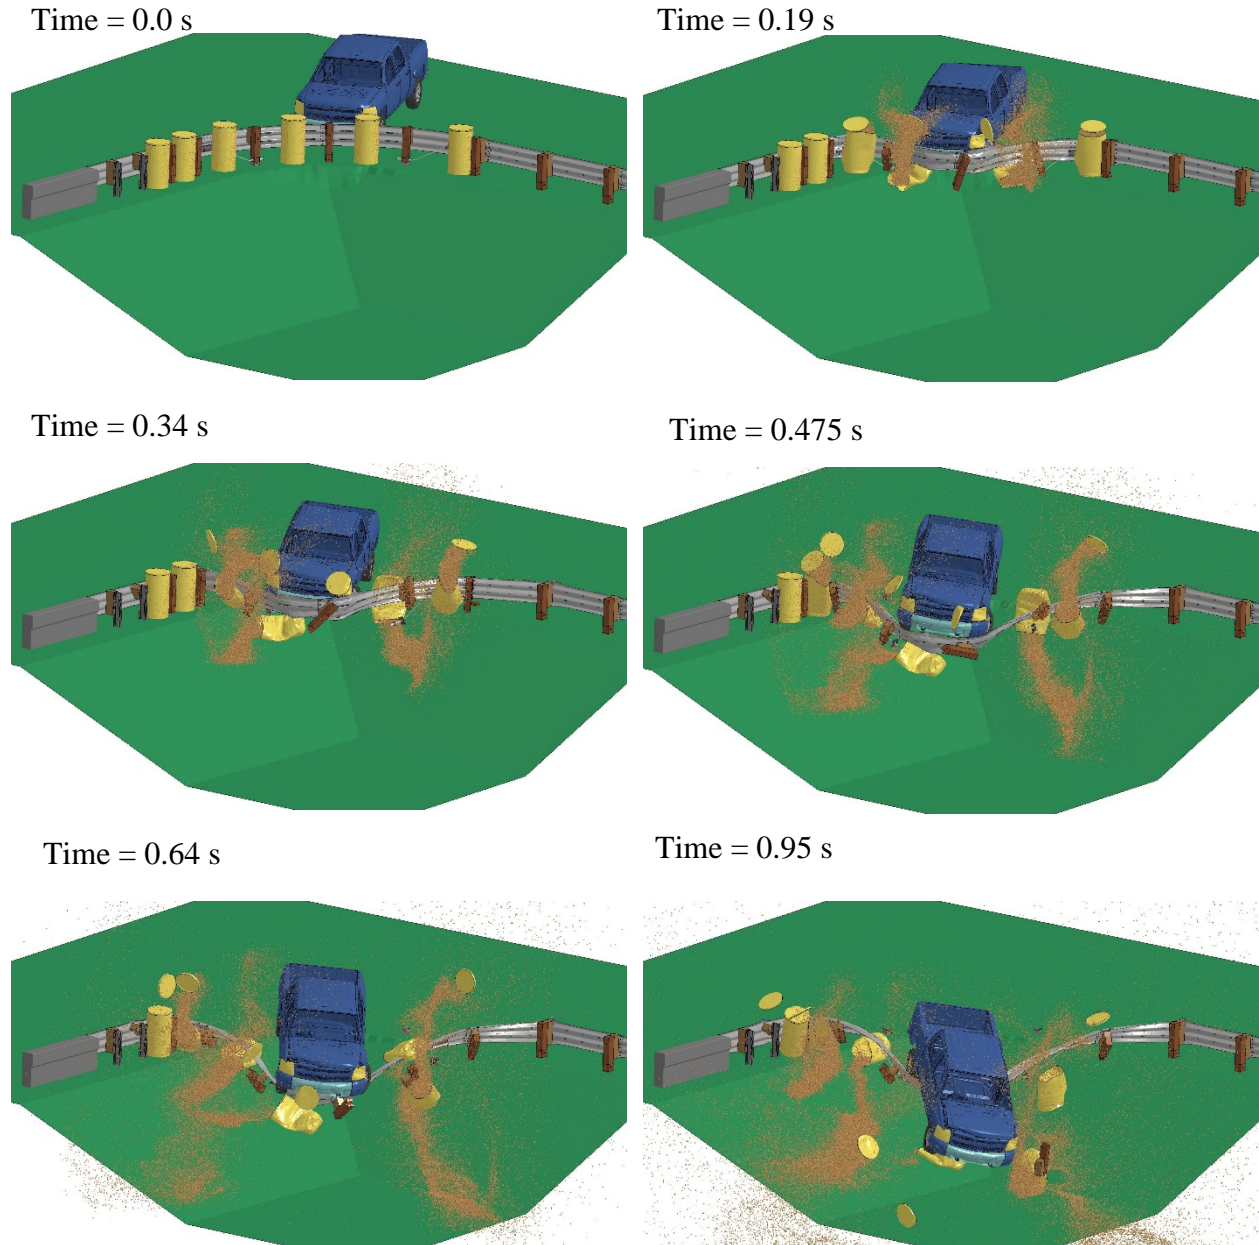
**Figure 3.38. Sequential Images of Truck Simulation with Two Tension Cables and Six 700-lb Sand Drums.**

Figure 3.38 depicts the truck throughout the simulation. The initial contact with the rail happened at 0.019 s. Before 0.20 s, two drums had dispersed the sand and two more drums were about to break as well. At approximately 0.45 s, the truck was riding up the rail. By 0.645 s, the

front two tires had completely gone over the rail. The last image shows the last state for the simulation where the truck had overridden the system.

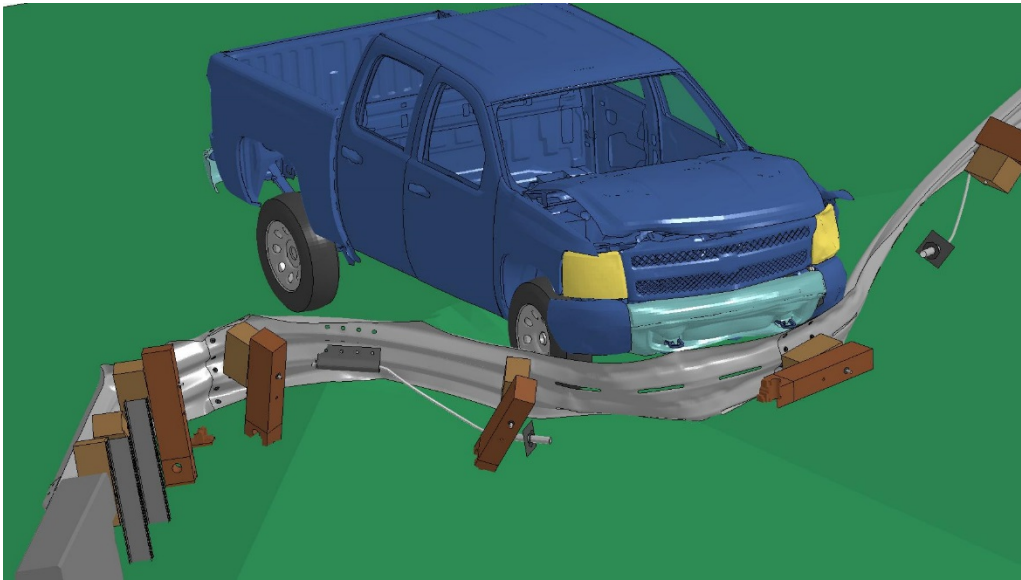
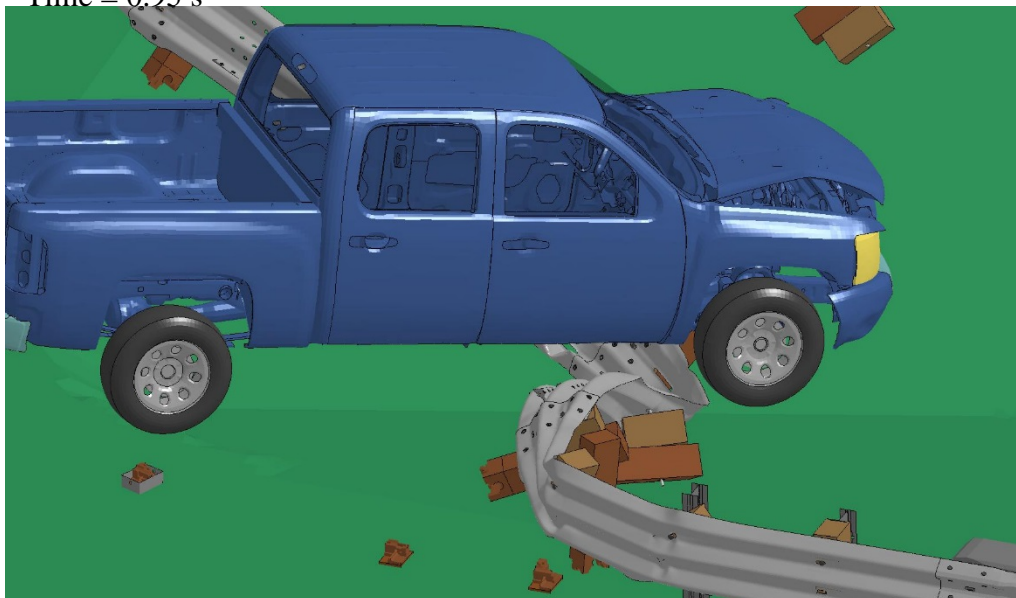
Figures 3.39 and 3.40 demonstrates a closer view of the truck impacting the rail. The drums were removed from the simulation to have a clear view of the deformation of the truck and the guardrail. Figure 3.39 shows approximately the time before the truck begins to ride over the rail. Figure 3.40 shows the final state of the simulation.

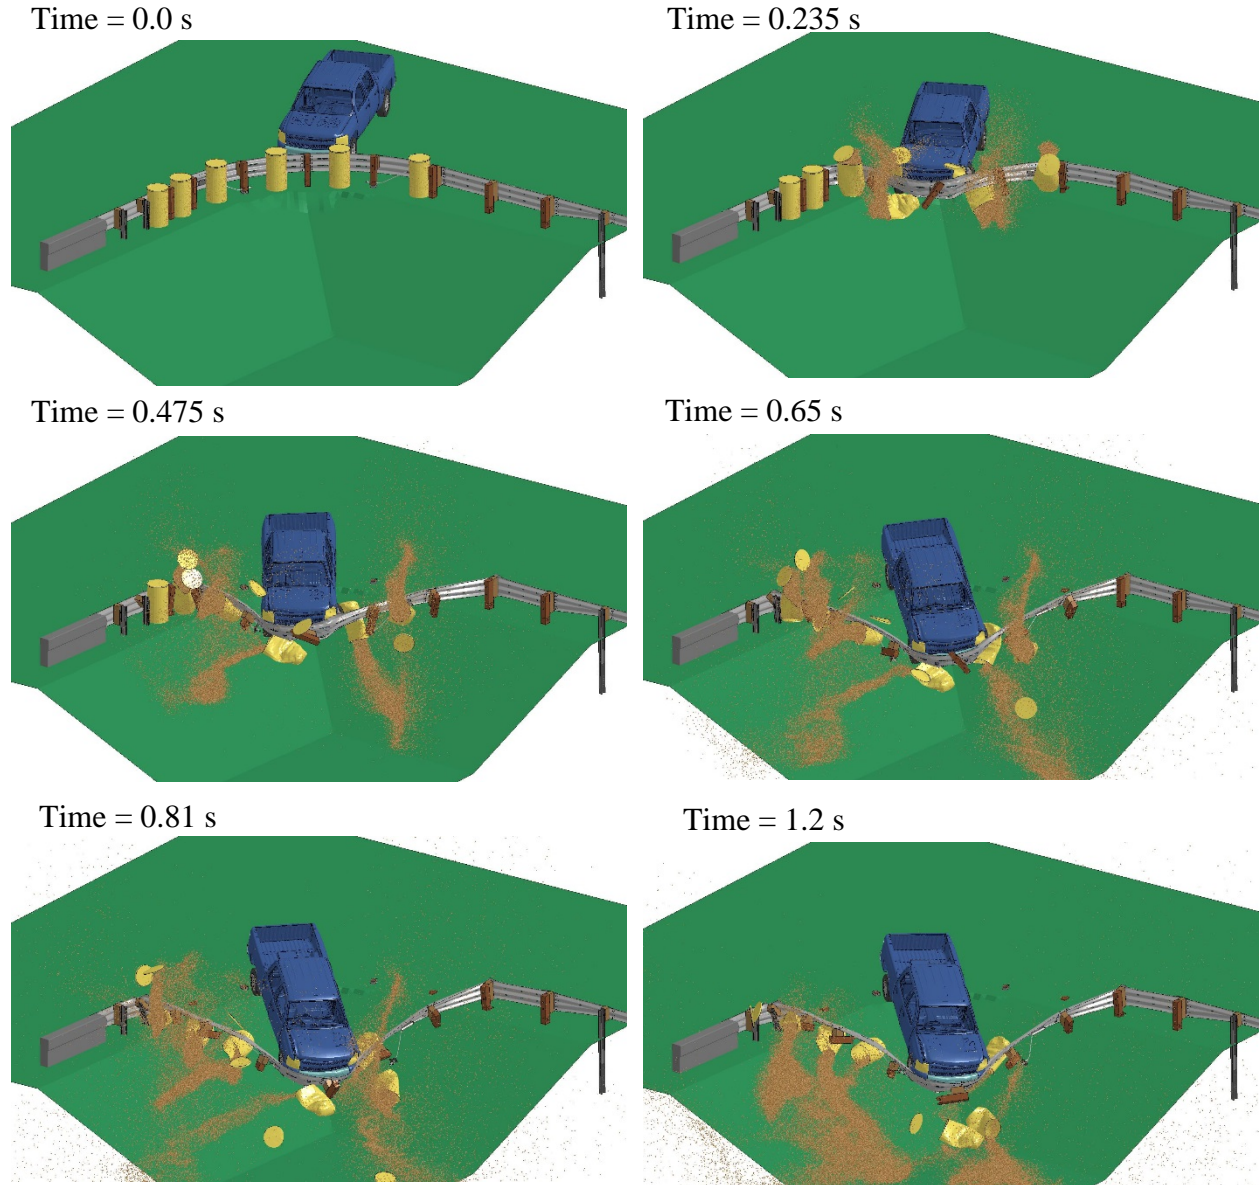
**Figure 3.42. Sequential Images of Truck Simulation with Two Tension Cables and Six 700-lb Sand Drums.**

Figure 3.42 shows the sequential images of the simulation. The first image shows the initial position of the system and is followed by four images of the truck interacting with the rail. Before 0.235 s, the guardrail system was already deforming into the ditch. The last image of the simulation shows the truck being captured by the rail.
