# CRASH TEST AND EVALUATION OF TL-2 SHORT RADIUS GUARDRAIL TREATMENT

**Test Report 0-6913-R1**

**TEXAS A&M TRANSPORTATION INSTITUTE  
COLLEGE STATION, TEXAS**

**TEXAS DEPARTMENT OF TRANSPORTATION**

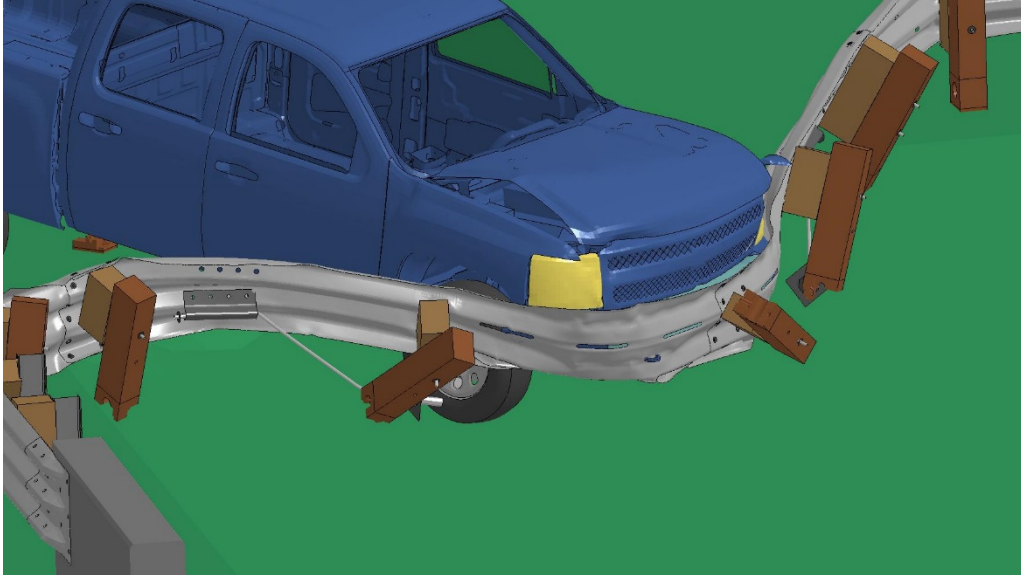
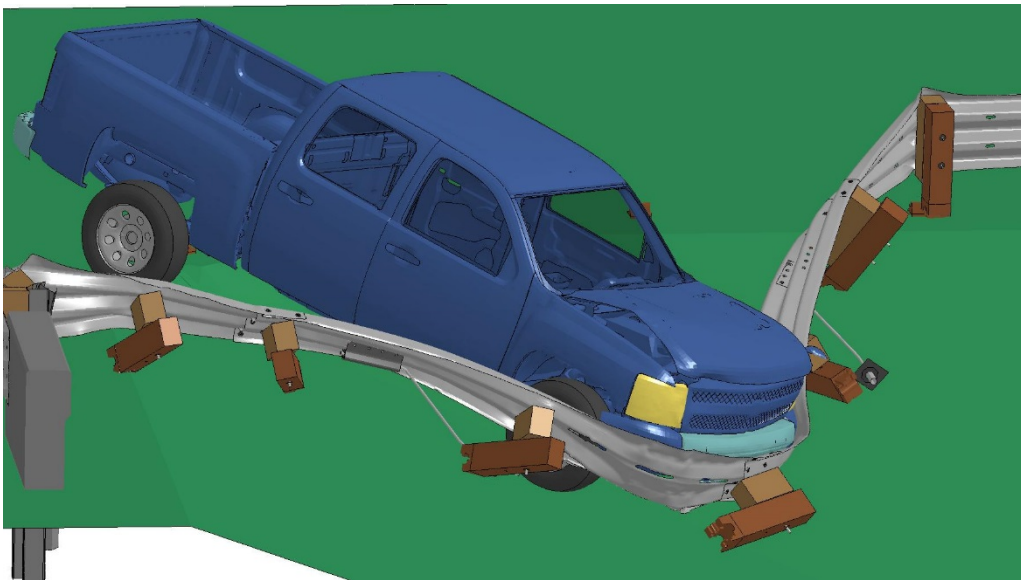
Figures 3.43 and 3.44 show a closer view of the deformation between the guardrail system and the truck. The drums were removed from the figures to have a clear view of the deformation.

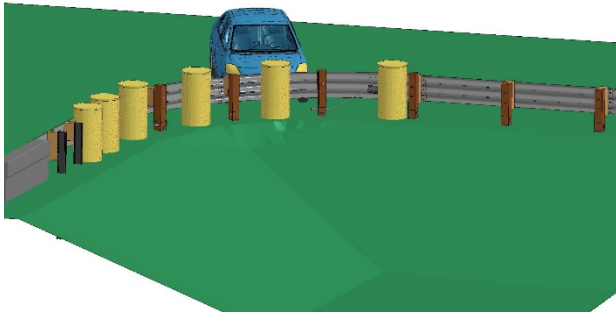
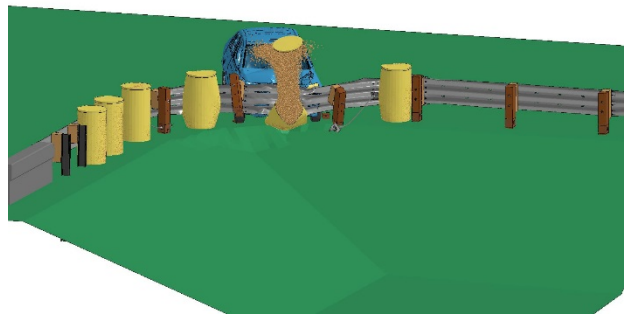
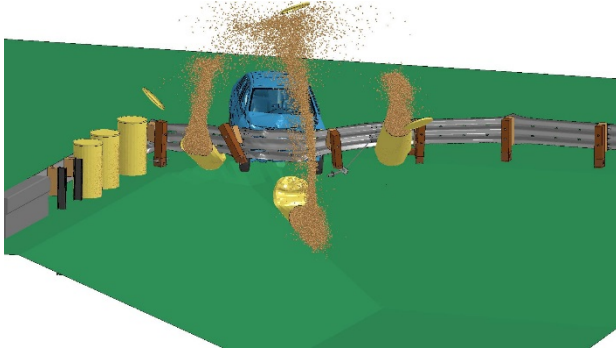
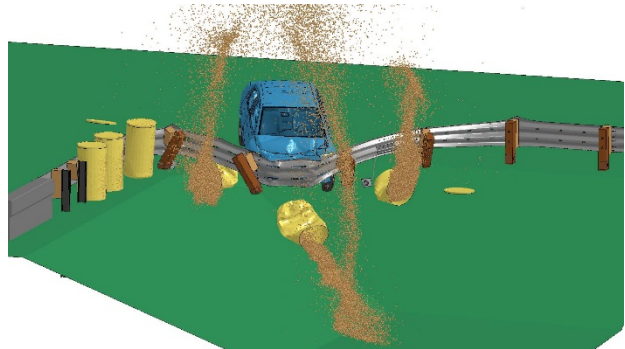
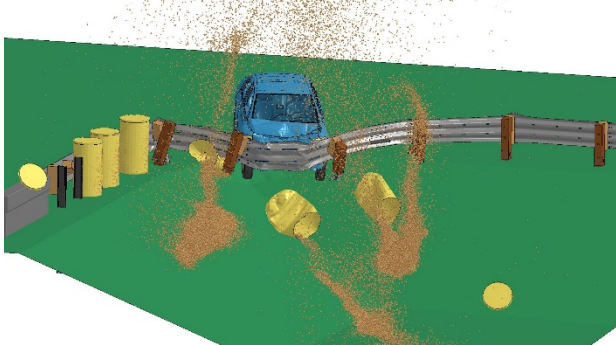
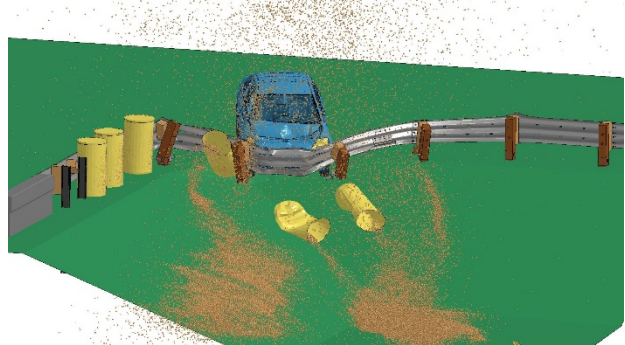
**Figure 3.47. Sequential Images of Car Simulation with Two Tension Cables and Six 700-lb Sand Drums.**

Figure 3.47 shows the sequential images throughout the simulation. The car remained stable during the simulation. The first image shows the initial position of the car and the system, and is followed by two images that depict the interaction of the car with the guardrail system and drums. At 0.27 s, the deformation from the car was present and three of the drums have broken and dispersed the sand. By 0.405 s, the car began to be captured by the rail. The last image displays the car being captured by the rail with three drums remaining intact and four out of the eight CRT posts broken.

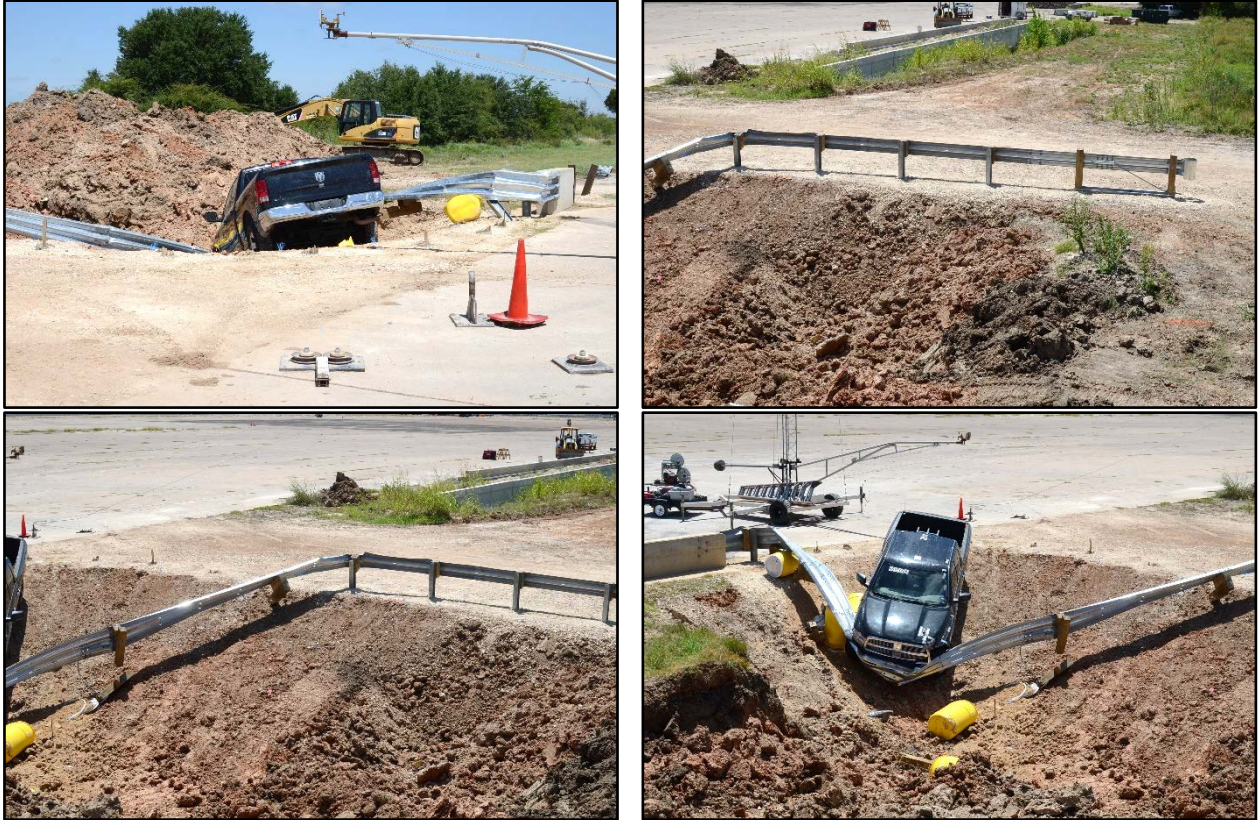
Figures 7.3 through 7.6 show the damage to the TxDOT low-speed short radius guardrail treatment. The soil around post 1 was slightly disturbed. Post 5 was displaced 0.75 inch through the soil toward the field side. Post 6 was displaced 8.5 inches through the soil toward the field side. Posts 7, 9, and 13 fractured at ground level but remained attached to the rail element. Posts 8, 10, 11, 12, and 14 fractured at ground level and separated from the rail element. Post 15 was displaced through the soil 5.5 inches toward the field side and 6.0 inches toward the parapet. Post 16 was displaced 1.0 inch through the soil toward the field side. Maximum dynamic deflection during the test was 24.2 ft, and maximum permanent deformation was 20.5 ft.

**Figure 7.3. TxDOT Low-Speed Short Radius Guardrail Treatment after Test No. 469137-3-1.**

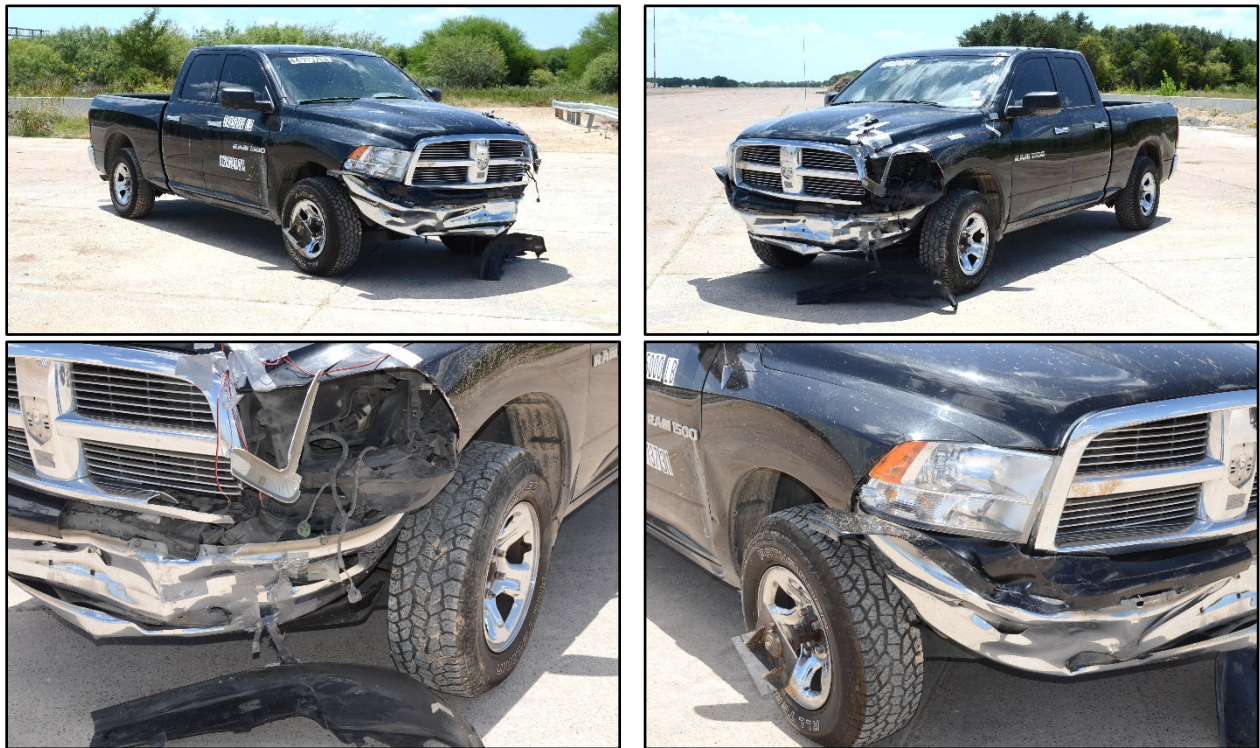
Figure 7.7 shows the damage the vehicle sustained. The front bumper, grill, headlights, right and left front fenders, radiator support, and right front door were damaged. Maximum exterior crush to the vehicle was 6.0 inches in the front plane at the both front corners at bumper height. No occupant compartment deformation or intrusion occurred. Figure 7.8 shows the interior of the vehicle. Tables D.3 and D.4 in Appendix D.1 provides exterior crush and occupant compartment measurements.

**Figure 7.7. Test Vehicle after Test No. 469137-3-1.**

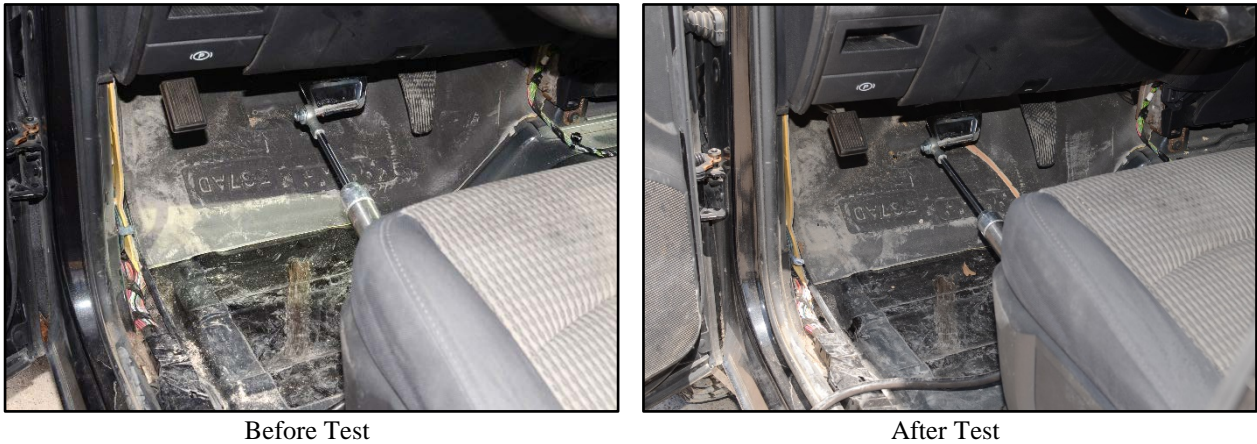
Figure 7.8. Interior of Test Vehicle for Test No. 469137-3-1.

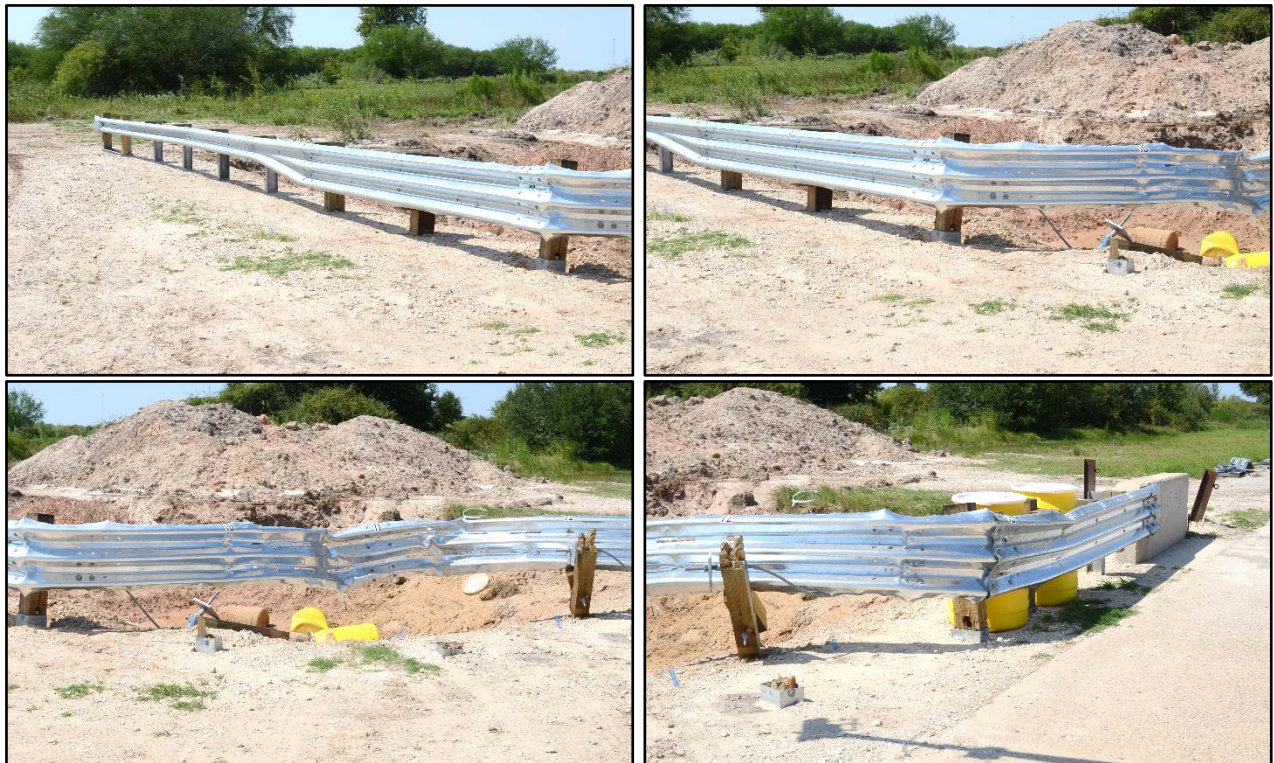
Figures 8.3 through 8.6 show the damage to the TxDOT low-speed short radius guardrail treatment. No disturbance of the soil around posts 1 through 6 was noted. Post 7 was displaced through the soil 1.0 inch toward field side. Post 8 was displaced through the soil 2.38 inches toward the field side and was leaning 85° toward the field side. Post 9 was displaced through the soil 9.25 inches toward the field side and was leaning 80° toward the field side. The ground tube for post 10 was displaced through the soil 3.75 inches, and the post fractured at the top of the ground tube. The ground tube for post 11 was displaced through the soil 0.25 inches, and the post fractured at the top of the ground tube. The ground tube for post 12 was displaced through the soil 0.38 inches, and the post fractured at the top of the ground tube. The ground tube for post 13 was displaced through the soil 0.12 inches, and the post fractured at the top of the ground tube. The soil was disturbed around post 14, and the rail element separated from the blockout. No disturbance of the soil around posts 15 and 16 was noted. Drums 1–4 were resting in the ditch, and drum 5 was pushed toward the field side 3.0 inches. Working width was 2.5 ft, and height of working width was below grade (vehicle in ditch). Maximum dynamic deflection during the test was 10.5 ft, and maximum permanent deformation was 10.5 ft.

**Figure 8.4. Test Article after Test No. 469137-3-2.**

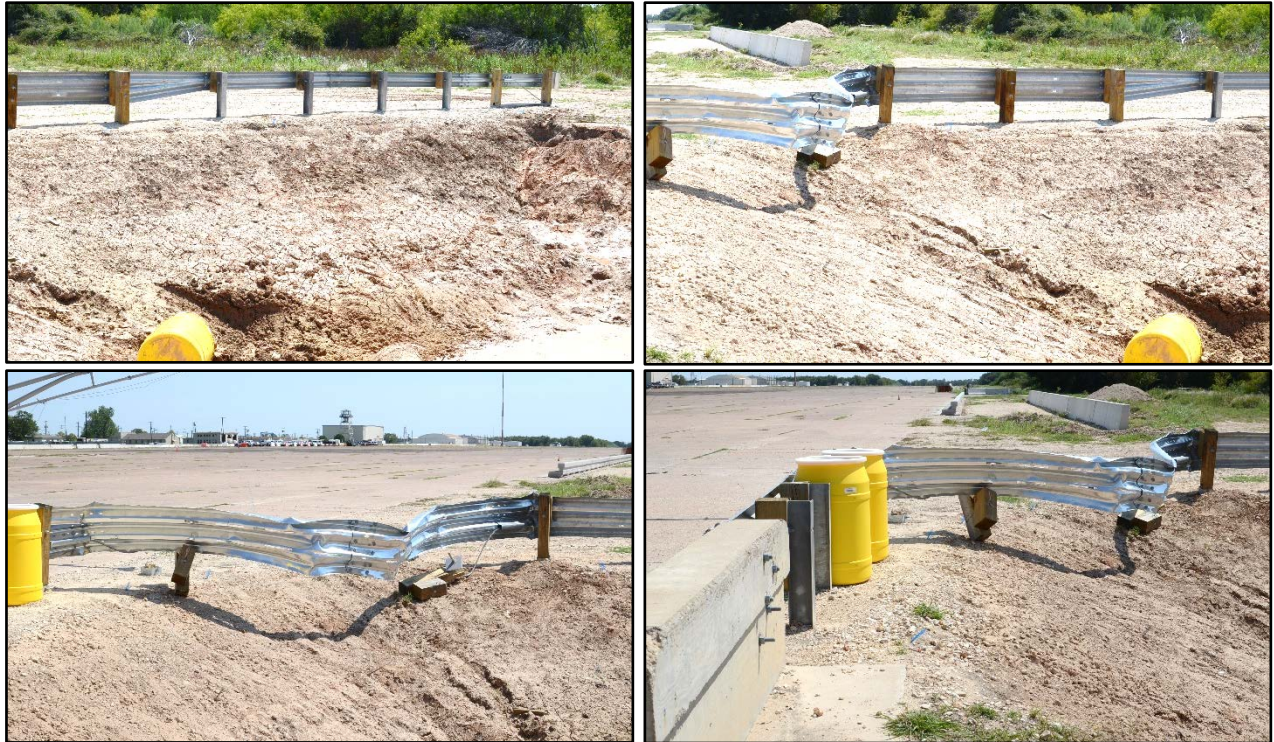
**Figure 8.5. Field Side of Test Article after Test No. 469137-3-2.**

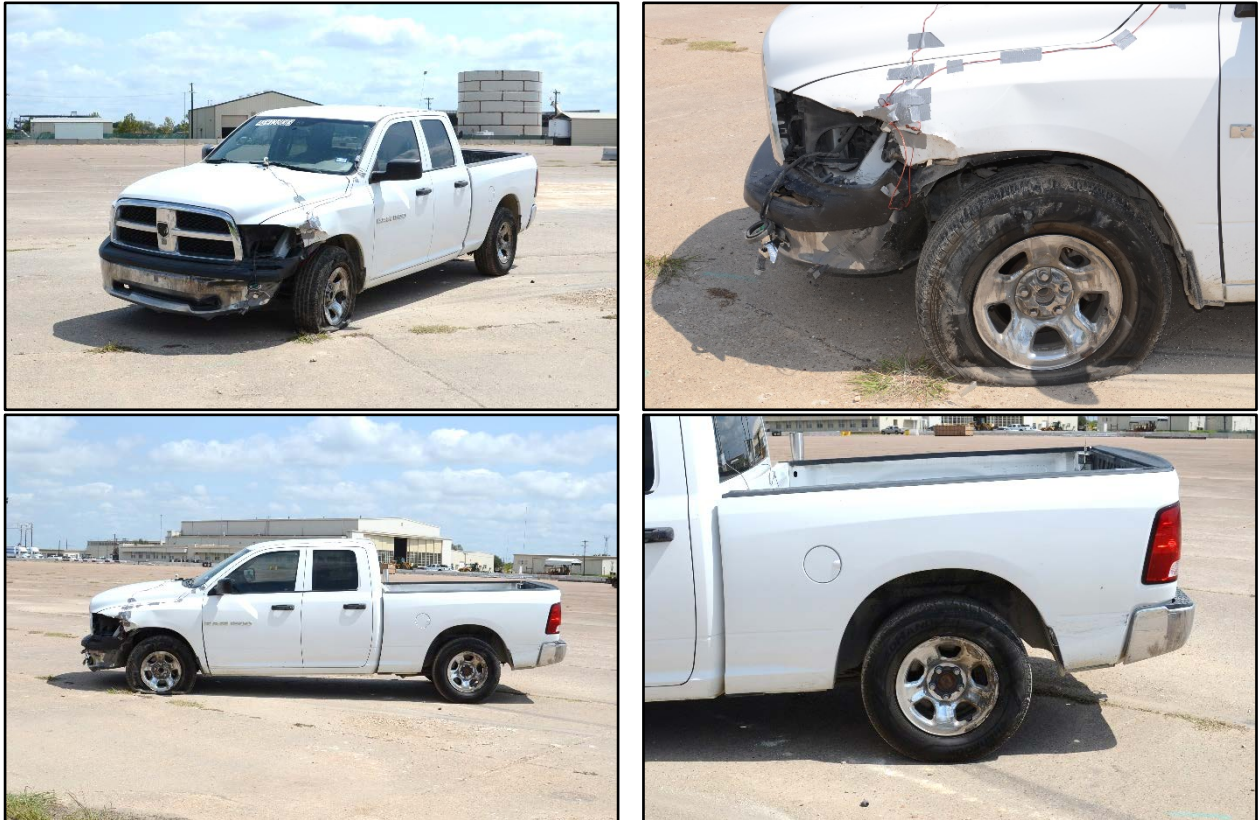
Figure 9.7 shows the damage the vehicle sustained. The front bumper, grill, left front fender, left tire and rim, left rear rim, left rear exterior bed, and left rear bumper were damaged. Maximum exterior crush to the vehicle was 9.0 inches in the front plane at the left front corner at

bumper height. No occupant compartment deformation or intrusion occurred. Figure 9.8 shows the interior of the vehicle. Tables F.3 and F.4 in Appendix F.1 provide exterior crush and occupant compartment measurements.

**Figure 9.7. Test Vehicle after Test No. 469138-3-3.**

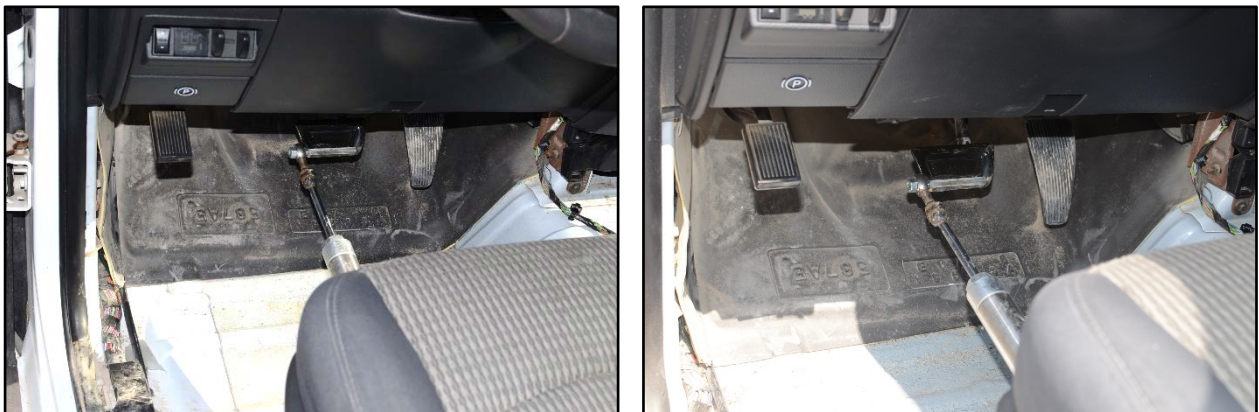
**Figure 9.8. Interior of Test Vehicle for Test No. 469138-3-3.**

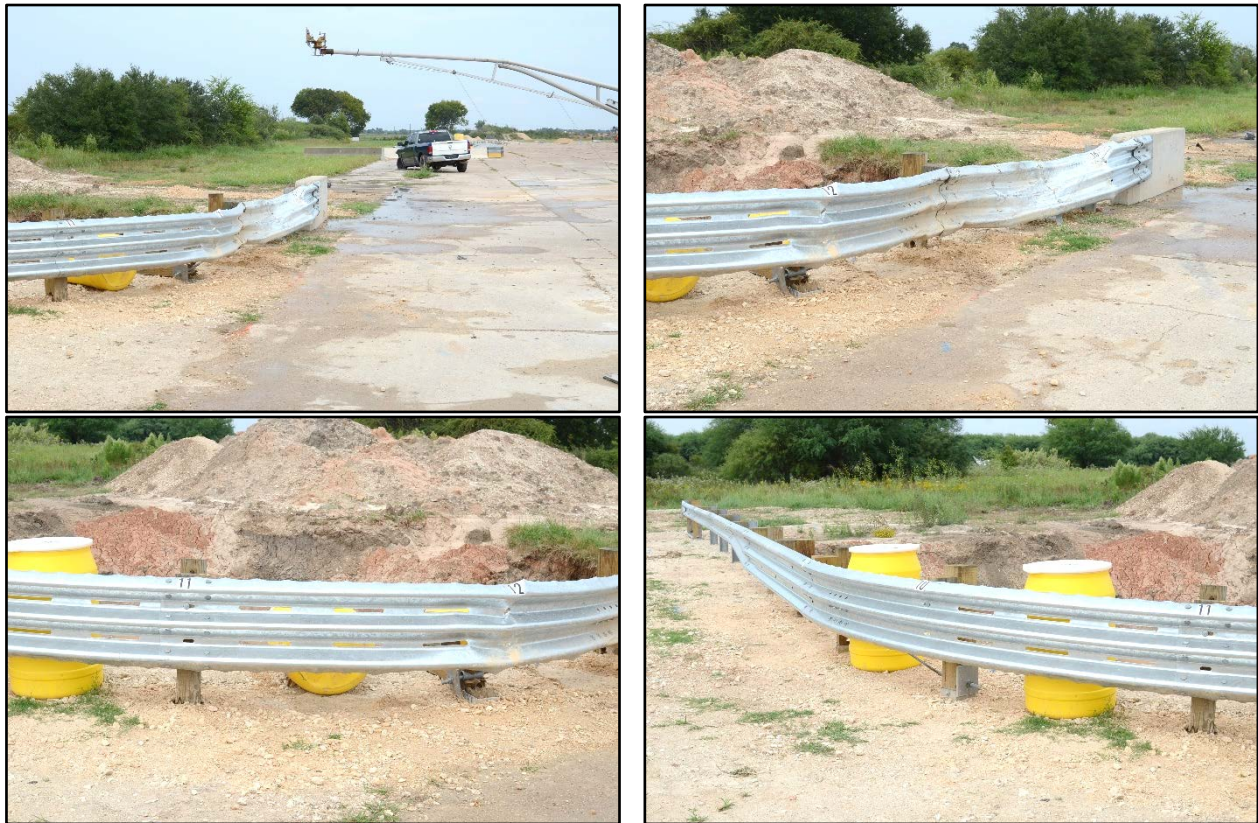
Figures 10.3 through 10.6 show the damage to the TxDOT low-speed short radius guardrail treatment. The soil around posts 1 through 9 showed no signs of movement, and the soil around post 10 was disturbed. Post 11 fractured at the top of the foundation tube and leaning 83° toward the field side, but remained in place, and the tube was displaced through the soil 0.12 inch toward the field side. Posts 12 fractured at the top of the foundation tube, separated from the rail element, and resting toward the field side adjacent to the tube; the tube was displaced 0.5 inch toward the field side. Posts 13 fractured at the top of the foundation tube, remained attached to the rail element, and was resting 21.5 inches toward the field side. Post 14 fractured at the top of the foundation tube, separated from the rail element, and was resting 36 inches toward the field side. Post 15 was leaning 38° toward the parapet and 69° toward the field side. Post 16 was leaning 67° toward the parapet and 88° toward the field side and displaced through the soil 0.38 inch toward the field side. Working width was greater than 20 ft, and the height of maximum working width was 3.5 ft. Maximum dynamic deflection during the test was 2.6 ft, and maximum permanent deformation was 1.8 ft.

**Figure 10.3. TxDOT Low-Speed Short Radius Guardrail Treatment after Test No. 469138-3-4.**

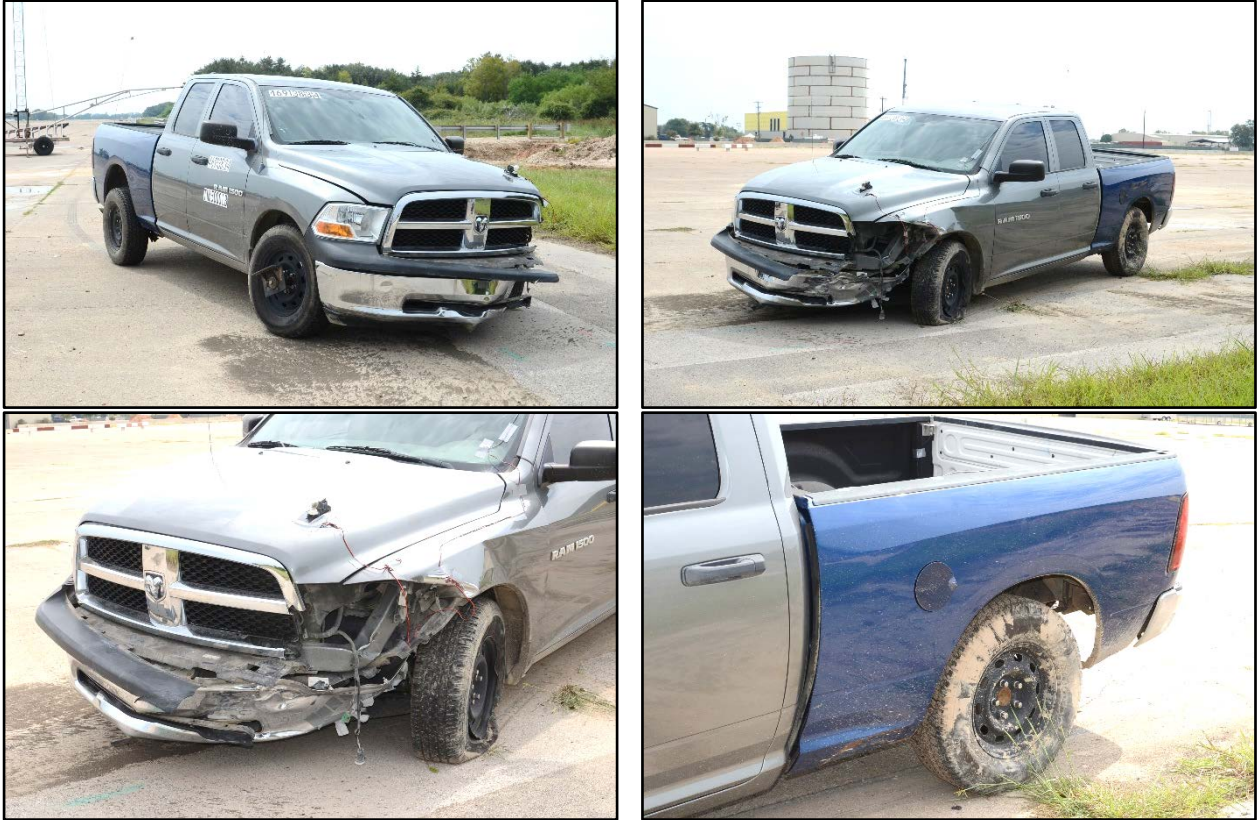
Figure 10.6 shows the damage the vehicle sustained. The front bumper, grill, radiator support, left front fender, and left tire and rim were damaged. Maximum exterior crush to the vehicle was 10.0 inches in the front plane at the left front corner at bumper height. No occupant compartment deformation or intrusion occurred. Figure 10.7 shows the interior of the vehicle. Tables G.3 and G.4 in Appendix G.1 provide exterior crush and occupant compartment measurements.

**Figure 10.6. Test Vehicle after Test No. 469138-3-4.**

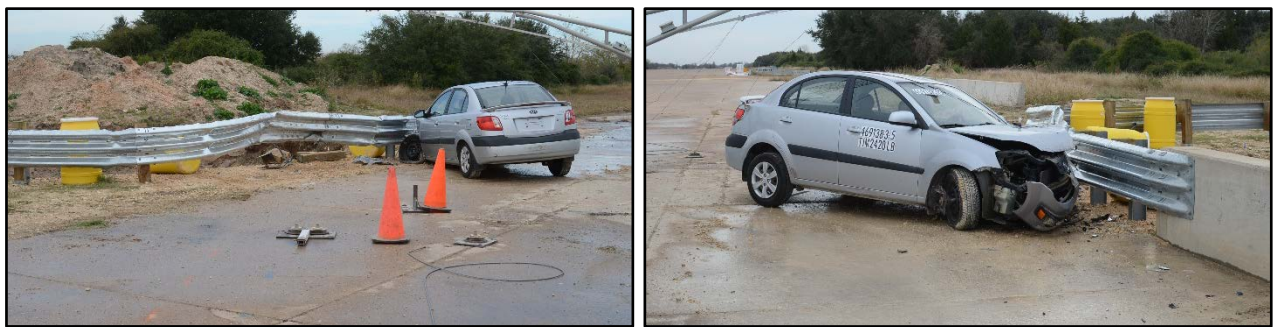
**Figure 11.3. TxDOT Low-Speed Short Radius Guardrail/Test Vehicle after Test No. 469138-3-5.**

Figure 11.3 shows the damage to the TxDOT low-speed short radius guardrail treatment. The soil around post 10 was disturbed, and post 11 was fractured near ground level and leaning 84° toward the field side. Posts 12–14 fractured at ground level and separated from the rail element. Posts 15 and 16 were pushed toward the field side 0.25 inch and 0.12 inch, respectively. Drums 1 and 2 were undisturbed, and drums 3 and 6 were overturned. Drums 4 and 5 were resting at the bottom of the slope. Working width was 5.8 ft at a height of 3.2 ft. Maximum dynamic deflection during the test was 5.0 ft, and maximum permanent deformation was 3.7 ft.

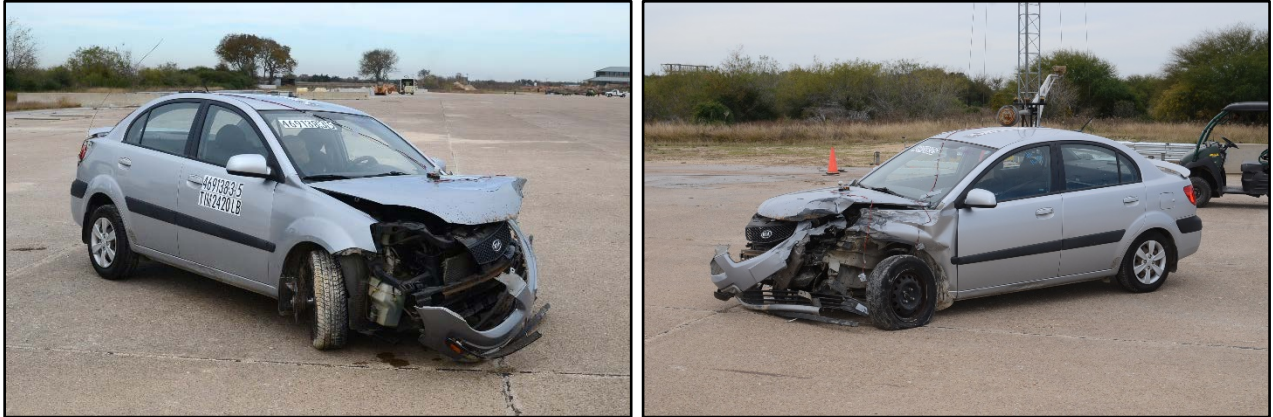
**Figure 11.7. Test Vehicle after Test No. 469138-3-5.**

Figure 11.4 shows the damage sustained by the vehicle. The front bumper, grill, radiator and support, hood, left and right front fender, left front tire and rim, and left front subframe were damaged. Maximum exterior crush to the vehicle was 26.0 inches in the front plane at the left front corner at bumper height. No occupant compartment deformation or intrusion was noted.

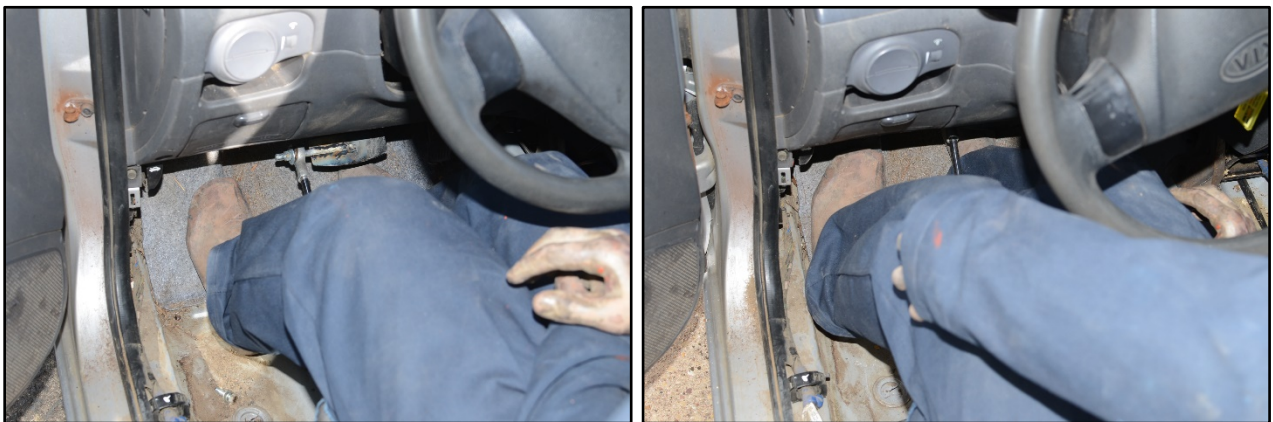
**Figure 11.8. Interior of Test Vehicle for Test No. 469138-3-5.**

Figure 11.5 shows the interior of the vehicle. Tables H.2 and H.3 in Appendix H1 provide exterior crush and occupant compartment measurements.
