# **MASH EVALUATION OF TxDOT ROADSIDE SAFETY FEATURES— PHASE III**

## **Test Report 0-6946-R3**

1. Report No. FHWA/TX-20/0-6946-R3		2. Government Accession No.		3. Recipient's Catalog No.	
4. Title and Subtitle <b>MASH EVALUATION OF TXDOT ROADSIDE SAFETY FEATURES—PHASE III</b>				5. Report Date <b>Published: May 2020</b>

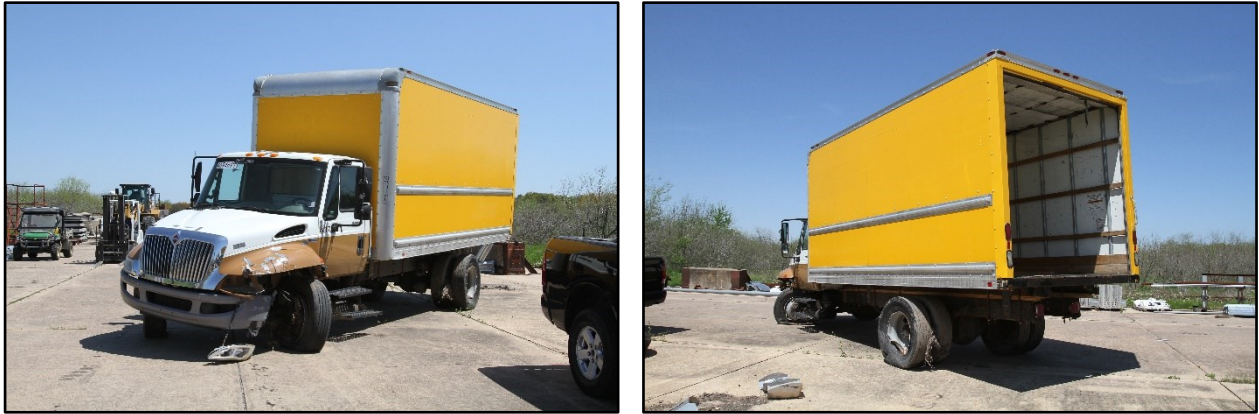
**Figure 2.6. Test Vehicle after Test No. 469469-1.**

Figure 2.6 and Figure 2.7 show the damage sustained by the vehicle. The front bumper, hood, left head light, left front tire and rim, left front spring and U-bolts, left side step, left corner of floor pan, left front corner of box, and left rear outer tire and rim were damaged. Maximum exterior crush to the vehicle was 14.0 inches in the front left corner. Maximum occupant compartment deformation was 5.5 inches in the front left corner of the floor pan. Table A.3 in Appendix A.3.1 provides details on the damage to the test vehicle.

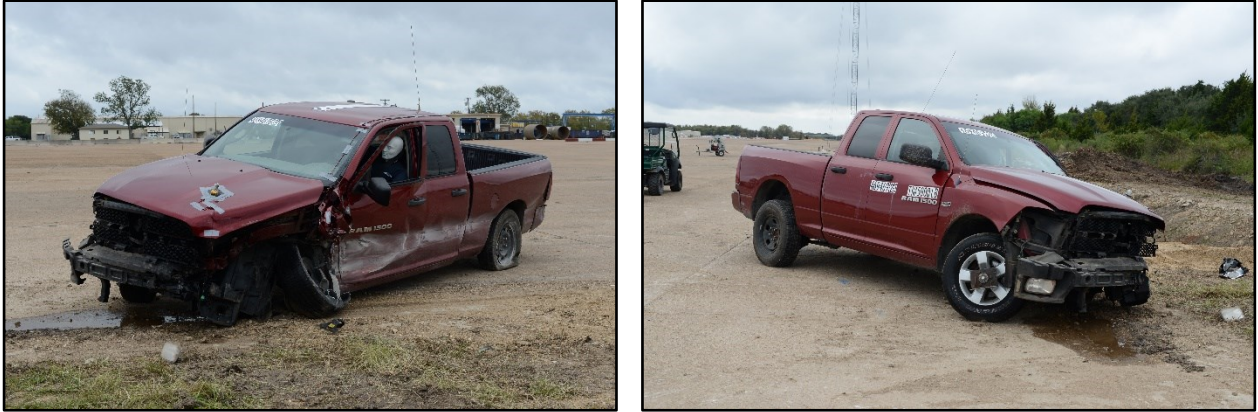
**Figure 3.6. Test Vehicle after Test No. 469469-2-1.**

Figure 3.6 and Figure 3.7 show the damage sustained by the vehicle. The front bumper, hood, radiator and support, left front fender, left front tire and rim, left frame rail, left upper and lower A-arms, left front floor pan and kick panel, left front door and glass and left rear door, left cab corner, left rear fender, and left rear tire and rim were damaged. Maximum exterior crush to the vehicle was 14.0 inches in the side plane at the left front corner at bumper height. Maximum occupant compartment deformation was 2.0 inches in the left side firewall area. Table B.3 and Table B.4 in Appendix B.3.1 provide the exterior crush and occupant compartment measurements of the vehicle.

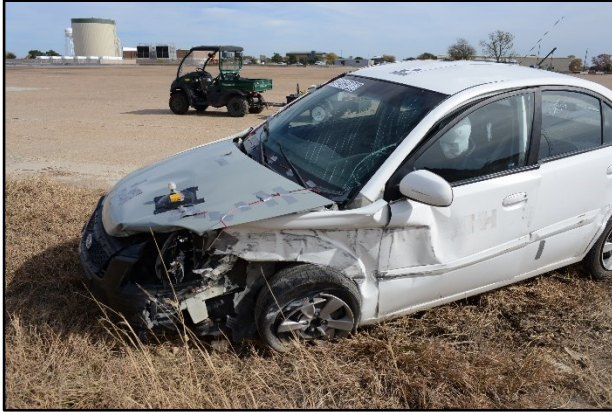
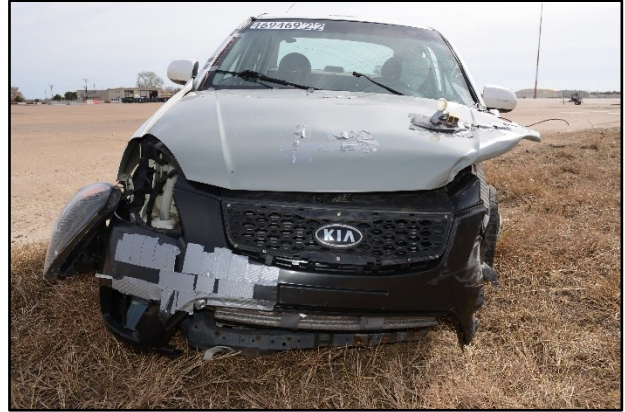
**Figure 3.12. Test Vehicle after Test No. 469469-2-2.**

Figure 3.12 and Figure 3.13 show the damage sustained by the vehicle. The front bumper, hood, radiator and support, left front head light, left front fender, left front strut and tower, left front tire and rim, left A post, windshield, left front floor pan, left front and rear door, left rear fender, rear bumper, and roof were damaged. Maximum exterior crush to the vehicle was 12.0 inches in the side plane at the left front corner above front bumper height. Maximum occupant compartment deformation was 2.0 inches for the interior height. Table B.6 and Table B.7 in Appendix B.4.1 provide exterior crush and occupant compartment measurements.

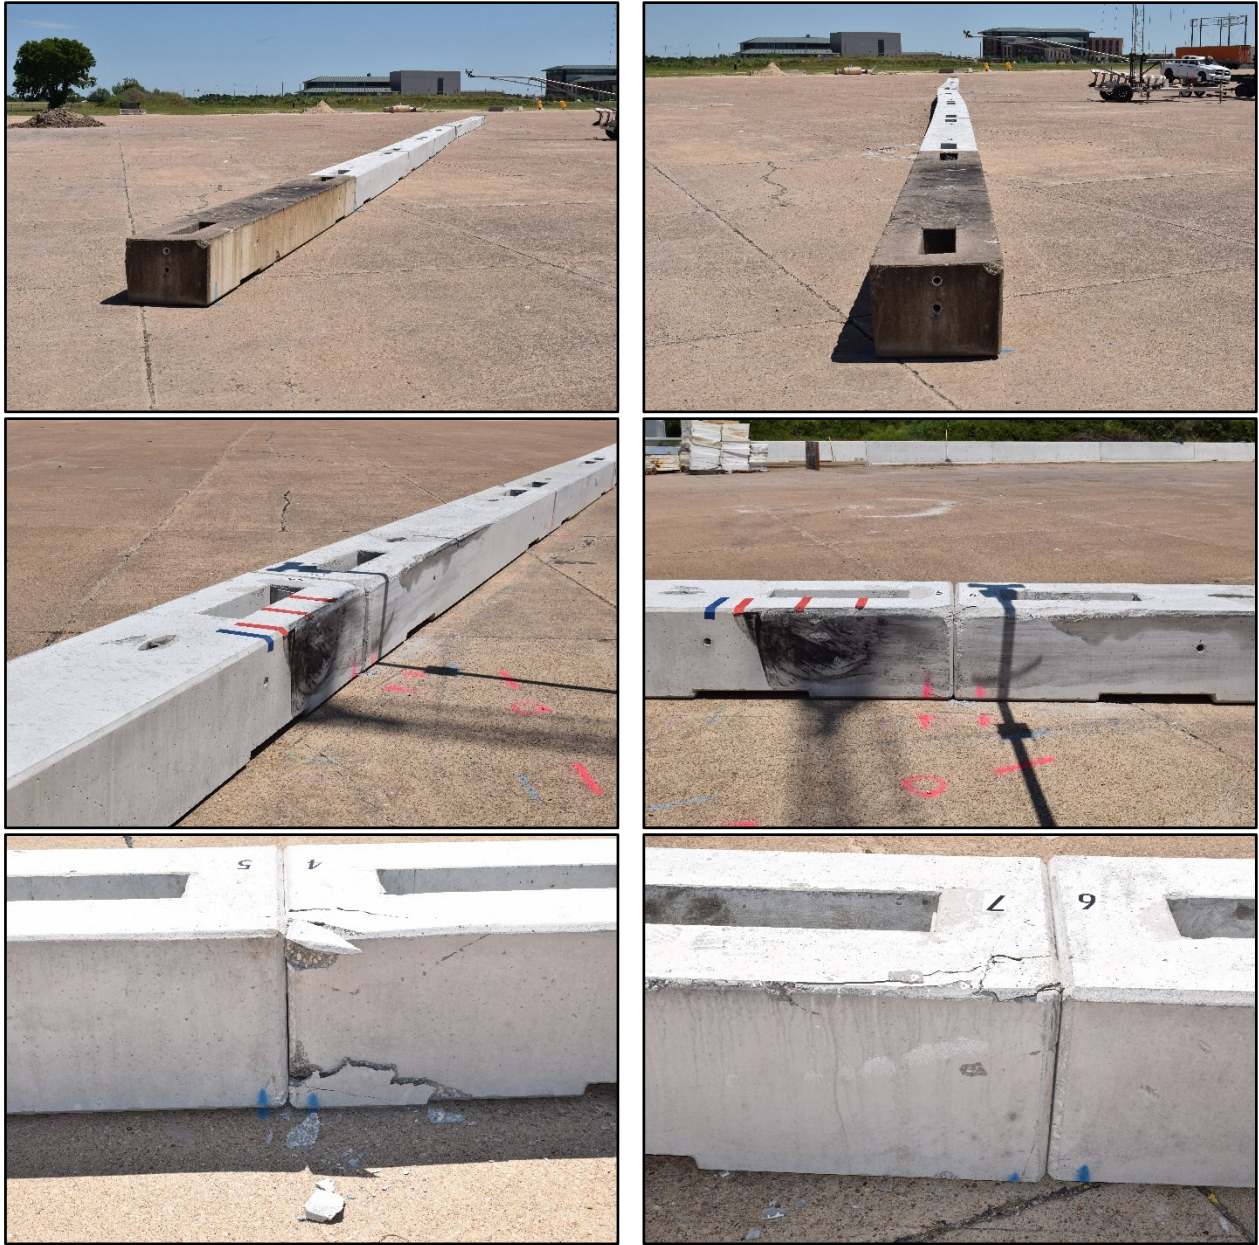
Figure 4.5. Low-Profile Barrier after Test No. 469469-3-2.

Figure 4.5 shows the damage to the low-profile barrier. The field side top corners were broken for a distance ranging from 10 to 18 inches on the downstream end of barrier segments 4, 5, and 7. There was minor cosmetic damage on the traffic side of barrier segments 5 and 6 near the joint. Table 4.2 shows the permanent field side displacement measured at the joints between segments.

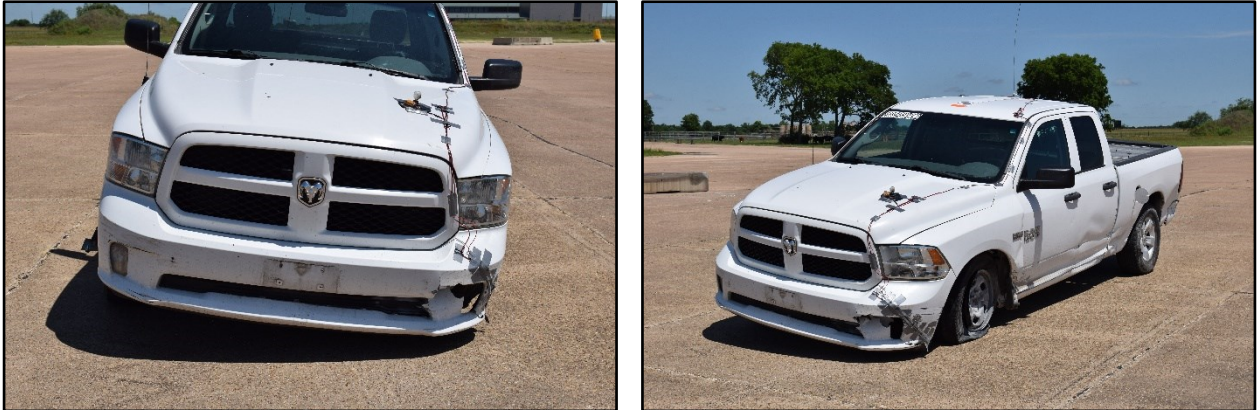
**Figure 4.6. Test Vehicle after Test No. 469469-3-2.**

Figure 4.6 and Figure 4.7 show the damage sustained by the vehicle. The front bumper, left front fender, left front tire and rim, left front door, left rear door, left rear door, left cab corner, left rear fender, left rear rim, and rear bumper were damaged. Maximum exterior crush to the vehicle was 2 inches in the side plane at the left front corner at bumper height. There was no observed occupant compartment deformation. Table C.3 and Table C.4 in Appendix C.3.1 provide exterior crush and occupant compartment measurements.

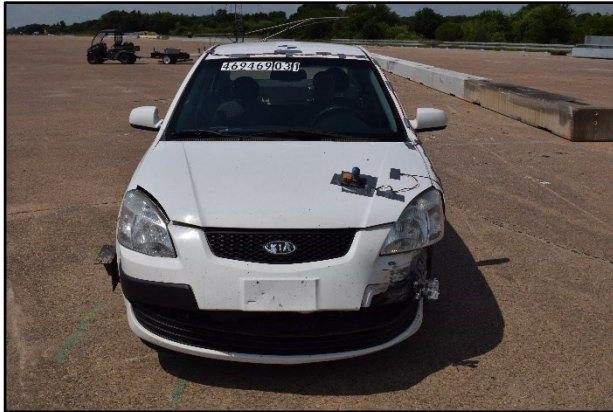
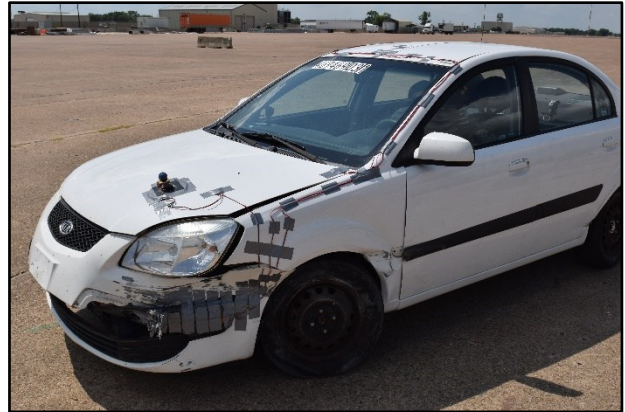
**Figure 4.12. Test Vehicle after Test No. 469469-3-1.**

Figure 4.12 and Figure 4.13 show the damage sustained by the vehicle. The front bumper, left front tire and rim, left rear door, left front fender, rear bumper, and left rear fender were damaged. Maximum exterior crush to the vehicle was 6 inches in the side plane at the left front corner at bumper height. There was no observed occupant compartment deformation. Table C.6 and Table C.7 in Appendix C.4.1 provide exterior crush and occupant compartment measurements.

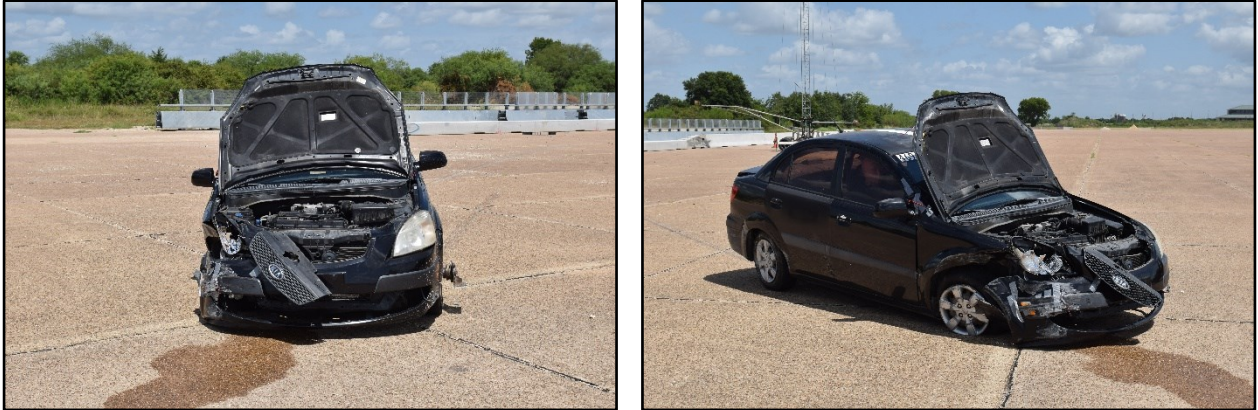
**Figure 5.6. Test Vehicle after Test No. 469469-4-1.**

Figure 5.6 and Figure 5.7 show the damage sustained by the vehicle. The front bumper, right front fender, right front tire and rim, right strut tower, right rear door, right head light, hood, right rear fender, right rear tire and rim, and rear bumper were damaged. Maximum exterior crush to the vehicle was 7 inches in the side plane at the right front corner at bumper height. There was no measurable occupant compartment deformation. Table D.2 and Table D.3 in Appendix D.3.1 provide exterior crush and occupant compartment measurements.

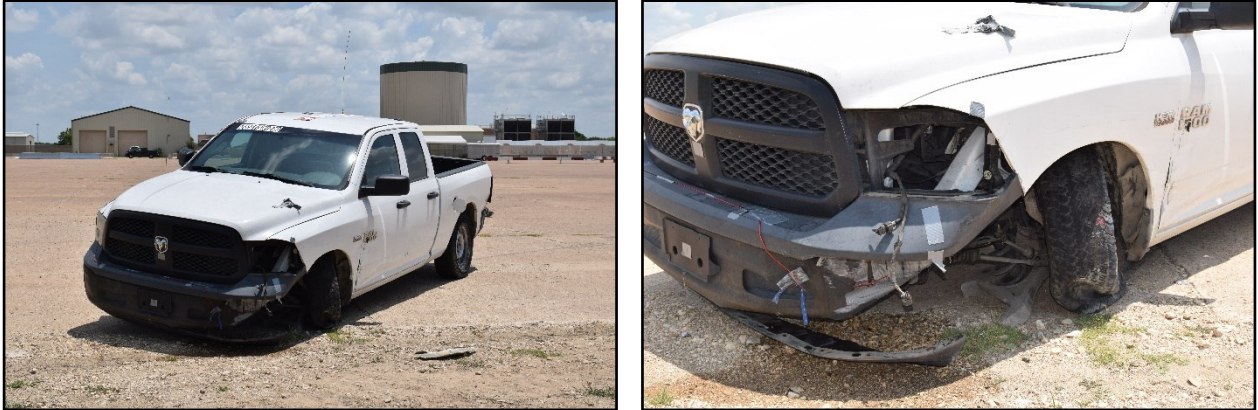
**Figure 5.12. Test Vehicle after Test No. 469469-4-2.**

Figure 5.12 and Figure 5.13 show the damage sustained by the vehicle. The front left bumper, left front tire and rim, left front door, left front fender, left headlight, and left front A-arm were damaged. Maximum exterior crush to the vehicle was 13 inches in the side plane at the left front corner at bumper height. There was no measurable occupant compartment deformation. Table D.6 and Table D.7 in Appendix D.4.1 provide exterior crush and occupant compartment measurements.

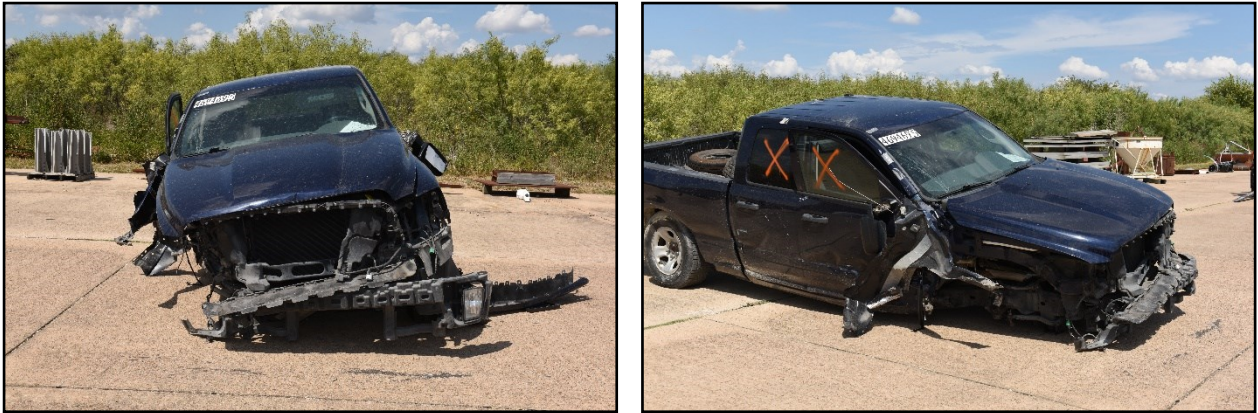
**Figure 6.6. Test Vehicle after Test No. 469469-5.**

Figure 6.6 and Figure 6.7 show the damage sustained by the vehicle. The front right bumper, hood, grill, radiator and supports, right front tire and rim, right front fender, right frame rail, right front upper and lower ball joints, right front upper and lower A-arms, front sway bar, right front door (8-inch gap at top), right front floor pan, right rear door, right cab corner, right rear fender, right rear rim, rear bumper, and right tail light were damaged. The windshield sustained stress cracks originating at the lower right and lower left corners. Maximum exterior crush to the vehicle was 10 inches at the front bumper at bumper height. The maximum occupant

compartment deformation was 4 inches at the lower right floor pan. Table E.5 and Table E.6 in Appendix E.3.1 provide exterior crush and occupant compartment measurements.

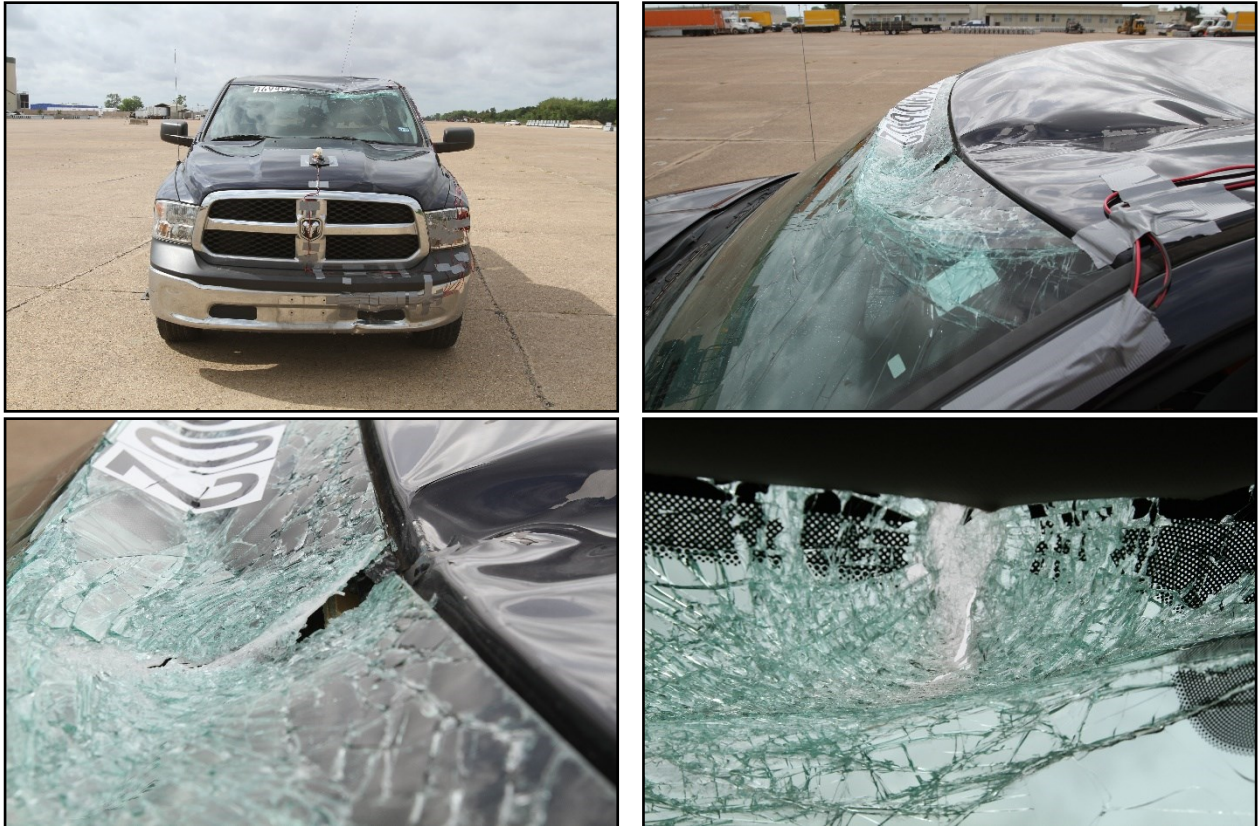
**Figure 7.6. Test Vehicle after Test No. 469469-06-02.**

Figure 7.6 and Figure 7.7 show the damage sustained by the vehicle. There was a 7-inch by 12-inch by 1-inch-deep dent in the front bumper, a 4-inch by 2.5-inch by 0.3-inch-deep dent in the hood, and a 33-inch by 48-inch by 3.3-inch-deep dent in the roof. The windshield had a 48-inch by 8-inch by 2.8-inch-deep area of damage, and there was a 4-inch-long tear in the windshield laminate. The maximum exterior crush of the vehicle was 1 inch. Maximum occupant compartment deformation was 3.5 inches at the center of the roof. Table F.3 and Table F.4 in Appendix F.2.1 provide exterior crush and occupant compartment measurements.

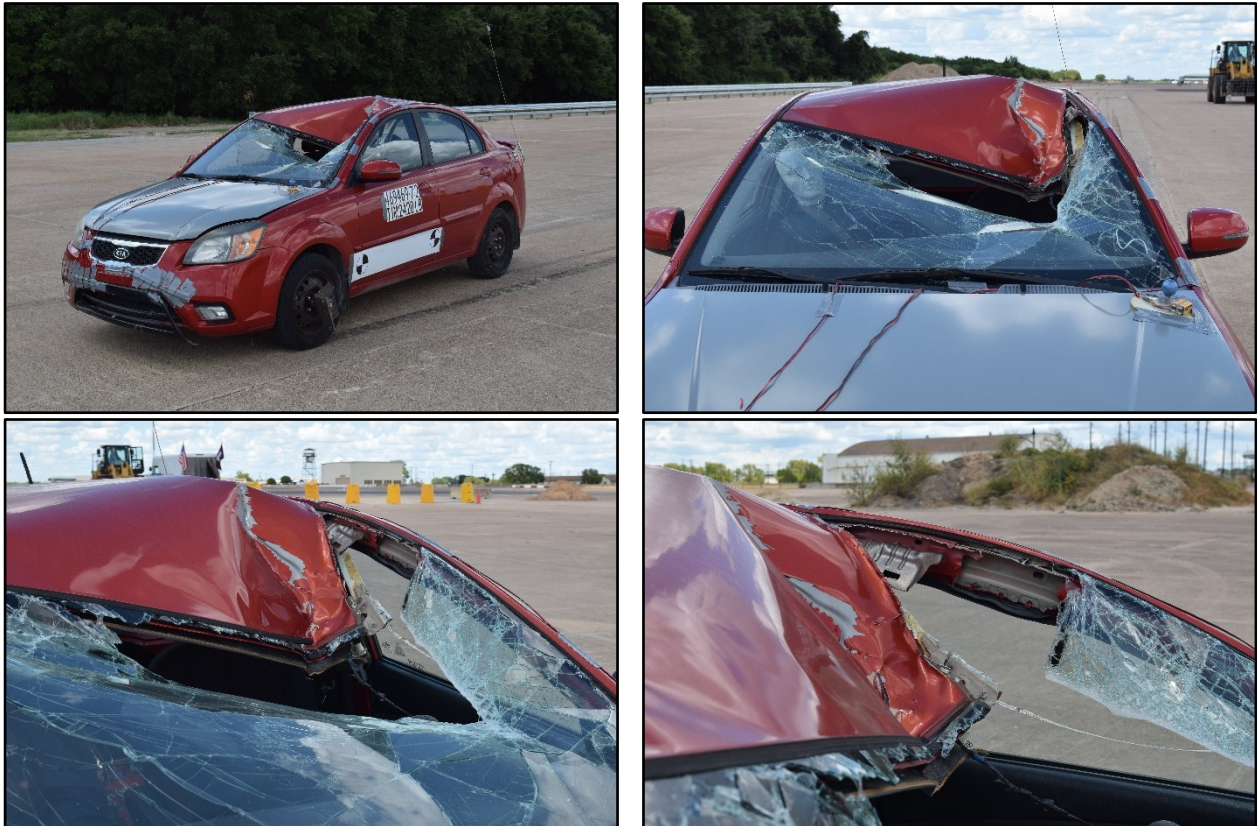
**Figure 8.6. Test Vehicle after Test No. 469469-07-02.**

Figure 8.6 and Figure 8.7 show the damage sustained by the vehicle. There was a dent 14 inches to the left of the vehicle centerline in the front bumper and hood. The windshield had a 44-inch by 31-inch by 13-inch-deep dent with a 6-inch by 24-inch cut in the laminate. The roof sustained a 41-inch by 27-inch by 12-inch-deep dent. There was also a 16-inch-long tear in the roof along the left seam line. There was no measurable exterior crush of the vehicle. The roof was pushed 11½ inches into the occupant compartment. Table G.4 and Table G.5 in Appendix G.1.2 provide exterior crush and occupant compartment measurements.

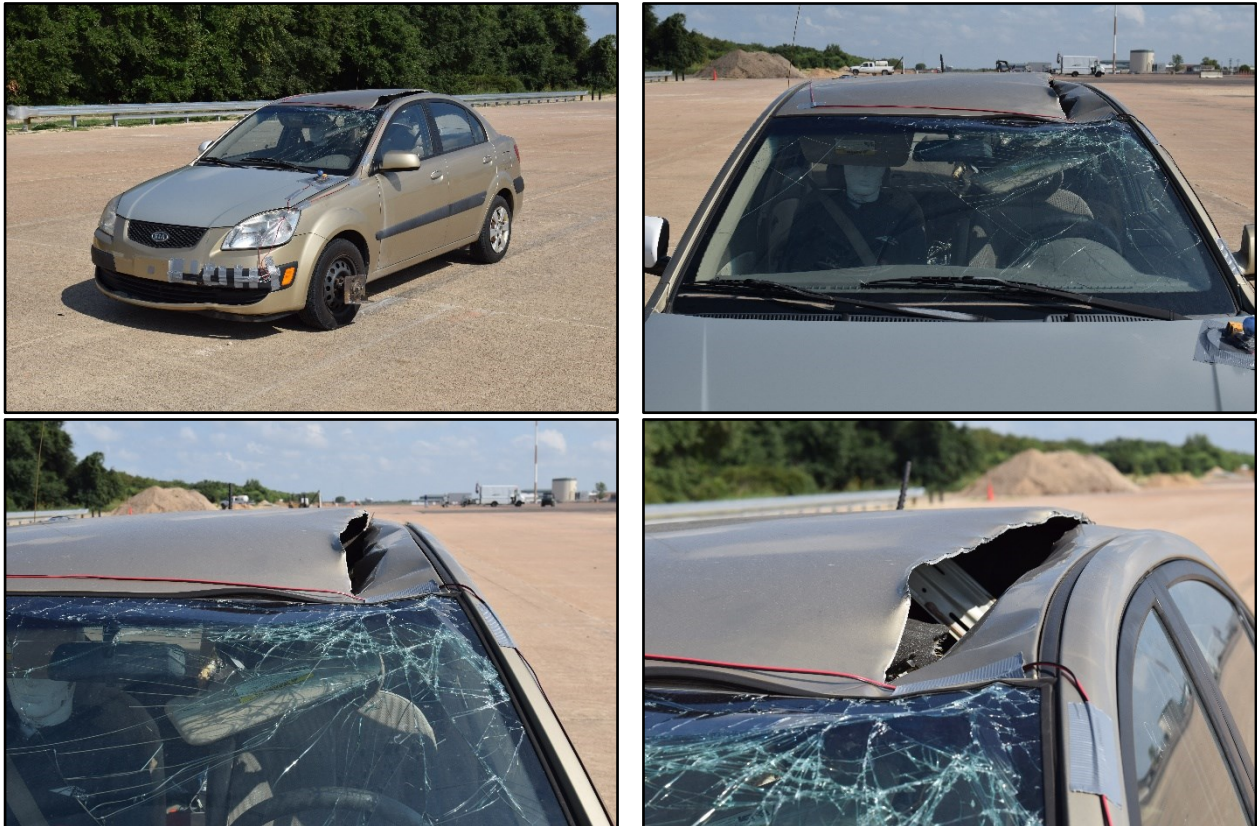
**Figure 8.14. Test Vehicle after Test No. 469469-07-05.**

Figure 8.14 and Figure 8.15 show the damage sustained by the vehicle. There was a dent located 14 inches to the left of the vehicle centerline in the front bumper and hood. The windshield was shattered in an area measuring 34 inches by 16 inches by 1 inch deep. The roof sustained a 4-inch-wide by 46½-inch-long cut. There was no measurable exterior crush of the vehicle. The deformation of the roof extended 11¼ inches into the occupant compartment. Table G.9 and Table G.10 in Appendix G.2.2 provide exterior crush and occupant compartment measurements.

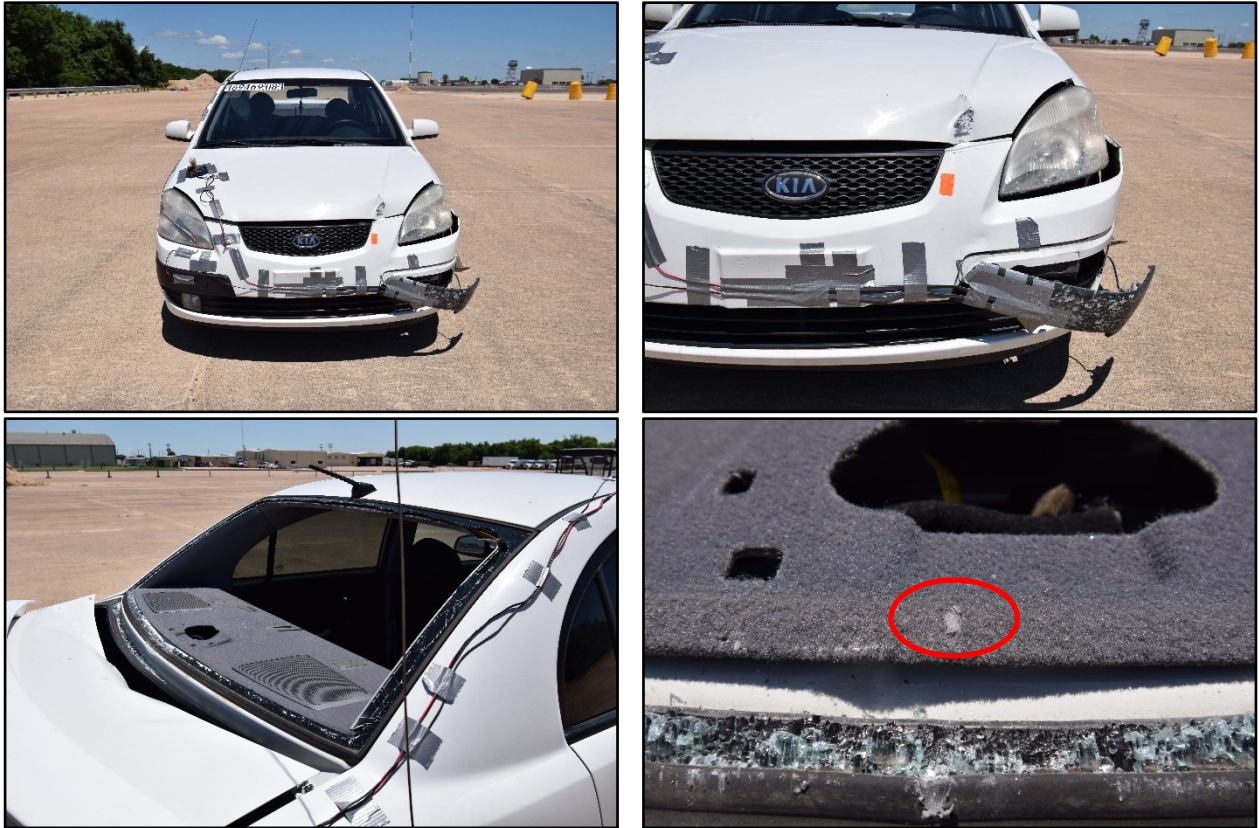
**Figure 9.6. Test Vehicle after Test No. 469469-08-01.**

Figure 9.6 and Figure 9.7 show the damage sustained by the vehicle. There was a 4-inch by 6-inch by 2.5-inch-deep dent in the front bumper and a 3-inch by 4-inch by 1-inch-deep dent in the hood, the trunk lid was dented, and the rear window was ejected. The maximum exterior crush of the vehicle was 2.5 inches at the front bumper. There was no measurable occupant compartment deformation. The package deck (shelf) under the rear window showed signs of penetration by the hardware that attached the sign to the support (Figure 9.6). Table H.2 and Table H.3 in Appendix H.3.1 provide exterior crush and occupant compartment measurements.

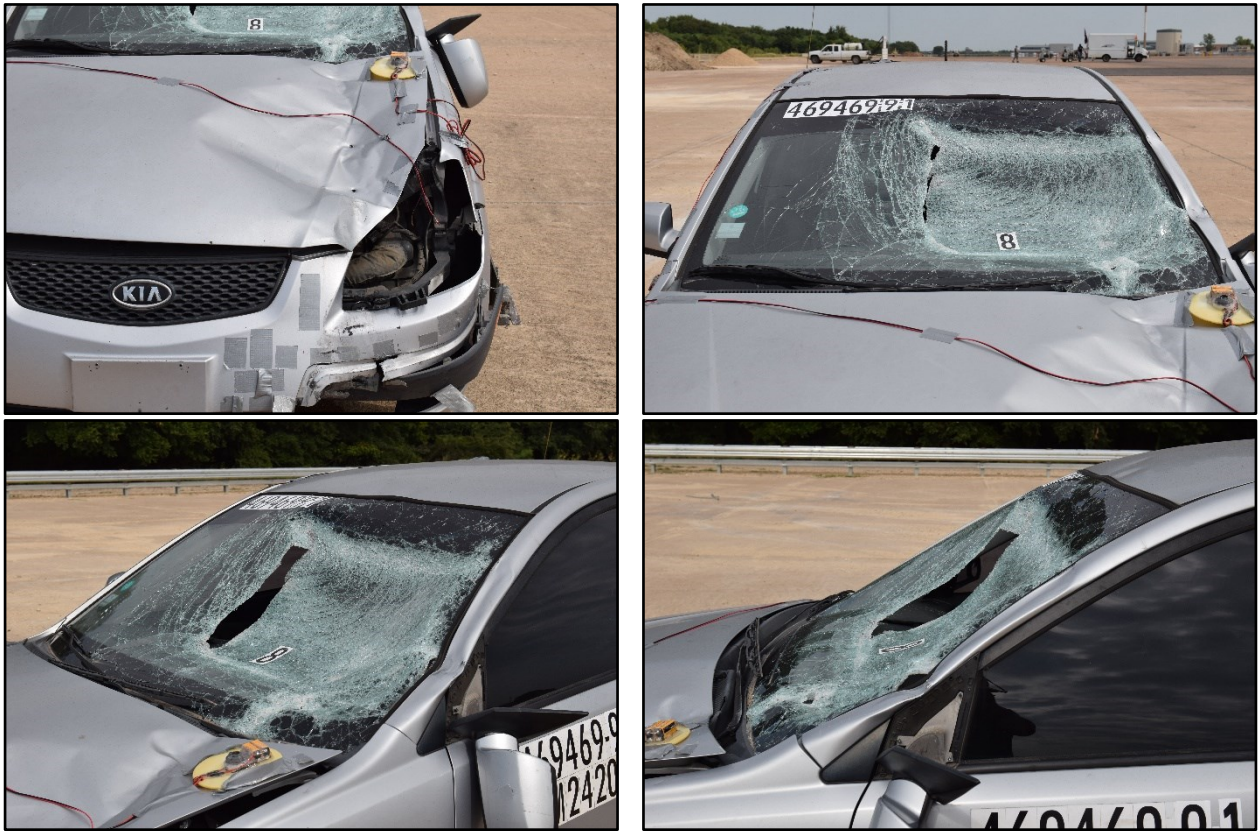
**Figure 10.6. Test Vehicle after Test No. 469469-09-01.**

Figure 10.6 and Figure 10.7 show the damage sustained by the vehicle. There was a dent in the front bumper and a 24-inch by 34-inch by 4.25-inch-deep dent in the hood including two 0.25-inch round holes that were 7 inches apart. The left headlight, left side mirror, left A-pillar, and radiator support were damaged. The windshield had a 37-inch by 32-inch by 6-inch-deep indentation and two cuts/tears in the laminate, one 16 inches long and one 3 inches long. There was no measurable exterior crush of the vehicle. The windshield deformed 6 inches into the occupant compartment and had a large cut in it as explained previously. Table I.2 and Table I.3 in Appendix I.2.1 provide exterior crush and occupant compartment measurements.

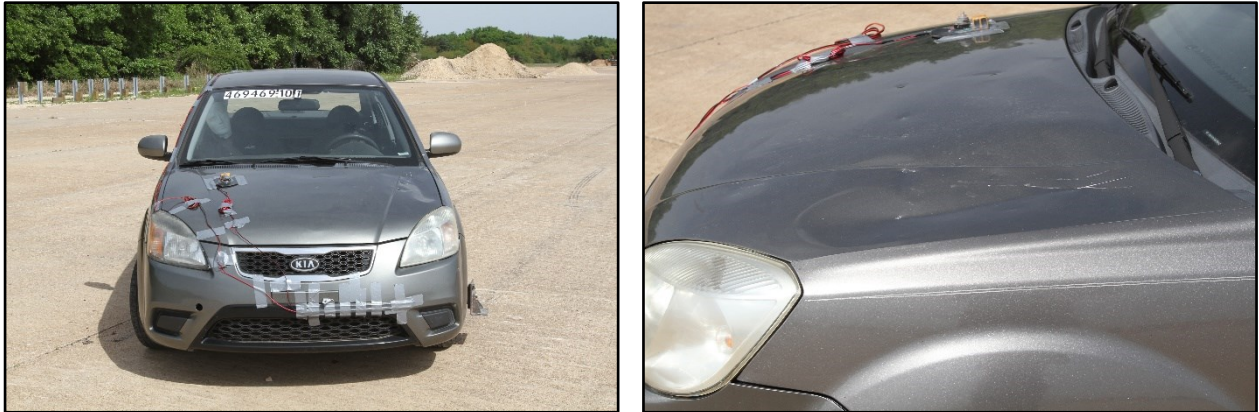
**Figure 11.7. Test Vehicle after Test No. 469469-10-1.**

Figure 11.7 and Figure 11.8 show the damage sustained by the vehicle. The hood of the vehicle suffered an 8-inch by 20-inch by  $\frac{3}{4}$ -inch-deep dent, and there were minor scuff marks on the bumper at the point of impact. There was neither measurable exterior crush nor interior deformation to the vehicle. Table J.2 and Table J.3 in Appendix J.1.2 provide further details.

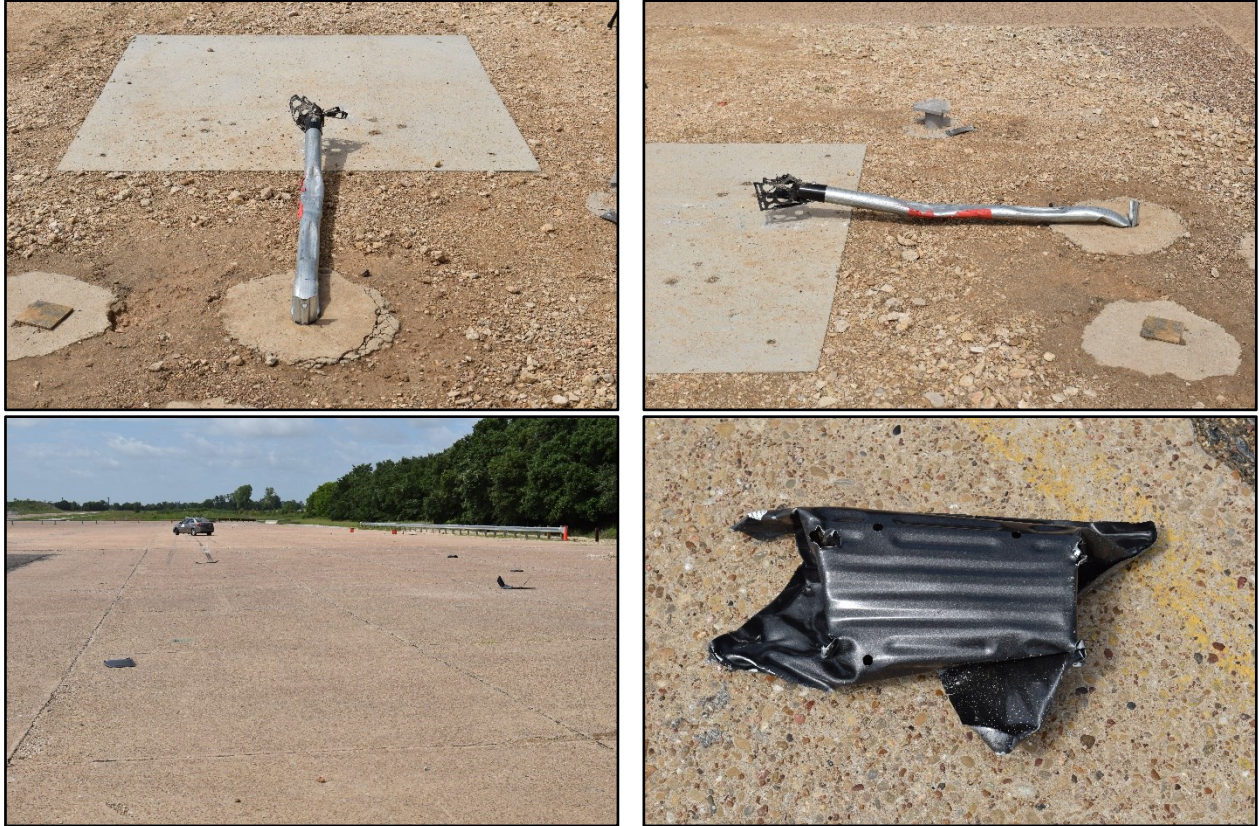
**Figure 11.14. Extra-Large Mailbox on Thin-Wall Galvanized Tube with Type 2 Foundation after Test No. 469469-10-2.**

Figure 11.14 shows the damage to the Centennial model mailbox on Type 2 foundation. The post pulled out of the socket 5 inches and then bent over flat against the soil/concrete. The mailbox was detached from the bracket and separated into four pieces that came to rest in an area ranging from 55 to 95 ft downstream of the point of impact and 5 ft left to 31 ft right of the travel path of the vehicle.

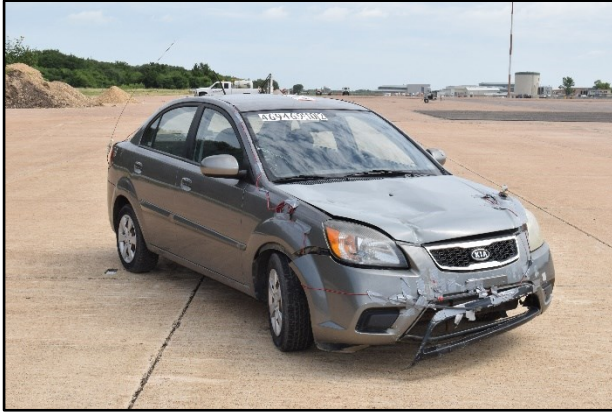
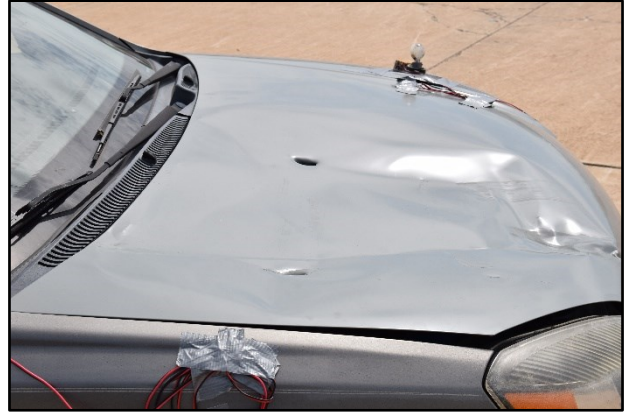
**Figure 11.15. Test Vehicle after Test No. 469469-10-2.**

Figure 11.15 and Figure 11.16 show the damage sustained by the vehicle. The right side of the bumper had a 3-inch dent, and the right side of the hood of the vehicle had a 29-inch by 31-inch by 1.3-inch-deep dent with 2.5-inch by 2-inch cuts. There was a small dent in the right A-pillar, and the bottom right of the windshield was fractured over an 8-inch by 8-inch area; however, there was no penetration of the windshield. There was a 3-inch dent in the bumper and no interior deformation to the vehicle. Table J.6 and Table J.7 in Appendix J.2.2 provide further details.

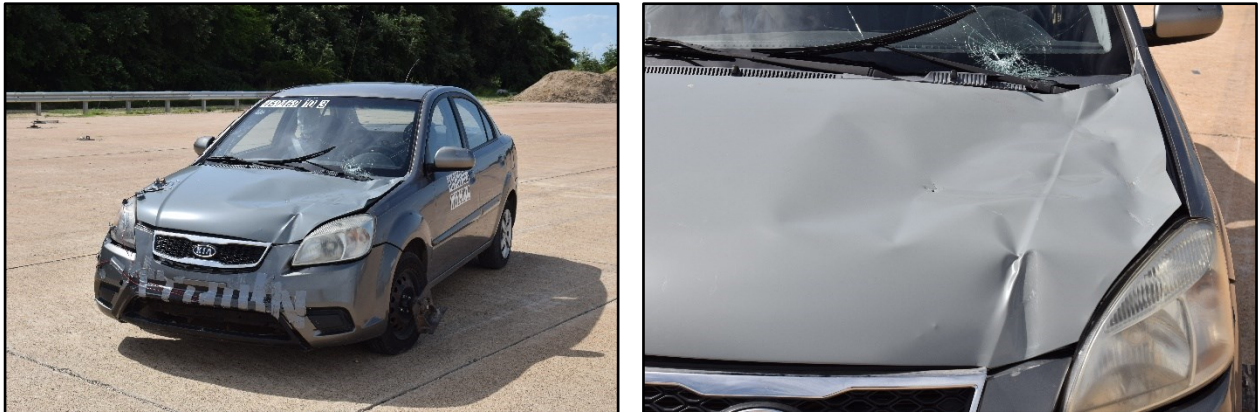
**Figure 11.23. Test Vehicle after Test No. 469469-10-3.**

Figure 11.23 and Figure 11.24 show the damage sustained by the vehicle. The front bumper sustained a 3-inch-deep dent, 14 inches from the centerline of the vehicle. The left side hood of the vehicle had a 26-inch by 33-inch by 1.5-inch-deep dent with a ¼-inch by ½-inch cut. The lower left area of the windshield was cracked over an area approximately 8 inches by 8 inches. There was no measurable exterior crush or interior deformation to the vehicle. Table J.10 and Table J.11 in Appendix J.3.2 provide further details.

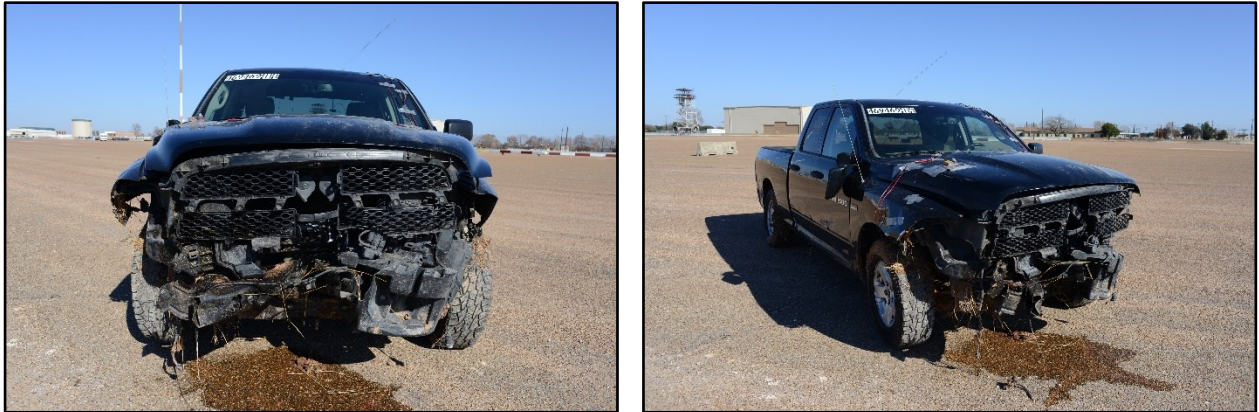
**Figure 12.6. Test Vehicle after Test No. 469469-11.**

Figure 12.6 and Figure 12.7 show the vehicle after the test. The front bumper, hood, grill, radiator and support, right and left front fender, right front and rear door, right and left head lights, right rear fender, and right rear tire and rim were damaged. Maximum exterior crush to the vehicle was 17.0 inches at the front bumper. There was no measurable occupant compartment deformation. Table K.5 and Table K.6 in Appendix K.3.1 provide exterior crush and occupant compartment measurements.

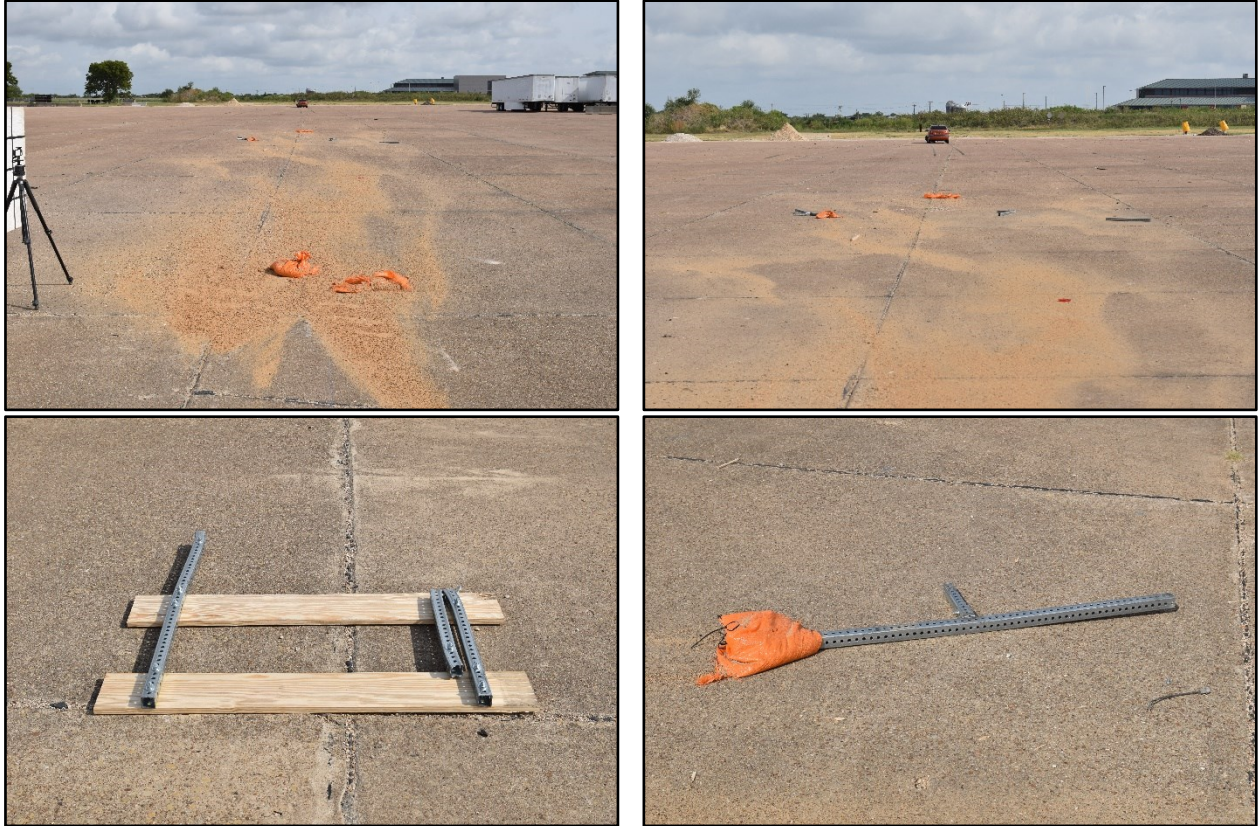
**Figure 13.5. Type III Barricade after Test No. 469469-12-01.**

Figure 13.5 shows the damage to the Type III barricade. Components of the barricade fractured into multiple pieces that were scattered 165 ft downstream, 13 ft to the right and 43 ft to the left of the original position. The largest section of debris consisting of two wood rails and the fractured uprights came to rest 142 ft downstream and 43 ft to the left of the original impact location.

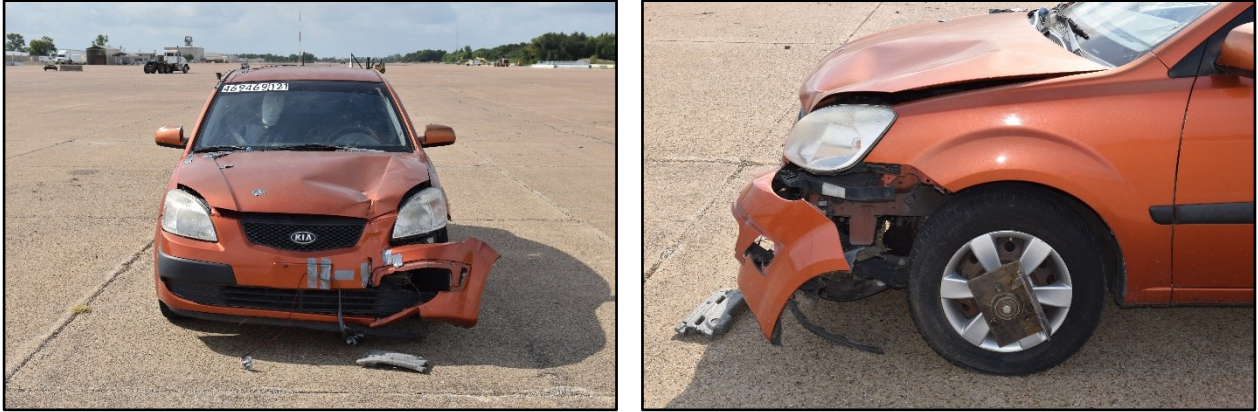
**Figure 13.6. Test Vehicle after Test No. 469469-12-01.**

Figure 13.6 and Figure 13.7 show the damage sustained by the vehicle. There was a 4-inch by 8-inch by 1.75-inch-deep dent in the front bumper and hood edge, and a 24-inch by 24-inch by 2.5-inch-deep dent in the top left side of the hood. There was no measurable occupant compartment deformation. Table L.2 and Table L.3 in Appendix L.2.1 provide exterior crush and occupant compartment measurements.

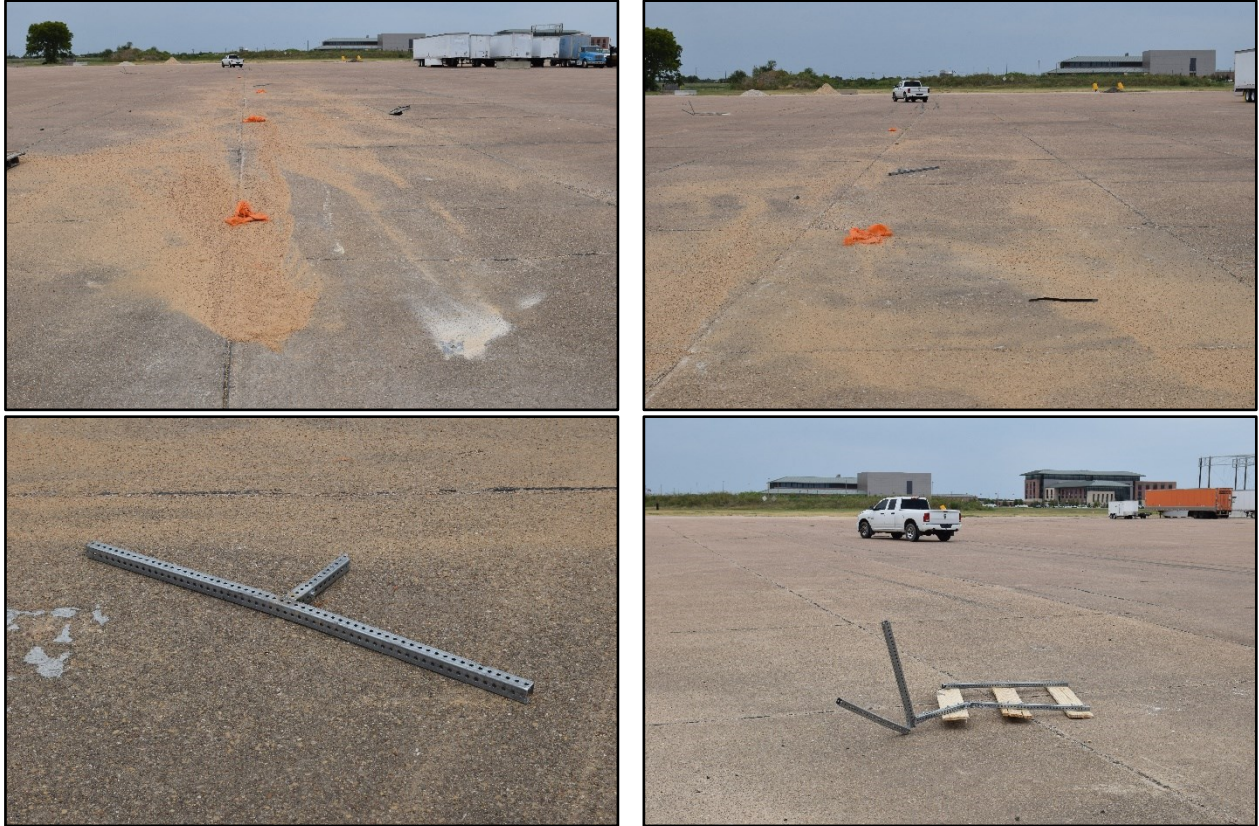
**Figure 13.11. Type III Barricade after Test No. 469469-12-02.**

Figure 13.11 shows the damage to the Type III barricade. The barricade separated into two pieces. One of the uprights fractured approximately 15 inches above grade. The lower portion of this upright and the attached skid came to rest 218 ft downstream and 40 ft to the left of the impact point. The remaining portion of the fracture upright, the other upright and skid, and the three rails remained together and came to rest 105 ft downstream of the impact point.

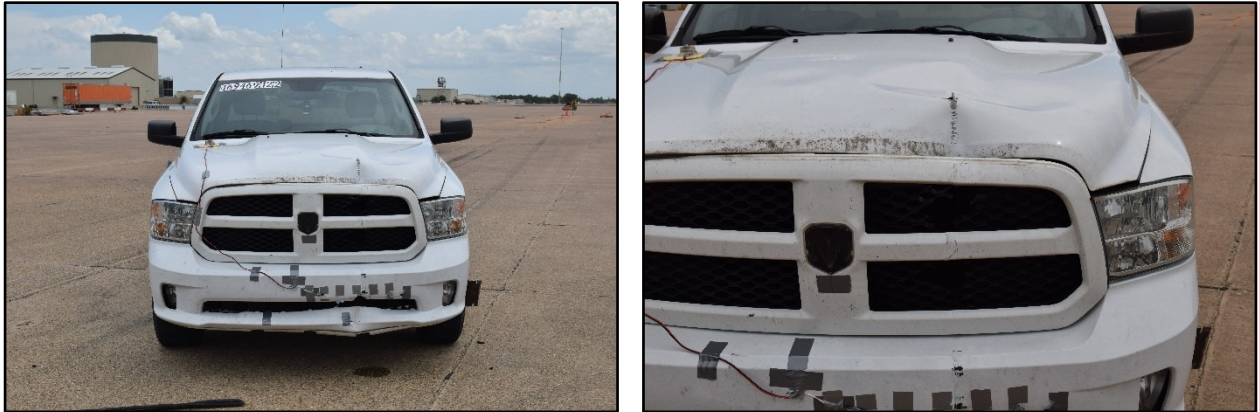
**Figure 13.12. Test Vehicle after Test No. 469469-12-02.**

Figure 13.12 and Figure 13.13 show the damage sustained by the vehicle. There was an 8-inch by 8-inch dent in the hood, including a 1-inch hole located 1 ft to the left of the centerline of the hood at the front. The front bumper and grill also sustained damage. There was no measurable occupant compartment deformation. Table L.6 and Table L.7 in Appendix L.3.1 provide exterior crush and occupant compartment measurements.

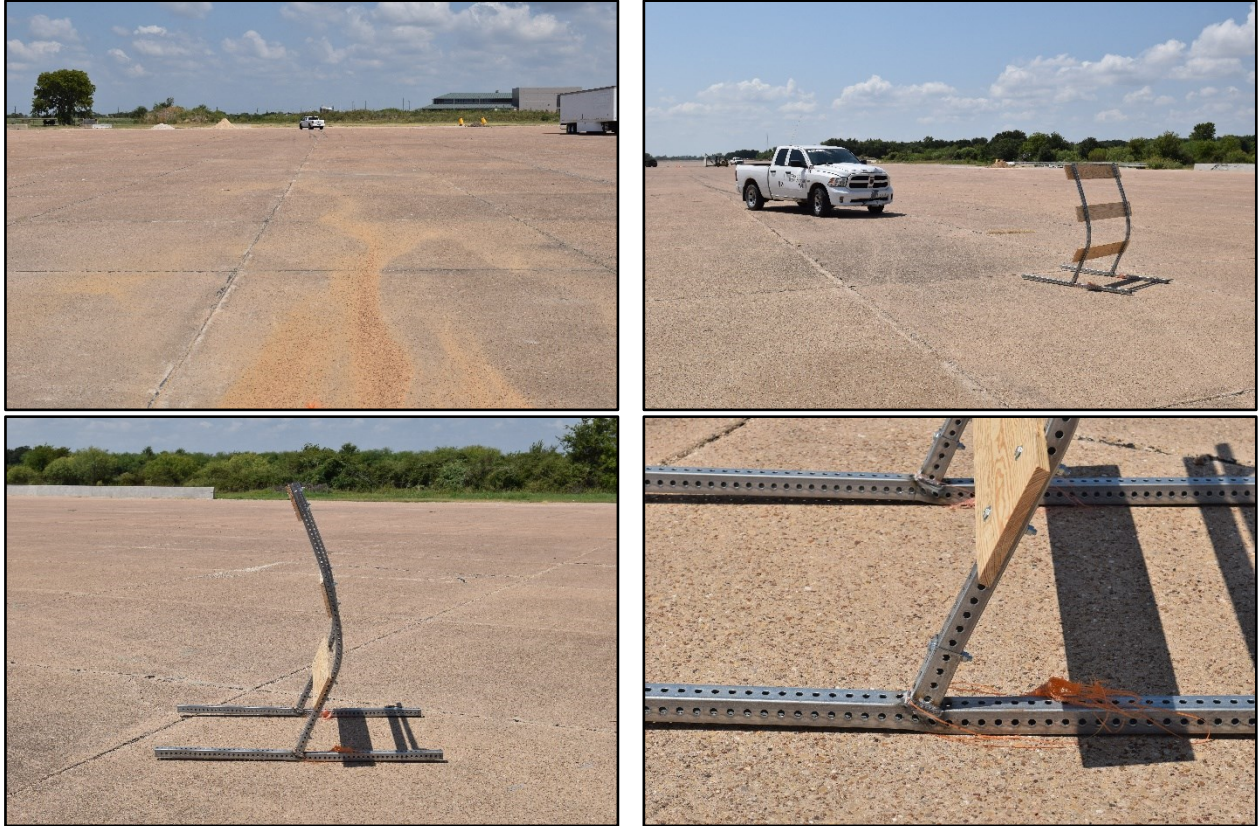
**Figure 13.17. Type III Barricade after Test No. 469469-12-03.**

Figure 13.17 shows the damage to the Type III barricade. The barricade remained mostly intact and came to rest 462 ft downstream and 14 ft to the left of the impact location. The welds were cracked at the base, and the supports were bent at 18 inches up from the base.

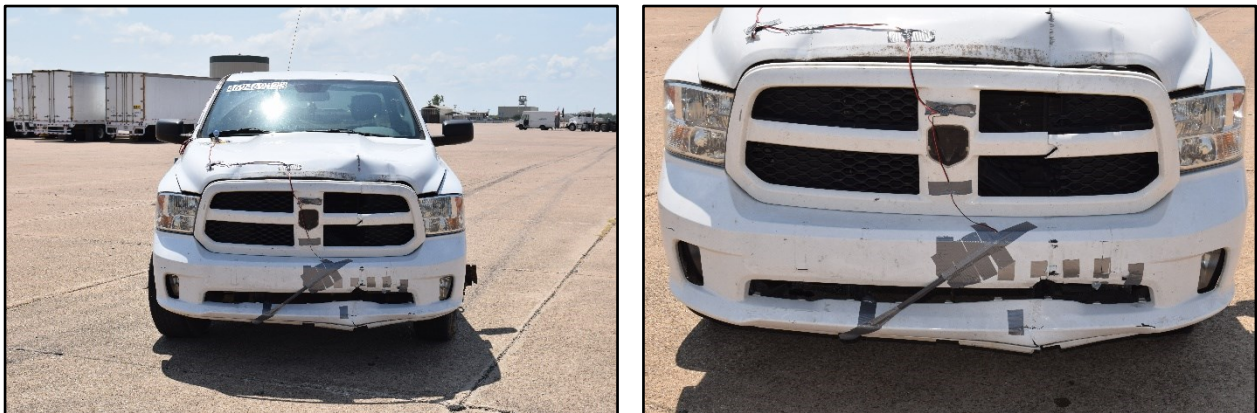
**Figure 13.18. Test Vehicle after Test No. 469469-12-03.**

Figure 13.18 and Figure 13.19 show the damage sustained by the vehicle. There were scuffs marks on the bumper and grill. There was neither measurable exterior crush on the vehicle nor occupant compartment deformation. Table L.10 and Table L.11 in Appendix L.4.1 provide exterior crush and occupant compartment measurements.
