# **MASH EVALUATION OF TxDOT ROADSIDE SAFETY FEATURES— PHASE III**

## **Test Report 0-6946-R3**

1. Report No. FHWA/TX-20/0-6946-R3		2. Government Accession No.		3. Recipient's Catalog No.	
4. Title and Subtitle <b>MASH EVALUATION OF TXDOT ROADSIDE SAFETY FEATURES—PHASE III</b>				5. Report Date <b>Published: May 2020</b>

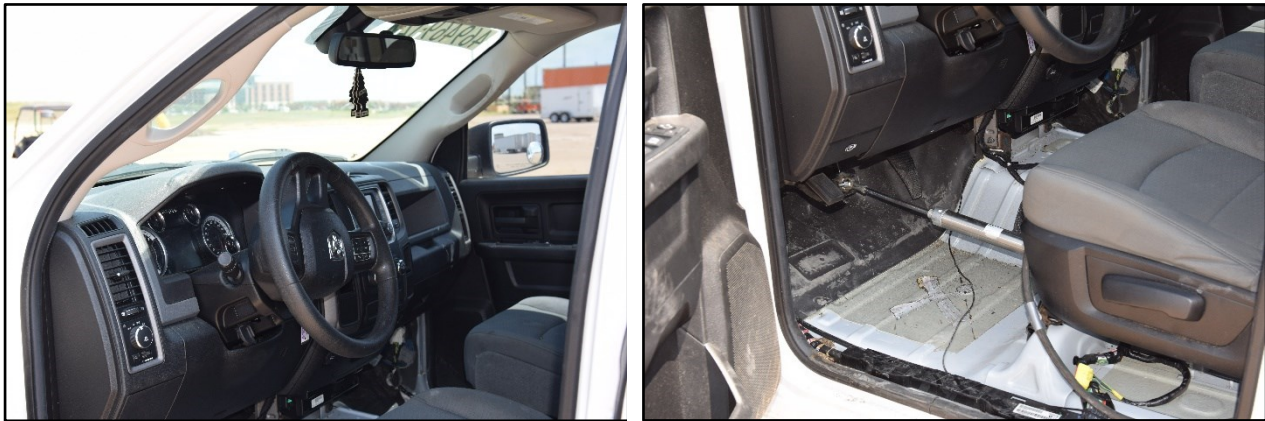
**Figure 13.19. Interior of Test Vehicle after Test No. 469469-12-03.**

Figure 13.18 and Figure 13.19 show the damage sustained by the vehicle. There were scuffs marks on the bumper and grill. There was neither measurable exterior crush on the vehicle nor occupant compartment deformation. Table L.10 and Table L.11 in Appendix L.4.1 provide exterior crush and occupant compartment measurements.

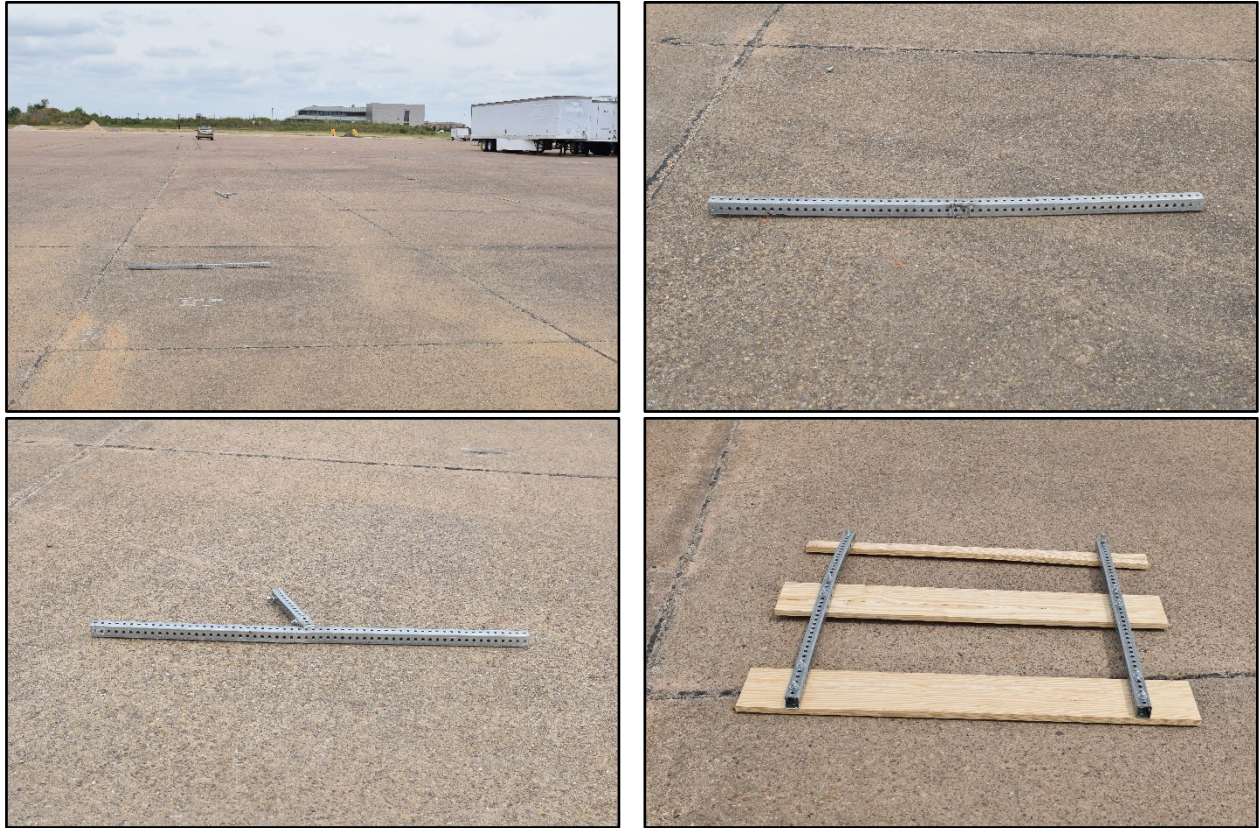
**Figure 13.23. Type III Barricade after Test No. 469469-12-04.**

Figure 13.23 shows the damage to the Type III barricade. The assembly separated into multiple pieces and came to rest in an area 105 to 262 ft downstream of the impact location and 24 ft right to 15 ft left of the impact path.

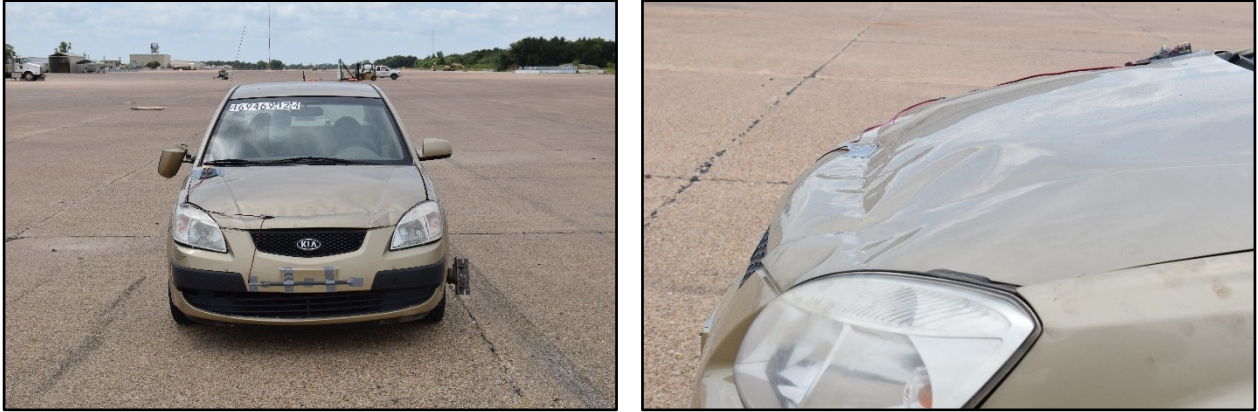
**Figure 13.24. Test Vehicle after Test No. 469469-12-04.**

Figure 13.24 and Figure 13.25 show the damage sustained by the vehicle. There was a 42-inch by 8-inch by 1.25-inch-deep dent along the front of the hood, and additional damage was sustained by the right head light. There was no measurable occupant compartment deformation. Table L.13 and Table L.14 in Appendix L.5.1 provide exterior crush and occupant compartment measurements.

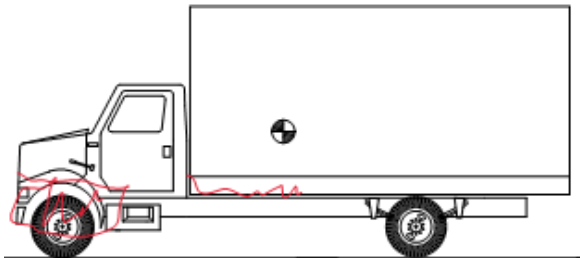
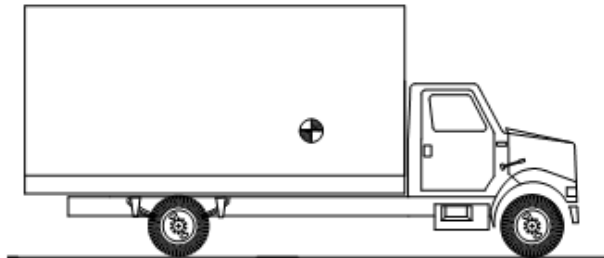
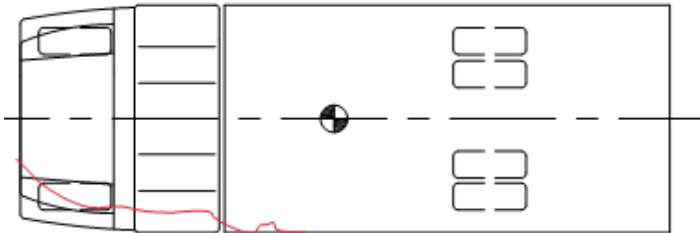
FT BUMPER
HOOD
LT HEAD LIGHT
LT FT TIRE & RIM
LT FT SPRING & U-BOLTS
LT SIDE STEP
LT FT CORNER OF FLOOR PAN
LT FT CORNER OF BOX
LT REAR OUTER TIRE & RIM

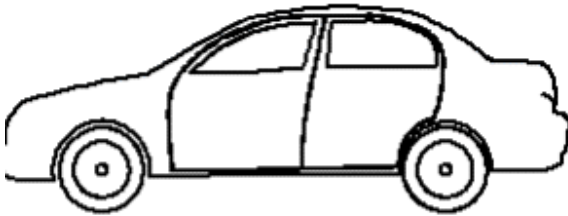
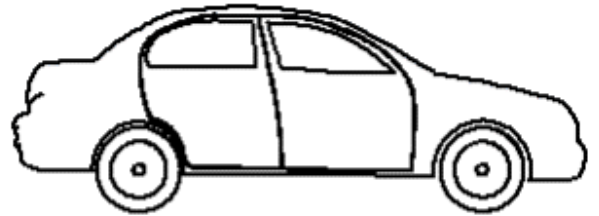
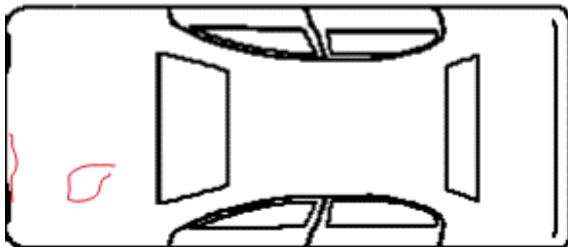
SKUFF MARKS ON FT BUMPER LT OF CL
HOOD 8" X 20" DENT .75" DEEP LT SIDE OF CL

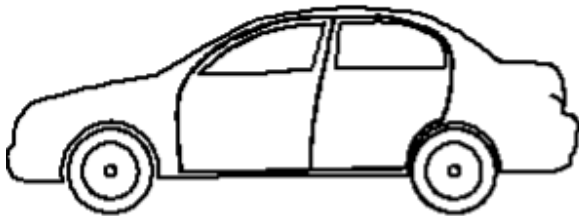
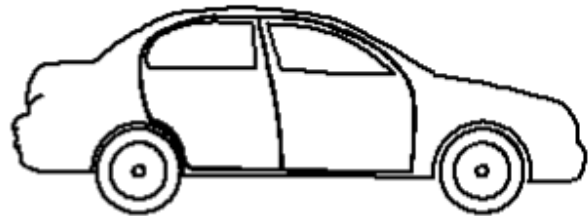
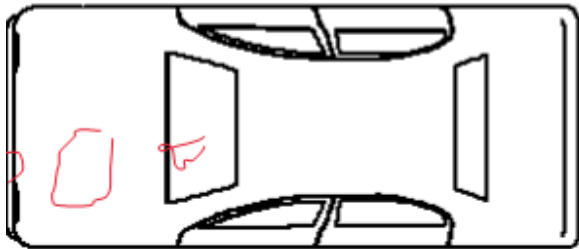
3" DEEP DENT IN FT BUMPER 14" TO LT OF CL
CL
26" X 33" DENT IN LT SIDE OF HOOD 1.5" DEEP WITH ONE .25" X .5 CUT
8" X 8" BREAK IN WINDSHIELD
