# DEVELOPMENT OF MODIFIED TxDOT SINGLE-POST SKID-MOUNTED SIGN SUPPORT

## Test Report 0-6968-R3

TEXAS A&M TRANSPORTATION INSTITUTE  
COLLEGE STATION, TEXAS

1. Report No. FHWA/TX-21/0-6968-R3		2. Government Accession No.		3. Recipient's Catalog No.	
4. Title and Subtitle DEVELOPMENT OF MODIFIED TxDOT SINGLE-POST SKID-MOUNTED SIGN SUPPORT				5. Report Date Published: June 2021

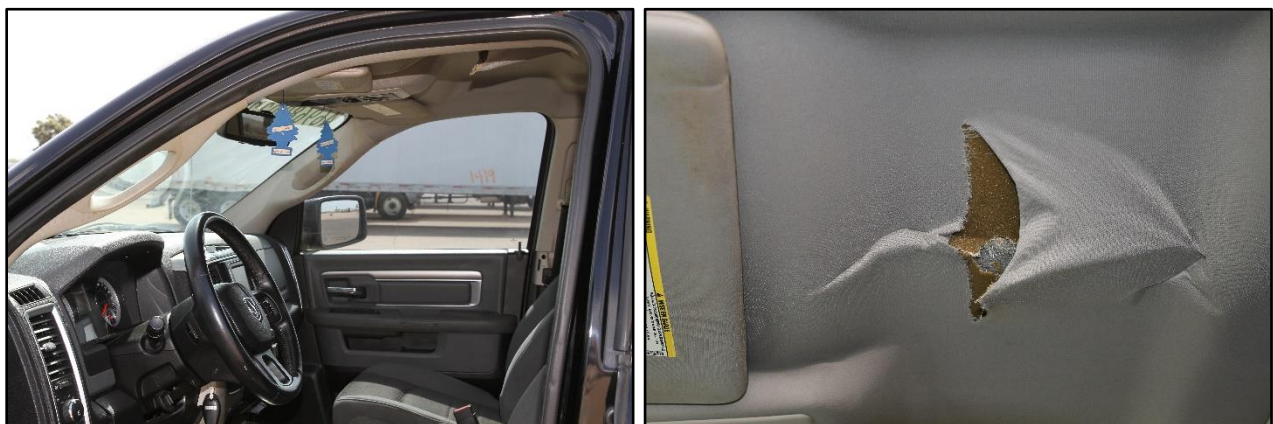
Figure 4.7. Interior of Test Vehicle after Test No. 469680-03-2.

During Crash Test No. 469680-03-2, the sign panel contacted the roof of the 2270P vehicle, sliced a 22-inch-long hole in the roof, and penetrated the occupant compartment over the driver’s seat. Film analysis indicated that while the tether cable prevented the fractured segments of the support post from separating, the amount of slack in the cable delayed its effectiveness in influencing the trajectory of the connected segments. A decision was made to reduce the length of the tether cable and remove the excess slack to more quickly engage the hinge mechanism provided between the two fracture segments of the support post. *MASH* Test 3-72 at 90 degrees was repeated on the redesigned single skid-mounted sign support, as described in the next chapter.

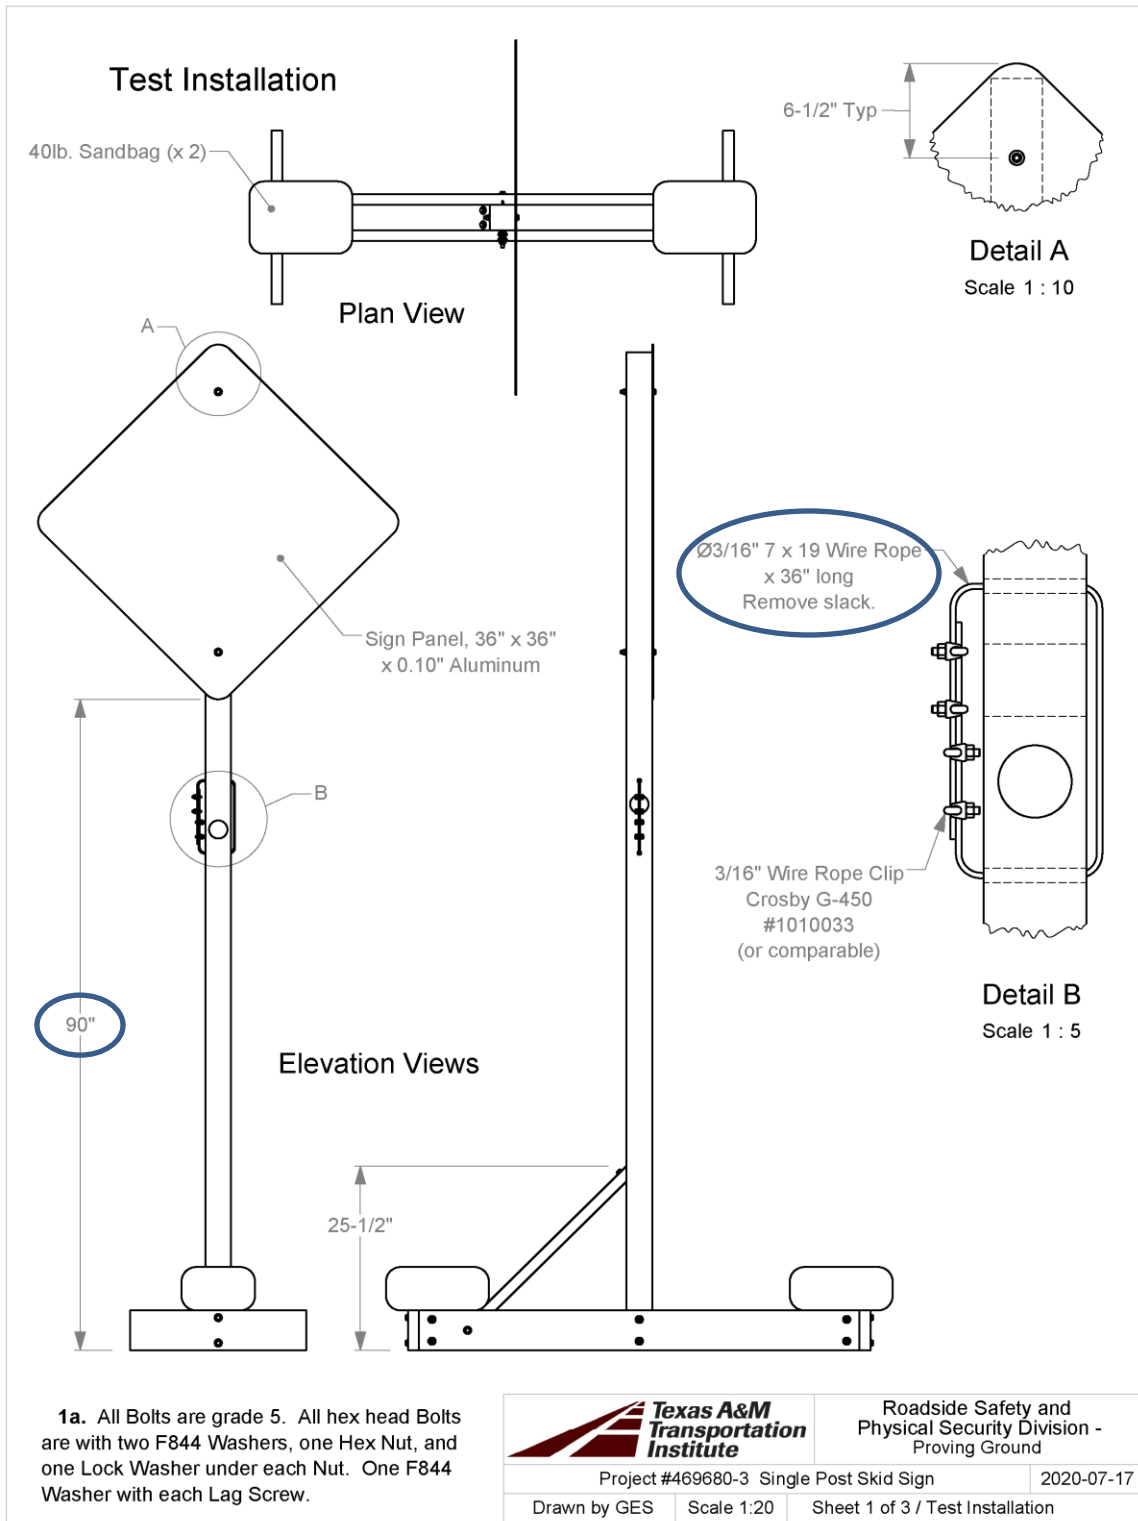
**Figure 6.1. Modified TxDOT Single Skid-Mounted Sign Support Details (Final Modification) for Crash Test Nos. 469680-03-2B, 469680-03-4, 469680-03-1, and 469680-03-3.**

The design of the single skid-mounted sign support remained the same as described in Section 5.1 with the following changes. The sign mounting height was increased by 6 inches, from 84 inches to 90 inches. The length of the vertical wood support post was correspondingly increased by 6 inches. Additionally, the height of the weakening holes in the wood support post was increased by 6 inches. The length of the tether cable remained at 36 inches with slack removed, as in Crash Test No. 469680-03-2A. Figure 6.1 presents overall details of the modified TxDOT single skid-mounted sign support, and Figure 6.2 provides photographs of the test installation. Appendix A provides further details of the final revisions on the modified TxDOT single skid-mounted sign support.

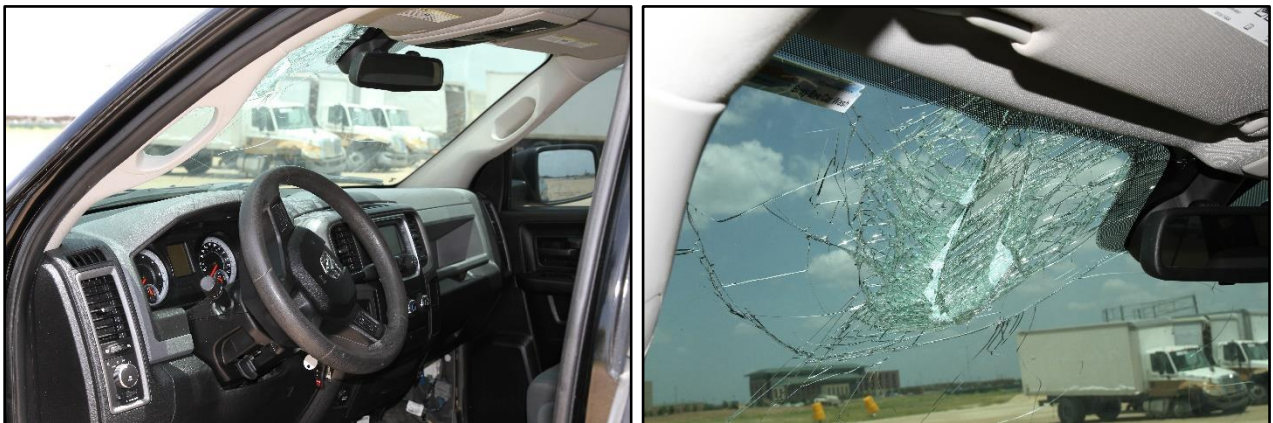
**Figure 6.7. Interior of Test Vehicle after Test No. 469680-03-2B.**

Figure 6.6 shows the damage sustained by the vehicle. The front bumper sustained a 4-inch  $\times$  5-inch  $\times$  0.25-inch deformation 13 inches to the left of the centerline of the vehicle. There was also a 4-inch  $\times$  3-inch  $\times$  0.5-inch deformation at the front edge of the hood 13 inches to the left of the centerline of the vehicle. The windshield was shattered over an area of 12 inches  $\times$  14 inches  $\times$  1 inch near the top center at the roofline; however, there was no tear or cut in the windshield laminate. There was an 8-inch  $\times$  6-inch  $\times$  0.75-inch deformation in the roof 13 inches to the left of the centerline with no tear or cut. No fuel tank damage was observed. Maximum exterior crush to the vehicle was 1.0 inch in the windshield. Maximum occupant compartment deformation was 1.0 inch in the windshield area. Figure 6.7 shows the interior of the vehicle. Tables D.3 and D.4 in Appendix D.1 provide exterior crush and occupant compartment measurements.

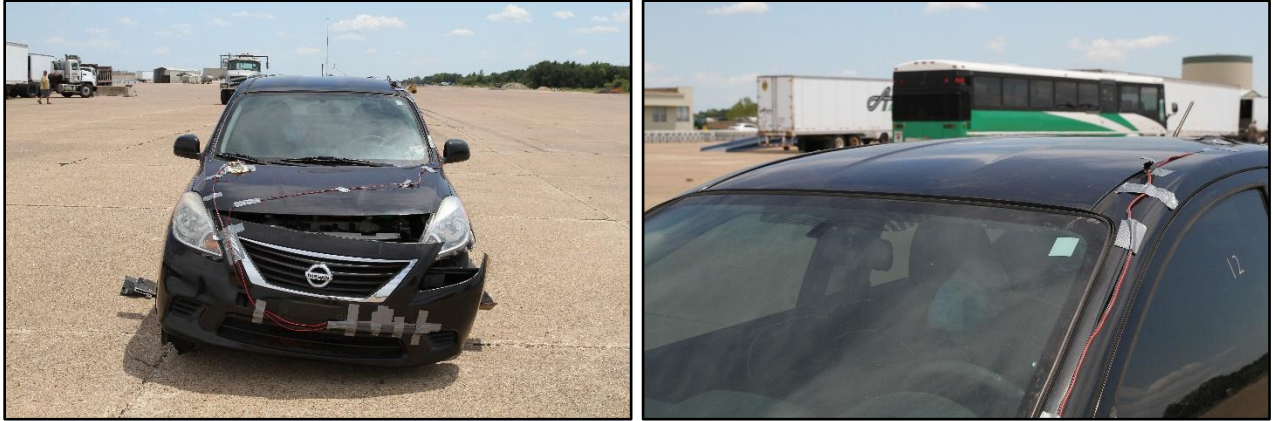
Figure 8.4. Test Vehicle after Test No. 469680-03-1.

Figure 8.4 shows the damage sustained by the vehicle. The front bumper sustained a 4-inch  $\times$  4-inch  $\times$  0.25-inch deformation 13 inches to the left of the centerline of the vehicle. There was also a small deformation in the hood and grill, and the lower radiator support was deflected 2.0 inches toward the rear of the vehicle. A small dent was noted in the oil pan; however, no fuel tank damage was observed. Maximum exterior crush to the vehicle was 0.25 inches in the front plane to the left of the center at bumper height. No occupant compartment deformation was observed. Figure 8.5 shows the interior of the vehicle. Tables F.2 and F.3 in Appendix F.1 provide exterior crush and occupant compartment measurements.

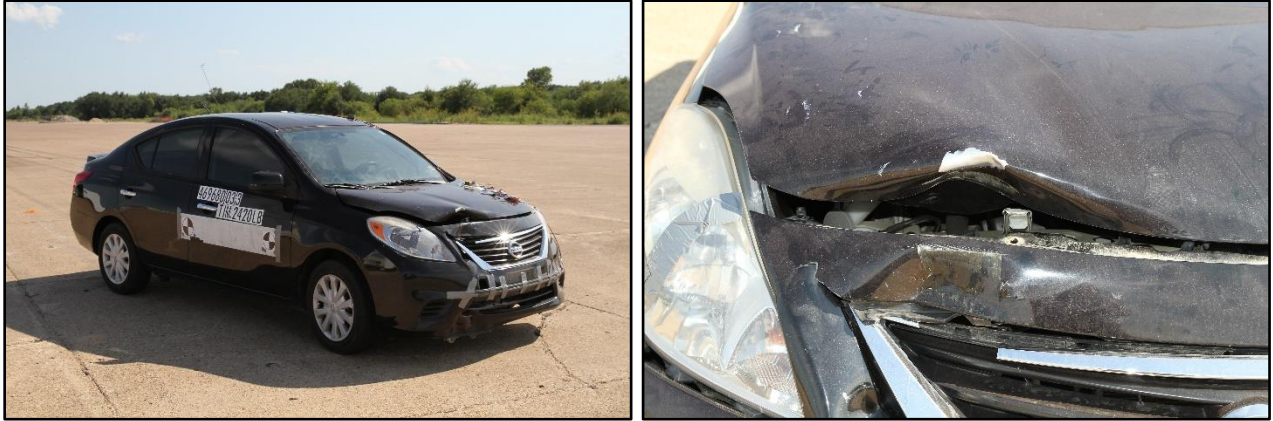
Figure 9.4. Test Vehicle after Test No. 469680-03-3.

Figure 9.4 shows the damage sustained by the vehicle. The front bumper and grill sustained a 24-inch  $\times$  4-inch  $\times$  1.0-inch deformation 13 inches to the right of the centerline of the vehicle. There was also a 4-inch  $\times$  4-inch deformation in the hood, which was also pushed rearward 2.0 inches. The lower radiator support was deformed. A small dent was noted in the oil pan; however, no fuel tank damage was observed. Maximum exterior crush to the vehicle was 1.0 inch in the front plane to the right of the centerline at bumper height. No occupant compartment deformation or intrusion was noted. Figure 9.5 shows the interior of the vehicle. Tables G.2 and G.3 in Appendix G.1 provide exterior crush and occupant compartment measurements.

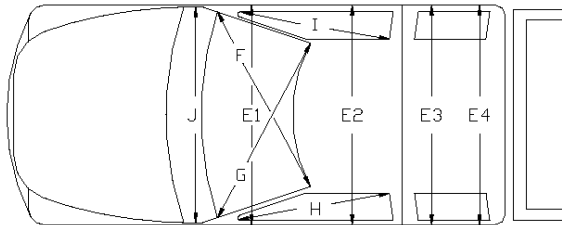
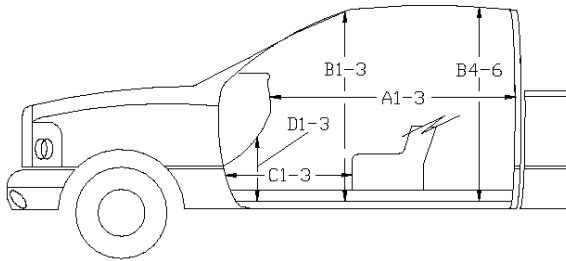
**Table B.4. Occupant Compartment Measurements for Test No. 469680-03-2.**

**Vehicle Roof Penetrated over Driver Seat**

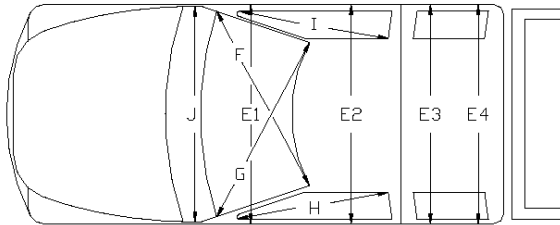
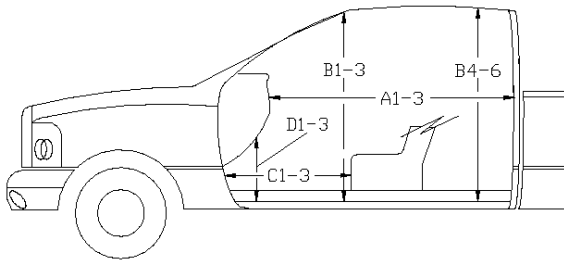
**Table C.4. Occupant Compartment Measurements for Test No. 469680-03-2A.**

**Vehicle Roof Penetrated over Driver Seat**
