MASH TEST 3-11 EVALUATION OF MODIFIED TxDOT ROUND WOOD POST GUARDRAIL SYSTEM

Test Report 0-6968-R4

TEXAS A&M TRANSPORTATION INSTITUTE

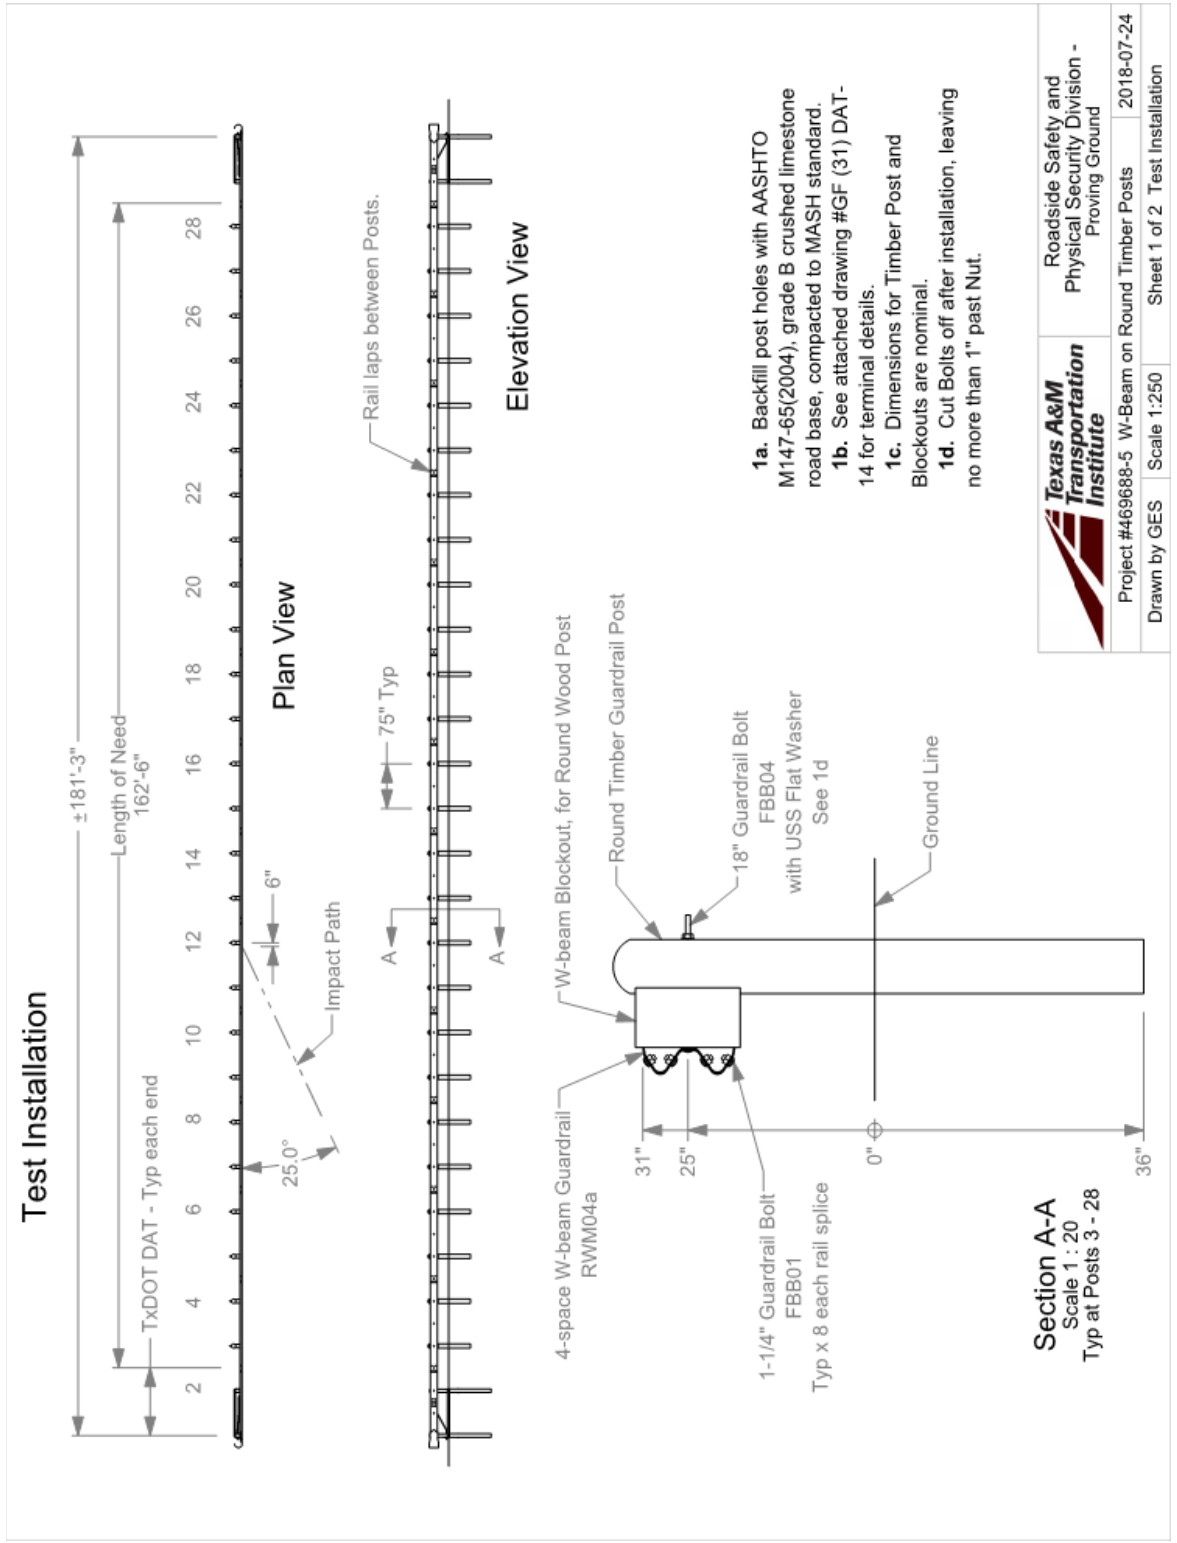
Figure 2.1. Overall Details of the Modified TxDOT Round Wood Post Guardrail System.

Figure 2.1 presents overall details on the round wood post guardrail system, and Figure 2.2 provides photographs of the completed test installation. Appendix A provides further details of the round post guardrail system.

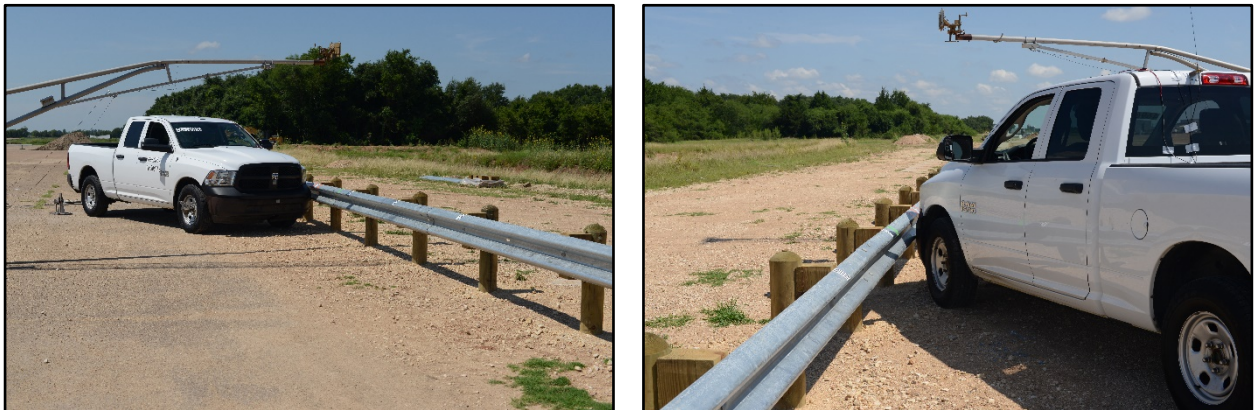
Figure 5.1. Guardrail/Test Vehicle Geometrics for Test No. 469688-5-1.

Figures 5.1 and 5.2 show the 2013 RAM 1500 pickup truck used for the crash test. The vehicle's test inertia and gross static weight was 5018 lb. The height to the lower edge of the vehicle bumper was 11.75 inches, and height to the upper edge of the bumper was 27.0 inches. The height to the vehicle's center of gravity was 29 inches. Table C.1 in Appendix C1 gives additional dimensions and information on the vehicle. The vehicle was directed into the installation using a cable reverse tow and guidance system, and was released to be freewheeling and unrestrained just prior to impact.
